NHL Steam Schooner Wapama
Condition Survey and Preservation Recommendations

Phase 1A Final Report

WAPAMA CONDITION SURVEY

D&P Report No. 2526-001
October 7, 2005

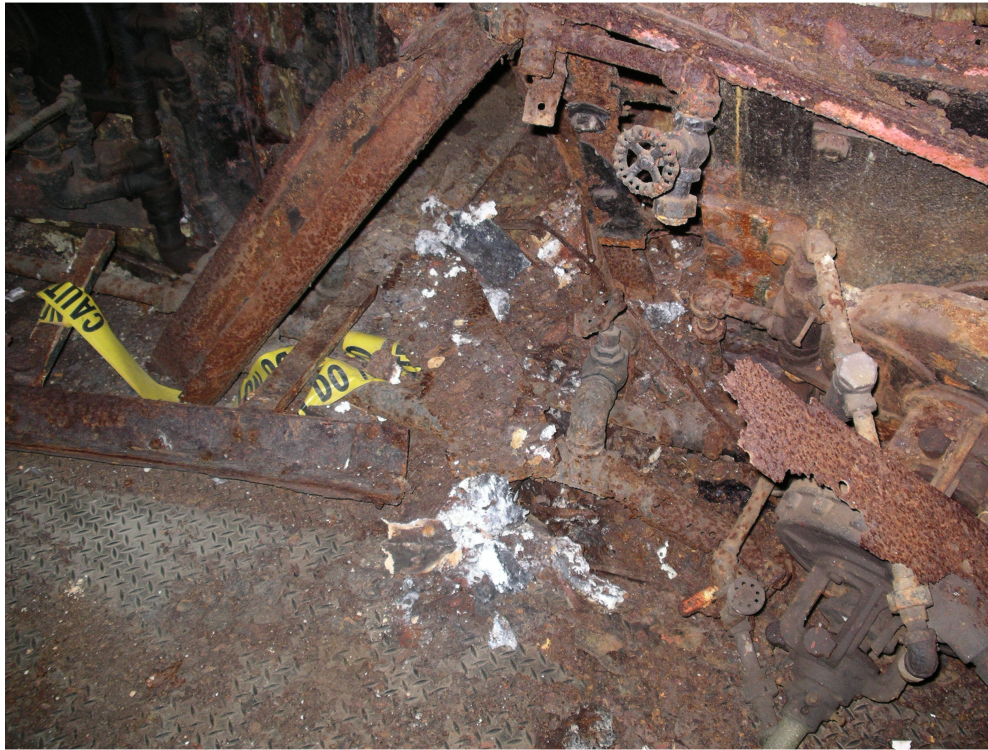
MATERIAL: BOILER INSULATION DEBRIS, STBD FIRE BOX AT DECK
CONTAMINANT: ASBESTOS

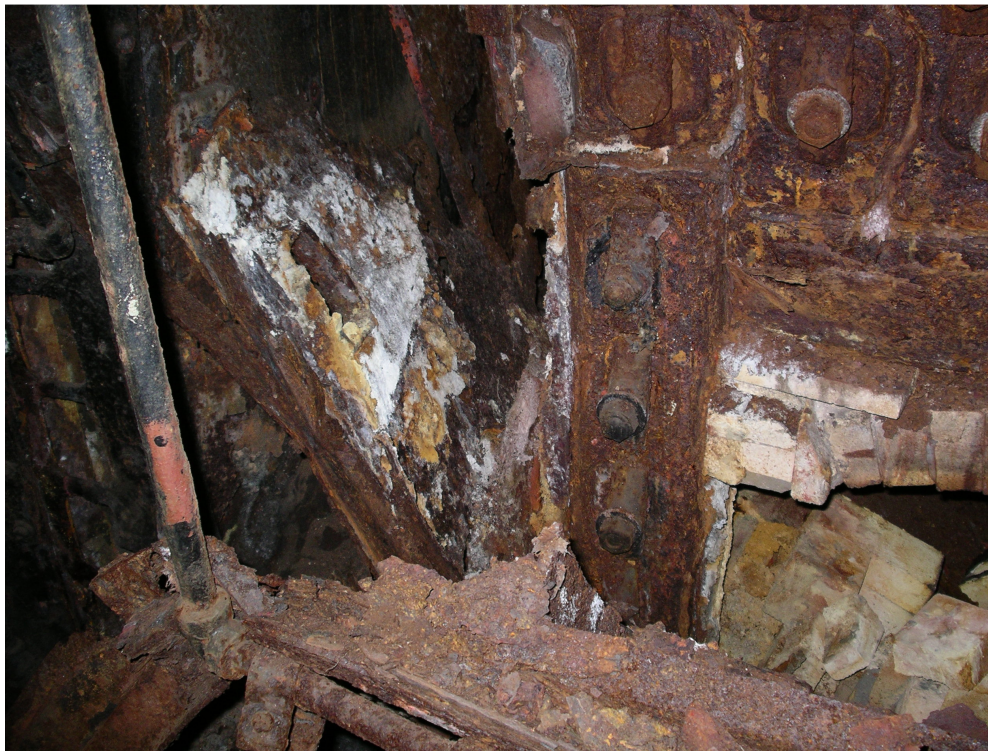
MATERIAL: BOILER INSULATION, STBD FIRE BOX AT BOILER
CONTAMINANT: ASBESTOS
