Theodore Roosevelt Home

Pre-Design Report

PMIS No. SAHI-077375

FEBRUARY 2009

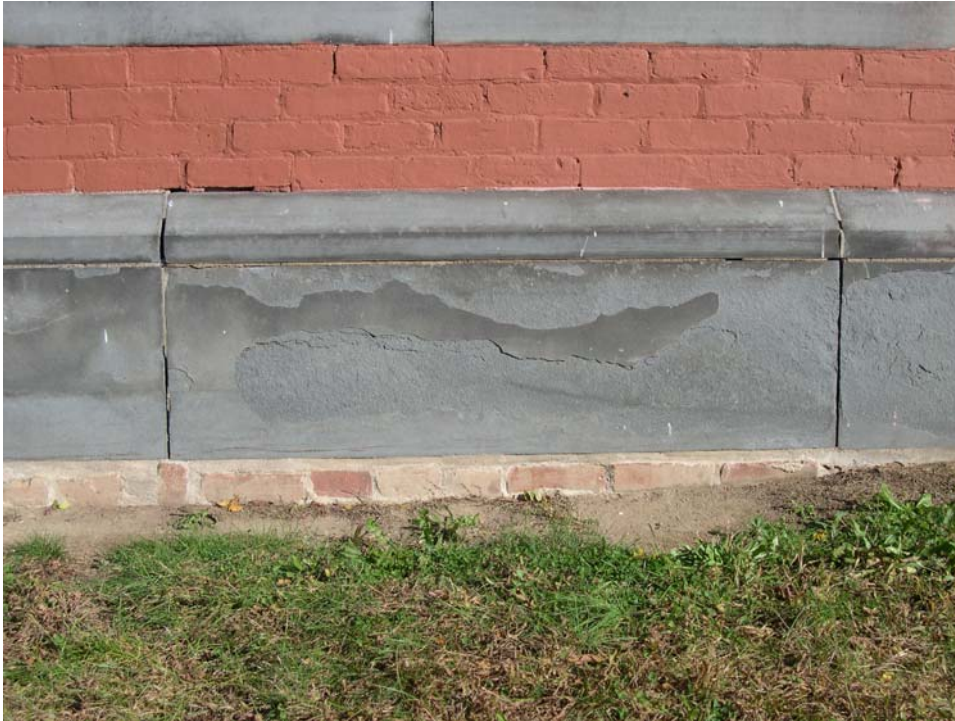
Exterior 5. Spalling bluestone water table and open mortar joints at the northwest corner of the 1905 north wing addition (JGWA 2008)

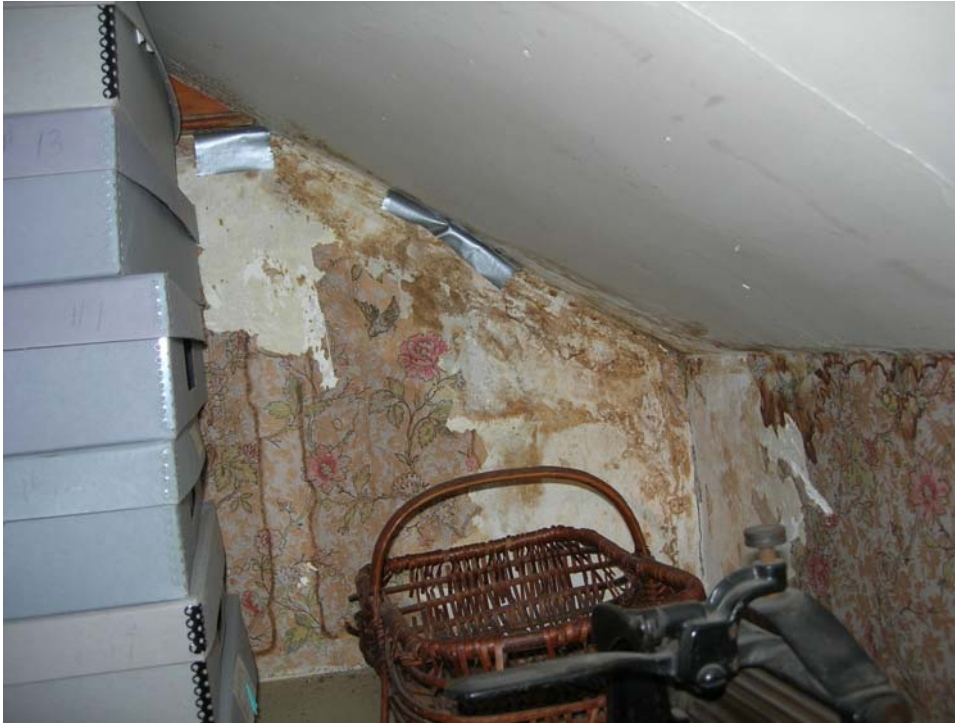
Plaster deterioration is visible throughout the house where water infiltration has occurred, and in areas around several chimneys and fireplaces. Following exterior restoration to eliminate water infiltration, interior painted and wallpapered plaster surfaces should be carefully repaired. Staff bathrooms located in the basement are in fair to poor condition, and require fixture replacement and the upgrade of existing finishes. The original passive ventilation system that utilized the central hall and attic spaces was extensively remodeled during the 1950s. This system should be restored to its original configuration, along with the restoration of historic finishes in five rooms on the third floor.

Interior 4. Room 213, “Alice’s Bedroom Closet”, exhibits extensive water damage and plaster deterioration along the northeast exterior wall (JGWA 2008)

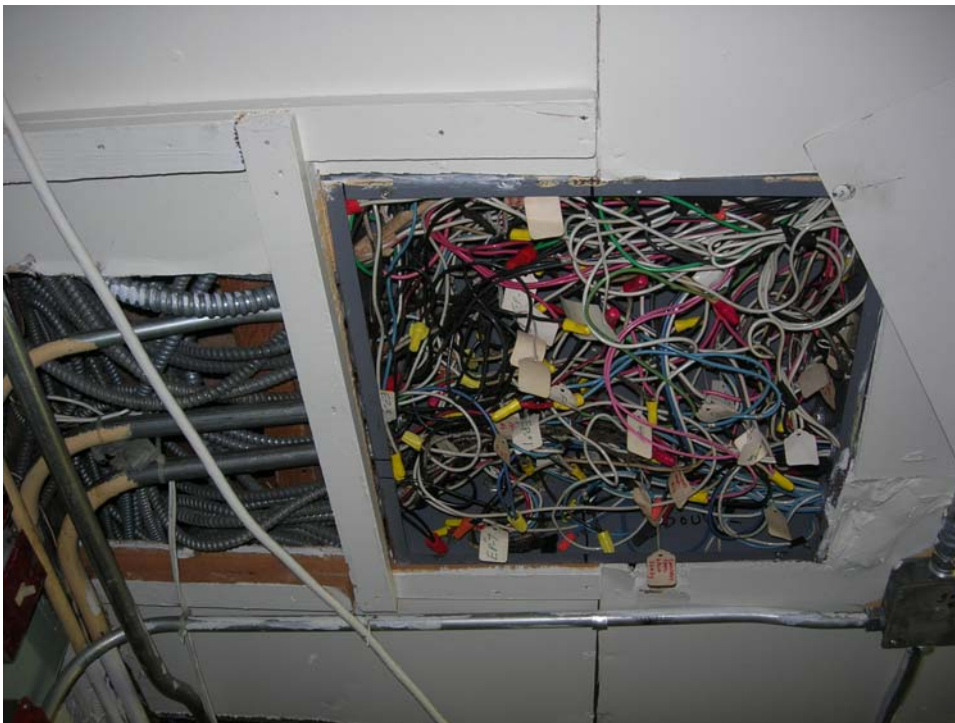
The electrical distribution within the building is in fair condition. The original 1905 electrical wiring system installed during construction of the north wing may still remain, and the 1918 electrical wiring throughout the remainder of the house is partially extant but may be de-energized. Several upgrade campaigns, most significantly in the 1950 and again in the 1980s, have modified the original distribution network.

Interior 5. Room 007, electrical splice box at ceiling (JGWA 2008)

New electrical distribution throughout the house is needed to provide adequate service for maintenance activities, as well as improved lighting within the interiors for egress and exhibits. Interior lighting upgrades will likely include both historic reproduction fixtures and modern exhibit lighting that utilized LED (light-emitting diode) technology. LED fixtures do not emit light in the ultraviolet range of the spectrum; they produce less heat; and they are energy efficient. Lighting control options will be studied to augment interpretive techniques and experiences.

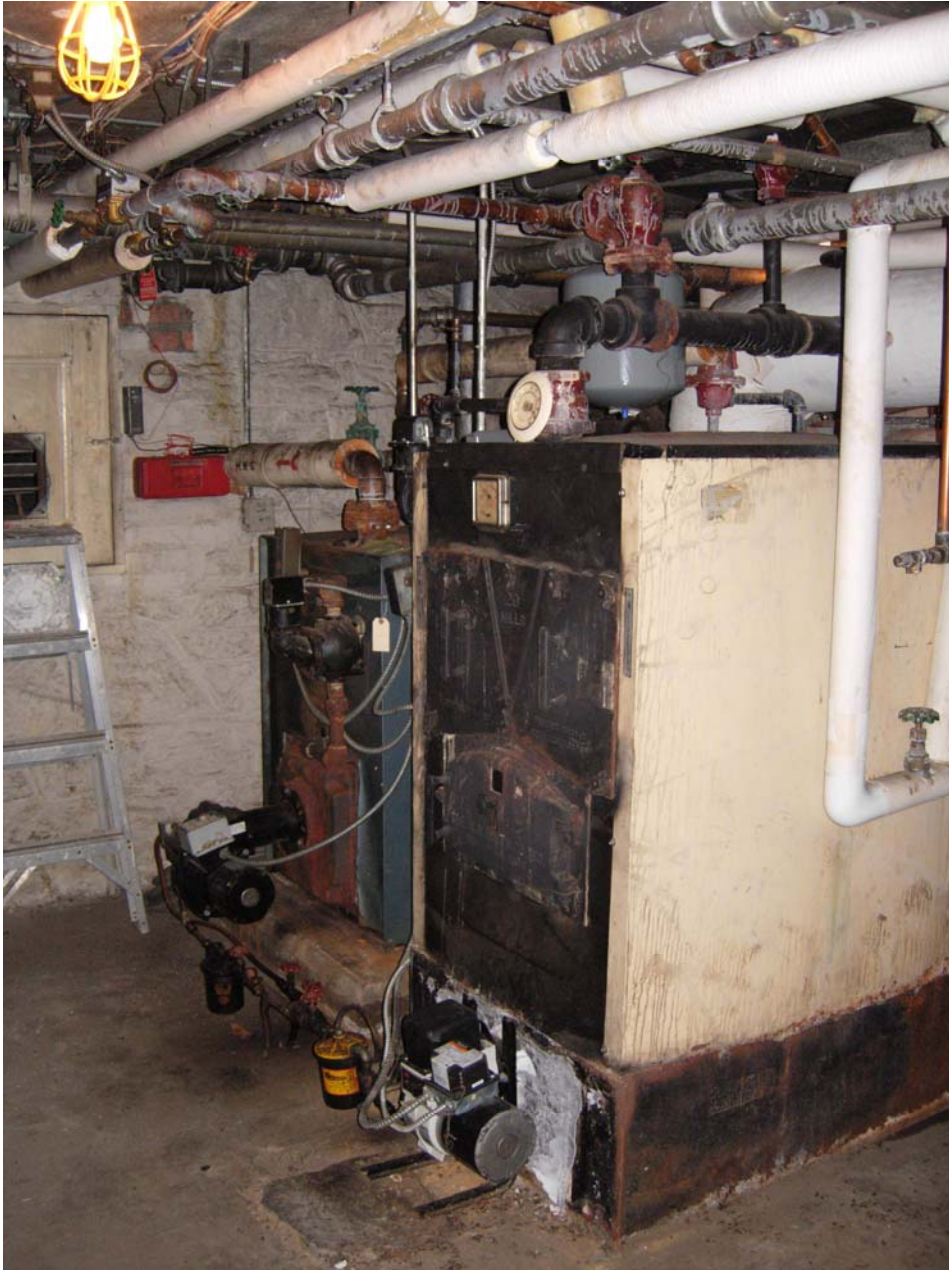
The existing mechanical systems, including two air handlers, two oil-fired boilers, and a series of non-original hot water radiators that are located in the east wing of the house, have exceeded their useful lifespan and are in poor condition. In particular the air handlers, which were installed in the late 1970s and provide heating, ventilation, and some humidification for the house, require replacement. The existing 4,000 gallon double-walled underground fuel oil tank is relatively new, is in very good condition, and has a leak detection alarm.

Interior 6. Room 008, existing oil-fired boilers (JGWA 2008)

The design of a new mechanical system should respect the existing configuration of the building envelope fabric, which likely has a high level of infiltration. Particulate filtration, acoustics, vibration isolation, and thermostatic control will be important considerations for the new system design, which should seek to reclaim aspects of the building's original active and passive heating and cooling strategies wherever possible. Additional research about the original heating and ventilation system should be undertaken to inform this effort. Effective climate control within the house will mitigate seasonal temperature and humidity fluctuations that currently contribute to the deterioration of the historic building fabric and the collections throughout the house. The need to provide air-conditioning for the house will be evaluated, and sustainable solutions for new systems and equipment that can also reduce operational costs will be explored throughout the design process.
