BENITO JUAREZ MONUMENT Sieve Analysis

Washington, D.C.

Final Report March 1, 2010 WJE No. 2009.5347

Benito Pablo Jaurez Monument & Plaza Investigative Condition Assessment and Report

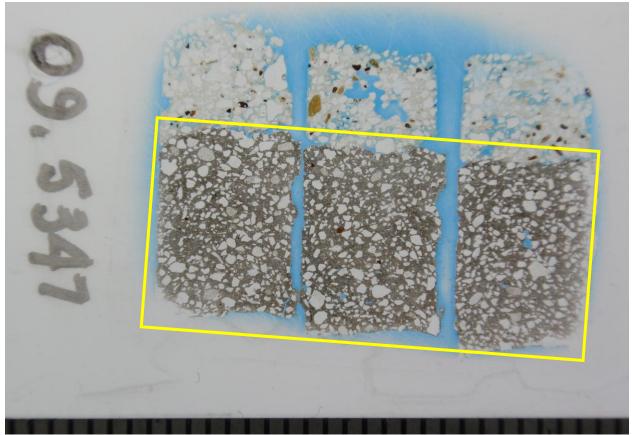
Figure 1 shows the distribution of sand particles in the thin section that was used for the petrographic studies. The angular nature of the sand particles and the uniform distribution throughout the mortar is apparent.

Figure 1. A close-up of the thin section used for the petrographic studies is pictured. The distribution of the sand in the gray mortar is shown in the area outlined by the box. The width of the field of view is 1.26 inch (32 mm).

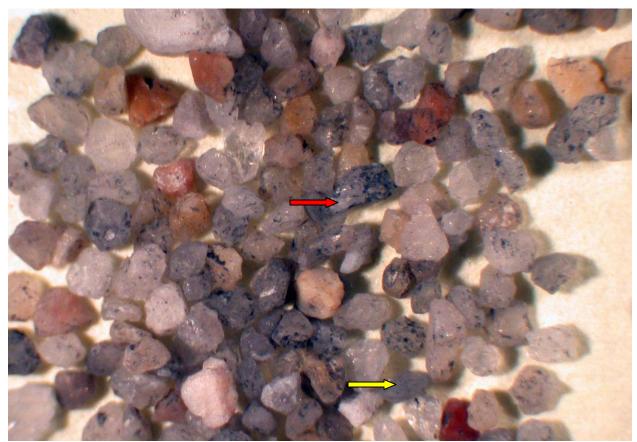
Soft gray particles were occasionally detected in the various sand fractions (Figures 2 through 5). Closer inspection of these particles contained in each of the sieve fractions revealed that they were composed primarily of remnants of the cementitious matrix that had not dissolved during the acid-dissolution procedure. Occasionally, these soft particles were seen to contain smaller siliceous sand particles surrounded by the soft gray material (Figure 3).

Figure 2. A close-up of the +30 mesh fraction is pictured. The yellow arrow marks one of the many soft gray particles contained in this fraction. The red arrow marks a siliceous sand particle that is still partially coated with mortar matrix. The width of the field of view is 0.5 inch (12.7mm).

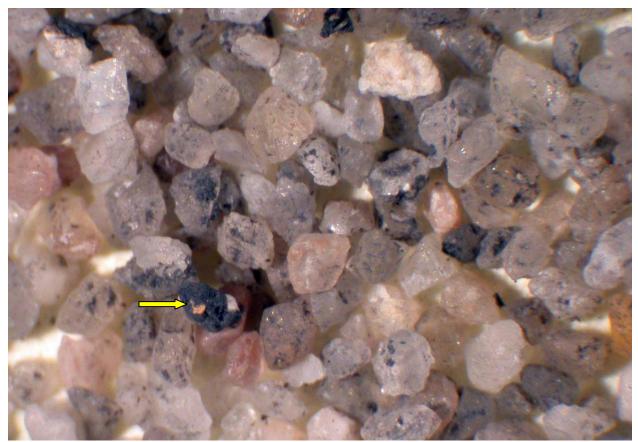
Figure 3. A close-up of the +50 mesh fraction is pictured. The yellow arrow marks one of the many soft gray particles contained in this fraction. This particle when touched with a needle probe was easily broken and found to contain smaller sand particles that would have passed the 50 mesh screen. The width of the field of view is 0.25 inch.

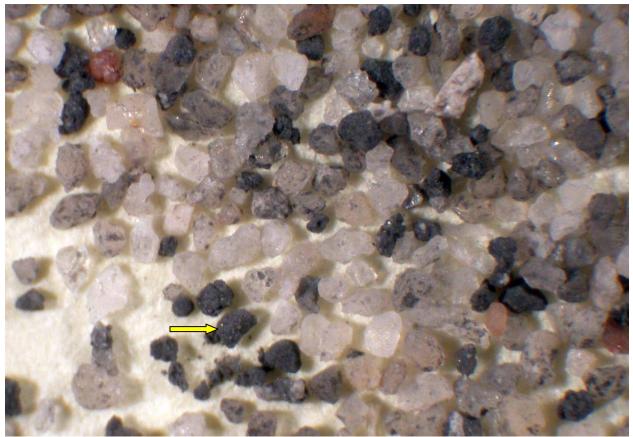
Figure 4. A close-up of the +100 mesh fraction is pictured. The yellow arrow marks one of the many soft gray particles contained in this fraction. Some of these gray particles, when touched with a needle probe, were easily broken and found to contain smaller sand particles that might have passed the 100 mesh screen. The width of the field of view is 0.25 inch.

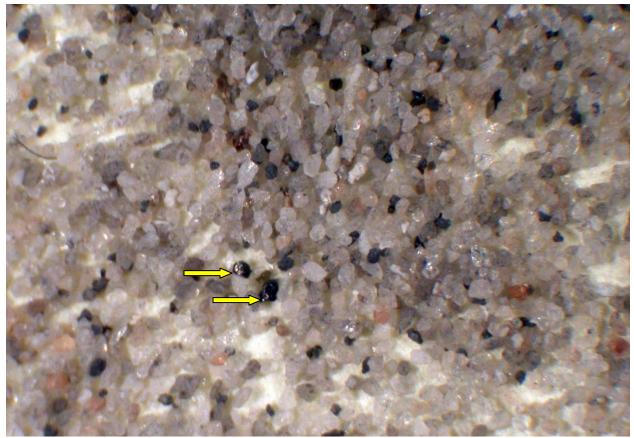
Figure 5. A close-up of the +200 mesh fraction is pictured. The photo was taken using reflected light. Most of the particles are composed of clean angular siliceous sand fragments and are generally free of coatings. However, a few medium gray soft particles are present too. Two particles tentatively identified as graphite are marked with arrows. Graphite could have been introduced with the pigment used in the mortar. The width of the field of view is 0.25 inch.

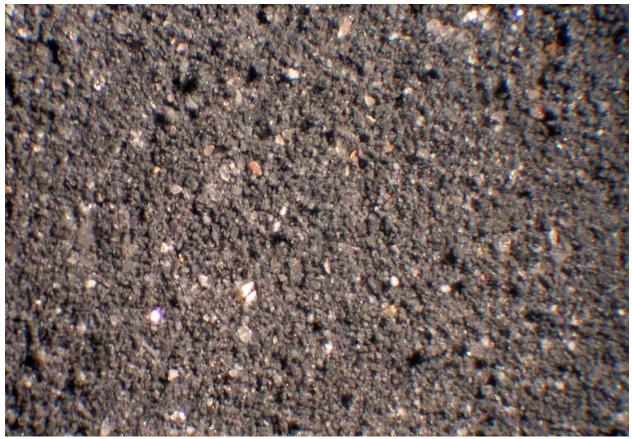
The pan fraction of the sample was composed of a combination of small angular siliceous particles and even finer sized black opaque material that represents the mortar pigment (Figure 6).

Although a small amount of angular siliceous particles was detected in the pan fraction of the sand, the bulk of material retained on this screen is likely composed of the insoluble remnants of pigment contained in the mortar.

Figure 6. A close-up of the pan fraction is pictured. The photo was taken using reflected light. An estimated 80% of the particles are composed of friable soft remnants of matrix or pigment. These matrix particles generally did not contain smaller sand particles. Angular white quartz and feldspar fragments are also visible. The width of the field of view is 0.156 inch.

If the pan fraction of the sand is eliminated from the calculations and the results for the remaining fractions are normalized, the resulting "calculated" sieve analysis may more nearly represent the original gradation of the sand.
