ASSESSMENT ANALYSIS

LOCATION: **WILSONIA**

BUILDING: **83377 Cedar Lane - empty**

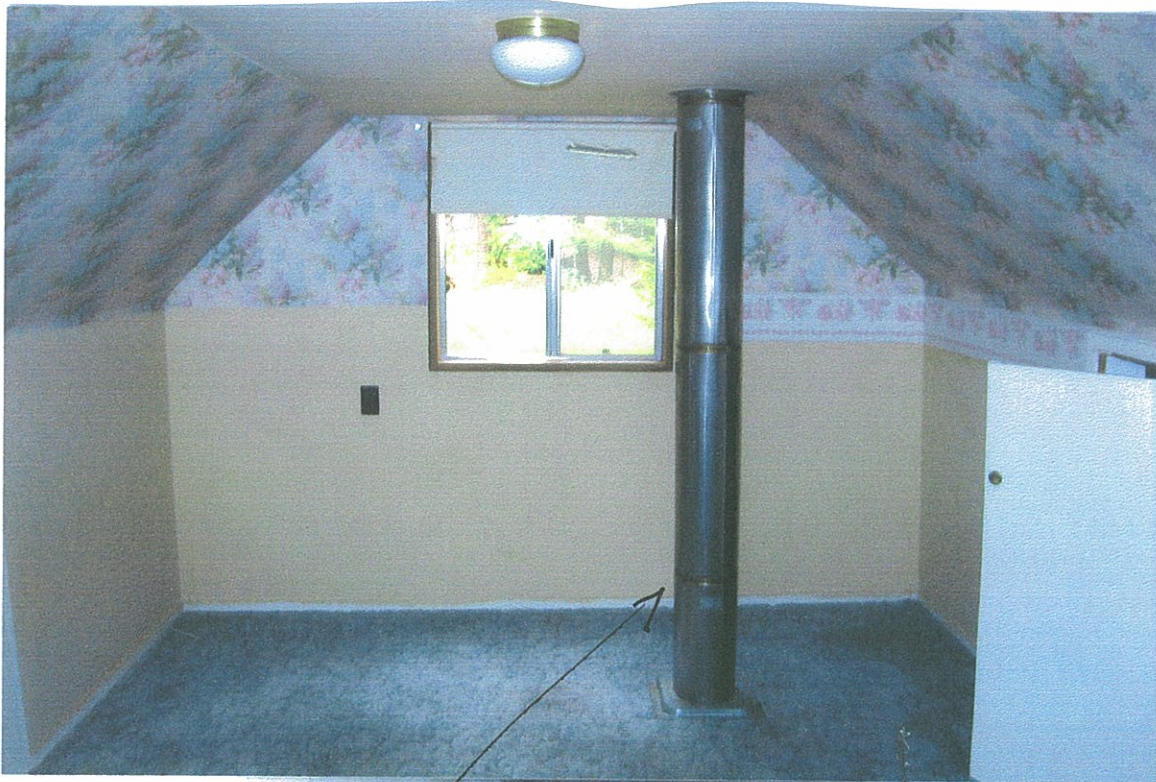
flue not
to code in
sleeping room
or near
combustibles

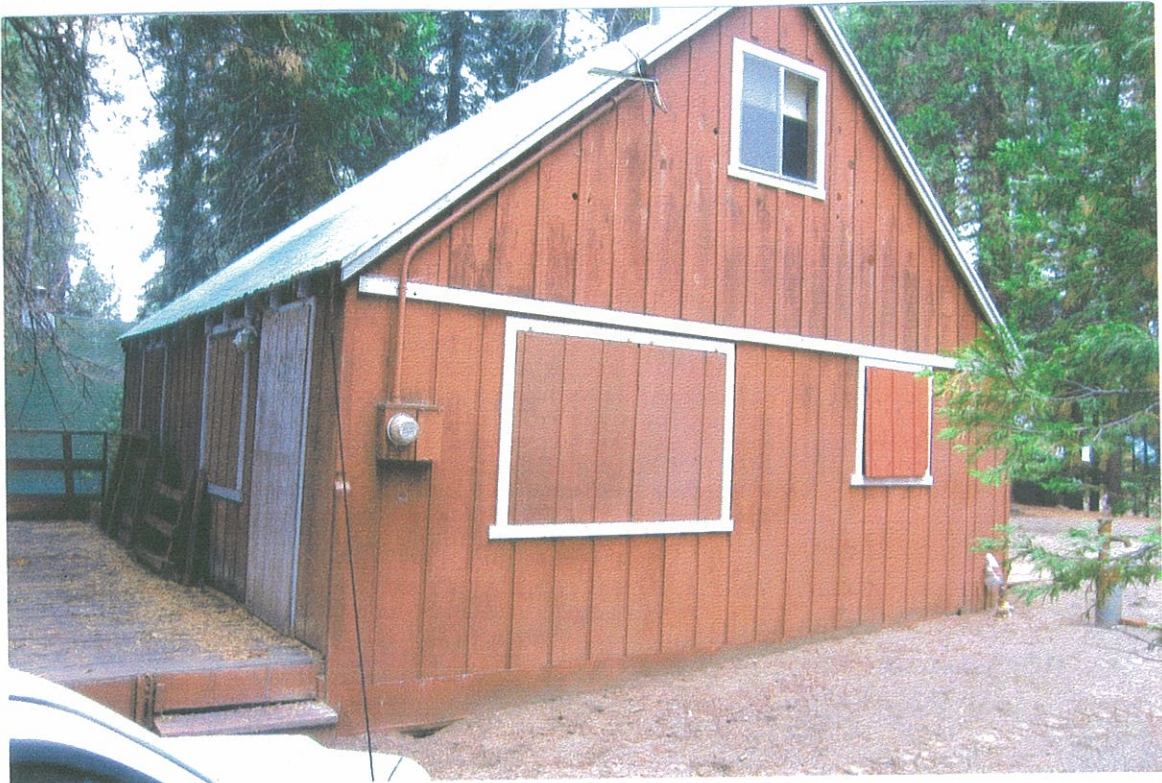
PAGE 116 item 2), 3)

Structure: This house has a deck on the rear (left side at street front). The deck on the rear is 2'-5" off on one end and the other end is 1'-9" off the ground with guardrails not up in their post slots in the deck. There is a tree in the middle of the deck with a hole that may be a human impact hazard. The deck is sloped towards the house when it should be sloped to the opposite edge (2% slope minimum) and the deck has dry rot. This house has a loft in the attic.

- 2) **LS – Replace and repair the decks and guardrails (per Code)**
- 3) **LS – Needs a new deck sloping away from house**

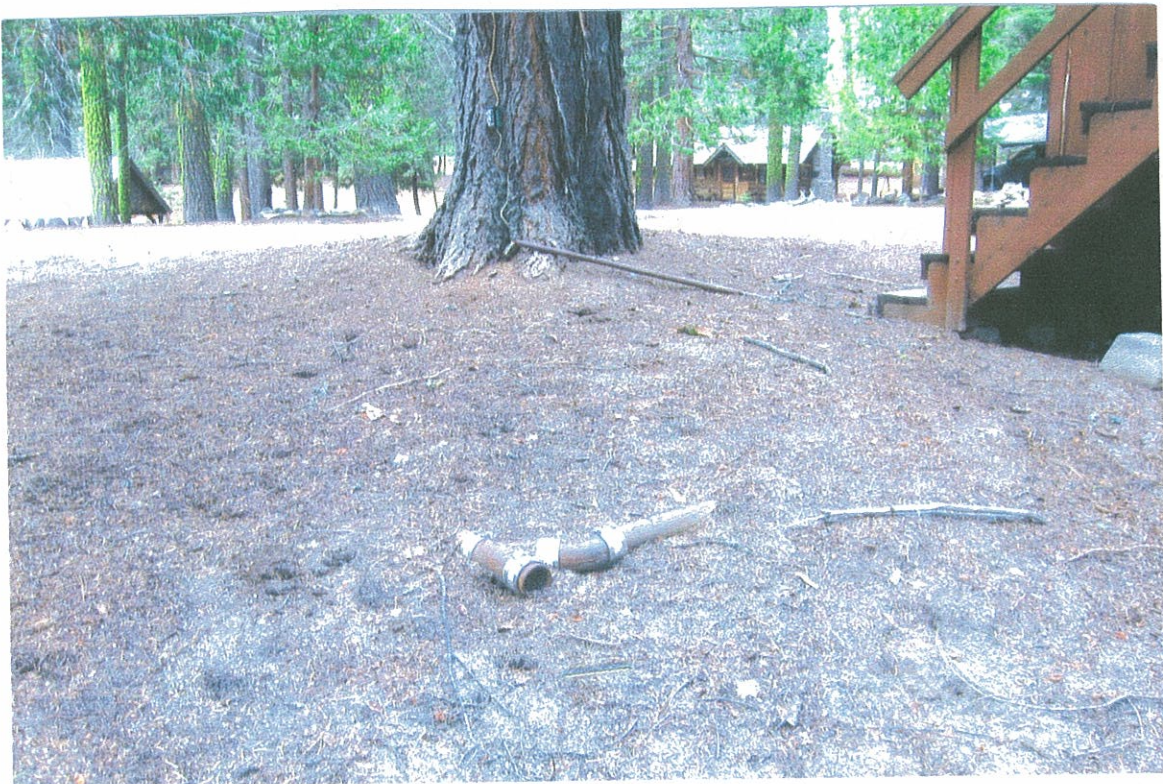
PAGE 116 item piping and
conduit
exposed - need
repair

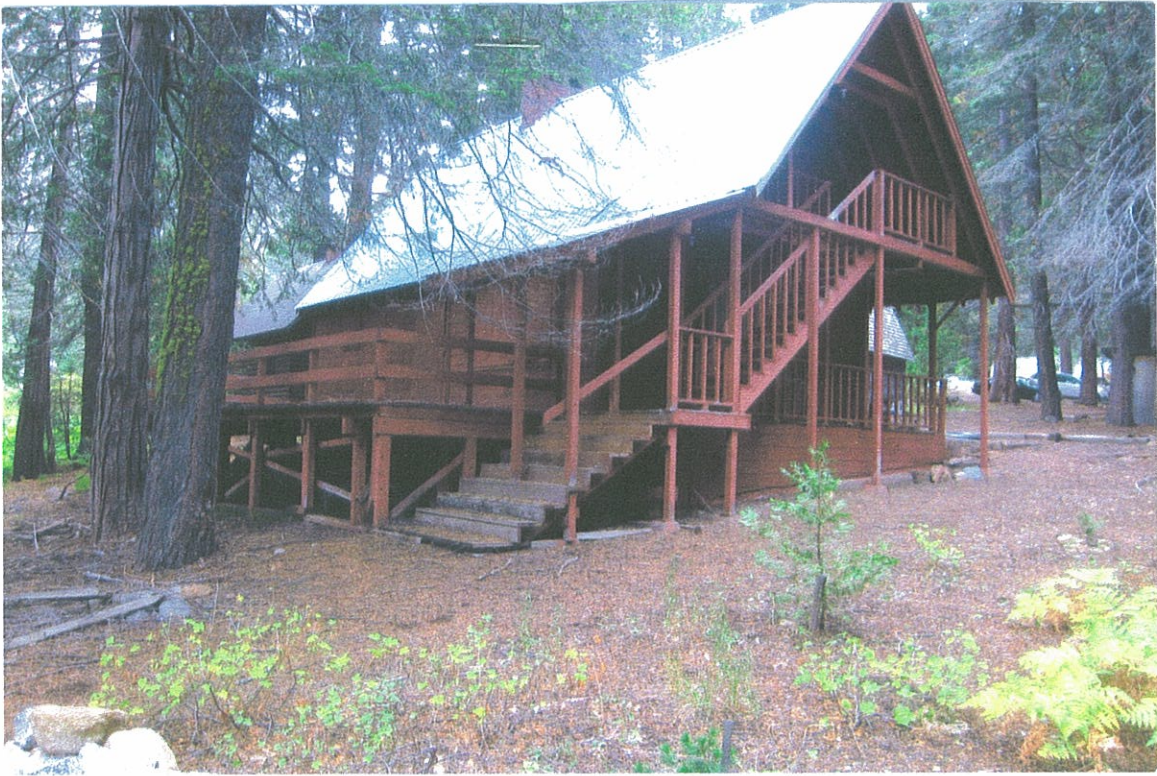
PAGE 119 item 2)

Structure: This house has a deck all around it and a second floor deck and exit on the right side. The deck on the rear is a ground deck (actually on the ground) and all wood members are rotten. The front guardrails are 32" high and have 2 boards and not appropriate picket spacing (per Code) for safety. There are no handrails on the exterior stairs. The roof area at the entry to the deck to get to the front door is redone and is slope and not the a-frame it was below. Throughout the house the ceiling joists are 2x12 at 24"o.c. There is no fire protection under the stair in the kitchen.

- 2) **LS** – Replace and repair the decks and guardrails (per Code)
- 3) **LS** – Need to fire protect the underside of the stairs with 5/8" sheet rock, Type X and fire block.

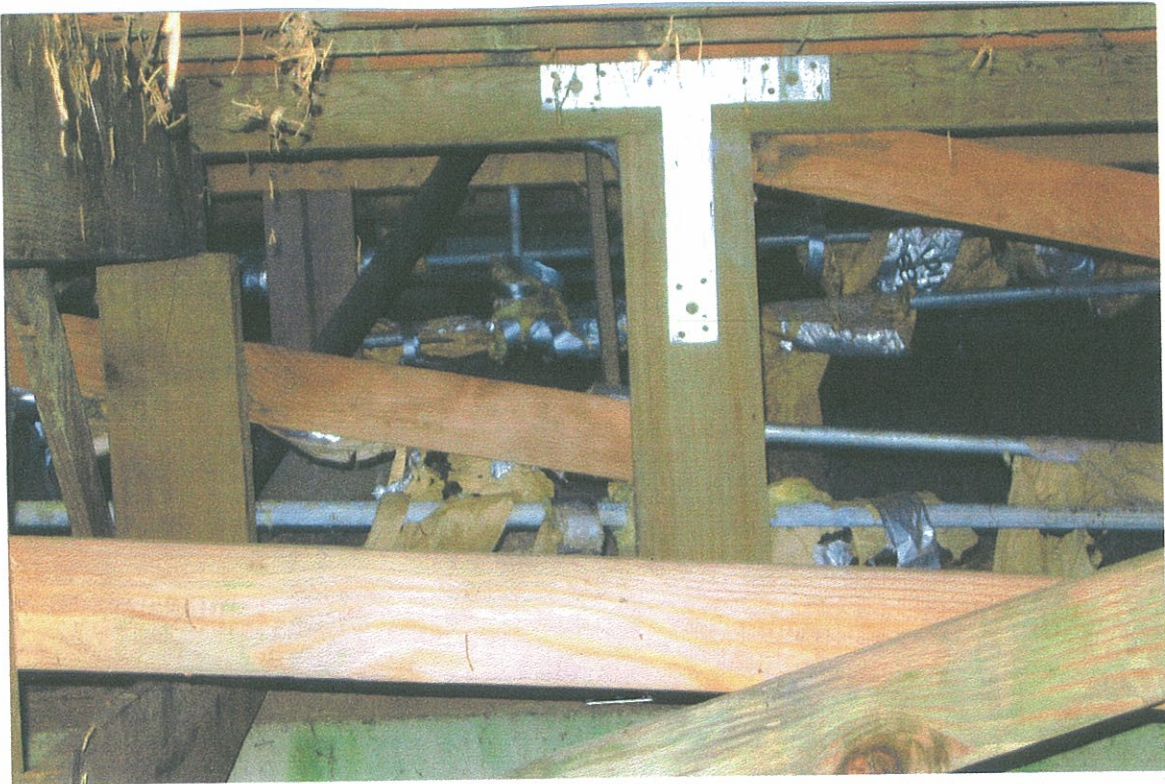
PAGE 119 item insulation on piping needs replacing

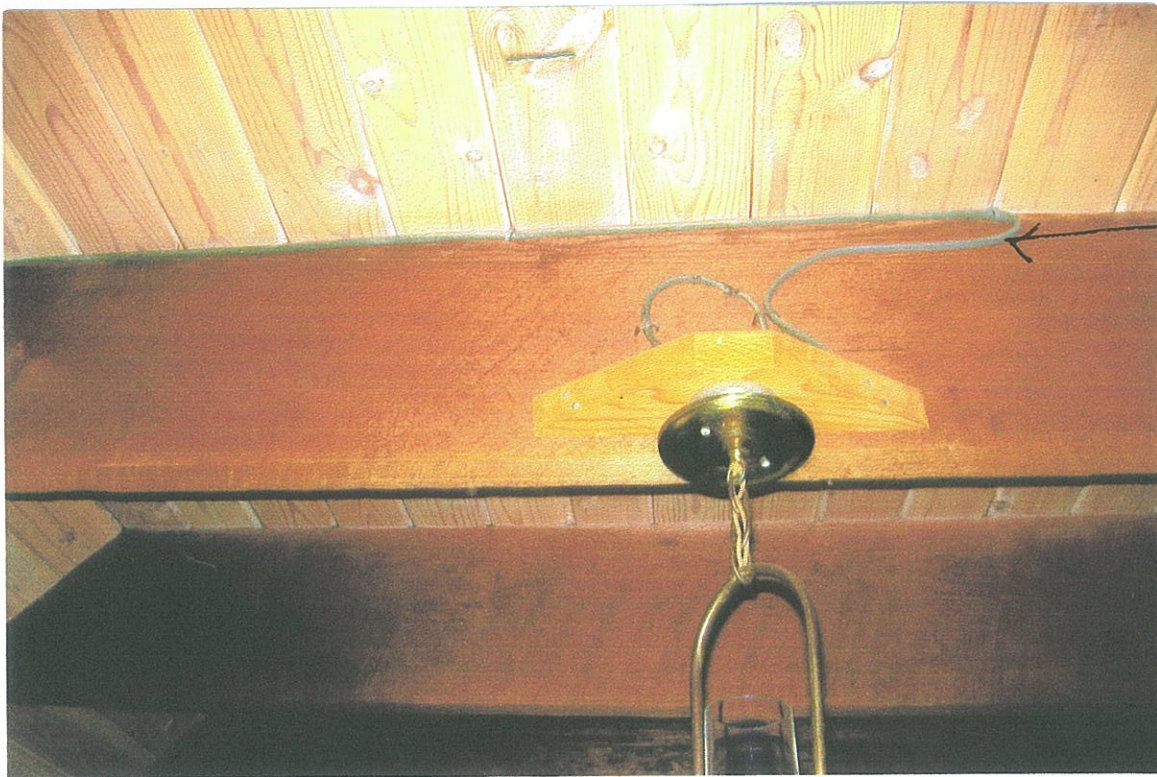
PAGE 119 ITEM 5)

Electrical: All the Romex wiring is unprotected (not in wall or conduit). The subpanel is in the bathroom over the lavatory. The main electric panel and meter are in the rear on the exterior of a shed with a ground rod/brass clip; 30Amp main switch and 60Amps main switch with meter. The conduit is interior-grade used on the exterior of this house for the lights. The insulator fixture with incandescent bulb, bulb is not protected and the GFCI? exterior outlet(s) are not WP (waterproof). The electricity was not working.

telephone
line
used for
wiring
light -
not to
code.

- 4) **LS** – Exterior outlet needs to be GFCI [as well as WP (waterproof)] (today's Code)
- 5) **LS** – All Romex needs to be in the walls or conduit protected.
- 6) **LS** – Appears no GFCI outlets in the bathroom or at the kitchen counters (today's Code)
- 7) **LS** – This house (today) needs minimum 100Amp main electric service
- 8) **LHS** – The subpanel in the bathroom needs to be relocated OUT of bathroom (maybe reverse the direction to hall/stairway)

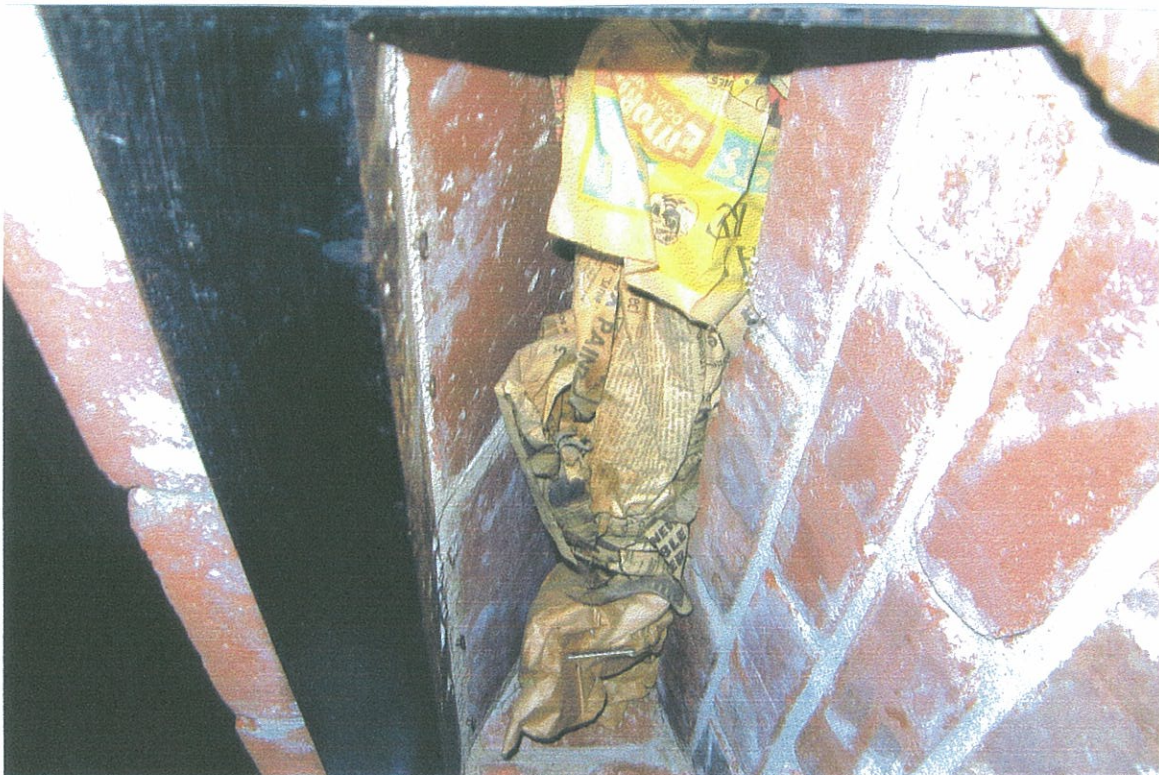
PAGE 120 item fireplace has no
damper - stuffed
with paper

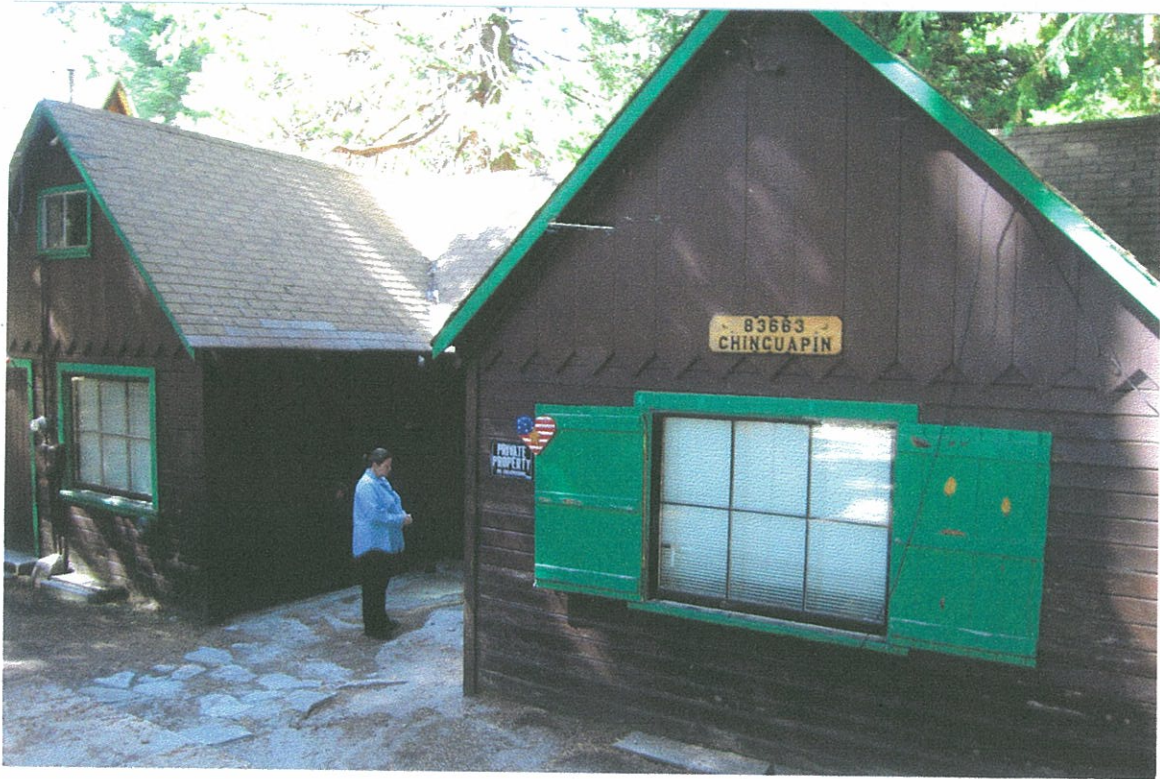
PAGE 124 Item 4), 8),

Electrical: This house has a pull-out main electrical switch with 2-50Amps and 2-30Amp circuits. There is no grounding at the panel and it is stranded aluminum with an exposed neutral. Outside fixtures are exposed incandescent/fluorescent bulb with porcelain insulator bases just under the eaves. Bedroom #1 has no grounded outlets. Bedroom #2 has an outlet without a cover with a yellow extension cord to a fan. This bedroom has 2 incandescent light 2" from the ceiling and the ceiling is blistered.

- 4) LS – Exterior outlet needs to be GFCI [as well as WP (waterproof)] (today's Code)
- 5) LS – Bedroom #2 ceiling lights need to be fixed that they do Not blister the ceiling
- 6) LS – Appears no GFCI outlets in the bathroom or at the kitchen counters (today's Code) and not 'grounded' properly at panel as per CODE
- 7) LS – This house (today) needs minimum 100Amp main electric service and including sub-panels, all circuits to be labeled
- 8) LS – There are 2 Romex wires at the front patio that need to be fixed (coming out of a sheet metal blue pipe/ducting)
- 9) LS – The exposed outlet on exterior of house below the kitchen window needs to be repaired
- 10) LS – The pump housing has unprotected Romex, needs to be repaired

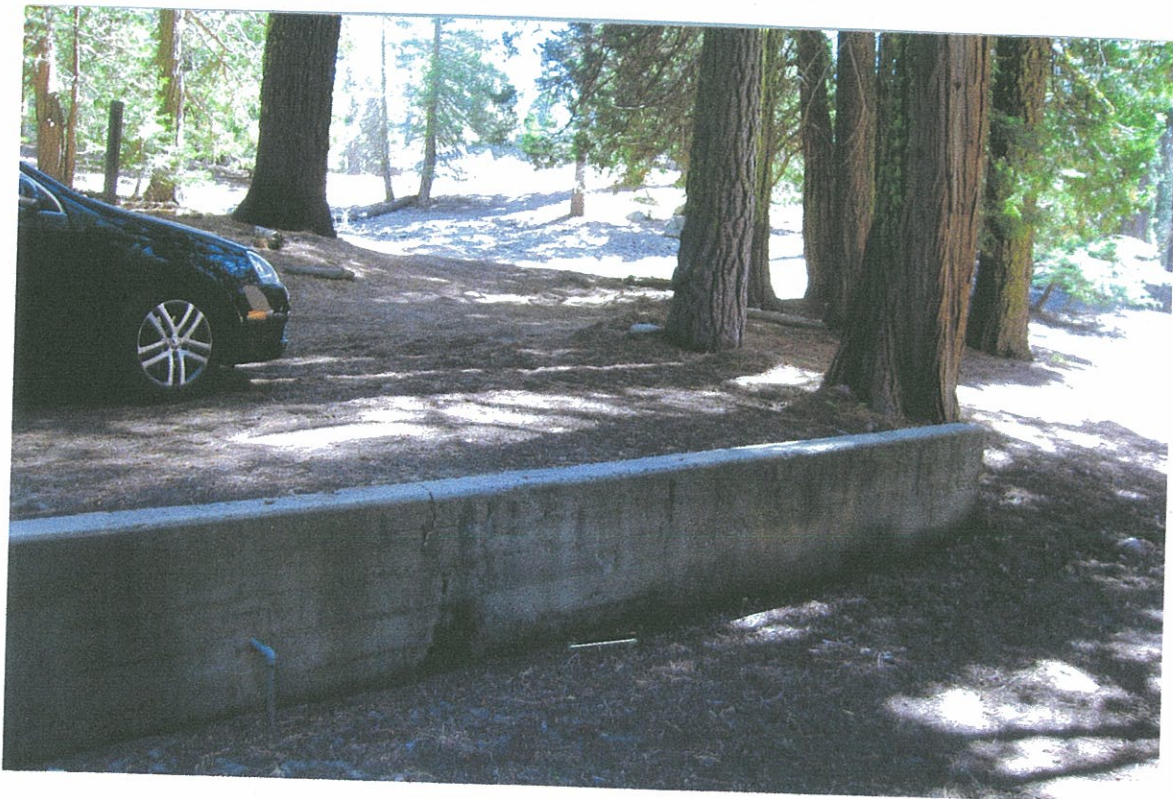
PAGE 124 item 2), 3)

The right rear deck is about 15'x15' and about 44" off the ground at the rear. The steps and other framing members off the right side of the deck are wood and are dry rotted. The rear steps off this deck are concrete, very irregular is in the 'rise' of the step itself which is a hazard. There is a guardrail at the rear steps at 34" high with pickets 7-1/2" – 2x4 spaced toe nailed with a 2x6 cap and a 2x6 base board. There is no handrail on this deck.

The front entry area is a concrete patio area has a retaining wall from the driveway/parking area that is over 48" high with no guardrails or handrails at the concrete steps coming down to the house. Steps actually into the house at the front door are 1/2" plywood and rotten.

- 2) **LS – Replace and repair the decks with guardrails/handrails (per Code)**
- 3) **LS – The front retaining wall must have guardrails at the top of the wall and a handrail down the steps to the front patio (to the front door)**

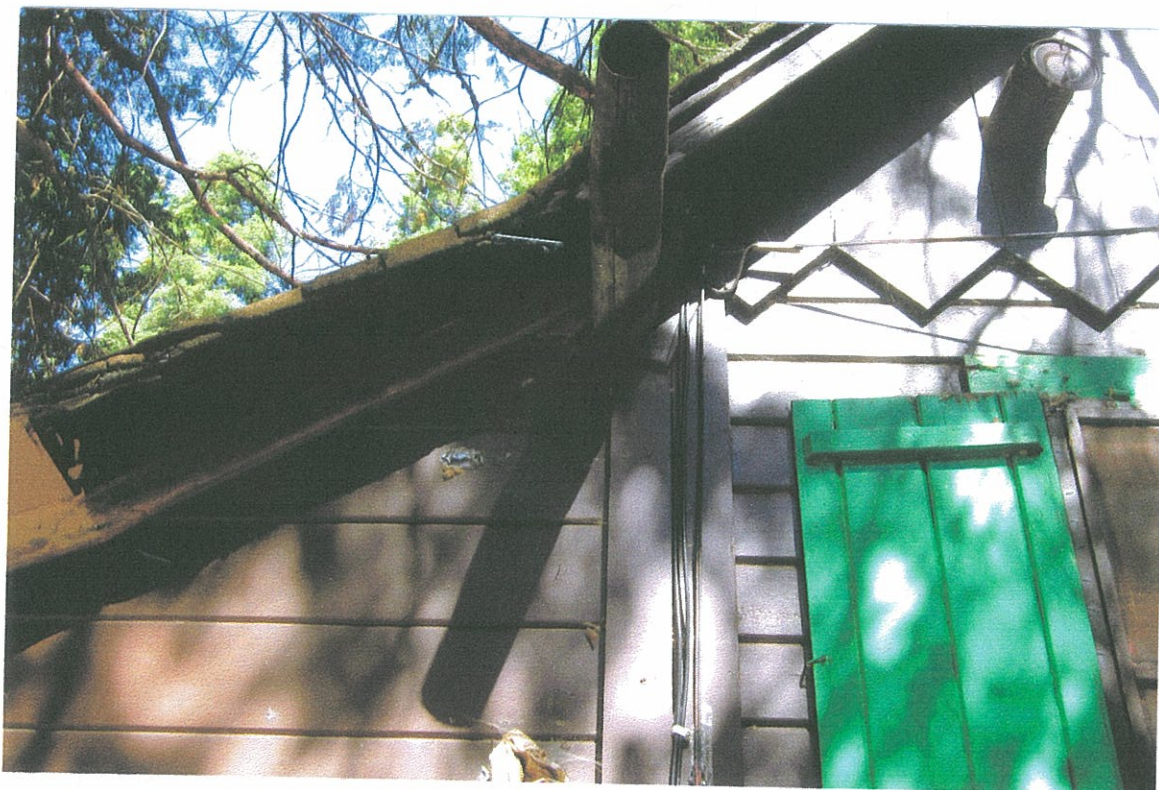
PAGE 125 item 11)

Plumbing: There is one bathroom and electric water heater. Appears that a vent pipe is within 24" of a kitchen window on the rear. Code is minimum 36".

- 11) H – The vent pipe needs to be fixed to be 36" away from an opening
- 12) LHS - The septic tank should not be under the house, check with local County Health Department for their regulations for location of septic

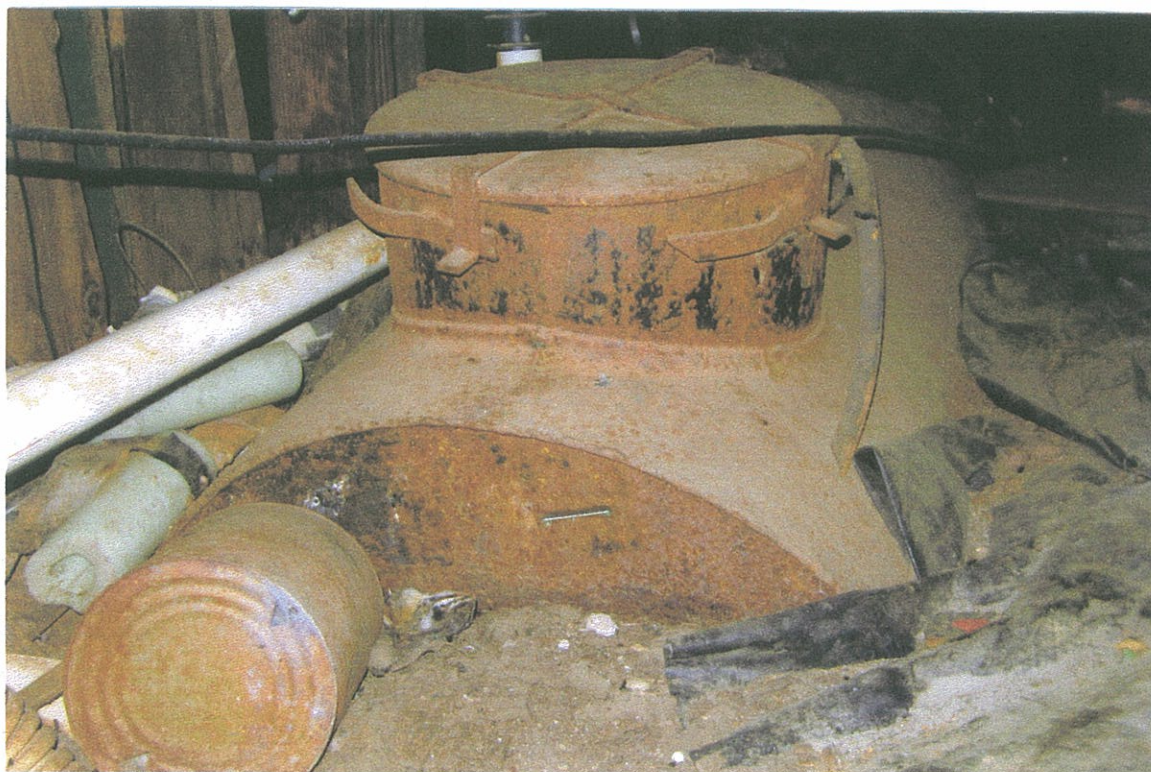
PAGE 125 item 12)

Foundation: Appears to be a pier and grade beam foundation. At the left side of this house is the foundation underfloor access about 4'x3' opening with doors hanging lopsided on the hinges. Just inside the access is the septic tank (under the living space) with a 6" rusty metal cleanout. Also, at the access opening is a 4" ABS (plastic, black pipe) for the front patio drainage with no screen on the end of the pipe.

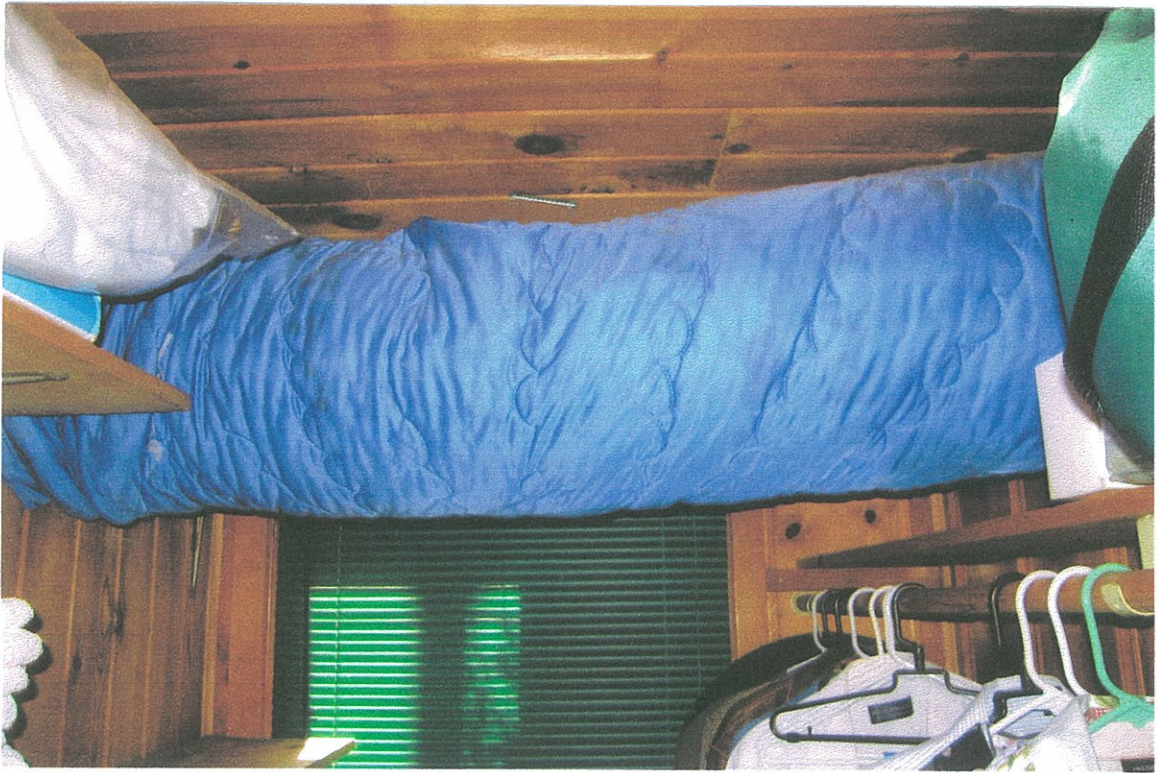
PAGE 125 item 13)

Mechanical: The heat source in this house appears to be double vented electric wall heater. No fan in the bathroom. This is where is 10" duct ends at in the bathroom from bedroom #2 (to heat up the bathroom, apparently).

- 13) LH – This 10" duct must be removed from the bedroom, closet, and bathroom (and install electric heater for some type of heating for the bathroom)

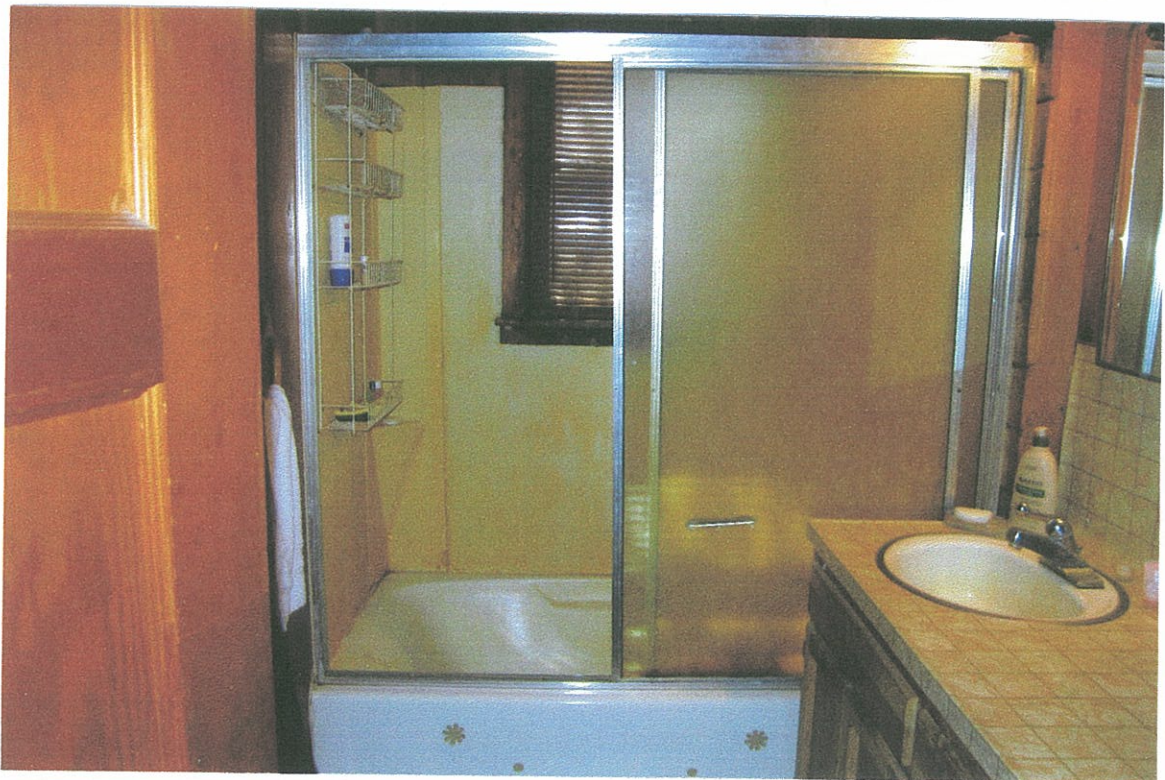
The bathroom has a water closet, lavatory vanity with mold and mildew, and a tub-shower combination (fiberglass surround) with sliding doors (tempered?) with mold/mildew, soap scum, and rust. The bathroom out is not GFCI but has an electric hair dryer with a 'grounding' prong cut off into this outlet at the medicine cabinet over the lavatory. There is a window over the tub-shower combination that is not 'tempered' as per CODE. The lighting in the bathroom is incandescent.

PAGE 125 item 16) need tempered glass doors on tub-shower and window.

**16) LS – The window in the tub-shower area needs to be replaced
with a 'tempered' (safety glass) window**

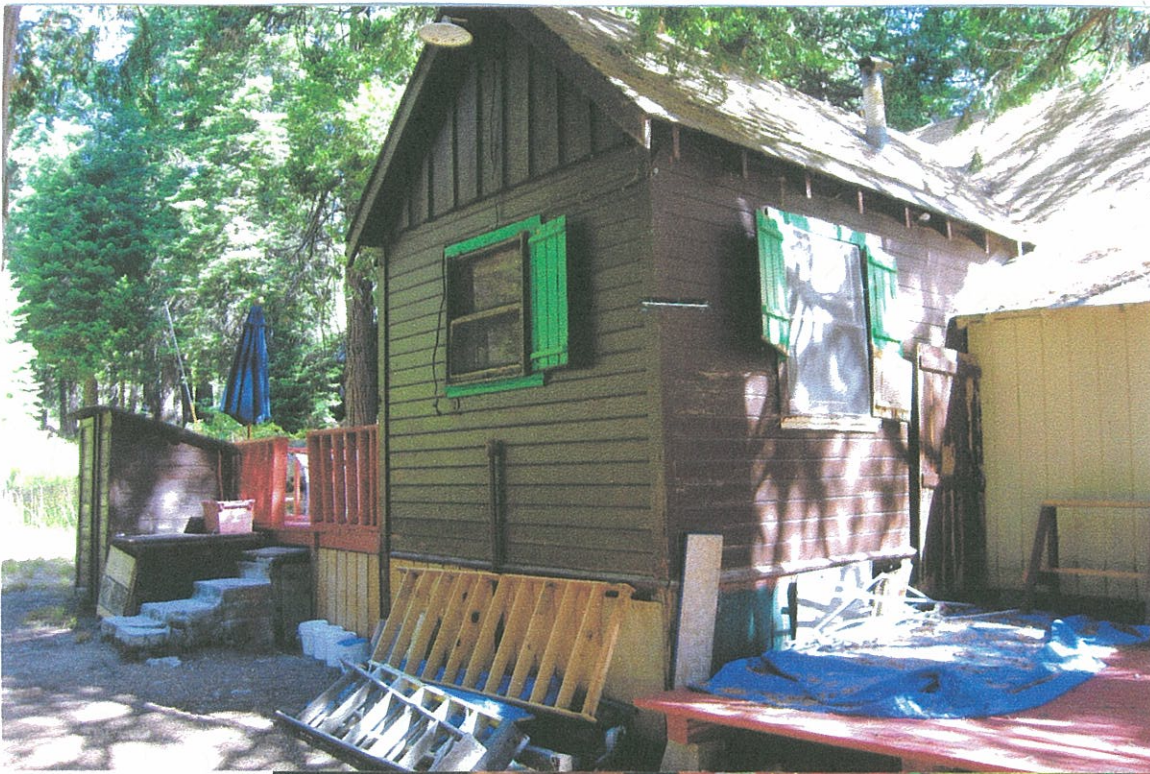
PAGE
126, 124
item
2), 3), and
14), 15)

Exterior of Building: The 10/12pitched roof is composition shingles that are worn. The siding is horizontal 1x6 wood at the bottom section below the plate and 1x10 vertical at the top section of the plate with wood windows and trim that is dry rotted. Exterior doors have dry rot and are not in good condition, weathered. All wood trim and eaves are wood and dry rotted. This is an all-electric house and appears that there is no propane visible.

- 14) H – Lot of dry rot on the exterior of house, needs to be replaced
- 15) S – The roof needs to be replaced and maybe the roof framing, also

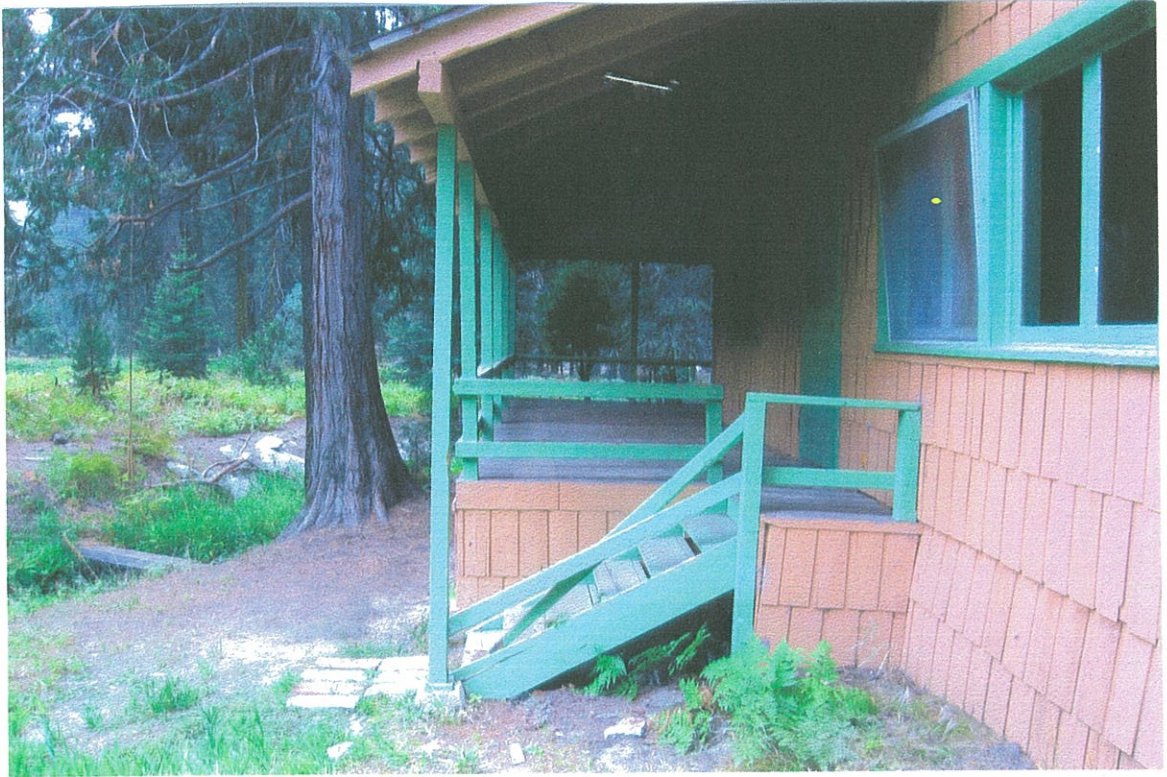
PAGE 132 item ²⁾ guardrails—
handrails, need
more pickets

- 2) **S – The wood framing and siding is on the ground, repair per Code**
3) **S – The chimney needs GI flashing at roof and other combustibles**

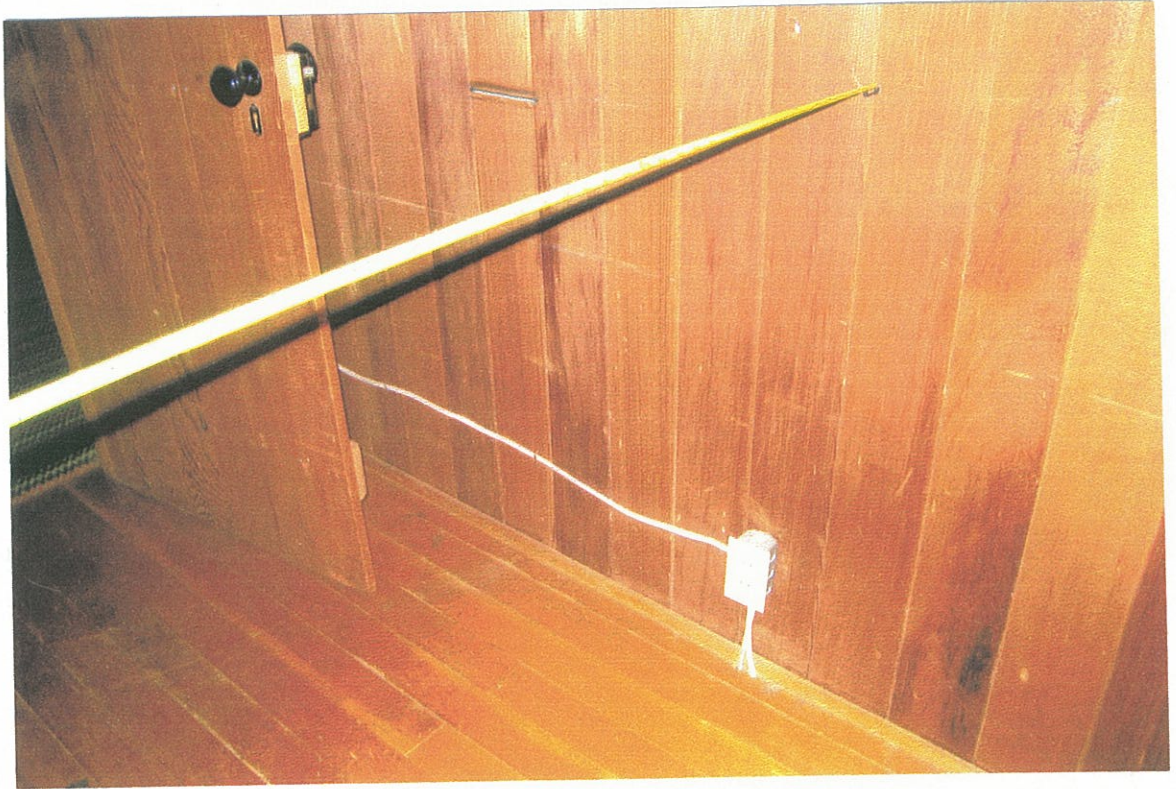
PAGE 134 item 4)

Electrical: There is a 125Amp (maybe 200Amp?) electric panel/meter with subpanel with breakers, labeled and weatherhead is at the rear of the building. The panel is locked with a padlock. PVC conduit with 2 metal cables in the area and also exterior outlets are WP but not GFCI (today's Code). Romex is exposed on the exterior and interior of this house. Romex is to be protected in conduit or walls. Electricity was cut off in this house.

4) LS – All Romex needs to be in the walls or conduit protected.

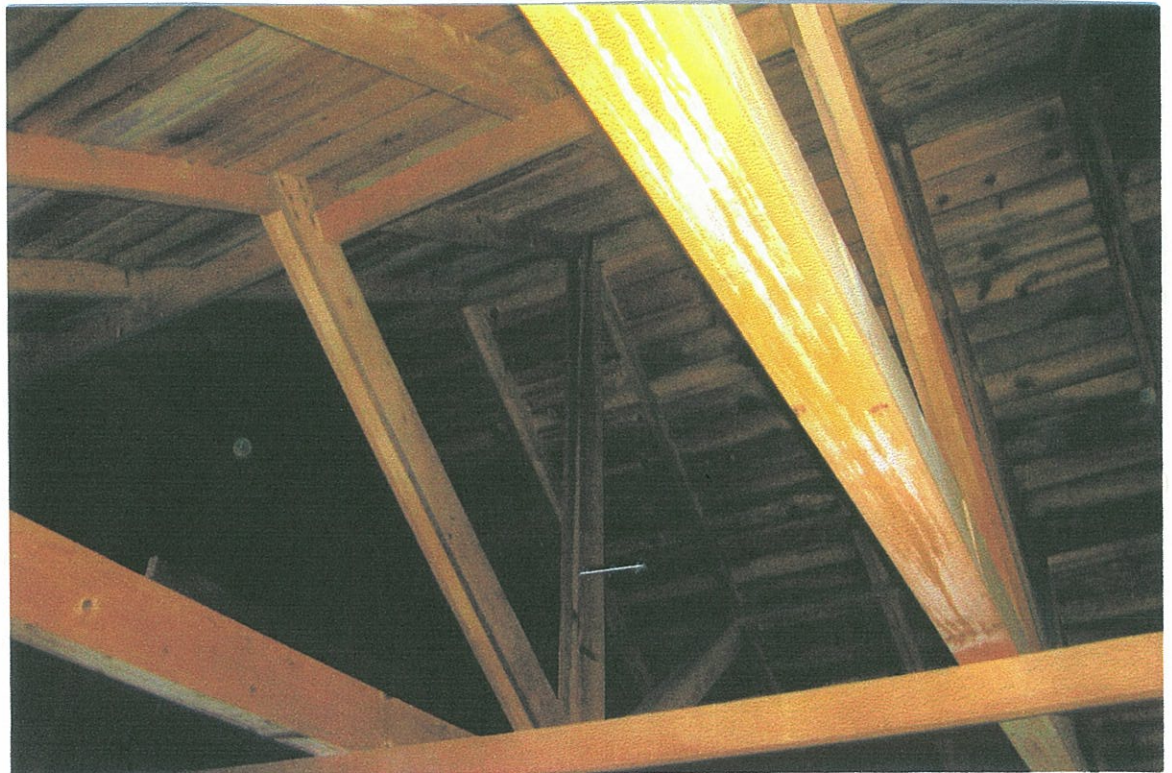
PAGE 134 item 2)

Structure: This house has a ramp going to a deck to the front entry. The ramp is 19" of the ground at the deck with no wheel curbs or handrail/guardrails (at the bottom of the ramp is a 3' concrete landing) and the deck is fair but has nails popping up at the front section. Fireplace chimney has a yellow tone and has iron braces at 5' from the top. The interior frame is vertical 1x6 wall skin with exposed full size-rough sawn rafters 2x4 every other is doubled at 30"o.c. The cross ceiling joist beams are 2-1x8sandwiched (2x8) with 4x8vertical and one each 4x8 angled to rafters. The kitchen is just 1x1x8sandwiched with the 4x8s.

2) LS – Not sure if this ceiling area and walls are structurally sound, need a structural engineer to check it out

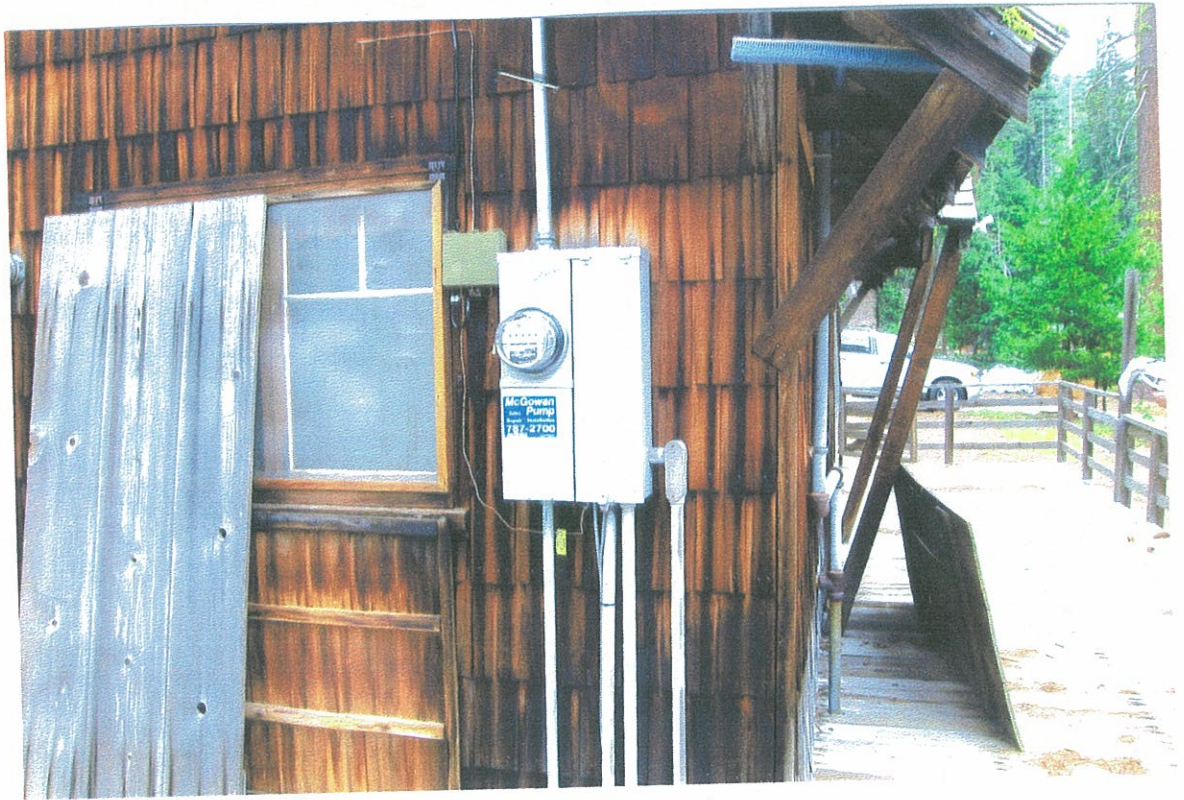
PAGE 135 item elec. panel

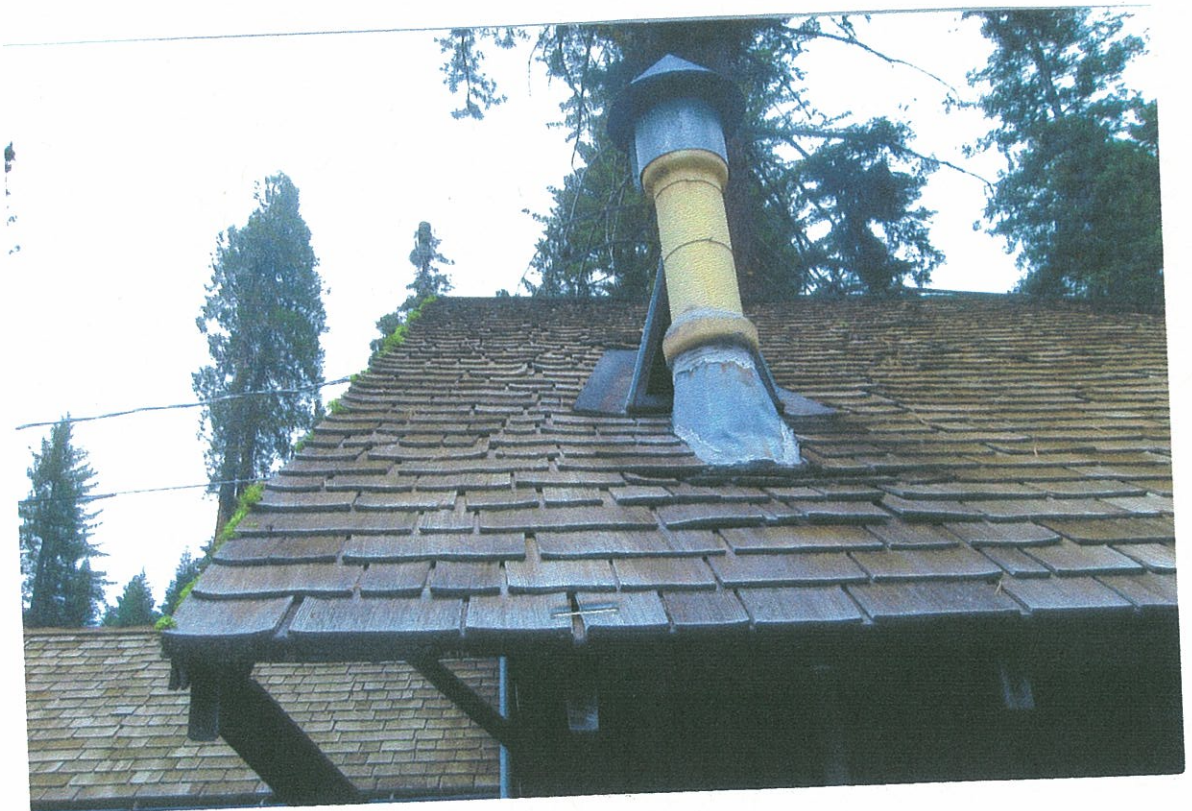
PAGE 135 item stove pipe
on exterior

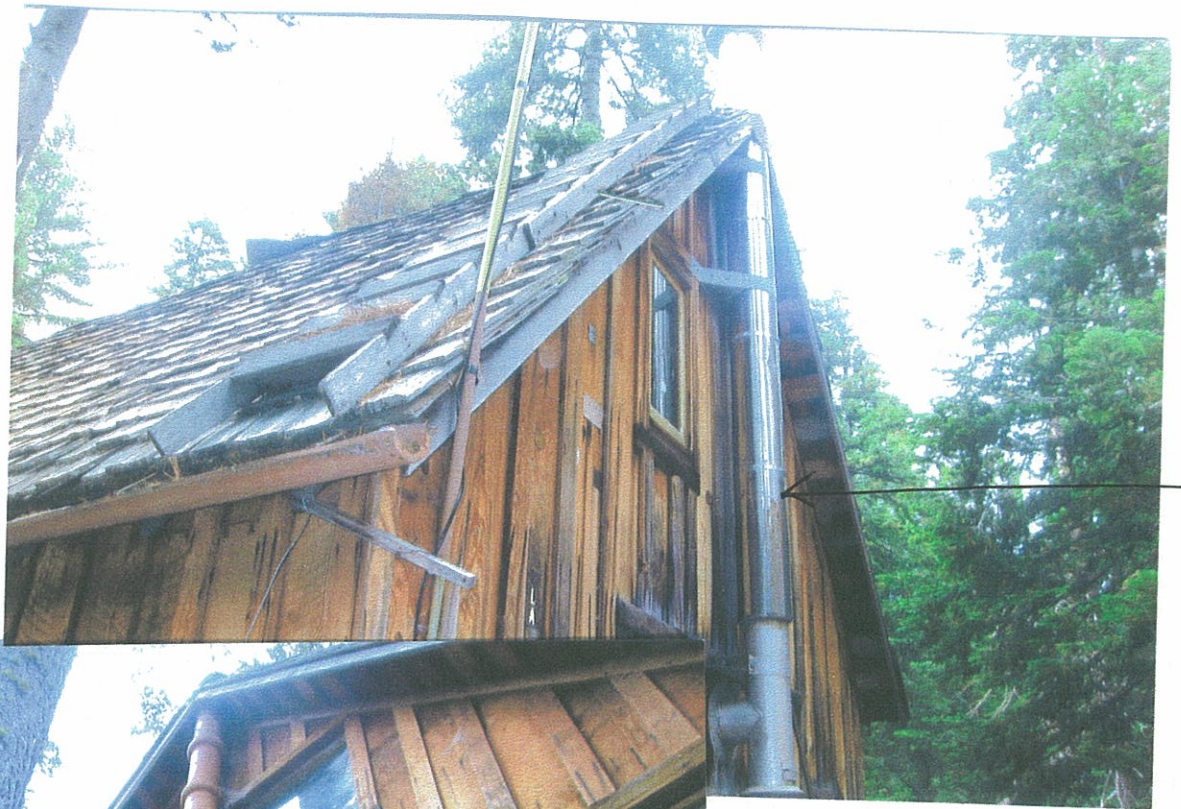
rear
(opposite) fairly
new
stove
pipe

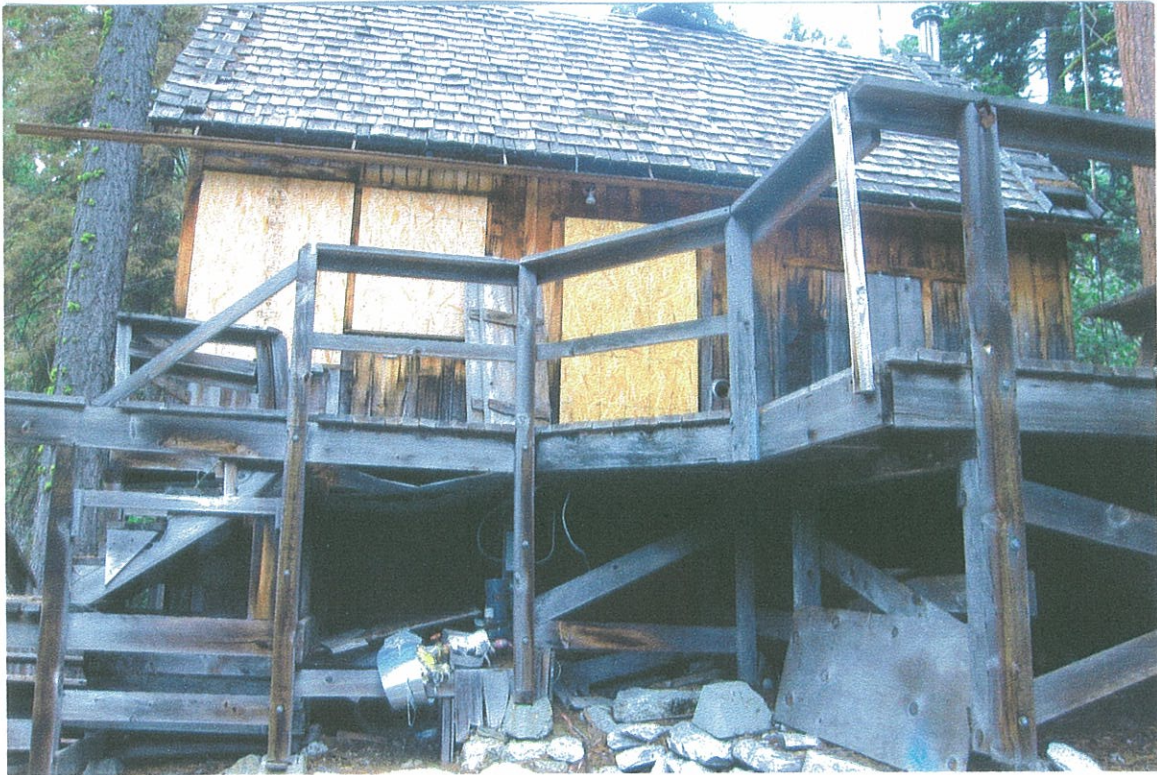
Structure: This house has a deck that really has no foundation or framing holding it up. The stairs to the deck (at the house main floor level) is dry rotted.

PAGE 139 item no positive connections
dry rot everywhere

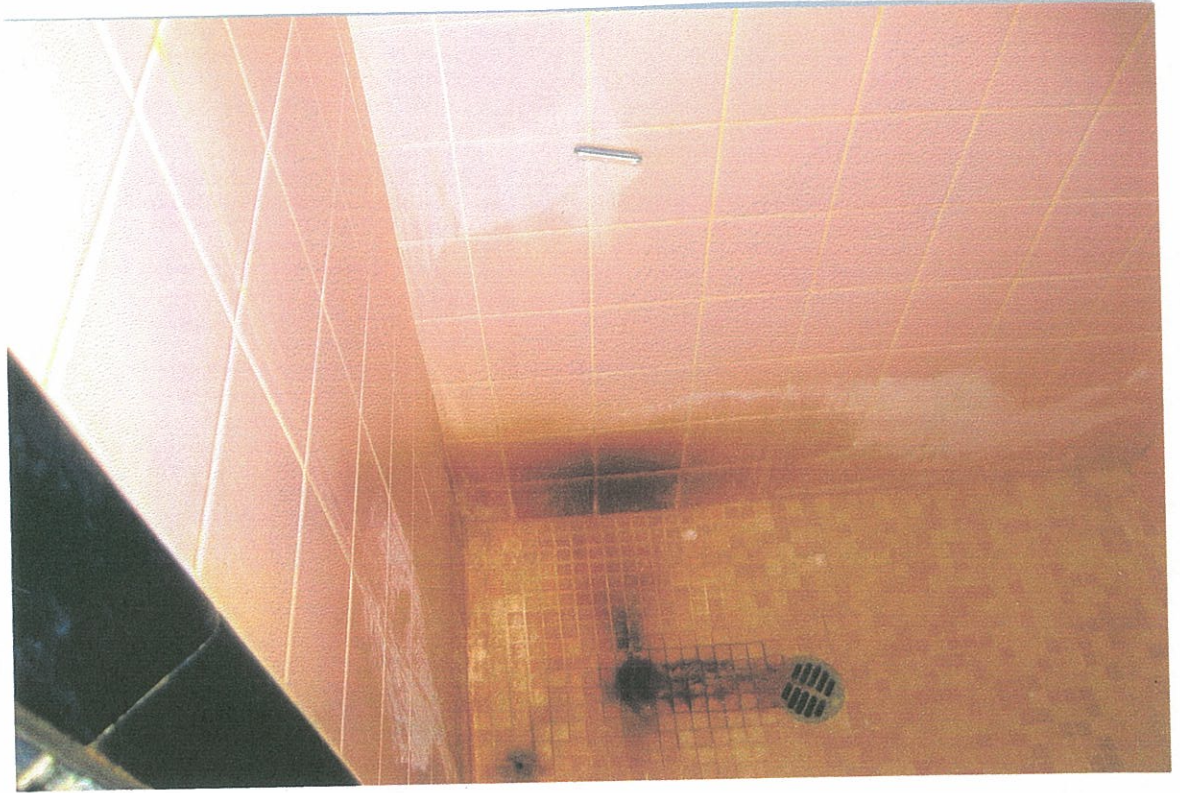
The bathroom has a water closet, lavatory vanity, and a neo-angle tile shower with rusty shower pan.

PAGE 142 item SHOWER PAN
 of walls -
 water staining
