ASSESSMENT ANALYSIS

LOCATION: **WILSONIA**

BUILDING: **83377 Cedar Lane - empty**

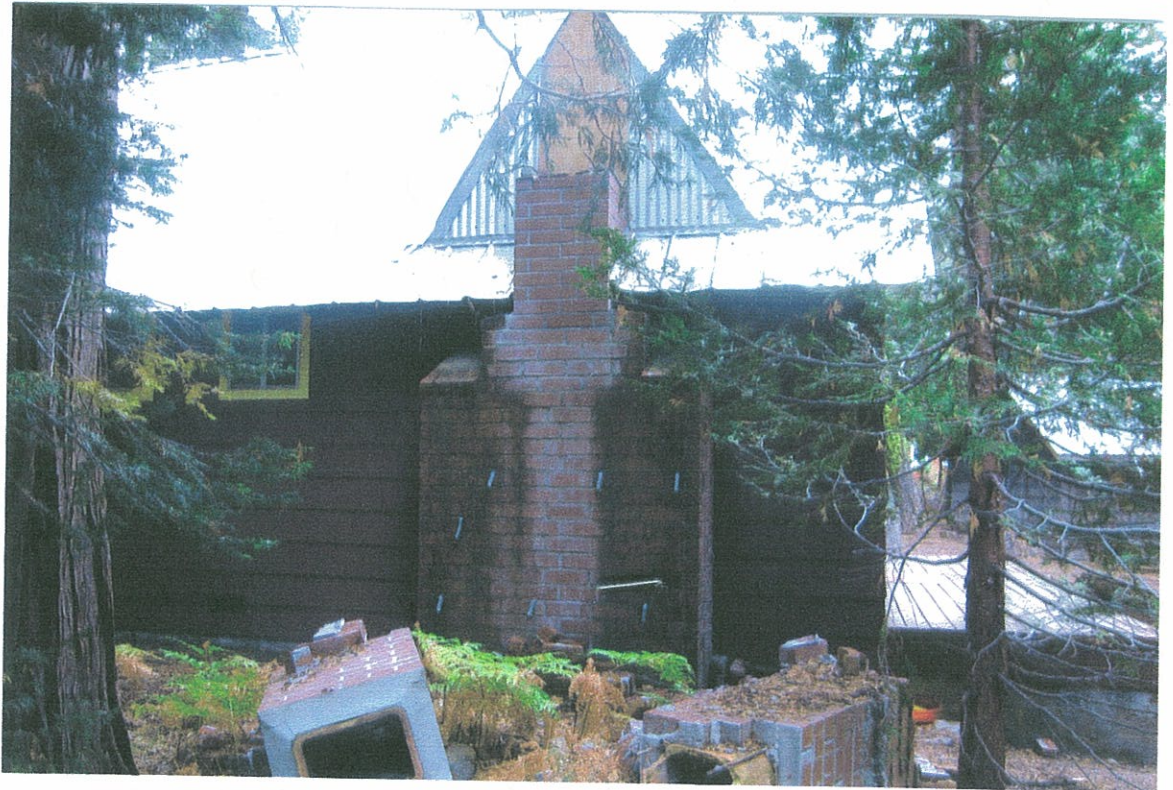
PAGE 142 item 1)

Structure: The roof area over the porch has fallen. The walls in the interior of this house s knotty pine and heated with stove/fireplace. There is a second floor with stairs up, handrails and guardrails, pickets good. The fireplace brick chimney has fallen at plate.

1) **HS – Chimney needs to be repaired**

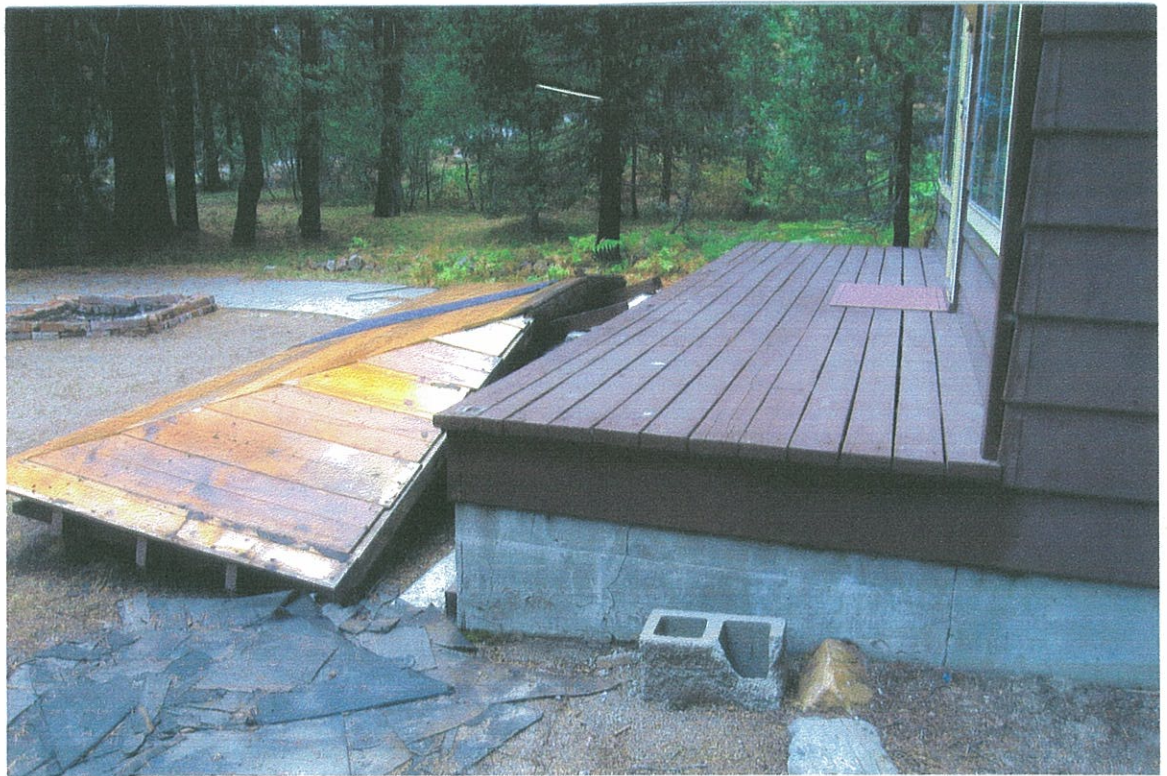
PAGE 142 item porch roof has fallen -

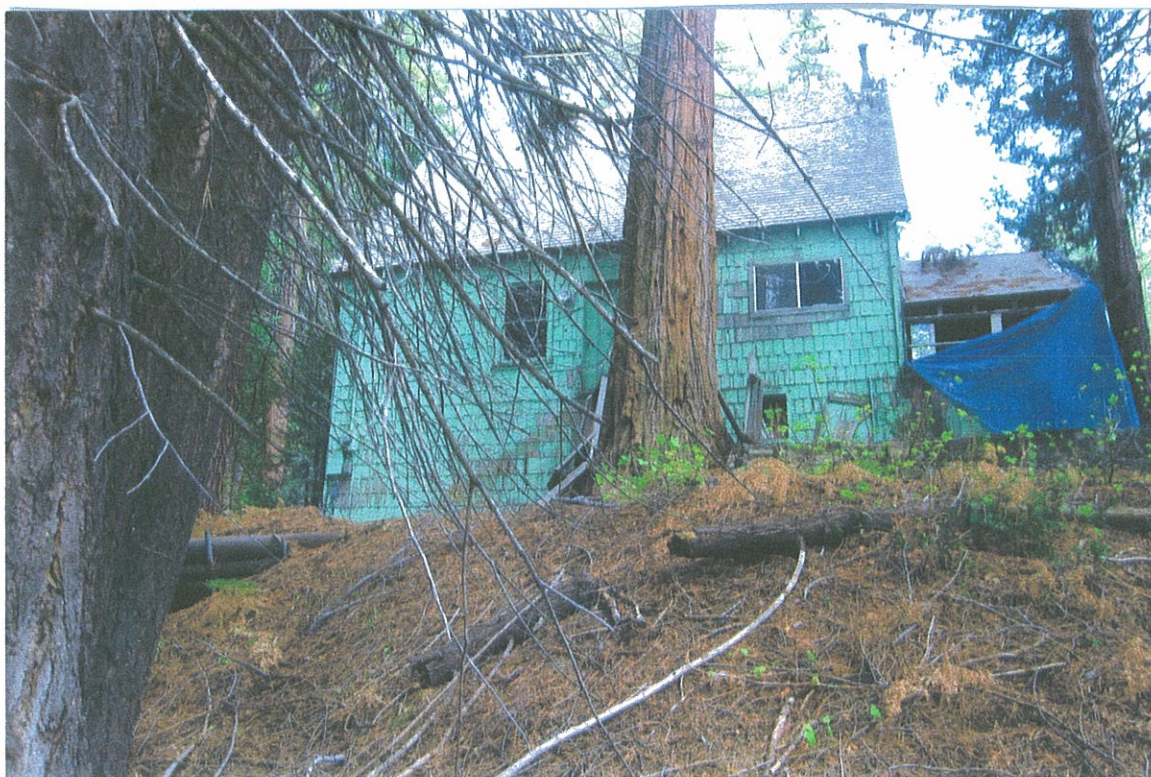
Exterior of Building: The 8/12pitched roof is wood shingle roofing that needs to be replaced. The siding is wood shingles, painted. **On the rear in about 8' from the floor level to the ground and there is NO stair, landing, or deck at the rear door, it drops straight to the ground from that door.**

PAGE 146 item no rear staircase

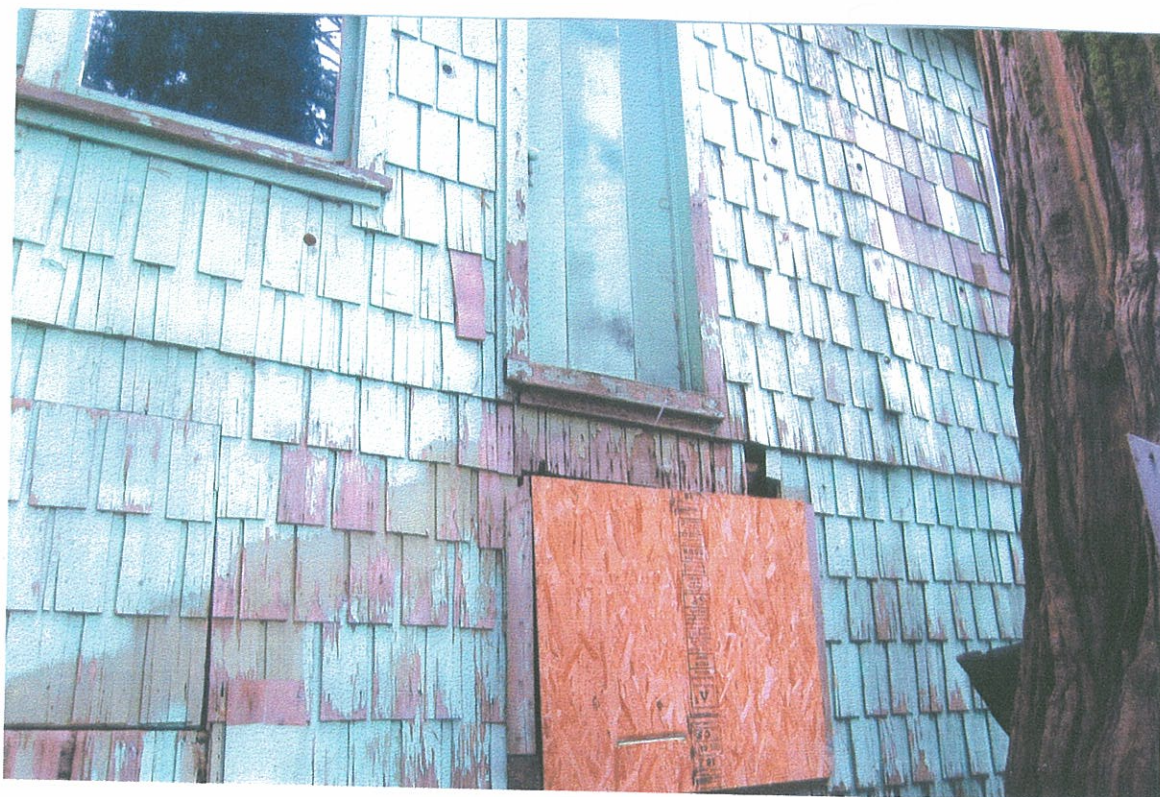
PAGE 146 item rear door —
