National Park Service  
U.S. Department of the Interior

# August 2011 Earthquake Damage Repair

Compliance Review -  
Denver Service Center &  
National Mall and Memorial Parks  
Washington, D.C.

July 2012

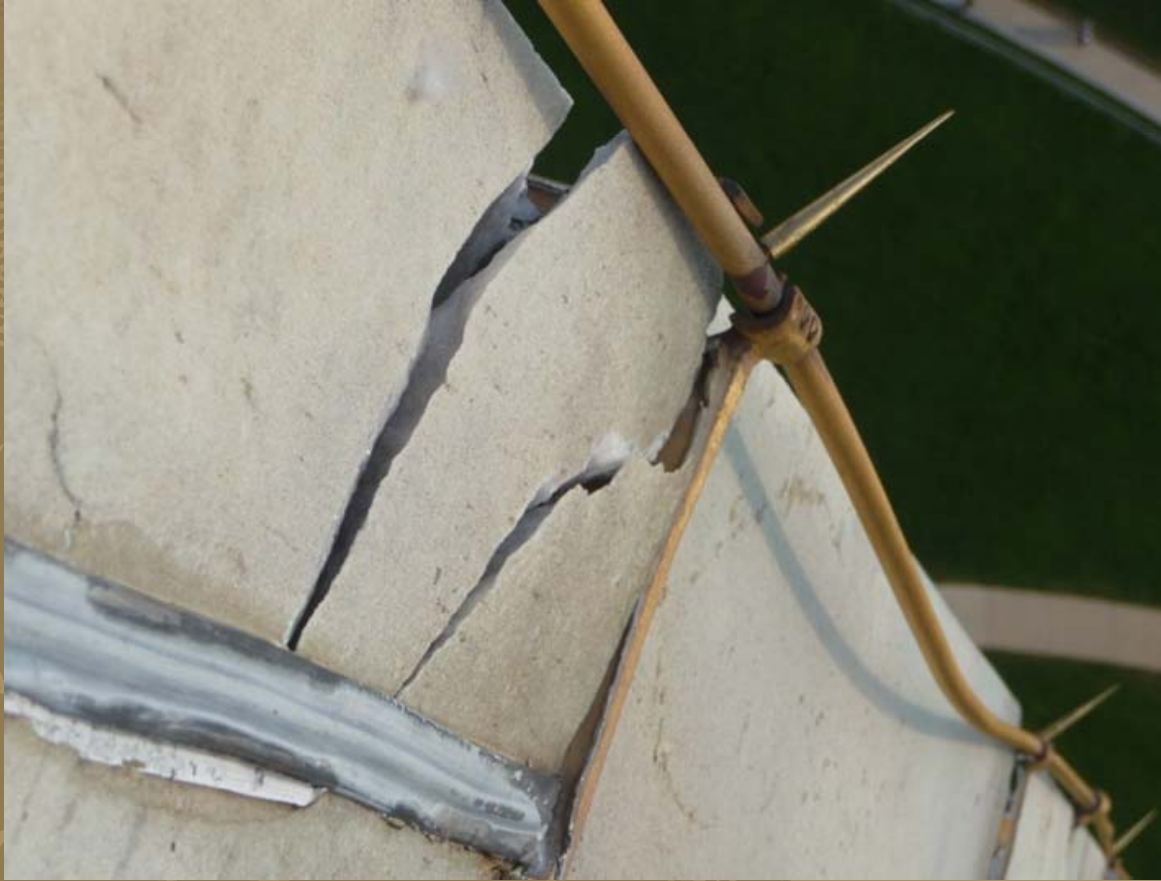
Exterior corner spall held in place by lead joint tee and lightning protection system.

Also seen is the damaged (out-of-alignment) lightning protection system.

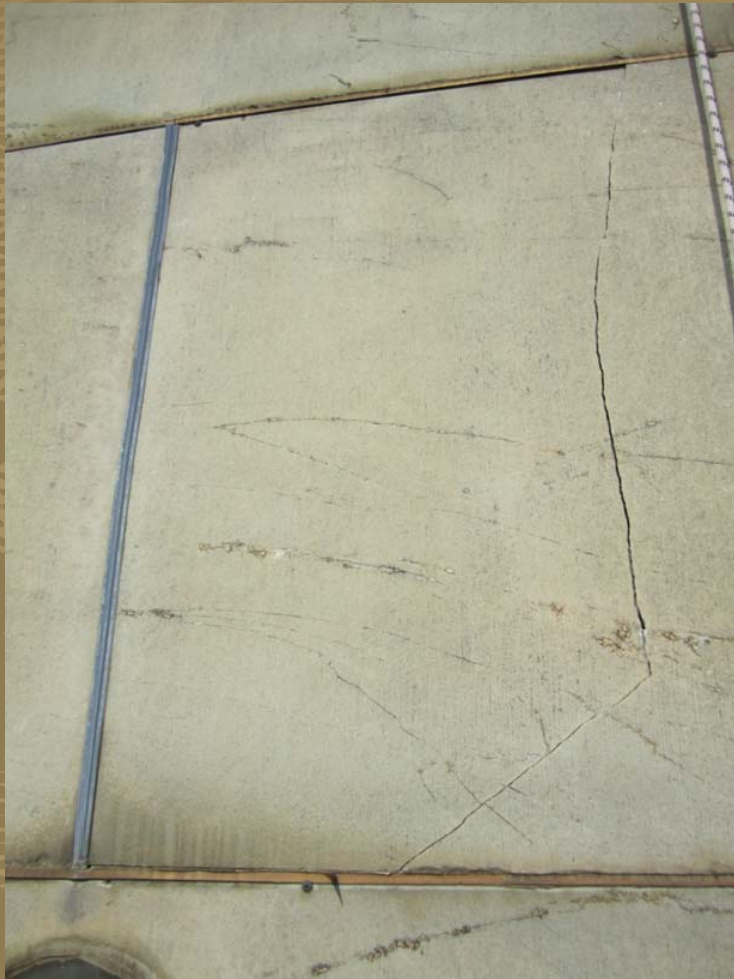
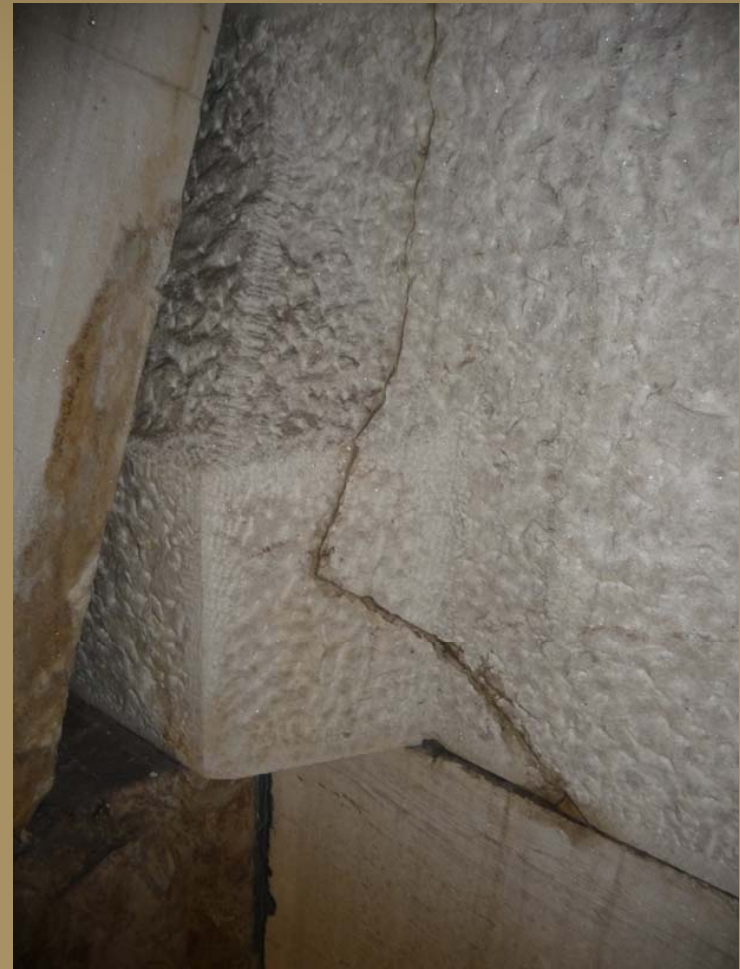
Cracked – through pyramidion panels and haunches.

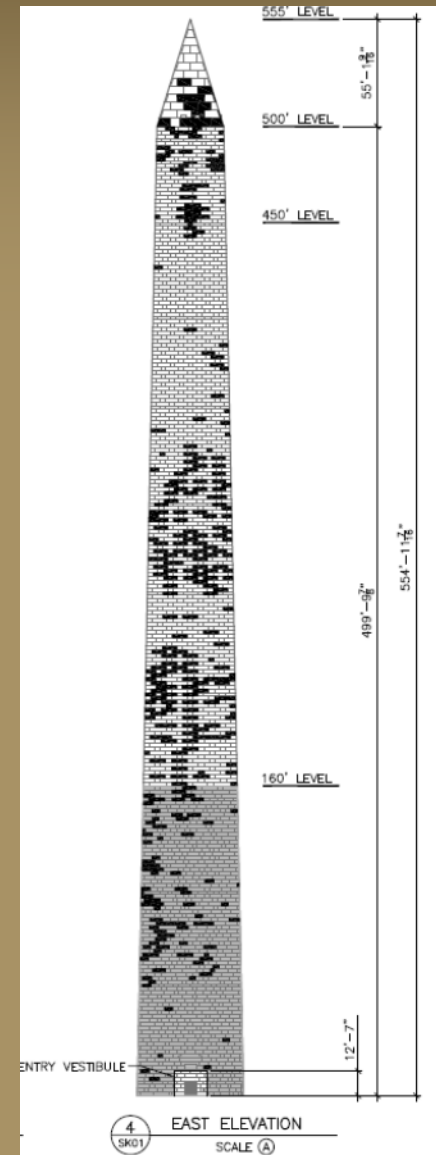
Elevation view of damaged exterior panels that require repair.

Based on the damage and engineering analysis, the repair plan was developed to replace in kind damaged masonry of the Monument.

Where needed, masonry anchors will be installed to strengthen damaged structural stone.

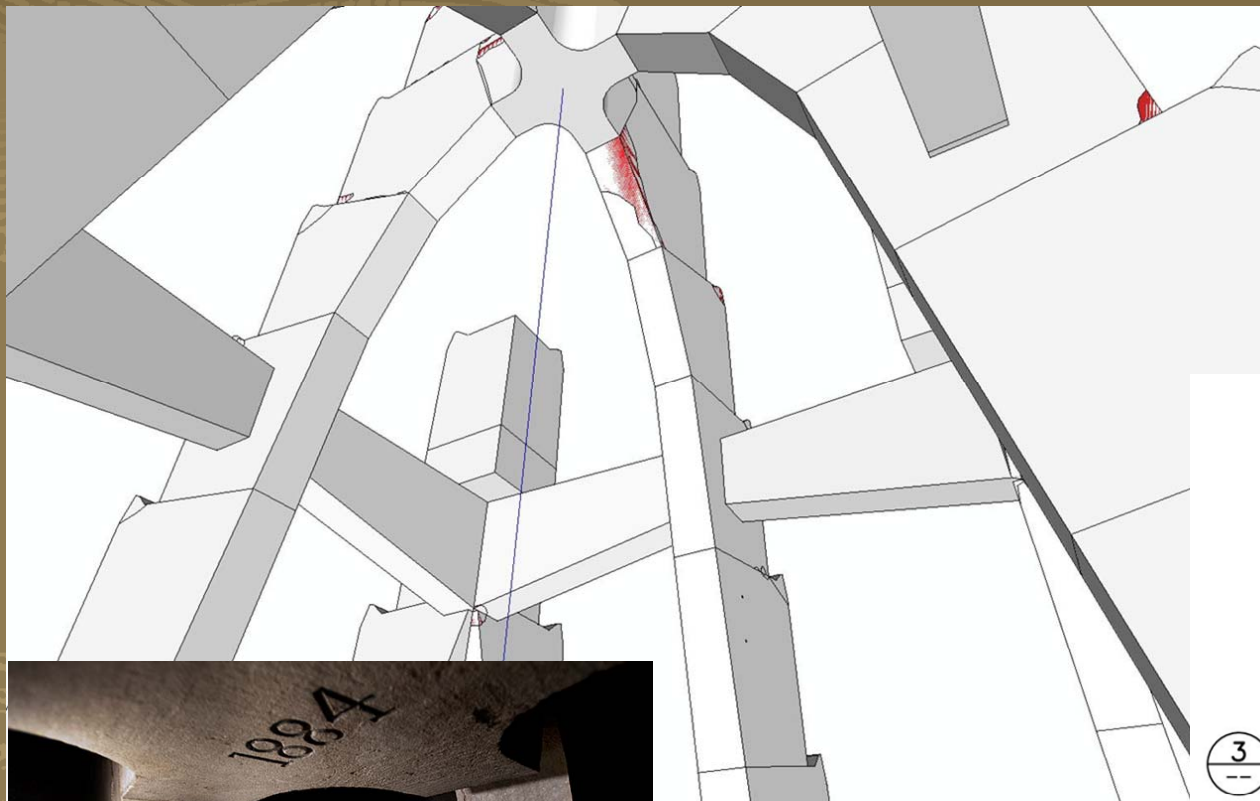
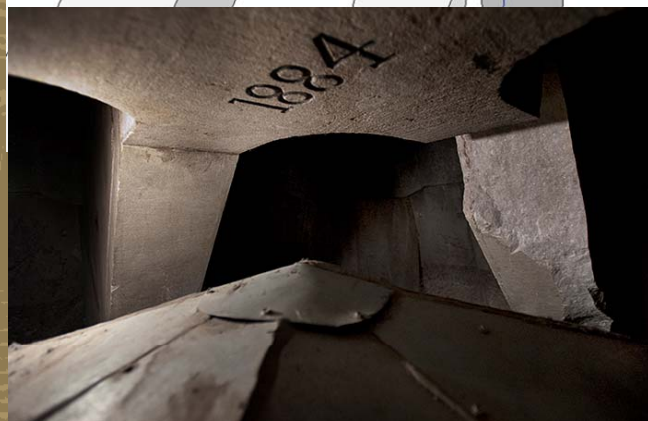
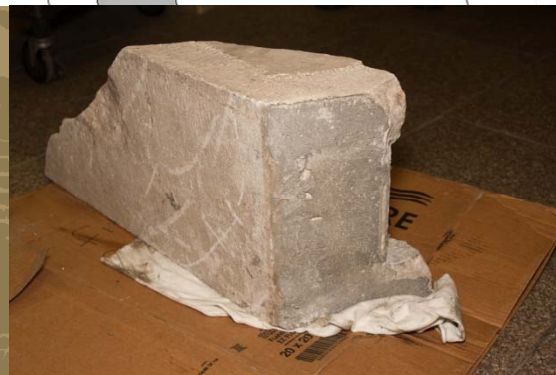
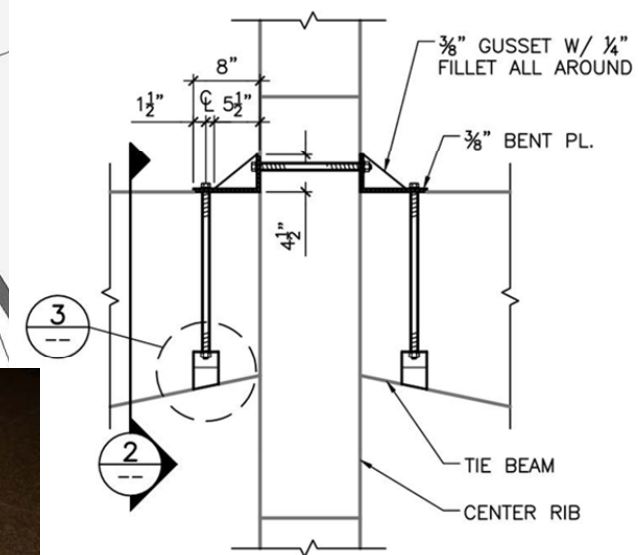
1  
S5.2

# Cracked Tie Beams at Center Ribs
