## Condition Assessment

## **ARCHITECTURAL**

The Carter G. Woodson Home is in poor condition. The building has been vacant for many years and the constant infiltration of water because of a leaking roof had caused significant to the exterior envelope, the wood and masonry structure and the interior finishes. Although the East Elevation is in good condition, the remaining elevations are in poor condition. Because of rot and termite damage to portions of the wood support system, the main stair is sagging as are the floors in several of the rooms. The deteriorating wood framing members in conjunction with open and failing mortar joints has caused near collapse of the west wall elevation at the third floor and the southwest corner of the two story addition. The lack of heat and proper ventilation of the interior along with the high level of water infiltration has led to damage of the plaster walls, the decorative wood elements and the wood flooring.

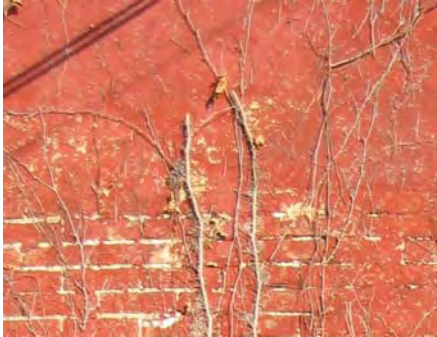
| EXTERIOR BRICK | SYMBOL | CONDITION | LOCATION | EXAMPLE IMAGE |
|---|---|---|---|---|
| | CC | Cementitious Coating | West Elevation | |
| | A cementitious coating has been applied to the top half of the West Elevation at the two story addition. Significant cracks in the brick load bearing wall have translated through the coating, causing it to be unstable and separate from the brick. (Photo: West Elevation at second floor line). | | Structural failure of the southwest corner of the West Elevation is caused by failing structure in openings on the South Elevation, resulting in cracks in the cementitious coating. Continuous vegetative growth has also contributed to increased moisture levels in the substrate and subsequent failing of mortar joints and coating. | |

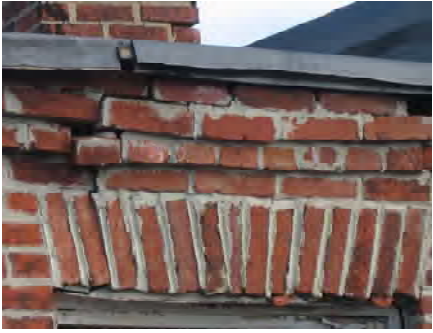
| EXTERIOR BRICK | SYMBOL | CONDITION | LOCATION | EXAMPLE IMAGE |
|---|---|---|---|---|
| | DIS-B | Dislocated Brick | North, West and South Elevations | |
| | Brick units that have shifted out of plumb or are not level. (Photo: West Elevation - Three Story Structure above Window W304). | | Dislocation of the brick units may be caused by differential movement within the masonry wall or deterioration of adjacent mortar caused by excessive penetration of moisture within the wall. | |

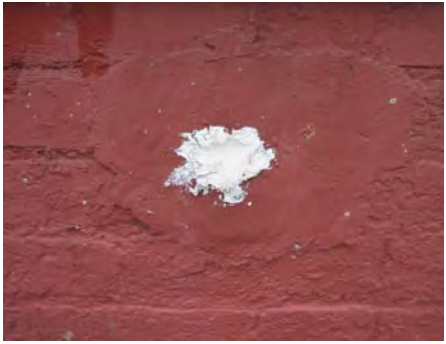
| EXTERIOR BRICK | SYMBOL | CONDITION | LOCATION | EXAMPLE IMAGE |
|---|---|---|---|---|
| | IC | Incompatible Patch | West and South Elevations | |
| | Previous repair of the masonry which is physically incompatible with the historic fabric (Photo: Patch at East Elevation below water course.) | | Previous penetrations through the brick which have been abandoned have required patching. The patching materials are not sympathetic to the historic fabric and may fail as a result of improper testing of the repair system or a misunderstanding of the long term effects of the repair from weathering. | |

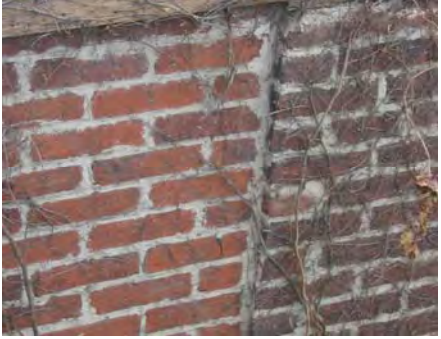
| EXTERIOR BRICK | SYMBOL | CONDITION | LOCATION | EXAMPLE IMAGE |
|---|---|---|---|---|
| | <b>Outward Bulging</b> | <b>OB</b> | North, West and South Elevation | |
| | Brick is showing evidence of bulging outward, in some cases as much two inches. (Photo: North elevation at joint between 1874 and 1880 two story additions). | | Weak mortar joints in conjunction with deterioration of the interior wood structure that gives lateral stability to the load bearing walls. Also, failing footings or a lack of footings could contribute to the bulging. | |

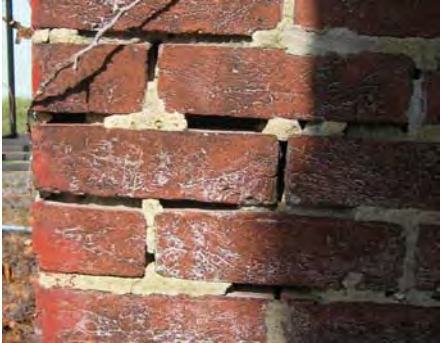
| EXTERIOR BRICK | SYMBOL | CONDITION | LOCATION | EXAMPLE IMAGE |
|---|---|---|---|---|
| | <b>OJ-B</b> | <b>Open Joints</b> | All Exterior Elevations | |
| | Complete or partial loss of pointing mortar. This condition allows moisture to migrate into the masonry substrate and may also result in potential structural instability. Open joints are most prevalent on the South Elevation but are also located across areas of all facades (Photo: South Elevation - West Corner). | | Joints open due to weathering or differential stress from movement within the building envelope. The mortar on the South, West and North elevations are particularly weak and susceptible to deterioration. | |

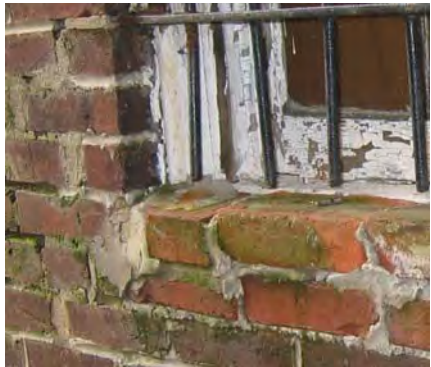
| EXTERIOR BRICK | SYMBOL | CONDITION | LOCATION | EXAMPLE IMAGE |
|---|---|---|---|---|
| | RS | Replacement Sill | South Elevation and West Elevation - Three Story Portion | |
| | Non-matching brick has been installed as a replacement for a previous wood sill. (Photo: South Elevation - Window W106). | | Rot and deterioration of the wood sills due to lack of regular painting and maintenance led to select sills being replaced. At the time of replacement, brick was used instead of wood. | |

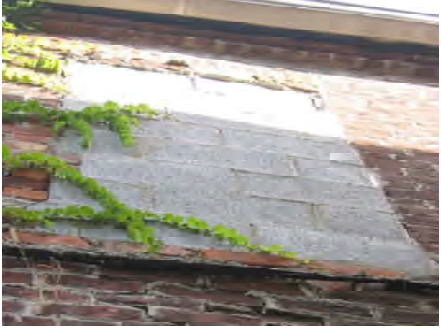
| EXTERIOR CONCRETE<br>MASONRY UNIT | SYMBOL | CONDITION | LOCATION | EXAMPLE IMAGE |
|---|---|---|---|---|
| | CMU-I | CMU Infill | West, South Elevation | |
| | Existing window opening has been filled with concrete masonry units either to stabilize opening or prevent entry through opening. (Photo: South Elevation - Infill at Window W107). | | Instability of brick masonry and mortar due to consistent moisture penetration as well as rotting of opening framing resulted in failed opening support. | |

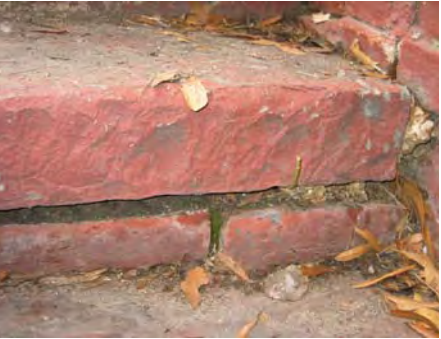
| EXTERIOR STONE | SYMBOL | CONDITION | LOCATION | EXAMPLE IMAGE |
|---|---|---|---|---|
| | DIS-S | Dislocation of Stone | Bluestone at East Elevation Stairs to Basement | |
| | Stone units that are out of plumb or not level. (Photo: West Elevation - Stairs to Basement Entry). | | Dislocation of individual stone units may be caused by differential movement, impact, deterioration of adjacent mortar or vegetative growth in mortar joints. | |

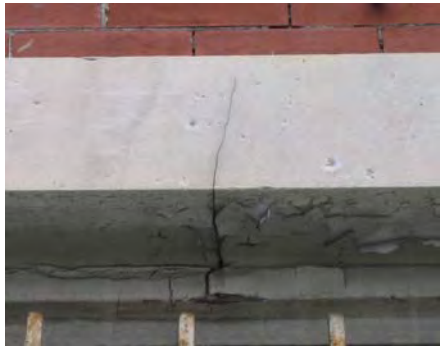
| EXTERIOR STONE | SYMBOL | CONDITION | LOCATION | EXAMPLE IMAGE |
|---|---|---|---|---|
| | HC | Hairline Crack in Single Unit | East Elevation | |
| | Fracture or fissure in single stone unit at mid-span. (Photo: East Elevation - Stone Lintel Above Window W203). | | Cracks through a single unit are due to excess flexural stresses within the wall system from differing expansion and contraction rates between mortar and the brick or from localized load increase due to expanding metal. It may also be caused by excessive loading of the center of the lintel span. | |

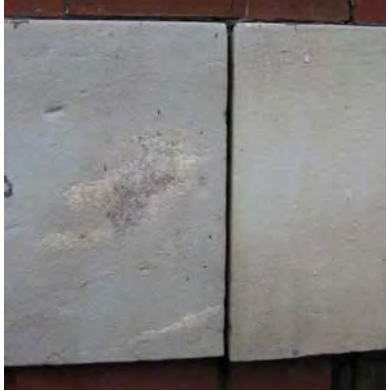
| EXTERIOR STONE | SYMBOL | CONDITION | LOCATION | EXAMPLE IMAGE |
|---|---|---|---|---|
| | OP-S | Open Joint | East Elevation | |
| | Complete or partial loss of pointing mortar. This condition allows moisture to migrate into the masonry substrate and may also result in potential structural instability. (Photo: East Elevation - Stone at Stone Water Course). | | Joints open due to weathering or differential stress from movement within the building envelope or due to weak mortar that is susceptible to deterioration. Loss of mortar is consistent at most stone locations on the East Elevation. | |

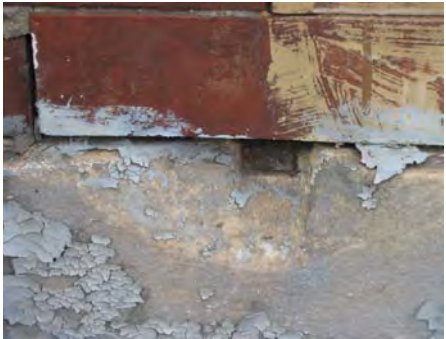
| EXTERIOR STONE | SYMBOL | CONDITION | LOCATION | EXAMPLE IMAGE |
|---|---|---|---|---|
| | SP-S | Stone Spall | East Elevation | |
| | Detachment of stone fragment from base stone unit. (Photo: East Elevation at Stone Water Course to the right of the Entry Door). | | Spalls may be caused by pressure within the stone, from impact damage, from the expansion of embedded ferrous elements or from repair materials that are overly hard in comparison to the surrounding substrate. | |

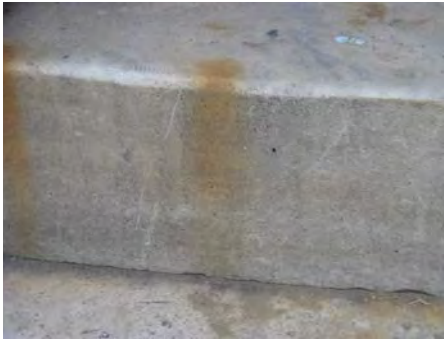
| EXTERIOR STONE | SYMBOL | CONDITION | LOCATION | EXAMPLE IMAGE |
|---|---|---|---|---|
| | ST-M | Staining-Metallic | East Elevation | |
| | When water runs off a corroding metallic element, the transfer of ions can cause metallic deposits to build up on masonry elements. This type of staining most often occurs with iron or steel (orange rust color). (Photo: Staining of marble at front door entry sill). | | Lack of regular maintenance and painting for the front door steel gate and front stoop iron railings has caused significant rust and loss of metal. On going exposure to water is causing splashing of metallic deposits on the stone, resulting in the staining. | |

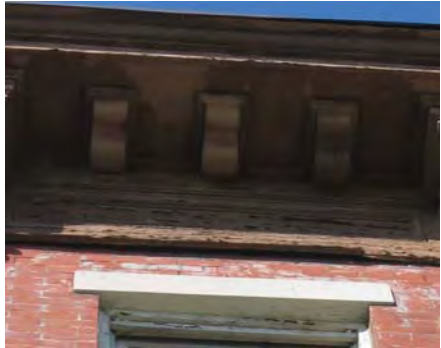
| EXTERIOR WOOD | SYMBOL | CONDITION | LOCATION | EXAMPLE IMAGE |
|---|---|---|---|---|
| | DIS-W | Dislocated Wood Member | East Elevation | |
| | Wood members that are out of plumb or have separated from the substrate. (Photo: East Elevation Painted Wood Cornice). | | Lack of regular maintenance and painting of the wood members has resulted in significant paint loss, allowing for wood to absorb moisture. The absorption of moisture caused the wood members to deform, pulling away from the substrate. | |

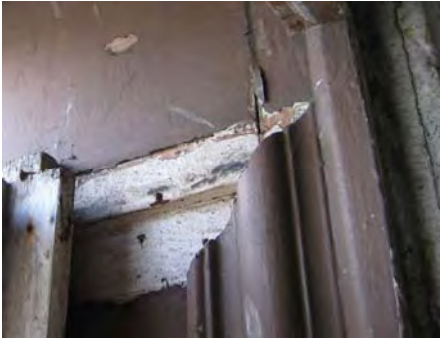
| EXTERIOR WOOD | SYMBOL | CONDITION | LOCATION | EXAMPLE IMAGE |
|---|---|---|---|---|
| | ME | Missing Element | Exterior Windows on North, West and South Elevations, Front Door | |
| | Missing component of wood members at window and door frames and trim. (Photo: East Elevation - Front Entry Door Paneled Return). | | Severe wood rot will eventually lead to disintegration of material and result in the loss of the element. Missing element may also be caused by rusting or inadequate anchoring or vandalism. | |

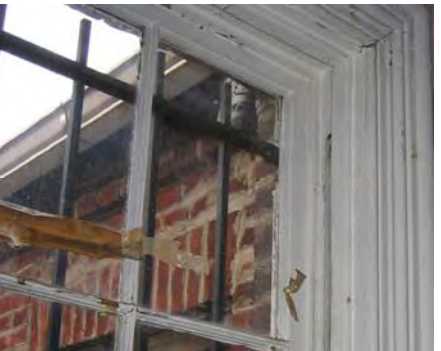
| EXTERIOR WOOD | SYMBOL | CONDITION | LOCATION | EXAMPLE IMAGE |
|---|---|---|---|---|
| | MP | Missing Putty | All Exterior Windows | |
| | Glazing putty loss at perimeters of glass lites. (Photo: South Elevation - Interior of Window W204). | | Continuous weathering leads to breakdown and drying out of the putty material, leaving these areas vulnerable to moisture penetration. | |

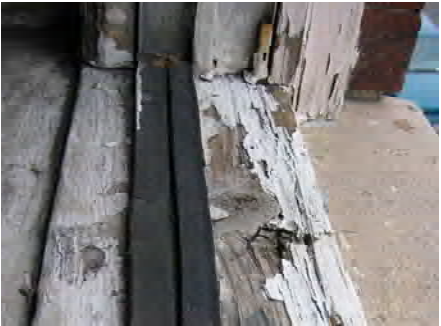
| EXTERIOR WOOD | SYMBOL | CONDITION | LOCATION | EXAMPLE IMAGE |
|---|---|---|---|---|
| | PL | Paint Loss | Wood Window Frames and Door Frames at All Exterior Elevations | |
| | Failure of paint coating, which acts as a protective sacrificial layer against weathering. The loss of paint exposes the wood substrate to moisture penetration, deterioration and eventually will lead to wood rot. (Photo: East Elevation - Sill at Window W201). | | Most paint coatings fail due to age and weathering. In some cases, when the substrate is not prepared correctly or is too wet, the coating cannot maintain a bond and will fail. Paint loss is most severe at areas of high weathering, such as window sills, base of frames, projecting elements and horizontal members. | |

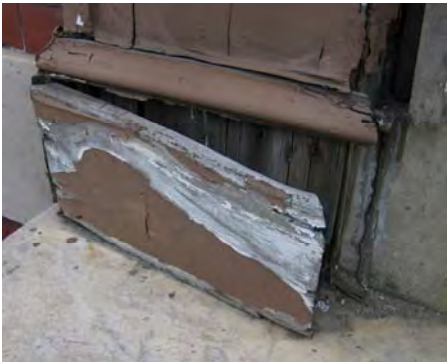
| EXTERIOR WOOD | SYMBOL | CONDITION | LOCATION | EXAMPLE IMAGE |
|---|---|---|---|---|
| | WR | Wood Rot | Windows at West and South Elevations | |
| | Decay of wood substrate, eventually leading to failure and loss of material. This process is accelerated by moisture, fluctuations in temperature and poor maintenance. (Photo: East Elevation - Base of Wood Surround at Entry Door). | | Failure of protective paint coating and prolonged exposure to direct weathering. | |

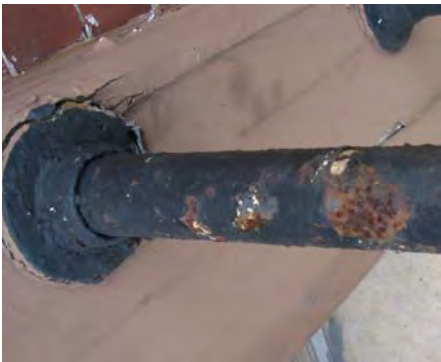
| EXTERIOR METAL | SYMBOL | CONDITION | LOCATION | EXAMPLE IMAGE |
|---|---|---|---|---|
| | CORR | Corrosion | Window Grilles on East, West and South Elevations, Cast Iron Entry Railing | |
| | Oxidation of the metal substrate, in severe cases, leads to through metal corrosion and loss of material. Corrosion may affect the color, texture or form of the metal object and cause staining to surrounding areas. (Photo: East Elevation - Cast Iron Railing). | | Paint loss and prolonged exposure to moisture. | |

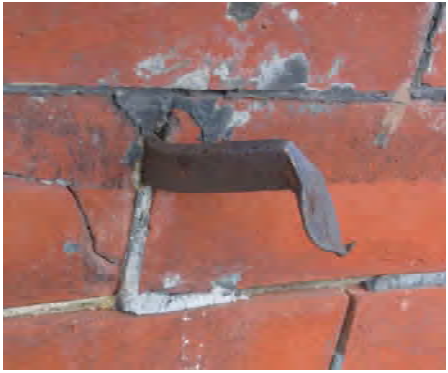
| EXTERIOR METAL | SYMBOL | CONDITION | LOCATION | EXAMPLE IMAGE |
|---|---|---|---|---|
| | FMA | <b>Ferrous Metal Anchors</b> | East Elevation | |
| | Ferrous metal strips set into mortar joints to surface mount materials to the brick masonry. (Photo: East Elevation above Window W102). | | Anchors were set into masonry to anchor signage and if not treated will continue to rust and expand, jeopardizing adjacent masonry stability. | |

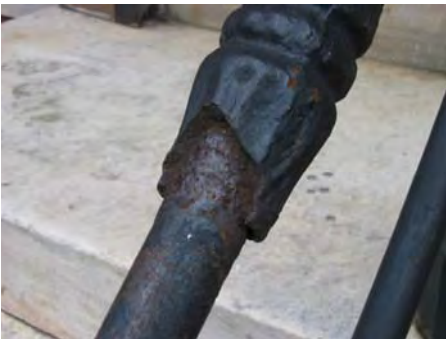
| EXTERIOR METAL | SYMBOL | CONDITION | LOCATION | EXAMPLE IMAGE |
|---|---|---|---|---|
| | MTL-LS | <b>Metal Loss of Section</b> | East Elevation - Cast Iron Entry Railing | |
| | Oxidation of the metal substrate, in severe cases, leads to through metal corrosion and loss of material. (Photo: East Elevation - Cast Iron Railing). | | Paint loss and prolonged exposure to moisture. | |

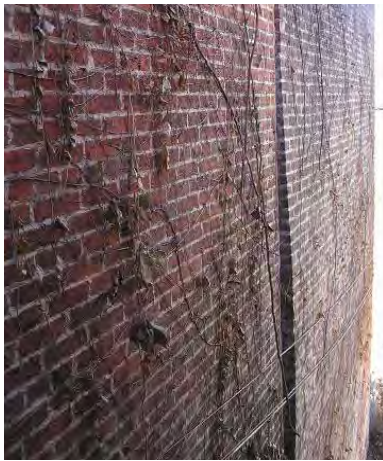
**Figure 4-024:** Bulging of north elevation. (RSA, 2006)

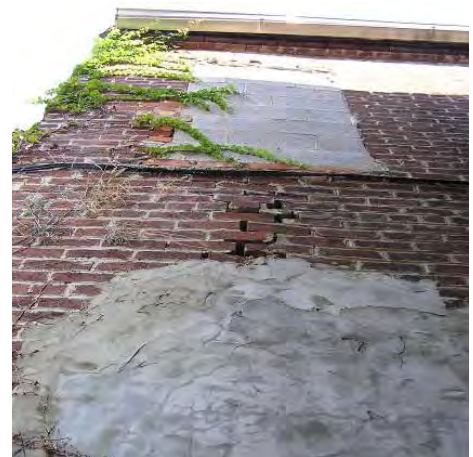
**Figure 4-026:** Cracking below second floor window W209. (RSA, 2006)

More severe cracking and shifting brick is shown in Figure 4-026 below window W209. Concrete masonry units (CMU) have been used as infill in W209 and D110A to prevent further structural deterioration. Not visible in this Figure 4-026 is the serious shifting of brick above the second floor window (W209).

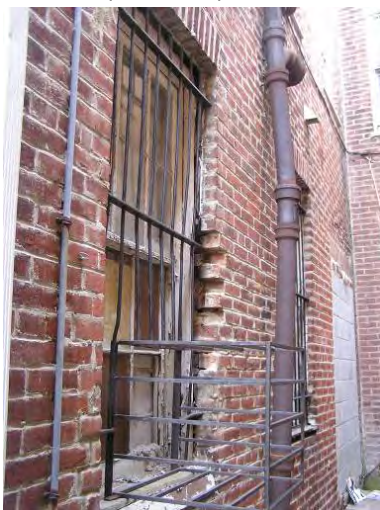
**Figure 4-027:** Spalling brick at first floor south wall window. (RSA, 2006)

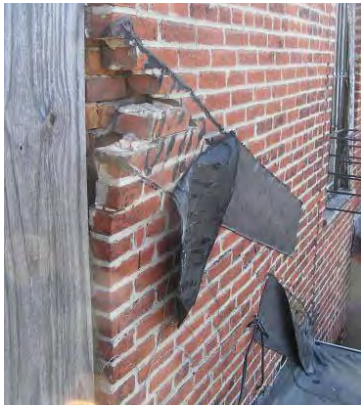
**Figure 4-029:** Cracking and bulging of west wall. (RSA, 2006)

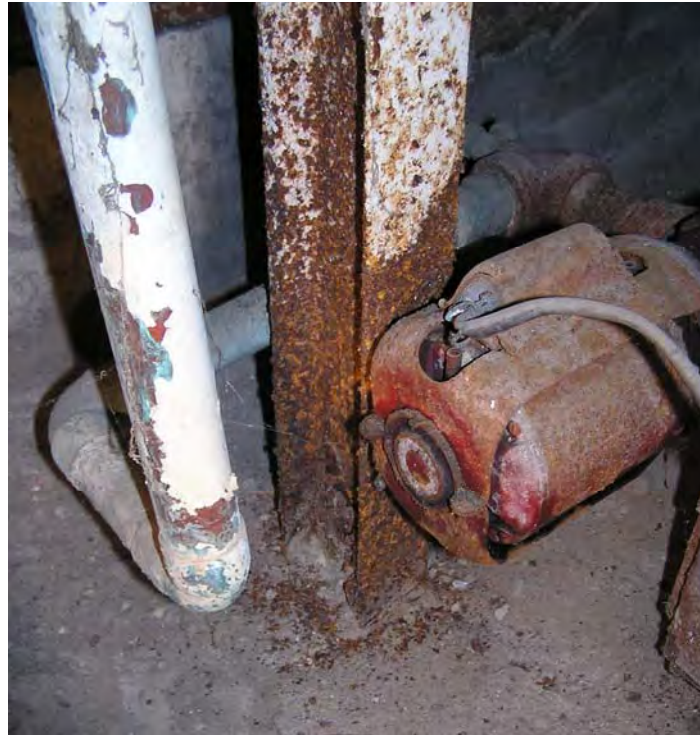
**Figure 4-040.** Rust and delamination at base of steel column. (RSA, 2006)

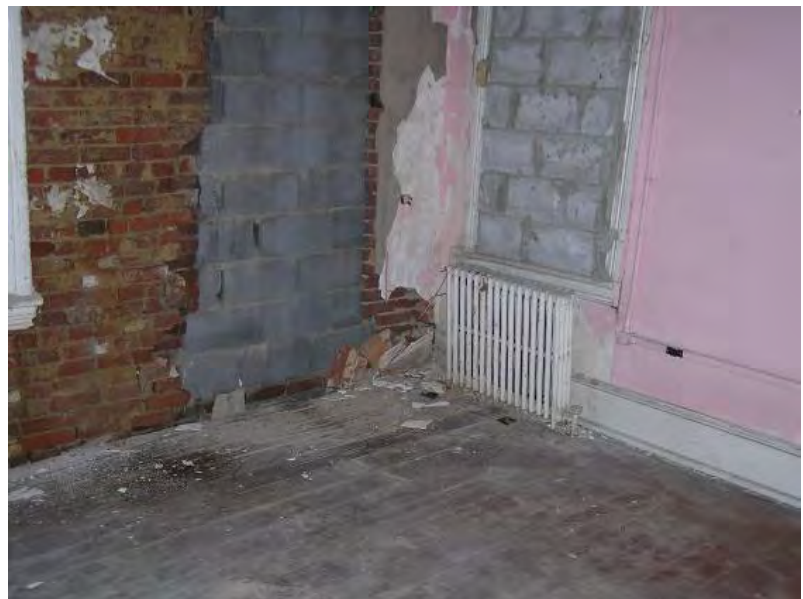
The first floor presents significant areas of sagging and displacement, particularly at the Period 2 two-story addition to the west. As depicted in Figure 4-045, the flooring in Room 110 suffers severe deterioration of both floor framing and perimeter masonry bearing walls. The framing in this location is over the crawlspace and has rotted and displaced along the south bearing conditions. The load bearing masonry, particularly along the window lines, has shifted and begun to disassemble. In Room 109, where the basement below transitions from crawl space to basement, there is further sagging of the floor (Figure 4-046). This is due to the rotted bearing ends of the floor joists observed from the basement area below.

**Figure 4-045:** Room 110 - First floor, southwest corner. (RSA, 2006)

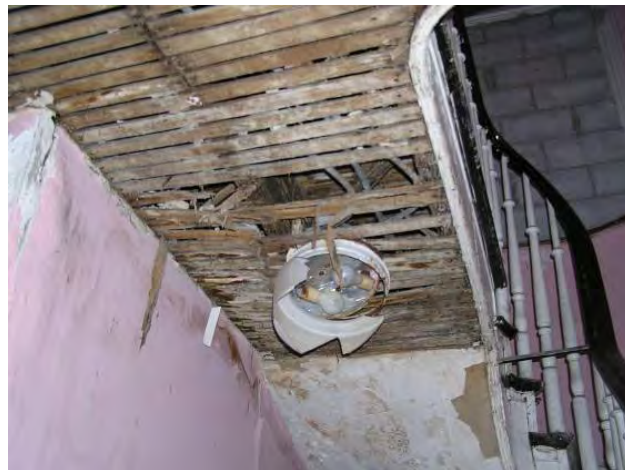
The stairwell, depicted in Figure 4-049, is deflecting downward toward the basement because of significant first floor framing deterioration observed in the basement below. The entire structural system including the upper story walls connected to the stair appears to be deflecting downward as well, corresponding to significant water penetration into the house from the roof joint at the three story elevation directly above the stair.

**Figure 4-049:** Room 103 - Fallen plaster at stairwell. (RSA, 2006)

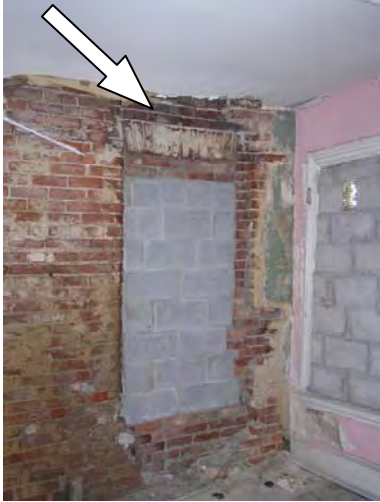
**Figure 4-052:** Room 210 - Brick failure at window. (RSA, 2006)

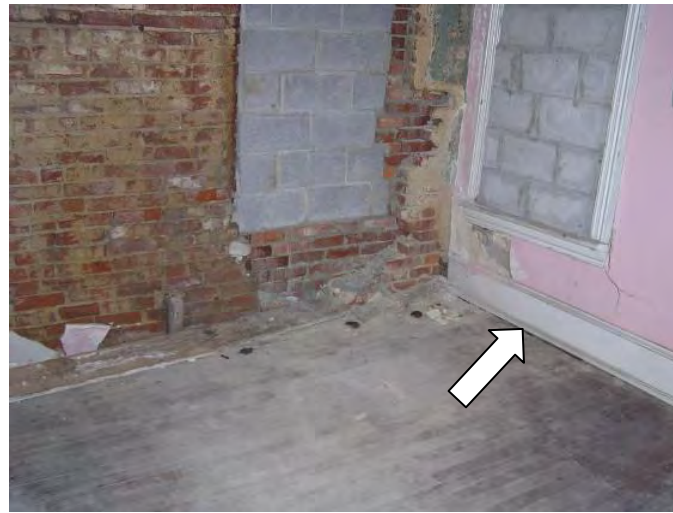
Significant structural deterioration is present in the two-story structure, translating up from the observations at the first floor and foundation levels. Most dramatic are the conditions observed in Room 210, where the brick masonry is unstable around and below window W209 on the south wall (Figure 4-052). The windows depicted are in-filled with CMU, possibly as a means of security as well as for temporary support of the failing flat arch construction at the window heads. The inner wythe of flat arch at the W209 has failed, and the masonry at the jambs and sill are largely disassembled.

**Figure 4-053:** Room 210 - Floor sagging. (RSA, 2006)

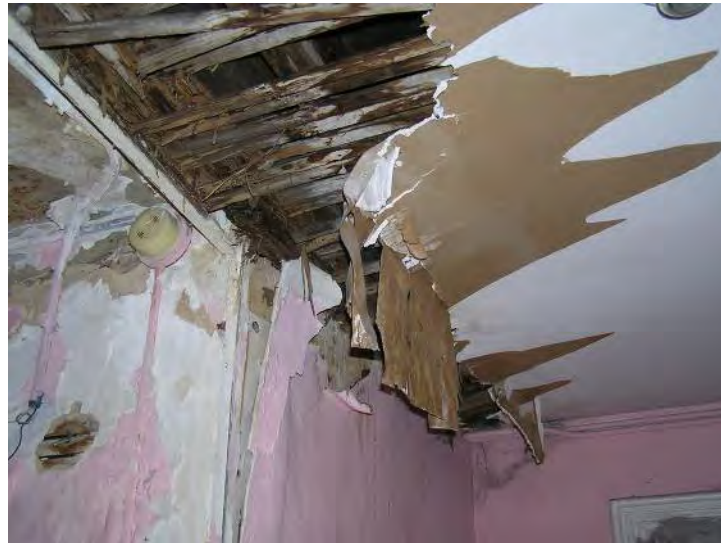
**Figure 4-057:** Room 201 - Fallen plaster ceiling and framing damage. (RSA, 2006)

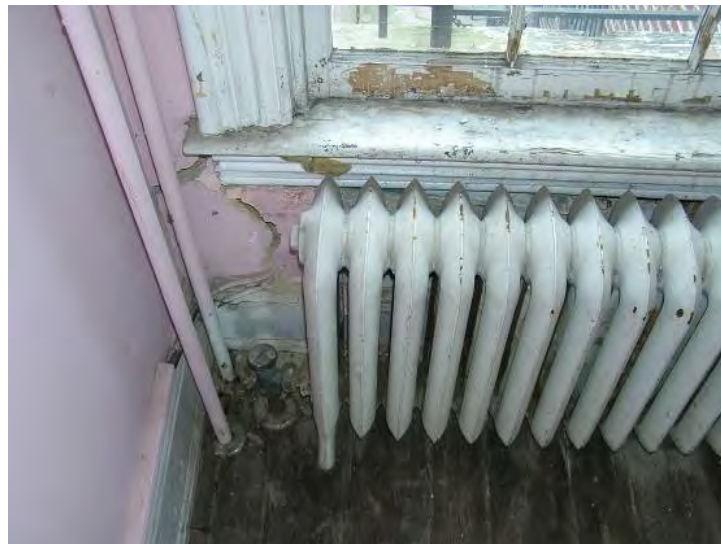
In Figure 4-056, 4-058, 4-059 & 4-060, significant cracking is evident below the sill at window W204 of Room 205. This is likely the result of a lintel or arch failure above the first floor window below. The window opening and radiator likely have contributed to increased moisture levels. As a result, it is likely that localized floor framing deterioration may also be found in this area. Typical third floor framing in this area consists of 2" x 9 ¾" wood joists @ 16" on center.

**Figure 4-059:** Room 205 - Cracks in wall. (RSA, 2006)

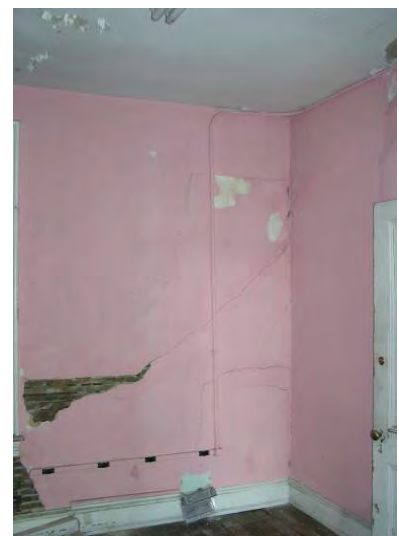
**Figure 4-061:** Room 305 - Diagonal cracks, west wall. (RSA, 2006)

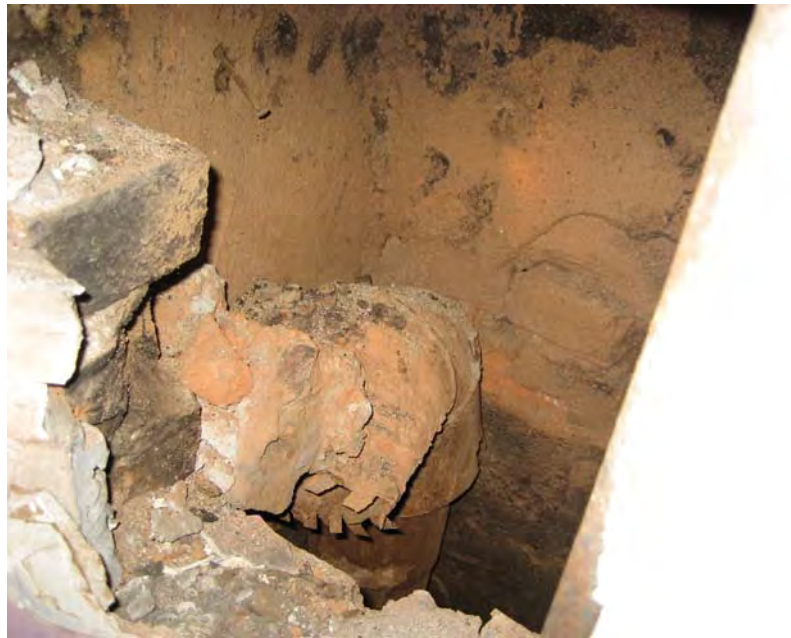
**Figure 4-078:** Elbow of metal tube in flue at third floor. (Photo: GHT, 2007)

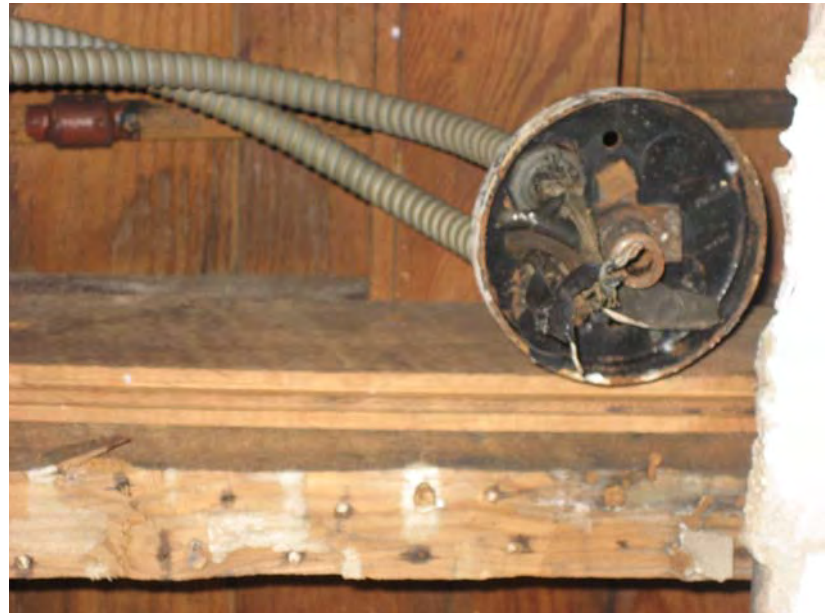
**Figure 4-086:** Retrofitted junction box at ceiling of second floor. (Photo: GHT, 2007)
