CULTURAL LANDSCAPE REPORT, AQUATIC PARK

SAN FRANCISCO MARITIME, NATIONAL HISTORICAL PARK

NATIONAL PARK SERVICE
PACIFIC WEST REGION
2010

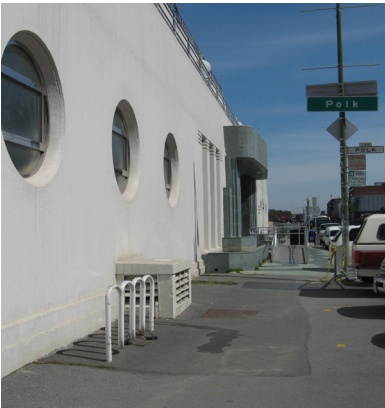
Figure 89. On the west side of the front entrance to the Bathhouse, a bicycle rack, accessibility ramp, and various small-scale features and utilities create a cluttered appearance. Note asphalt paving where planting bed was originally located. (NPS, 2010)

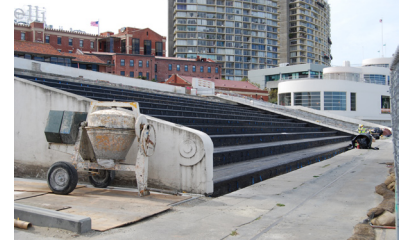
Figure 90. View of the East Bleachers showing new waterproofing material applied during rehabilitation. Note mildew on the concrete wall. Cleaning and repainting this portion of the structure is important to the character of the structure, and should be integrated into overall maintenance. (NPS, 2009)

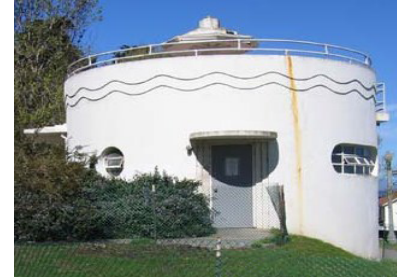
Figure 92. Staining on the exterior of the West Convenience Station. (NPS, 2007)

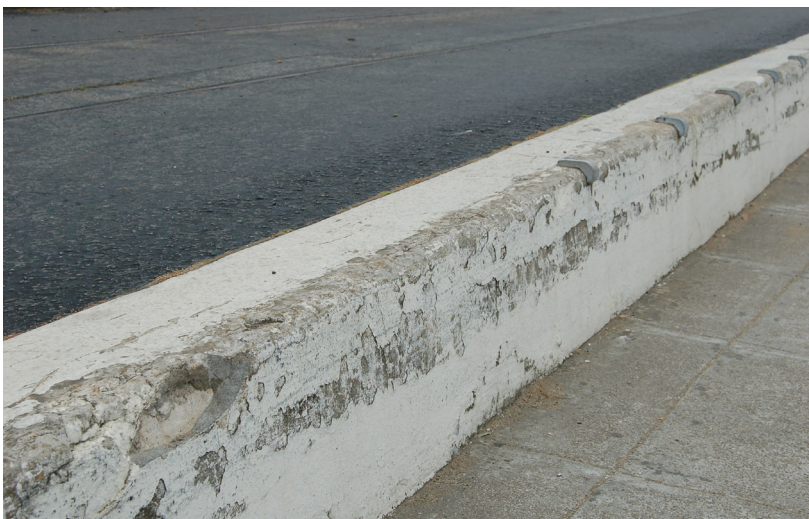
Figure 96. Flaking and loss of material along the concrete wall occurs as deterrent bolts fail and water penetrates the under layers of the concrete. Repair may require patching, reapplication of a skim-coat, or some combination. View of the east end of the wall, looking west. (NPS, 2007)

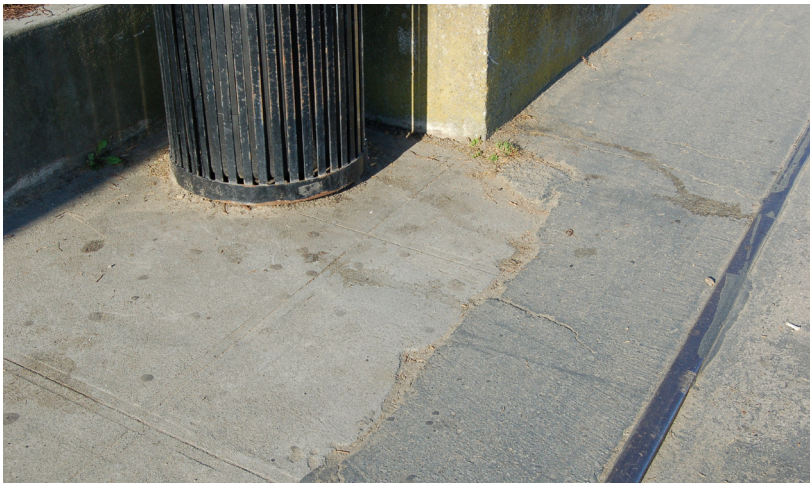
Figure 100. In some areas walkways have been resurfaced with paving added over existing layers creating a patchwork of materials. (NPS, 2008)

- paving material. (Figure 100)
 - Remove excess paving material in places where past repairs have altered the historic width, alignment, material, edge treatments, or character of the historic walkway.

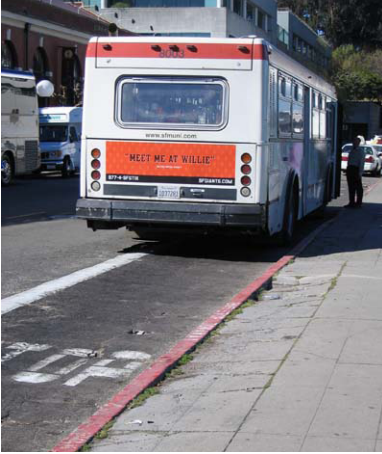
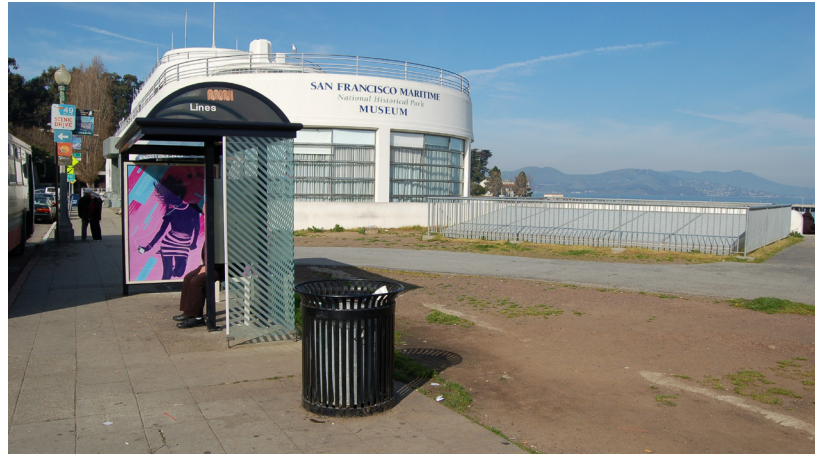
Figure 107 a&b. The bus stop located on the east side of the Bathhouse is an area significantly impacted by heavy use in a relatively compact zone. Overall, the combination of degraded concrete sidewalks, denuded vegetation, damaged concrete curbs, visually incompatible structures, and a diverse variety of small-scale features create an adverse impact to the NHL district. View from the shelter looking east along Beach Street. (NPS, 2006)

- Relocate the bus shelter north of the current sidewalk to create additional space for pedestrians waiting for the bus.
- Work with the city to relocate or remove the current bus stop as a way to mitigate impact to Aquatic Park and the NHL district.

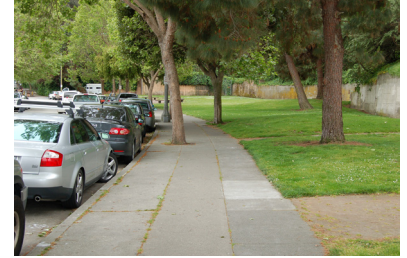
Figure 108. Displaced, cracked, and patched sidewalk along Van Ness Avenue next to Pocket Park. At a certain point, rather than patching, a holistic approach to rehabilitation of the sidewalk will assure a more uniform character. View looking south. (NPS, 2008)

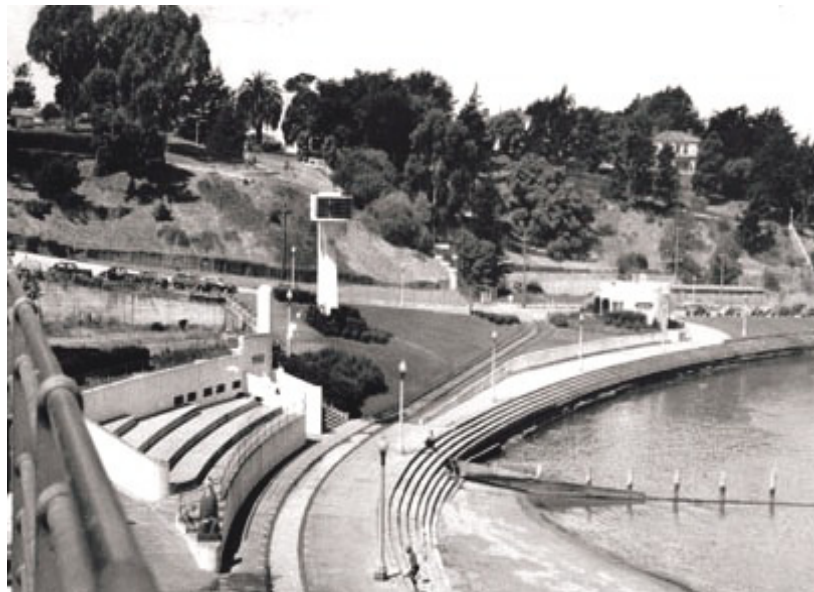
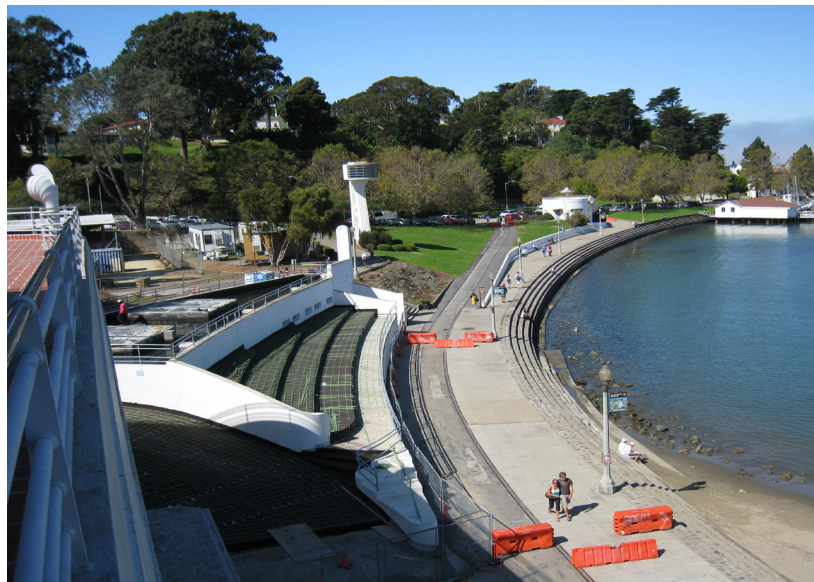
Figure 109 a&b. Comparison showing the degree to which vegetation has encroached on the slope above Van Ness Avenue (Fort Mason). Historically this area had a more open vegetative character during the period of significance for Aquatic Park. Top: view looking west, 1946. (Courtesy of the San Francisco History Center, San Francisco Public Library AAA 6697; bottom: view looking west, 2009 (NPS, 2009)
