Subject: NEPA and NHPA Clearance: 2011-041 Yosemite Valley, Correct Tecoya Dorm and Y Apartments Egress (39131)

Project: 2011-041 Yosemite Valley, Correct Tecoya Dorm and Y Apartments Egress

Hughes Associates, Inc. (HAI) has prepared this egress analysis report for Tecoya Dorms and Y Apartments to identify the existing egress conditions, identify egress deficiencies, and make recommendations for correction. The information within this report is based upon a site survey conducted on July 19, 2011 and documentation from the Condition Assessment conducted by others in 2008 for the Y Apartments. A Condition Assessment was not provided for the Tecoya Dorms. Compliance with accessibility provisions are not within the scope of services for this egress analysis and have not been reviewed.

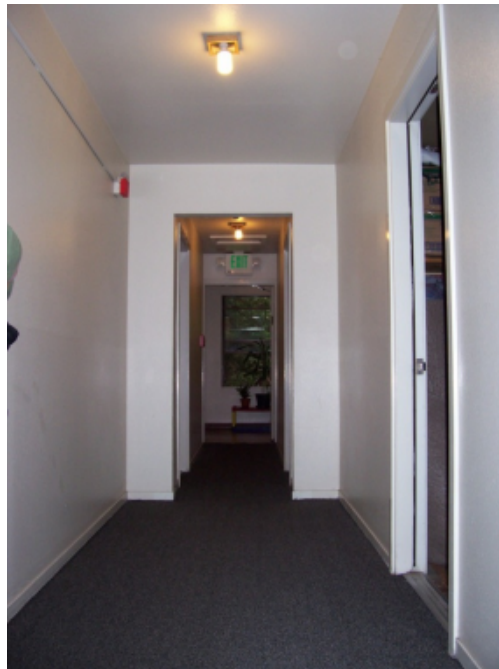
Figure 1: Tecoya A-D, Third Floor Corridor

1. Tecoya A – D, Egress Width: At the Third Floor of each of these buildings, the corridor narrows at both ends to a width of approximately 33 inches. For existing buildings, NFPA 101, Section 7.3.4.1.2 (referenced by NFPA 101, Section 29.2.3.1) permits the width of the exit access to be not less than 28 inches. Although the existing configuration complies with NFPA 101, the condition of a corridor narrowing in the path of egress travel is rather unusual. Therefore, the condition has been documented with the appropriate code reference to alleviate future concerns. The existing arrangement is also supported by CHBC, Section 8-502.2.

The Third Floor of each building serves a very small calculated occupant load of eight (8) persons. The dorm residents are non-transient occupants and are familiar with the paths of egress and conditions of egress. Because the buildings are not provided with elevators, occupants traverse the exit access path daily. Additionally, the provision of automatic sprinkler protection throughout each building is a significant enhancement to the life safety features of the building.

Recommendation: No modifications are feasible or warranted given the existing constraints of the building and occupant familiarity as noted.

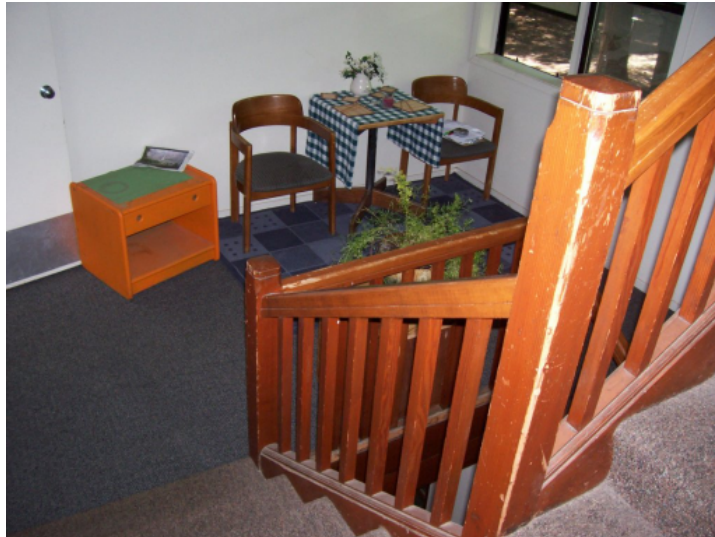
Figure 2: Door Blocked Open, Combustibles in Stairway Enclosure in Tecoya E

2. Tecoya A-F, Exit Enclosures: For the three-story buildings, the exit stairs are required to be enclosed in one-hour fire resistance rated assemblies. Door assemblies are also required to be one-hour fire protection rated and self- or automatic-closing. From visual observation only, the stairways appear to be provided with the required rating. Listing labels are provided on many of the door assemblies opening to the stair enclosure. Although many are painted, the few labels that were observed indicate one-hour fire protection rated door assemblies. For the majority of stairway enclosures however, doors are blocked open using a variety of devices such as plants, shoes, bungee cords, etc. Blocking doors open in this manner breaches the rated enclosure. (NFPA 101, Sections 29.2.2.3, 7.2.2.5.1.1 and 7.1.3.2)

- a. Provide listed or approved magnetic hold-open devices on the door assemblies to prevent doors from being blocked open by artificial methods that breach the enclosure. The magnetic hold-open devices are being incorporated into the Fire Detection and Alarm System Upgrade associated with CIF 5019 Upgrade Fire Safety to Residential and Guest Facilities.

- b. Remove all combustibles from the interior of the stairway enclosures. This item includes the small closets in Tecoya A-D that are located within the stair enclosures, directly beneath the stairway runs. Exit enclosures shall not be used for any purpose that has the potential to interfere with its use as an exit. Although combustible materials were found at many locations within the stair enclosures, the problem is prevalent within Tecoya E and F (NFPA 101, Sections 7.1.3.2.3 and 7.2.2.5.3.1). NFPA 101, Annex Section A.7.1.3.2.3 clarifies that use of exit enclosures for storage or for installation of equipment not necessary for safety is prohibited. It also states that the intent is for the exit enclosure to essentially be “sterile” with respect to fire safety hazards.

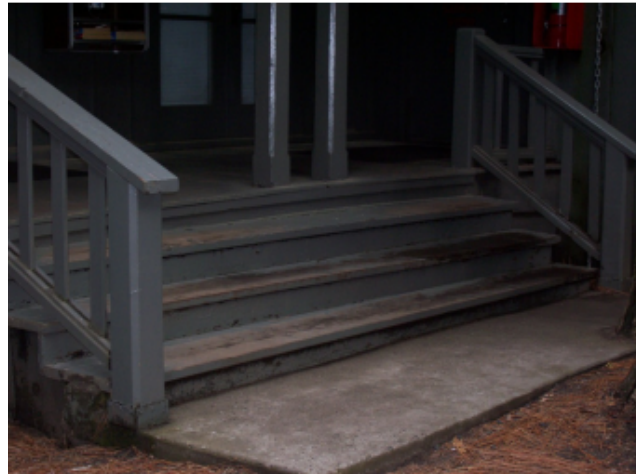
Figure 4: Stairway to Grade Between Tecoya A and B

- a. At the porch between Tecoya A and B, the exterior stairway to grade has a significant variation in the riser dimensions within the single flight. However all risers are less than 7 inches in height. Reconstruction of the stairway, with conforming handrails is recommended.

- a. Replace the stairway to grade at the porch between Tecoya A and Tecoya B to include conforming riser/tread and handrails.
- b. Replace the stairway to grade at the porch between Tecoya C and Tecoya D to include conforming riser/tread and handrails.

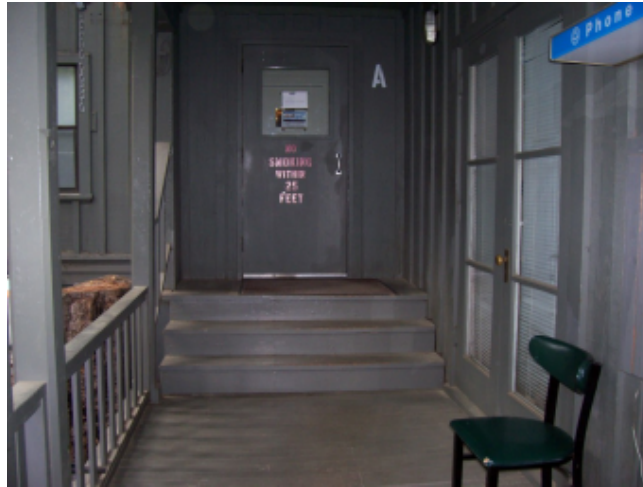
Figure 5: Discharge from South Stair in Tecoya A

- b. The three risers at the stairway located at the discharge from the south stair of Tecoya A leading onto the porch between Tecoya A and B range between 7 inches and 8.75 inches. The physical and historic character restraints at this location make it infeasible to reconstruct the stairway with maximum 7-inch risers with dimensional uniformity. However, it may be possible to reconstruct the stairway with three risers all less than 8 inches in height as allowed for existing stairways. It is recommended that at least one conforming handrail be provided for this stairway and the possible reconstruction of the stairway be considered in conjunction with the historic preservation architect.

- c. Replace the stairway at the exit discharge from Tecoya A south stairway, leading to the porch. Complete conformance for new construction may not be feasible. However, it may be feasible for the reconstruction to comply with riser/tread dimensions as allowed for existing stairways. Provide conforming dimensional uniformity between risers and treads. Provide at least one code conforming handrail. Feasibility of replacement should be discussed with the historic preservation architect during the next phase of the project. If replacement is not feasible, without impact to the historic character of the building or district, it is recommended that at least one conforming handrail be provided and treads be marked with a slip-resistant material or paint of contrasting color.

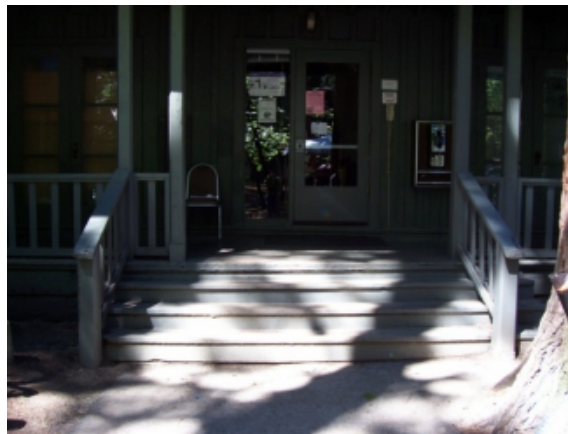
Figure 6: Stairway to Grade Between Tecoya C and D

- c. At the porch between Tecoya C and D, the exterior stairway to grade has a significant variation in the riser dimensions within the single flight, ranging between 6 inches and 8.5 inches. Reconstruction of the stairway, with conforming handrails is recommended.

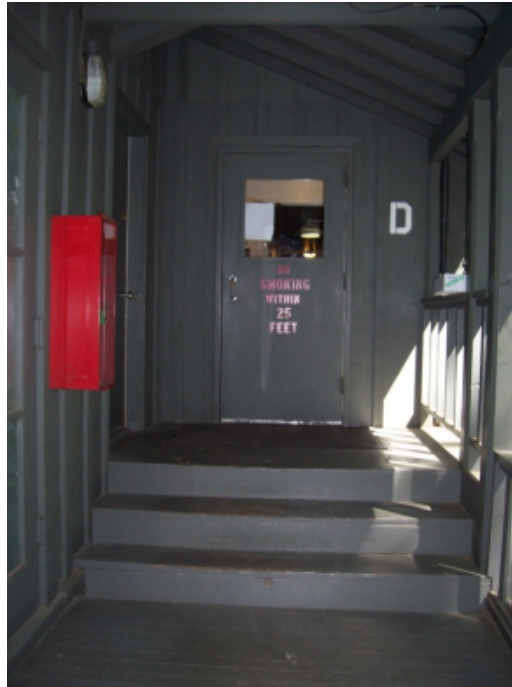
Figure 7: Discharge from South Stair in Tecoya D

- d. The three risers at the stairway located at the discharge from the south stair of Tecoya D leading onto the porch between Tecoya C and D range between 6.75 and 7.25 inches. Additionally, the treads range between 10 inches and 11.25 inches. The feasibility of reconstructing the stairway with three consistent riser and tread dimensions should be considered in conjunction with the historic preservation architect. It is recommended that at least one conforming handrail be provided for this stairway.

- d. Replace the stairway at the exit discharge from Tecoya D south stairway, leading to the porch. Provide conforming dimensional uniformity between risers and treads. Provide at least one code conforming handrail. Feasibility of replacement should be discussed with the historic preservation architect during the next phase of the project. If replacement is not feasible, without impact to the historic character of the building or district, it is recommended that at least one conforming handrail be provided and treads be marked with a slip-resistant material or paint of contrasting color.

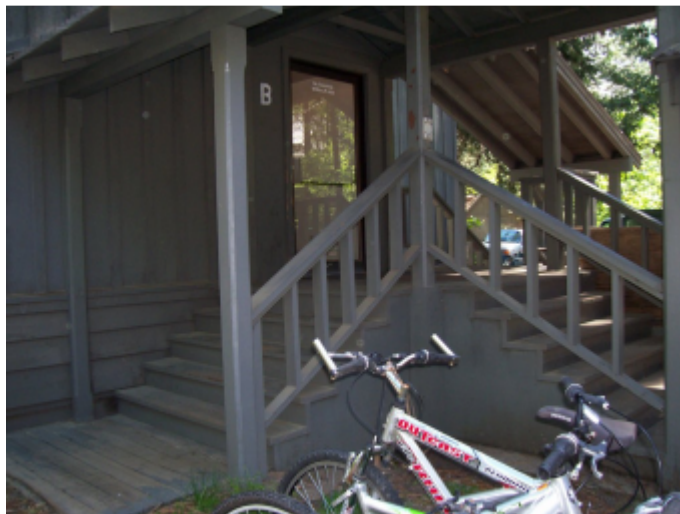
Figure 8: Tecoya "End" Stairways (Photo at B south end)

- e. At the north ends of Tecoya A and D and the south ends of Tecoya B and C (adjoining the breezeway), the exterior stairway riser and tread dimensions and variations within a flight reasonably conform to the requirements of NFPA 101. Any deviations observed were minor and predominantly due to wear on the stairway.

Recommendations: No modifications are proposed.

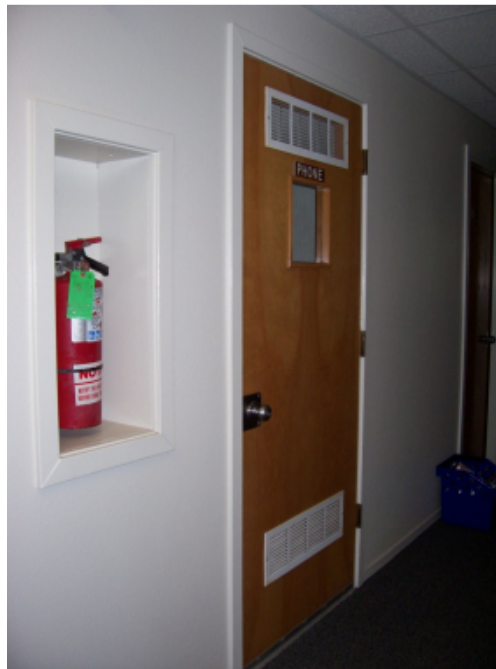
Figure 9: Tecoya E-F Phone Closets

6. Tecoya E and F, Corridor Door Assemblies: Tecoya E and F have rooms labeled as phone closets that open to the corridor. Corridor walls are required to resist the passage of smoke. Doors to these closets are provided with louvers. Although no fire-resistance rating of corridor walls is required in fully sprinkler protected dormitories, louvers are limited to the lower one-third of the wall or door height. The louvers are located in the top one-third and lower one-third of the door height. (NFPA 101, Sections 29.3.6.1.3 and 29.3.6.4.4)

Recommendation: Remove louvers from the top one-third of the door height and provide a solid barrier to resist the passage of smoke. If the rooms are no longer utilized as phone closets, it is recommended that all louvers be removed and replaced with construction that will resist the passage of smoke. Although NFPA 101 allows the louvers in the lower one-third of the door, removal is recommended, because it was observed that these closets are utilized for storage purposes.

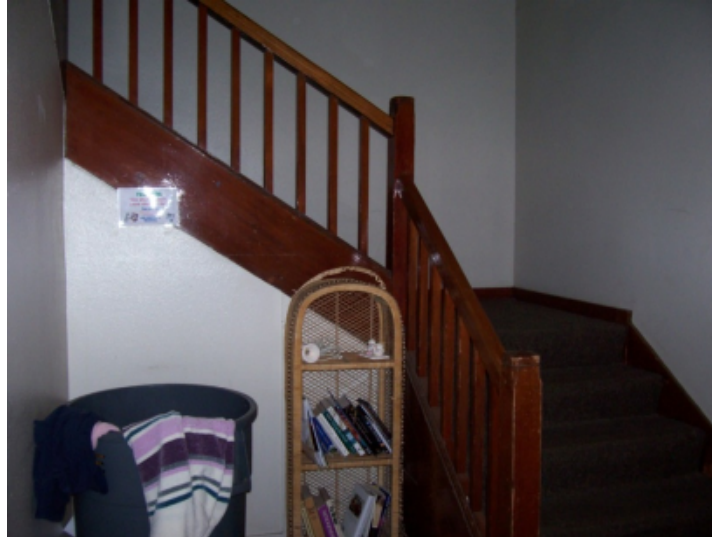
Figure 10: Tecoya E North Stairway

7. Tecoya E-F, Stairway Rise/Tread Dimensions: The interior exit stairways for Tecoya E and F are wood with carpet flooring. The risers within each flight of stairs are generally less than 7 inches in height. However, within individual flights of stairs the dimensions are not uniform and in several cases exceed the maximum 3/8-inch allowed for a single flight. It appears that part of this deviation is due to the normal “wear-and-tear” of the significant use of the wood stairways over time. This condition appears more apparent in the locations where occupants tend to regularly step on each tread.

Recommendation: The condition is not severe and does not represent a distinct hazard. The overall occupant load for the building is very low and the permanent residents utilize the stairways on a regular basis. CHBC, Section 8-502.3 specifically addresses that existing stairs with risers and treads or width at variance with the regular code are allowed if determined by the enforcing agency not to constitute a distinct hazard. The addition of automatic sprinkler protection throughout the buildings will also significantly improve the fire protection and life safety features of the building. As an existing condition with a marginal discrepancy from the NFPA 101 requirements, recommendations for modification are not proposed.

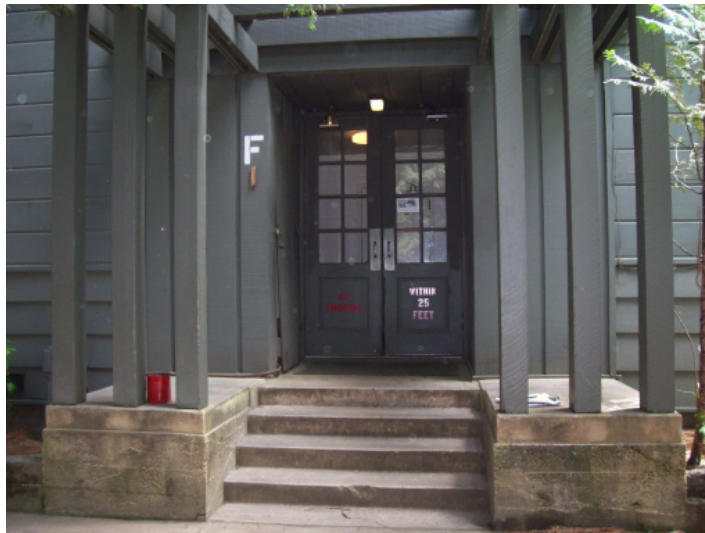
Figure 11: Tecoya F North Entrance Stairway

8. Tecoya E-F: There are no handrails on the existing concrete exterior entry stairs at the north and south entrances for Tecoya E and F.

Recommendation: Provide at least one handrail for each stairway.

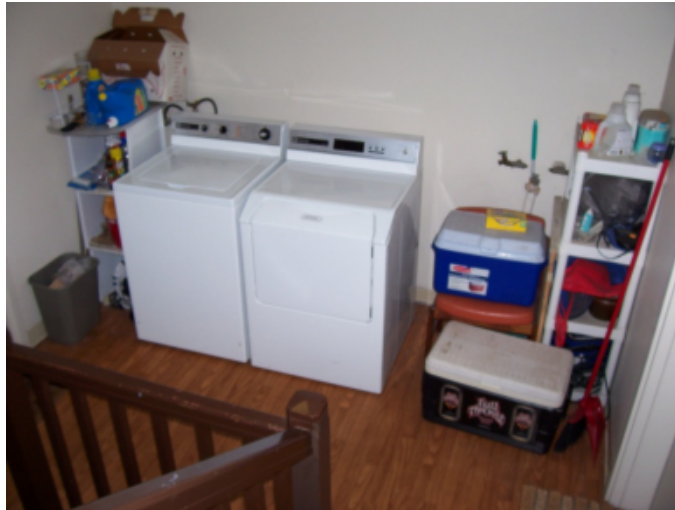
1. Laundry equipment and other combustibles are located within the north and south stair enclosures at each floor landing level.

Recommendation: Laundry equipment and all other combustibles shall be removed from the stair enclosures. NFPA 101 specifies that an exit enclosure shall not be used for any purpose that has the potential to interfere with its use as an exit. In conjunction with removal of the laundry equipment, any penetrations of the stair enclosure for venting or electrical outlets shall be properly sealed and protected. (NFPA 101, Sections 7.1.3.2.3 and 7.2.2.5.3.1)

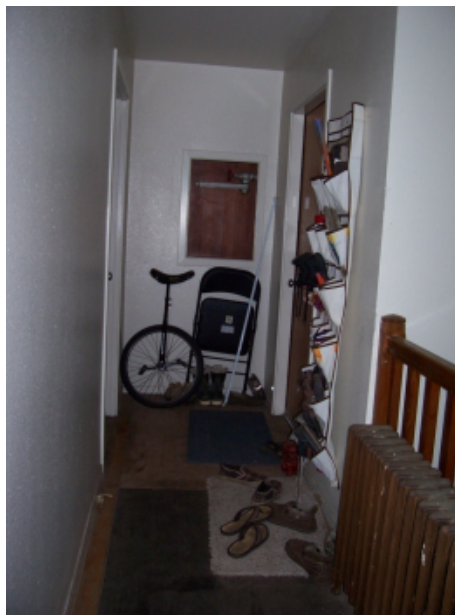
2. Combustibles are located in the center stairway landings.

Recommendation: All combustibles shall be removed from the stairway landings (NFPA 101, Sections 7.1.3.2.3 and 7.2.2.5.3.1)

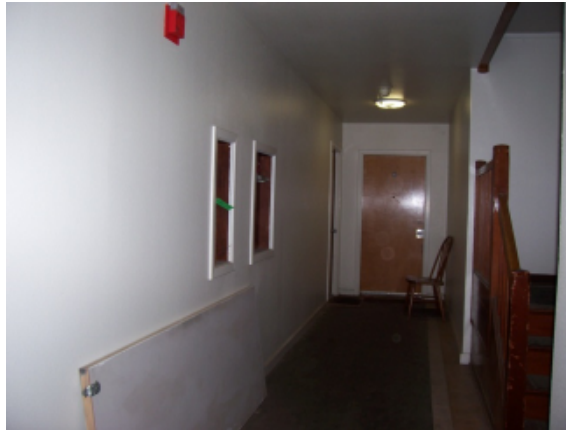
- c. The door assemblies that open to the center stairway are hollow wood door assemblies. Either self-closing devices are not provided or self-closing hinges are non-functional. It is unlikely these door assemblies afford any fire protection. It is recommended that the door and frame assemblies be replaced with self-closing one-hour fire-protection rated assemblies.

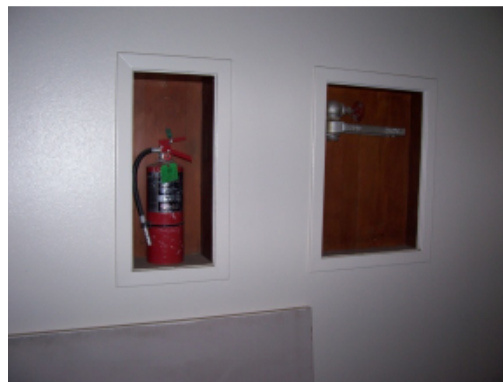
- d. Remove recessed hose cabinets and fire extinguisher cabinets located within the center stairway enclosure. The standpipe and hose is no longer required. Flush-mounted fire extinguisher cabinets can be provided. Seal the openings created by the recessed cabinets with Type X, 5/8-inch gypsum wallboard at a minimum. This will improve the fire-resistance of the stairway enclosures, although an actual fire-resistance rating of the wall assembly will not be determined.

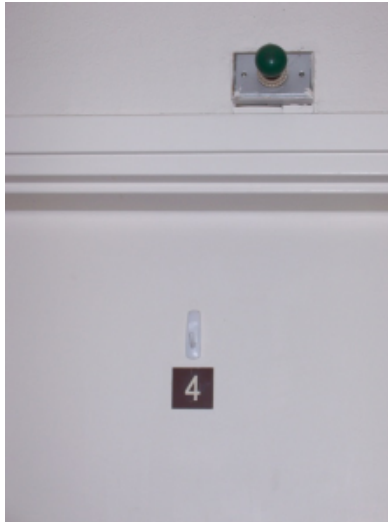
4. There are a few existing penetrations within the stairway enclosures that are either not permitted or are not properly sealed. As examples, these penetrations include an electrical receptacle for a light bulb and dryer vent lines. The observed penetrations are not allowed by NFPA 101.

Recommendation: Removal of the penetrations, patching, sealing, and painting is recommended.

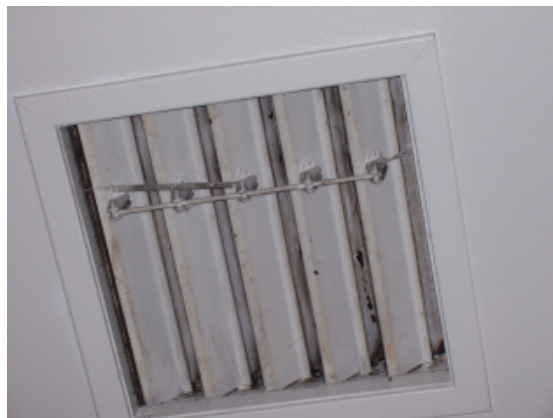
5. The north and south stairways are provided with louvered ventilation openings at the ceiling of the third story landings. The louvers are normally open, but provided with fusible link elements that will close the louver if actuated. NFPA 101, Section 7.1.3.2, limits openings in exit enclosures to door assemblies from normally occupied areas, with few exceptions. None of the exceptions recognize the presence of the ventilation louvers. Based upon conversations with DNC staff, it is believed that the louvers do not open to an attic area that spreads throughout the building, but is limited to the stair shaft enclosure area. Because the louvers are designed to close in the event of temperature rise, there is no unusual hazard associated with the presence of the louvers.

Recommendation: Recommendations for modification are not proposed.

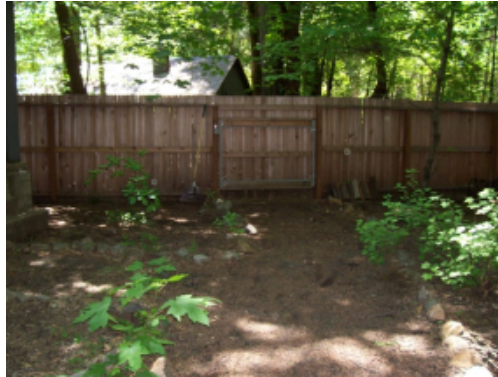
6. The grade level discharge from the center stairway occurs through a fenced yard. There are two gates that lead to the public way from the yard. The gates swing against the direction of egress travel and the locations are not obvious because the design is consistent with the adjoining fence material. The gates are remotely located from the building. It is extremely unlikely that an untenable environment will be created within the yard due to the size of the yard, ability to move away from the building and that the yards are open to the sky above. The occupant load utilizing the gates is extremely low. Therefore, retaining the gates that swing against the direction of travel offers a reasonable level of life safety.

Recommendation: Provide appropriate egress hardware and differentiate the gate locations from the fencing materials to be obvious to occupants of the building. This can be accomplished with permanent weather-resistant signage.
