Canal Lockkeeper's House

Historic Structure Report

National Mall and Memorial Parks
Washington, District of Columbia

Prepared by:
QUINN EVANS ARCHITECTS
August 2011

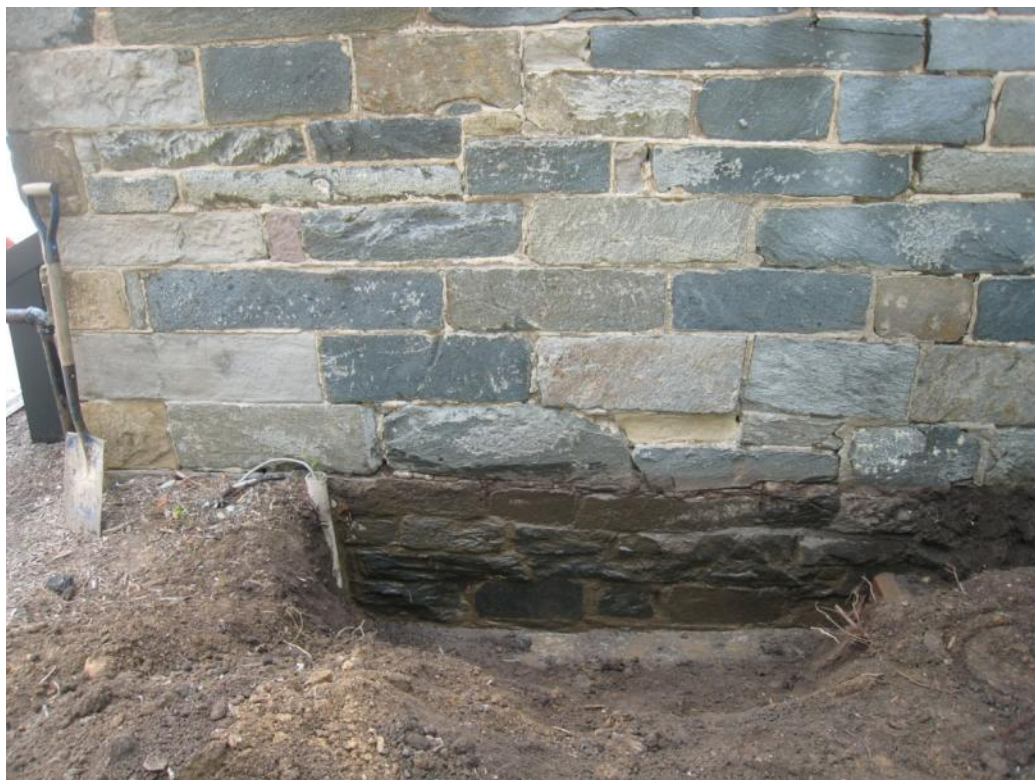
Figure 1.1.22. Test pit along the west elevation near the northwest corner (QEA, July 20, 2010). A long, thin stone similar to the others was not found at this location.

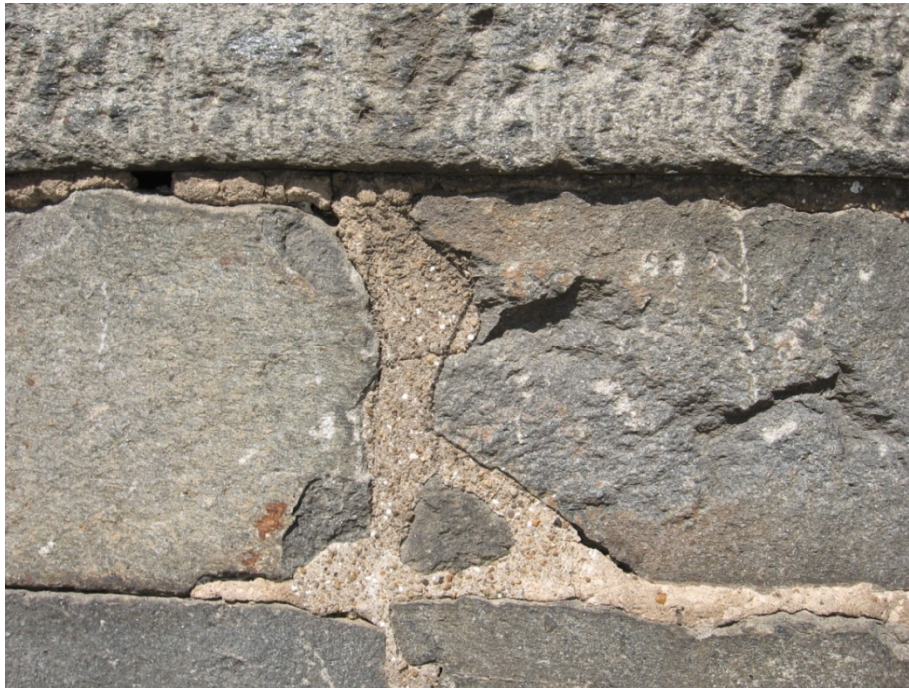
Figure 1.3. 7 Photograph of mortar located on the south elevation. This mortar is a crudely struck with large aggregate. It consists of yellow, brown, and white aggregate and tan sand. The aggregate is similar to that used in 1915 foundation and the mounting block.

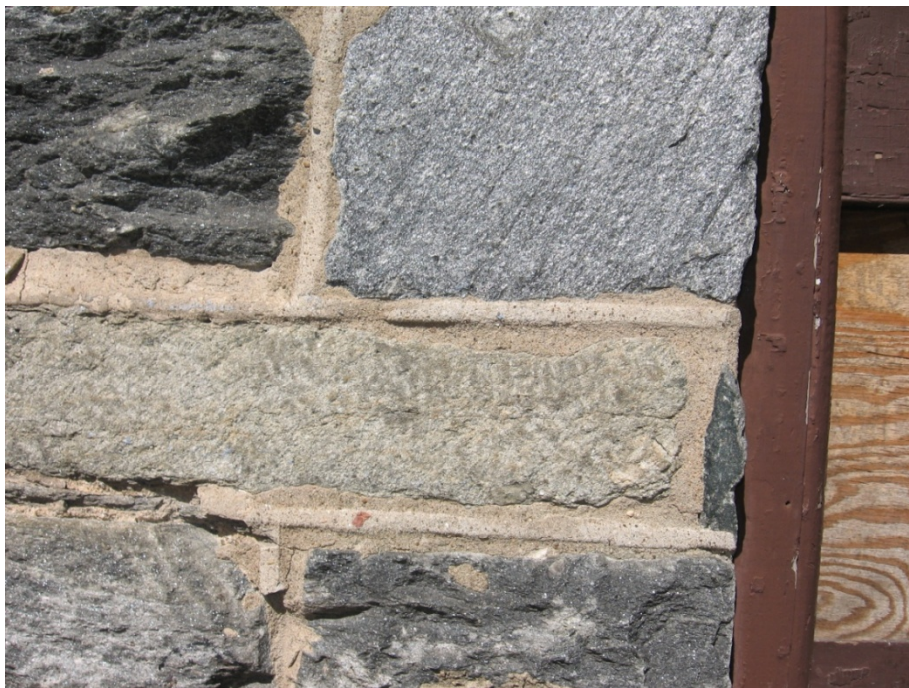
Figure 1.3. 8 Photograph of mortar found at both sides of south door. This is a raised profile mortar of medium aggregate brown, beige, white, and tan on top of darker beige. This may be the desired final appearance. This mortar probably dates to when the south door masonry opening was cut, probably during the 1916 renovation.

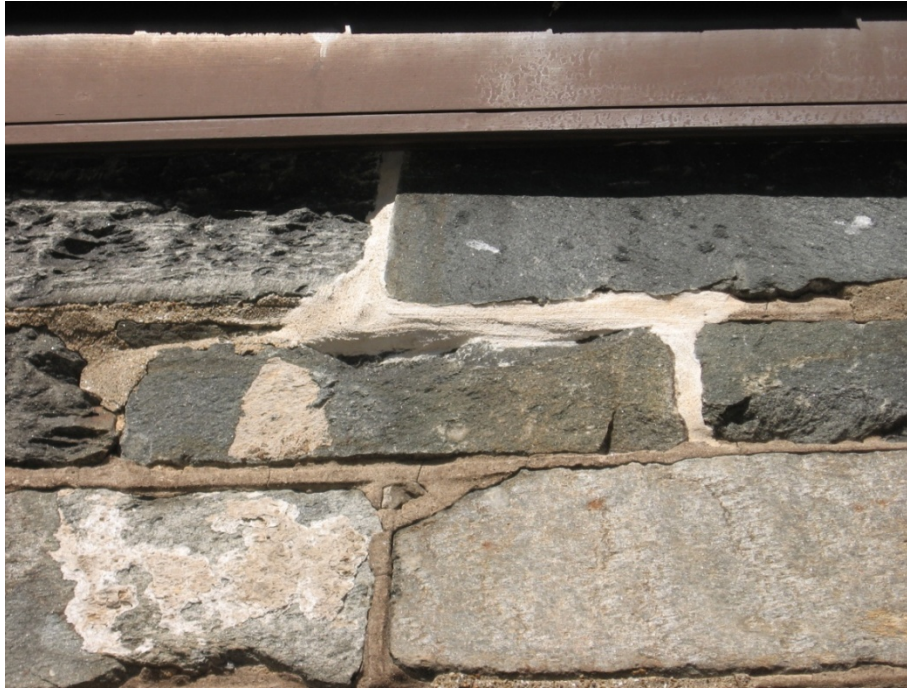
Figure 1.3. 9 Photograph of a very fine white mortar found on a couple of locations of the south elevation, obviously a replacement mortar.

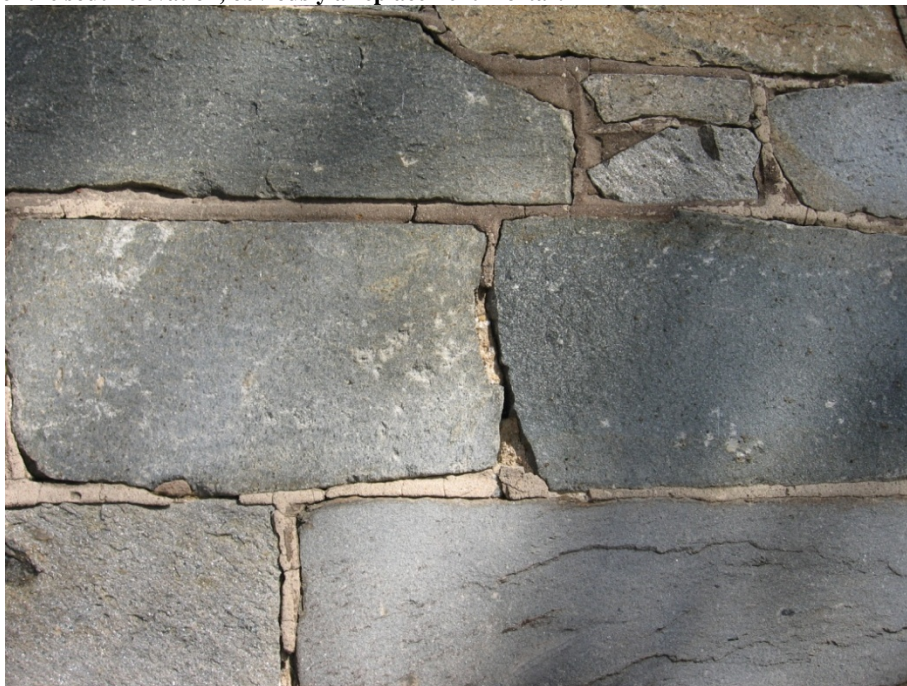
Figure 1.3. 10 Photograph of a mortar located on both east and west elevations that has a thin layer of brown mortar on top of a tan fine aggregate mortar.

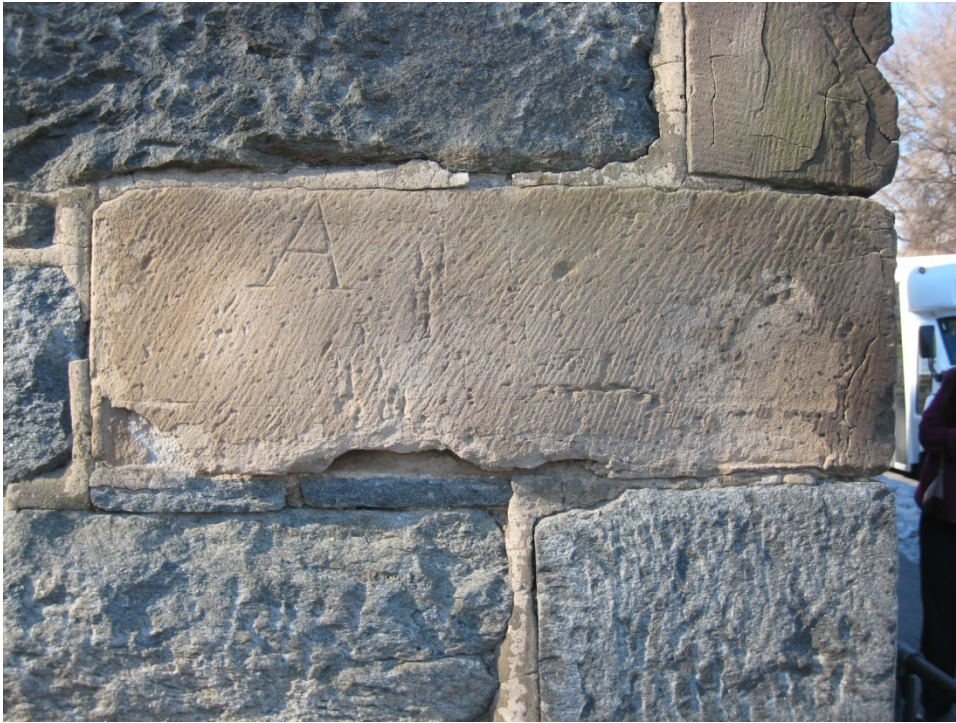
Figure 1.4. 1 Sandstone quoin at northeast corner (QEA, 2009). Note the "A" graffiti.

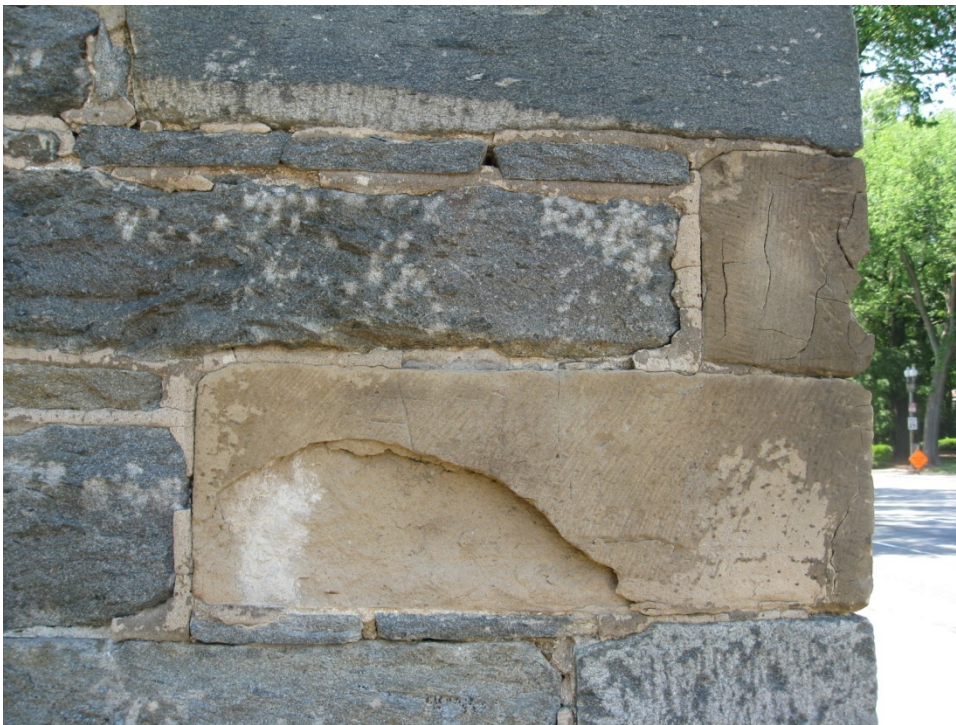
Figure 1.4. 2 Sandstone quoin at northeast corner (QEA, 2011). Note how the spalling stone is even more deteriorated in just two years.

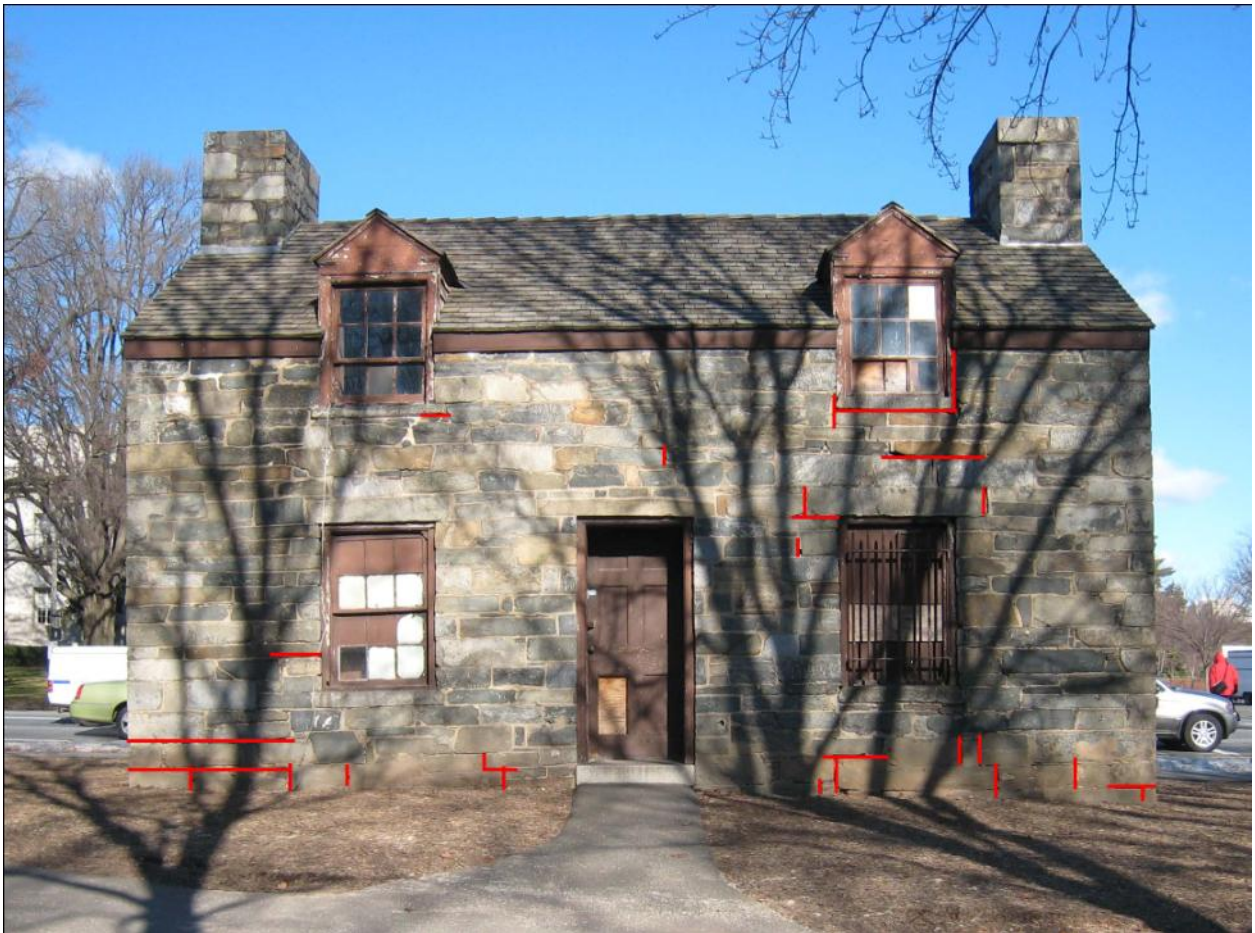
Figure 1.4. 3 South elevation of Lock House B of regularly coursed uneven ashlar stone (QEA, 2009). Red indicates large joint cracks from loss of mortar. Note the plywood panel in the door, the painted lites, and the plywood in the southeast dormer.

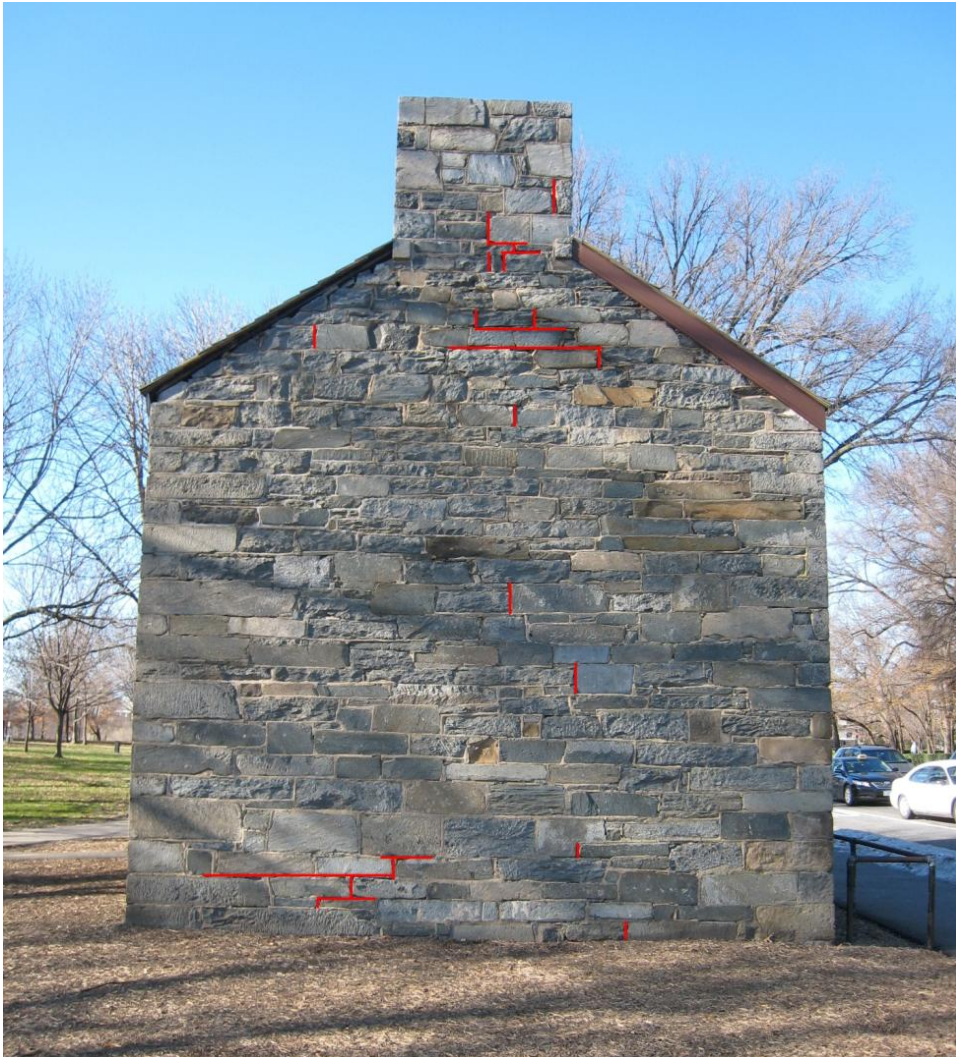
Figure 1.4. 4 East elevation of Lock House B with randomly coursed ashlar stone (QEA, 2009). Red indicates joint cracks. Note the missing barge board at the gable.

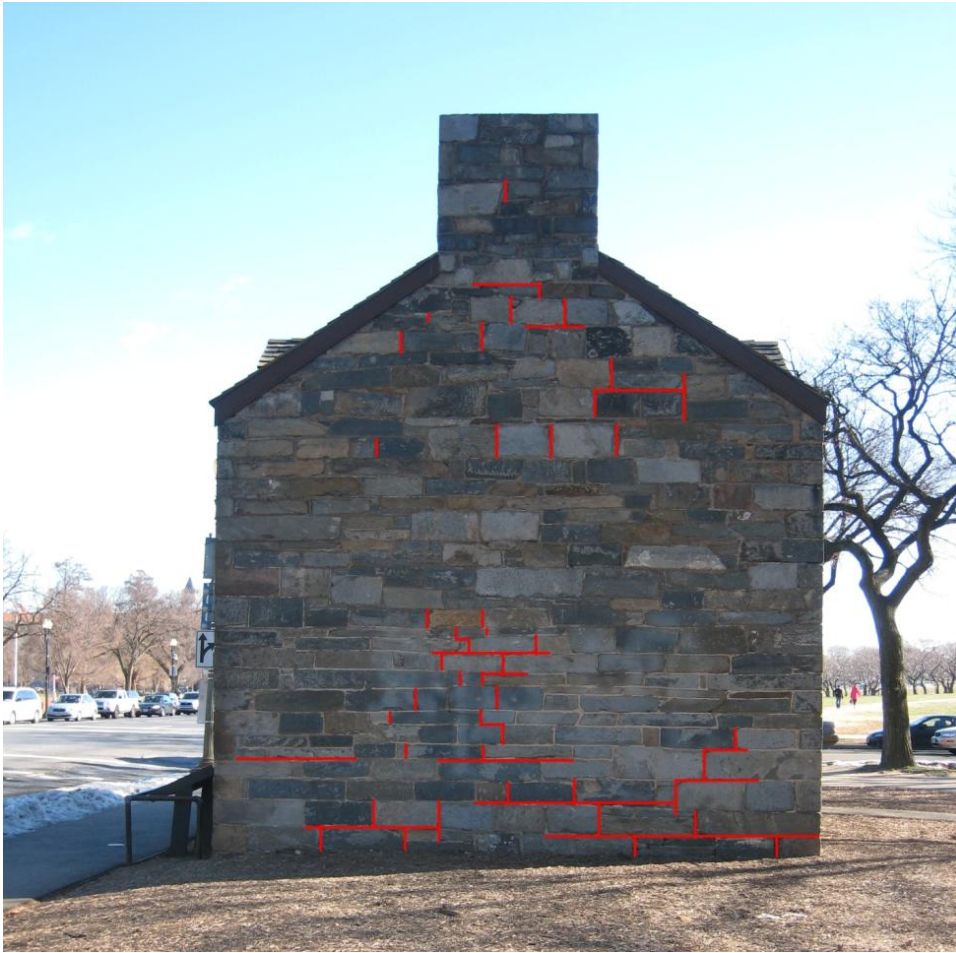
Figure 1.4. 5 East elevation of Lock House B with randomly coursed uneven ashlar stone (QEA, 2009). Red indicates large joint cracks due to loss of mortar.

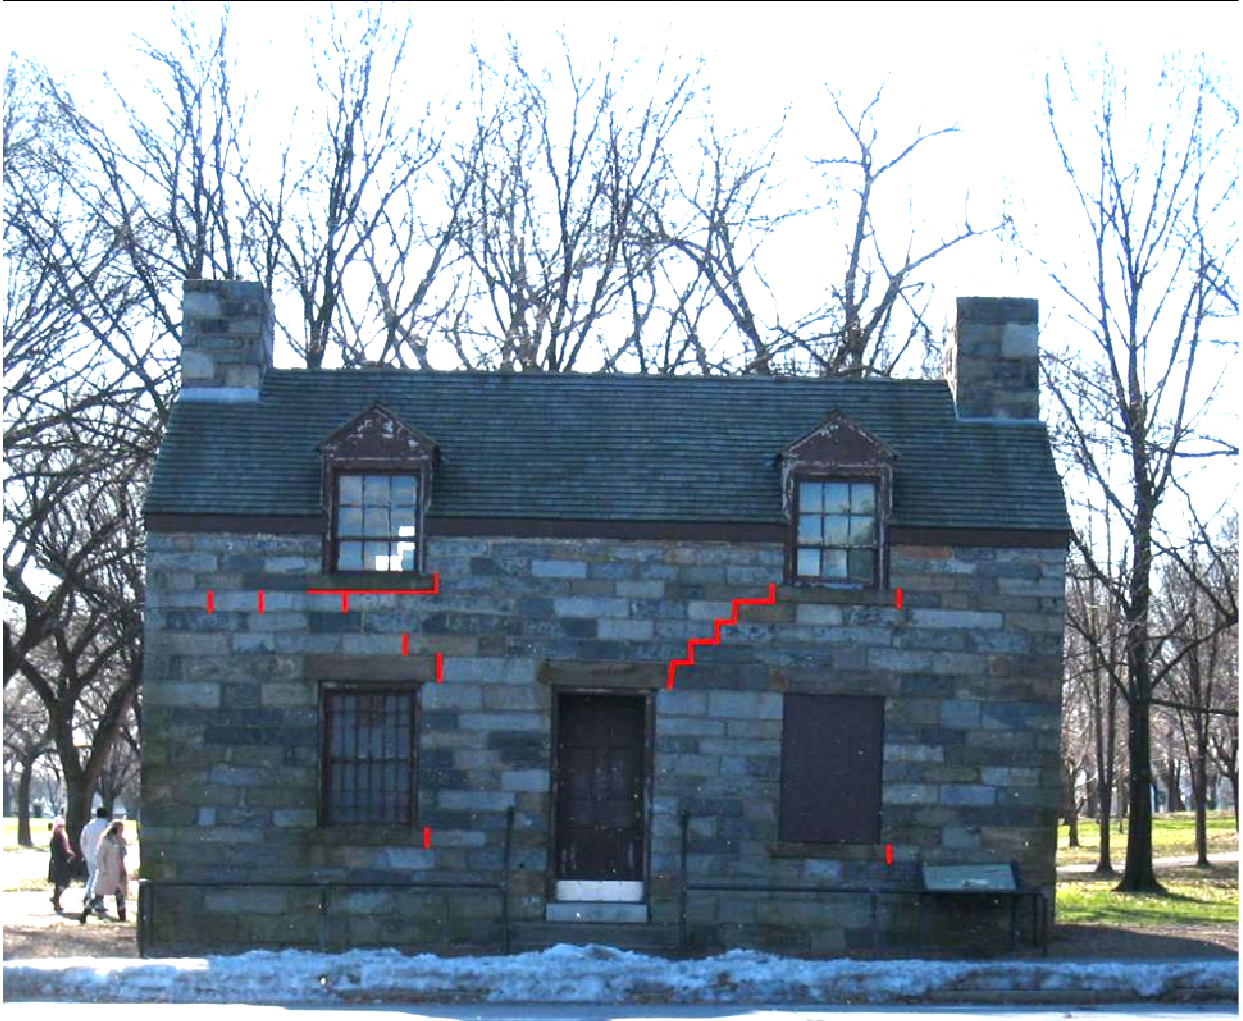
Figure 1.4. 6 North elevation of Lock House B (QEA, 2009). Red indicates large joint cracks between the regularly coursed ashlar stone.

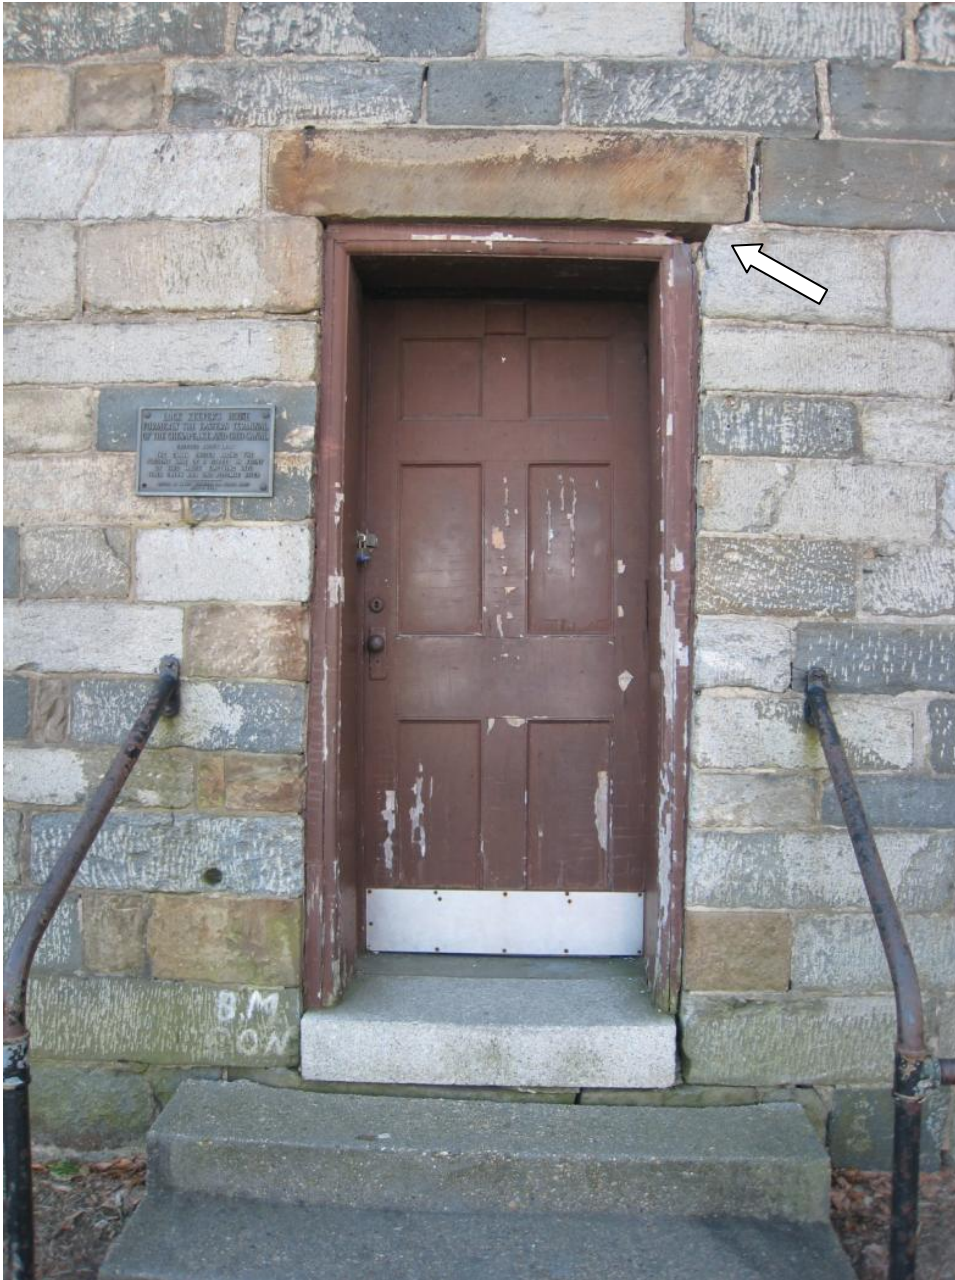
Figure 1.4. 7 North door (#101) (QEA, 2009). Note the large gap at the top right of the frame and the graffiti at the bottom left. The graffiti has been there since at least 1943. It is visible in photos that date to that year. There is a hole to the left of the door from the previous pipe railing. Also note the addition of a kickplate and padlock.

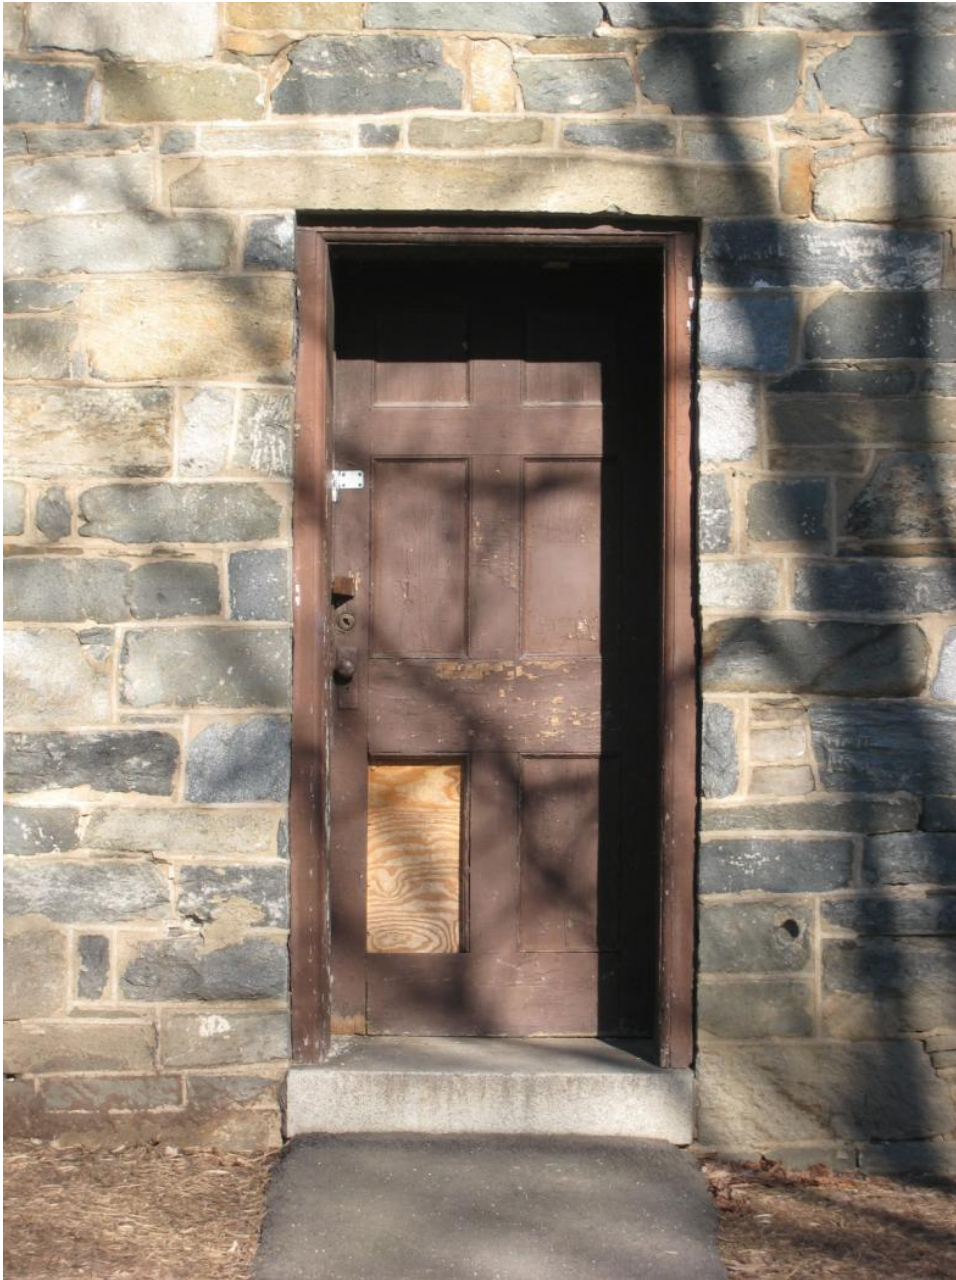
Figure 1.4. 8 South door (#102) (QEA, 2009). Note the hole in the stone on the right from an earlier pipe railing.

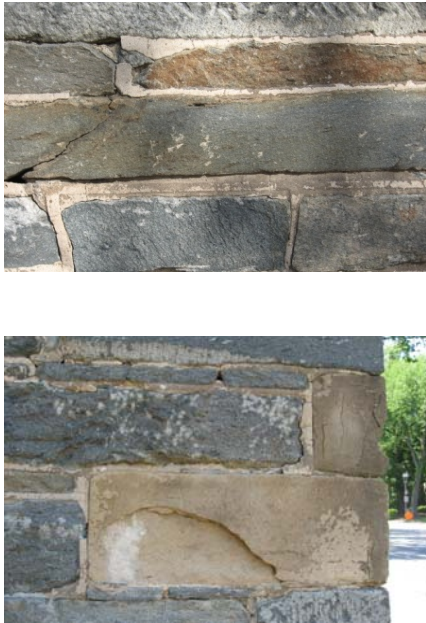
<p>The majority of the stone is a locally quarried metamorphic stone in the gneiss family. This material would have similar properties to granite. It is a superior building stone which generally exhibits little deterioration from weathering. Colors range from dark blue, black and also include medium beige and brown tones.</p> <p>There are a handful of beige-colored wall stones that may be Aquia Creek sandstone. They have suffered severe surface erosion. The non-sandstone stonework could be cleaned, but otherwise, is in very sound condition.</p>
Mortar Joints

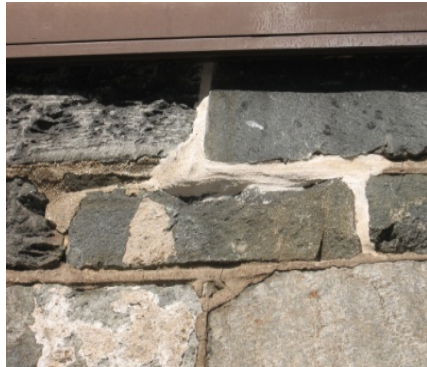
<p>There are many (perhaps more than 5) types of mortar present. This image illustrates three of the more common ones: the brighter white is relatively recent, the raised rope joint is fairly prevalent, and in the upper left, the mortar has exposed aggregate piece the size of small peas.</p> <p>Virtually all of the mortar appears to be from the 20th century in that it is hard and firm, probably with a good quantity of Portland cement.</p>

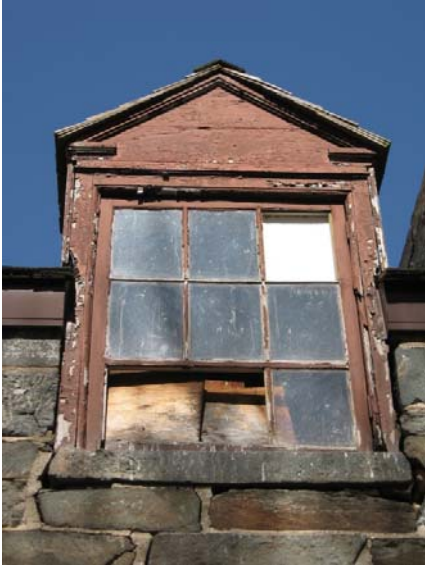
<p>The condition of the paint coating on many elements is poor. Most exterior wooden elements were installed in the restoration of 1916 which also most likely included the sashes. This has exposed these elements to the weather. It is possible that wood rot is present, but now invisible. The technology to repair and recondition wood and paint coatings is well understood. Several of the glass panes and a muntin are missing and should be replaced. The remaining panes should receive new glazing putty. Once complete, these treatments can provide continued satisfactory service life.</p> <p>Prior to rehabilitation, every piece of exterior wooden trim should be probed to confirm condition and uncover hidden damage.</p>

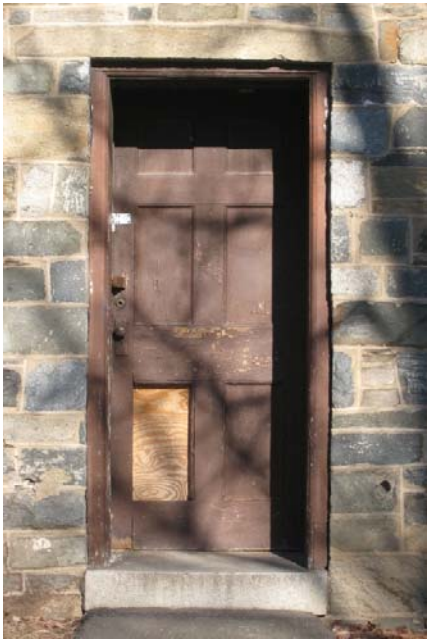
<p>These elements also installed in the NPS restoration of 1916. See above for treatment recommendations.</p>
