**Everglades National Park
Monroe County, FL**

**Engineering Analysis and Feasibility
of
Repairing or Replacing Failed Dams
and
Limiting Salt Water Intrusion in Cape Sable
Everglades National Park**

**Prepared by:
URS Corporation Southern
7650 Corporate Center Drive, Suite 401
Miami, Florida 33126-1220**

April 2012

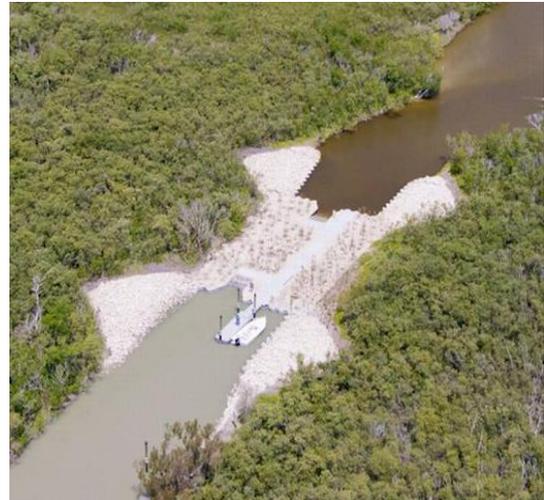
Photo 1 – Reconstructed East Cape Dam

The failed dams on the Homestead and East Cape Canals have been recently replaced in October 2010 through March 2011, with 100 foot long earthen structures bounded at each end by two sheet pile bulkheads and rip rap armoring with sheet piling along the banks on all four corners. **Photo 1** shows the re-constructed East Cape Canal extension dam. These structures were designed to last 50 years under normal overtopping events and have substantially reduced saltwater intrusion and freshwater loss from the interior marshes while also addressing safety and illegal access issues. With the completion of these dam replacements, it is envisioned that drainage flows out of the Cape Sable interior areas will occur via other drainage features such as the currently open Raulerson Canal, East Side Creek and other more northern natural discharge routes.

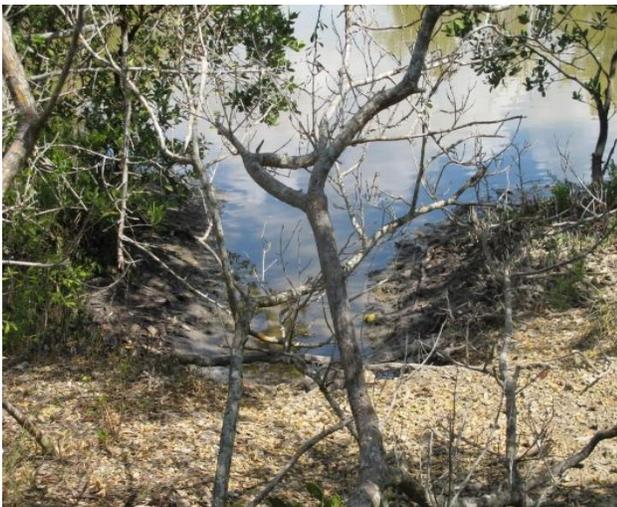
2N - North Side Dam Erosion

It is somewhat apparent that the dam plug is being frequently used by crocodiles moving along the ditch and over the ditch/dam plug. As shown on **Photos 2N and 2S**, a worn path with eroded side slope slides are clearly evident on the top of the plug and the north and south sides of the plug fill respectively. It is postulated and it appears that some of the experienced erosion is potentially associated with the claws of crocodiles digging into the fill sides slopes of the plug as they crawl over the plug area. The loosened fill is then eroded away by a combination of factors including rainfall, higher water level rises on the sides of the dam plug and the long term downslope movement of loose material as the crocodiles move up and down the dam slopes. However, additional reported observations by others who have periodically visited the dam site over the last several years have indicated that there was some accelerated erosion of the dam slopes as the result of storm surge events since 2005 primarily believed associated with Hurricanes Katrina and Wilma.

The north side of the plug is less vegetated as shown in **Photo 2N** above and in general, the observed erosion has propagated to a more significant degree into the dam section compared to the south side of the plug. The House Ditch width is also much more sizeable north of the dam plug and it is possible that some small wind driven wave action may also be contributing to the dam plug erosion on the north face of the dam during higher water level conditions in the interior marsh. The north side erosion are appears to be about 8 to 9 feet in width, in excess of 10 feet in length and on the order of 3 feet deep north of the dam.

As indicated earlier, it is important to note that this ditch plug has likely experienced several storm surge and overtopping events since the mid - 1900s and more recently since the early to mid-2000's. That being said, the observed existing erosion conditions are considered manageable at the present time and for the foreseeable near future. However, over the longer term with anticipated sea level rise over the next several decades, such overtopping events may become more frequent and problematic and the potential for accelerated erosion at this dam site as well as other low lying areas in the region will increase in future decades. Without remediation, the erosion will eventually propagate through

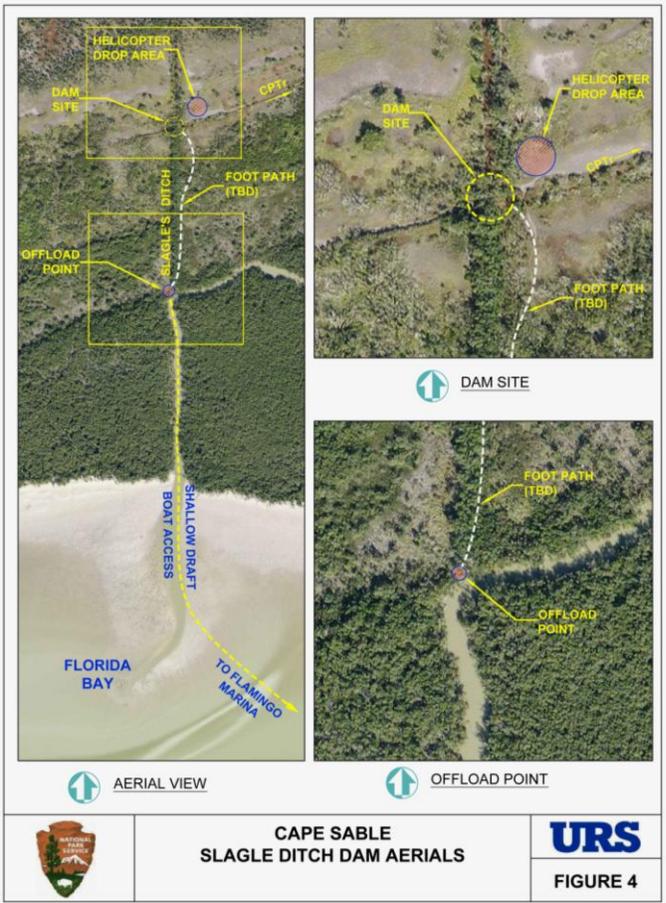
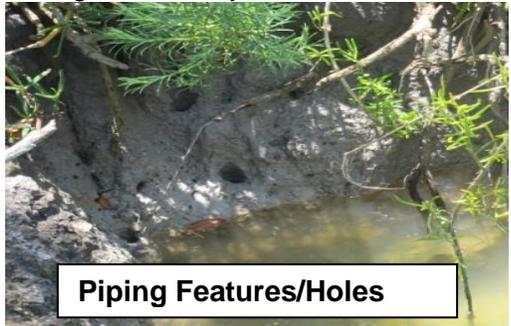
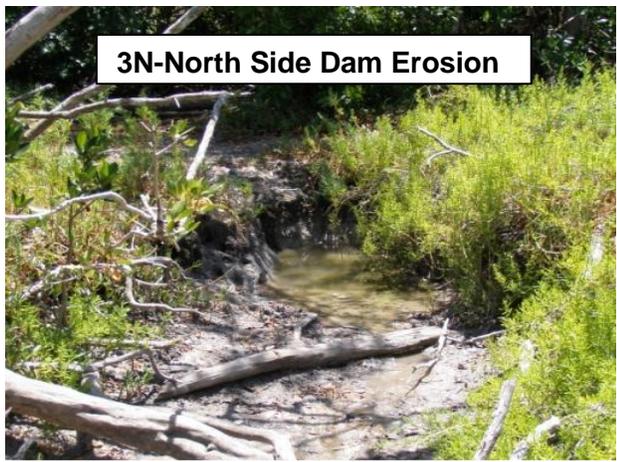
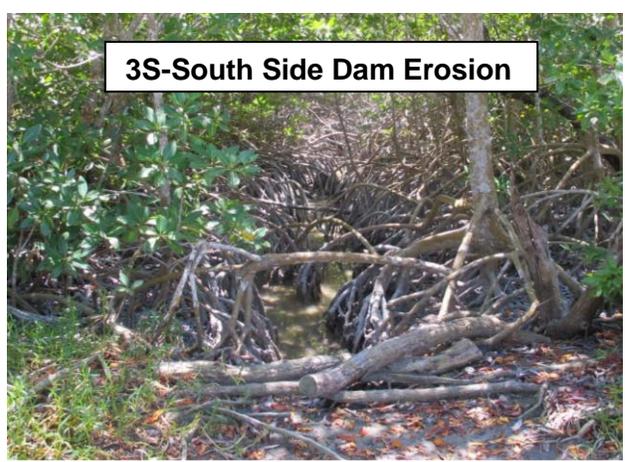
Photo 3 – North & South Views of Slagle’s Ditch Dam Erosion

The earthen dam on Slagle's Ditch as shown in the **Photo 3** picture set below has been eroding at an apparent more significant rate compared to the House Ditch dam and in August 2009, the first sign of lateral seepage was noticed thru the dam in small side erosion piping features/holes. During an inspection performed in December 2011, water was observed to be seeping/flowing through a number of golf ball to fist sized holes running horizontally thru the dam.

These holes appear to have been initially excavated by small to medium sized crabs on the north side of the dam fill. Such crabs are typically found in the region and they are known to borrow into the softer limemud ground beneath the upper compacted dam fill. It is also possible that macro-pores and flow conduits associated with decayed root systems may be contributing to the observed seepage. The December 2011 field inspection indicates that the dam cross-section is currently only partially intact but the remaining cross-width has been reduced to roughly 10 feet.

Now that seepage water is observed to be potentially propagating through the Slagle earthen dam plug, concern is expressed that the remaining portion of the dam plug could become quickly eroded and the ditch dam structure could potentially fail in a few years, if not sooner. Of the two, House and Slagle Ditch dams, the Slagle dam plug is in the worst erosional condition, is of imminent pending breach failure and in need of the most immediate attention and remediation of the eroded conditions.

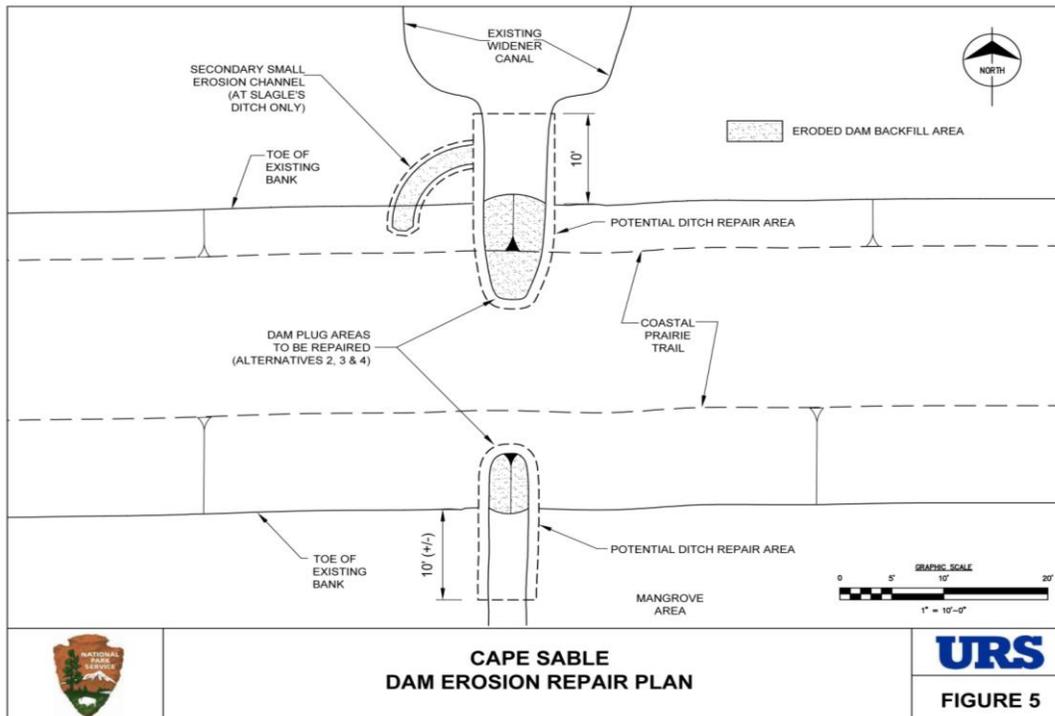
Figure 5 presents a conceptual plan view of the erosion occurring at the House and Slagle Dams which is in need of repair.

While the dams are of a similar nature, there are some important distinctions between them that are important to re-highlight. The House dam is more intact however, the erosion area and ditch

continuation south of the dam are more pronounced and are frequently used by crocodiles moving along the ditch and up and down the dam slopes. As shown in previous **Photo 2**, the north House ditch and erosion area are relatively open and readily accessible. At the Slagle dam, as shown in **Photo 3**, the south ditch and erosion area is much smaller in size and is heavily overgrown with Mangroves and their root systems. The previous Slagle ditch alignment is minimally evident south of the dam and it is likely that only smaller crocodiles would be able to make their way through the Mangrove root system if at all. The north Slagle's dam erosion is more extensive compared to the House dam, has propagated further into the dam section and is exhibiting signs of seepage and piping through the dam fill. In addition to the main ditch path leading up to the dam, a secondary erosion channel has developed on the north and west side of the dam. Smaller seepage features were also noted in the eroded dam face at the end of this secondary feature. Both of these erosion features would need to be mitigated.

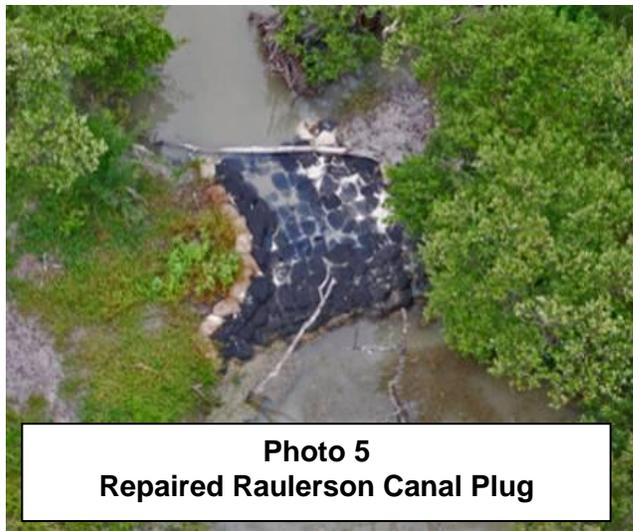
Photo 5
Repaired Raulerson Canal Plug

Two separate repair efforts have been undertaken on the Raulerson Canal since the initial breach occurred. The first repair was in December 2007 and the second repair was in March 2008. During the second repair effort as shown in **Photo 5**, Everglades National Park maintenance staff used approximately 100,000 pounds of material (760 sand bags, 1240 bags of Sakcrete, wire baskets, and geo-fabric) to restore the canal dam/plug to its former dimensions.

The plug reportedly settled somewhat over the next several months and inspectors noted some signs of erosion on the marine face of the plug and some evidence of seepage piping through the plug in the summer of 2008.

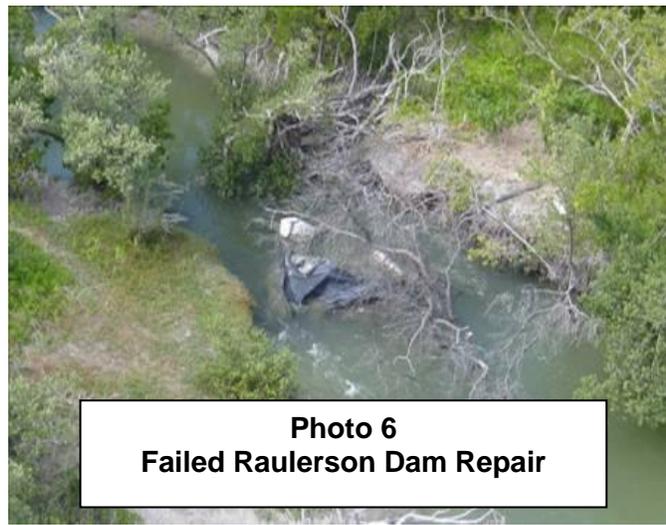
Photo 6
Failed Raulerson Dam Repair

By the fall of 2009 as shown on **Photo 6** the repair had failed catastrophically and salt water was observed flowing freely through the canal. As of November, 2010, the breach was roughly 20 feet wide and nearly the same width as the canal. Inspection of the breach and canal in December, 2011 indicated the canal and breach had widened further to approximately a 25 foot width.

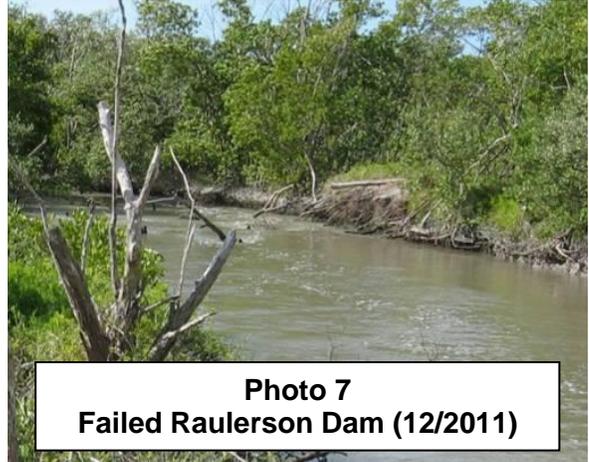
As shown in **Photo 7**, the Raulerson Canal continues to erode rapidly and the volume of salt water entering the interior marshes, and volume of fresher water flushed from the marshes, is expected to also increase. This is the same scenario that existed with the failed Homestead and East Cape Canal Extension dams before the recently completed dam projects blocked flow through these canals. The increased salinity resulting from the failed Raulerson Dam will most likely lead to degraded habitat for juvenile crocodiles and wading birds in the northern portion of the Cape Sable interior marshes. This area is vital habitat for the population of small fish that serve as the food base for roseate spoonbills, wood storks, and other wading birds and game fish. Furthermore, the breach is now large enough for motorized and other vessels to pass through, opening the door to illegal access to the Cape Sable wilderness. The failed dam debris remaining in the canal represents a safety hazard to anyone trying to boatover the failed dam plug and adjacent areas.
