Chapter 3. Existing Condition and Analysis / Affected Environment

1 This chapter presents the summary and
2 analysis of the current condition of the
3 archeological landscape of Hopewell
4 Culture NHP. Narrative text, diagrams, and
5 photographs describe the existing condition
6 using a series of landscape characteristics.
7
8 The condition assessment is undertaken to
9 understand the archeological landscape as
10 a whole. It identifies and documents those
11 qualities and features that contribute to the
12 park's historic character, retain integrity,
13 and contribute to the significance of the
14 landscape. Field reconnaissance, undertaken
15 in October 2014, assisted in the recording of
16 the archeological landscape.
17
18 This chapter is organized to present the
19 existing condition and analysis evaluation
20 for the study area first, which includes the
21 evaluation of landscape characteristics that
22 relate to the study area as a whole. This is
23 followed by a condition assessment and

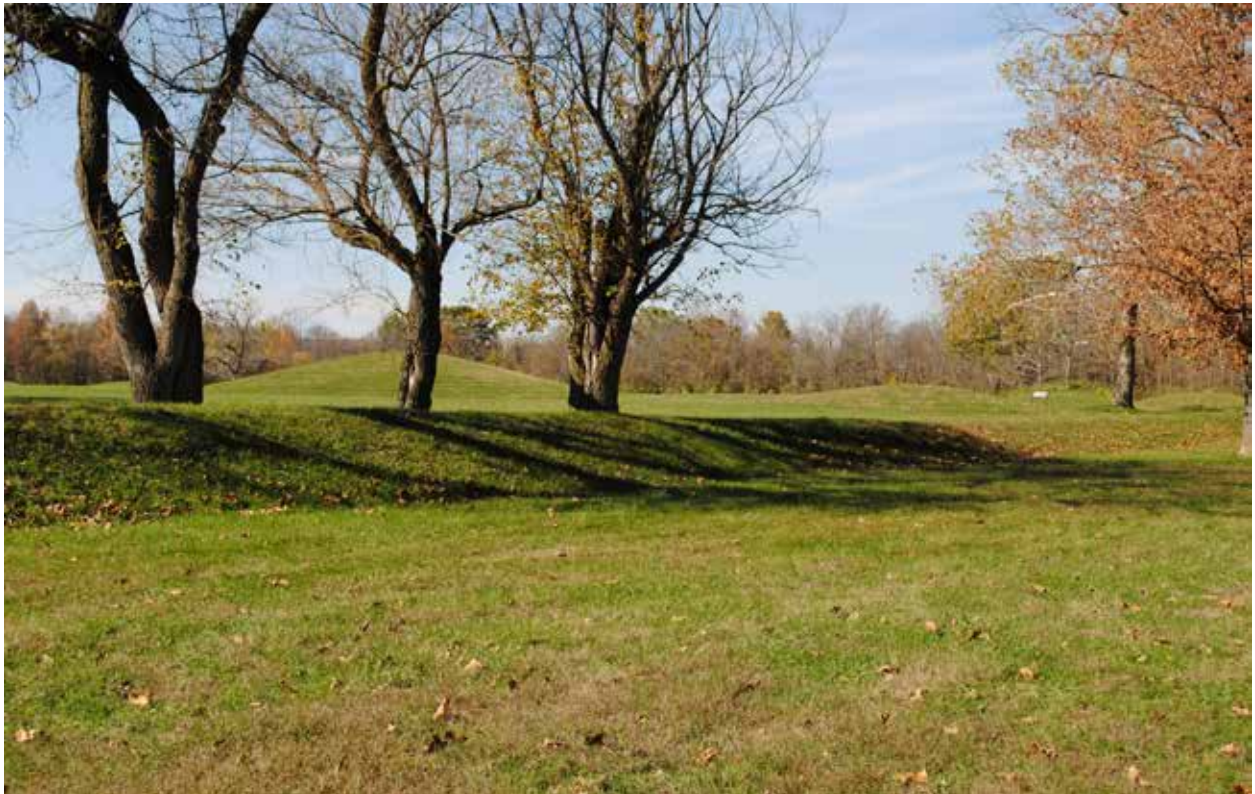
36
37 The reconstructed mounds are vegetated
38 with mown lawn. The above and below-grade
39 portions of the mounds are in good condition.
40 However, they continue to be impacted by
41 foot-traffic and mowing. Roots of mature
42 trees within the enclosure maybe negatively
43 impacting extant below-grade features.

Figure 3-36. Mature trees occur on the earthen wall and may be negatively impacting the archeological landscape. (Mundus Bishop 2014)

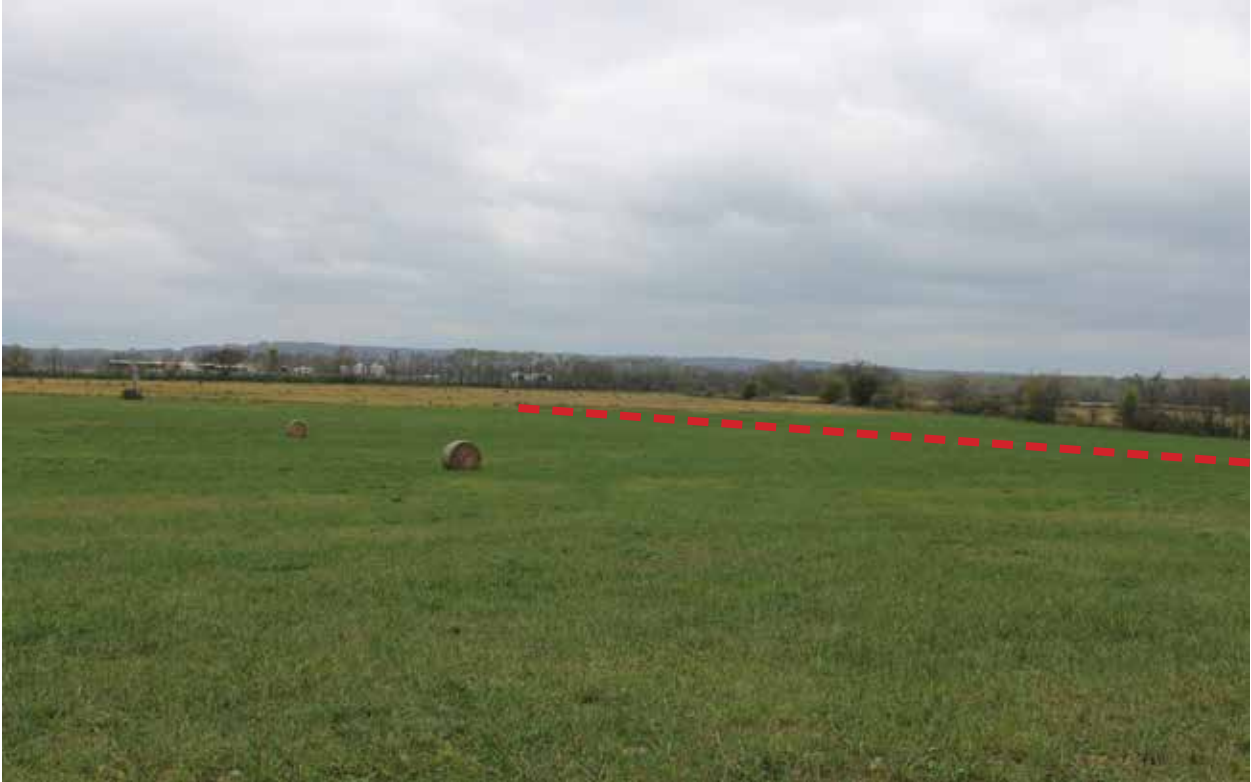
Figure 3-55. Within the circular enclosure, looking northwest, October 2014. Edge of the Great Circle is barely perceptible along the dashed line. (Quinn Evans Architects 2014)

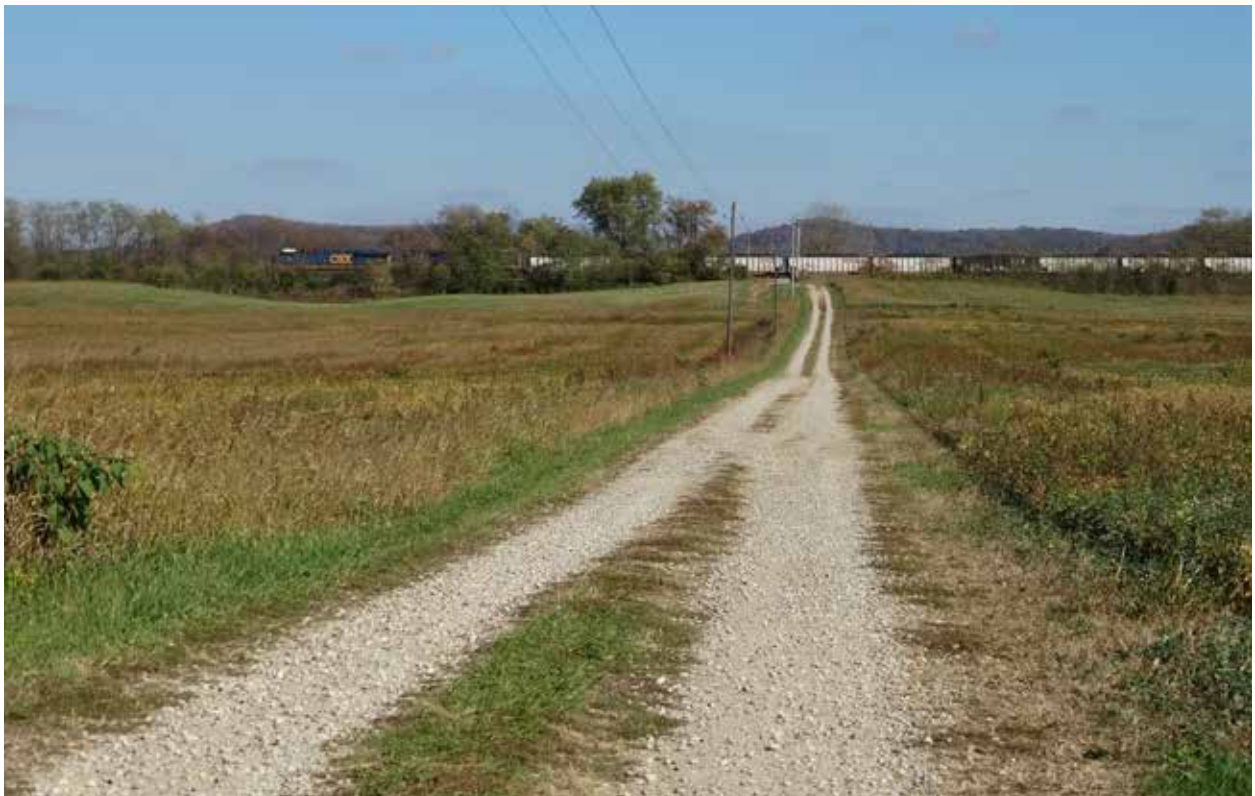
Figure 3-59. Proximity of active railroad to earthwork complex, looking east from west side of Square Enclosure, October 2014. (Quinn Evans Architects 2014)

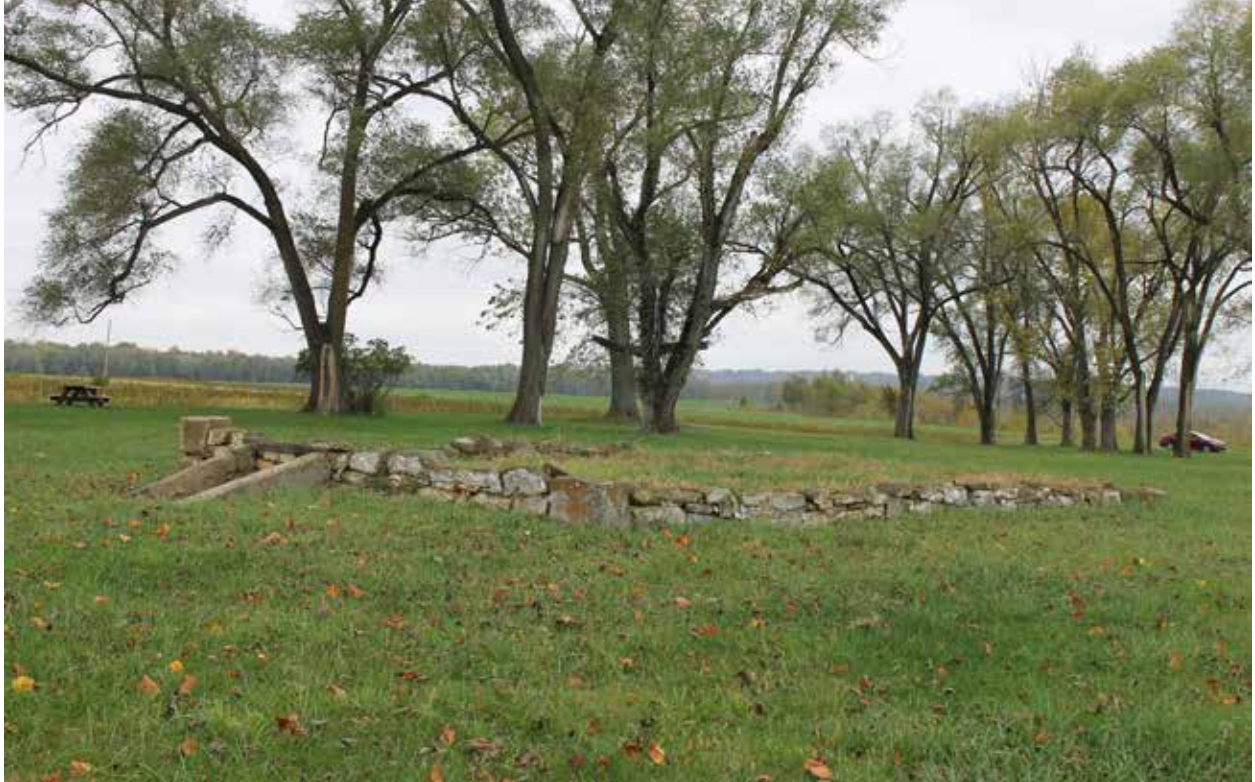
Figure 3-65. Non-native Siberian elms and maples in poor condition at Cryder Farmstead, October 2014.
(Quinn Evans Architects 2014)

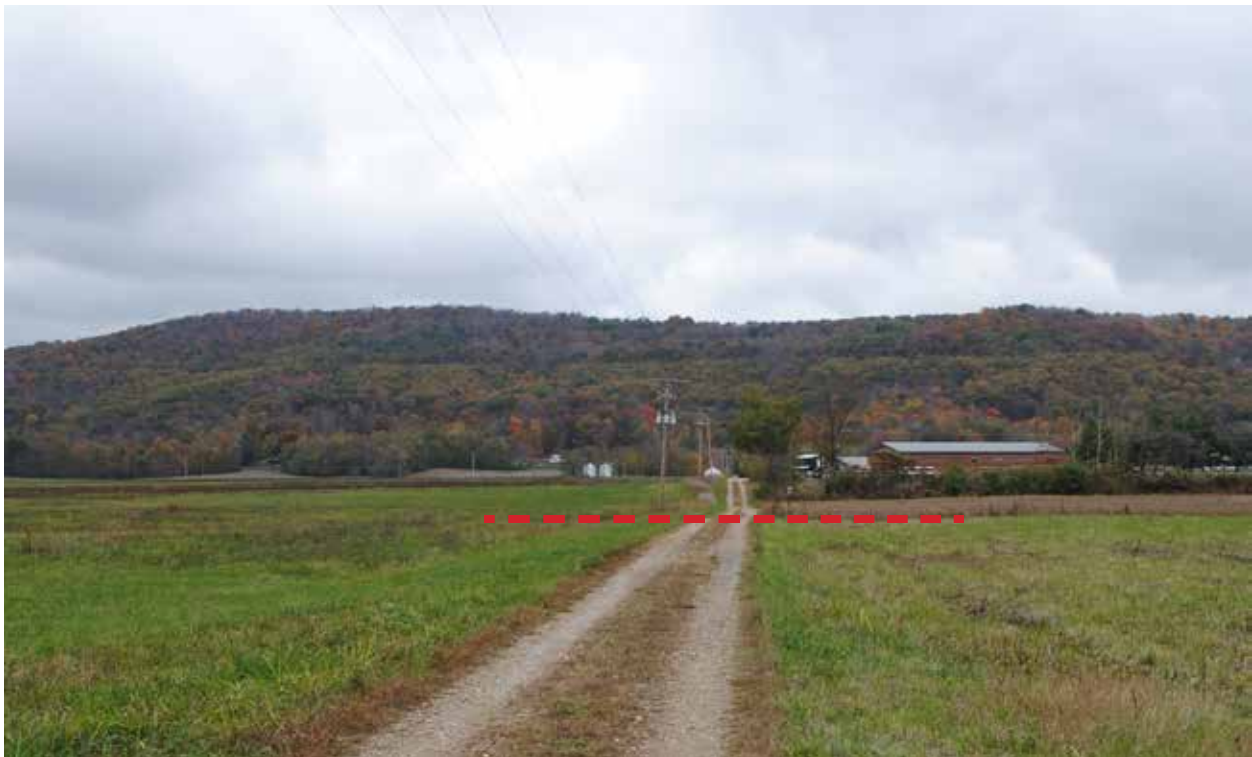
Figure 3-117. Dill Road is a north south route that connects ends at the edge of Paint Creek. The dirt road is eight feet wide and crosses the Large Square earthwork, shown as a dashed line. (Mundus Bishop 2014)

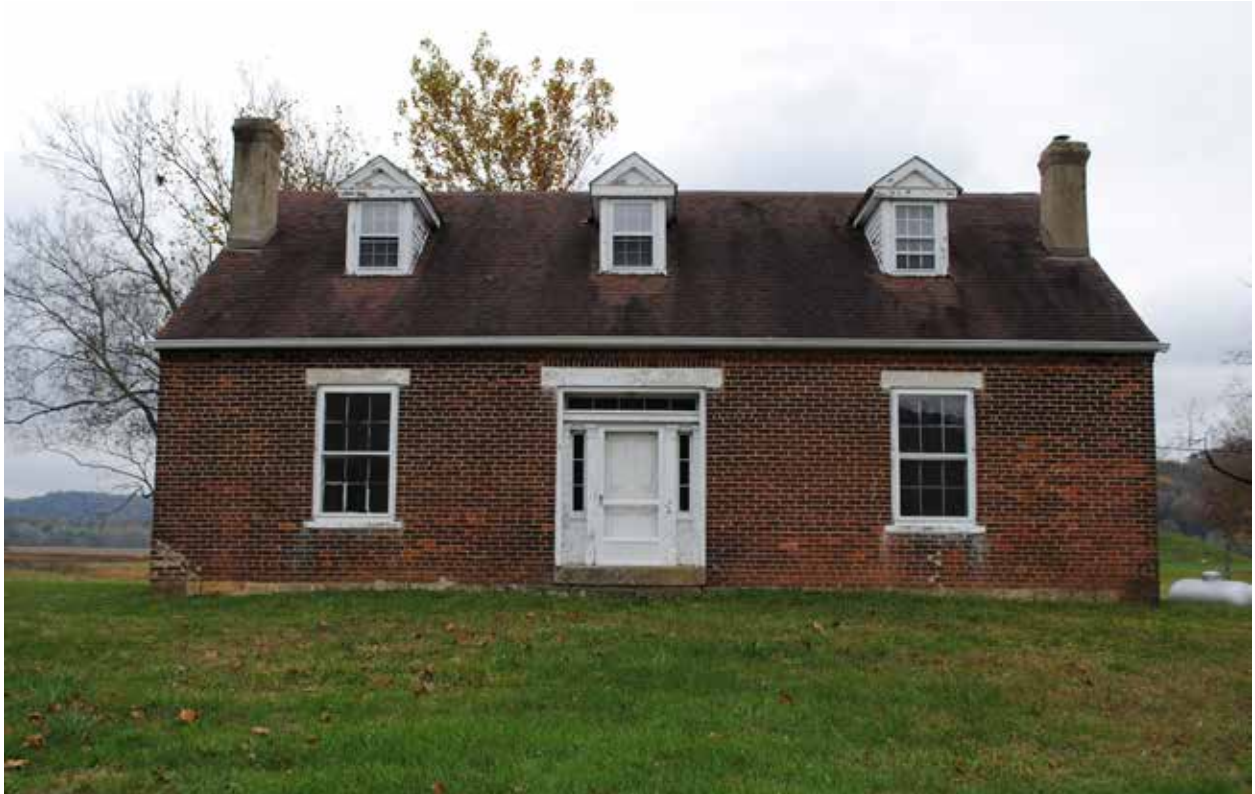
Figure 3-126. The Blackstone House is on top of a portion of the Large Circle, and is in fair condition. (Mundus Bishop 2014)

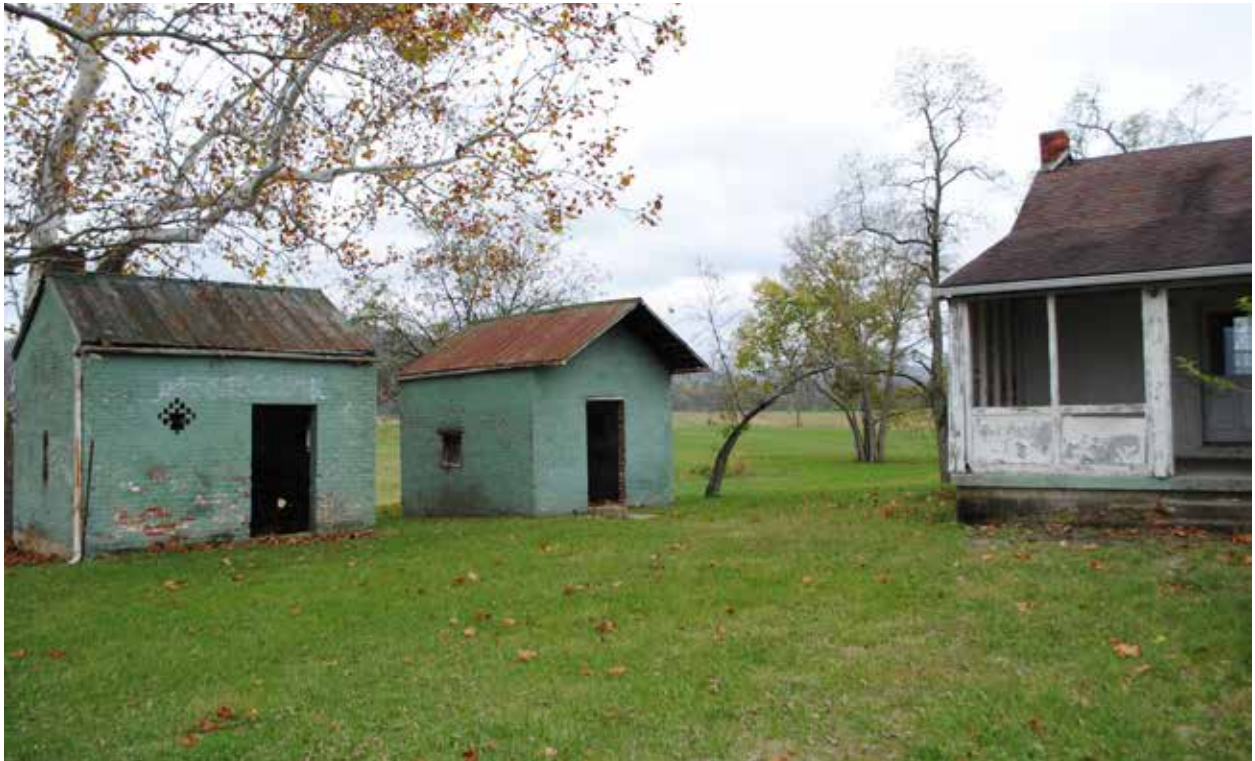
Figure 3-127. Two outbuildings south of the Blackstone House, both are in fair to poor condition. (Mundus Bishop 2014)

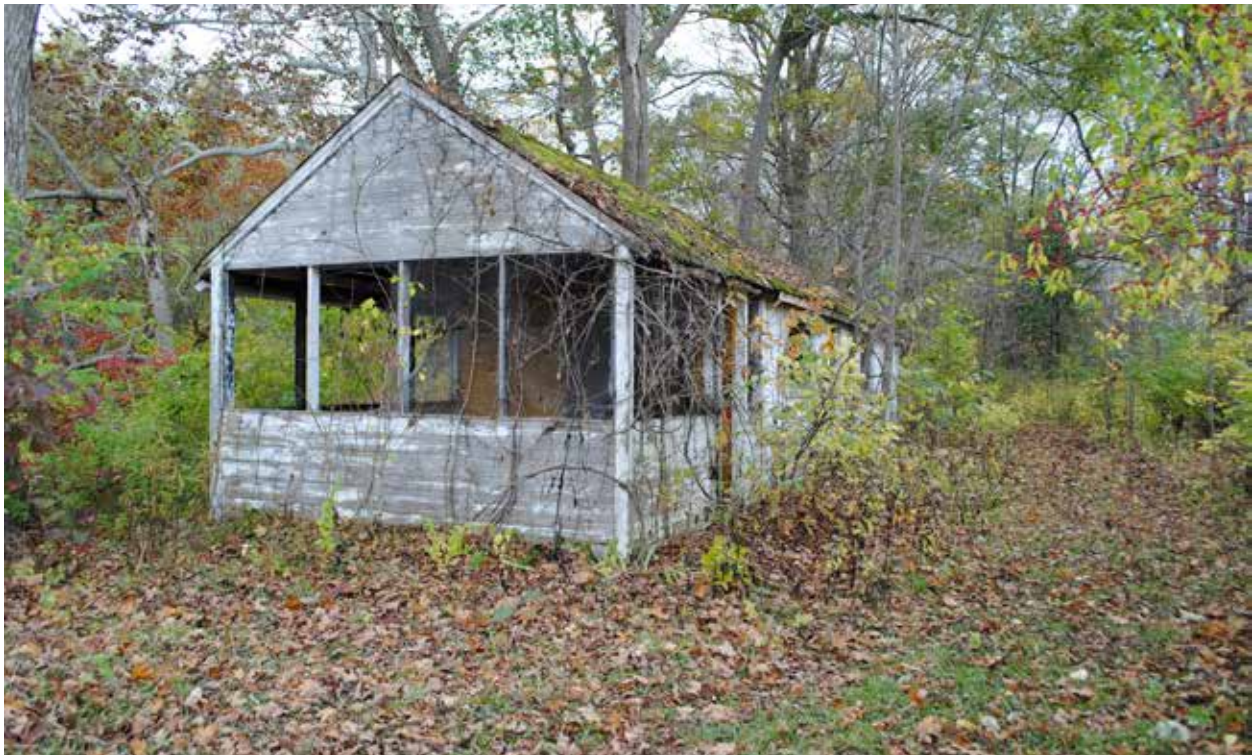
Figure 3-129. A white, wood frame fish camp building has three rooms with a lean-to. The building is in poor condition. (Mundus Bishop 2014)

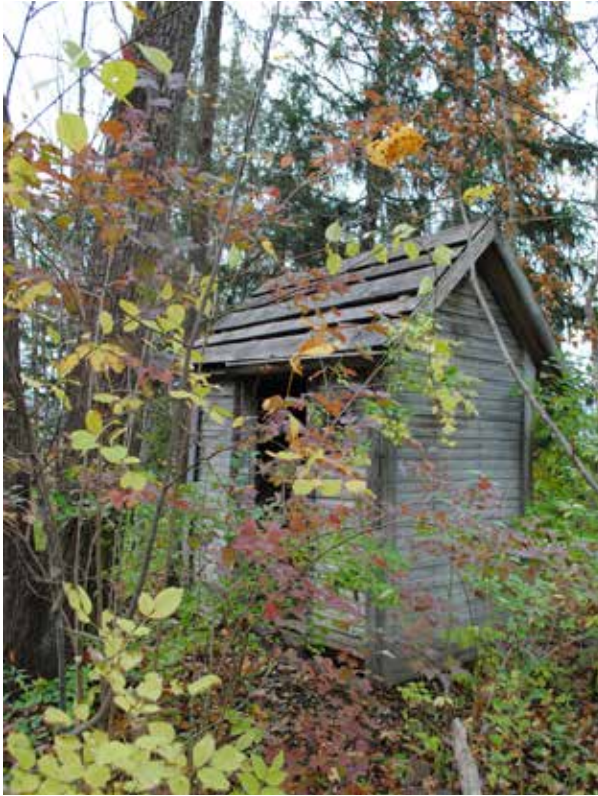
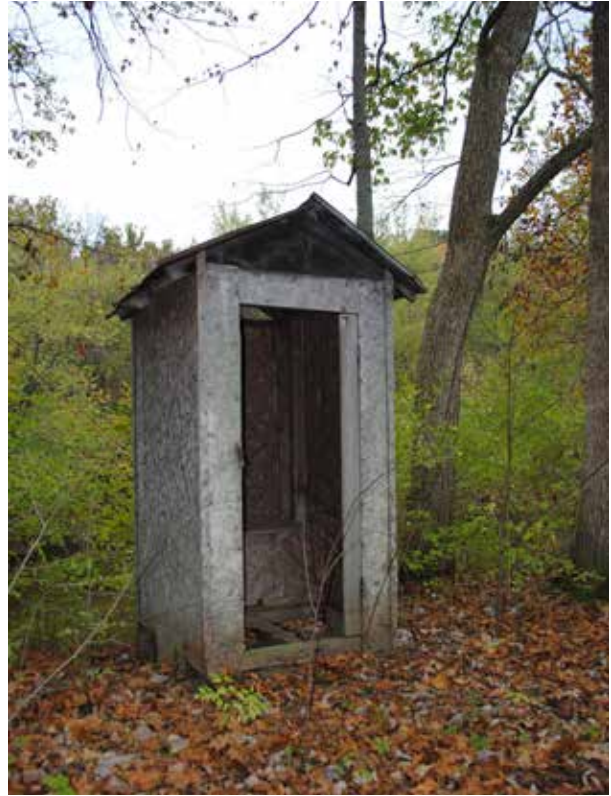
Figure 3-130. A gray cedar wood frame privy with a wood roof is part of the fish camp. The shed has no shingles, no door, but an interior bench. (Mundus Bishop 2014)

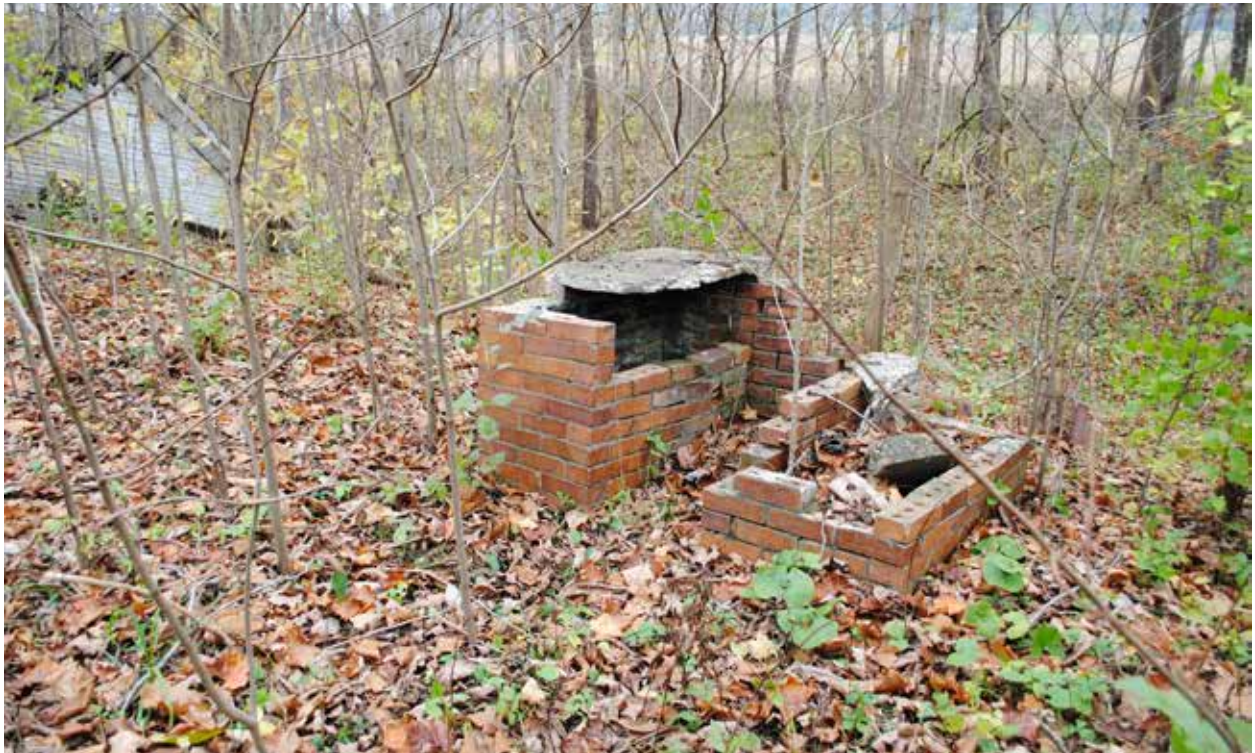
Figure 3-131. A building remnant near the fish camp is in poor condition and may be hazardous. (Mundus Bishop 2014)

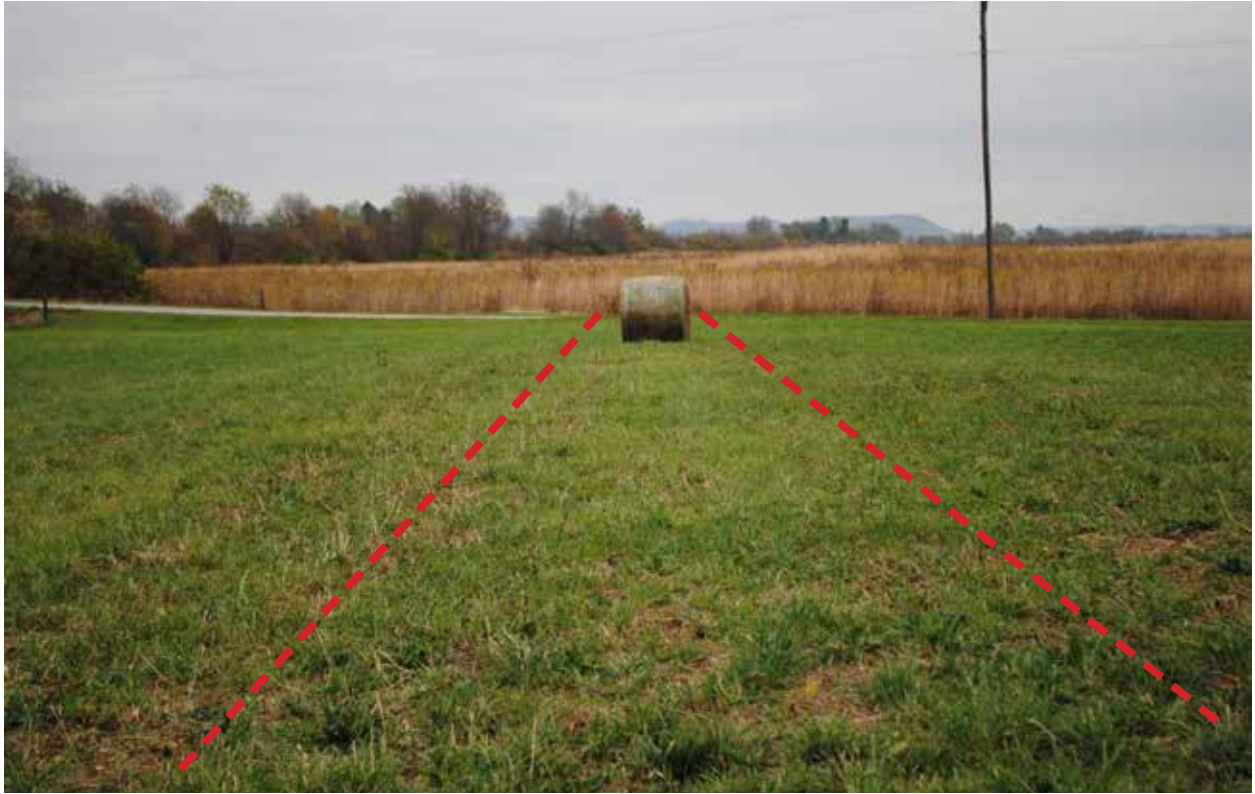
Figure 3-139. The Great Circle earthen wall, shown as a dashed line, is difficult to discern to the untrained eye. (Mundus Bishop 2014)

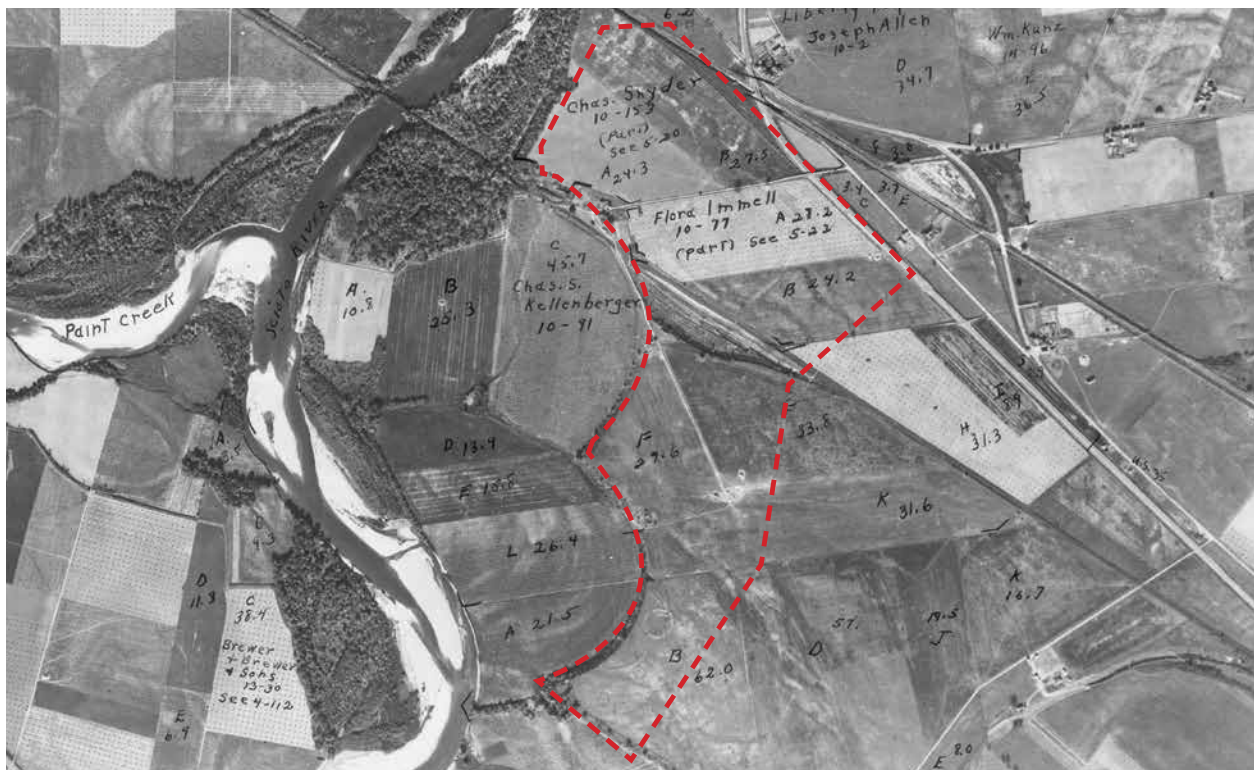
Figure 3-145. In 1938, the Great Circle, Octagon, and South Earthworks were visible. Over time, these features became deteriorated from agricultural practices. Today, only the Great Circle and portions of the Octagon remain visible. (Hopewell Culture NHP Archives)
