Chubb Hollow

1 Maintenance Area

Big Spring Landscape Character Area

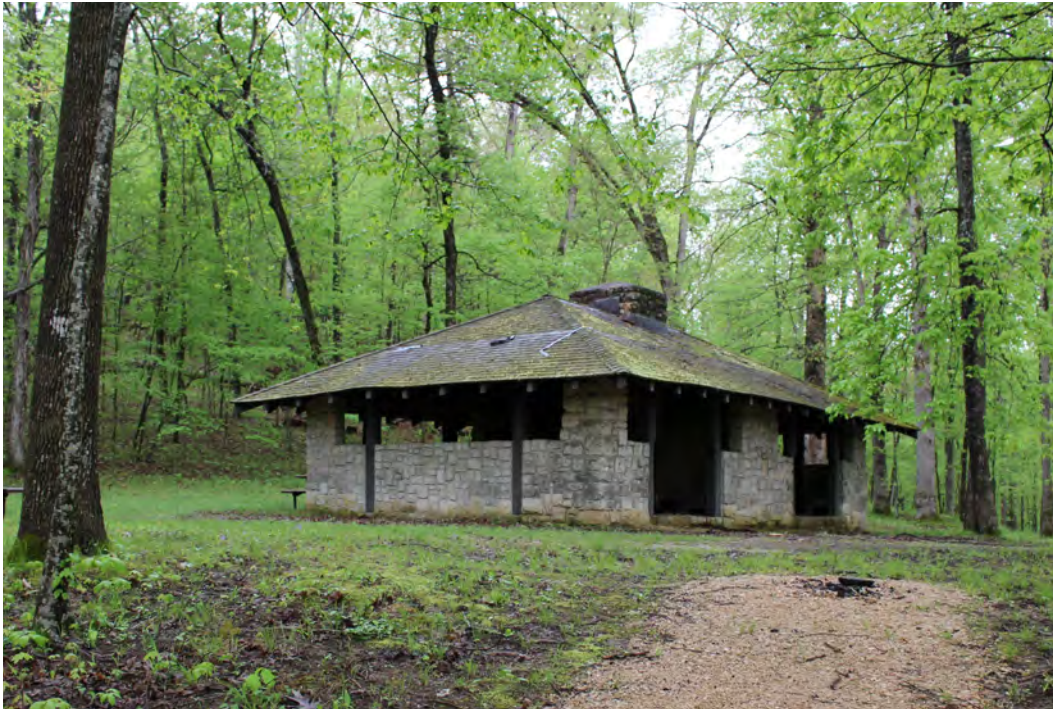
Figure 3-102. The two room Chubb Hollow Open Shelter House (HS-247) is in fair condition. (Mundus Bishop 2016)

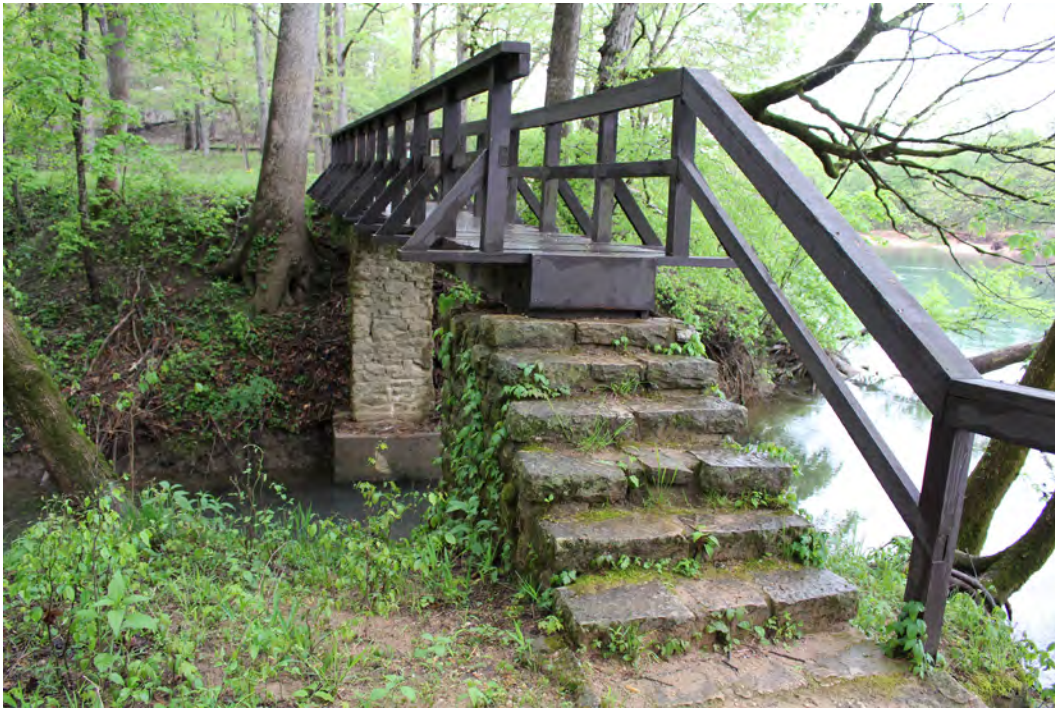
Figure 3-104. Chubb Hollow Foot Bridge (HS-456) wood decking and railing rebuilt, date unknown. Only the stone piers are contributing. (Mundus Bishop 2016)

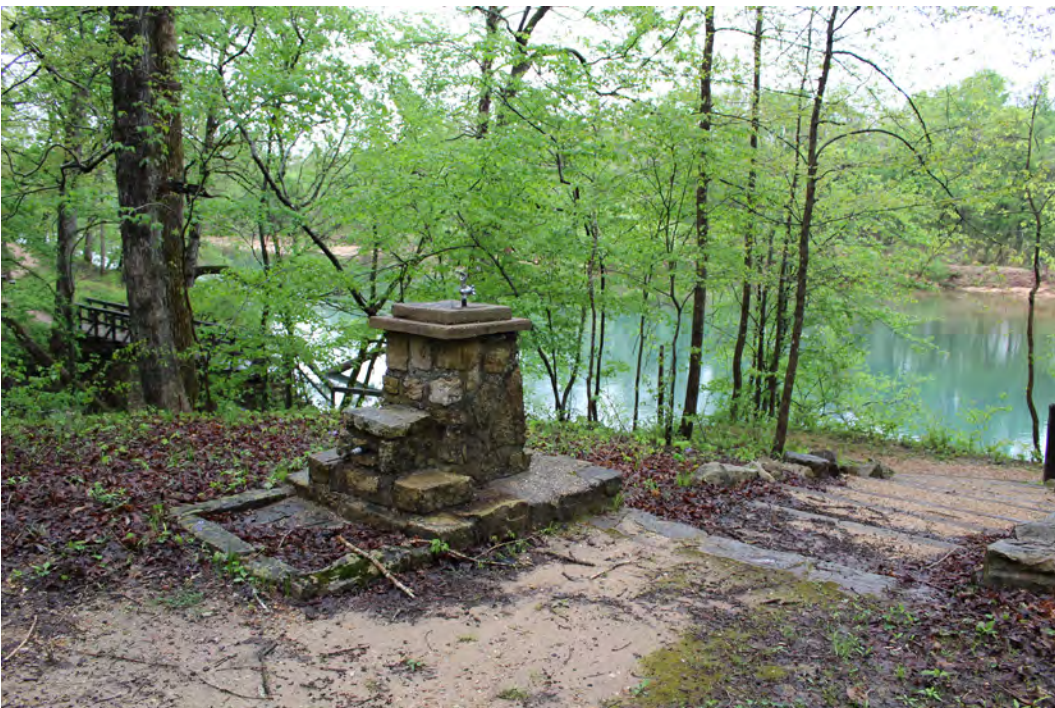
Figure 3-105. There are four CCC built drinking fountains (Fountain #4, #5, #6, #7 (HS-712)) in Chubb Hollow, all are in need of repair. (Mundus Bishop 2016)

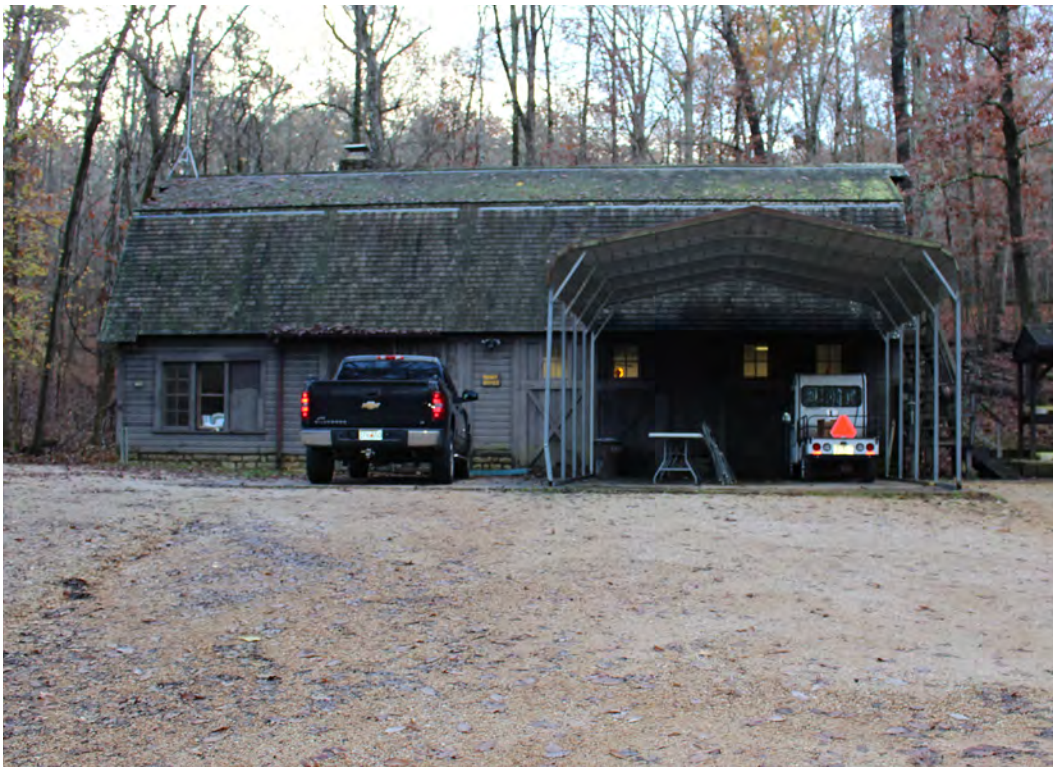
Figure 3-114. Maintenance Shop (HS-417). (Mundus Bishop 2015)

Buildings and Structures			
Feature	Description	Condition	"Contributing / Non-Contributing"
Maintenance Shop (HS-417) (1936)	Building - 25'x50' gambrel roof building with a cut-stone foundation and chimney, drop siding, and two pairs of outward swing garage doors. First floor interior has one large bay and two smaller offices. An exterior staircase at gable end leads to the second floor. Windows throughout are 6-lite wood sash. Metal canopy 28' x 16' is on the north side of the Maintenance Shop (HS-417). It has a concrete pad below the canopy and gravel on three sides. A concrete sidewalk connects from pad to wooden staircase on the west side of the building.	Good	Contributing
Maintenance Fuel Storage Tanks (After 1978)	Wood fenced area with propane tanks and maintenance equipment, associated with the Maintenance Shop (HS-417).	Good	Non-contributing
Maintenance Storage Building (HS-418) (1936)	Building - CCC built single story, front gable with asphalt shingle, one room building 20'-6"x20'-6" with a mortared cobblestone foundation, clapboard siding, 9-lite wood sash windows, and tongue and groove interior walls. Concrete steps to door with an "Electric Shop" sign overhead.	Fair (some rotting boards at bottom)	Contributing

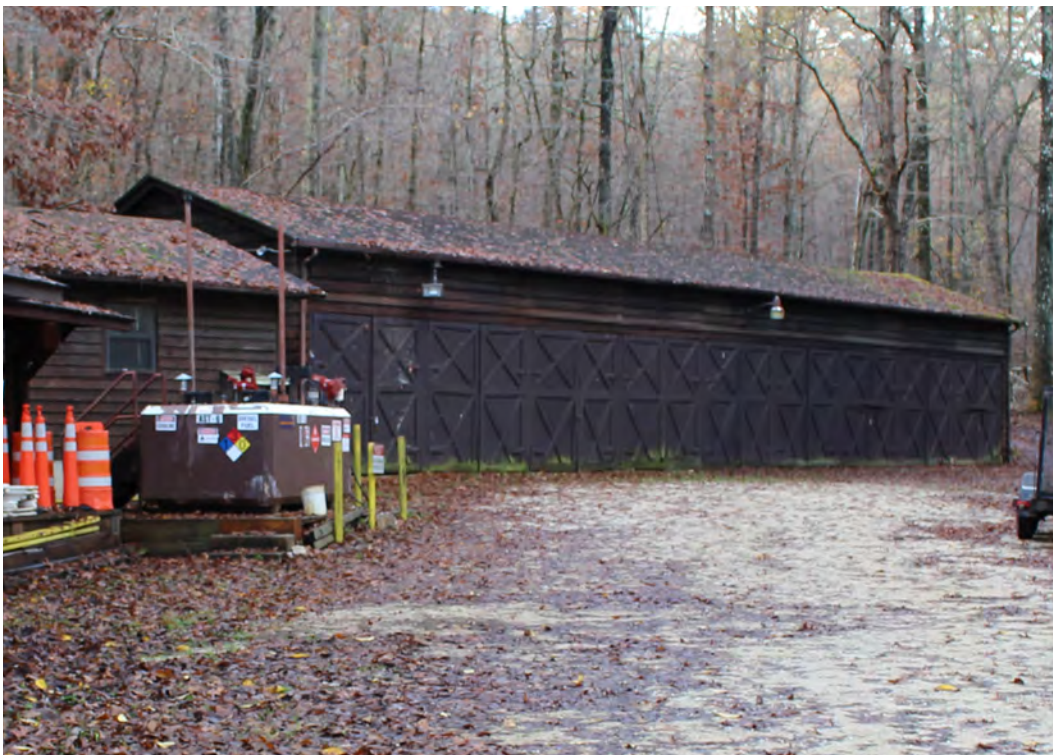
Figure 3-118. Maintenance Garage (HS-419). (Mundus Bishop 2015)

Maintenance Garage (HS-419) (1935)	Building - CCC built Rustic style, single story wood frame building 25'-5"x92'-6" with a saltbox roof. It sits on a cut-stone foundation and is sheathed with clapboard siding. There are nine sets of cross-braced double doors, the floor is concrete, and the windows are 9-lite wood sash. 3' wide concrete sidewalk extends to the entrance.	Fair / poor (water damage at foundation)	Contributing
Maintenance Storage Building #419A (After 1978)	Building - Single story, front gable with asphalt shingles, one room building 15'x16' with a concrete foundation, and clapboard siding. A roll-up garage door is on the side of the building.	Poor (wood timbers broken and contain rot)	Non-contributing
Maintenance Flammable Storage Shelter (After 1978)	Building - Raised wooden platform with asphalt shingle, gable roof. It has a work table and is used to store flammable materials.	Fair (wood beams are rotting)	Non-contributing

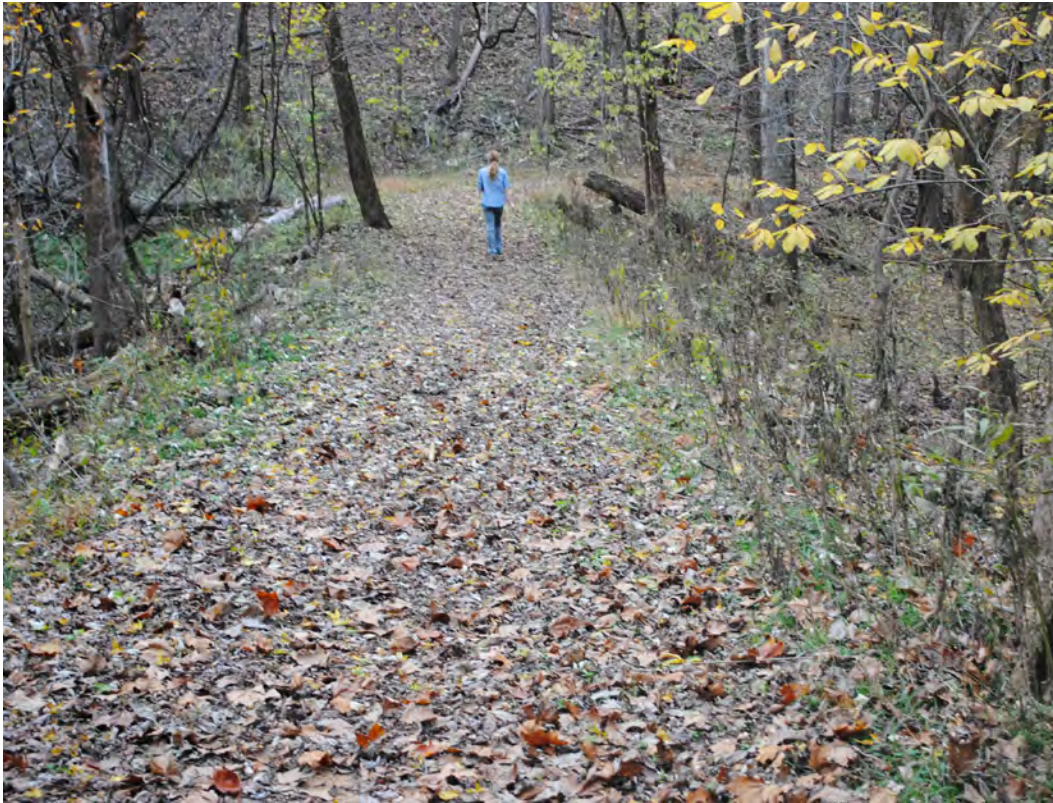
Figure 3-125. Slough Trail over Big Spring Stone Dike (HS-711) #5. (Mundus Bishop 2015)

10
11 The five Big Spring Stone Dikes (HS-711)
12 were built in 1934 along the slough to protect
13 Big Spring from flood waters. Of the five, Big
14 Spring Stone Dikes #3 and #5 remain, the
15 others have been damaged due to flooding.
16 Both were built of wood framing and rubble
17 fill. Big Spring Stone Dikes #5 (700' length) is
18 an integral part of the Slough Trail and is used
19 as a pedestrian crossing across the slough.
20 Big Spring Stone Dikes #3 (600' length) is
21 visible from the slough trail. The landforms
22 associated with the other three Big Spring
23 Stone Dikes remain, but they are difficult to
24 discern.
