## 1 **Buildings and Structures**

1 **Small Scale Features**

## 1 Vegetation

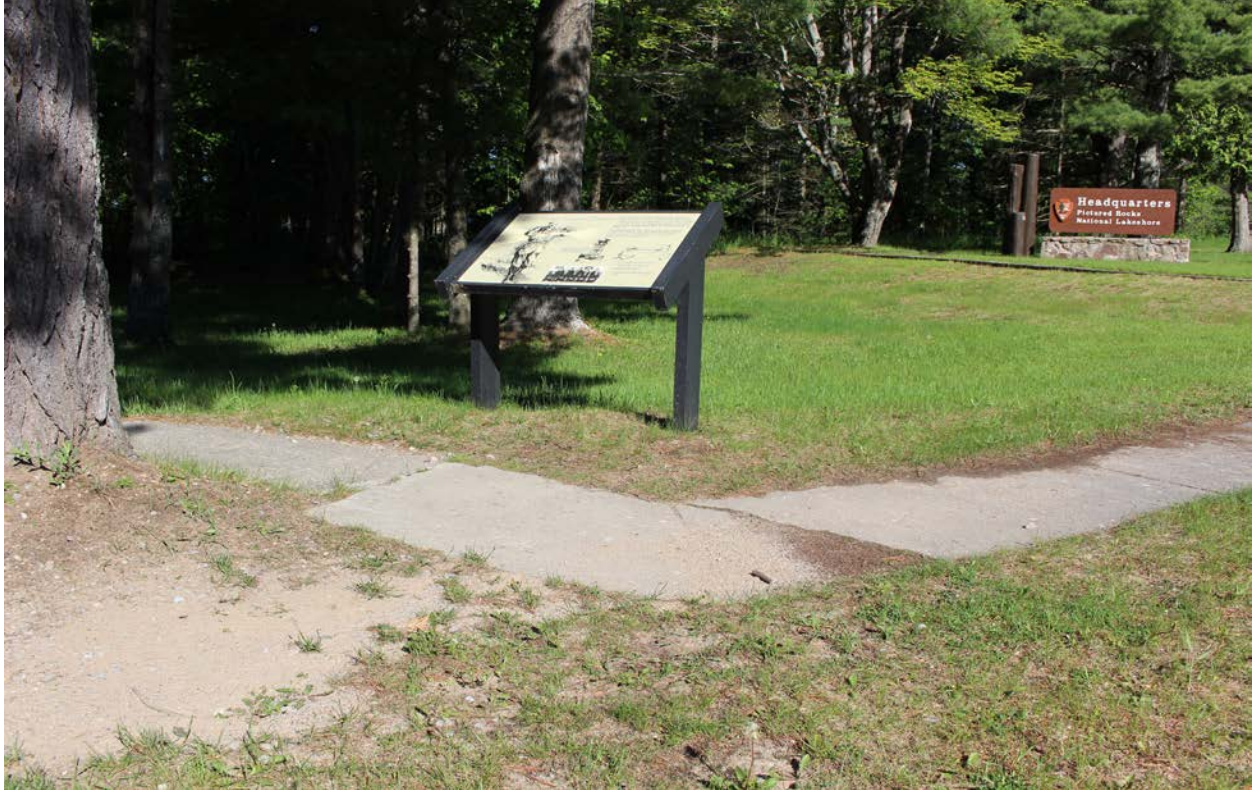
Figure 3-32. The North South Main Walk has been damaged at the south end by erosion and uplift due to tree roots, especially where it turns towards the Boathouse, above. (source: Mundus Bishop 2016)

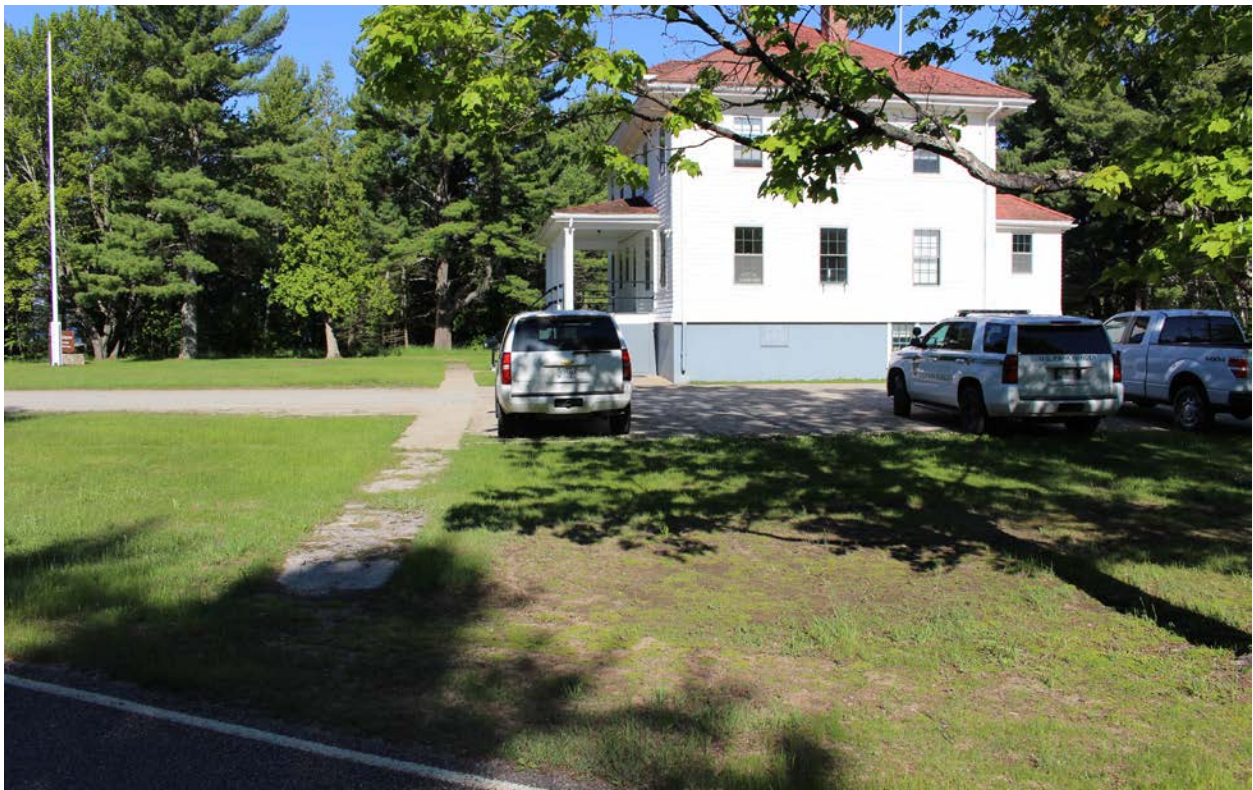
Figure 3-33. The Station Walk extended to the east, to connect to the residences on the opposite side of Sand Point Road. This portion of the walk is in poor condition. (source: Mundus Bishop 2016)

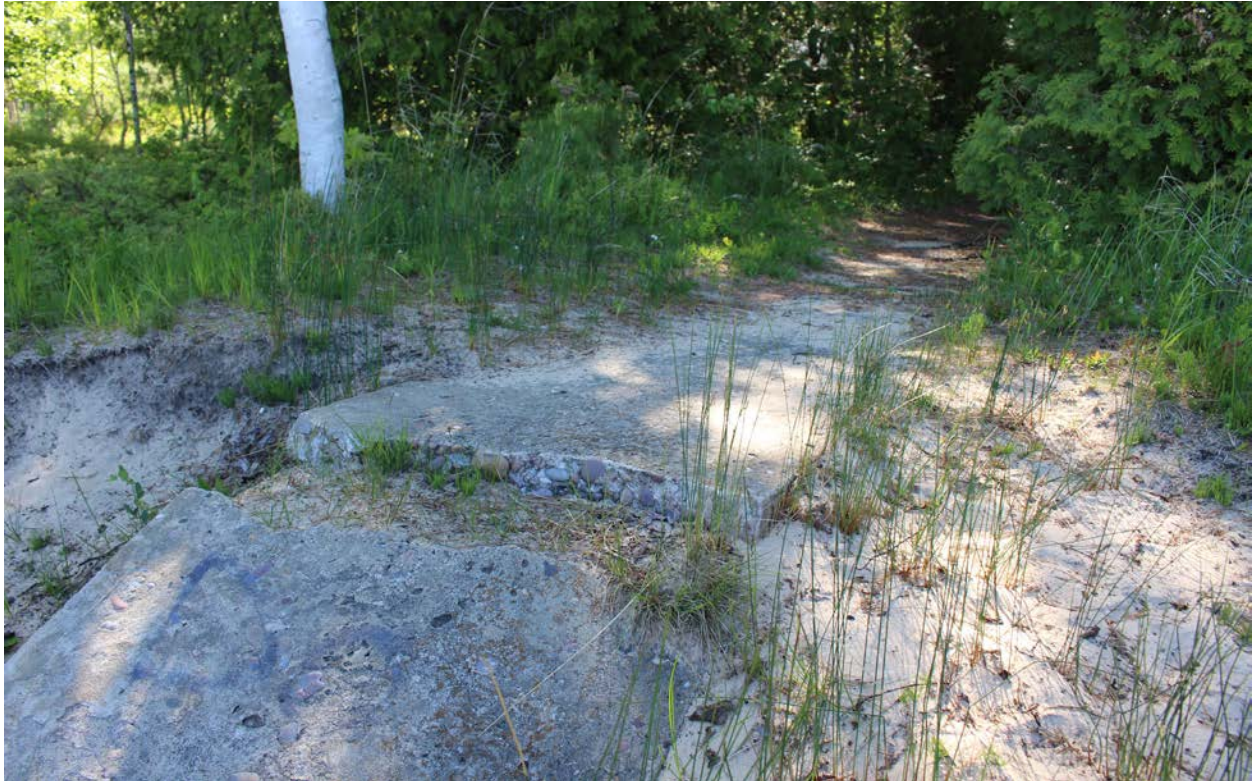
Figure 3-34. The walk to the Lookout Tower is damaged by erosion of the beach, and the end of the walk has washed out. (source: Mundus Bishop 2016)

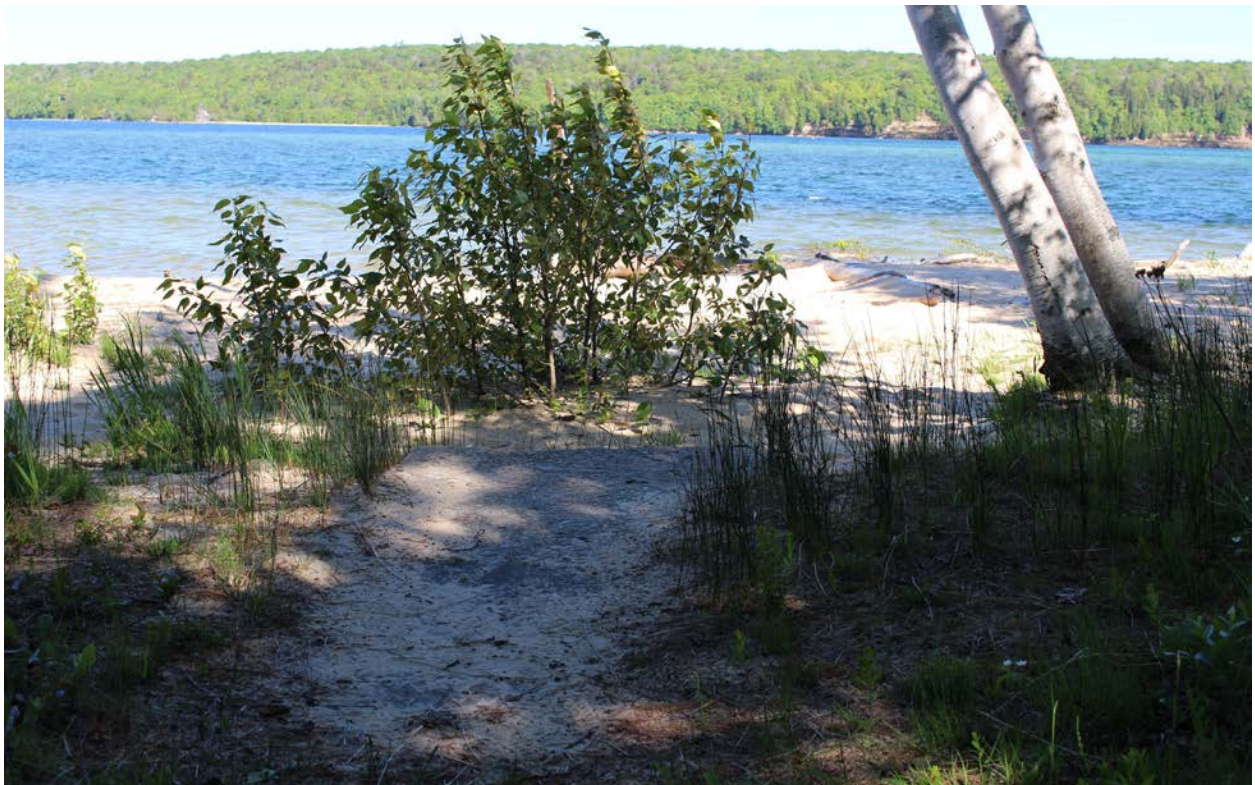
Figure 3-35. The walk to the Lookout Tower disappears into the sand. The loss of the walk diminishes the integrity of the circulation pattern. (source: Mundus Bishop 2016)

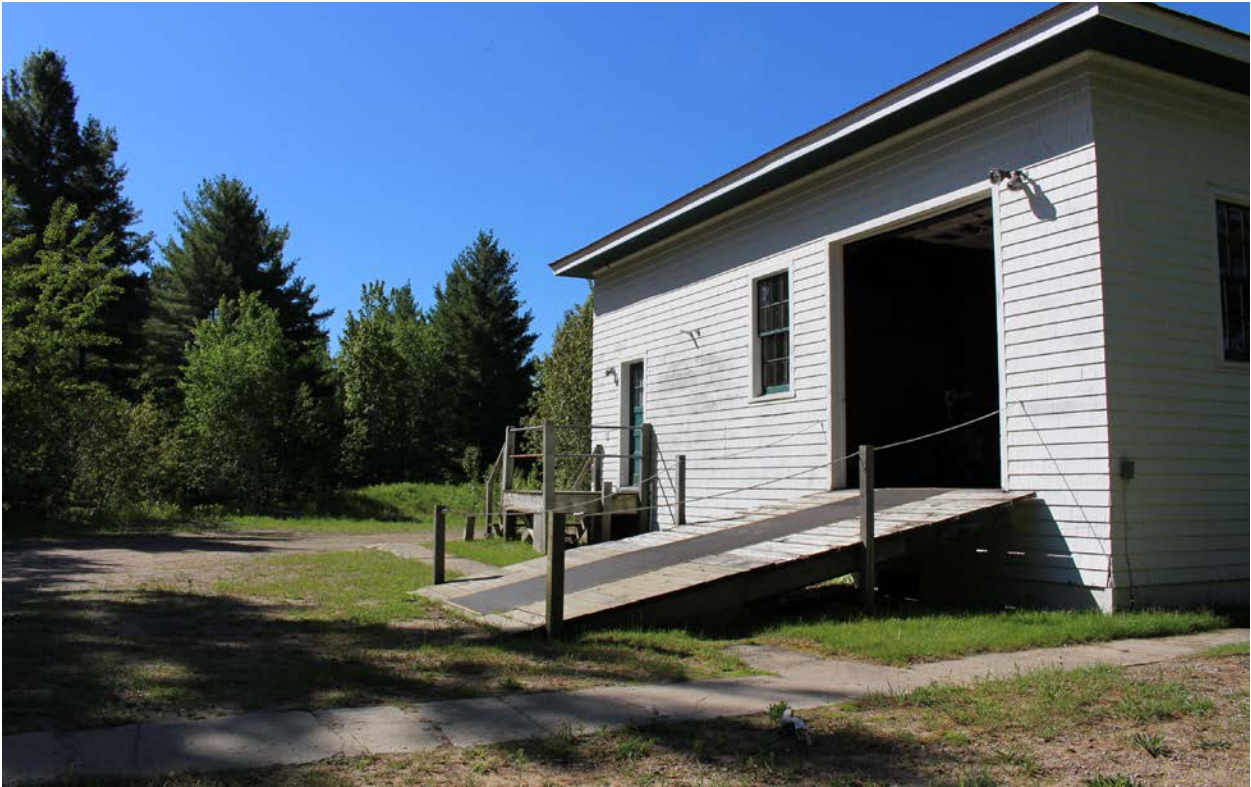
Figure 3-36. Concrete walks surround the Boathouse on three sides. The east walk has been covered over by the ramp, and is in poor condition. (source: Mundus Bishop 2016)

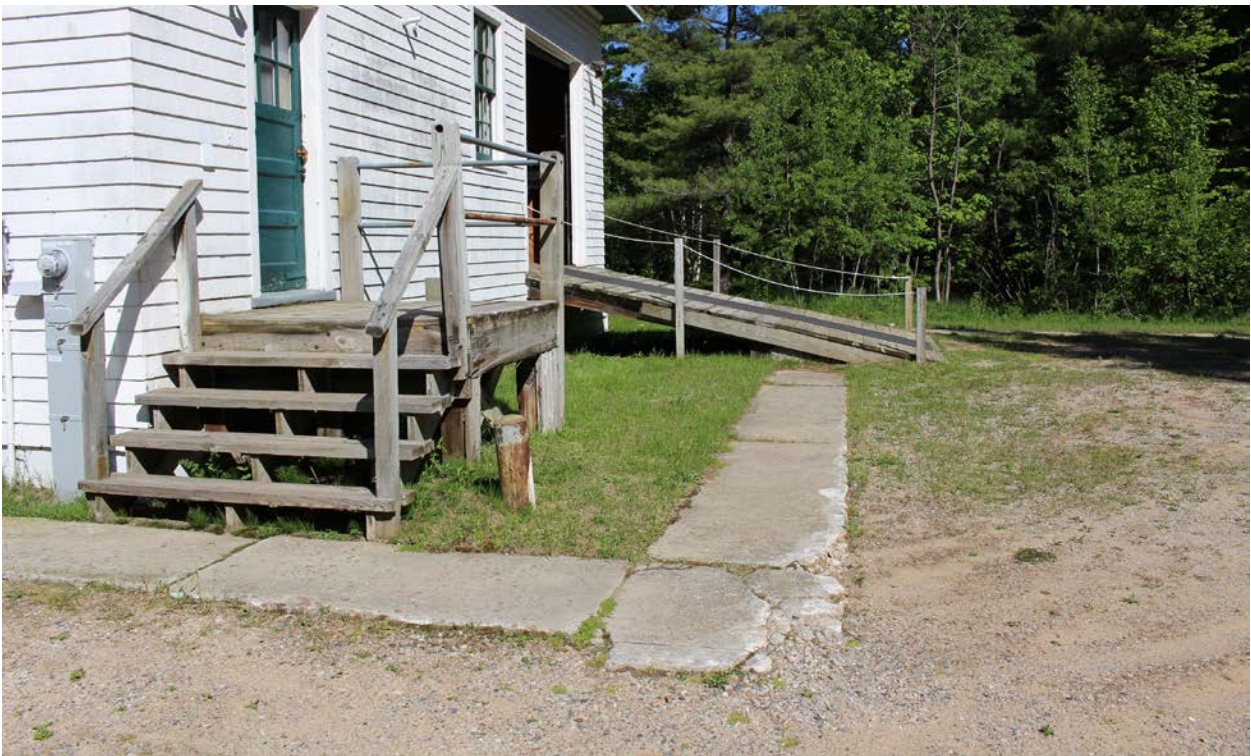
Figure 3-37. The porch and steps, and ramp into the Boathouse are recent additions in historic locations, although the ramp was shorter historically. Note poor condition of concrete walk in foreground. (source: Mundus Bishop 2016)

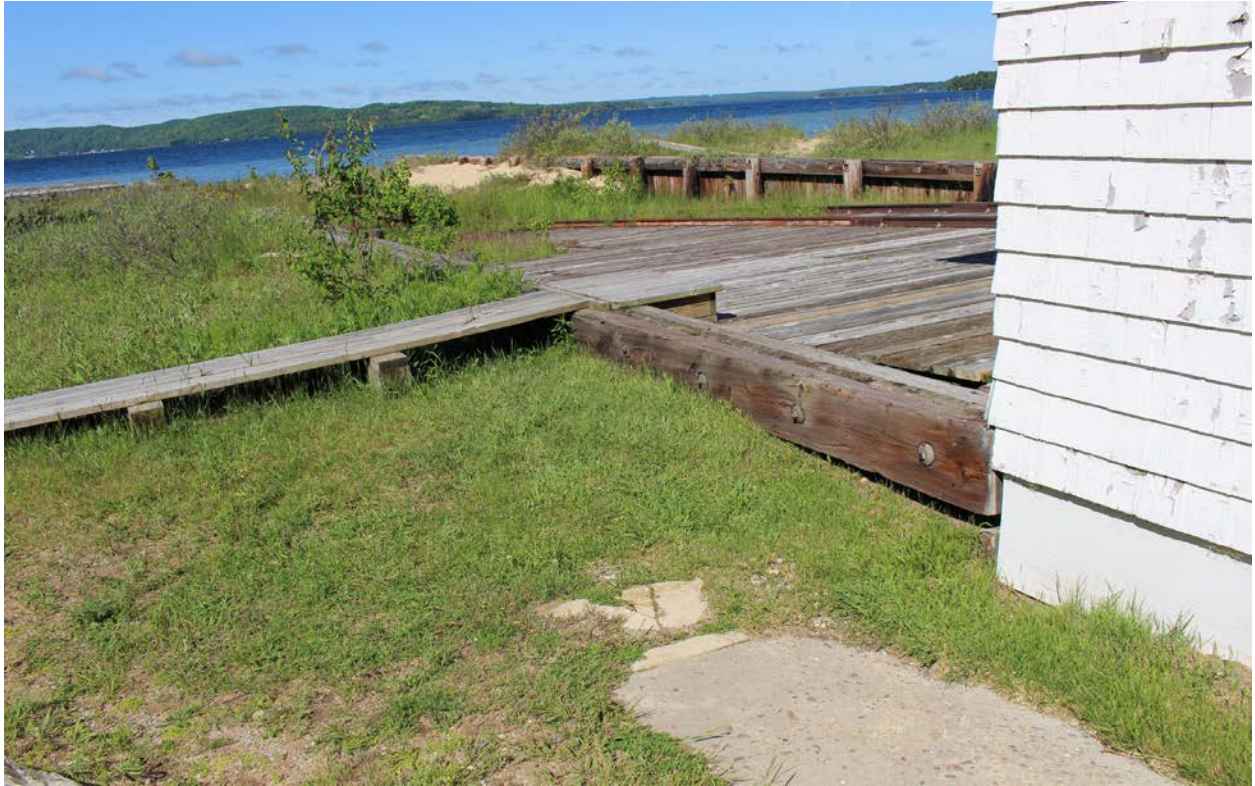
Figure 3-38. The concrete walk at the south facade of the Boathouse, in foreground, is in poor condition. The boardwalk, at left, connects to the Launchway with a wooden step. (source: Mundus Bishop 2016)

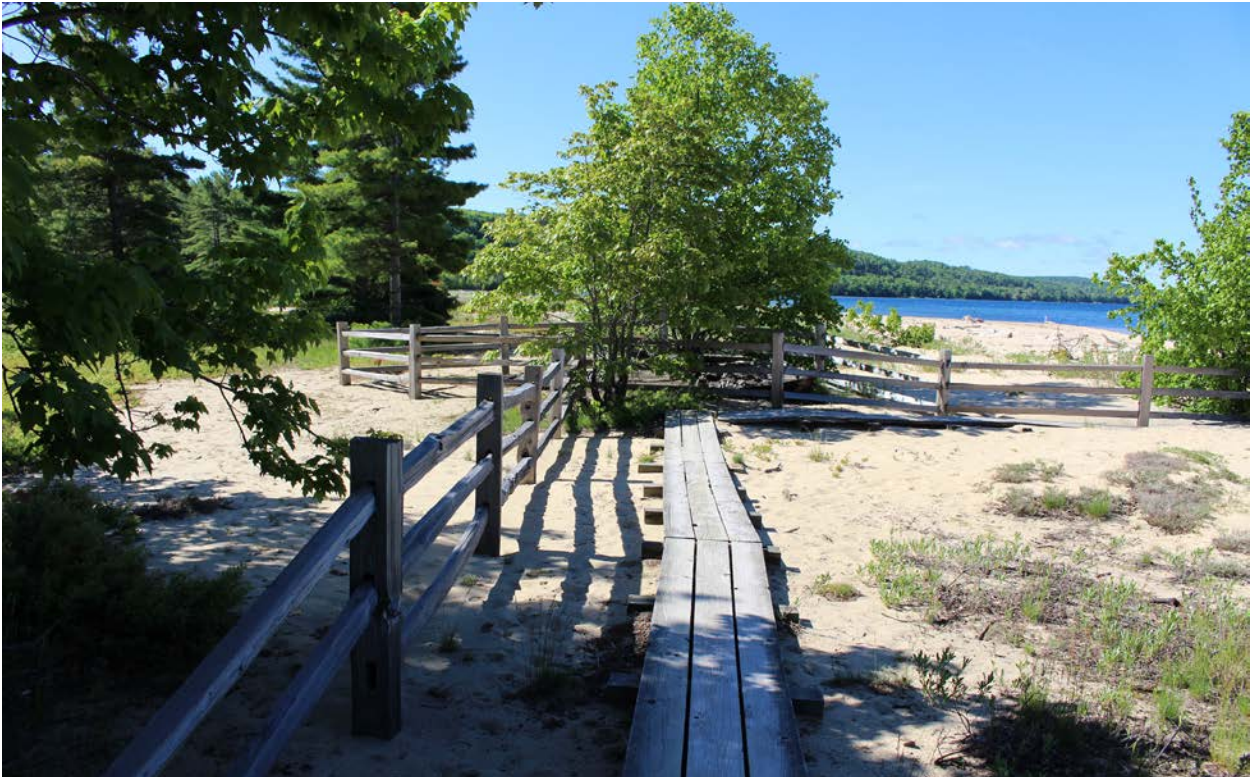
Figure 3-40. The boardwalk leads to the boat hull, behind fence in background, and then turns towards, where portions of the boardwalk are washed out. (source: Mundus Bishop 2016)

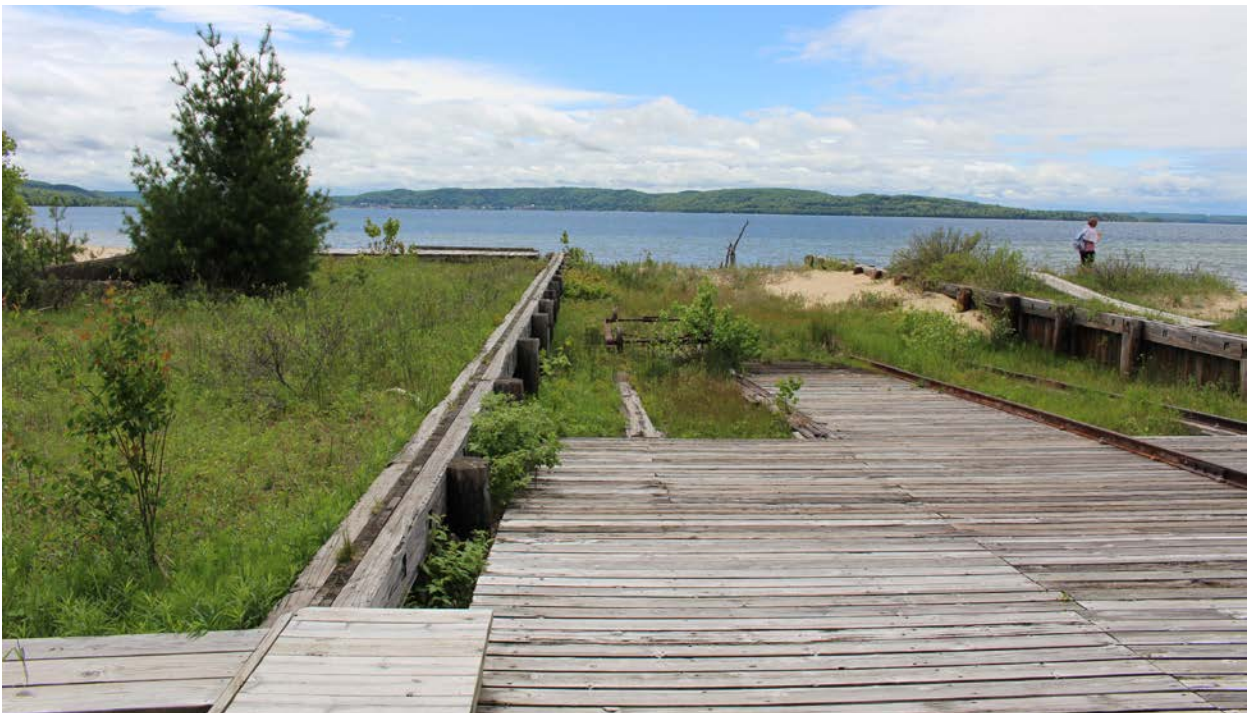
Figure 3-41. The Launchway is in fair to poor condition. Today, water routes do not reflect the historic pattern because the Launchway and Boathouse are no longer actively used. (source: Mundus Bishop 2016)

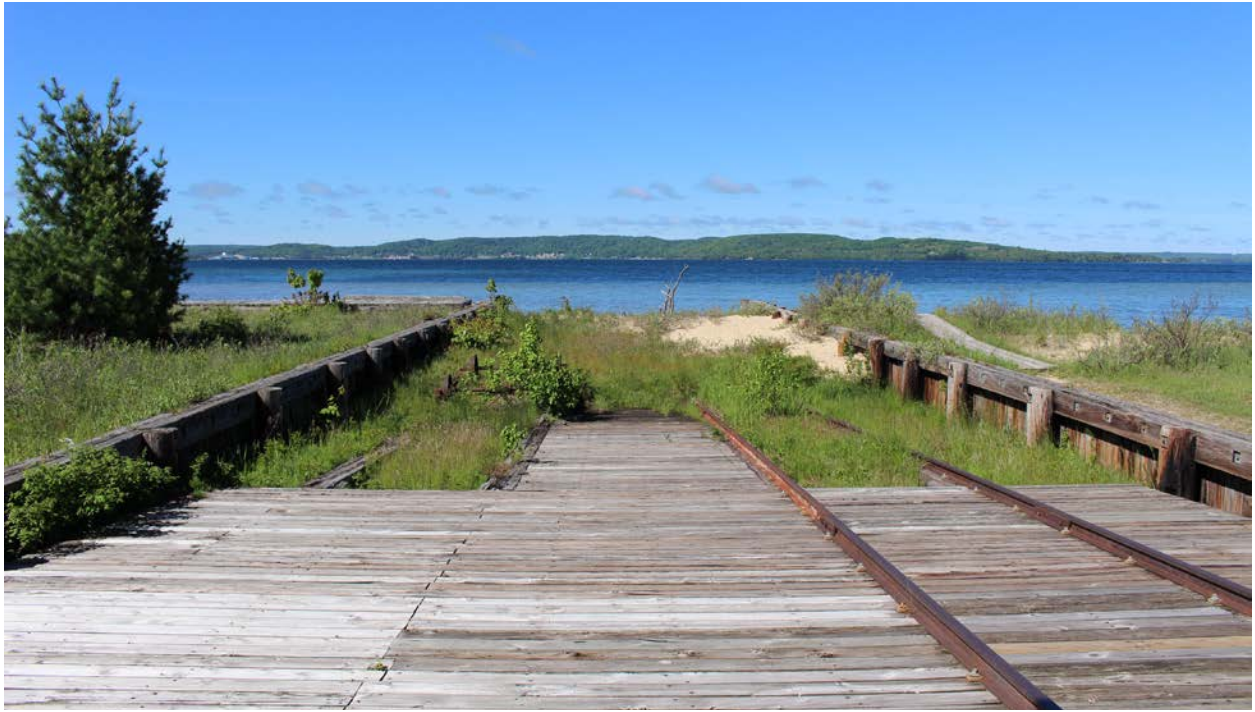
<b>Launchway</b>	Wood ramp to water with (2) rail lines (1 extant). Edged with heavy timber bulkhead on either side. Lake end is partially obscured by sand and soil, vegetation in center. Trolley for moving boats, on south rail. (2) 2x6 framed box pedestrian decks access launchway from boardwalk at the south and steps at the north.	Fair to Poor	Contributing
<b>Lookout Tower Foundation</b>	(4) Concrete beveled tops with bolts, submerged in lake. Foundation is all that remains of the non-extant prefabricated metal Lookout Tower placed at the tip of Sand Point	Poor	Contributing
<b>Communications Tower Foundation</b>	Concrete level pad, metal foundations. All that remains of non-extant Communications Tower	Fair	Contributing
<b>Shop</b>	Non-Extant	N/A	N/A
<b>Garage Foundation</b>	Square concrete pad with center drain.	Fair	Non-Contributing
<b>Rock Revetment</b>	Angular rock; never properly placed = wrong size; from Lookout Tower to parking area	Fair	Non-Contributing

Figure 3-46. The Launchway is in fair to poor condition. Sand and vegetation have covered the west end of the Launchway, diminishing the spatial relationship that once existed between the structure and the lake. Northwest winds across Lake Superior shift the sands at Sand Point, creating a general trend of younger beach ridges from southeast to northwest along Sand Point. (source: Mundus Bishop 2016)

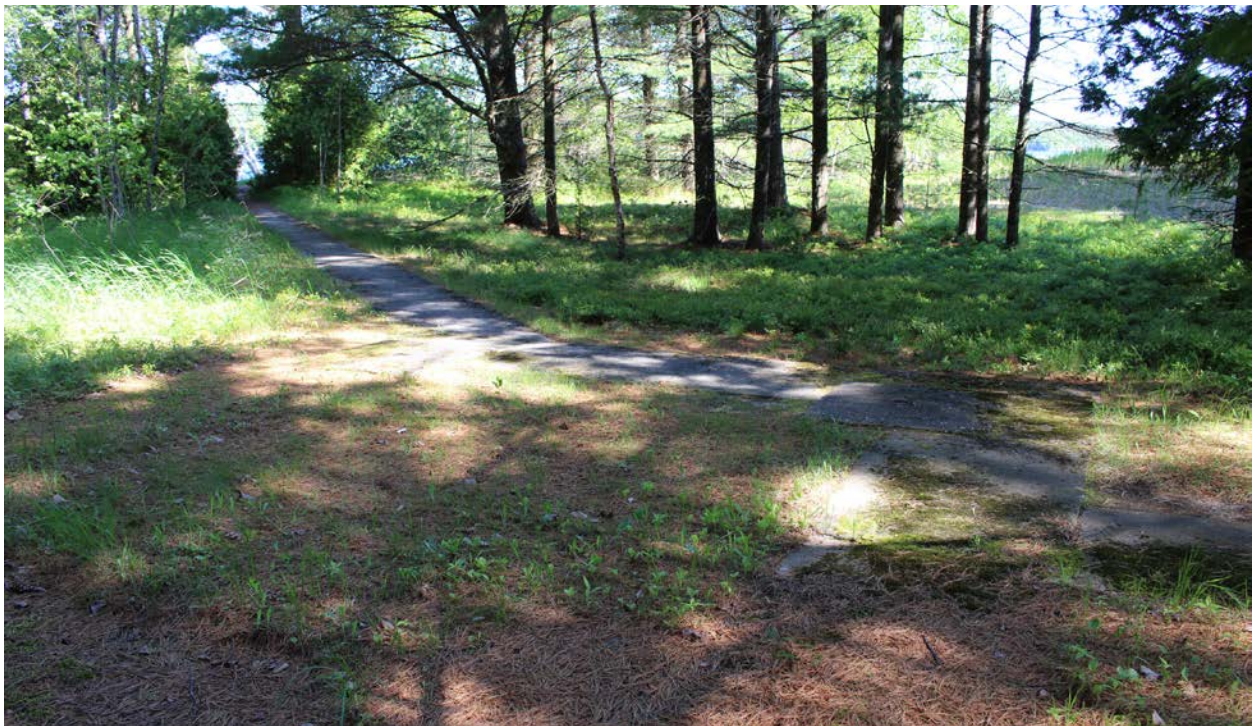
Figure 3-47. The foundation of the Communications Tower is covered by dirt and debris, and enclosed by dense forest, making it difficult to discern the scale of the structure that once stood here. (source: Mundus Bishop 2016)

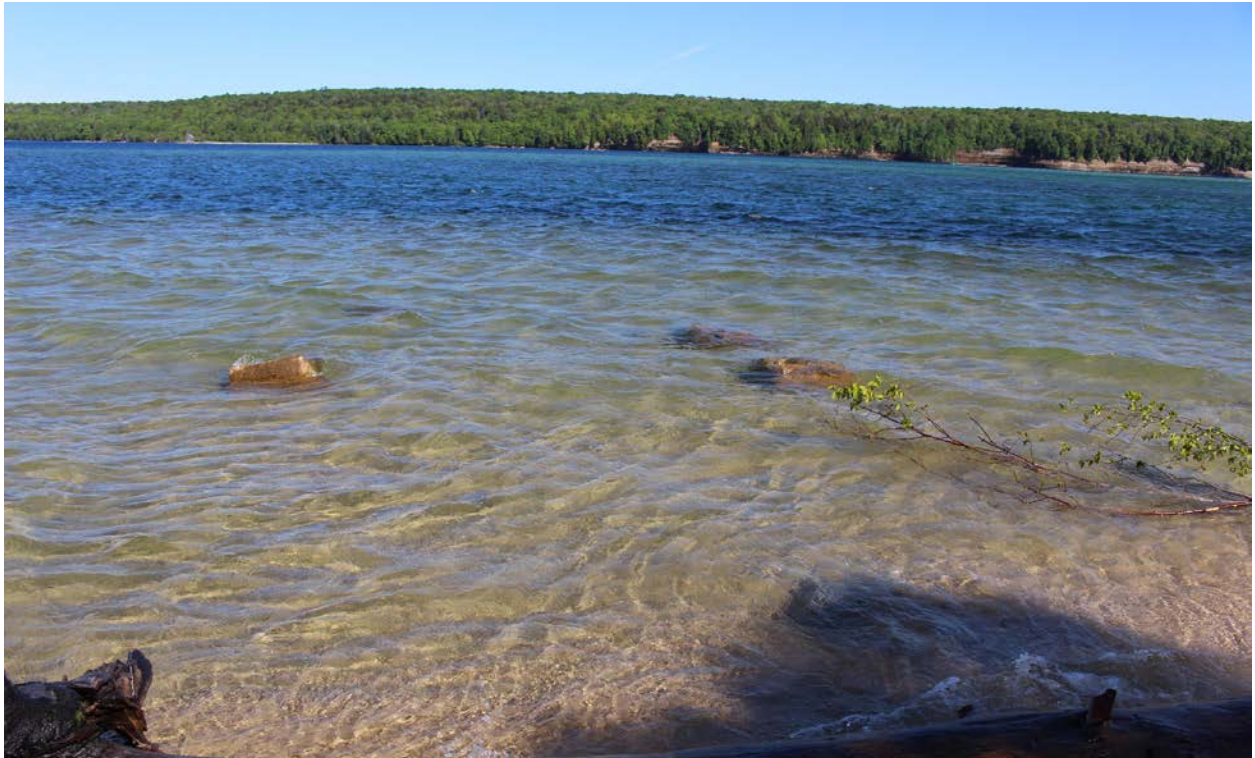
Figure 3-48. The extant foundation of the Lookout Tower is visible as four concrete block submerged in the lake. Loss of the structure has negatively impacted the pattern of buildings and structures across the cultural landscape. The loss of sand at Sand Point is part of the natural cycle of beach erosion and accretion. (source: Mundus Bishop 2016)

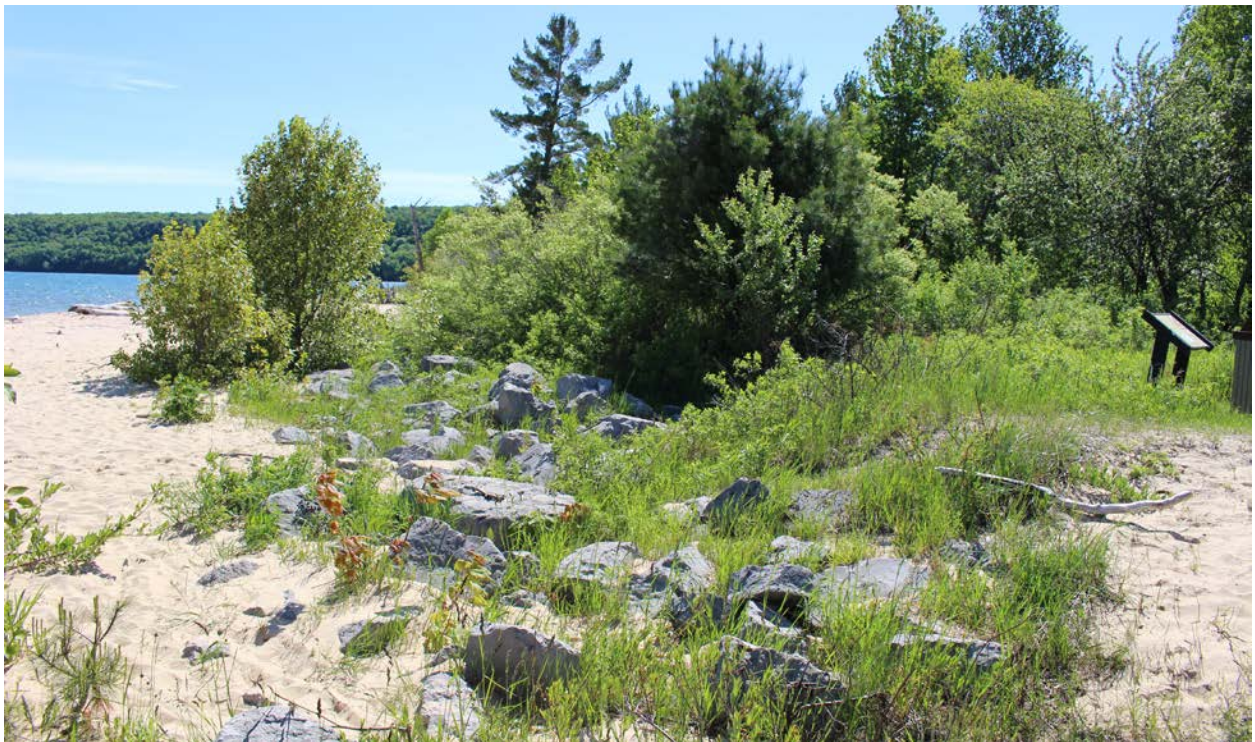
Figure 3-49. The rock revetment at the north edge of the study area is a non-contributing feature added in the early 1990s. It does not reflect the historic condition of the landscape. (source: Mundus Bishop 2016)

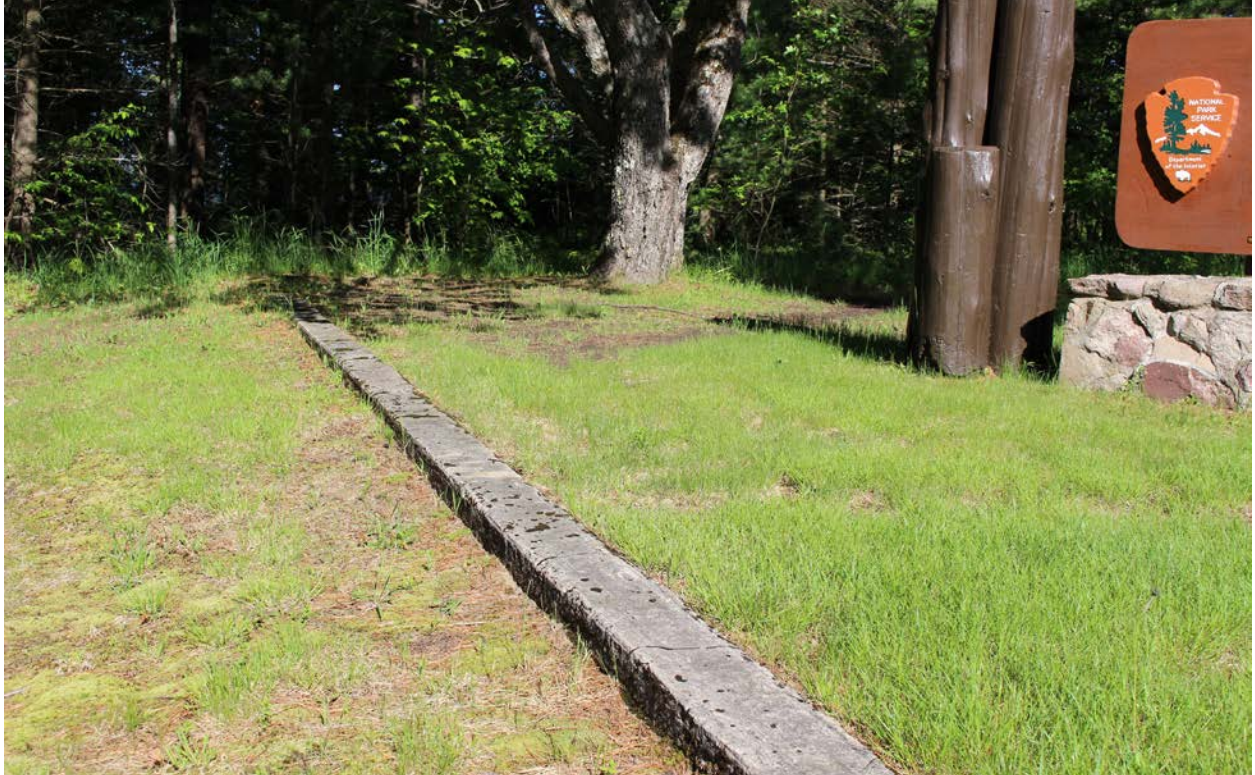
Figure 3-50. The concrete curb at the south edge of the Life Saving Station is the most easily seen portion of the curb that once framed the formal outdoor space around the building. (source: Mundus Bishop 2016)

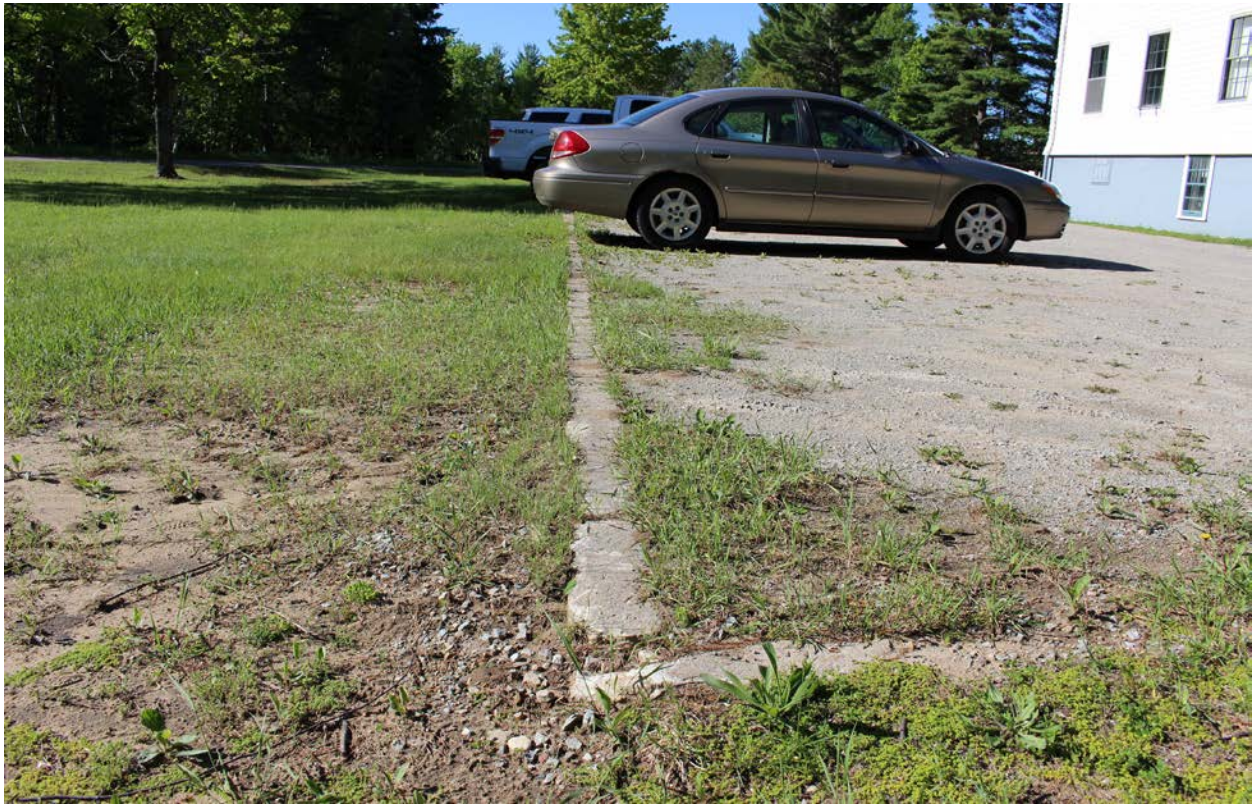
Figure 3-51. The concrete curb at the east edge is in poor condition and does not enclose the formal lawn space, as was the original design intent. (source: Mundus Bishop 2016)

25 concrete curb was modified on the east side  
26 of the Munising Life Saving Station, when the  
27 staff parking area and drive was expanded.  
28 Portions of the curb were either removed or  
29 have been covered by fill material. The loss  
30 of the continuous curb framing a rectangular  
31 space around the building has damaged the  
32 legibility of the feature and disrupted the  
33 formal space around the building. The other  
34 recent small scale features are minimal in  
35 scale and are relatively unobtrusive.

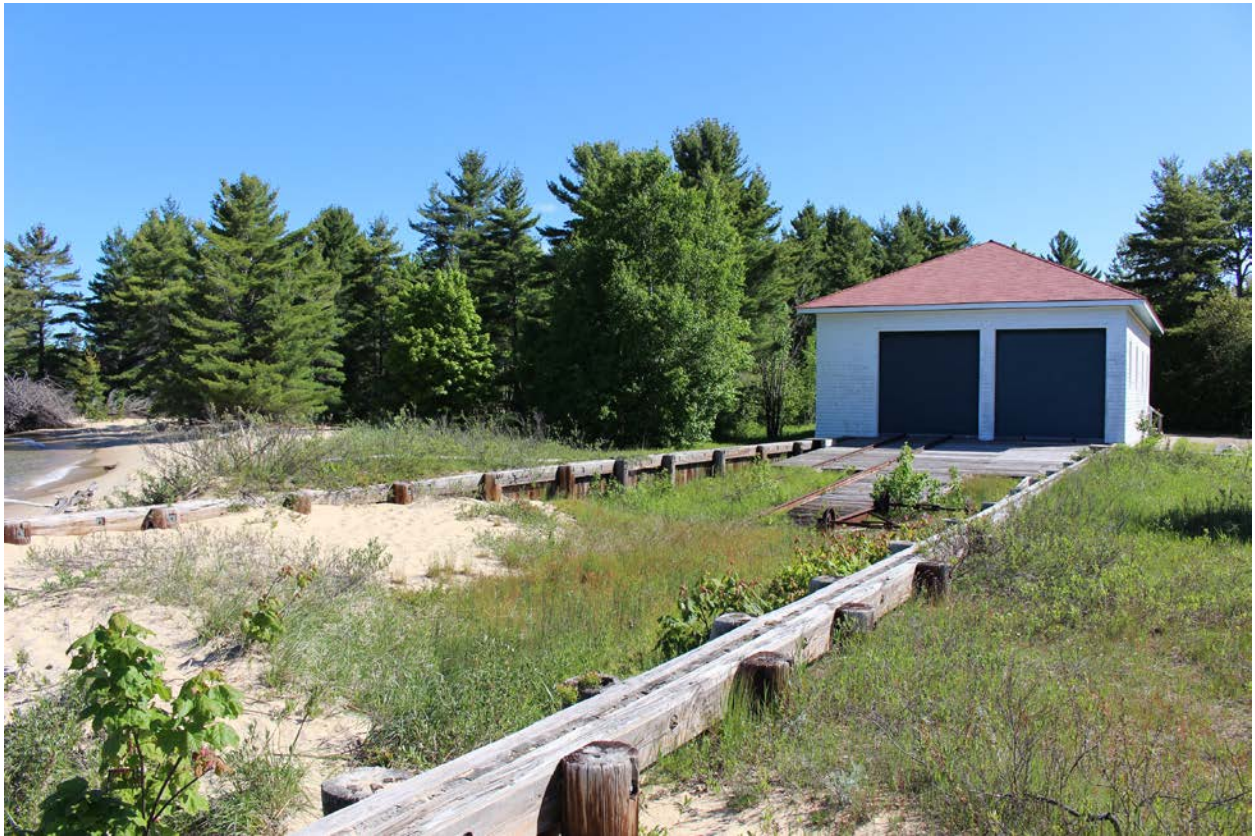
Figure 3-62. Since the closing of the station, dune grasses and smaller vegetation have regrown into once cleared areas, including within the Launchway. Note the view to Grand Island is no longer apparent due to growth of mature forest trees. (source: Mundus Bishop 2016)
