FEBRUARY 2017		TITLE OF PROJECT CULTURAL LANDSCAPE REPORT AND ENVIRONMENTAL ASSESSMENT	
UNITED STATES DEPARTMENT OF THE INTERIOR		TITLE OF DRAWING ILLUSTRATION 3-2 USCG STATION EXISTING CONDITION PLAN	
PICTURED ROCKS NATIONAL LAKESHORE MUNISING, MICHIGAN		NAME OF PARK SAND POINT/MUNISING USCG LIFE SAVING STATION	
625-135194		REGION MIDWEST	STATE MICHIGAN
		COUNTY ALGER	3-7

## Existing Condition and Analysis by Landscape Characteristic

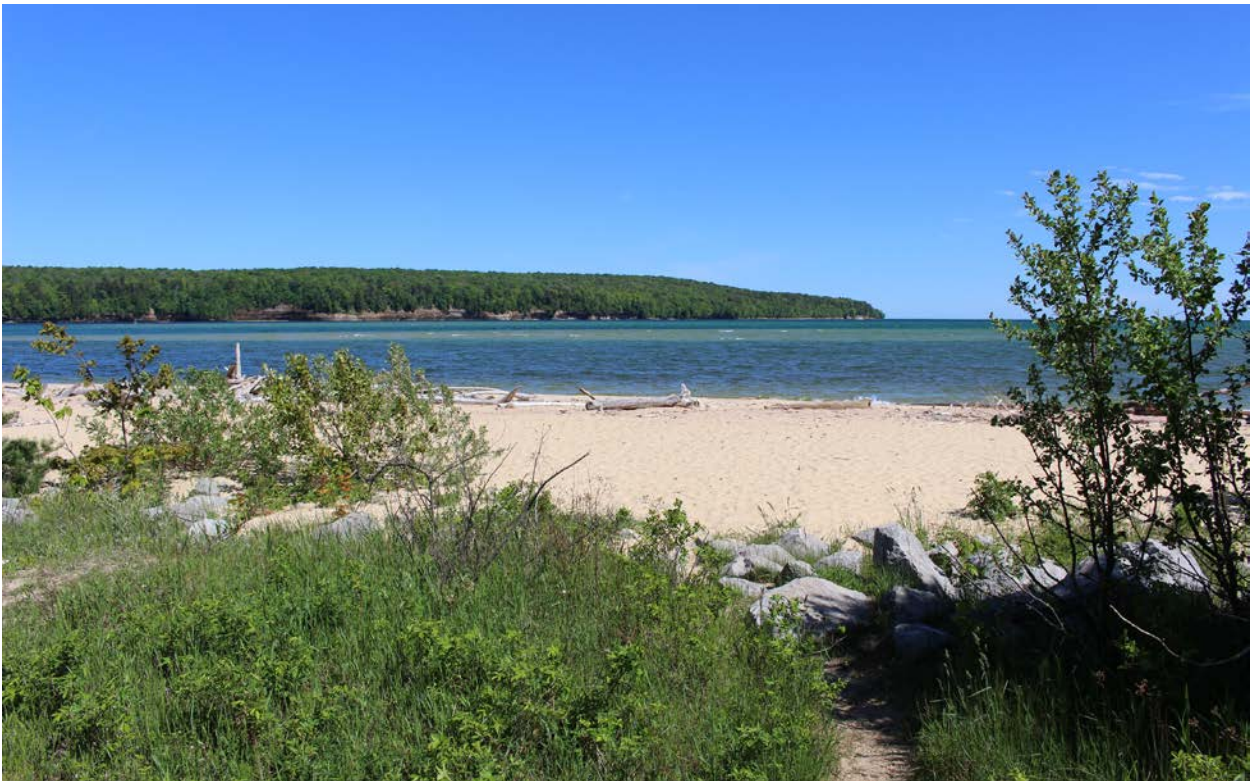
Figure 3-2. Lake Superior reached record setting water levels in the mid-1980s, resulting in very rapid retreat (erosion and inundation) of the northern Sand Point shoreline. The NPS added a rock revetment to the north edge of Sand Point, in foreground of photograph. The sand beach has rebuilt, but not to the extent that existed during the period of significance. (source: Mundus Bishop 2016)

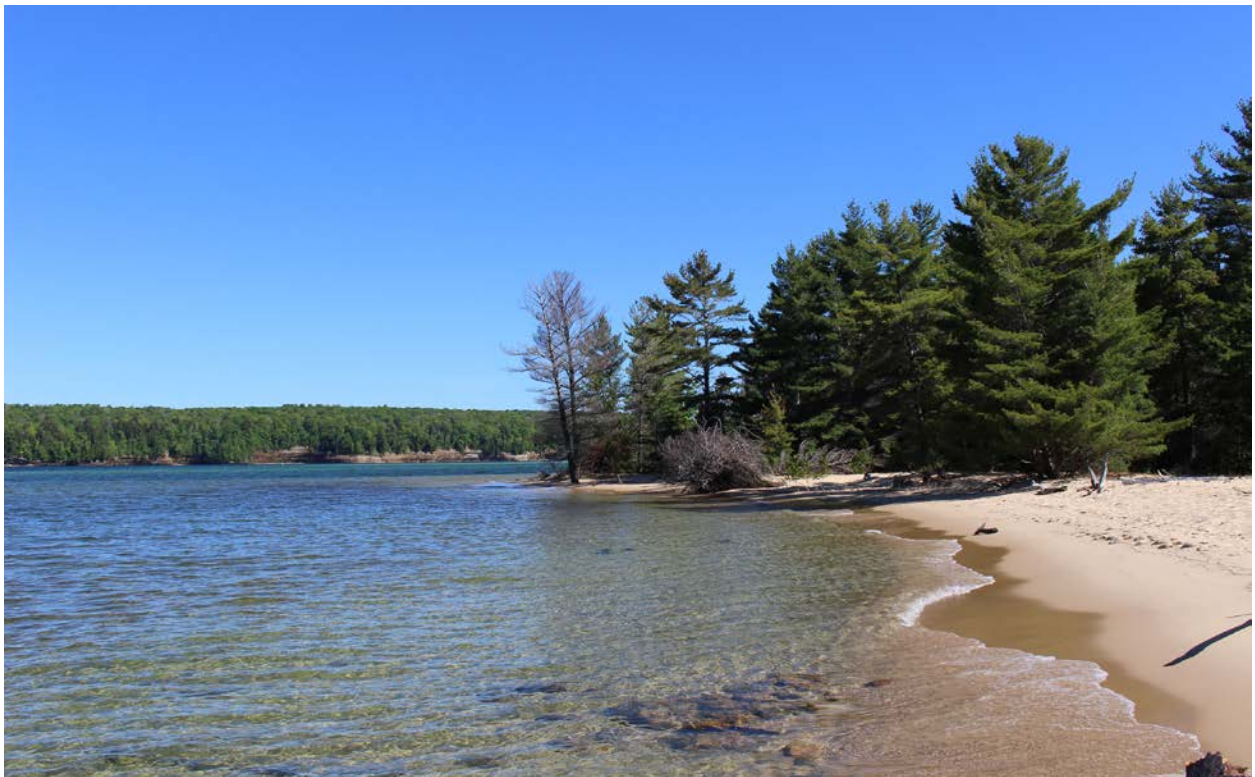
Figure 3-4. On the south side of the point the lakeshore cuts inland resulting in some vegetation being flooded. (source: Mundus Bishop 2016)

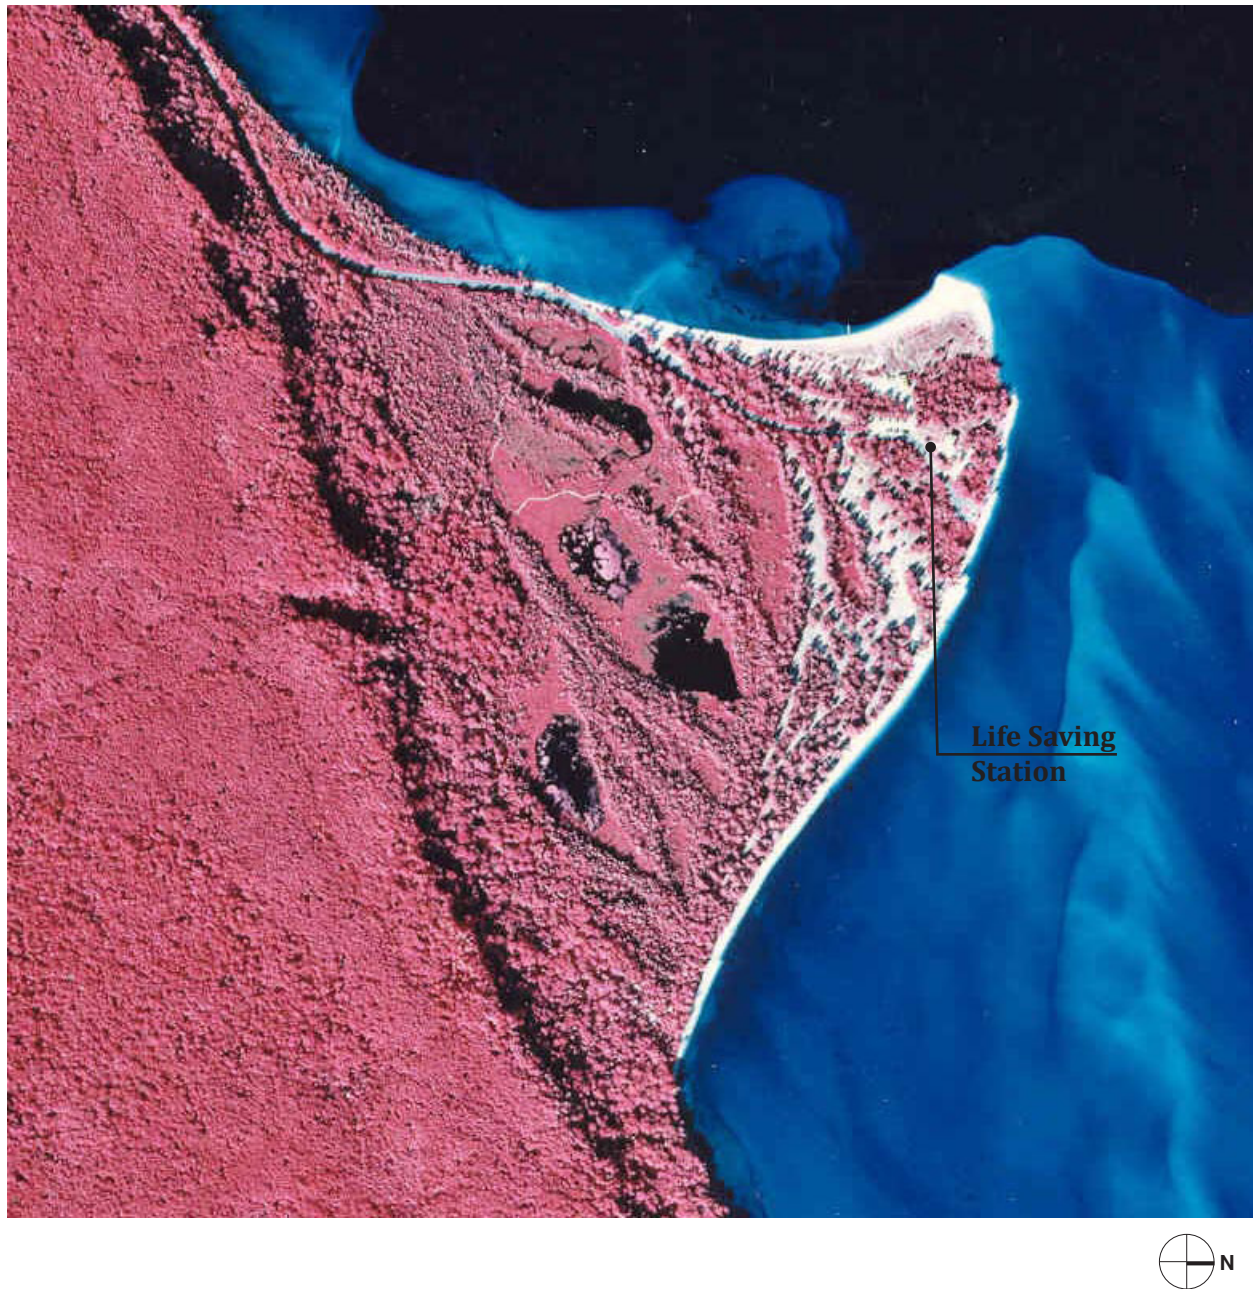
Figure 3-6. Erosion has removed much of the sand at Sand Point since the 1970s, altering the appearance of the point. "Aerial of Sand Point, 1994." (source: PIRO Archives)

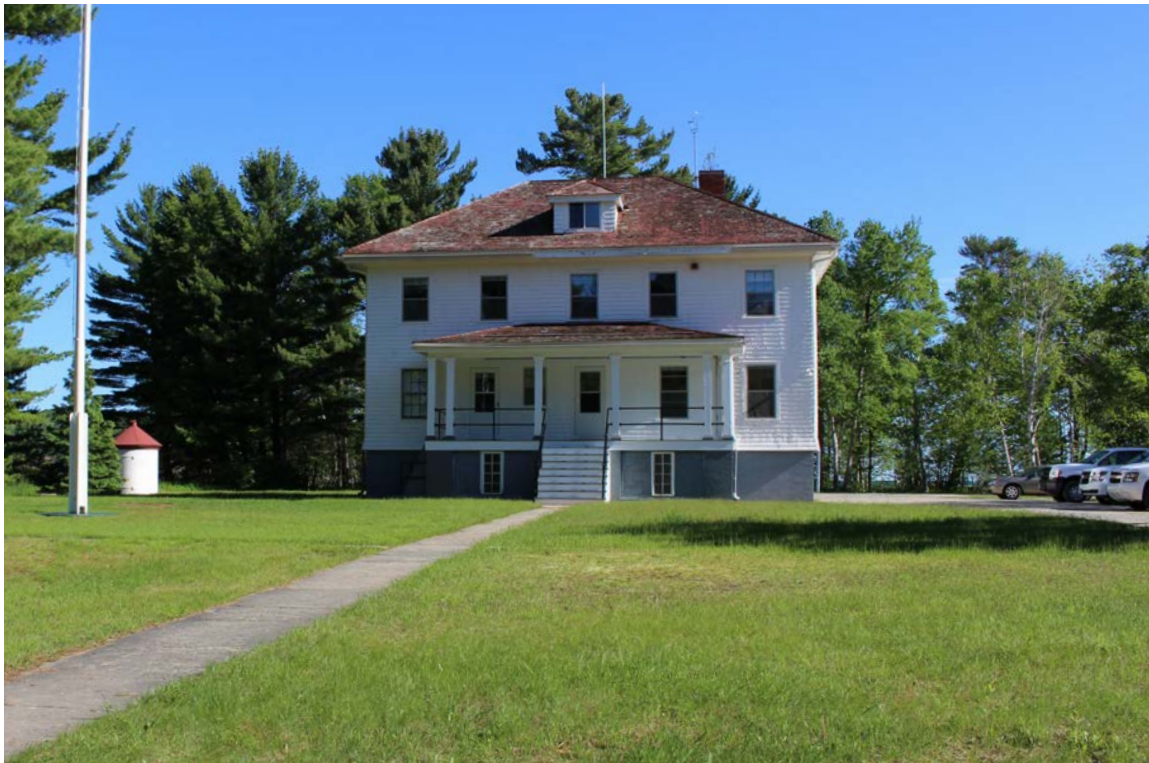
Figure 3-10. Since the period of significance, the spatial organization has been modified by the expanded staff parking area and loss of views to the water. (source: Mundus Bishop 2016)

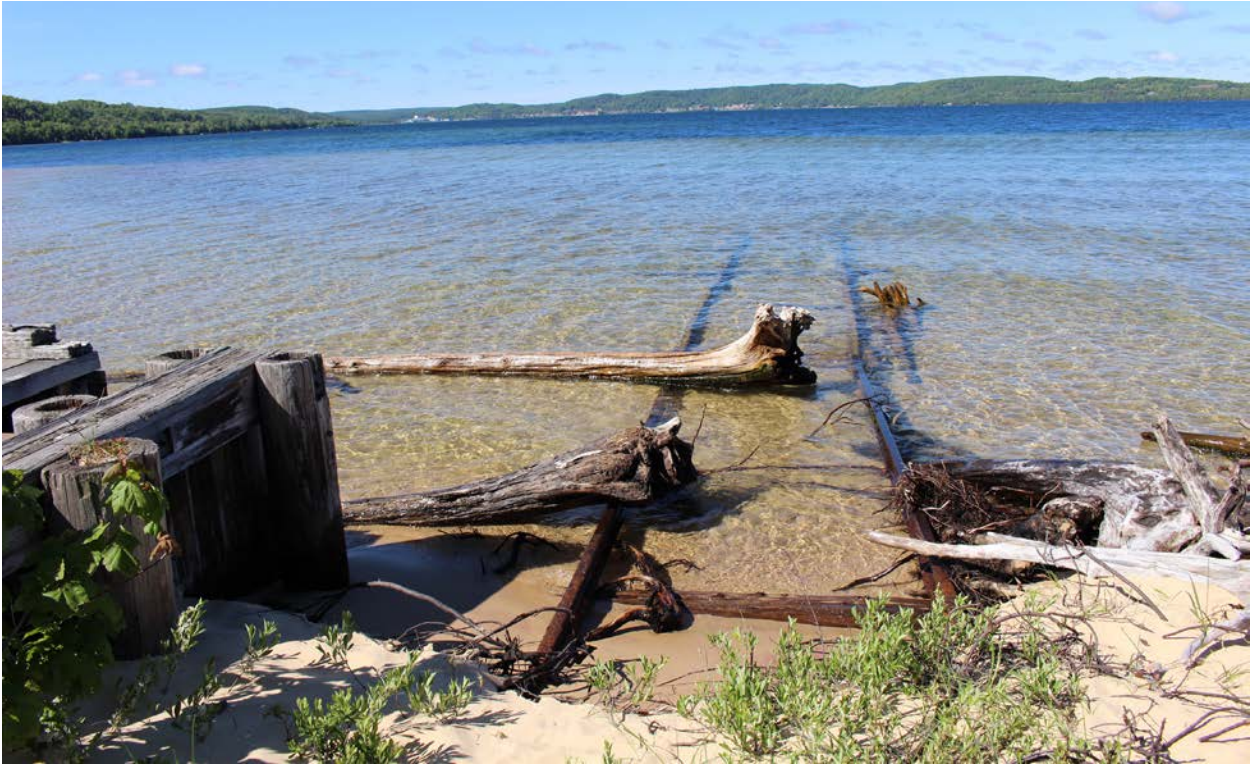
Figure 3-11. The Launchway was placed south of the point, in a sheltered location from strong winter storms. The twin sets of rails are partially extant. The dock, at left, is a reconstruction in an historic location at the end of the Launchway. (source: Mundus Bishop 2016)

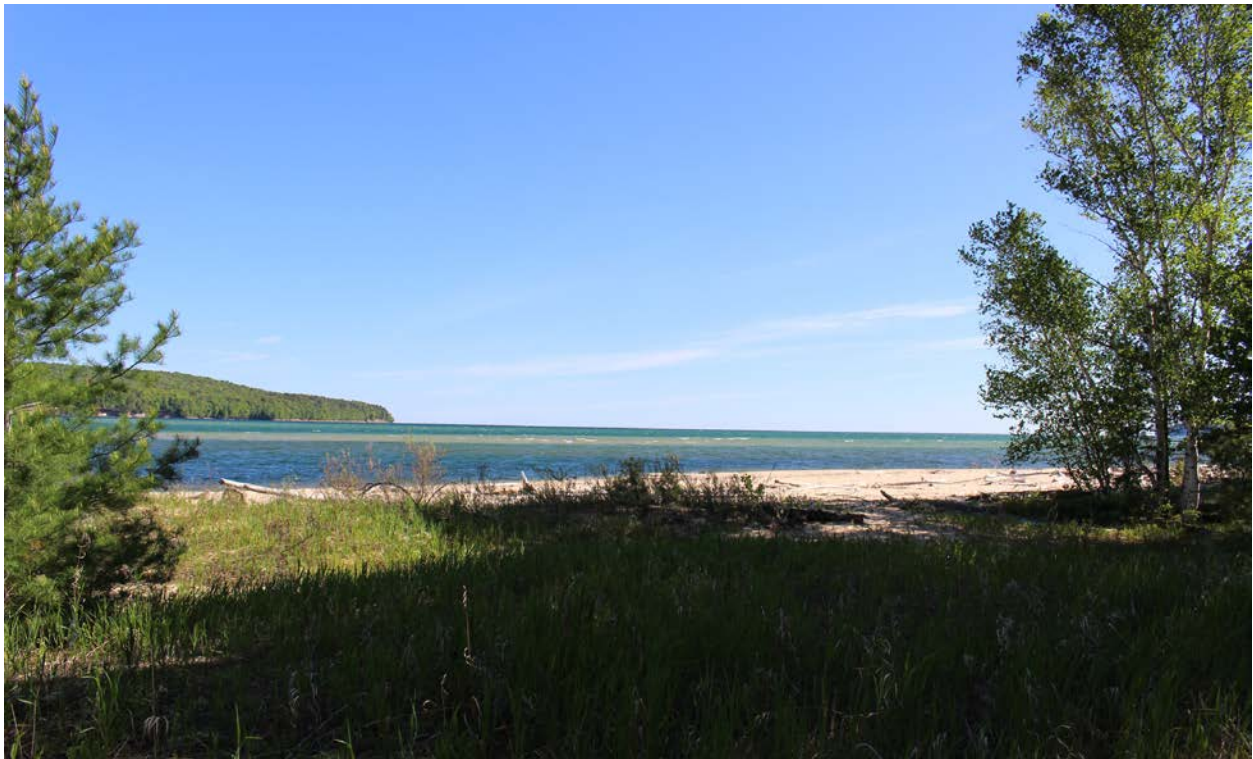
Figure 3-16. A similar view today, looking towards Grand Island. The view remains open across the beach but smaller trees encroach upon the view. (source: Mundus Bishop 2016)

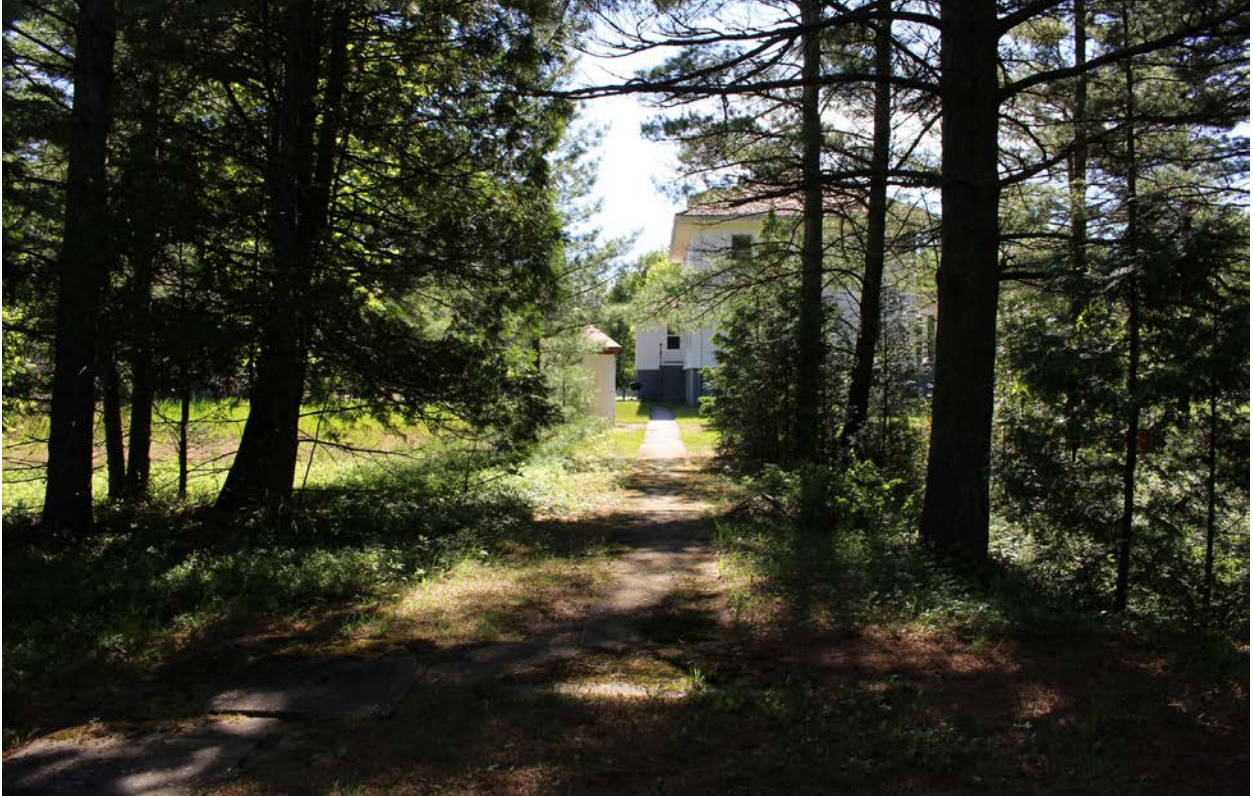
Figure 3-20. The walk to the former Communications Tower is covered with dirt and debris. Vegetation obscures the view between the Life Saving Station and the former tower. (source: Mundus Bishop 2016)

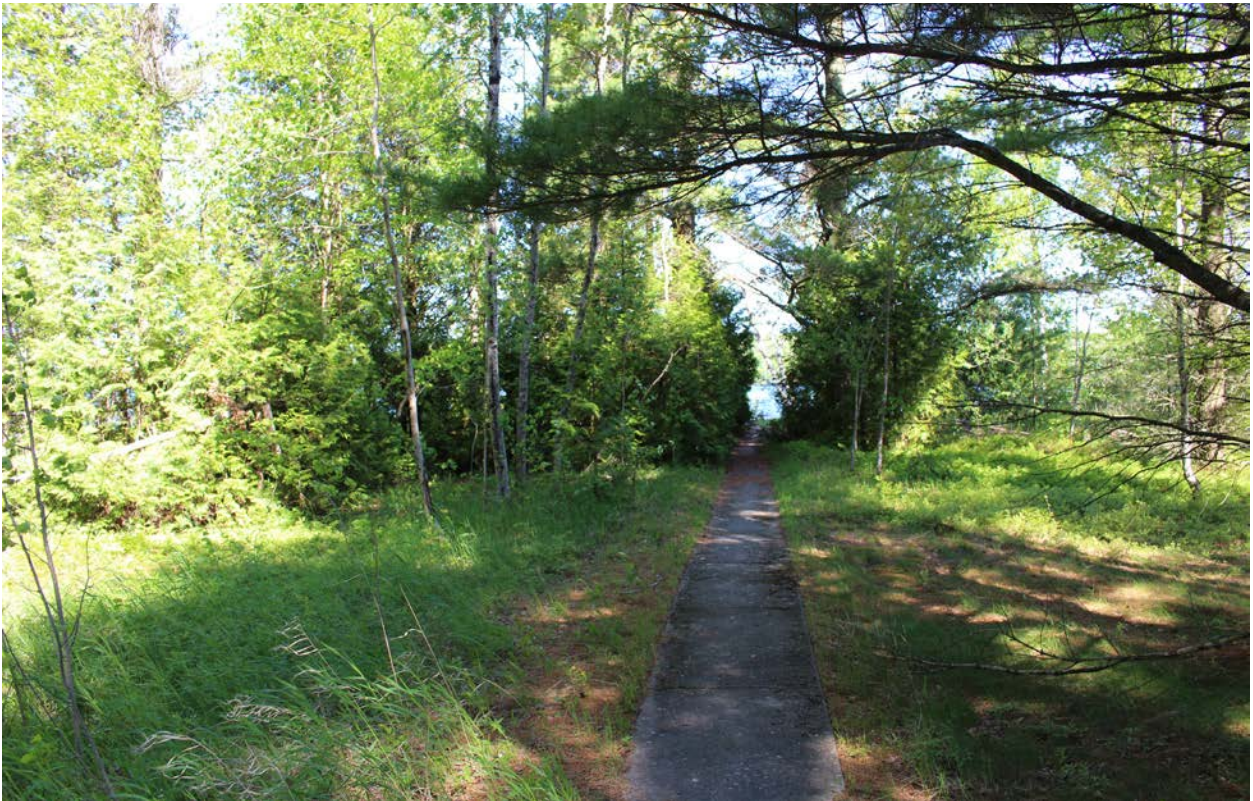
Figure 3-21. The walk between the Communications Tower and the Lookout Tower is in fair condition, portions are covered by encroaching vegetation. (source: Mundus Bishop 2016)

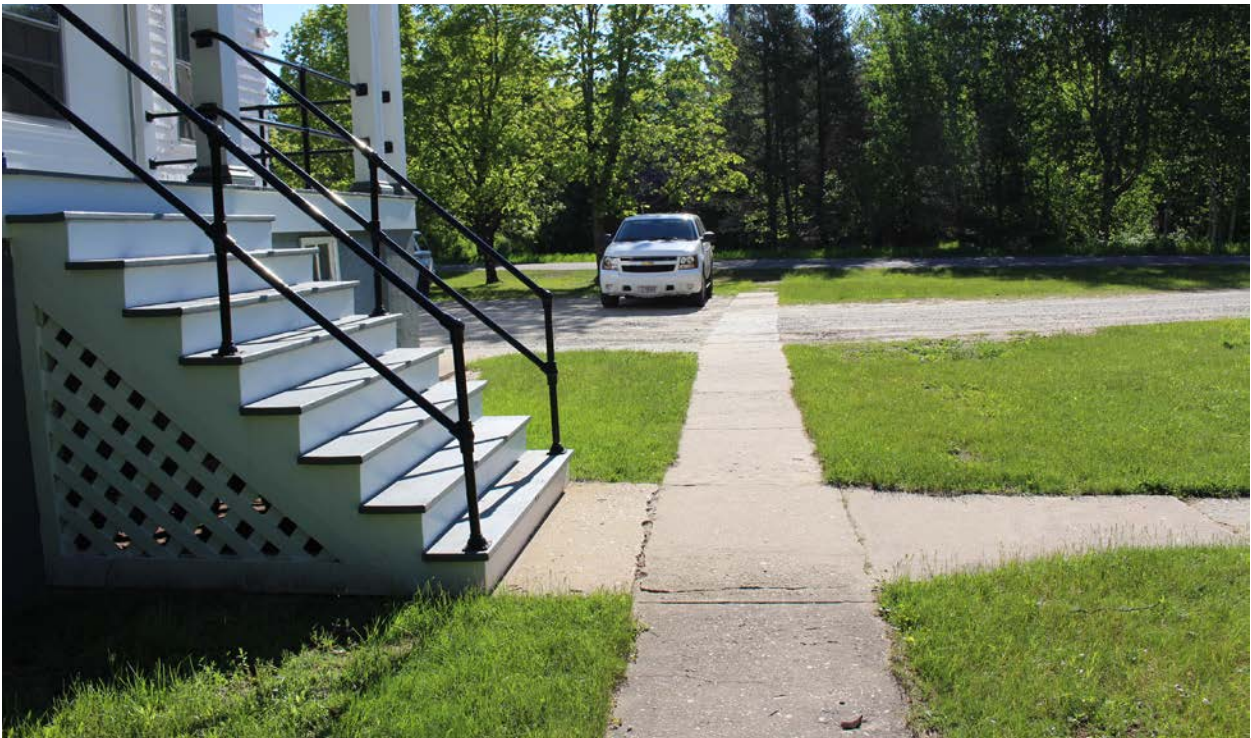
Figure 3-29. The Station Walk at the south facade of the Life Saving Station is in fair condition; damaged where the entrance drive crosses the sidewalk, at rear of photograph. (source: Mundus Bishop 2016)

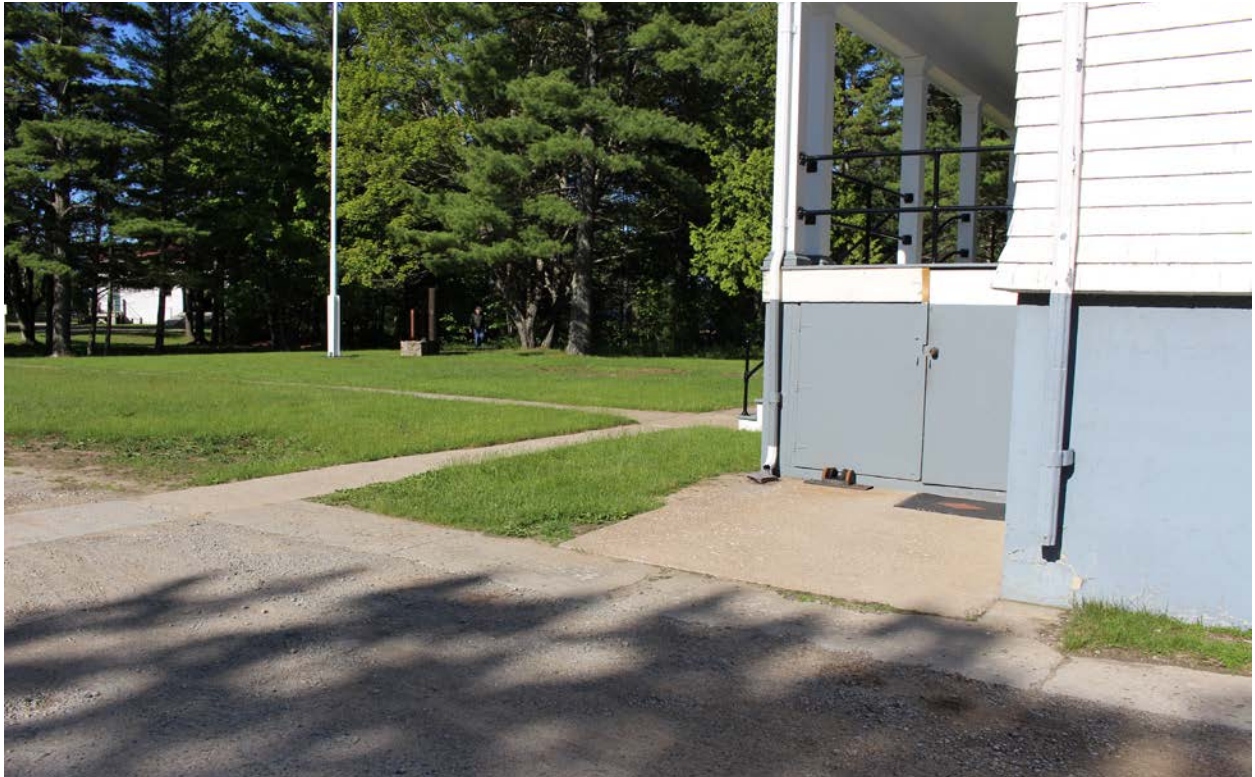
Figure 3-30. The Station Walk on the southeast corner of the Life Saving Station is in fair condition. (source: Mundus Bishop 2016)

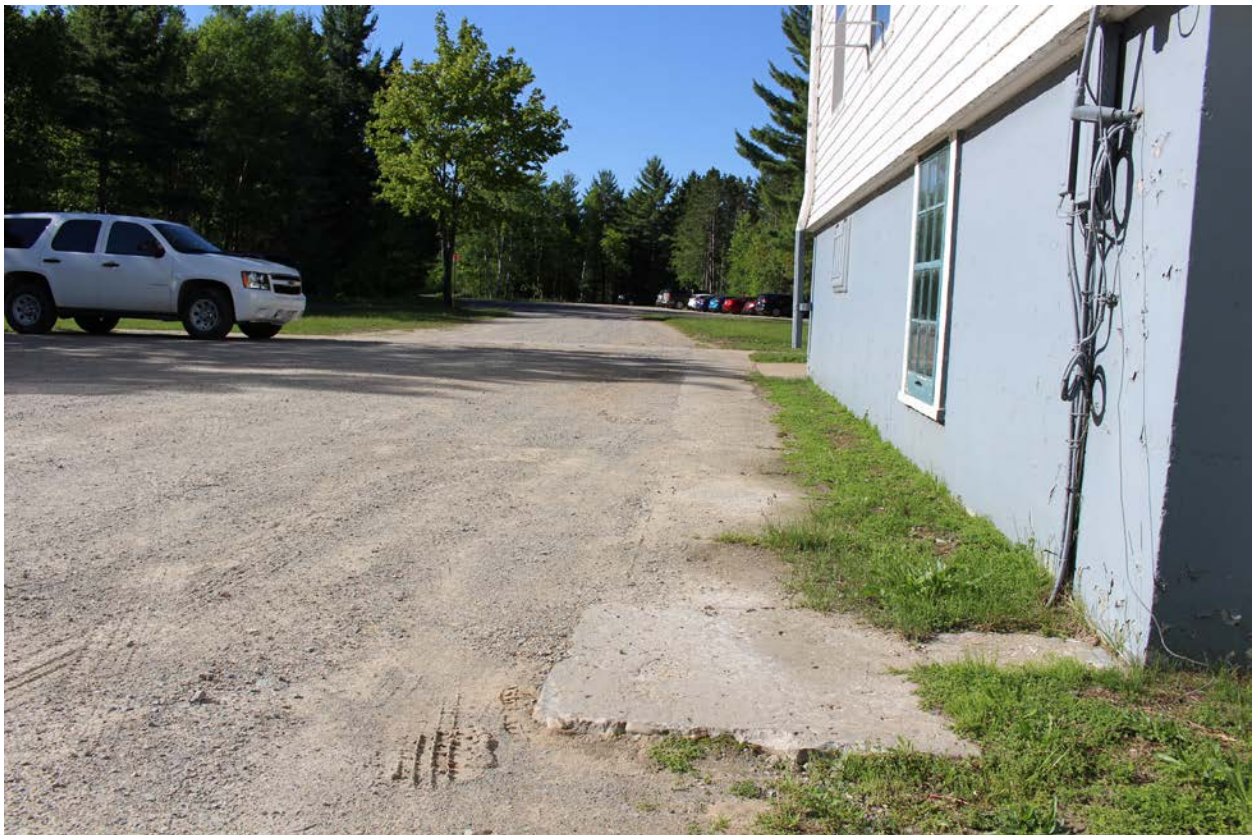
Figure 3-31. The Station Walk on the east side is damaged adjacent to the staff parking area. (source: Mundus Bishop 2016)
