# PHOTOGRAPHIC RECORD

## National Capital Region Wetland Restoration Action Plan Catoctin Mountain Park Spring 2016

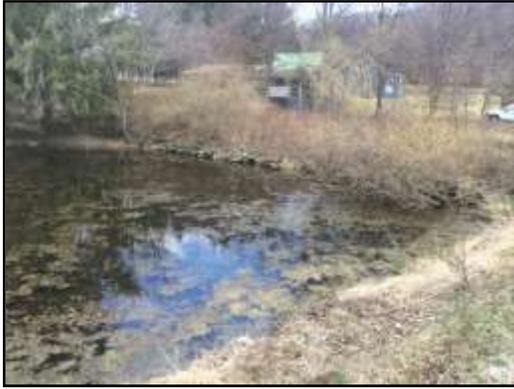
Open Water Pond #2 on the northern portion of CATO-1.

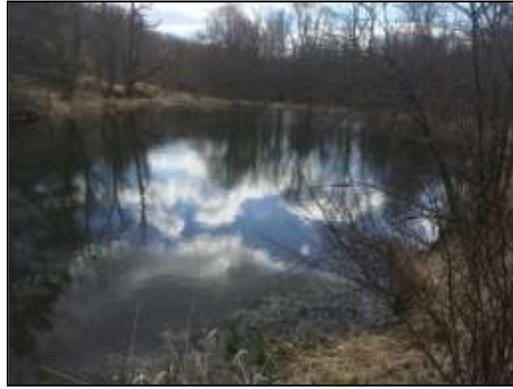
Open Water Pond #1 on the southern portion of CATO-1.

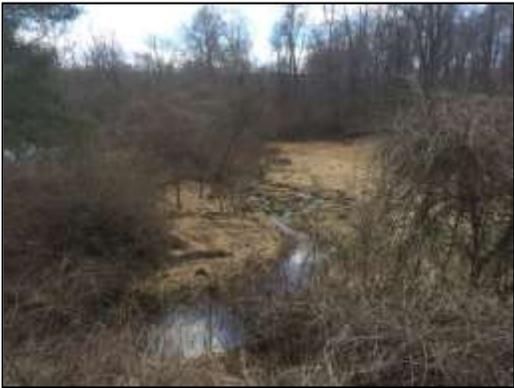
Stream channel located at CATO-1.

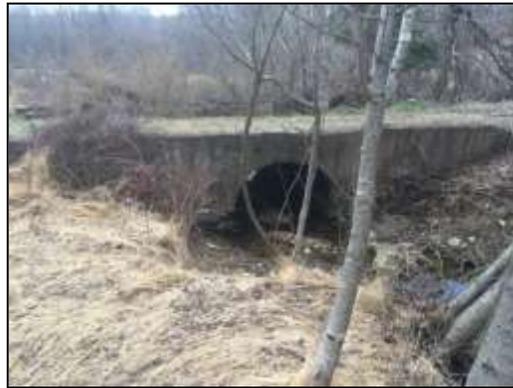
Culvert at existing driveway crossing located at CATO-1.

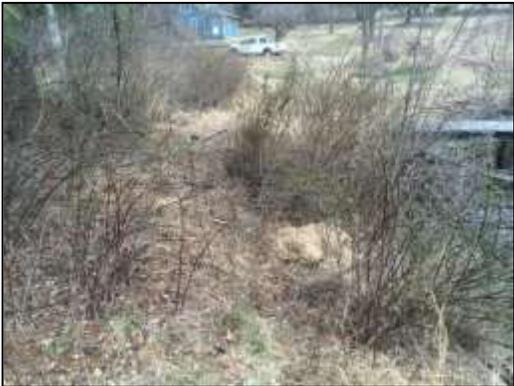
Pond berm located along southern pond at CATO-1, dominated by multiflora rose.

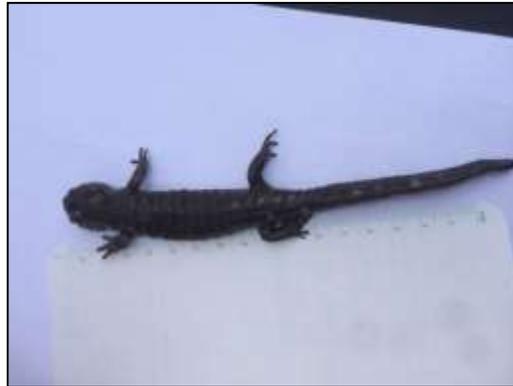
Spotted salamander found at CATO-1.

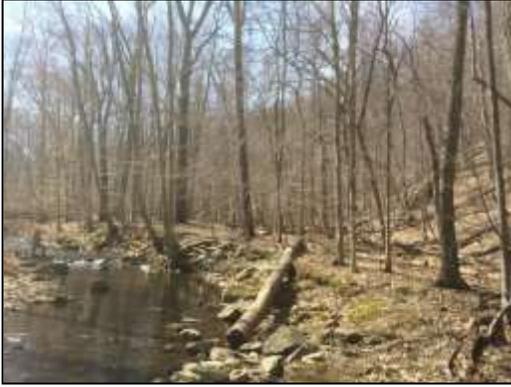
Stable stream bank located at the downstream portion of CATO-2.

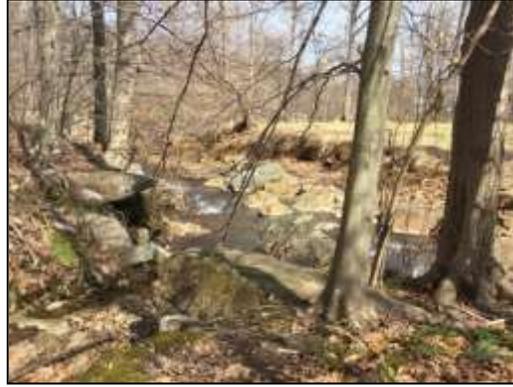
Eroded bank located at CATO-2.

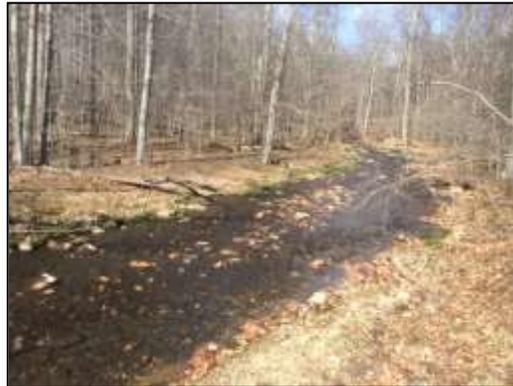
Stable stream channel located downstream of CATO-3.

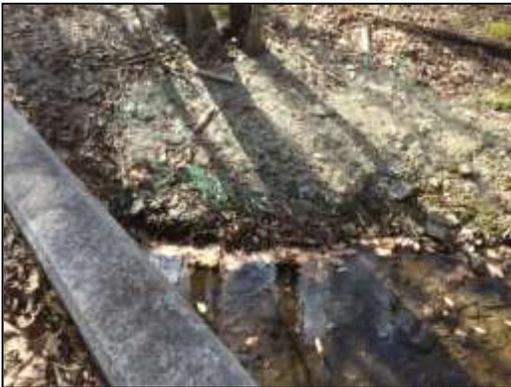
Bank erosion downstream of the culvert at CATO-3.

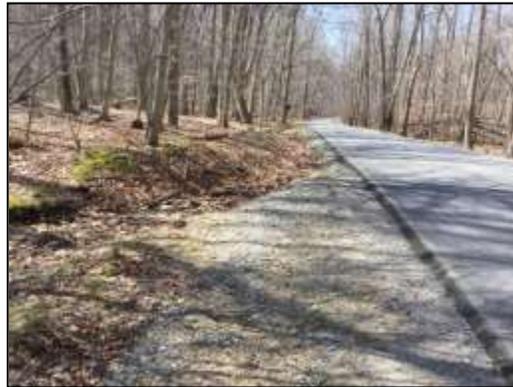
Roadside drainage swale collecting gravel runoff at CATO-3.

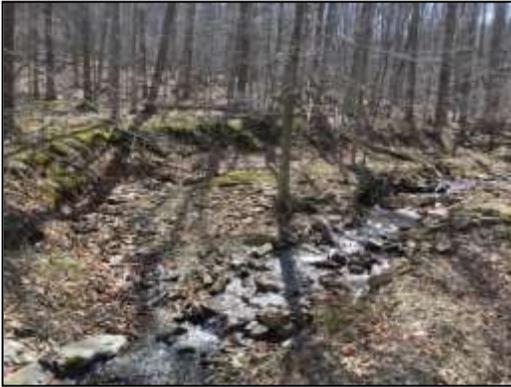
Stream channel located upstream of the culvert at CATO-3.

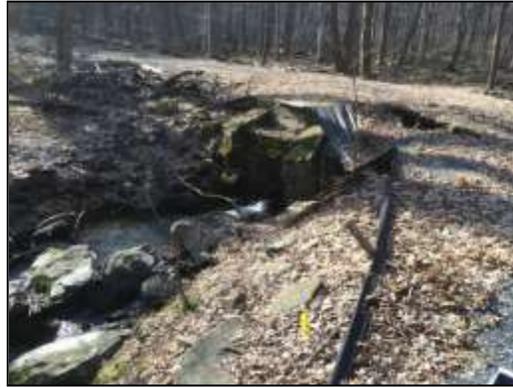
Downstream end of the historic culvert located at CATO-17.

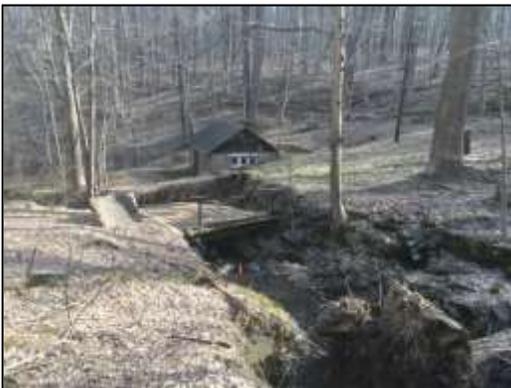
Eroded stream channel on downstream portion of CATO-17.

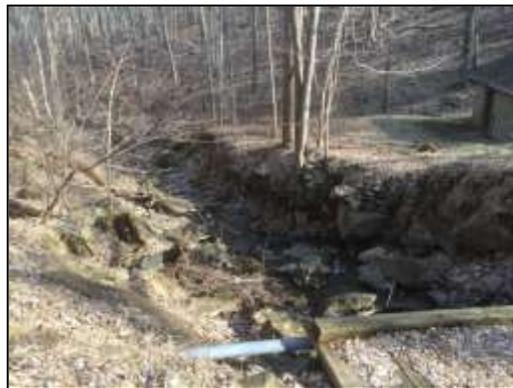
Severely eroded stream banks at CATO-17.

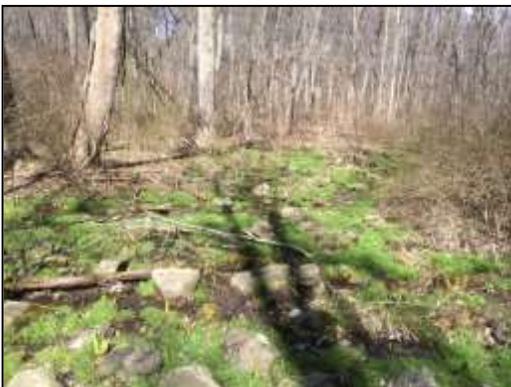
High quality headwater wetland area at CATO-6. Example of dropped site.

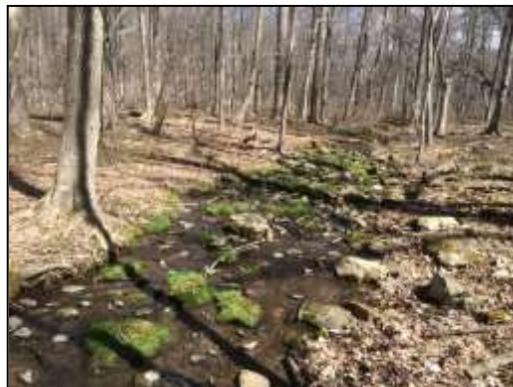
Stable stream channel located at CATO-6. Example of dropped CATO stream site.

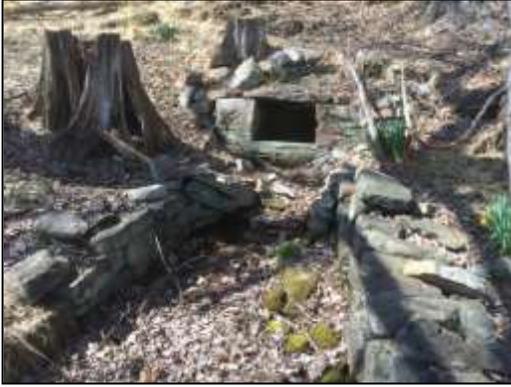
Historic spring house remains at CATO-7.

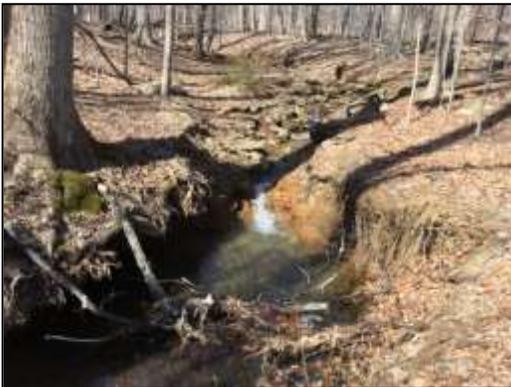
Existing head-cut within the stream channel at CATO-15.

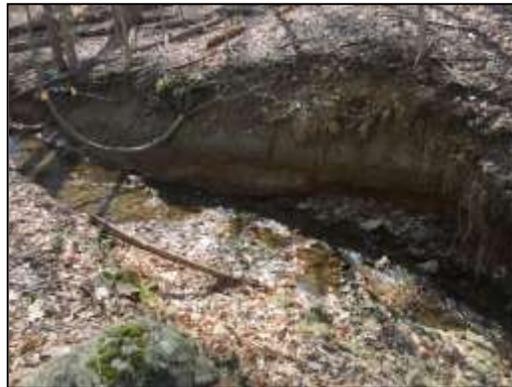
Undercut bank and erosion at CATO-15.

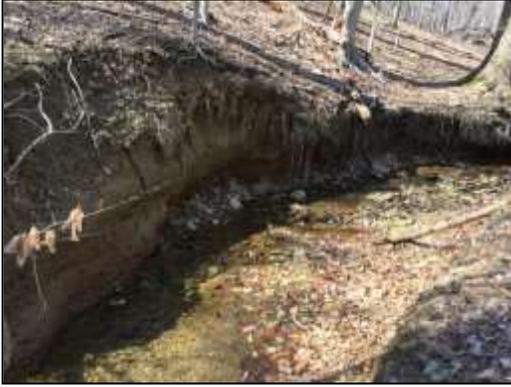
Undercut bank and erosion at CATO-15.

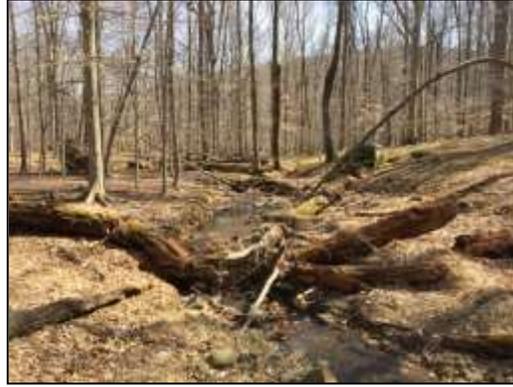
Stable stream at the downstream end of CATO-15.

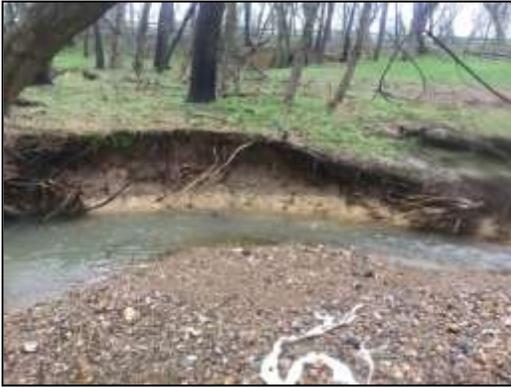
Highly eroded stream bank along WUS-1 at MONO-1.

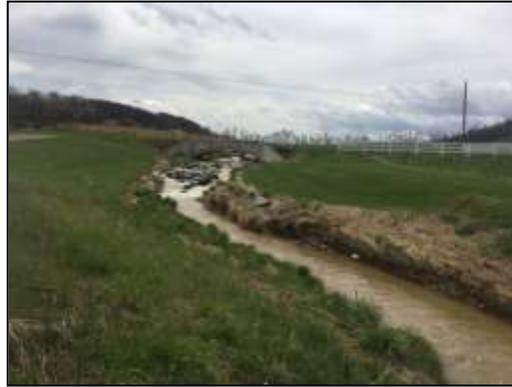
Upstream portion of WUS-1 at MONO-1.

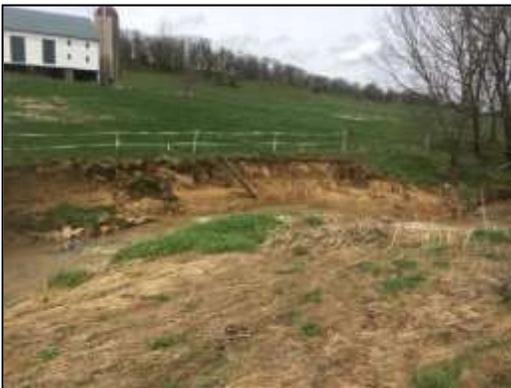
Highly eroded stream bank along the upstream portion of WUS-1 at MONO-1.

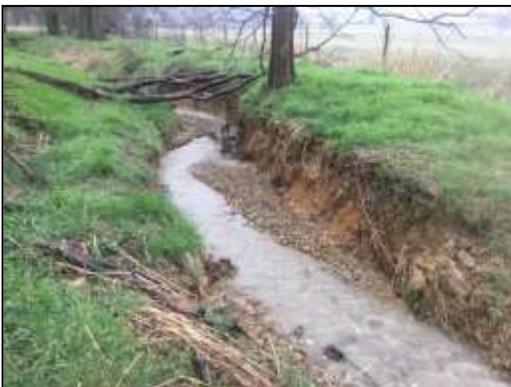
Eroded stream bank along WUS-2 at MONO-1.

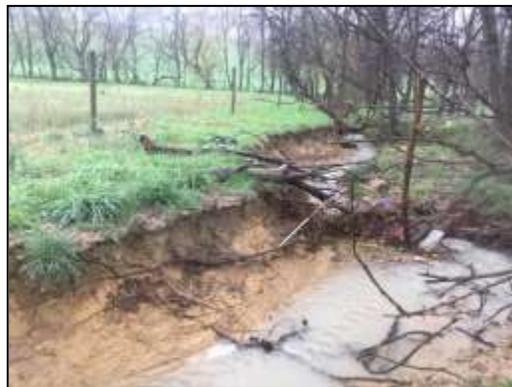
Eroded stream bank and lack of riparian buffer along WUS-2 at MONO-1.

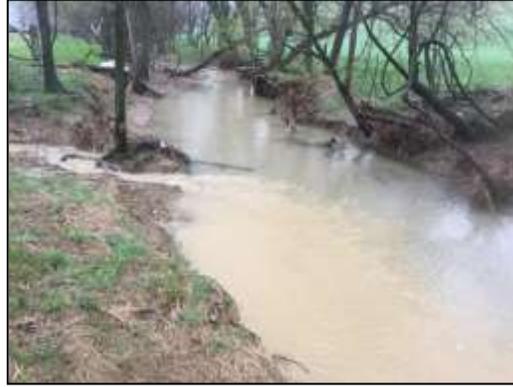
Visible sediment load from WUS-2 into WUS-1 at MONO-1.

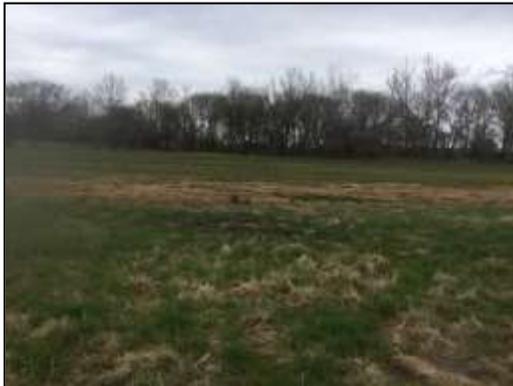
Wetland 1 located at MONO-1.

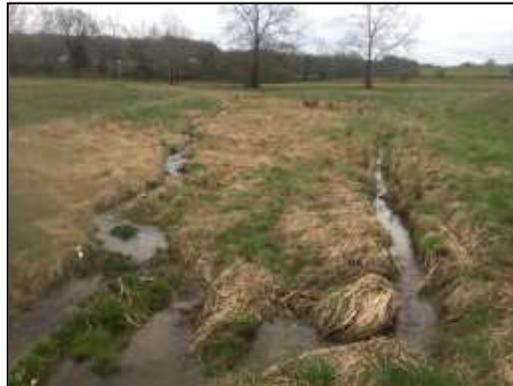
Channelized drainage within Wetland 1 at MONO-1.

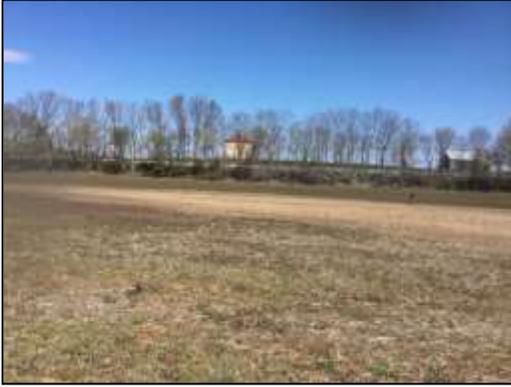
Prior converted wetland area at MONO-5.

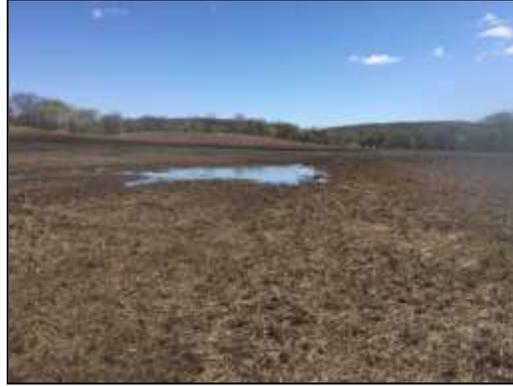
Standing water within agricultural field located at MONO-5.

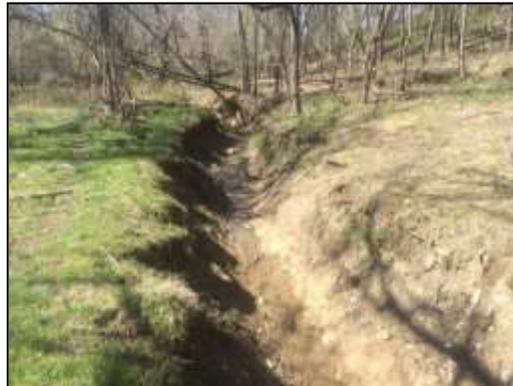
Channel erosion at MONO-10.

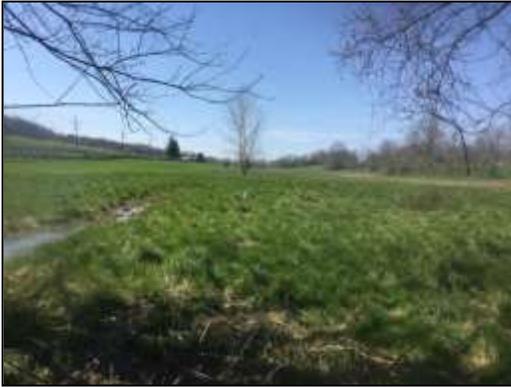
Channelized drainage located at HAFE-2.

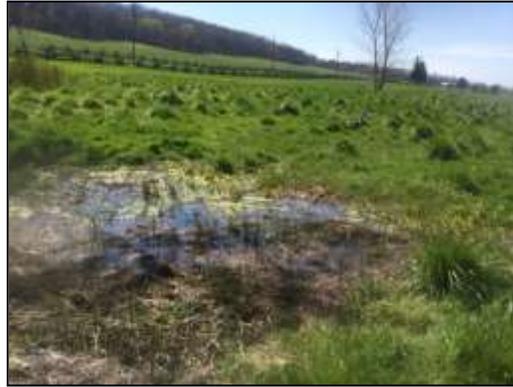
Overview of emergent wetland located at HAFE-2.

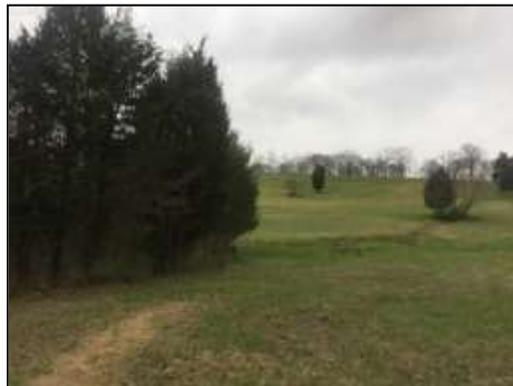
Overview of project site HAFE-4.

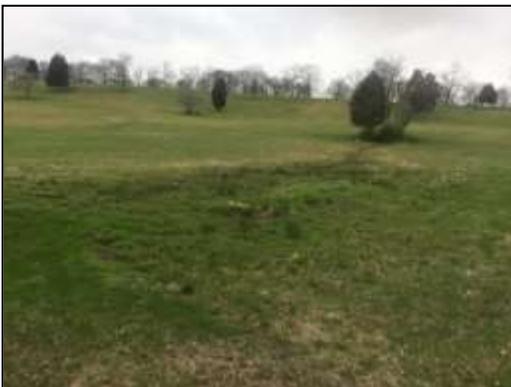
Emergent wetland located at HAFE-4.

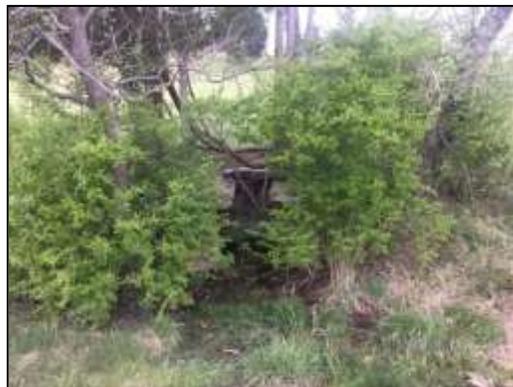
Spring house identified at HAFE-4.

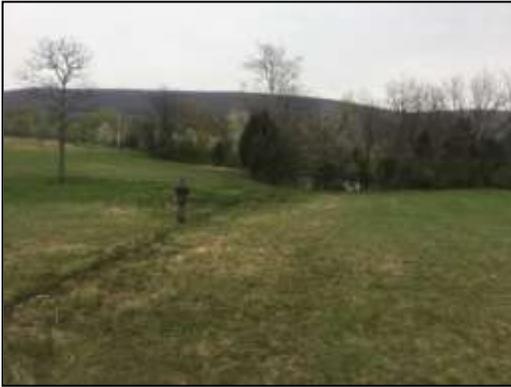
Wetland draining into pond at HAFE-4.

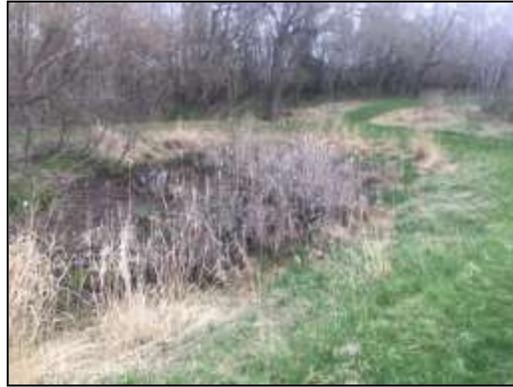
Small emergent wetland at HAFE-6.

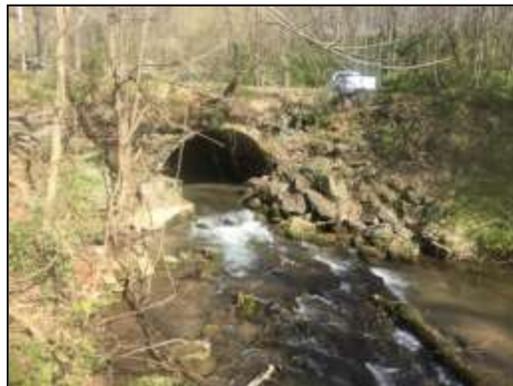
Road crossing with culvert located at HAFE-7.

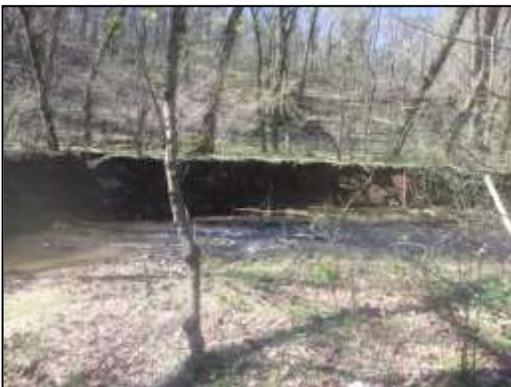
Severely eroded bank and incision at HAFE-7.

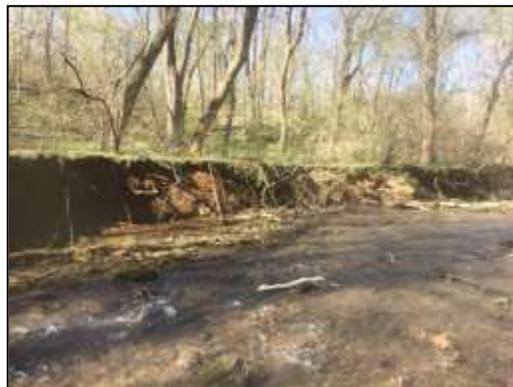
Bank erosion at HAFE-7.

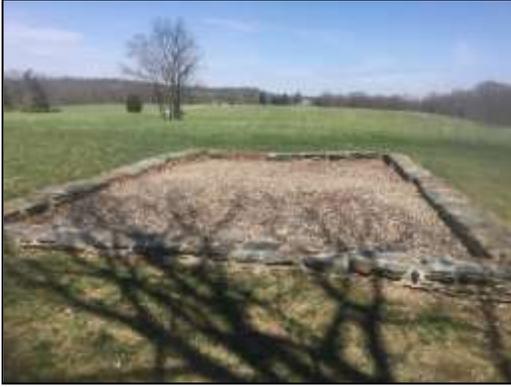
Filled in wetland/historical structure located at HAFE-8.

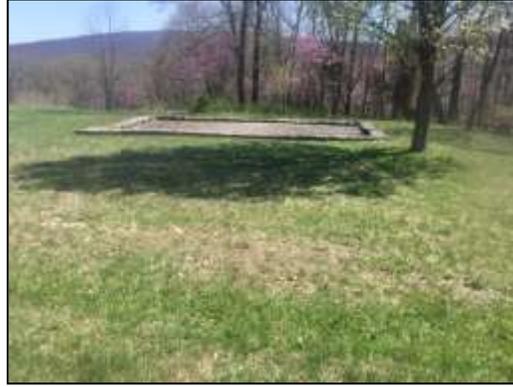
Filled in wetland/historical structure located at HAFE-8.

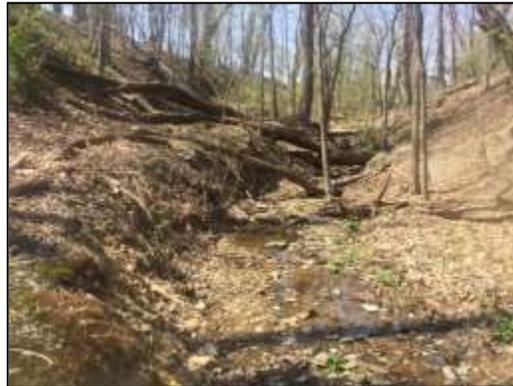
Woody debris and eroded stream bank at HAFE-9.

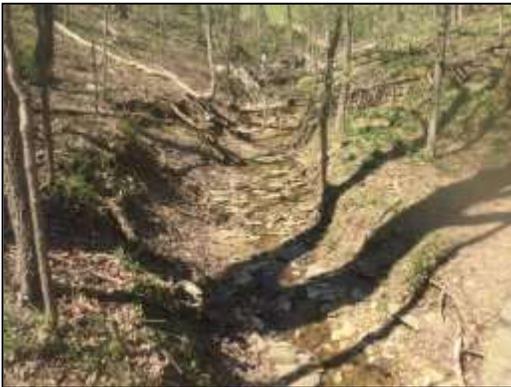
Stream bank erosion located at HAFE-9.

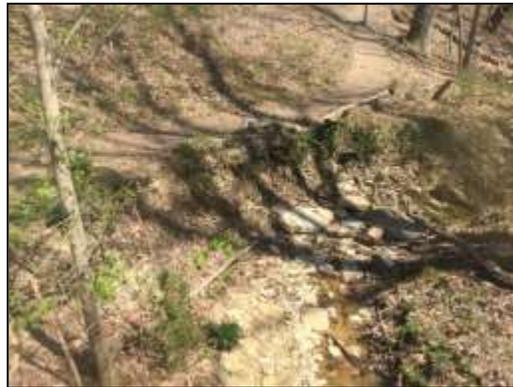
Stream bank erosion near footpath located at HAFE-9.

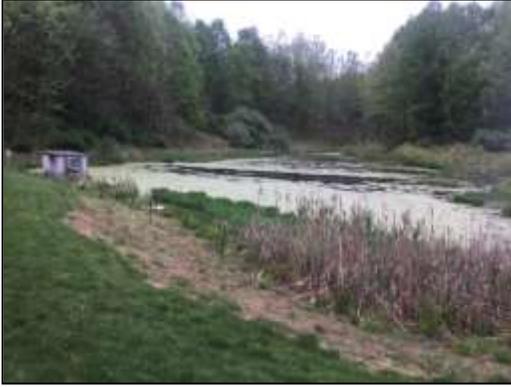
Stormwater management pond located upstream of CHOH-1.

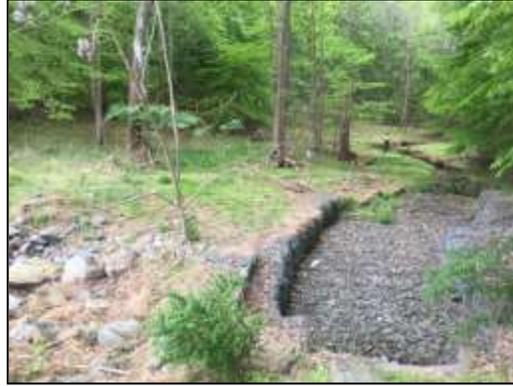
Gabbion baskets located at the head of WUS-1 at site CHOH-1.

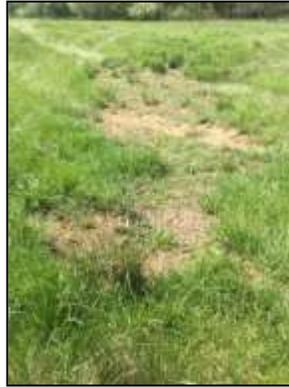
Wetland hydrology indicators observed at CHOH-6.

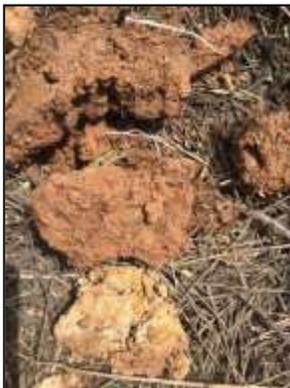
Hydric soil samples collected at CHOH-6.

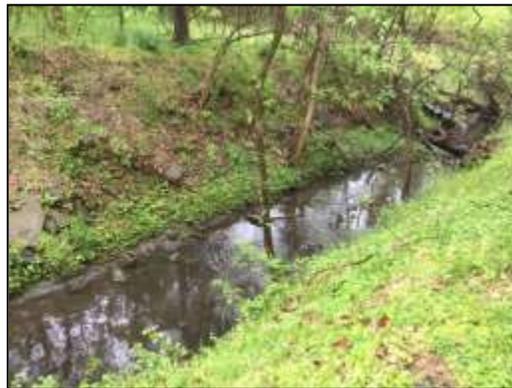
Stream channel at CHOH-12.

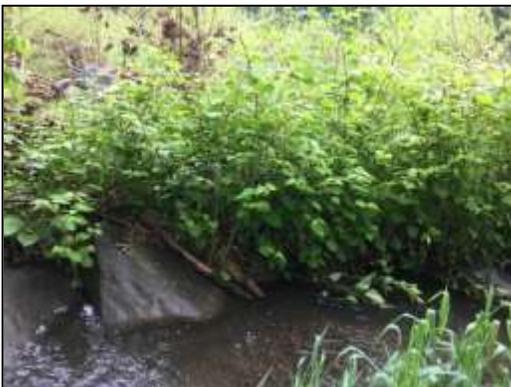
Invasive species along the stream bank at CHOH-12.

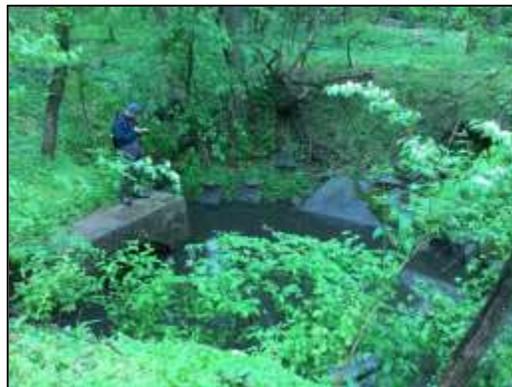
Outfall structure located at the upstream portion of CHOH-12.

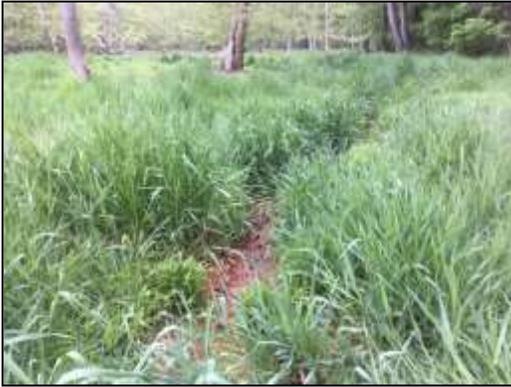
Reed canary grass located within the forested wetland at CHOH-13.

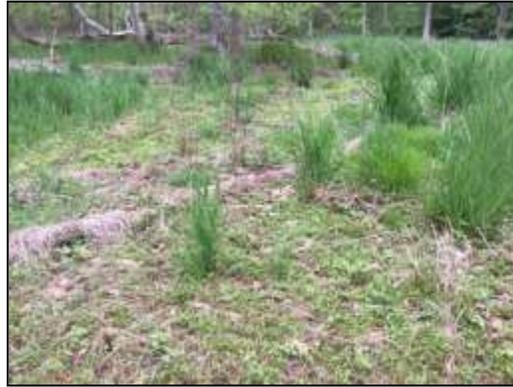
Forested wetland located at CHOH-13.

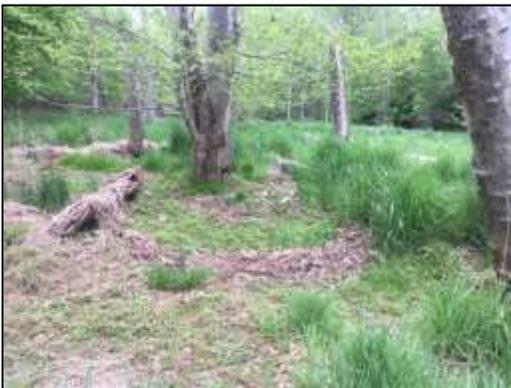
Forested wetland area at CHOH-13.

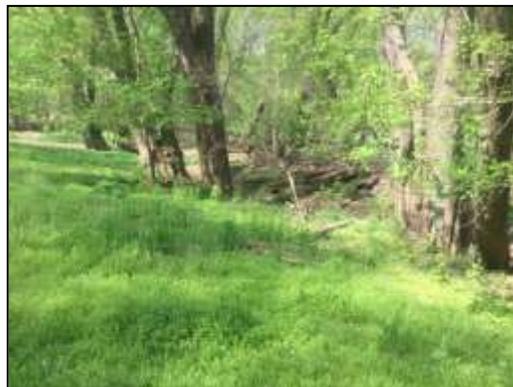
Lack of riparian area along the stream channel at CHOH-17.

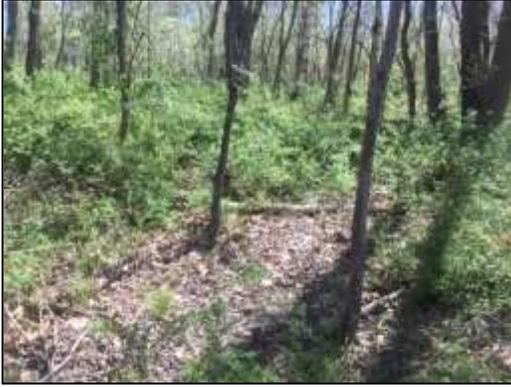
Overview of Multiflora Rose wetland at CHOH-18.

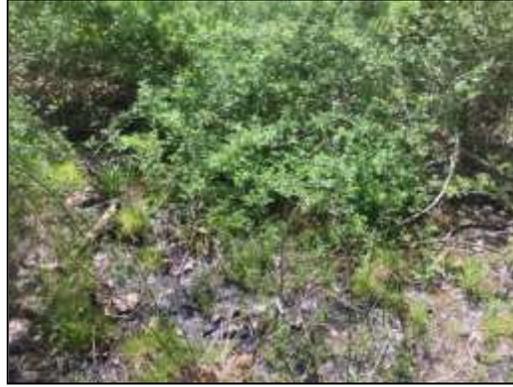
Surface water and soft rush located within the wetland at CHOH-18.

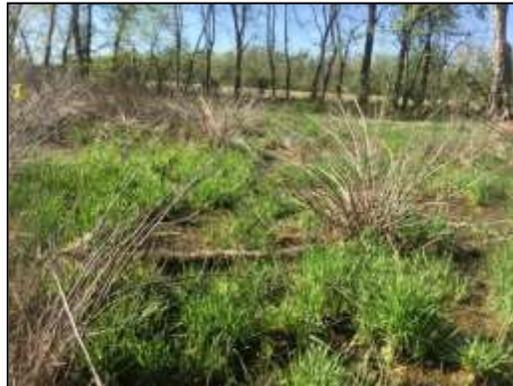
Buttonbush and reed canary grass identified within the wetland located at CHOH-19.

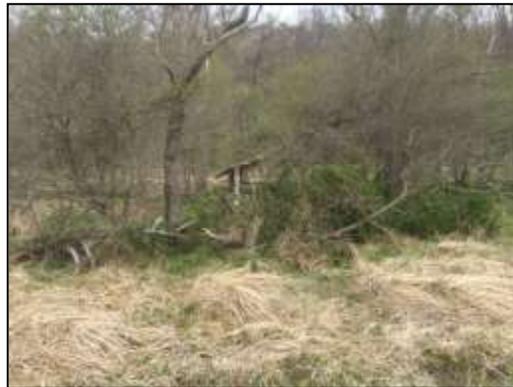
Transition area from emergent wetland to forested wetland at CHOH-23.

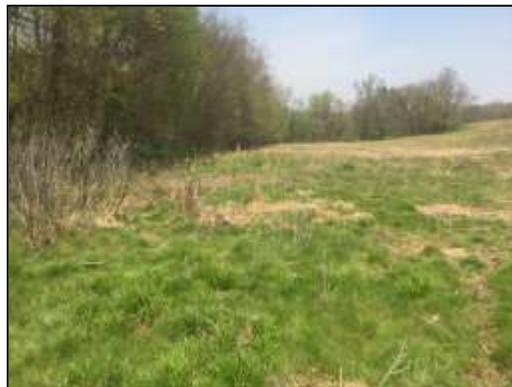
Emergent wetland along the edge of the agricultural field at CHOH-25.

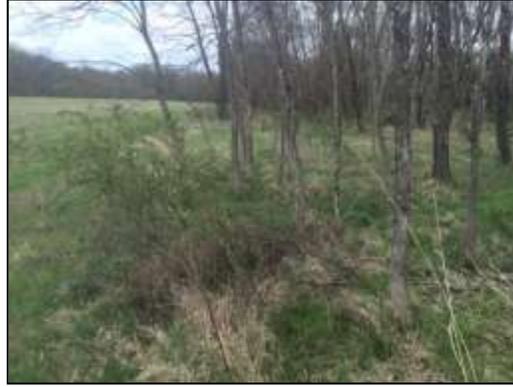
Multiflora rose observed along the edge of the forested wetland at CHOH-27.

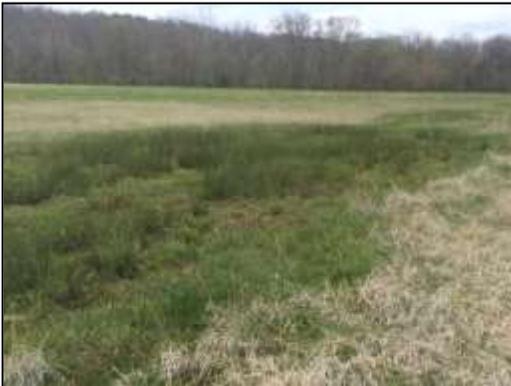
Emergent wetland dominated by soft rush at CHOH-27.

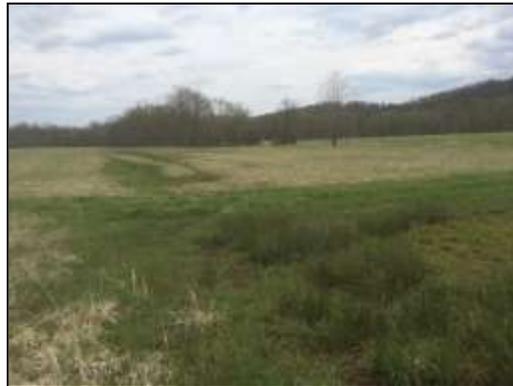
Emergent wetland dominated by soft rush at CHOH-27.

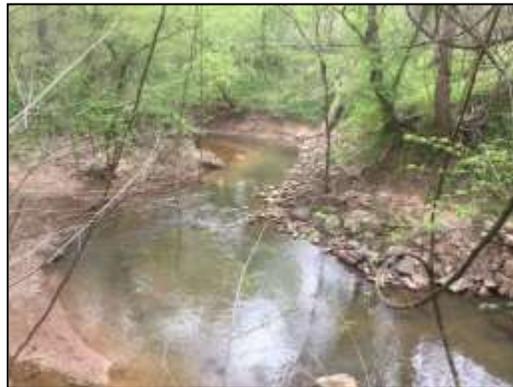
Stream channel located at CHOH-29.

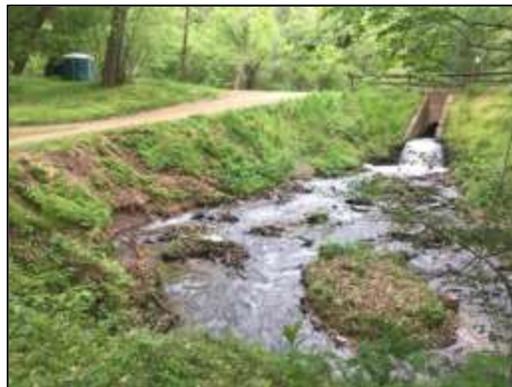
Outfall structure and adjacent roadway located at CHOH-31.

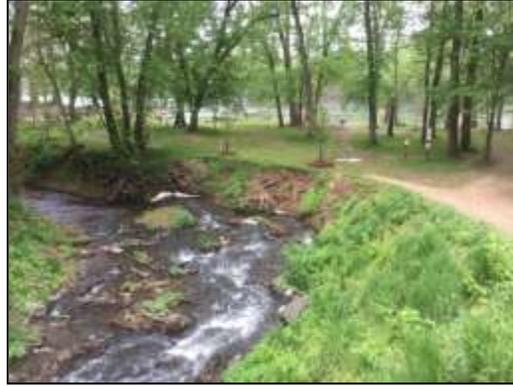
Lack of mature and dense riparian buffer along the stream channel at CHOH-31.
