Site ID MONO-6 WET-1 Potential Restoration Area 2.19 (Acres) Date of Field Assessment 4/6/2016 Existing Land Use Old field Old field, stream, residential, Adjacent Land Use road Distance to Nearest Road 100 RTE Species Present? No Known Cultural Concern? No Stream Restoration Yes Opportunity? Site Currently Wetland? Yes Site Formerly Wetland? No Evidence of Disturbance No Soils Score 8 8 Hydrology Score Existing Vegetation Score 6 Geomorphic Score 9 Surrounding Land Use Score 6 Function and Value Score Presence of Invasive Species 5 Score Site Disturbance Score 3 Ease of Access Score Stormwater Influence Score 8 Total Score 69 Invasive Species Control? No Native Plantings? Yes Yes Restore Hydrology? Increase Diversity? Yes Convert Open Water to No Vegetated? Convert Emergent to Yes Shrub/Forested Increase Asthetic or Yes Educational Value Other No Wetland area recently planted with trees hydrology exists along west side. Ground water likely,

Site ID
 MONO 6

CHOH-01 Site ID Potential Restoration Area 0.05 (Acres) Date of Field Assessment 4/27/16 Existing Land Use Forested Park land Stormwater management; Adjacent Land Use mowed maintained turfgrass; Mcmansions; forest Distance to

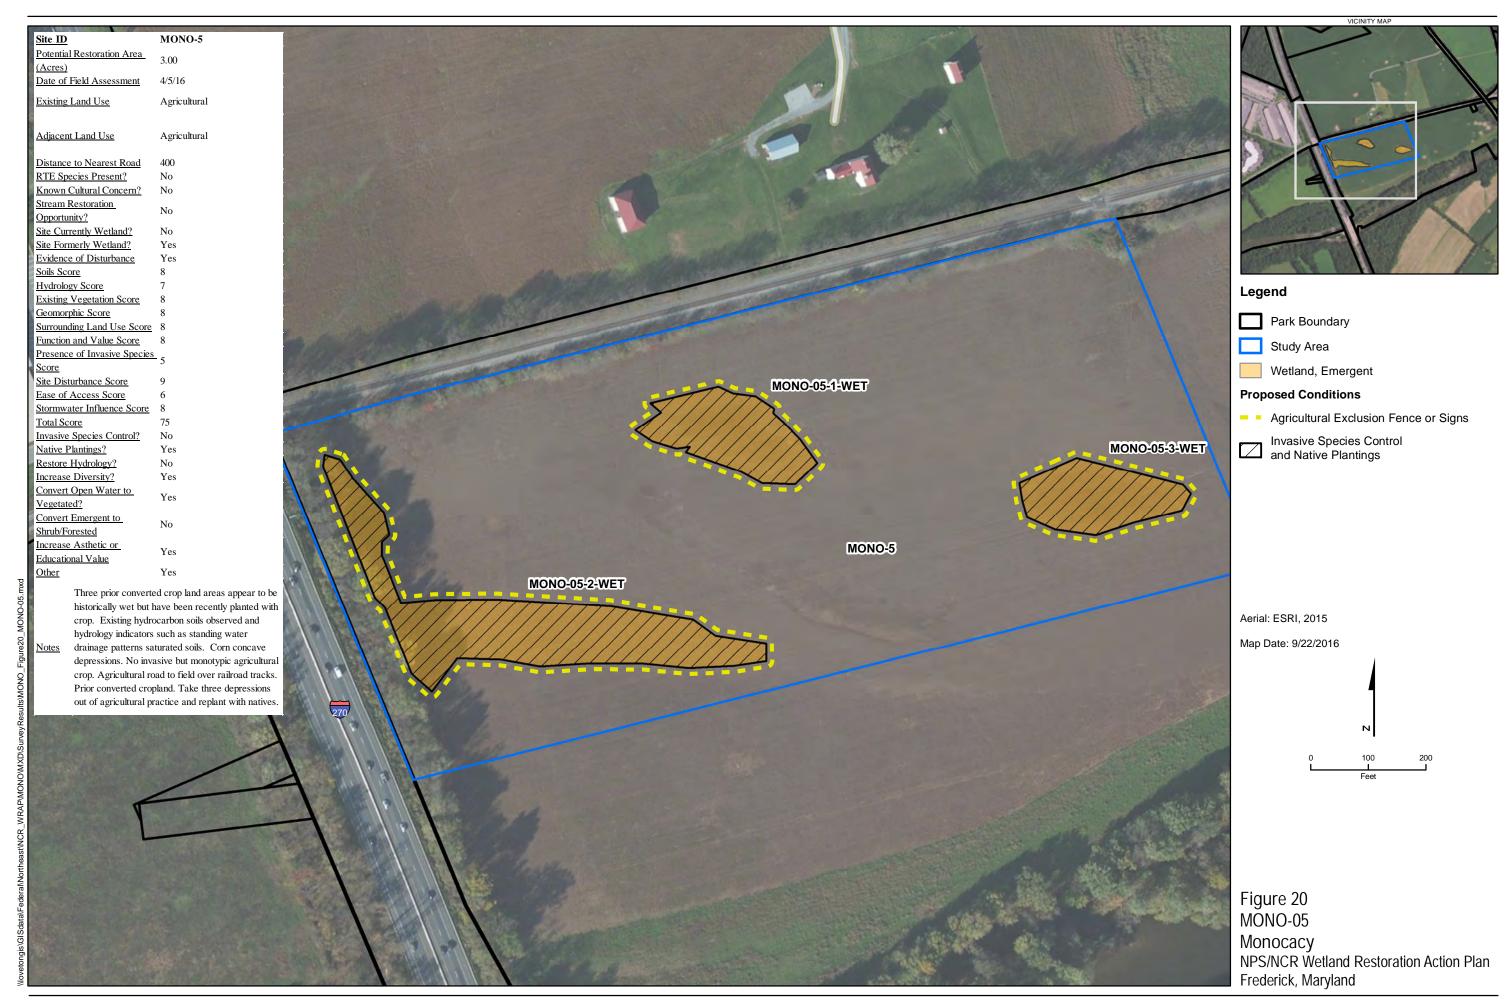
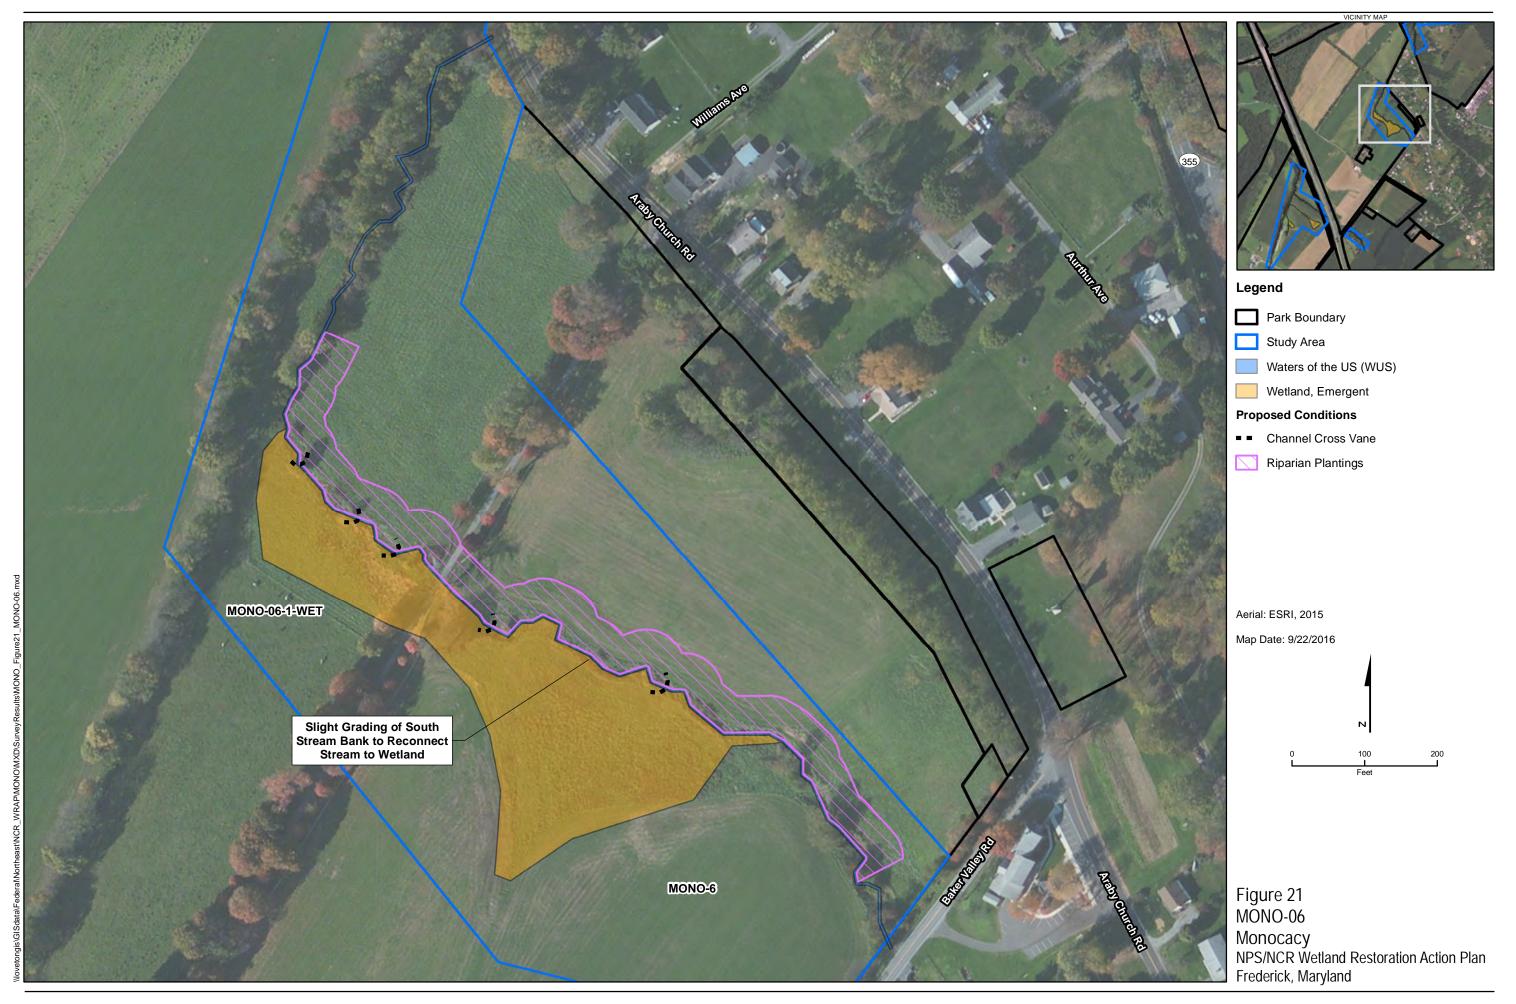
is likely from runoff and groundwater small channel exists along west side. Ground water likely, surface water runoff from surrounding field. Grass and recently planted trees. Adjacent to stream, surrounding topography slopes to wet area. Disconnected from stream due to erosion. Road bisects wetland. Wetland area adjacent to road has standing water and small channel flowing to stream

Paved road crosses stram channel, concrete culvert carries stream under road, channel is much more seriously eroded after culvert. Open field on either side of channel with minimal invasive species. Mild to moderate erosion in upper reach, erosion is more severe in lower reaches. Banks are soft soil. Topography of surrounding land slopes down to the channel. Some small vegetated beaches exist adjacent to channel. Area consists of mostly grasses with some trees along bank. Reccommendations include: old field habitat creation, channel stabilization, fish

passage, and reduction of sedimentation.
