MAMMOTH HOT SPRINGS HOTEL

Historic Structures Report

Yellowstone National Park

March, 2015

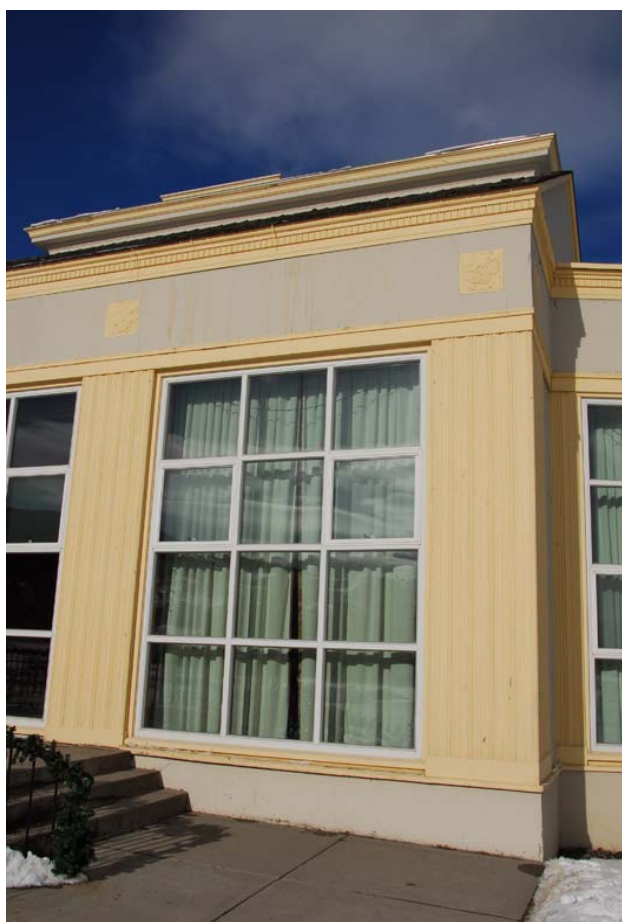
Figure 7: Looking north at a typical restored Map Room window. The windows are in good condition.

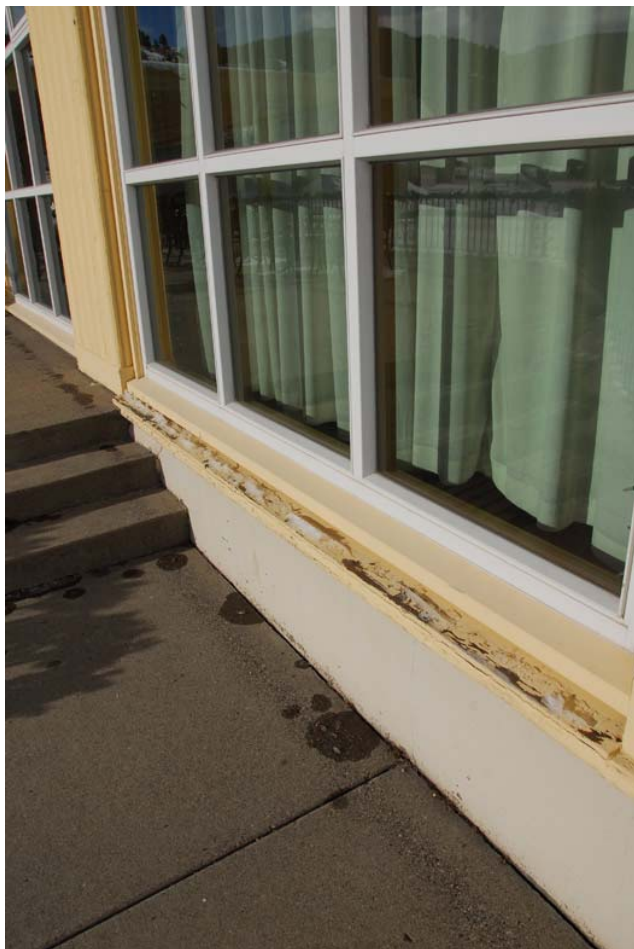
Figure 8: Looking northwest at the deteriorating sill along the restored windows

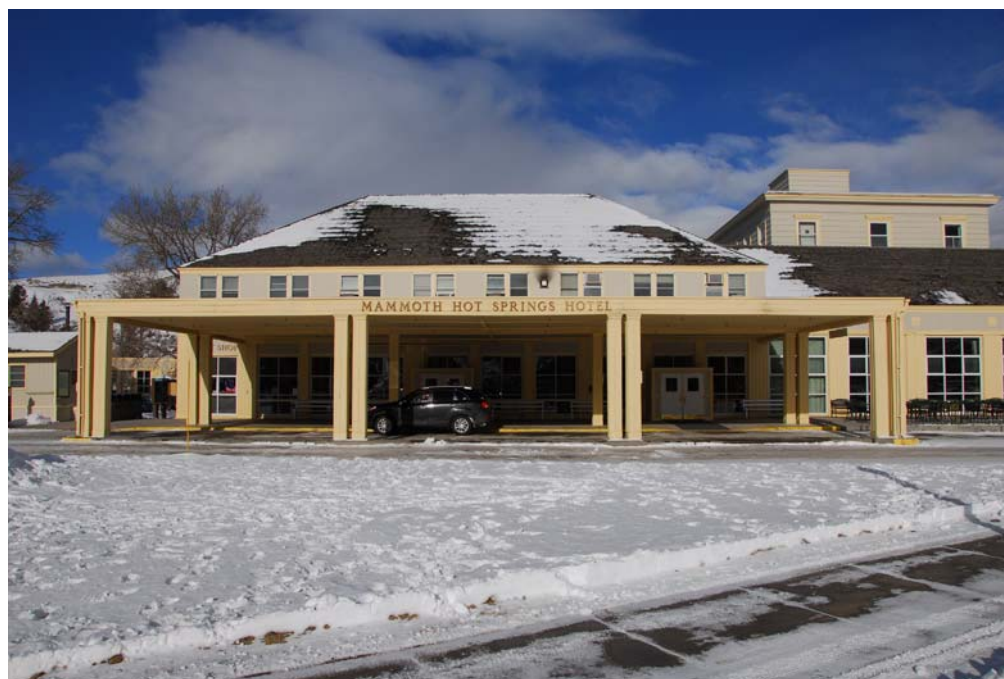
Figure 9: Looking north at the front facade and porte-cochere. The flat roof does not drain properly and causes problems of deterioration on the fascia and around the gutter areas.

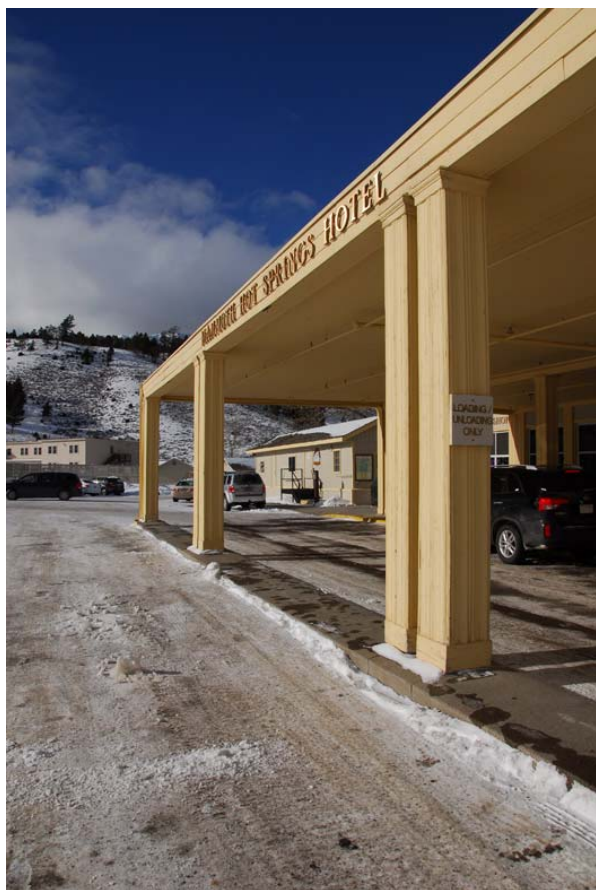
Figure 10: Looking northwest at typical fluted wood columns on the porte-cochere. Note the deteriorating bases and tops of the columns. Paint is also peeling.

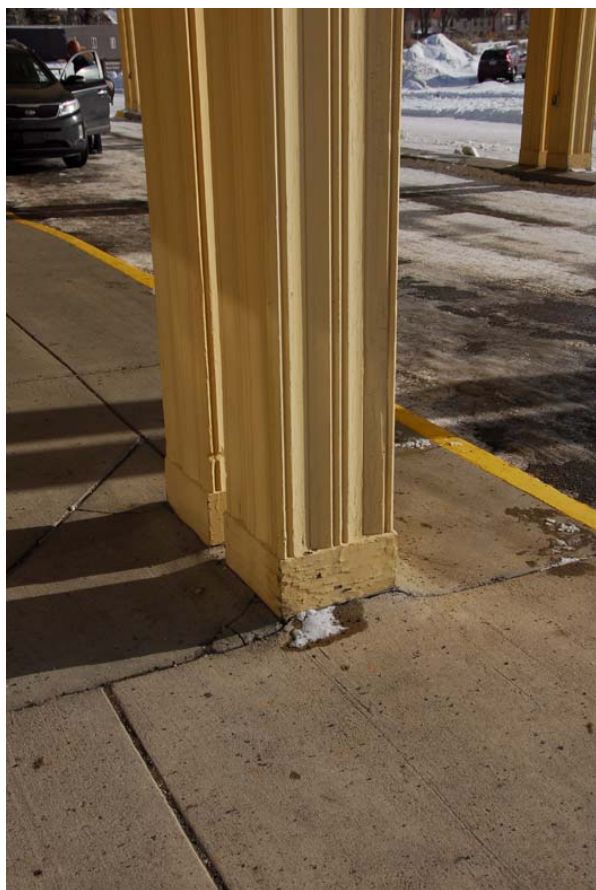
Figure 11: Looking east at a base of the interior columns. Note the rotted wood base.

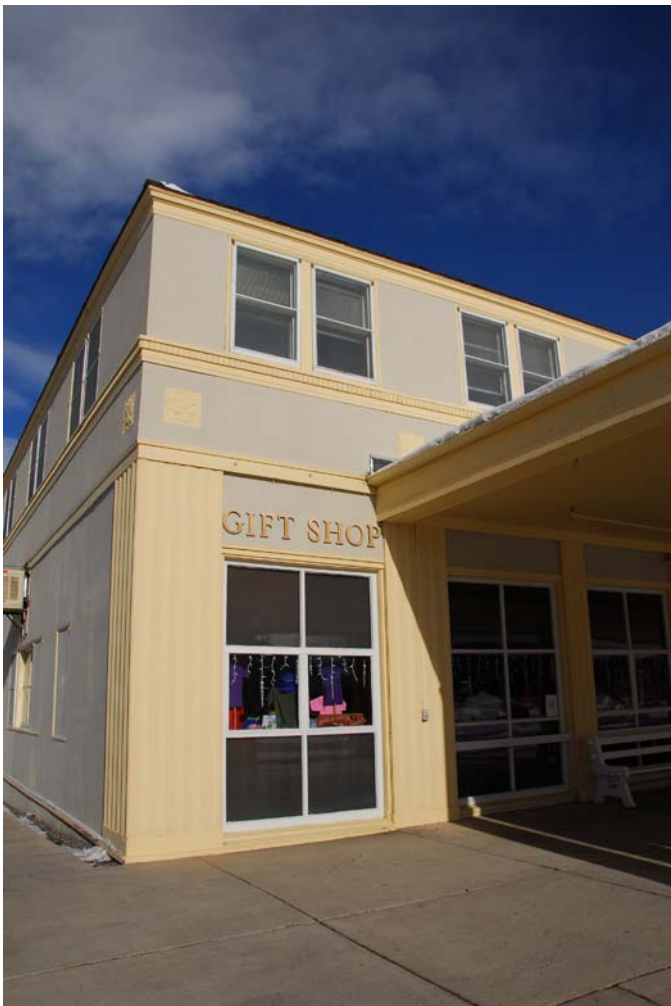
Figure 13: Looking north at the intersection of the porte-cochere roof and the wall of the front of the building. The upper office windows and lower gift shop windows are in need of repair. There is some rot in the sills and upper windows are loose.

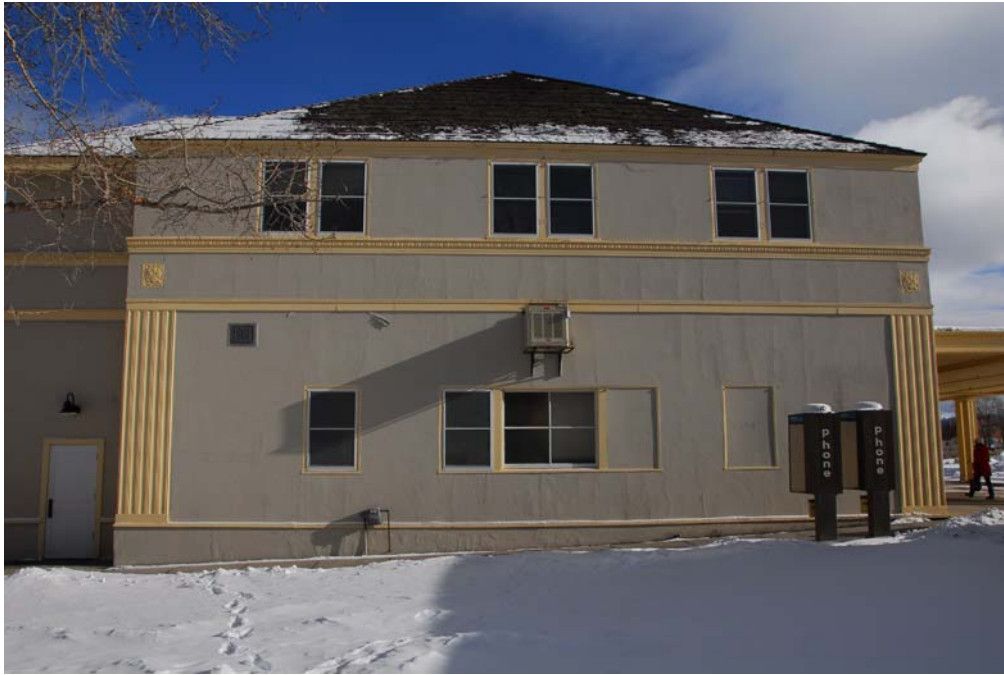
Figure 14: Looking east at the building. There are several settlement cracks in this wall both on the interior as well as the exterior. Note the air conditioning unit and the filled in windows on this elevation.

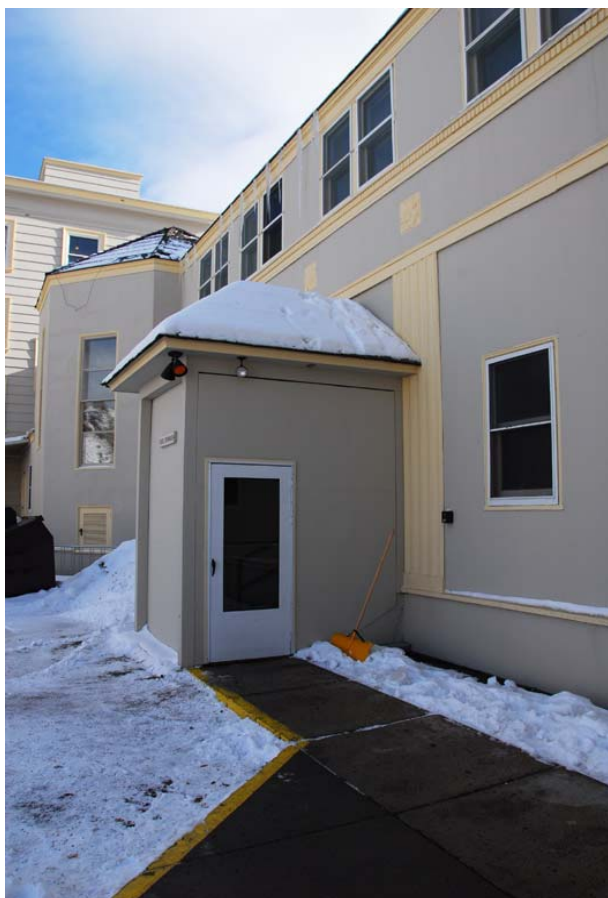
Figure 17: Looking southeast at the rear of the Lobby portion of the building. Note the winter infill of the walls around the rear entrance to the lobby. The windows are in fair condition with aluminum storm windows added to them.

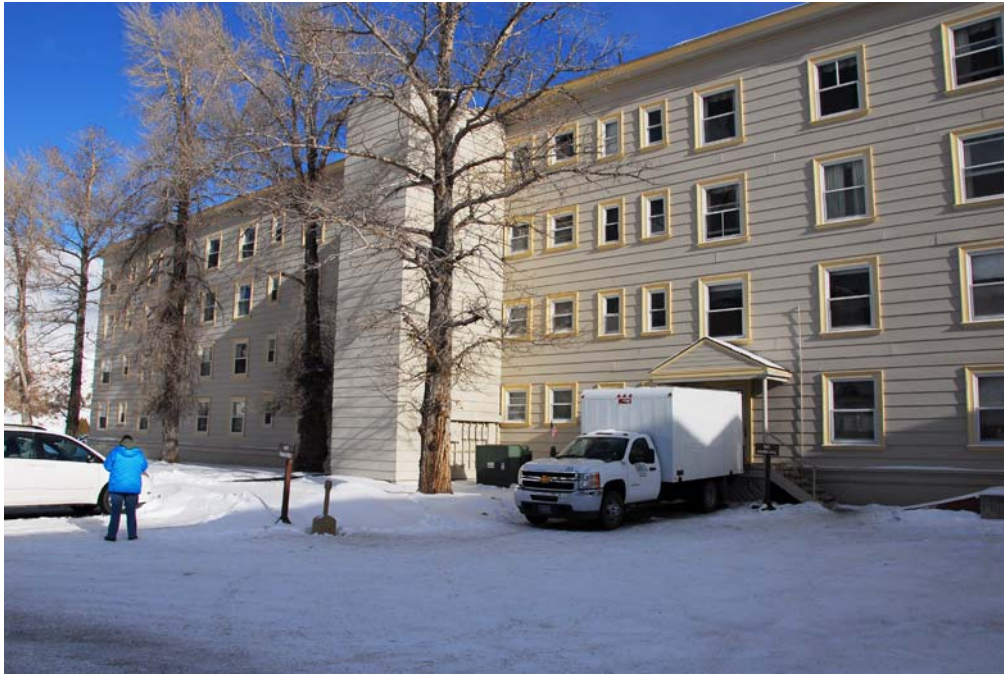
Figure 18: Looking northeast at the west side of the 1913 guest room wing. The wing is in good condition with some minor peeling paint and some rot around the laundry dock. The windows are in fair to poor condition. The window sash are loose and do not work very well. They are covered with aluminum storm windows.

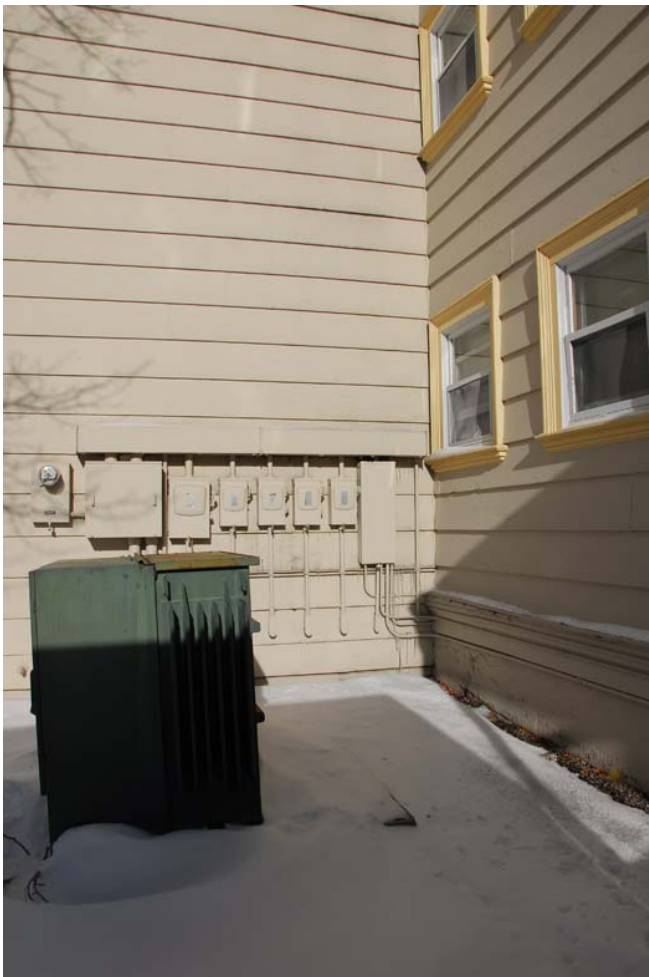
Figure 19: Looking north at the intersection of the enclosed egress stair base and the wing. Note the electrical panels for the wing. Also there is some deterioration of the concrete foundation of the wing because of water penetrating into the base.

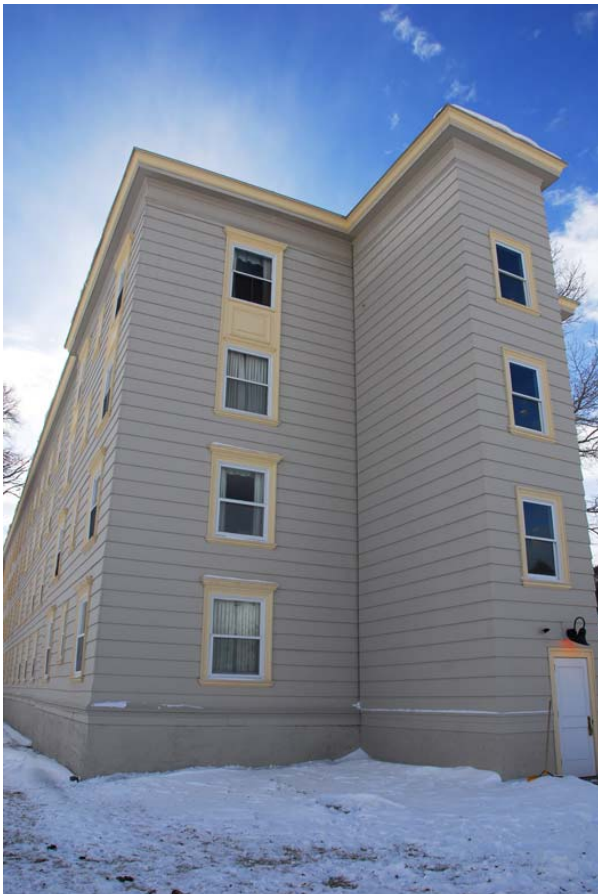
Figure 21: Looking south at the north end of the wing. Note the later enclosed egress stair. The walls are generally in good condition having just recently been painted.

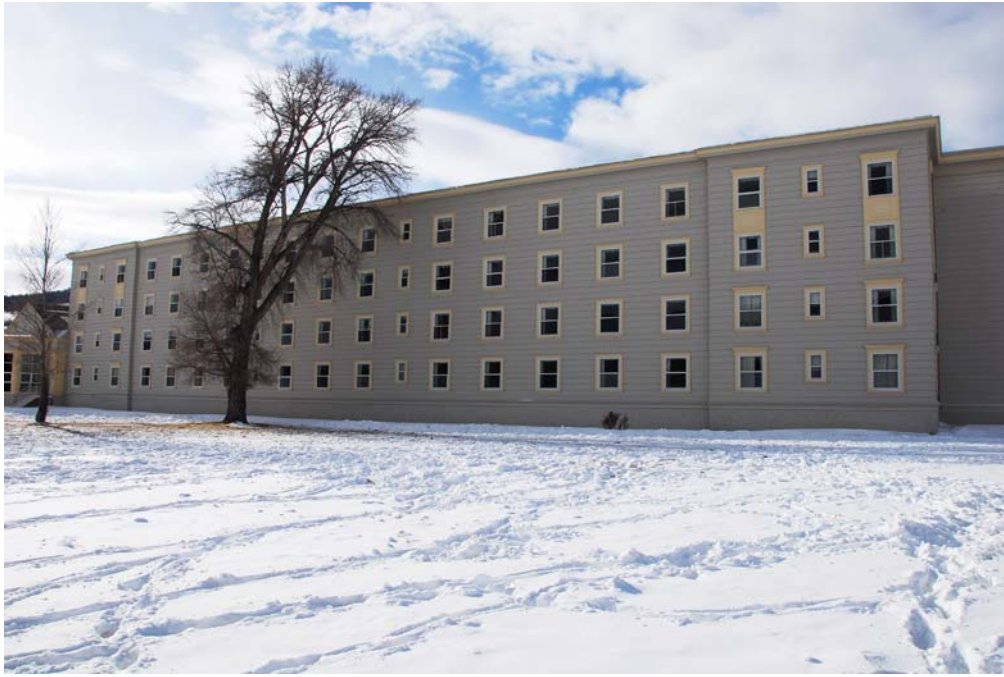
Figure 22: Looking southwest at the 1913 guest room wing. The wing is generally in good condition with the exception some peeling paint at the base and the windows.

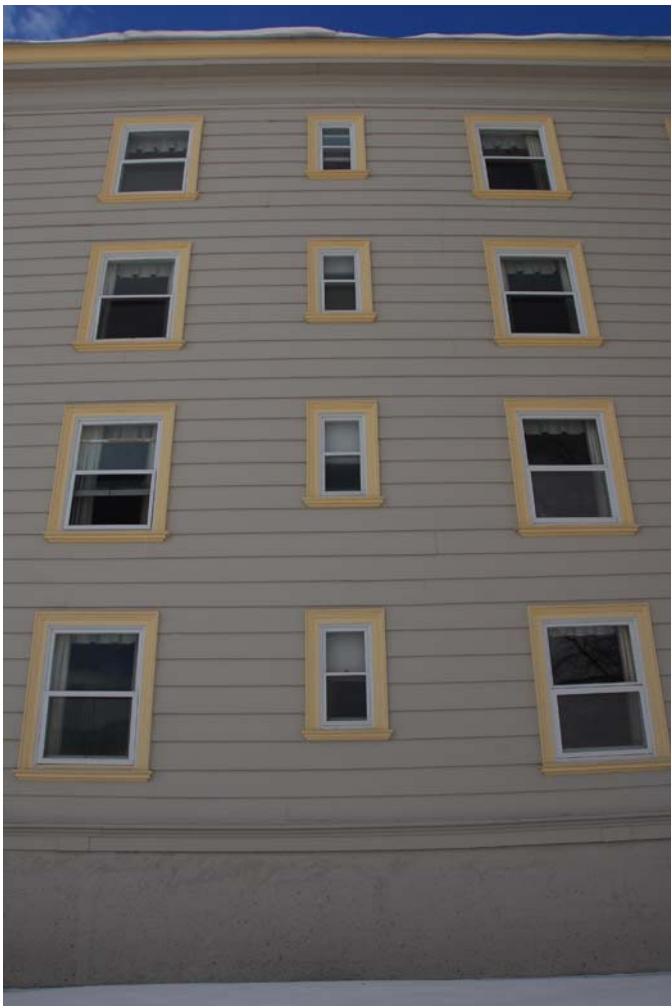
Figure 23: Looking west at the bank of room windows on the east facade of the wing. The wood double-hung windows are in fair to poor condition and are covered with a poorly fitting aluminum storm window.

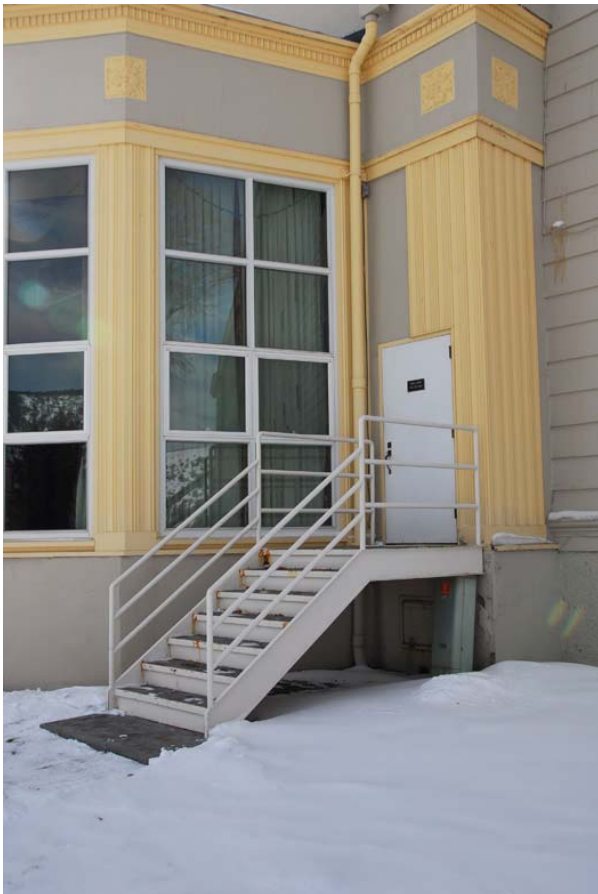
Figure 25: Looking northwest at the egress door and stair from the Map Room. The stair is rusted and the gutter does not work very well from the intersection of the Map Room roof and guest wing.

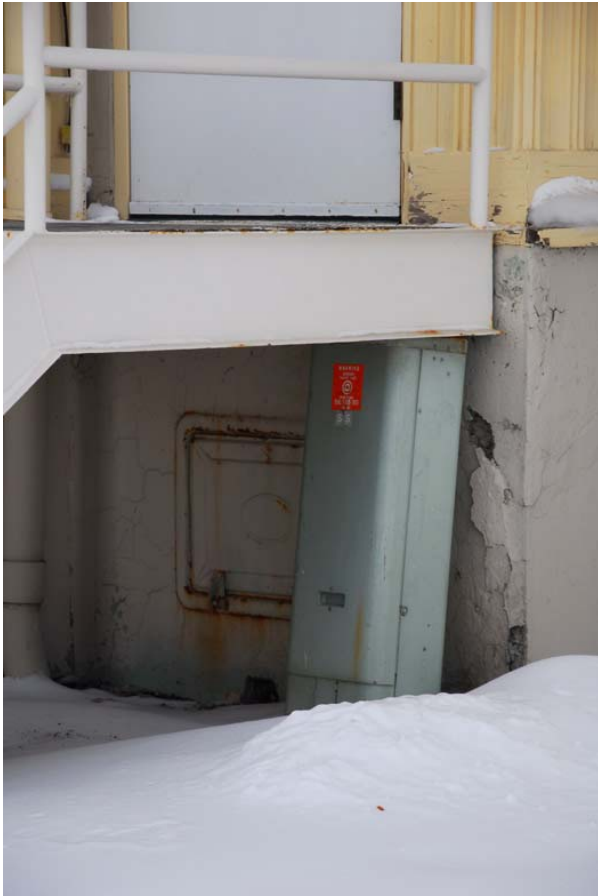
Figure 26: Looking southwest at the foundation base under the exit stair. Water is penetrating into the concrete foundation and causing some deterioration.

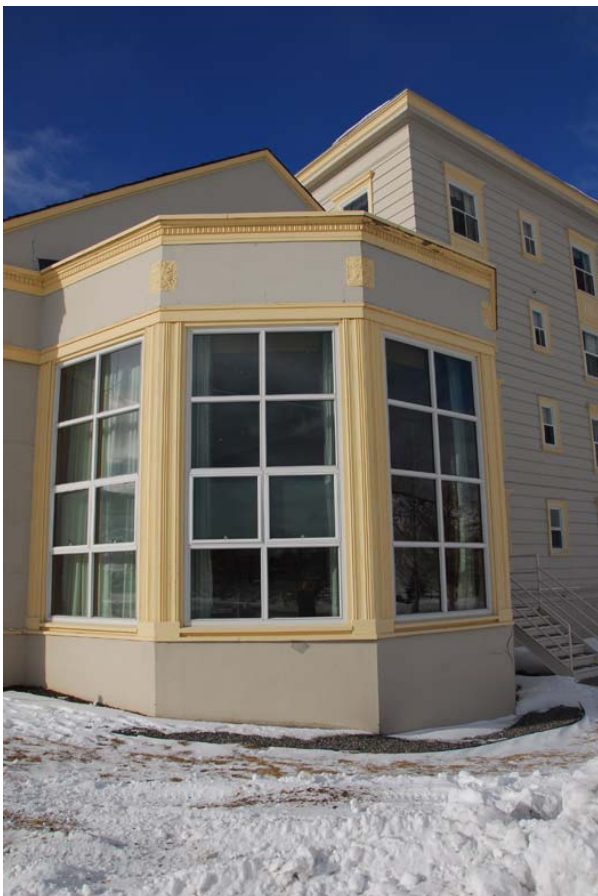
Figure 27: Looking west at the end bay of the Map Room. The windows have been restored and are in good condition. There are some cracks in the base of the bay.

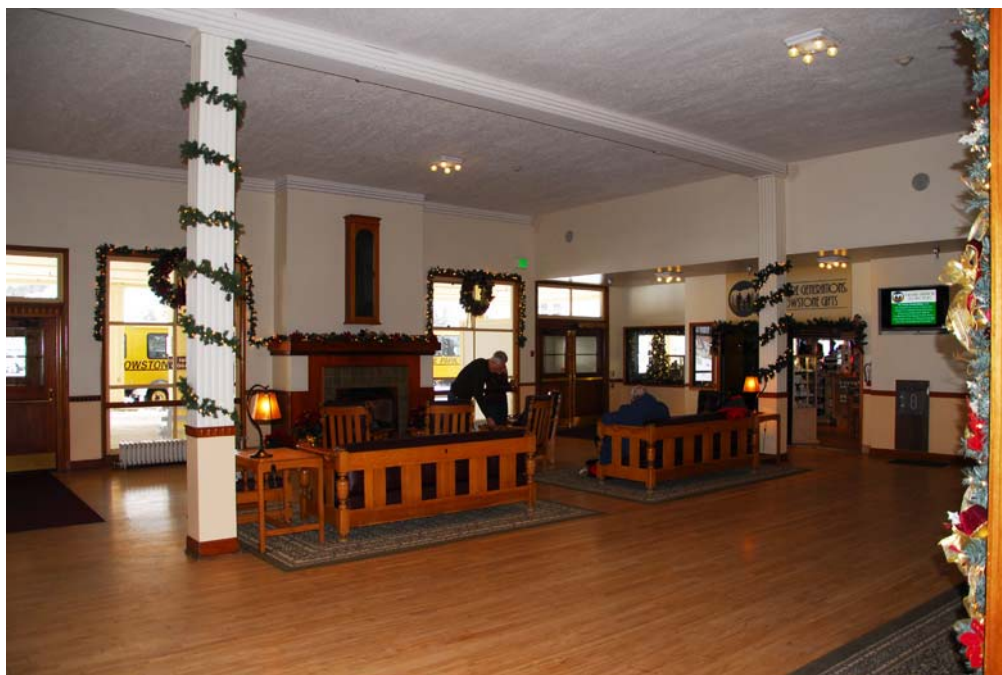
Figure 28: Looking southwest at the lobby towards the gift shop. The anodized aluminum storefront of the gift shop is not compatible with rest of the original charter-defining features of the rest of the lobby.

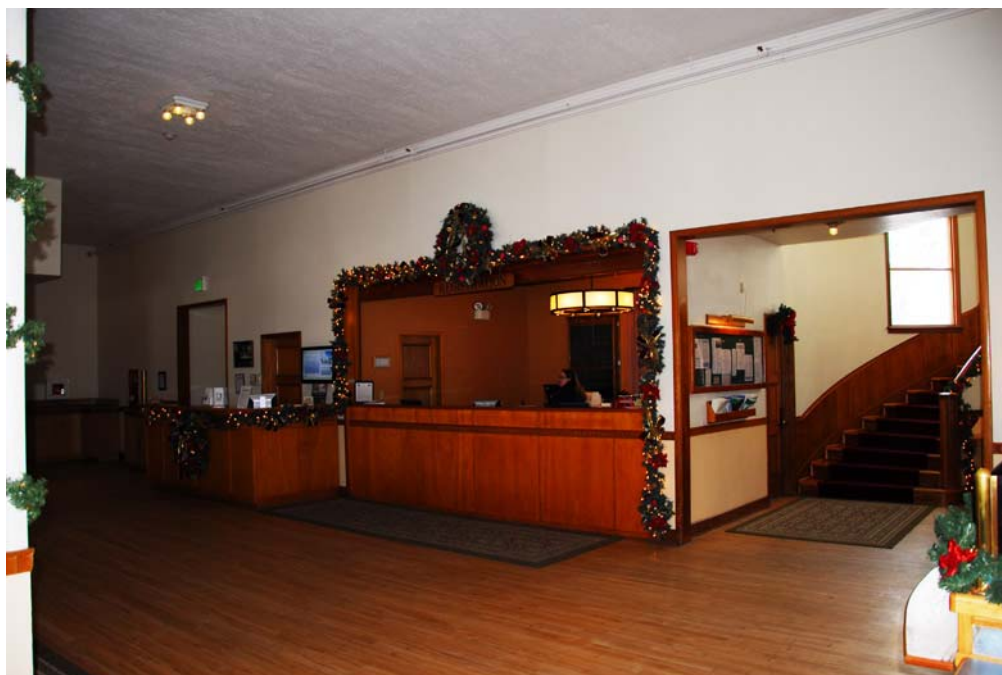
Figure 29: Looking northwest at the registration desk and stair to the second floor spaces. All of the woodwork is original to the building and in fair condition with some minor wear and dried wood.

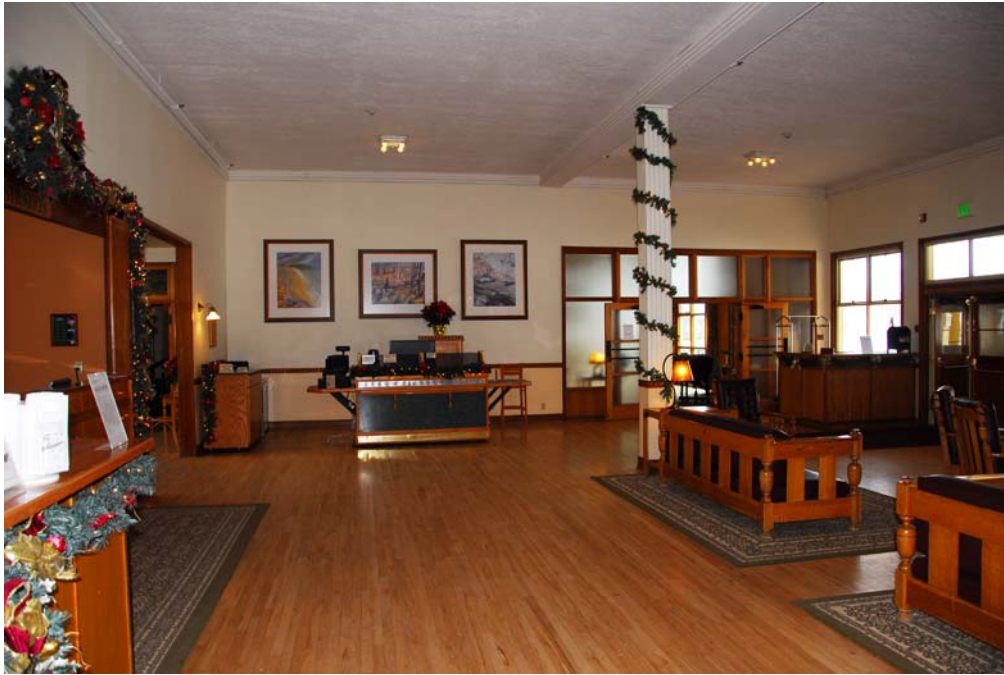
Figure 33: Looking east at the lobby towards the Map Room entrance. Note the espresso cart on the left of the entrance and the bellman's desk to the right. Generally the historic plaster and woodwork is in good condition.

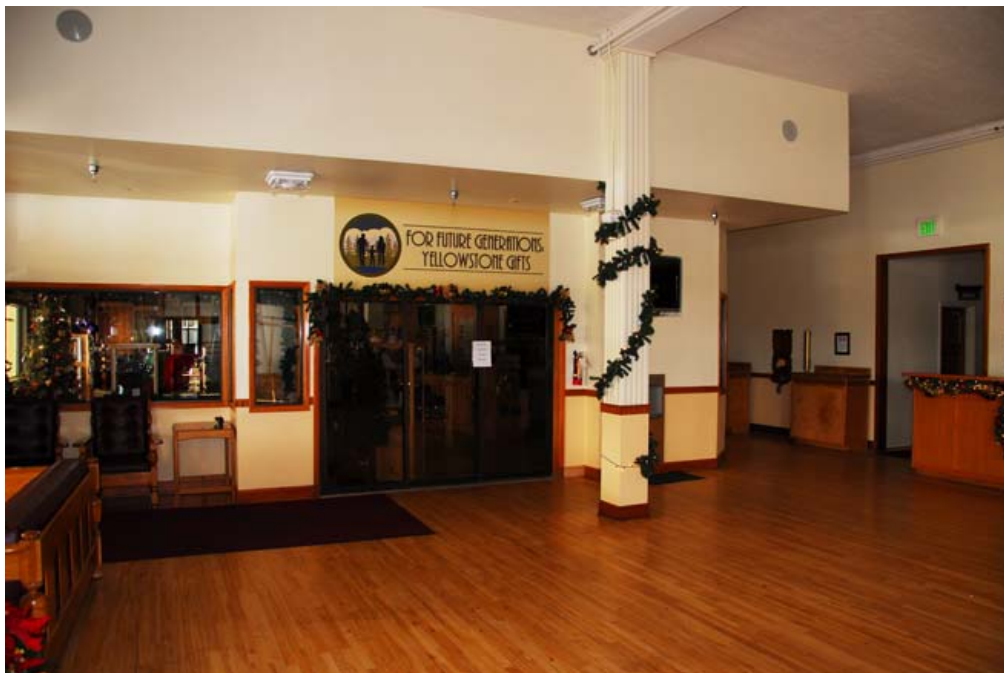
Figure 34: Looking west at the entrance to the gift shop. The aluminum storefront is not compatible with the rest of the lobby.

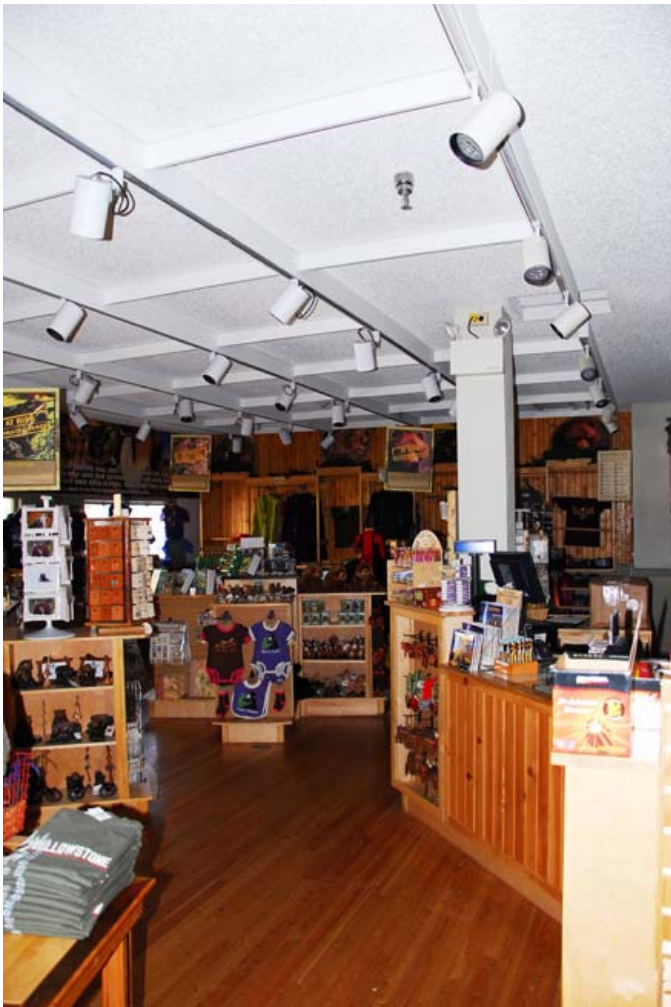
Figure 35: Looking west at the gift shop from the lobby. The materials are generally in good condition. The lighting fixtures are not very energy efficient.

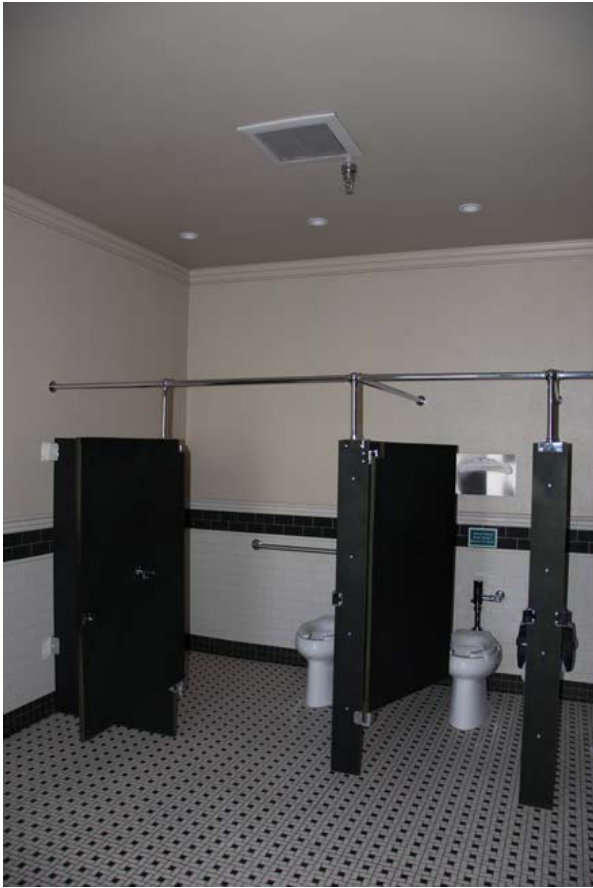
Figure 43: Looking south at the toilet area. The ventilation of the space is poor.

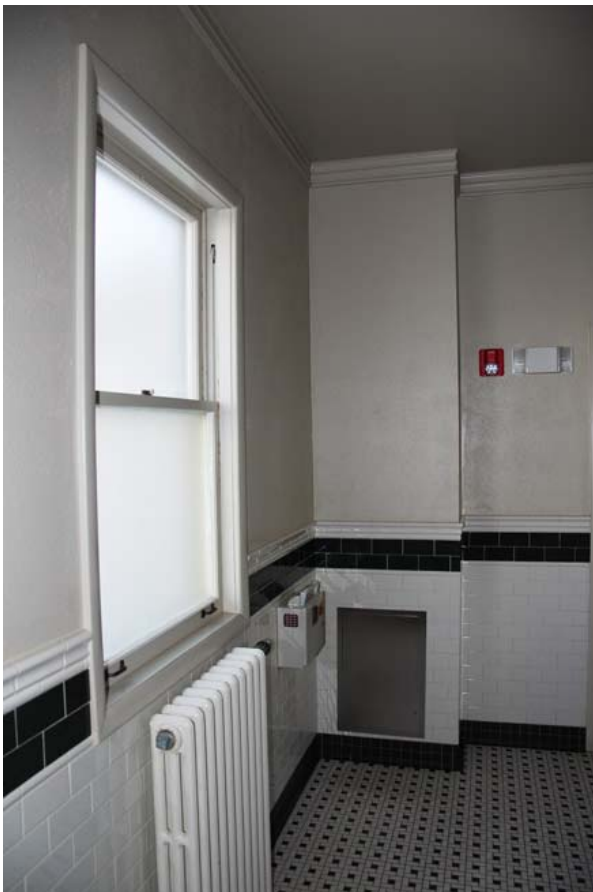
Figure 44: Looking east at the window and cast iron radiator. The window is in fair condition. The heating system is not very efficient.

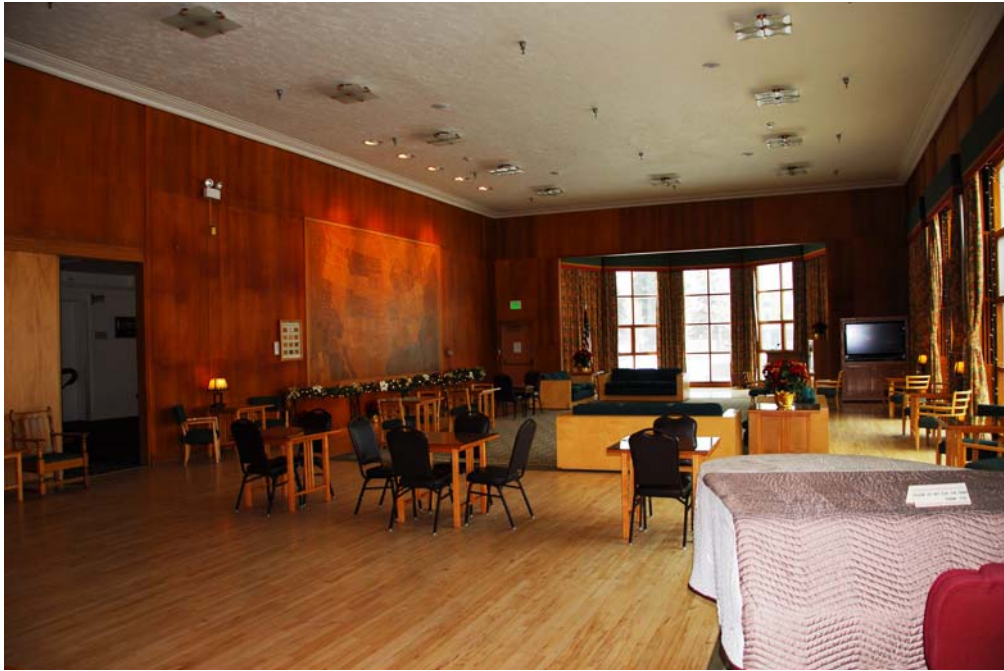
Figure 47: Looking east at the Map Room. The wall paneling and the woodwork is all original to the space. The wood is dry and has some stains because of the ultraviolet light from the windows.

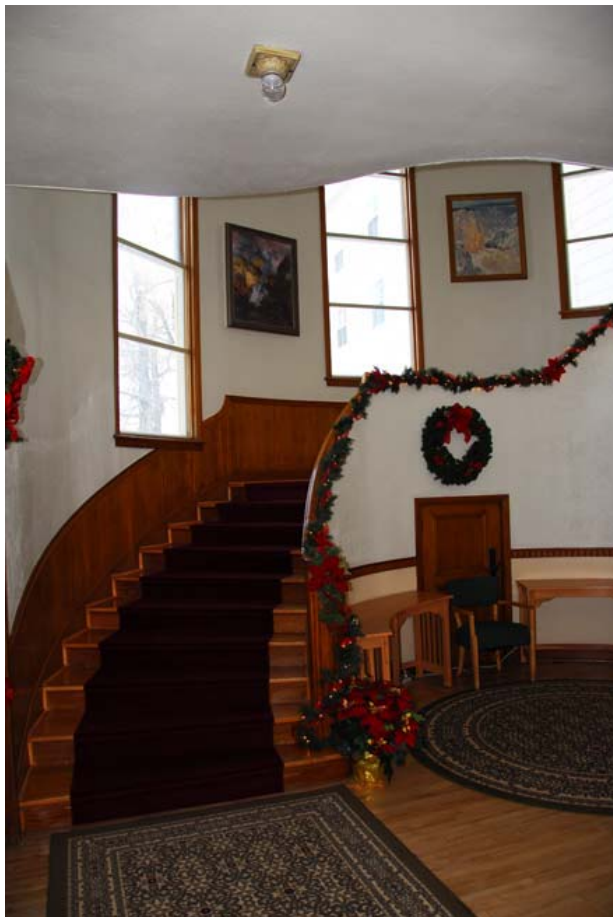
Figure 54: Looking north at the stair to the second floor offices and rooms. The stair is original and in good condition.

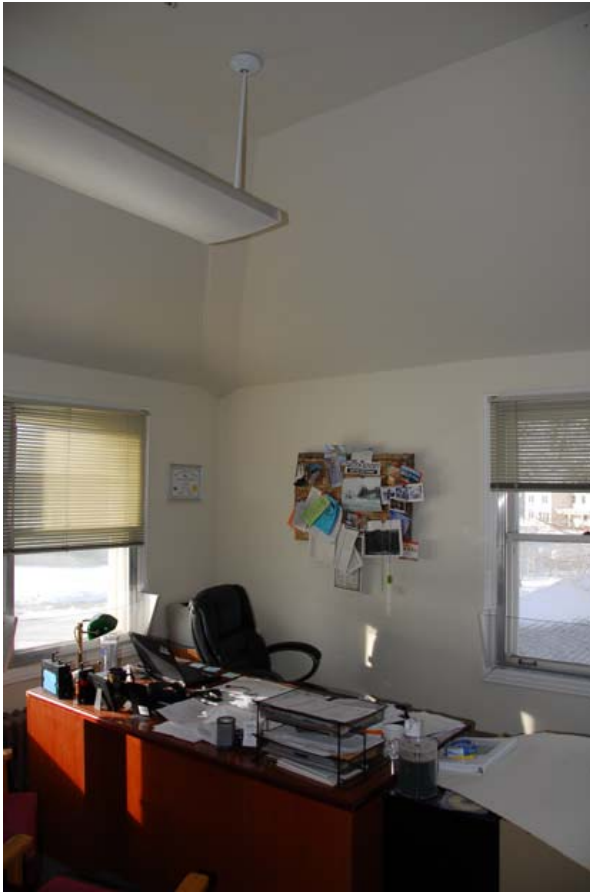
Figure 63: Looking southwest at a typical office on the second floor. Note the plaster cracks in the corner of the space and along the west wall. The windows are in fair condition.

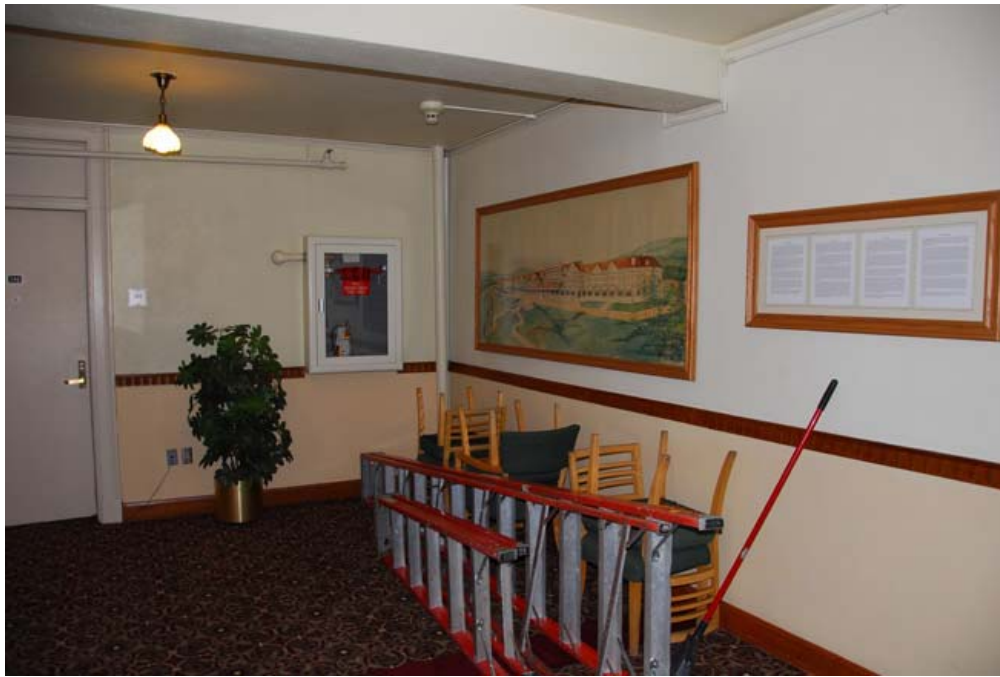
Figure 69: Looking east at the entrance lobby to the first floor rooms. Note the steam pipe, fire suppression systems, and exposed conduit for the fire detection that have been installed in the historic space.

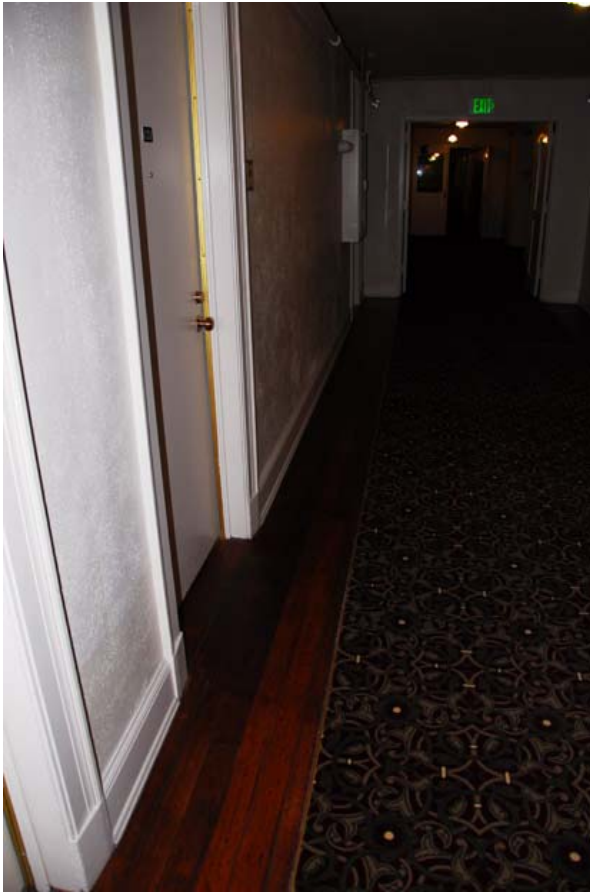
Figure 75: Looking at a typical floor detail in the corridors of the guest wing. There is a typical carpet with fir wood floors along the perimeter. The wood is somewhat worn but in fair condition.

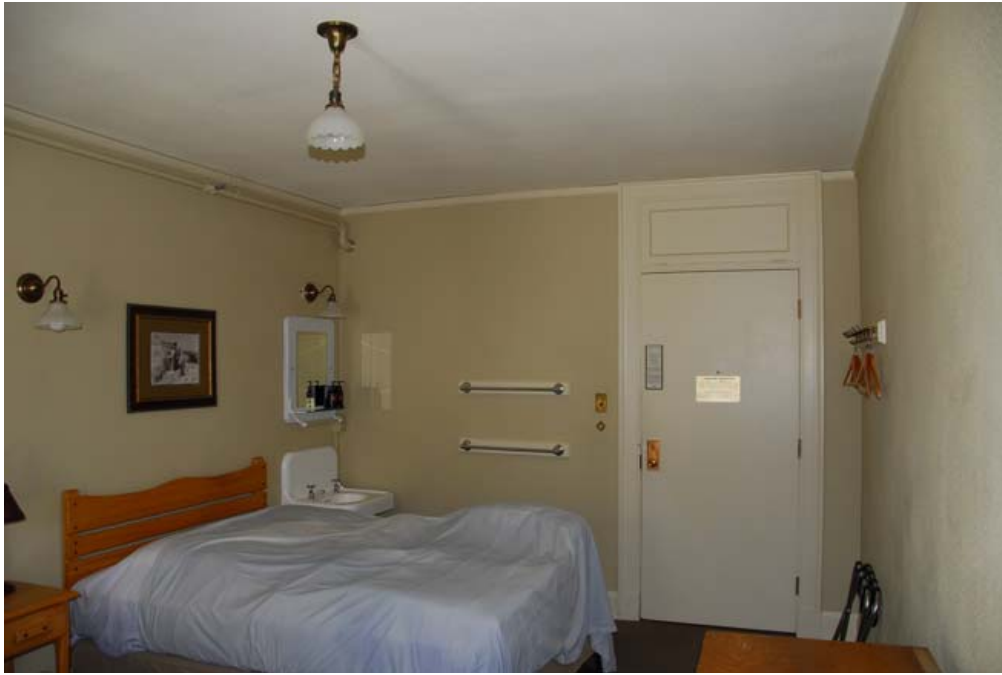
Figure 77: Looking west at Room 115, which does not have a bathroom and is typical of several rooms in the wing. Note the sink in the corner of the room. The room is generally in good condition with some wear around the doorways.

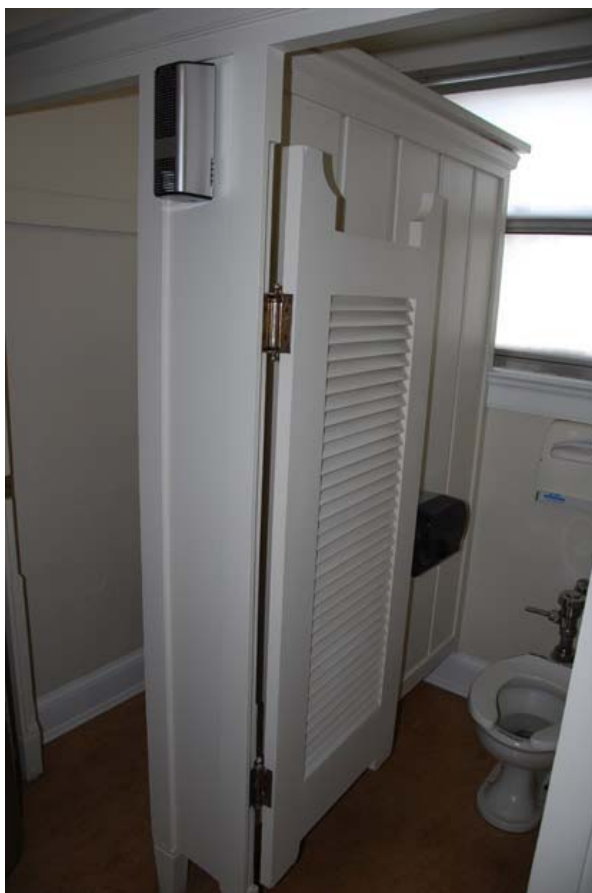
Figure 96: Looking west at the toilets and toilet stalls in the men's bathroom. The area around the window is exposed to moisture from condensation in the winter months.

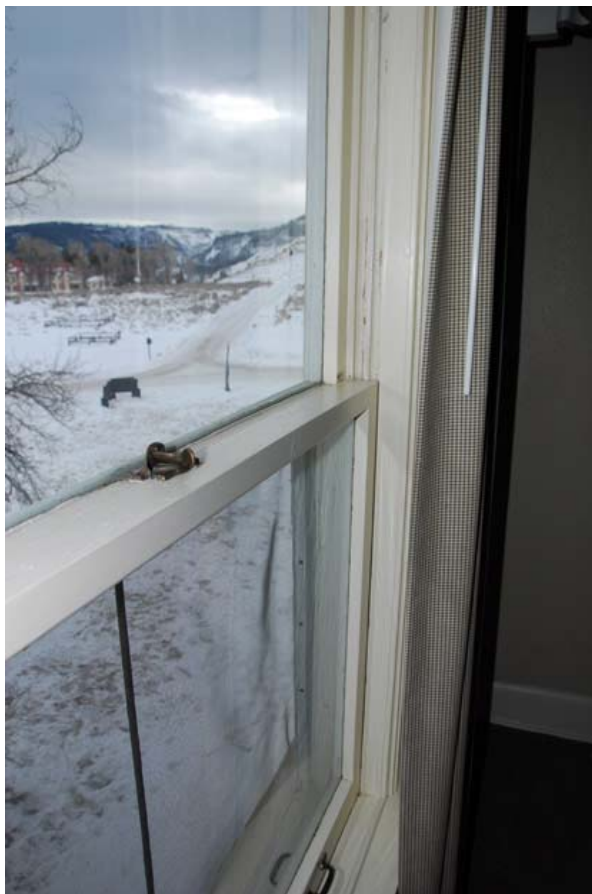
Figure 127: Looking at a detail of the window. There is some peeling paint, rot in the sill, and the aluminum storm window screens on the outside are in need of repair.

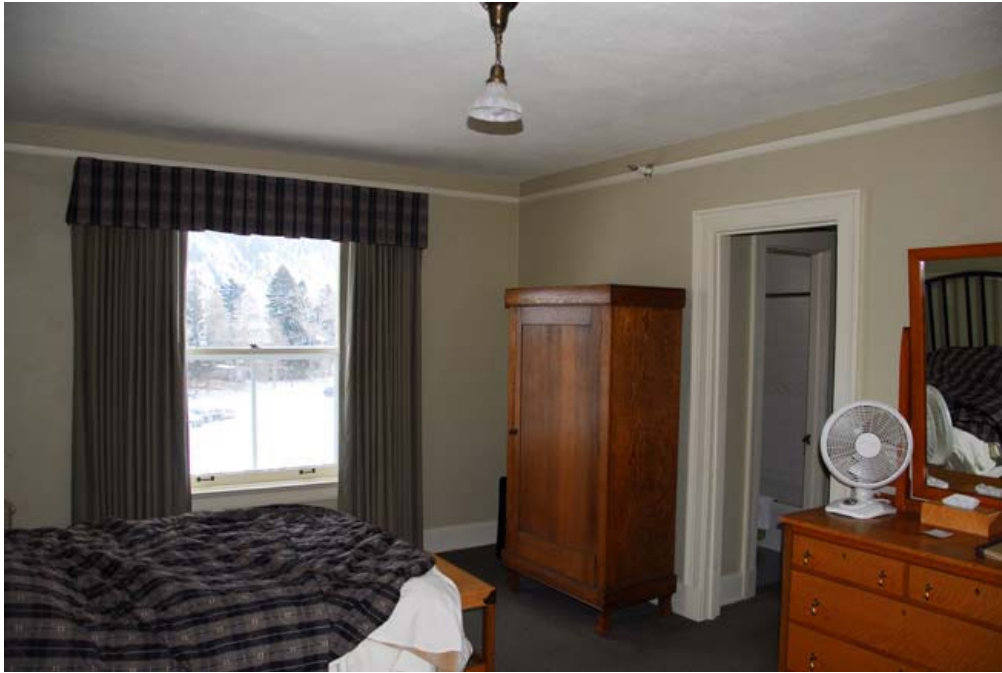
Figure 156: Looking east at the bedroom suite and the window. The window is in fair to poor condition.

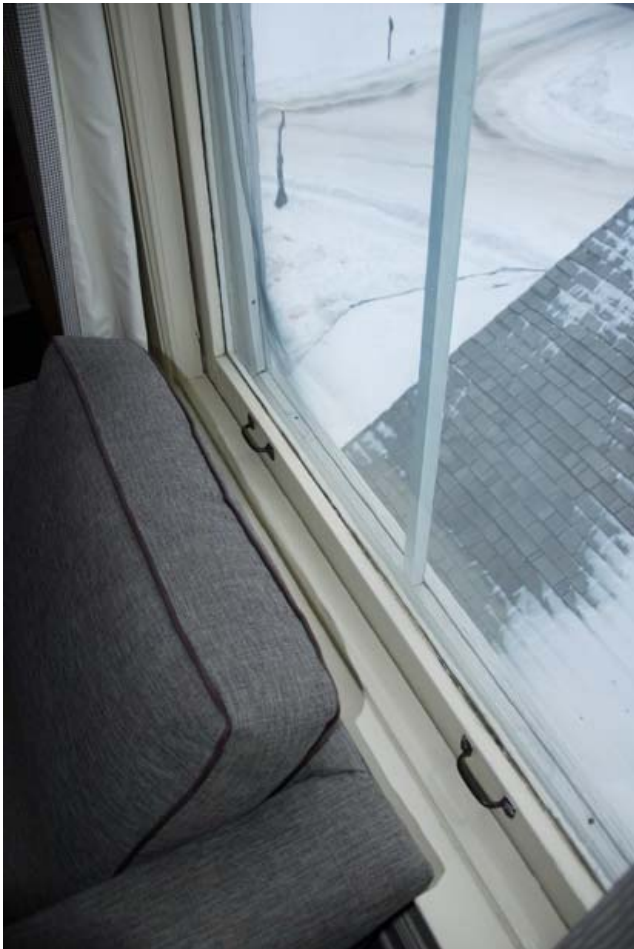
Figure 157: Looking at the sill of a typical window in the suite that is typical of all of the rooms in wing. The wood sills are weathered and some have broken or rotted wood. The storm window does not work very well.

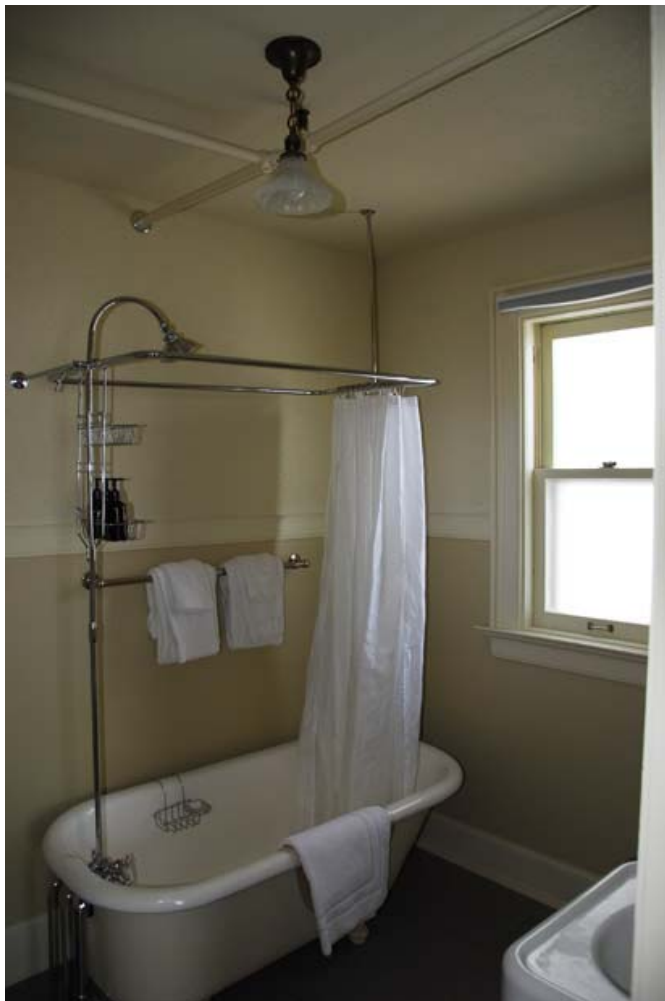
Figure 165: Looking southwest at the bathroom with the original claw foot tub. The tub has been adapted for a shower. The window is in fair condition. Humidity is a problem in most bathrooms because of the lack of ventilation.
