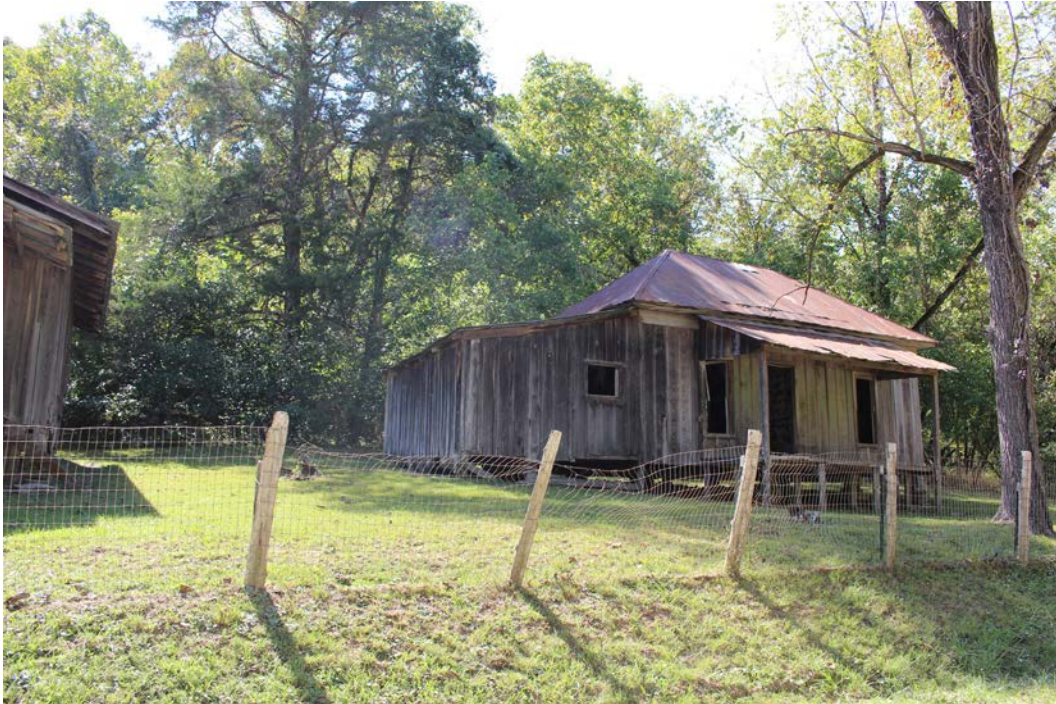
Matrix 3-15. House Row - Buildings and Structures/Ruins				
Feature	Date	Description	Condition	Contributing/ Non-Contributing
Mulholland Building Site		Non extant - No surface ruins visible	Poor	Contributing
Bundy House	c 1899	Building. One story structure, rectangular in plan with an addition on the south and a porch on the east. Original building has a hipped roof and the addition and porch have shed roofs. Roofing is corrugated metal which is rusting and bent in places. Wood siding is vertical board and batten with broken and missing pieces and deterioration at grade. Foundation is stone and wood piers. Windows and doors are missing though trim is generally intact at openings. Interior finishes - wood flooring, walls and ceiling - are damaged and missing in many places. Wallpaper remnants are visible on the walls and ceiling. In some rooms, significantly deteriorated flooring, possibly linoleum, is visible in places.	Fair	Contributing

Figure 3-137. Bundy House. (Mundus Bishop 2017)

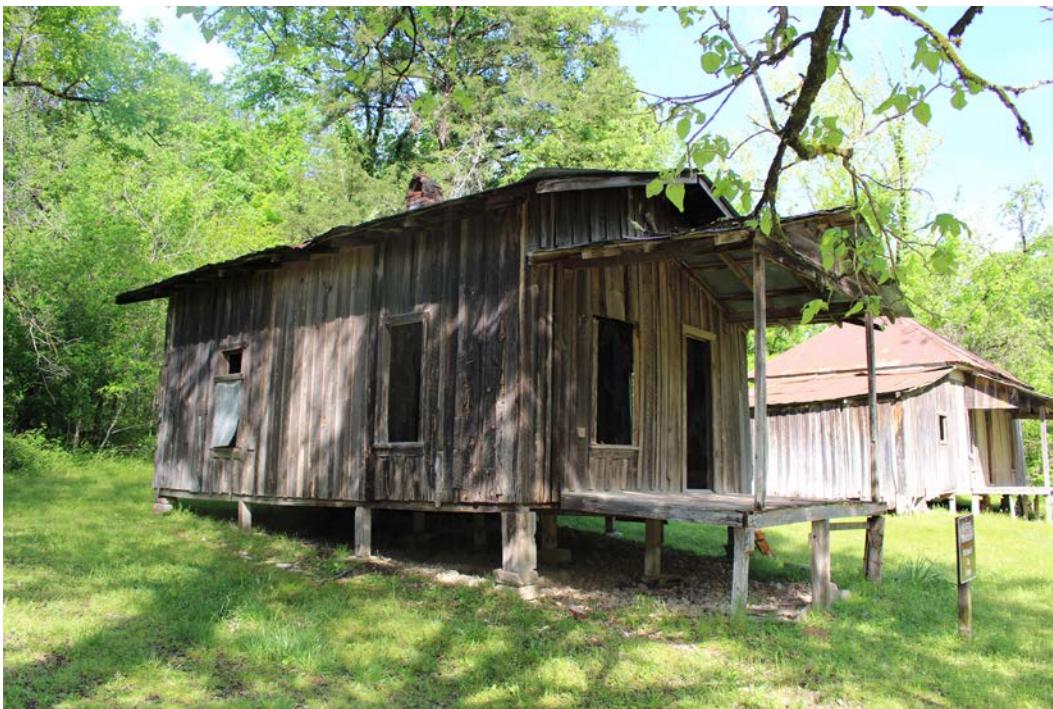
Matrix 3-15. House Row - Buildings and Structures/Ruins				
Feature	Date	Description	Condition	Contributing/ Non-Contributing
Wash House	c 1899	Building. One story structure, rectangular in plan with a porch on the east elevation. Both building and porch have a gable roof with corrugated metal roofing that is bent and rusted in places. A brick chimney extends above the roofing at approximately the center of the roof. Siding is vertical board and batten which has broken and missing boards in places. Foundation is stacked stone and wood piers. No windows or doors are extant but trim remains at some openings. Interior finishes - wood flooring, walls and ceiling - are damaged and missing in many places. There are wallpaper remnants on the walls and ceiling. On the west side of the building, significantly deteriorated flooring, possibly linoleum, is visible in places.	Fair	Contributing
Kastning House	c 1899	Building. One story structure, rectangular in plan with an addition on the west and porch on the east. The main building has a gable roof and the addition and porch have shed roofs. Roofing is corrugated metal that is rusting and bent in places. Original structure has a symmetrical front elevation with two front doors and horizontal painted wood siding. The addition has vertical wood siding. Foundation is stacked stone piers. Windows were wood, double hung and pieces of some windows and trim remain. No doors remain but wood trim is intact at some openings. Interior finishes - wood flooring, walls and ceiling - are damaged and missing in many places. There are wallpaper remnants in the living room and sections of newspapers intact on the walls of the addition.	Fair	Contributing

Figure 3-139. Wash House. (Mundus Bishop, 2017)

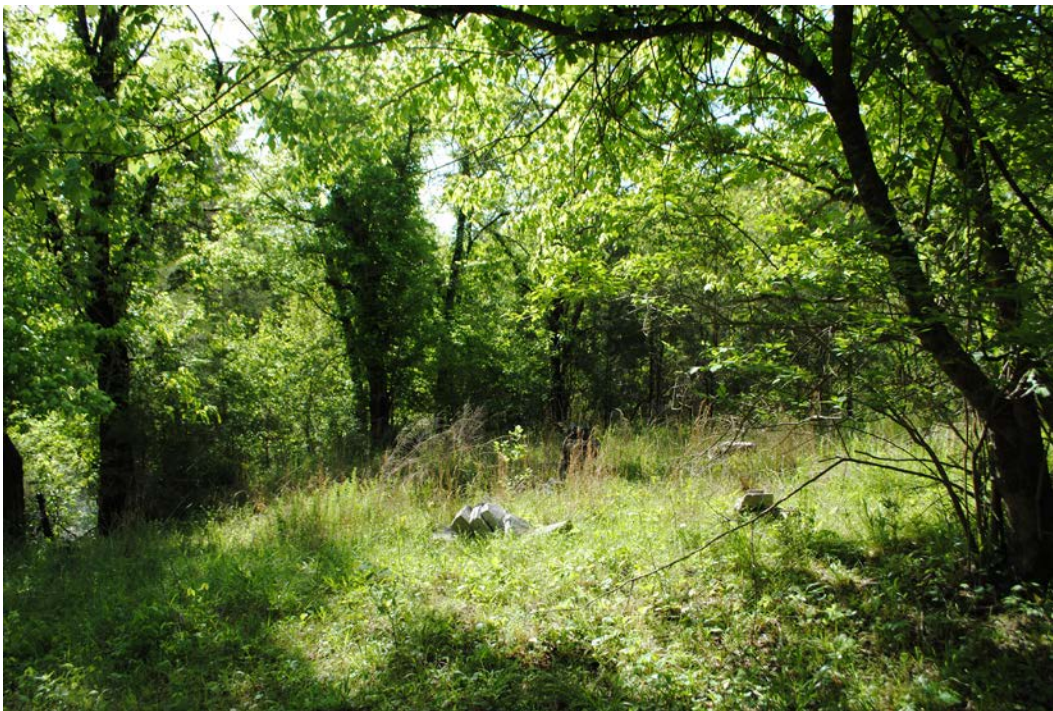
Brantley House Ruins	c 1899	Ruins. Stone pier foundations.	Poor	Contributing
Gotley House Site	c 1899	Non extant - No surface ruins visible	Poor	Contributing
Raby House Ruins	c 1899	Ruins. Some of the stone foundation piers are partially intact.	Poor	Contributing

Figure 3-143. Brantley House Ruins. (Mundus Bishop 2017)

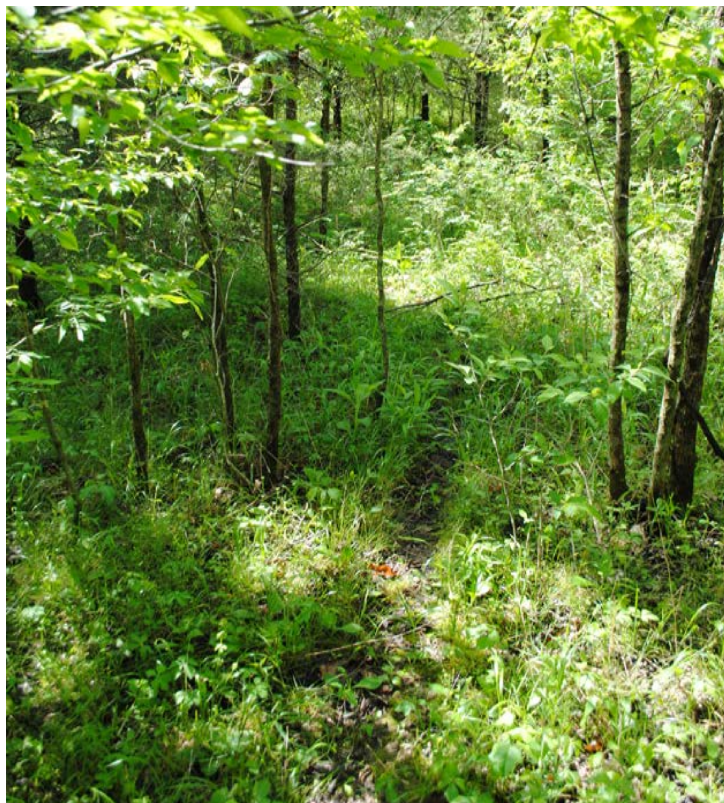
Figure 3-145. Raby House Ruins. (Mundus Bishop, 2017)

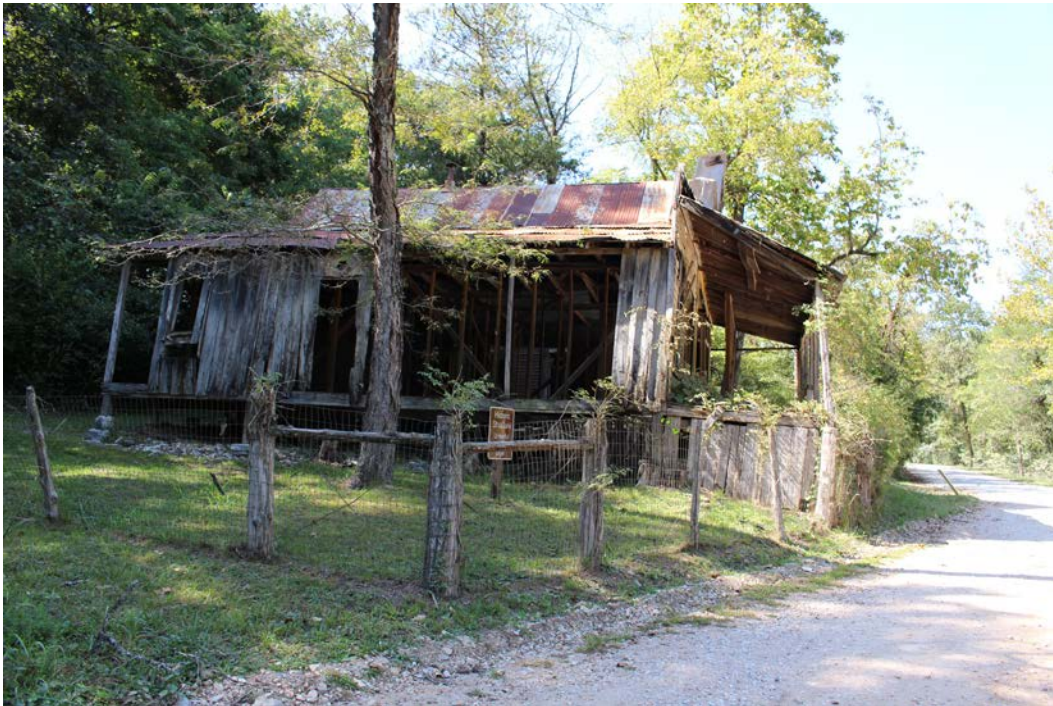
Taylor-Medley General Store	c 1899	Building. One story, symmetrical structure, rectangular in plan with a gable roof and an open porch covered by a shed roof on the front elevation. A faux storefront above the porch conceals the gable roof on the primary elevation. Roofing is corrugated metal which is rusting through in places. It is a wood framed structure with vertical wood board cladding attached directly to the frame. Cladding is missing in places and where it remains, it is typically deteriorated at grade. A structural stabilization project in 2011 installed concrete piers and an internal wood frame to keep the building standing. No windows or doors are extant but trim remains at a few openings. Interior finishes are no longer extant or are severely damaged, with large portions of the wood flooring, wall and ceiling finishes missing.	Poor	Contributing
Store Site		No visible surface remains	Poor	Contributing

Figure 3-149. Taylor-Medley General Store. (Mundus Bishop 2017)

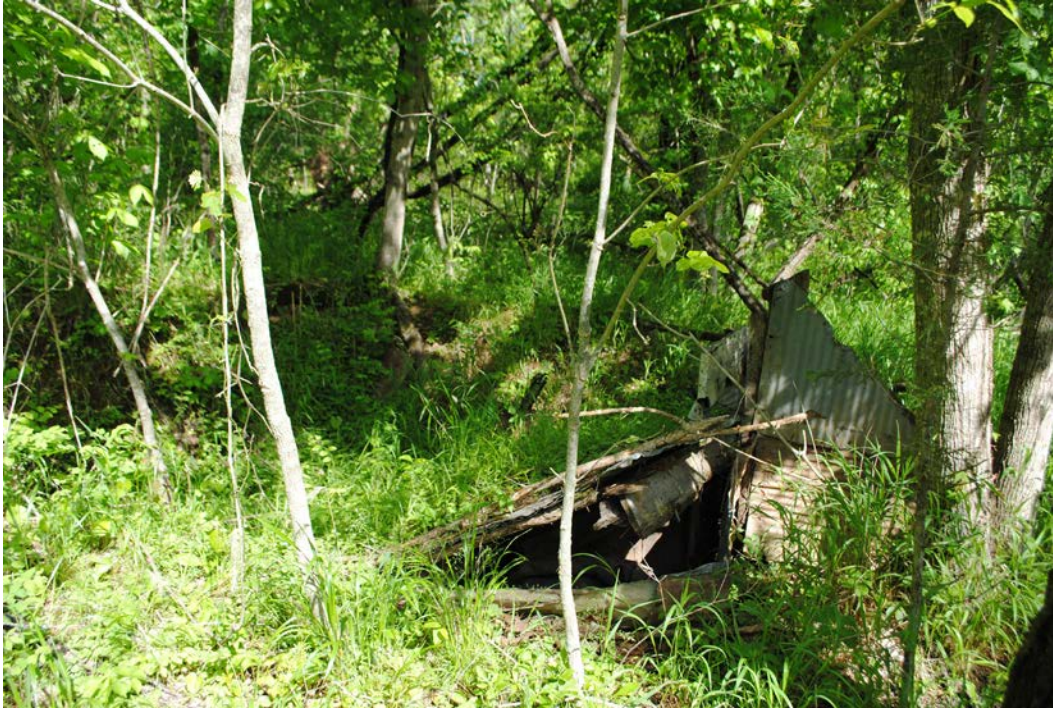
Figure 3-150. Chicken House. (Mundus Bishop 2017)

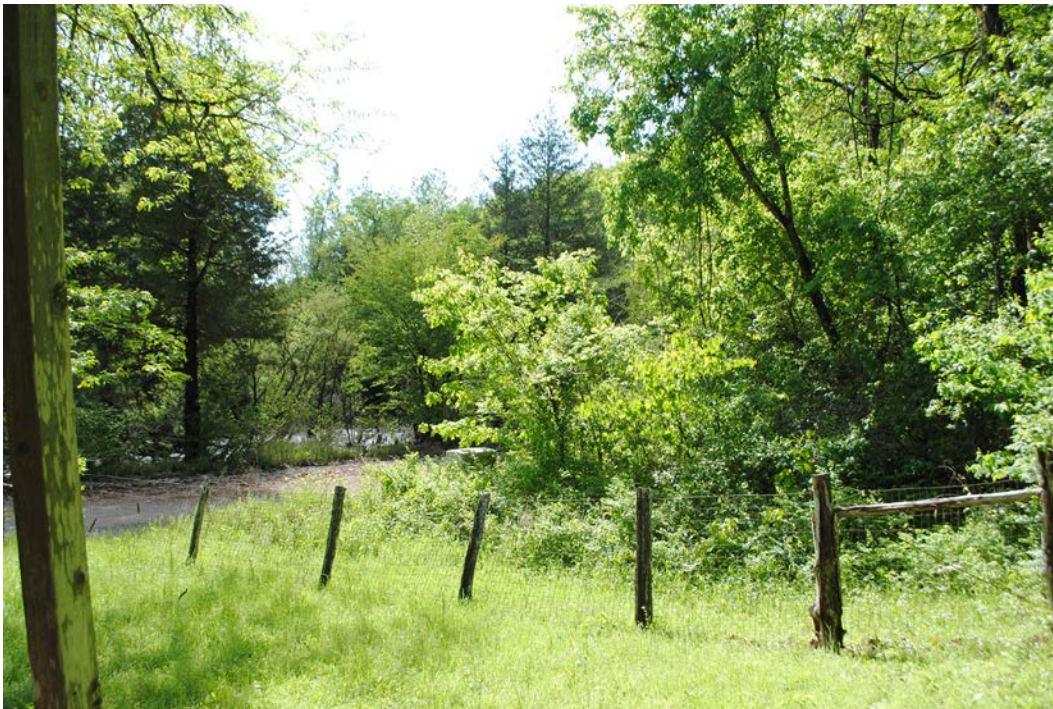
Figure 3-151. Wire Fence. (Mundus Bishop 2017)

NPS Fencing		Wood post, woven wire fence; 4' height. Between Rush Road and houses	Good	Non-Contributing
NPS Signage		Regulatory signs, wood post and metal "Historic Structure Unlawful to Enter" approx. 2.5' height. Interpretive sign, wood post and metal, 6' height	Good	Non-Contributing
