<b>Matrix 3-12. Morning Star Hotel, Mill, and Mine Community - Buildings and Structures</b>				
<b>Feature</b>	<b>Date</b>	<b>Description</b>	<b>Condition</b>	<b>Contributing/ Non-Contributing</b>
<b>Rush Smelter</b>	1886	Standing structure. Square in plan and constructed of stone and mortar with small openings on two sides. Building narrows at two locations from grade to the top, with stone ledges at these locations. Plants and moss are growing on both ledges.	Fair	Contributing
<b>Rush Blacksmith Shop</b>	1935	Standing Building. One story structure, rectangular in plan with a gable roof. Two doors on the main elevation lead to two separate interior spaces - the workshop and the living area. Roofing is corrugated metal with a round metal exhaust pipe that extends above it. Pieces of wood framing mounted to the building are all that remain from the awning over the workshop door. Exterior walls have vertical board and batten siding. The wood is deteriorated in places and many of the battens are broken and missing. Foundation is poured in place concrete which is cracked in places. No windows or doors are extant but trim remains at some openings. The concrete and brick forge is extant

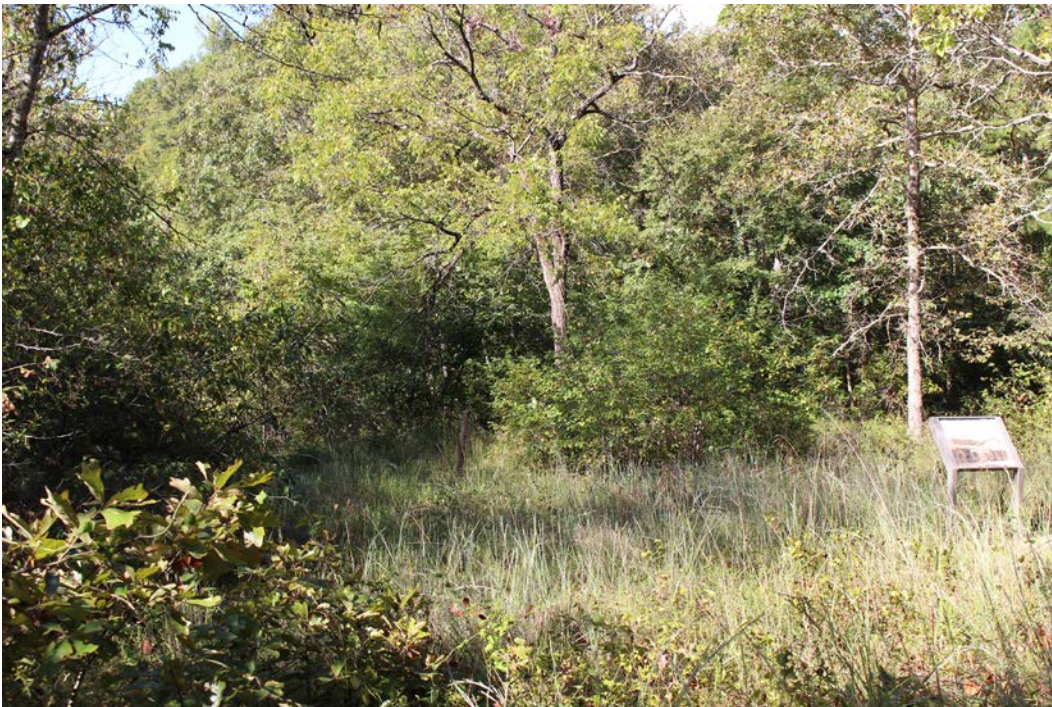
Figure 3-107. The same view as above. The only remains of the Chase and Mulholland Store and Morning Star Mine Office are concrete foundations, a collapsed brick chimney and depressions. (Mundus Bishop 2017)

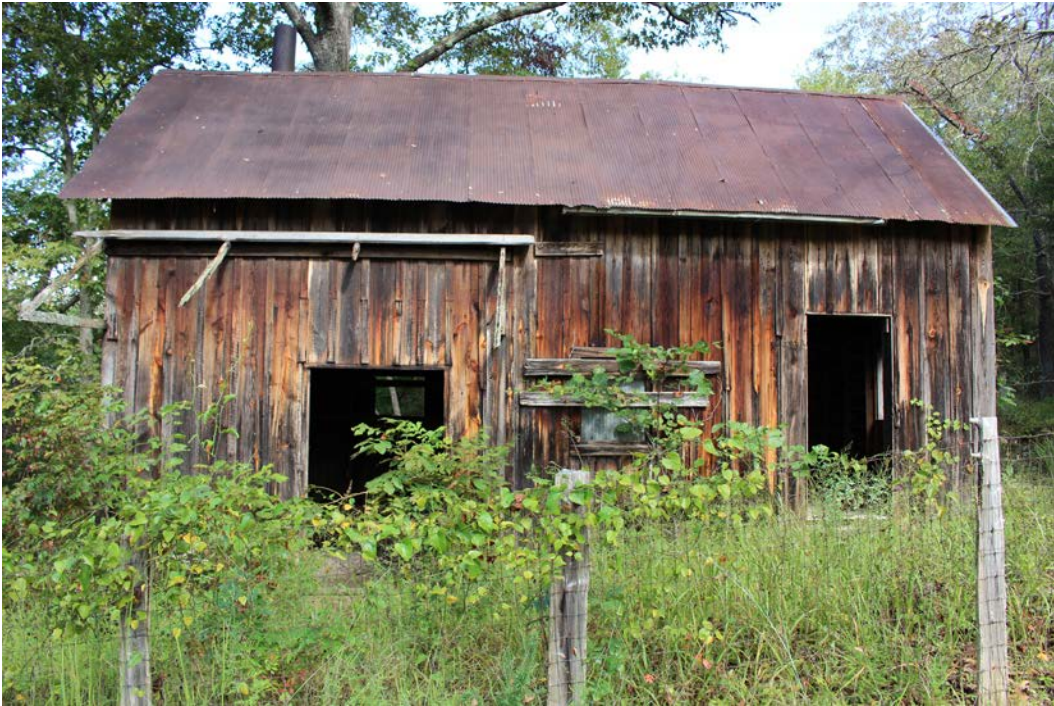
Figure 3-110. Rush Blacksmith Shop. (Mundus Bishop 2017)

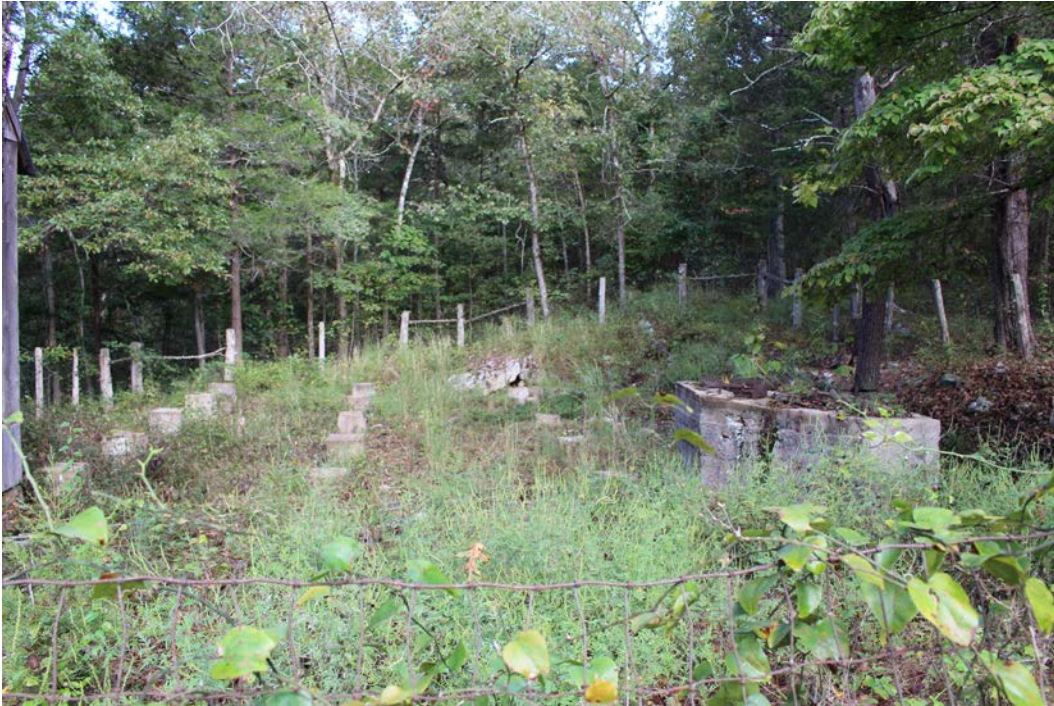
Figure 3-111. Warehouse piers and foundations. (Mundus Bishop 2017)

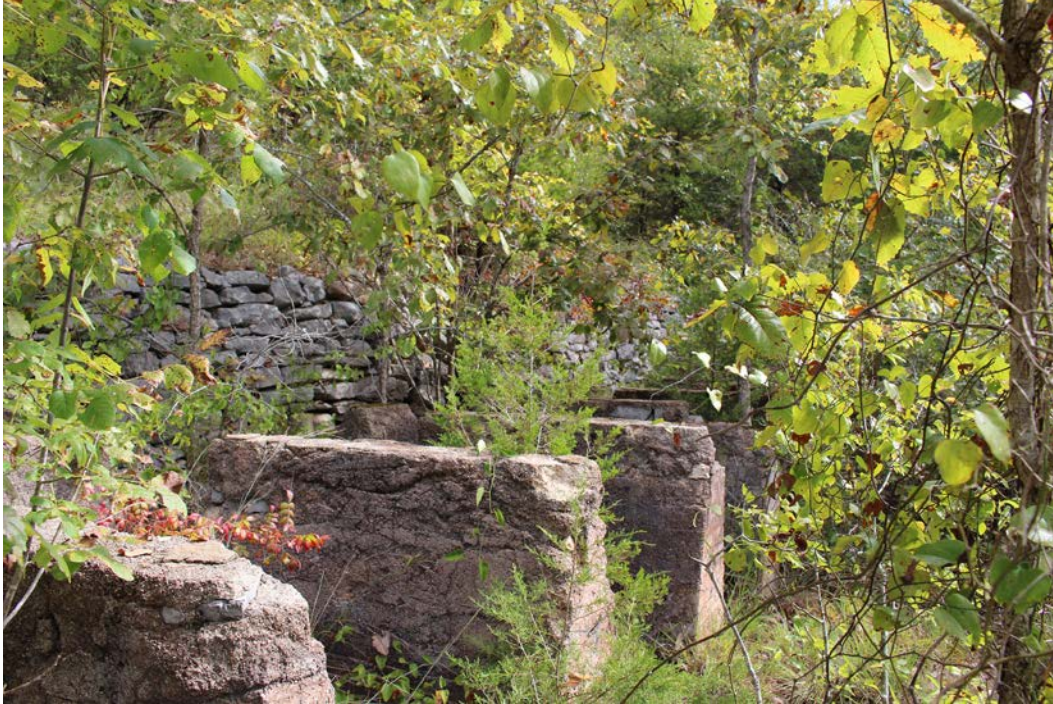
<i>Spillway</i> - concrete wall 4' height by 18" width both sides	Fair	
<b>Morning Star Mill Stone Retaining Wall</b>		Extends south side of Mill, from tailings, boiler room, and tower. Dry stacked, 6" height and 24" wide stones and approximately 12-18" depth, height varies, 3' to 8' height	Fair	Contributing
<b>Morning Star Mill Stone Tower Ruins</b>		No surface ruins visible	Poor	Contributing
<b>Tramway Ruins</b>		<i>Concrete Piers</i> - flat-top concrete piers at hillside 24" height	Poor	Contributing
<b>Barn Ruins</b>	c 1902	No surface ruins visible	Poor	Contributing
<b>Courthouse Site</b>	c 1916	No surface ruins visible	Poor	Contributing
<b>Hopper House Ruins</b>		No surface ruins visible	Poor	Contributing
<b>Morning Star Shelter</b>		Contemporary wood shelter, 12'x10' on concrete pad. Interior wood benches and interpretive panel	Good	Non-Contributing

Figure 3-112. Stone and concrete piers, and stone retaining wall (rear) at Morning Star Mill ruins. (Mundus Bishop 2017)

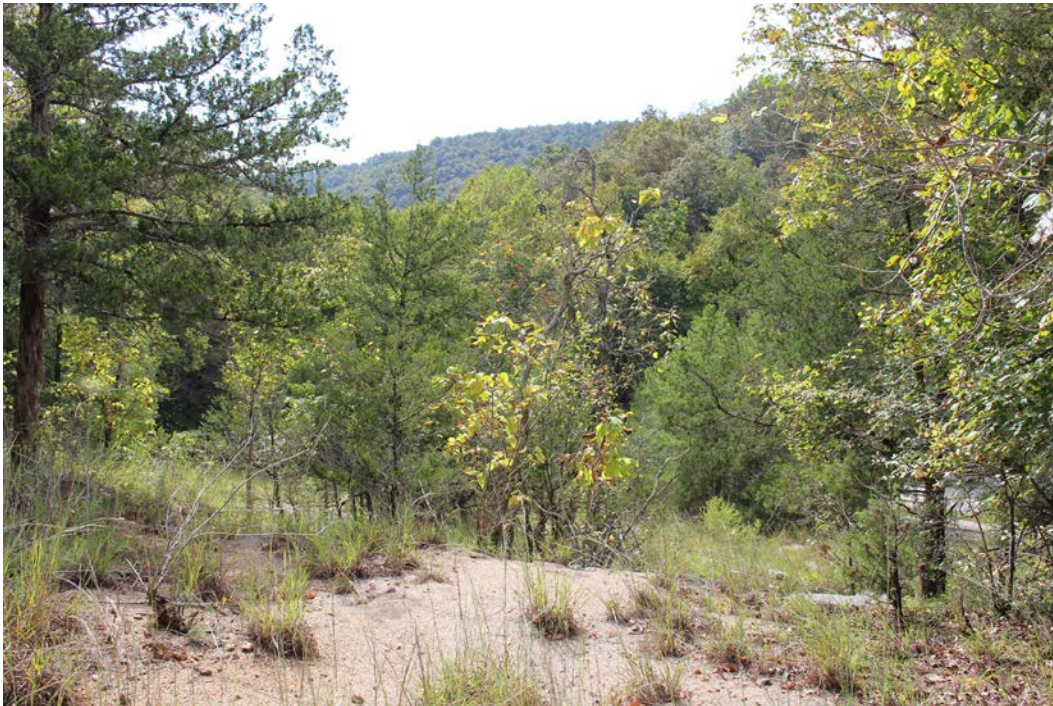
Figure 3-113. Tailings pile at Morning Star Mill ruins. (Mundus Bishop 2017)

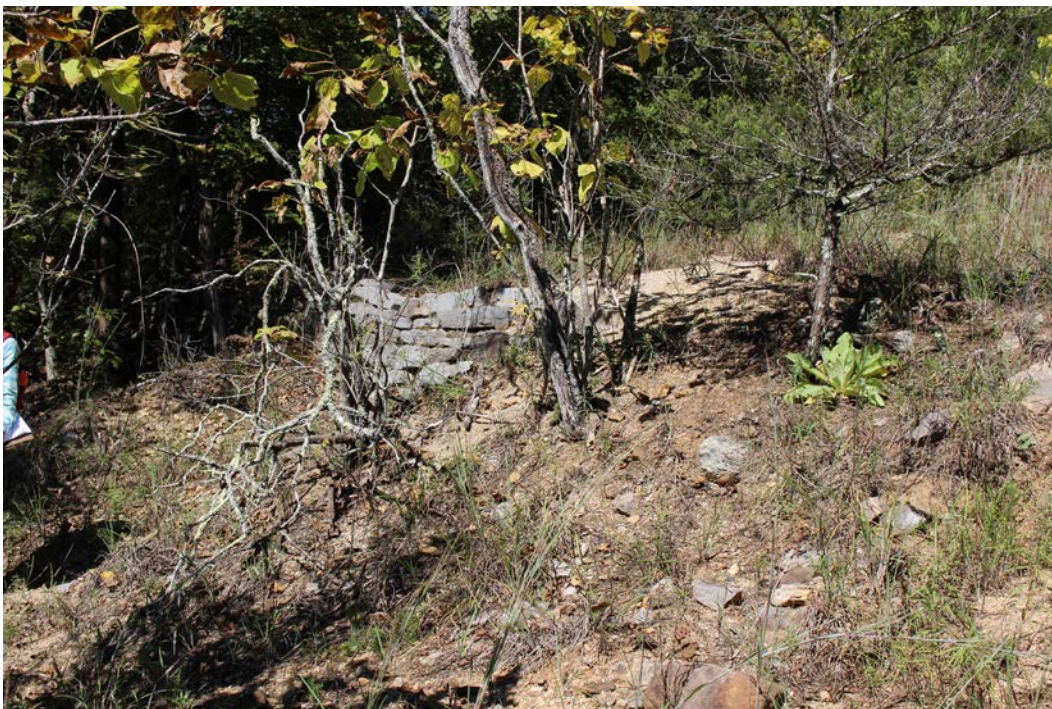
Figure 3-115. Morning Star Mill Stone Retaining Wall, near Boiler Room. (Mundus Bishop 2017)

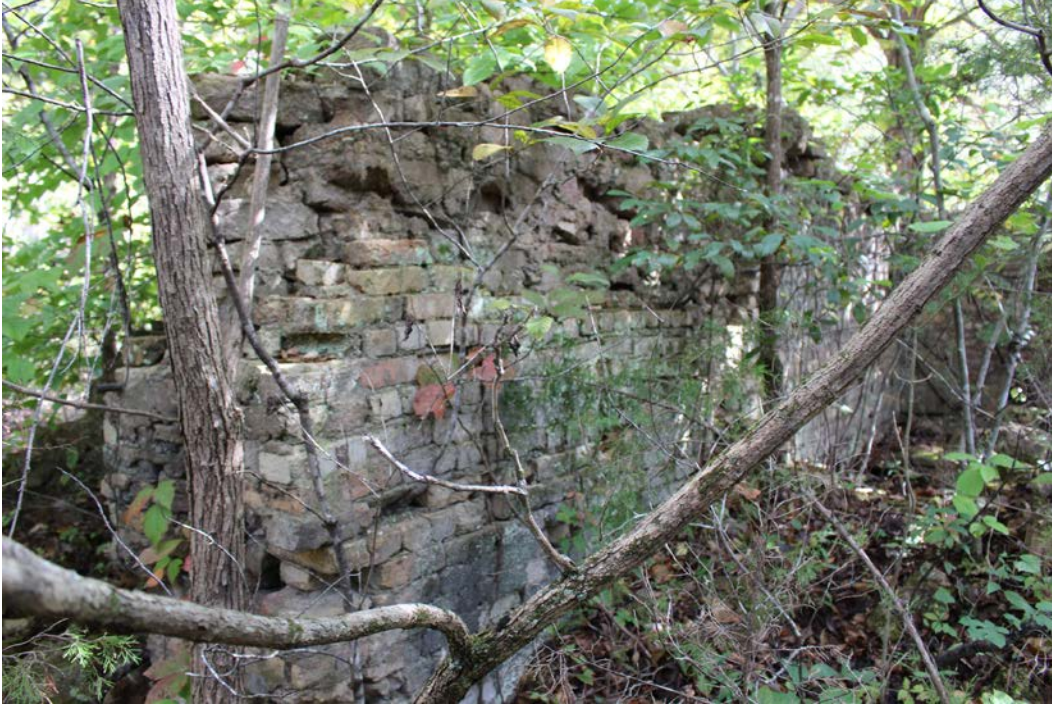
<i>Foundation</i> - Concrete edge 9" wide at perimeter of boiler room +/- 6" height.	Poor	
		<i>Boiler Smokestack</i> - Metal debris, 36" diameter	Poor	
		<i>Stone Retaining Wall</i> - Uphill side of Mill. Stone and mortar cantilevered/battered, set in two courses, width varies 24" height to 8-12'height.	Fair

Figure 3-116. Morning Star Mill ruins Boiler Room. (Mundus Bishop 2017)

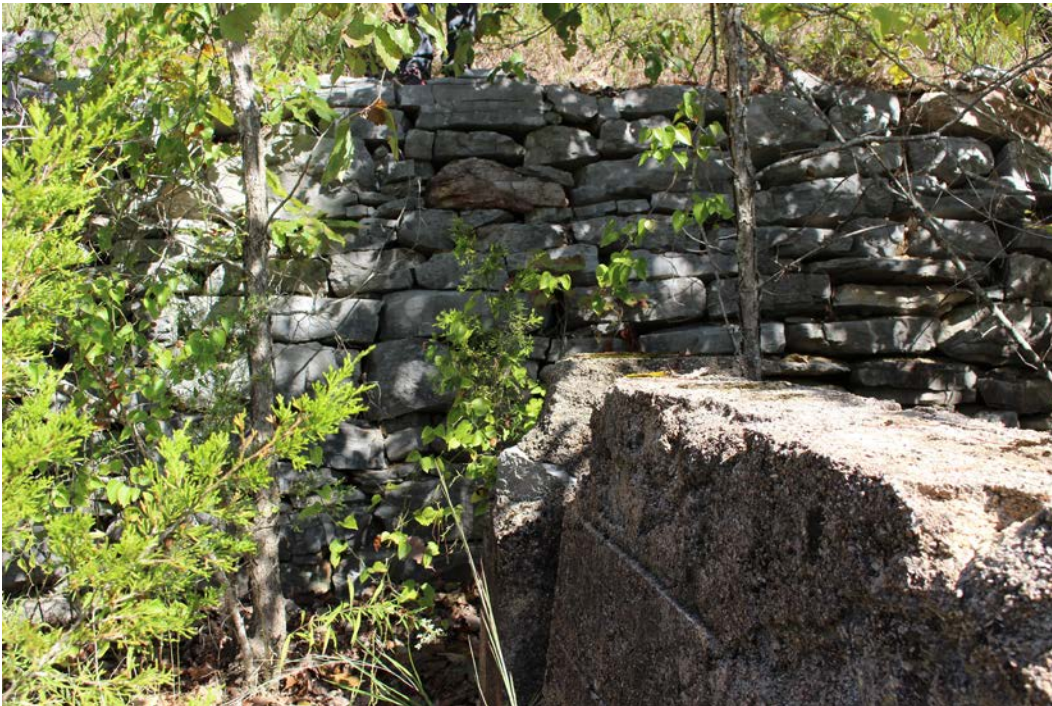
Figure 3-117. Stone retaining wall and concrete pier. (Mundus Bishop 2017)

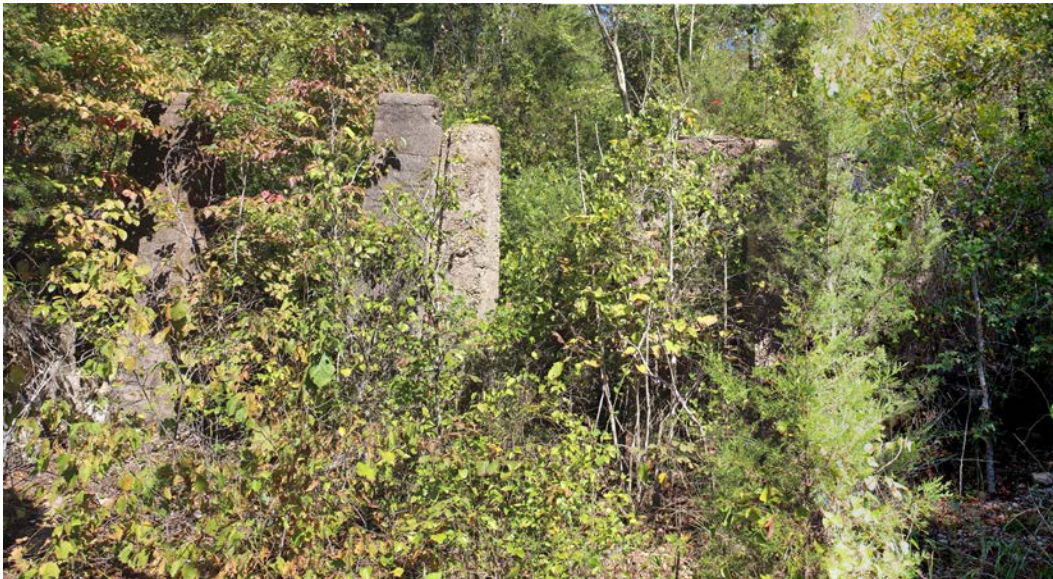
Figure 3-123. Morning Star Mill retention basin concrete spillway, same view as above. (Mundus Bishop 2017)

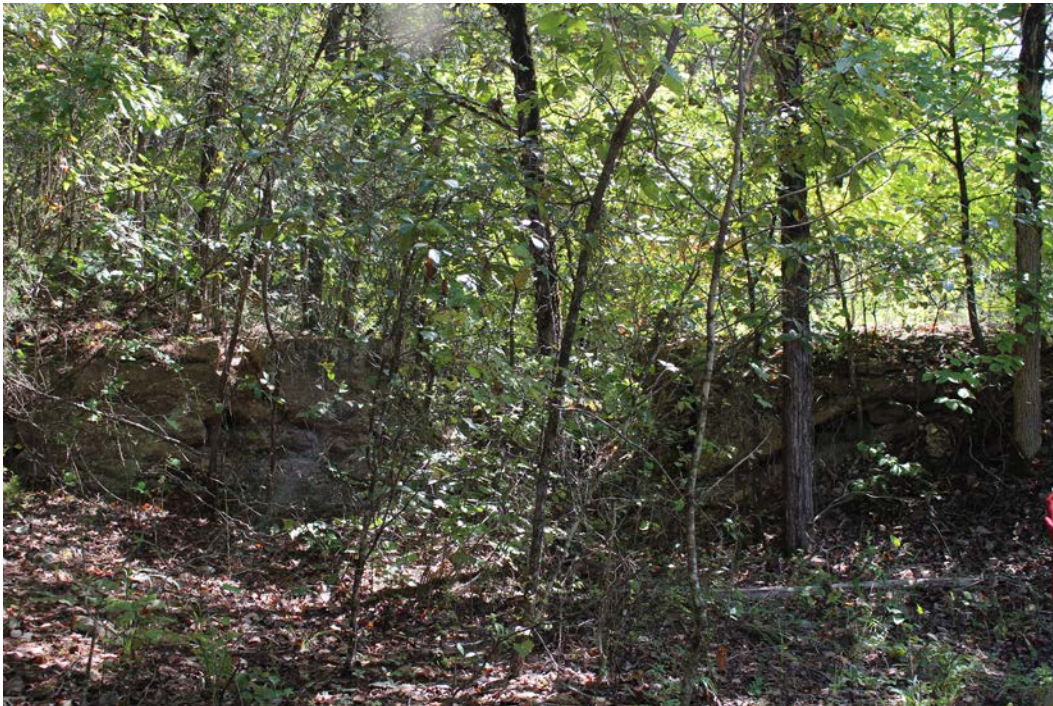
Figure 3-125. Morning Star Mill retention basin. (Mundus Bishop 2017)

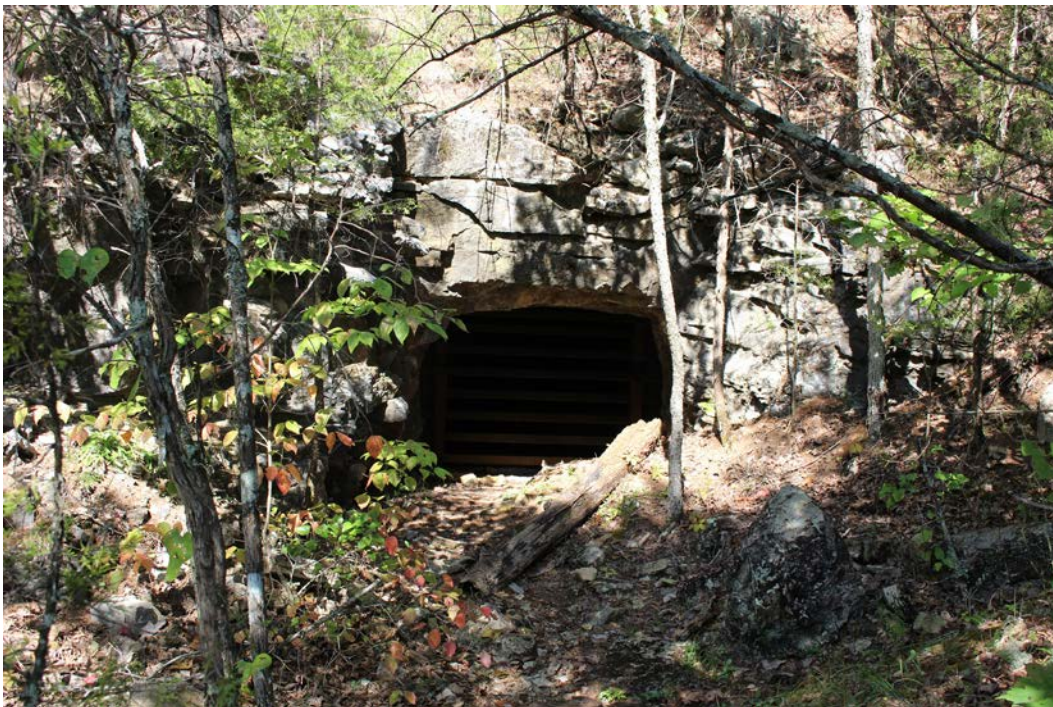
Figure 3-130. Morning Star Mine (M1) opening 1. (Mundus Bishop 2017)

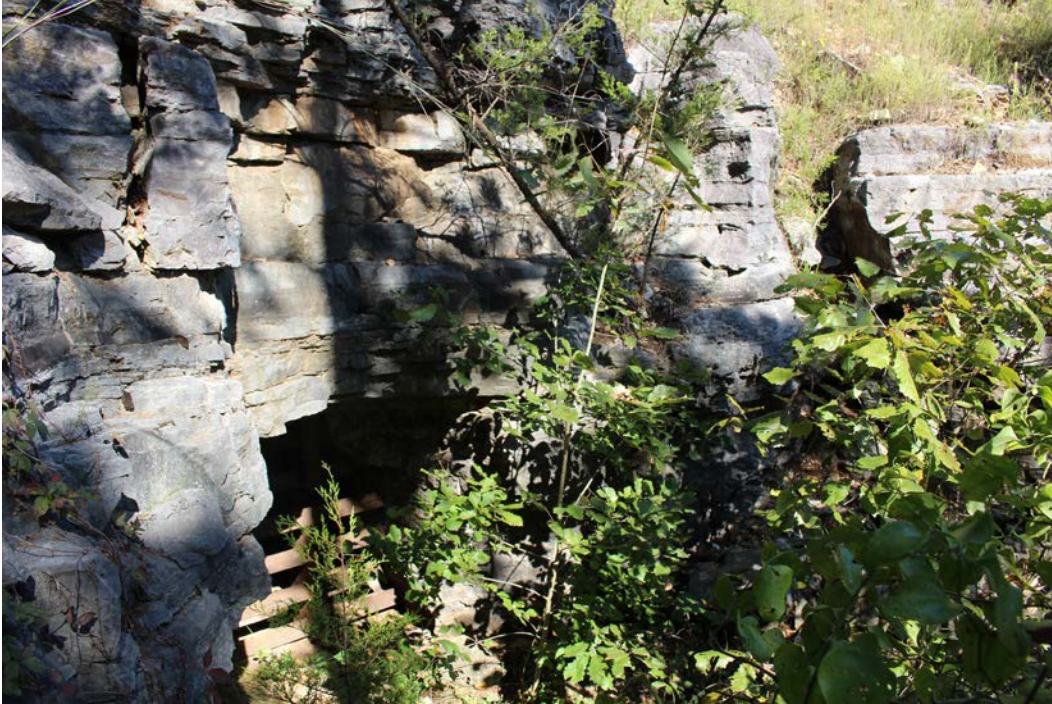
Matrix 3-13. Morning Star Hotel, Mill, and Mine - Morning Star Mine (M1)				
Feature	Date	Description	Condition	Contributing/ Non-Contributing
Building Site		Dry-stack 4' height to grade 12' width	Fair/Poor	Contributing
Morning Star Drift Mine A		Short, excavated into hill side no evident opening/shaft filled in or surface excavated	Fair	Contributing
Morning Star Drift Mine B		Short, excavated into hillside no evident opening/shaft filled in or surface excavated, young dense cedars	Fair	Contributing
Morning Star Drift Mine C		Stone faced 7'x7'x7' room long cut from road	Fair	Contributing
Morning Star Loading Platform		Stone, dry-stacked 10' width x 2.5' height obscured by dirt and vegetation	Fair	Contributing
Morning Star Mine Opening 1		Opening 1 - Single opening (near Open Cut) 8' width x 5.5' height, metal grate fence, cliff face 15' height, 5' overhang		Contributing
		Opening 2 - Single opening 5' width x 4' height, metal grate fence, cliff face, 15' height overhang 3' wide

Figure 3-131. Morning Star Mine (M1) opening 2. (Mundus Bishop 2017)

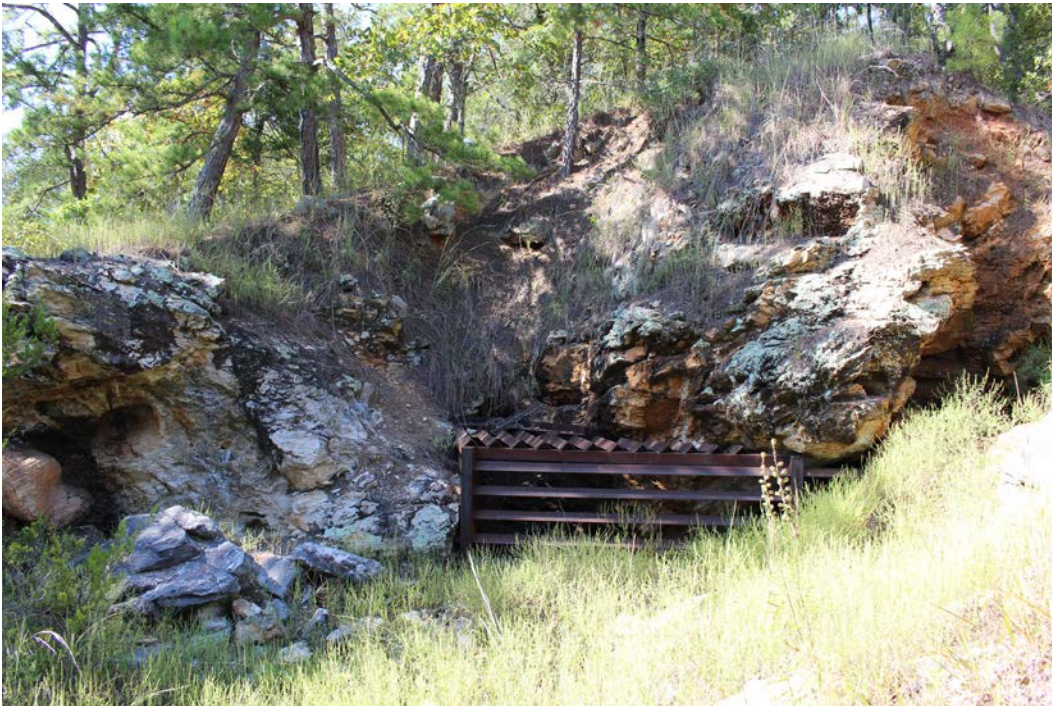
Opening 3 - Single opening shaft mine, metal grate fence both vertical and horizontal 3-4' height, 15' width opening caved in, cliff face 15', no overhang		
Morning Star Shaft		20' diameter x 15' depth with dark unfenced 3' hole at bottom	Fair	Contributing
Morning Star Mine Open Cut		Narrow cut at opening with 20' side walls. Interior of cut mostly level, some rock fall and pines. Chainlink fence at entrance	Good/Fair	Contributing
Morning Star Mine Spoils Pile			Fair	Contributing

Figure 3-132. Morning Star Mine (M1) opening 3. (Mundus Bishop 2017)
