**SUMMARY MEMO:**

**ENCHANTED VALLEY CHALET  
SITE FLOOD HAZARDS**

Technical Assistance for **OLYM**.

Date: 4-26-18

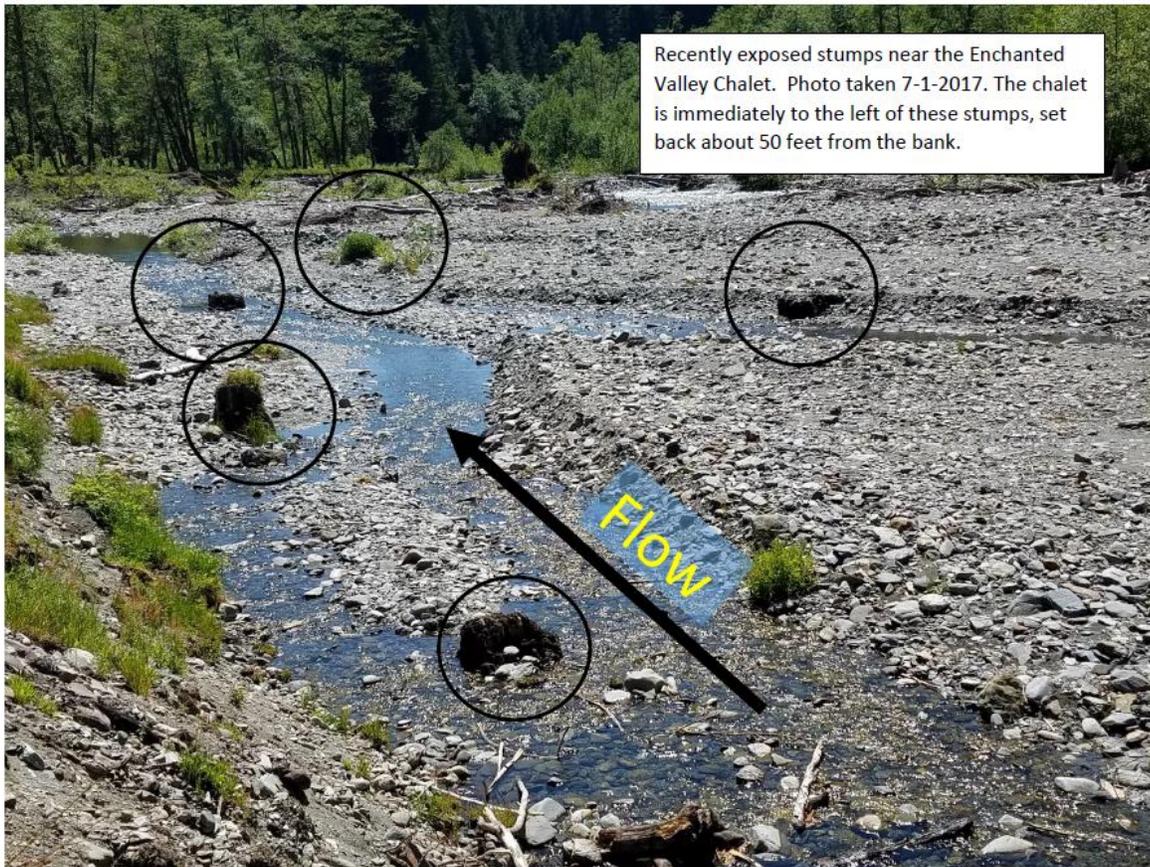
The strategy was to identify previously buried tree stumps or snags recently re-exhumed by river bank erosion (figure 9). The assumption is that the trees were originally entombed (smothered, but not toppled) by the paleo-river terrace emplacement and re-exposed (but again not toppled) by recent river bank and bed erosion. The tree may or may not have been dead when buried. In either case, the sampled ages would represent the maximum terrace age.

In the field, multiple potential sample trees were identified (figure 9), and we considered 11 sample locations to determine if the samples had not been moved by the river, and had been smothered by the terrace landform. For example, we excavated an area around the base of the stump to see if the roots were embedded in the stream bottom. Ultimately four samples were collected (figure 10) using standard field protocols. Of those, the park made the decision to analyze two samples (#189 and #203 in figures 11 and 12, respectively) which were sent for analysis to Beta Analytic. The specific two samples were chosen by us to represent both the near-Chalet area, and the upstream reach. The detailed dating reports are in figure 13 (a, b). The remaining two samples have been retained, and are available for future analyses.

**Figure 9.** Paleo-tree stumps exhumed by bank erosion winter 2016-17. Photo Pat Crain, OLYM.

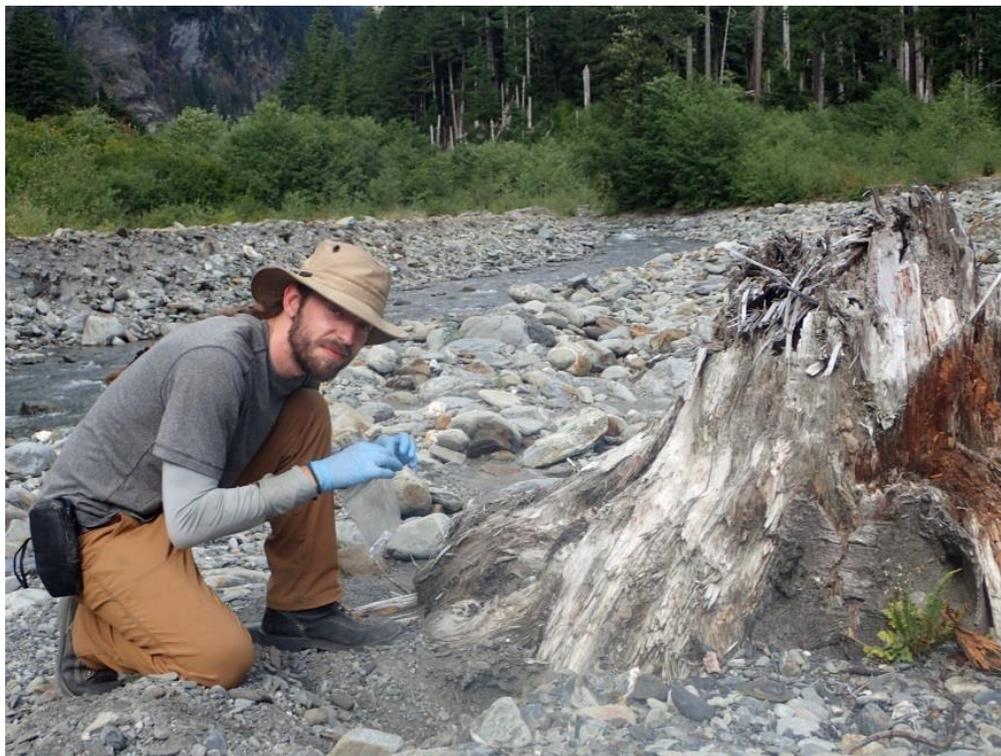
Despite our precautions, sample #189, taken from a stream-bed wood location, turned out to be a very recent tree. It was most likely a stump (figure 11) that floated in and was partially buried, appearing to be a recently exhumed tree. The sample date was not further considered. The 2<sup>nd</sup> sample analyzed, (#203), was from a stream bank stump that had been recently exhumed (winter 2016-2017) as seen in figure 12. We are much more confident that it was truly *in situ* based on the recent exposure.

**Figure 11.** Sampling site #189. Taylor Kenyon pictured.

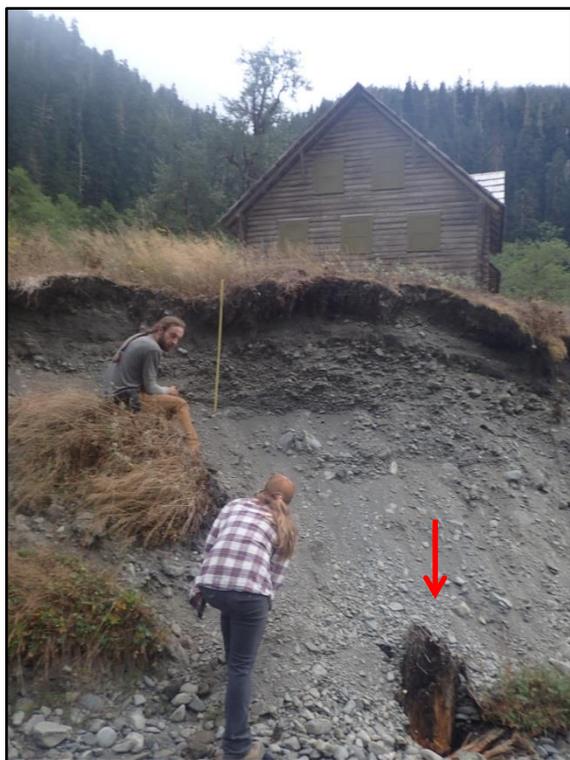
The conventional radiocarbon age of sample #203 is 320+/- 30 before present (BP), which corresponds to the age range of 1482 AD to 1594 AD years old (calibrated dates, 95% probability), thus representing a maximum terrace age of about 1500 AD. Calibrated date is defined in the Glossary (Select Definitions).

**Figure 12.** Sampling site #203. Stump recently exposed by erosion below Chalet (arrow).

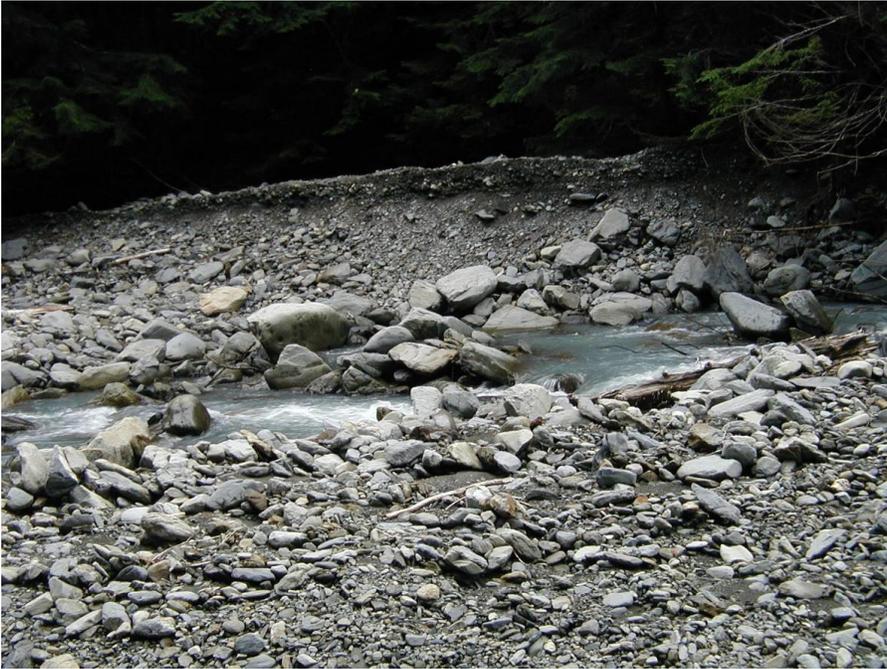
The initial triggering event, a large debris flow (figure 14), was also recognized. However, the specific sediment delivery system (sediment bulges) had not been recognized at that time. Based on field observations in summer 2017 and reexamination of my 2005 field photos, it is clear that sediment bulges were the linking mechanism. Additionally, the subsequent bank erosion in the Chalet area (post-2004 and continuing to this day) is associated with an incising river (Kennard 2014). When the recent series of sediment bulges reach the Chalet area we can expect stream bed aggradation and associated bank erosion or avulsions on the order of 100s of feet, as occurred in 2002-2004.

**Figure 14.** Sediment deposits up to 20 feet above channel, upper Enchanted Valley (2005).

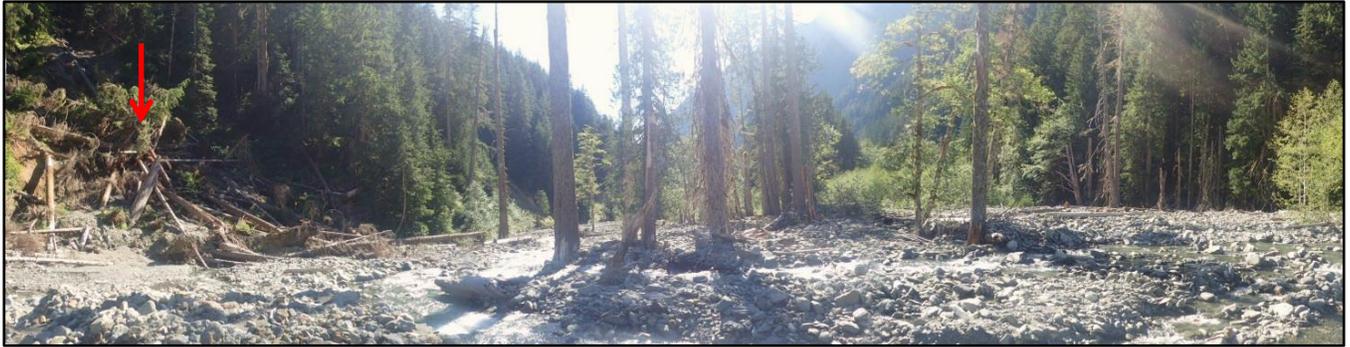
Spatially, sediment bulges extended through the Upper channel segment (figure 4) into the upper Confined channel segment. They have locally aggraded the river bed by several meters (tens of feet), and the stream has responded by migrating from the elevated surface to the now lower surrounding floodplain or terrace, sometimes getting pinned adjacent to the valley wall. (As a side note, recent trail damage on the valley walls by headward erosion, was associated with channel movements forced by sediment bulge emplacements, figure 18 a, b.)

(a) Stream pushed valley left (looking downstream). Note valley wall erosion (arrow).

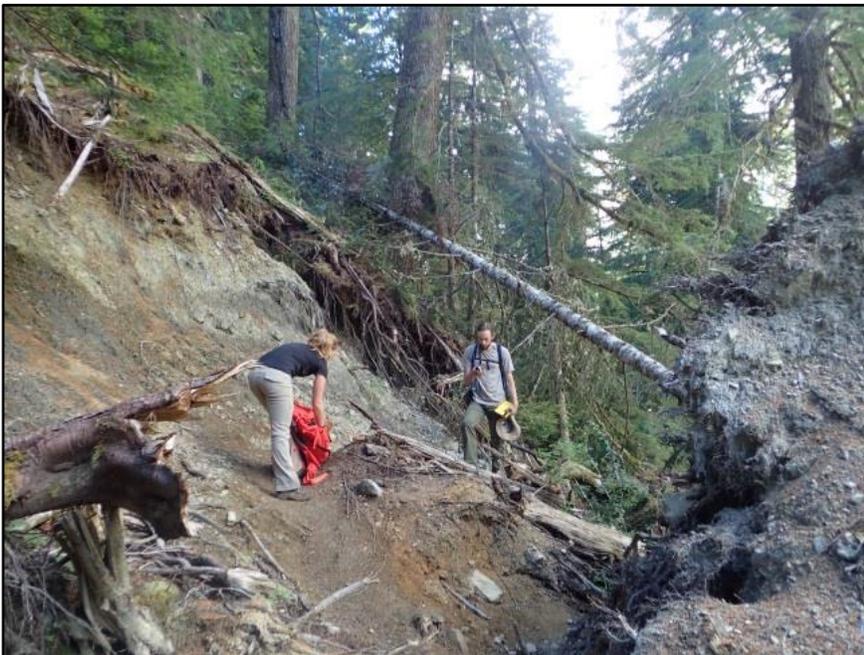
(b) Associated trail damage (higher up, valley left).

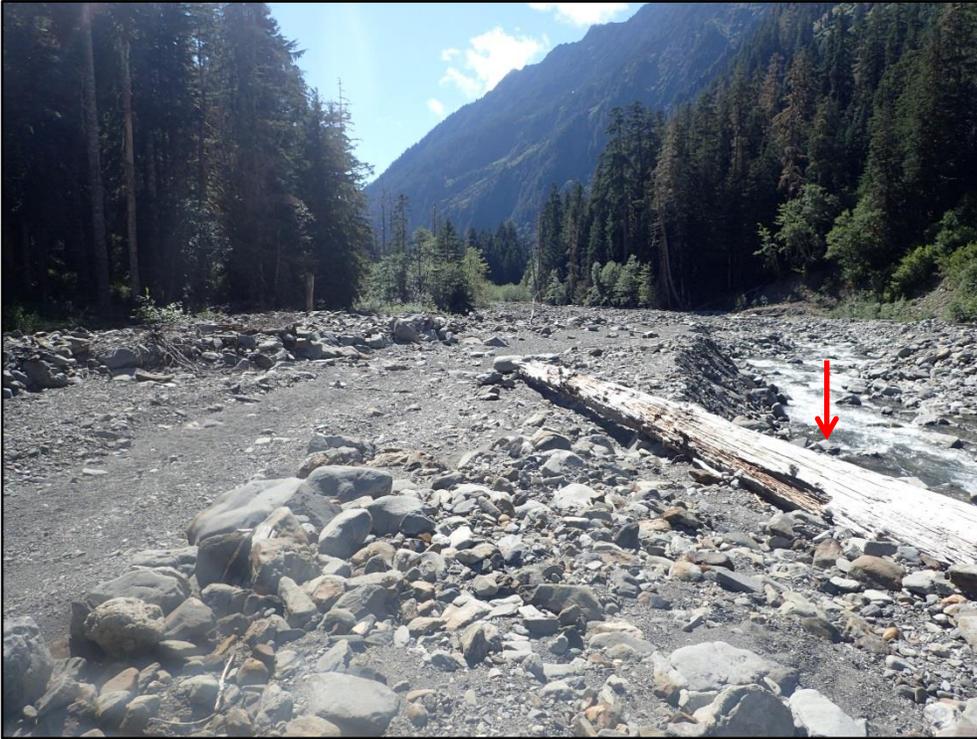
The upstream (1<sup>st</sup> order) bulges are the oldest, and the stream has started to incise into them (figure 19). This tends to 'lock-in' the channel over time and if the stream is incised into the bulge, away from the valley wall, the avulsion and bank erosion potential is minimized until the next large input of sediment starts the process over again. The less mature, downstream bulges (2<sup>nd</sup> and 3<sup>rd</sup> order) have destabilized the stream, resulting in active stream bank, terrace, and valley wall erosion (figure 20). In these more recently formed bulges, the stream channel has not had time to re-equilibrate, and incise down to its former lower position. As a result, the newly formed, out-of-balance stream channel is relatively unconfined, with shallow stream banks, and more prone to migrate across the bulge and valley floor during relatively low stream flows.

**Figure 19.** Mature (incised) 1<sup>st</sup> order bulge.

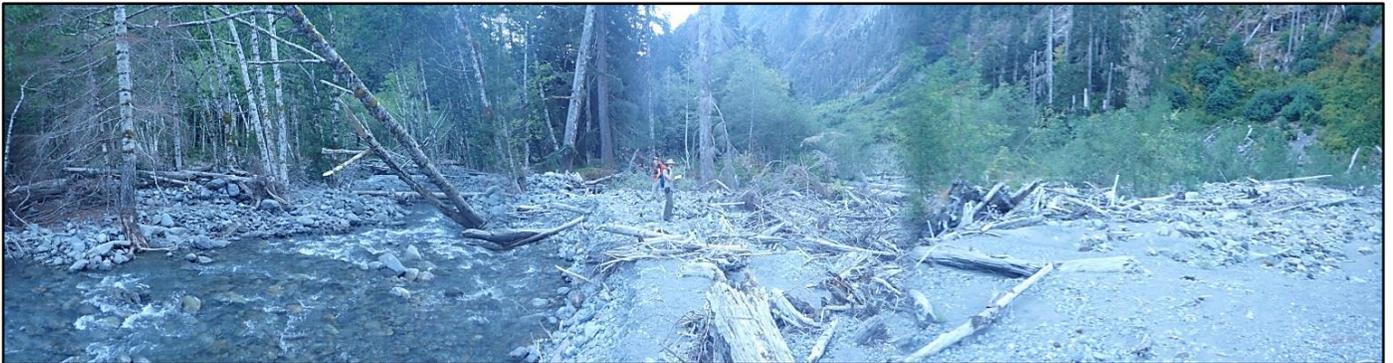
**Figure 20.** Active 2<sup>nd</sup> order bulge.

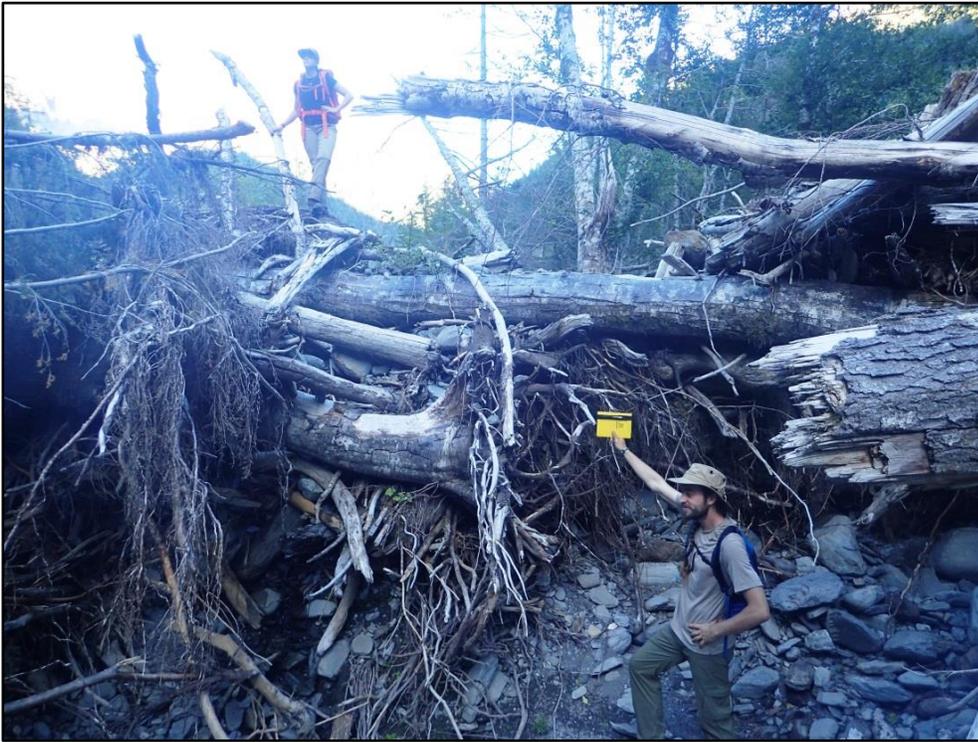
The most downstream bulge (figure 21) is a large 3<sup>rd</sup> order feature. This bulge is likely interacting with substantial amounts of wood from an earlier climax snow avalanche that deposited copious amounts of uprooted old growth trees to the valley bottom. It is located in the upstream end of Confined channel segment (figure 4). Confined channel segments favor more rapid sediment transport than unconfined reaches, such as the Upper and Lower channel segments.

**Figure 21.** 3<sup>rd</sup> order bulge
