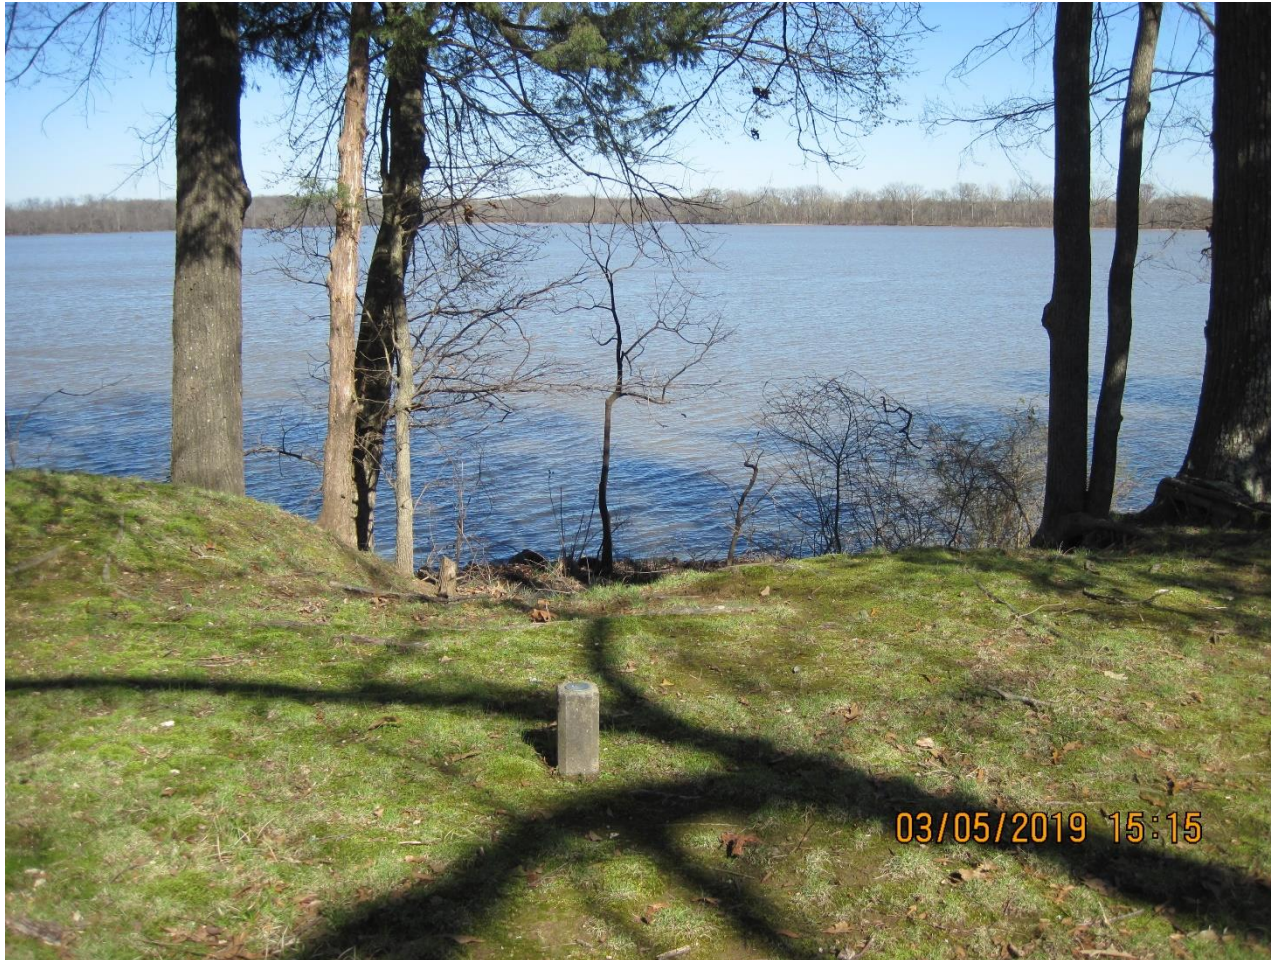
*Figure 1 Facing east looking at Post Bend Lake*

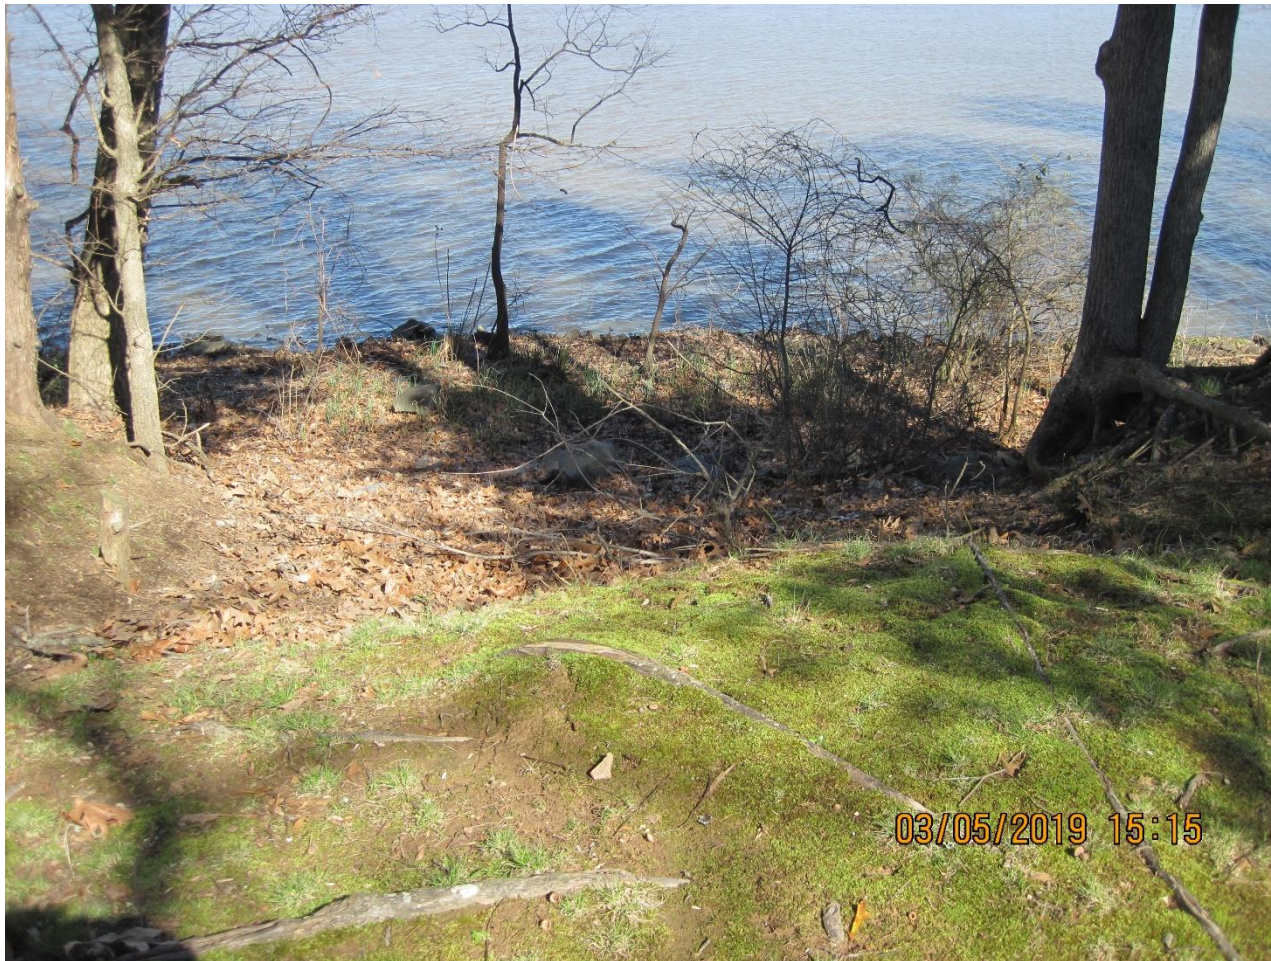
*Figure 2 Facing east looking down eroded bank*

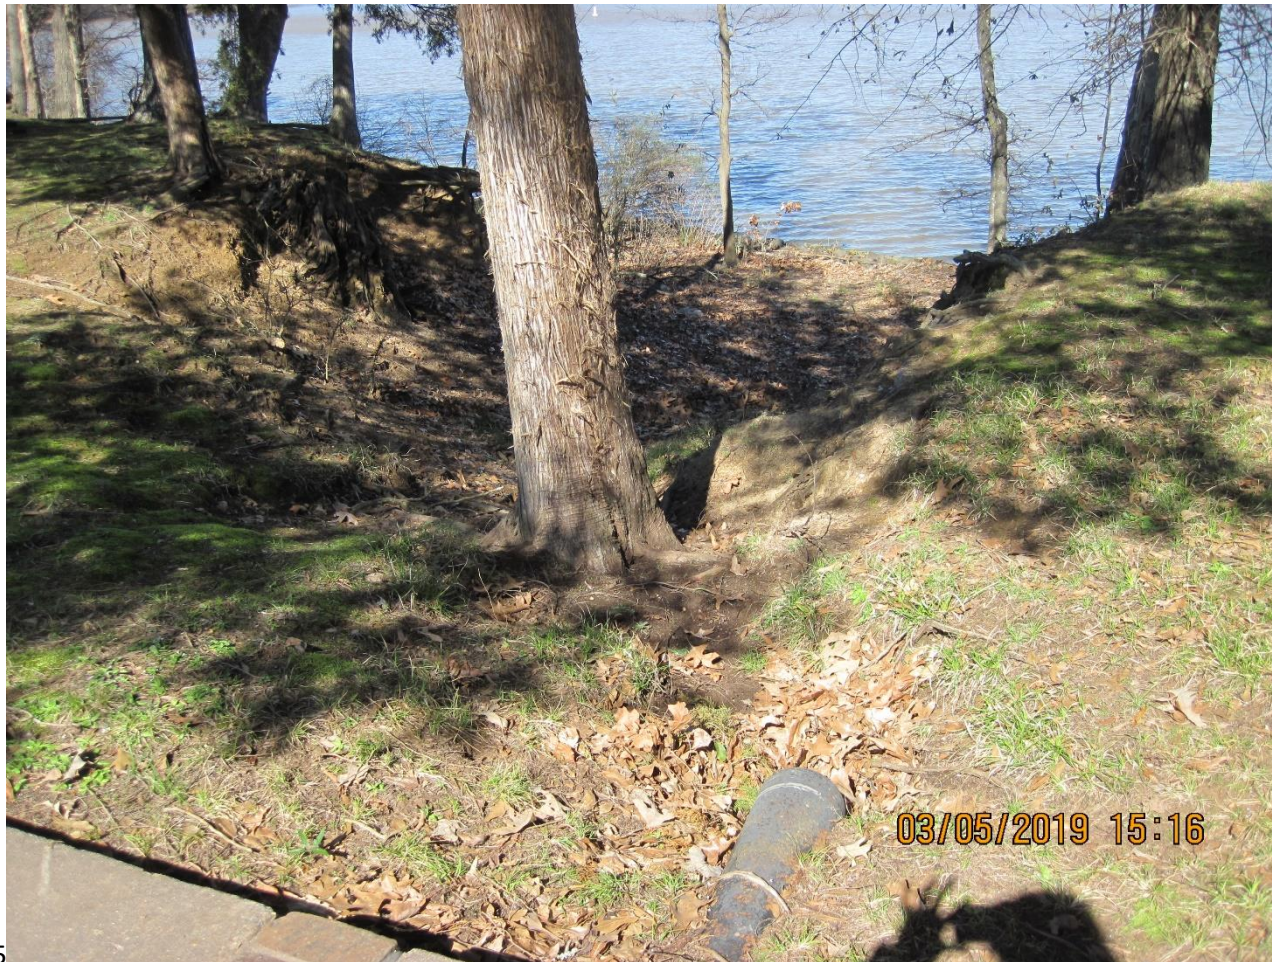
Figure 4 Facing east showing extensive erosion. This is another angle of Figure 3

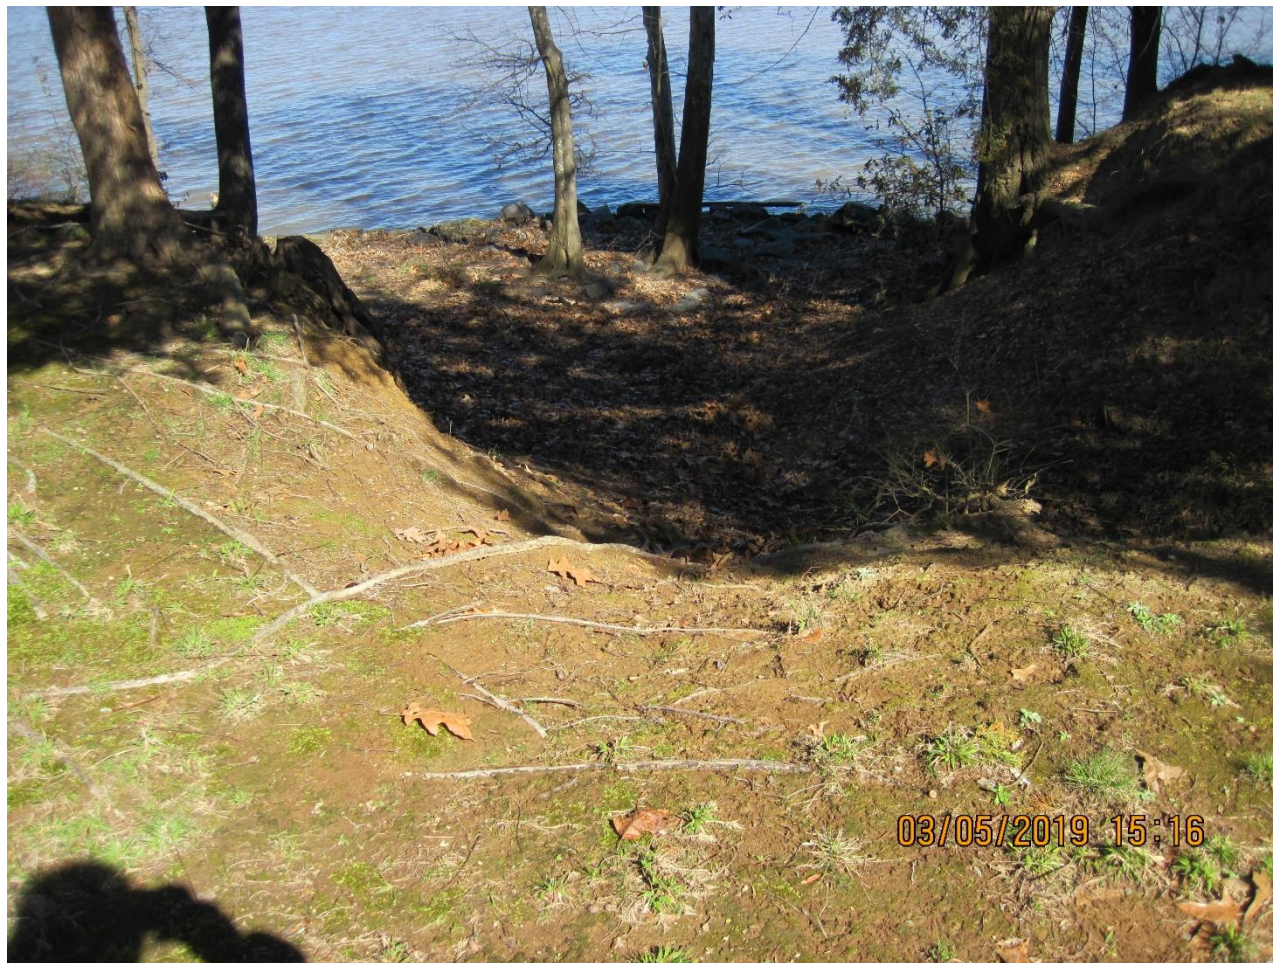
*Figure 6 Facing east showing another foot path contributing to erosion*

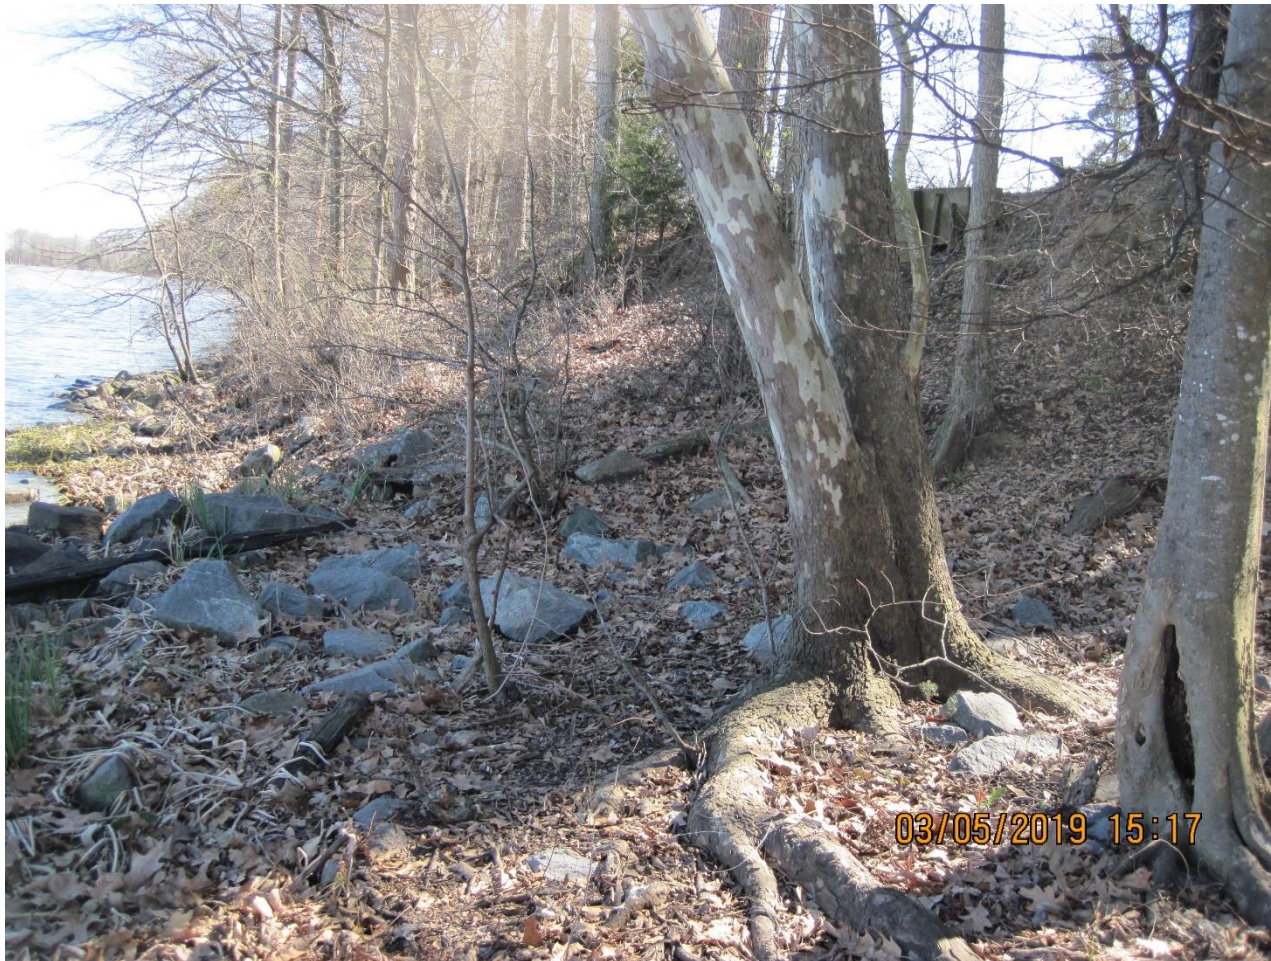
*Figure 11 Facing S. View of shoreline and USACE rip-rap erosion control*

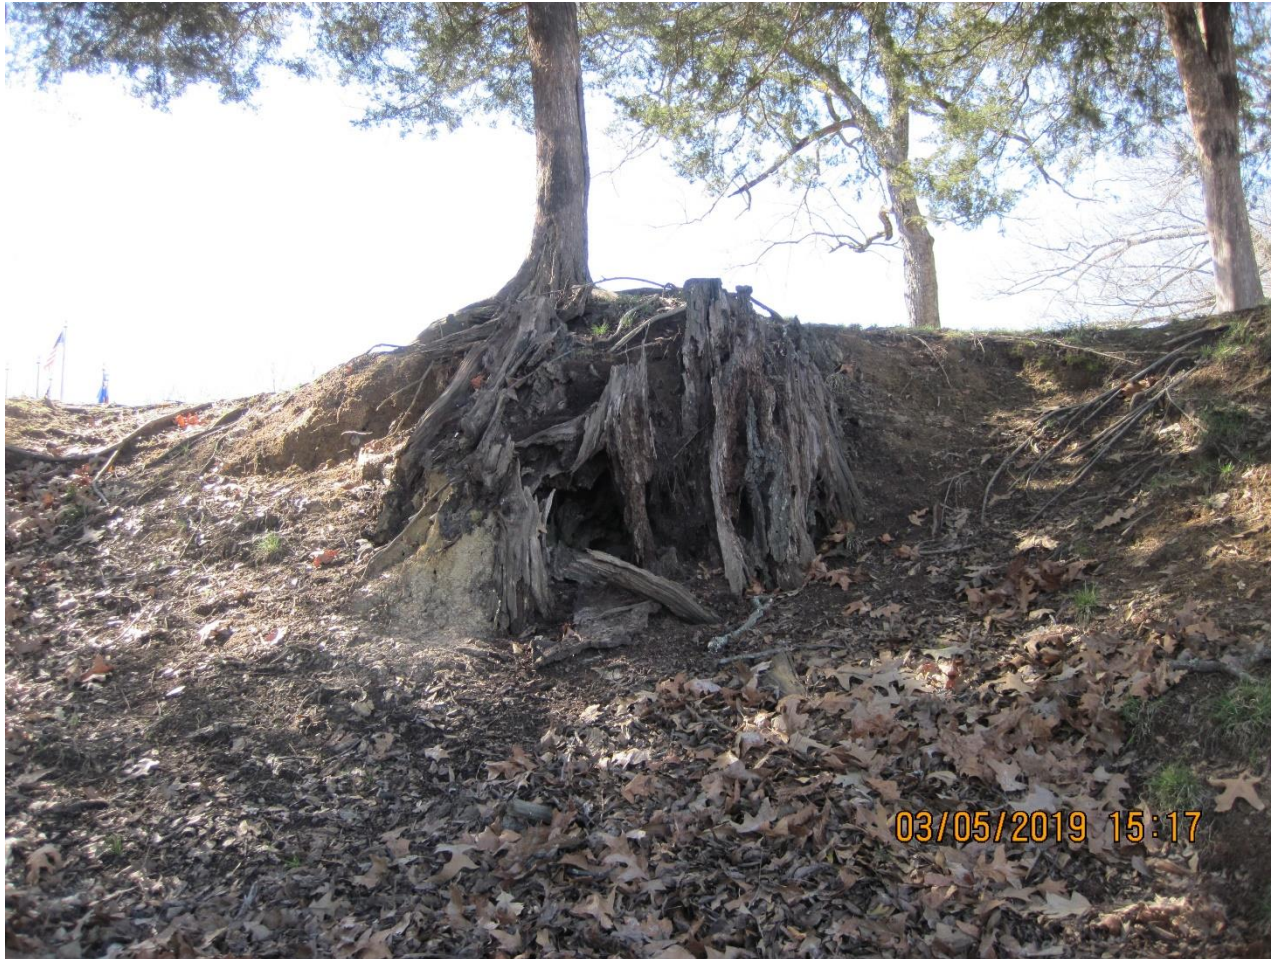
*Figure 12 Close-up of erosion undermining tree from Fig. 10*
