## **EXISTING CONDITIONS PHOTOGRAPHS**

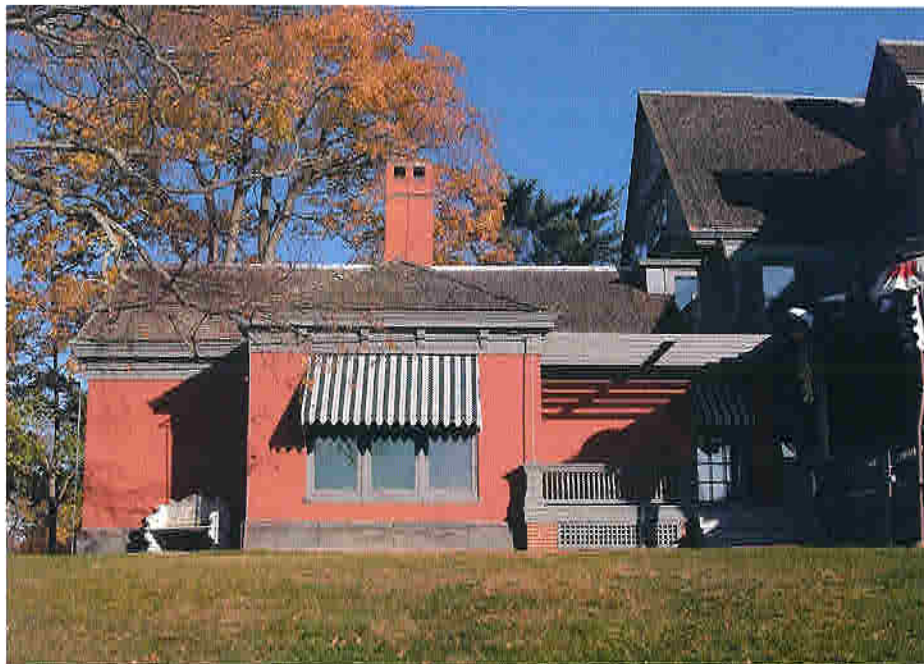
*Exterior 4. The west elevation of the 1905 Trophy Room addition; the spalling of the bluestone water table is visible from this distance. The roof shingles in this area are showing signs of curling. [JGWA, 2008]*

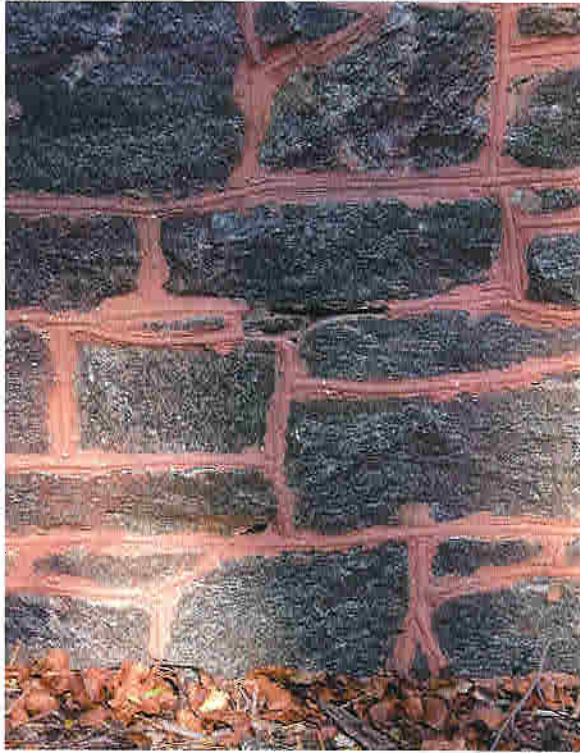
*Exterior 5. Open mortar joints in the foundation wall in the southeast corner of the Theodore Roosevelt Home. [JGWA, 2008]*

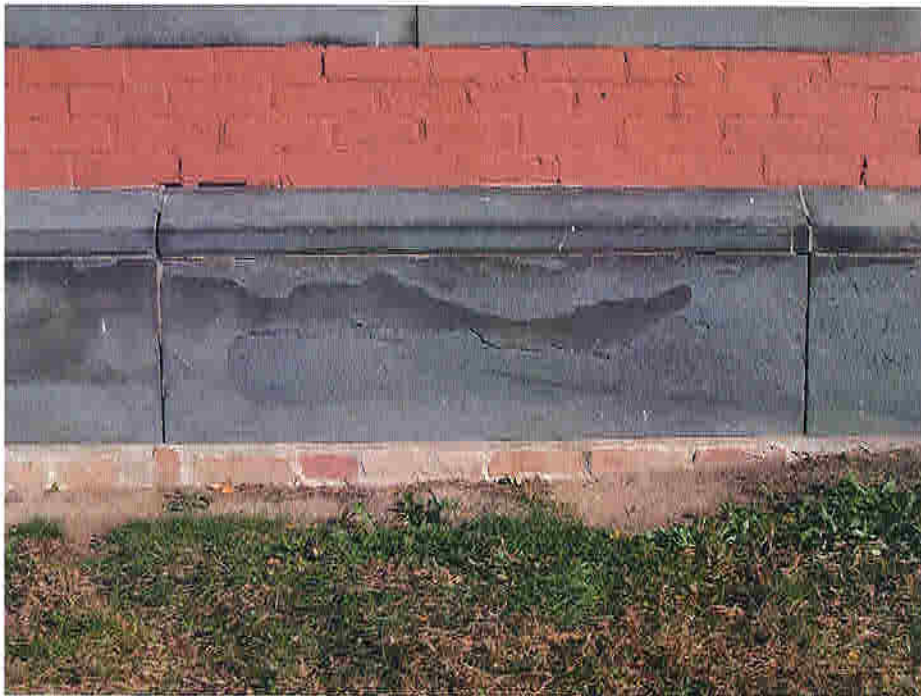
*Exterior 6. Spalling bluestone water table and open mortar joints on the northwest corner of the 1905 Trophy Room addition. [JGWA, 2008]*

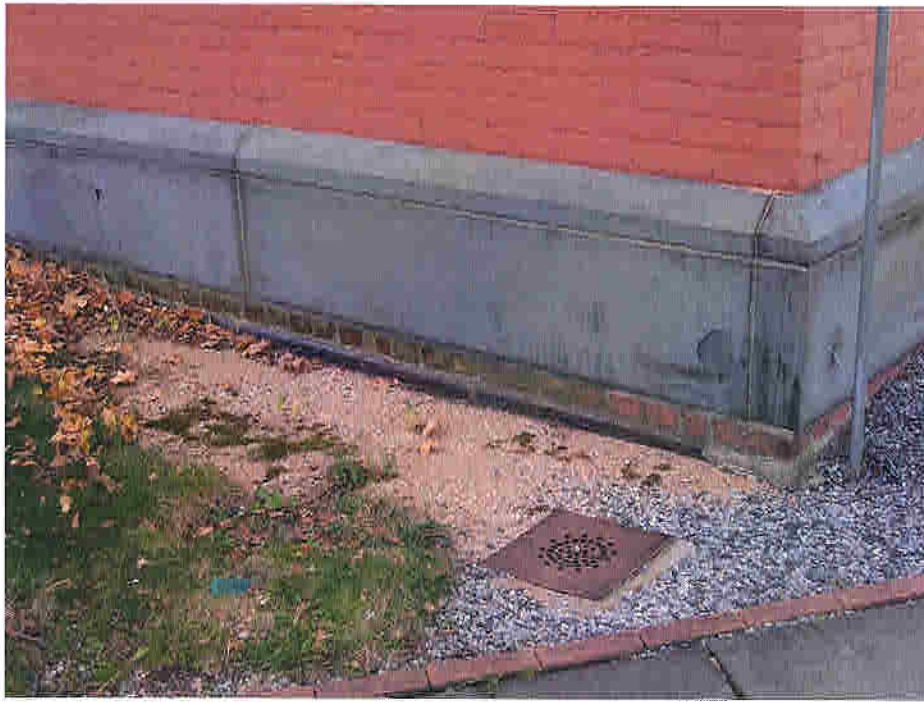
*Exterior 7. The lower section of the northeast corner of the 1905 Trophy Room addition. Note the rain-scoured grass, exposed soil, active biological growth and spalling bluestone water table. [JGWA, 2008]*

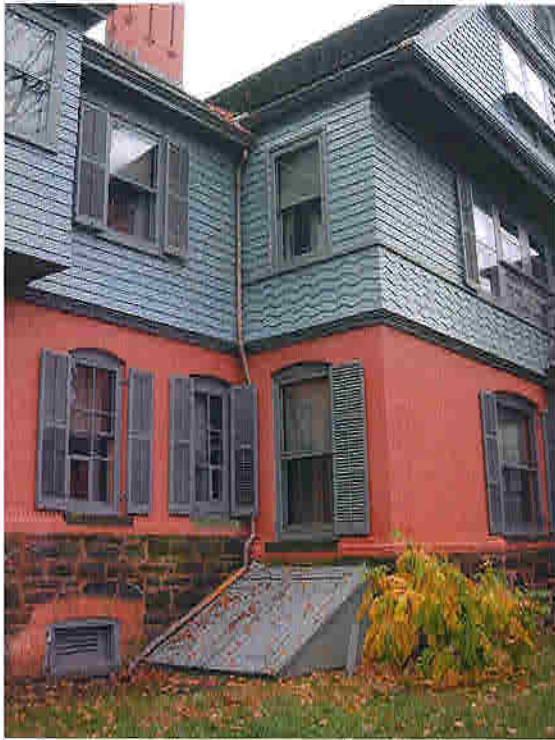
*Exterior 8. The wooden bulkhead over the stairs to the basement. Note the algae growth on masonry surfaces. [JGWA, 2008]*

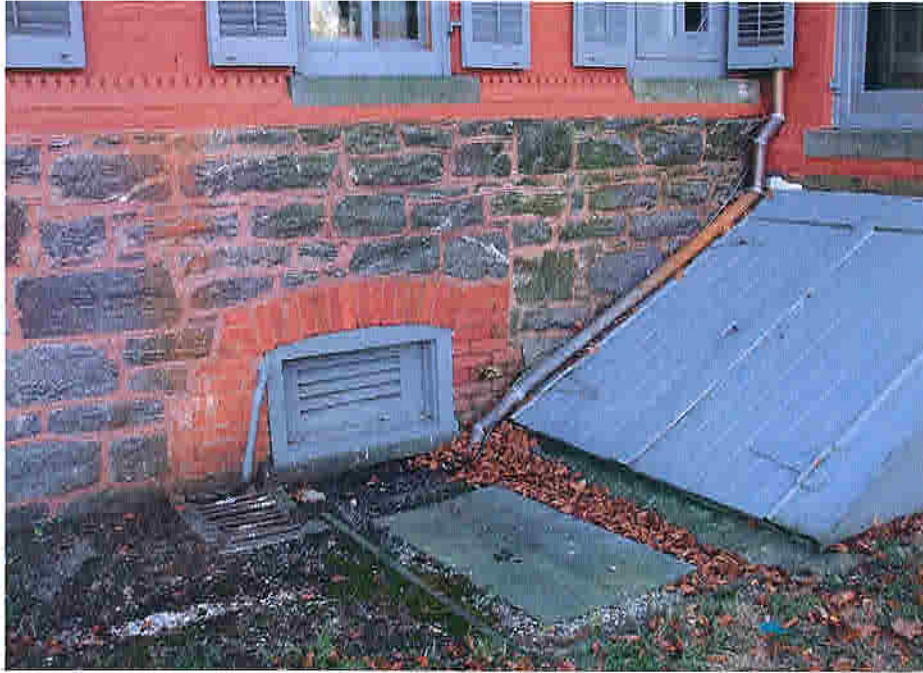
*Exterior 9. A closer view of the basement bulkhead. Note the stained masonry surfaces, open mortar joints, and deteriorated downspout. The grade slopes towards the house. [MACTEC, 2008]*

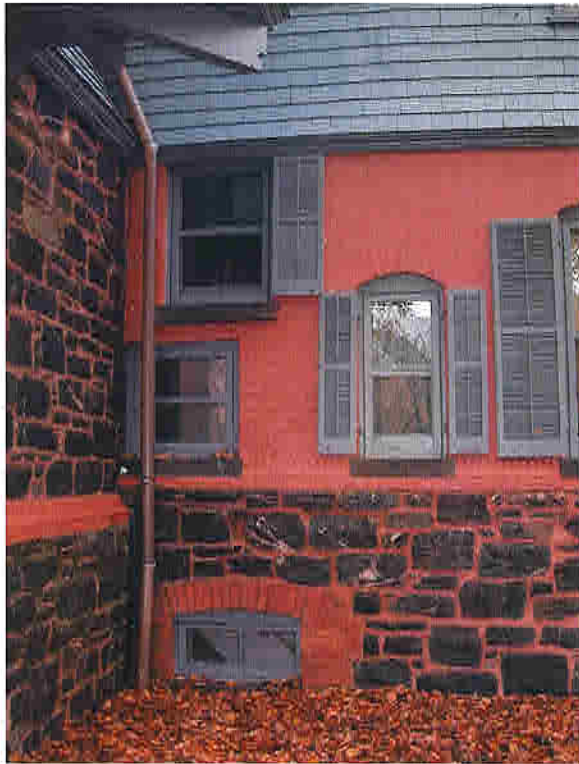
*Exterior 10. The corner outside of the 1952 stairwell modification; window locations are not original to the 1885 design. Significant water infiltration problems occur at this corner inside the house. [JGWA, 2008]*

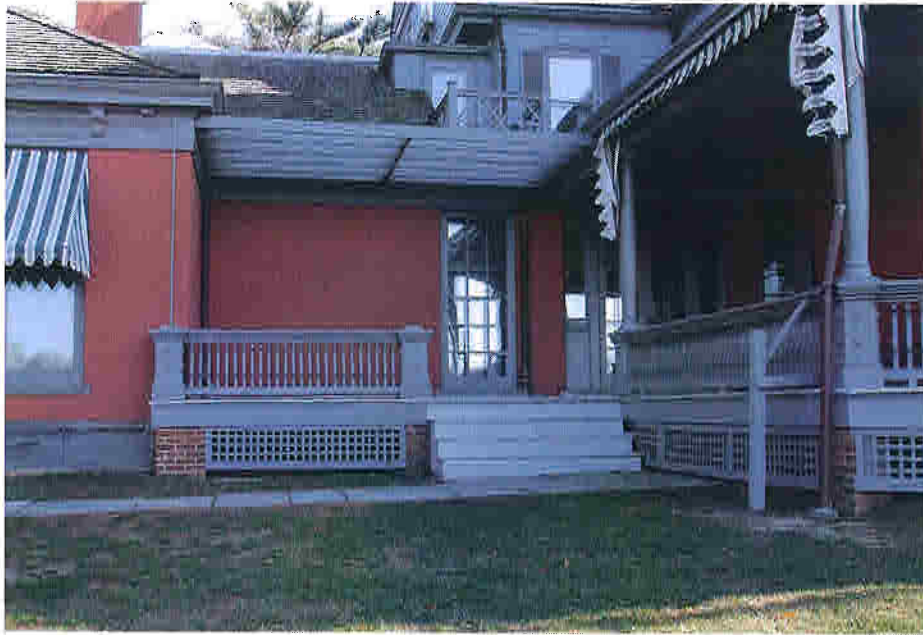
*Exterior 11. A detail of the corner where the 1905 addition meets the original house. Note the area of eroded grass and exposed soil surrounding the downspout on the right side of the photograph. [MACTEC, 2008]*

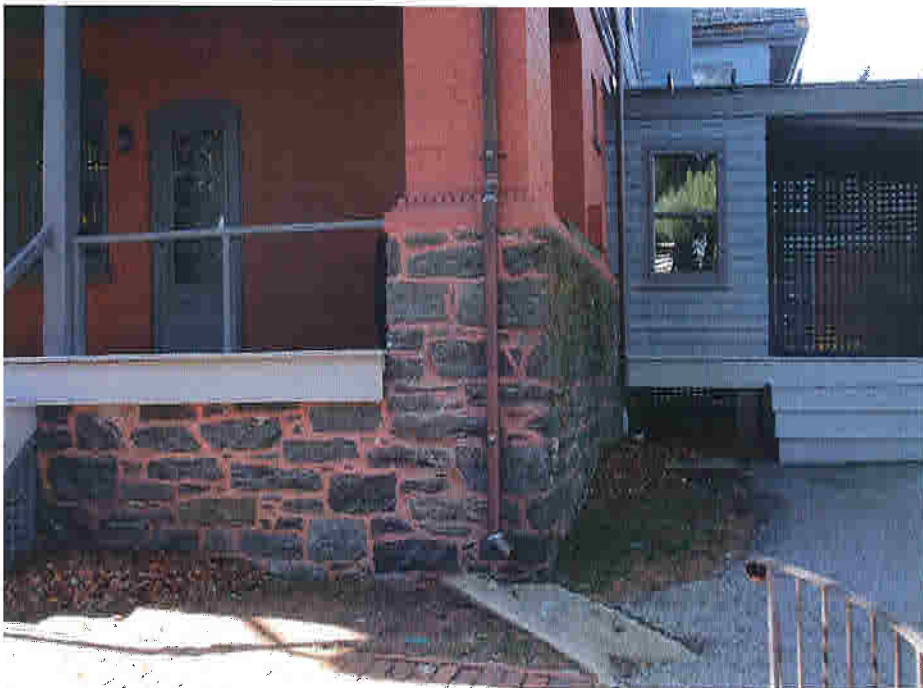
*Exterior 12. The east side of the Maid's Porch showing a downspout daylighting into a concrete drainage culvert. The brick mortar joints are open, and gaps are covered in paint. [MACTEC, 2008]*

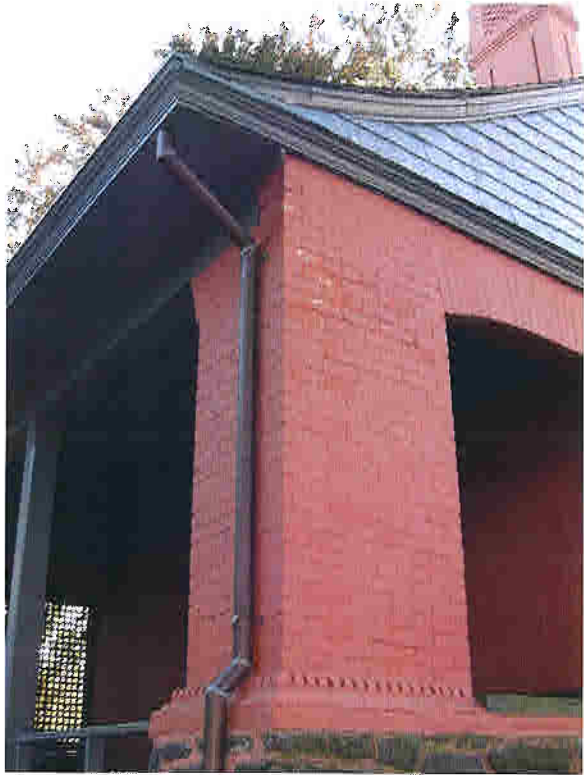
*Exterior 13. The Maid's Porch, showing active algae growth on masonry surfaces as well as the blistering paint on the brick columns. [JGWA, 2008]*

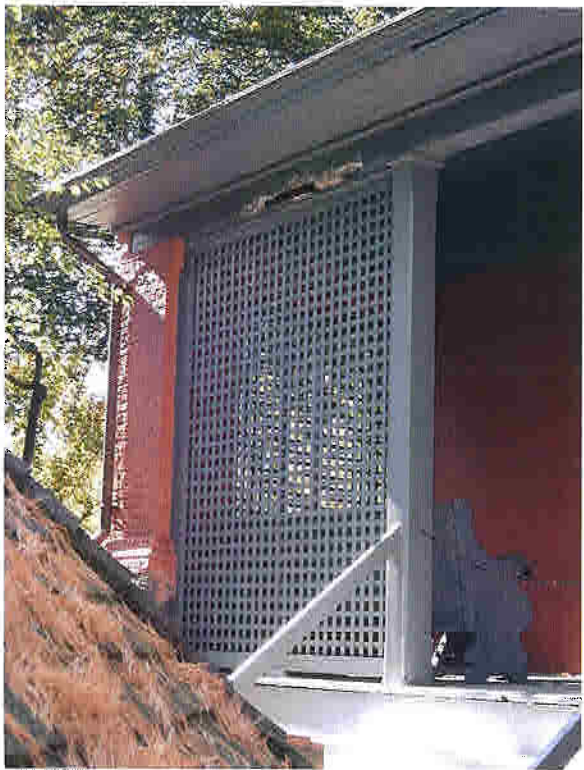
*Exterior 14. Southeast corner of the Maid's Porch, showing excessive deterioration of wood soffit. [JGWA, 2008]*

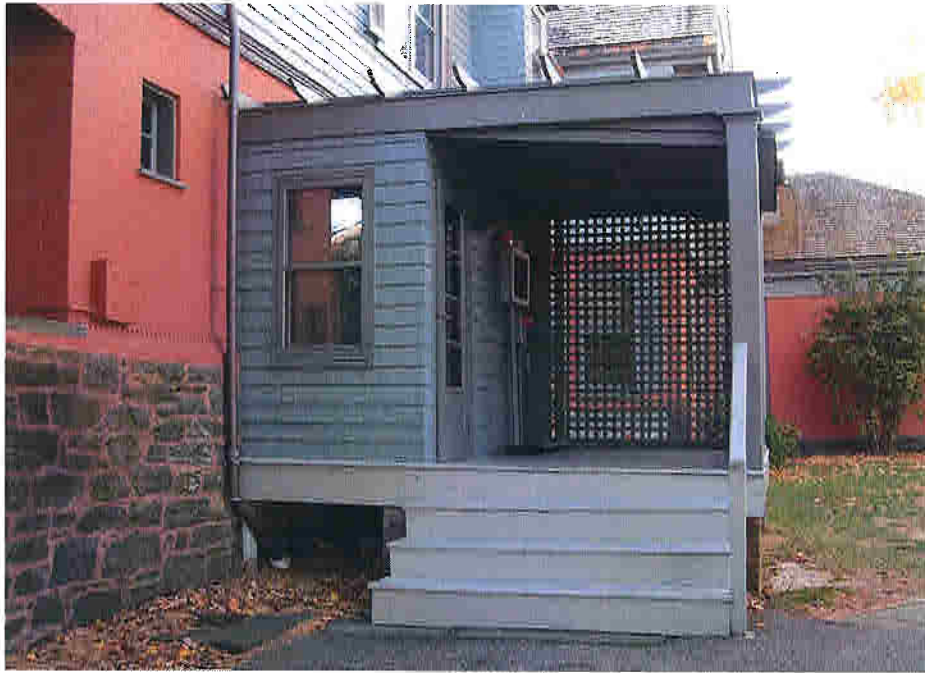
*Exterior 15. The east side of the rear entry porch. The tongue and groove decking is buckling. Significant water infiltration and rot are found in the soffit. [JGWA, 2008]*

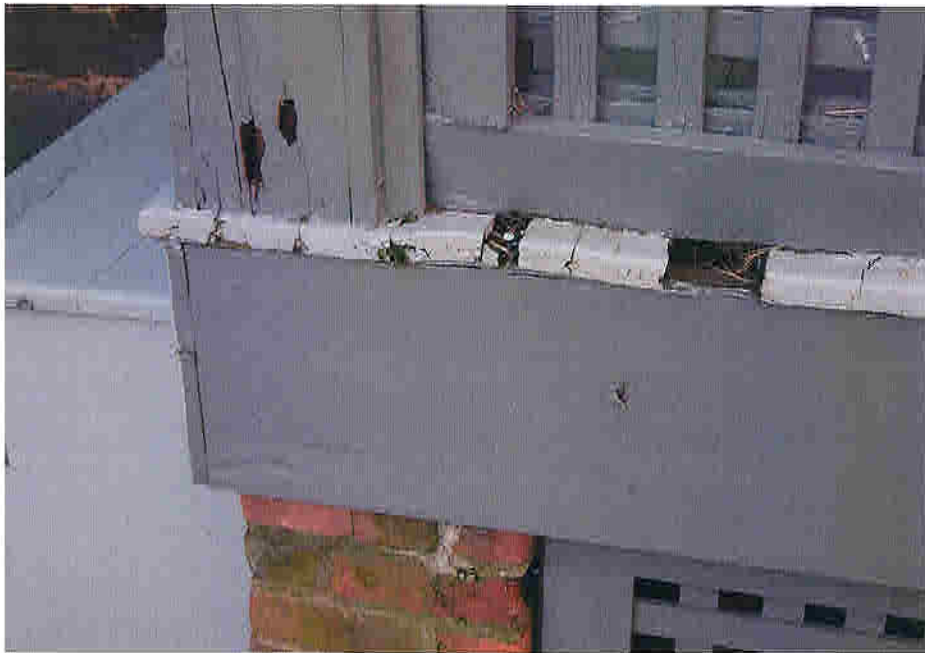
*Exterior 16. Detail of the northeast corner of the wood-framed rear entry porch. Note the missing and rotten wood as well as the active biological growth on the brick and wood surfaces. [JGWA, 2008]*

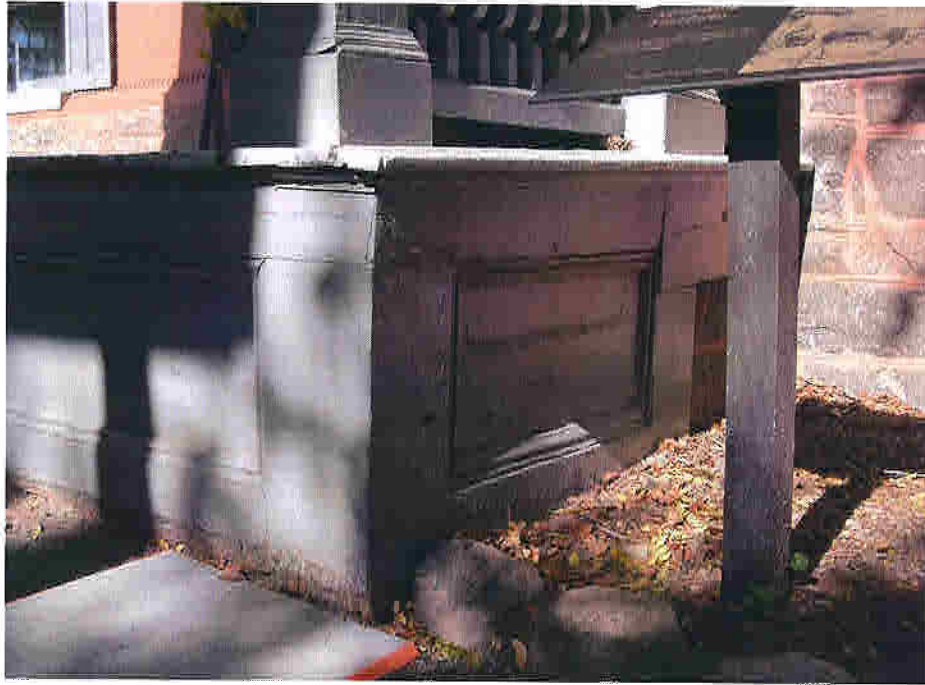
*Exterior 17. The southeast corner of the "Mounting Platform" in the Porte Cochere. Note the poor condition of the wood paneling, and the peeling and cracking paint. [JGWA, 2008]*

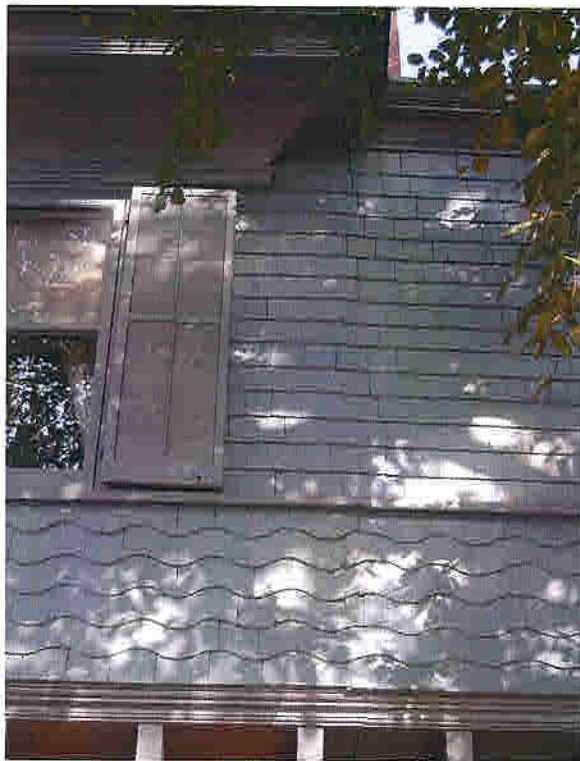
*Exterior 18. The 1910 cantilevered bathroom addition. Note the misalignment and separations in the wall shingles and wood trim. [JGWA, 2008]*

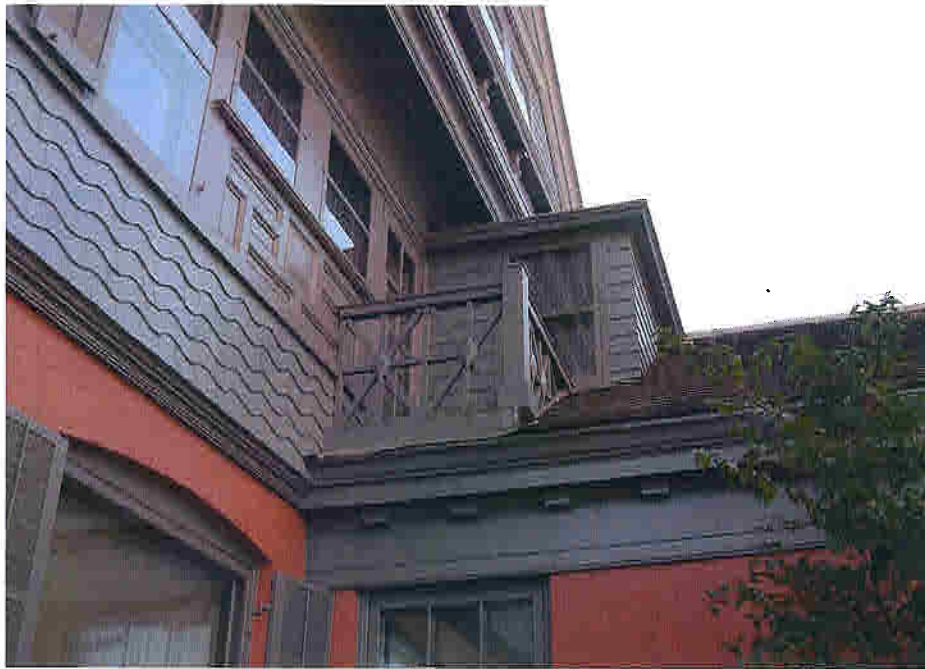
*Exterior 19. The wooden balcony on the second floor of the east elevation. The wooden railings are deteriorated and there is a great deal of algae growth on the roof shingles in this area. [JGWA, 2008]*

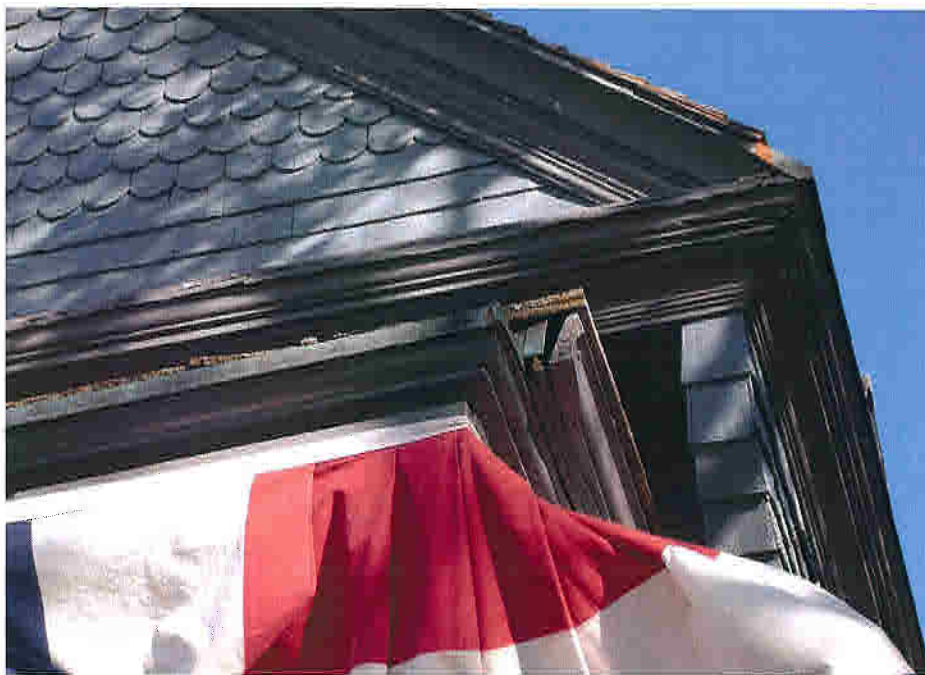
*Exterior 20. The southwestern corner of the wrap-around porch, showing open areas of trim and deteriorated roof shingles. [JGWA, 2008]*

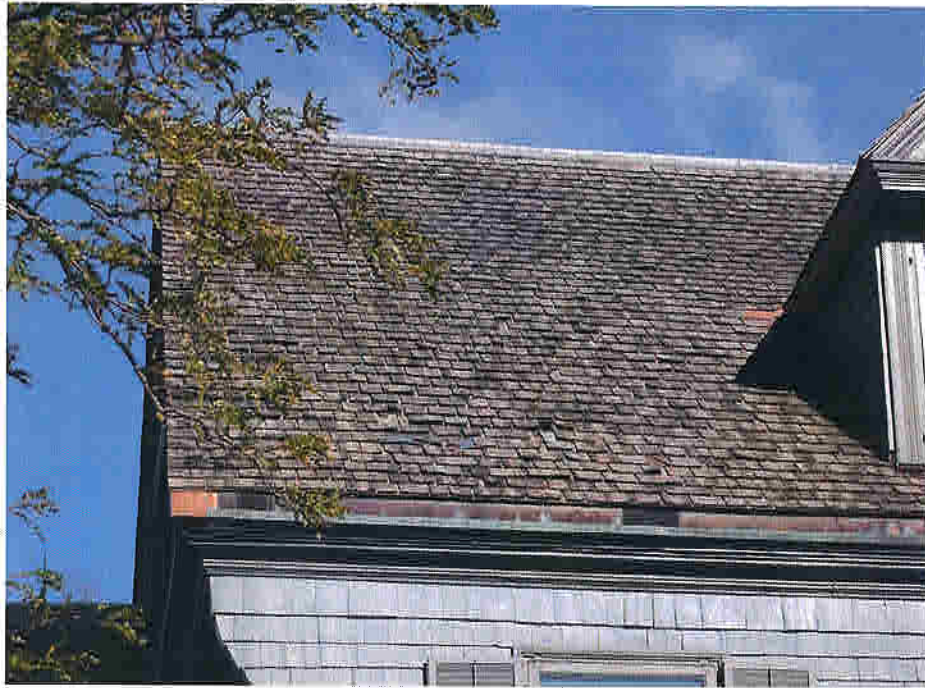
*Exterior 21. The southwest corner of the roof, showing missing and buckling shingles and scoured copper sheet metal wash at the end of the gutter. [JGWA, 2008]*

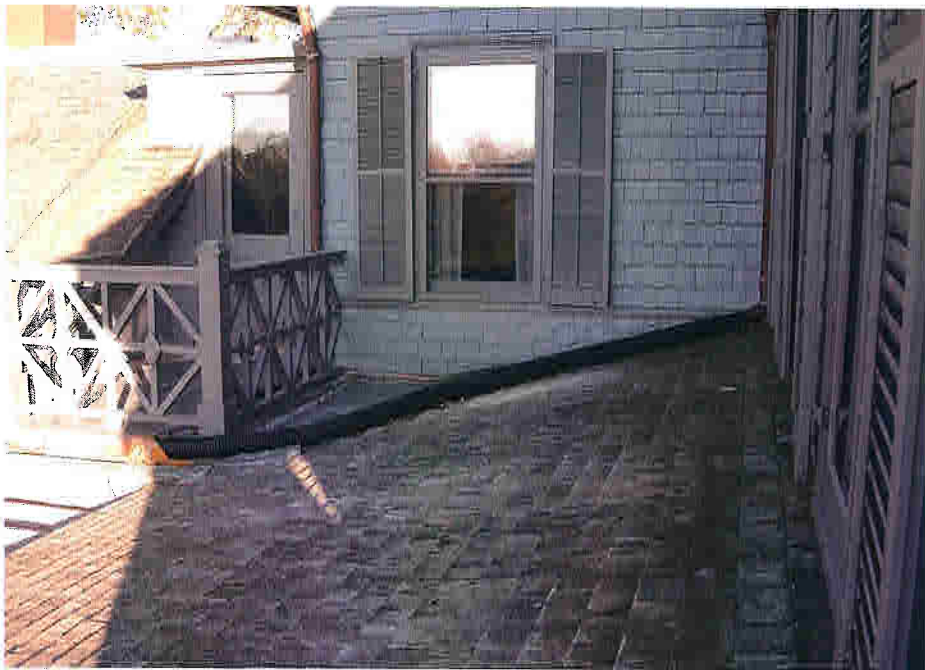
*Exterior 22. The northwest roof over the wrap-around porch, showing the improvised plastic tube to improve drainage. Also note the algae growth on the roofing shingles. [JGWA, 2008]*

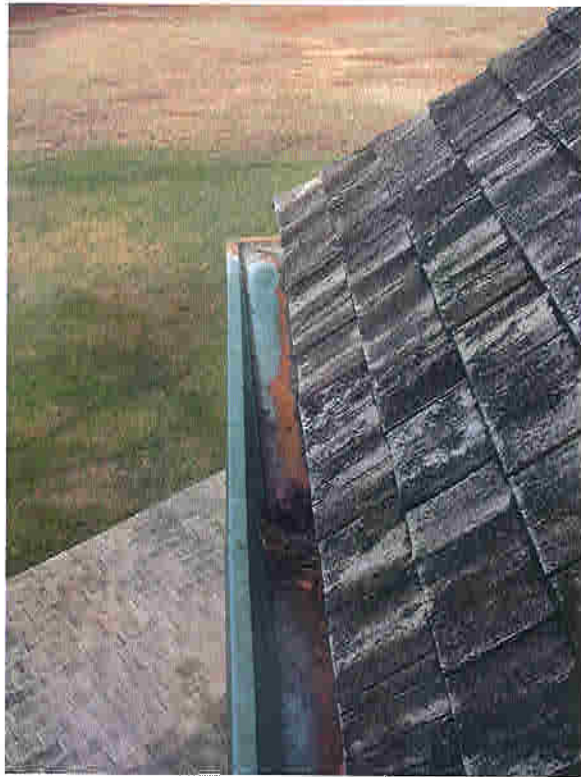
*Exterior 23. Detail of the roof off of the master bedroom balcony, showing the condition of the shingles, as well as the shallow depth of the gutters and the scouring of the copper sheet metal. [JGWA, 2008]*

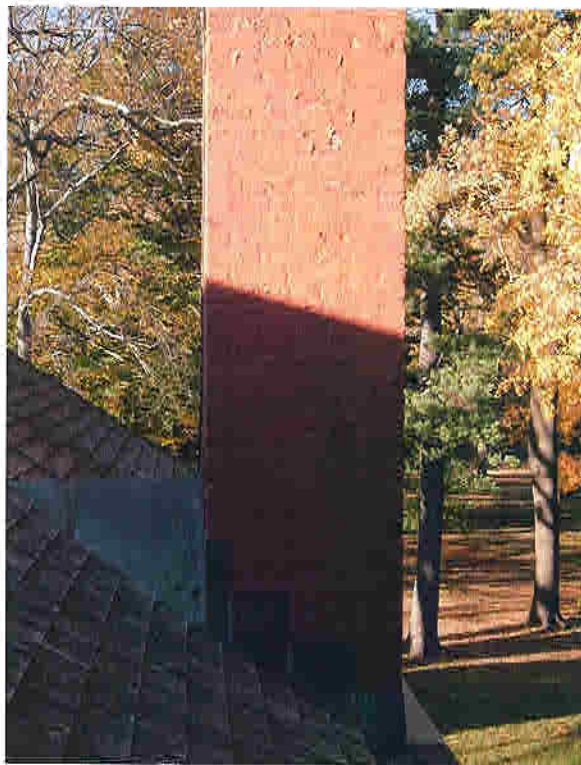
*Exterior 24. The south side of the Trophy Room chimney. Note the flaking and missing paint. [JGWA, 2008]*

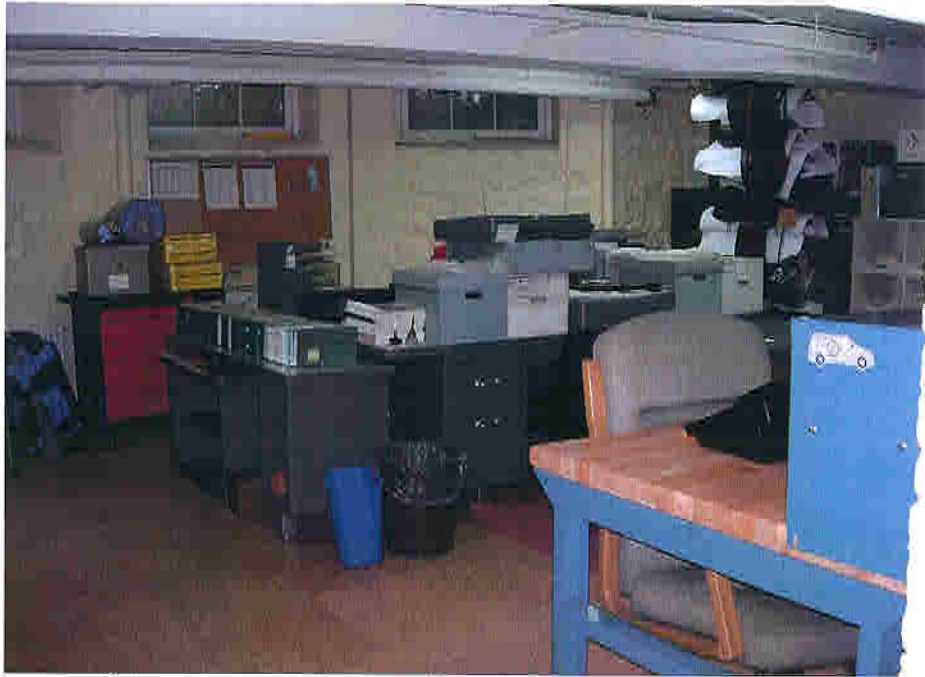
*Interior 1. Room 001. The exterior wall in the office area of the basement. The masonry wall is covered with waterproof paint but is showing signs of water damage. Areas of paint are beginning to deteriorate and, in some areas, are flaking off. [JGWA, 2008]*

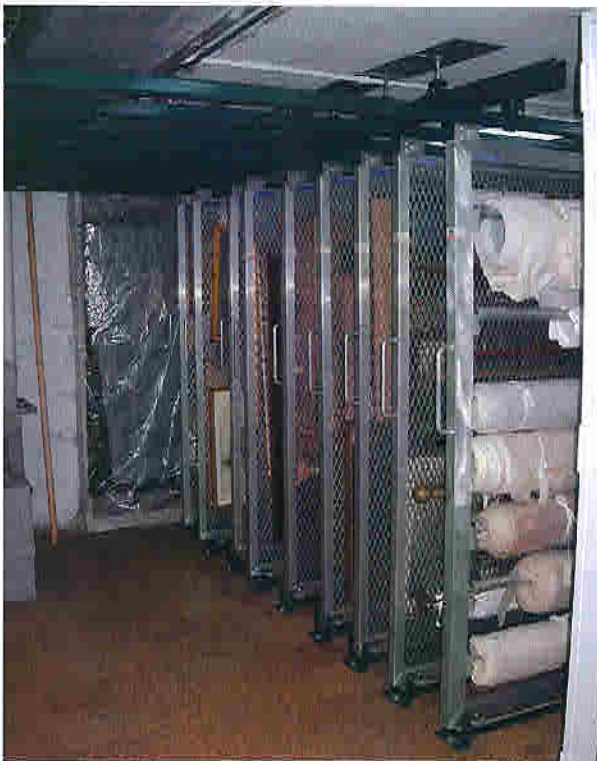
*Interior 2. Room 003, the collections storage area in the basement. Exterior masonry walls are showing evidence of water infiltration. [JGWA, 2008]*

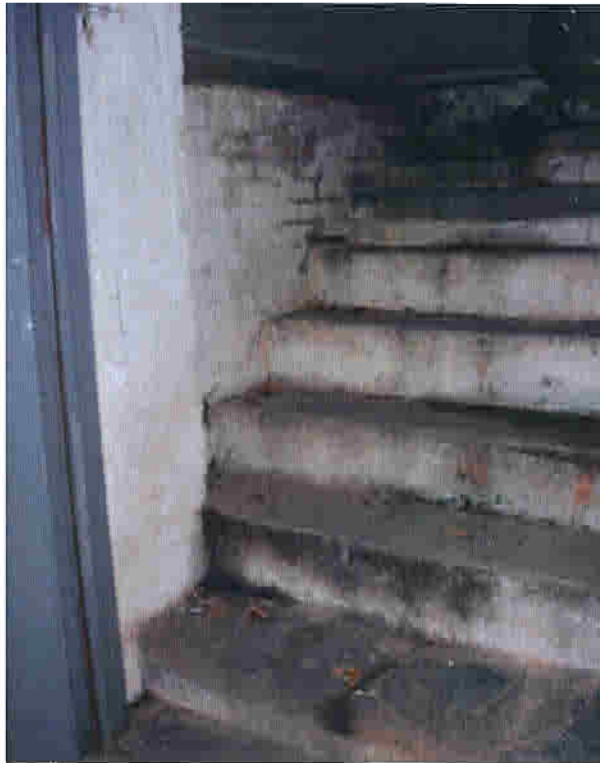
*Interior 3. The basement access stairs into Room 007. The brick foundation walls are beginning to spall and mortar is failing. Staining is clearly evident on the poured concrete stairs, and the wooden bulkhead is beginning to rot. The metal door frame is beginning to corrode. [JGWA, 2008]*

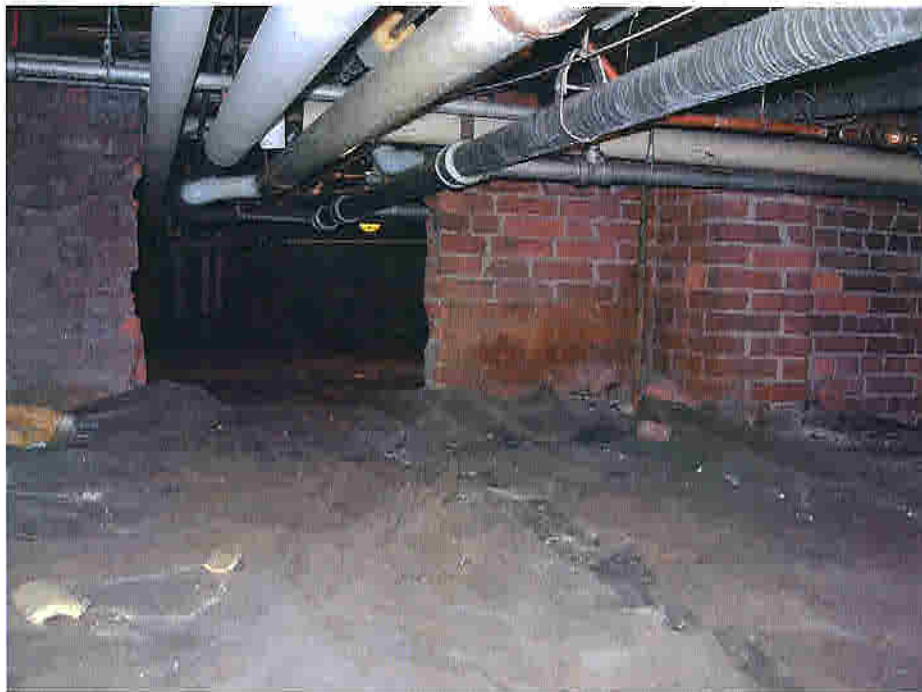
*Interior 4. Room 010, the unexcavated crawlspace. Plastic sheeting covers the dirt floor, however there is little evidence of water infiltration problems. [JGWA, 2008]*

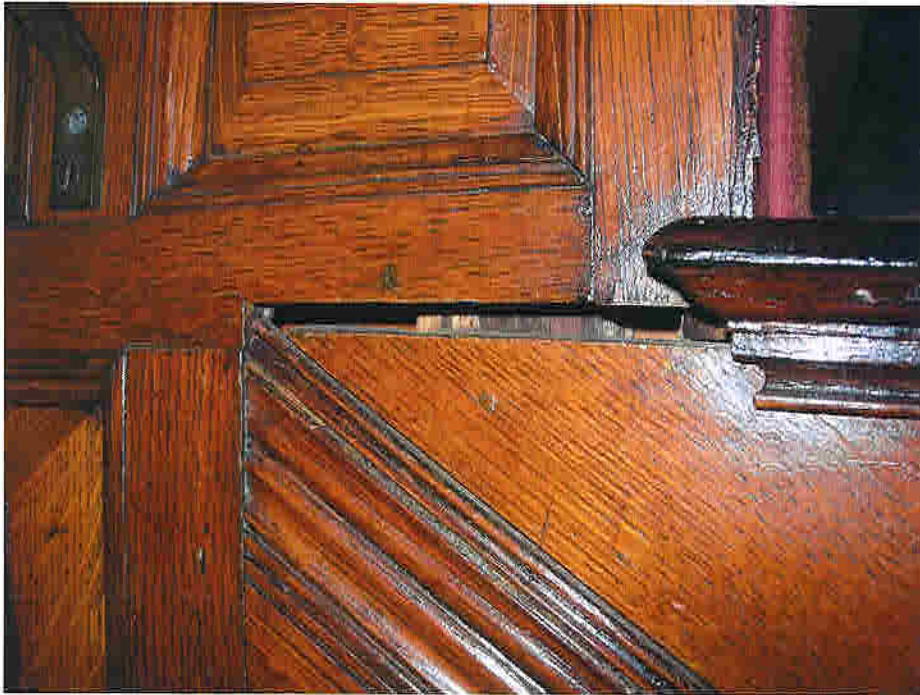
*Interior 6. A detail of the main stair. The weakened structure is evidenced in multiple locations by separation of the wood paneling. [JGWA, 2008]*

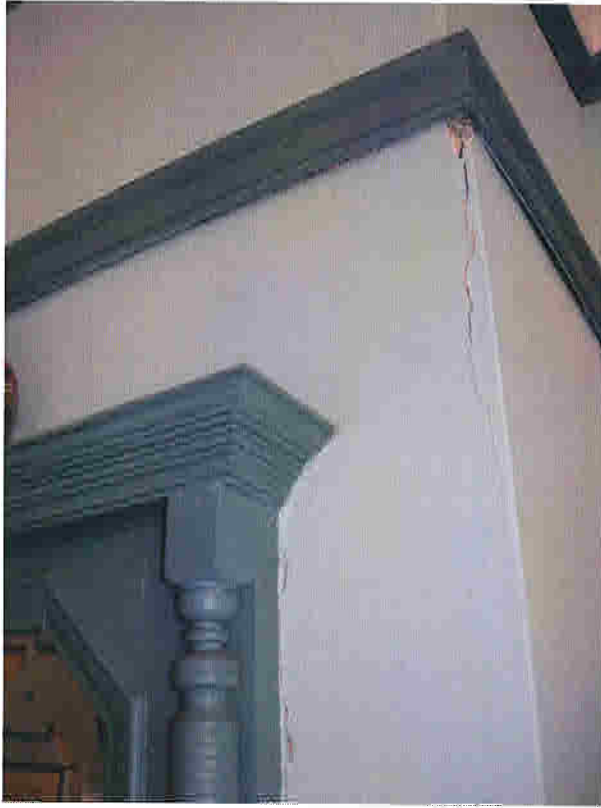
*Interior 7. Room 102, the "Drawing Room." Plaster cracking is visible, and the wood trim is separating from the wall around the fireplace. [JGWA, 2008]*

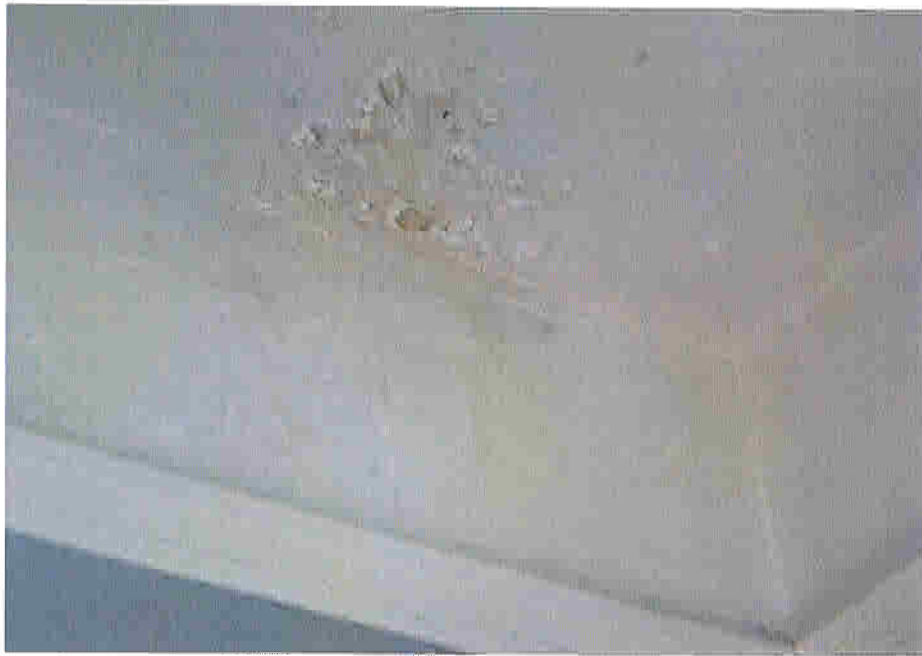
*Interior 8. Room 203, the "Gate Room," showing water-damaged plaster and paint peeling from the surface of the southwest wall and ceiling. [JGWA, 2008]*

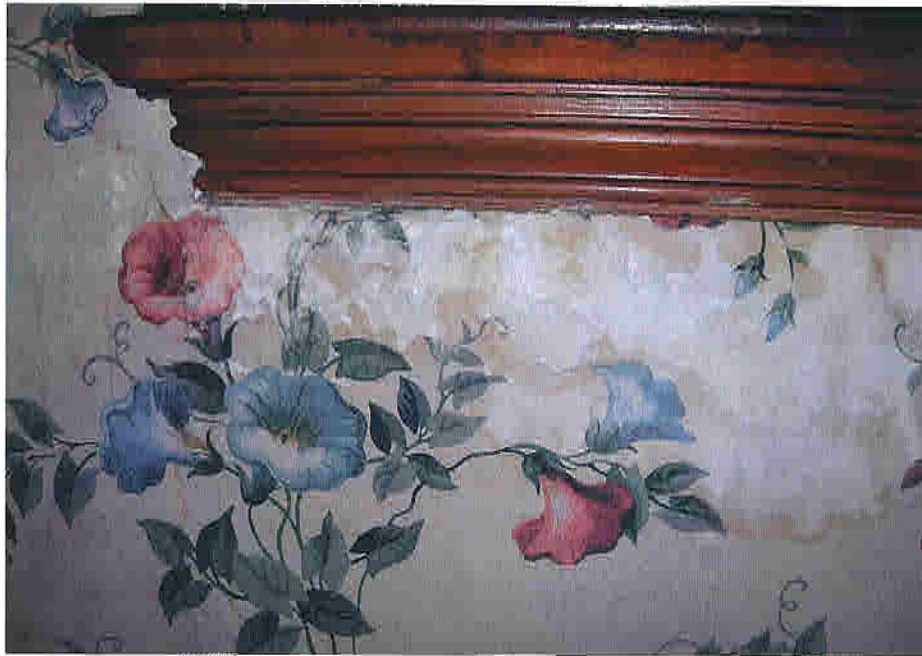
*Interior 9. Room 208, the "Double Guestroom." Evidence of water infiltration, water damaged plaster and stained wallpaper around the window and under the sill. [JGWA, 2008]*

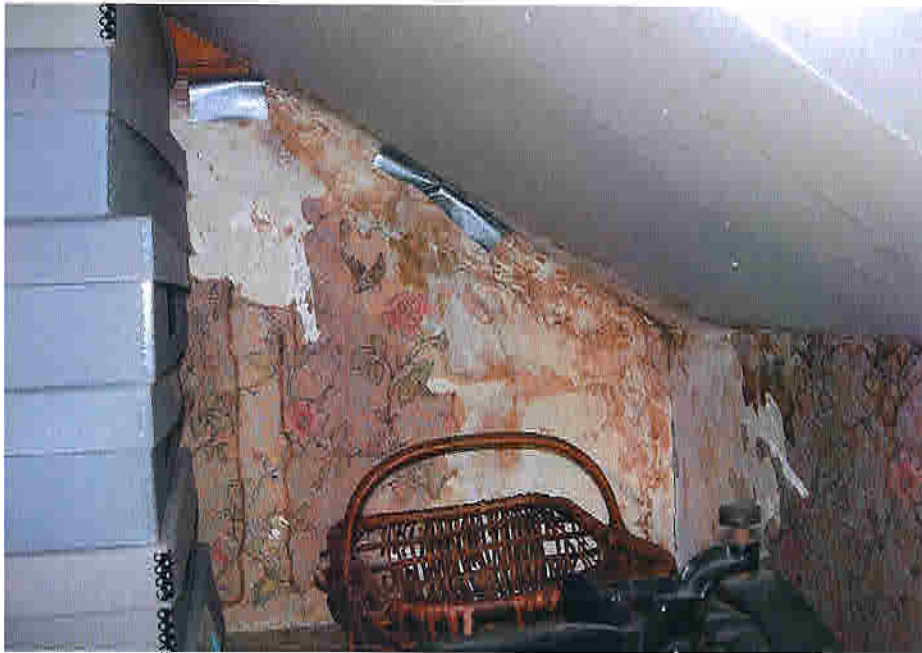
*Interior 10. Room 213, "Alice's Bedroom" closet. Extensive water damage on the northeast exterior wall and ceiling in storage area with deterioration of wallpaper and failing plaster. [JGWA, 2008]*

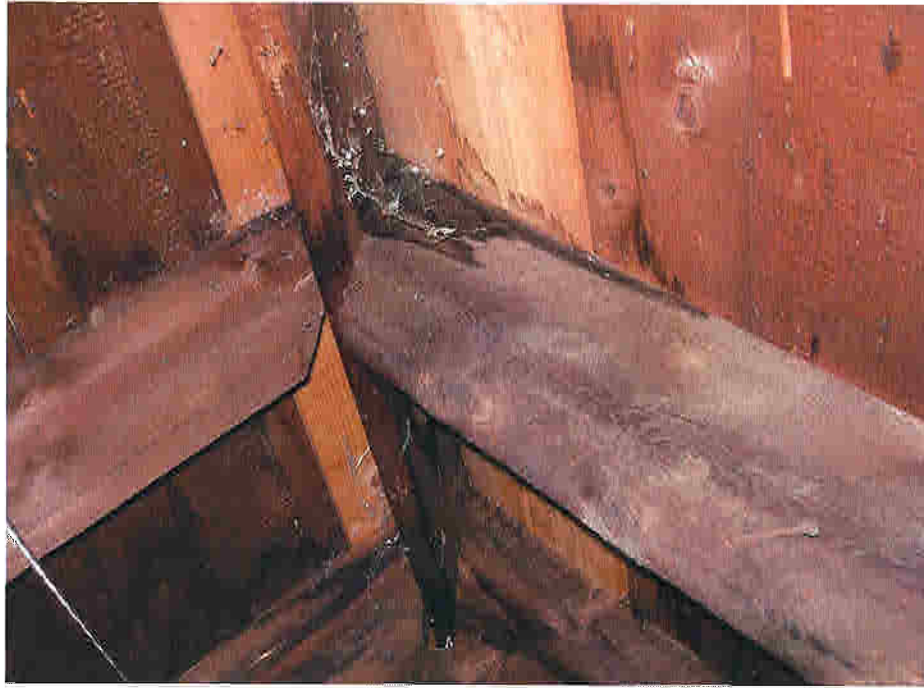
*Interior 11. The roof rafters in the attic. Water infiltration is evidenced by brown staining on the areas of contemporary (lighter) and original (darker) wood sheathing. [JGWA, 2008]*
