Existing Conditions

Introduction

This chapter describes through narrative text, contemporary photographs, labeled base mapping, and analytical diagrams, the current conditions and extant landscape features associated with the Vicksburg National Military Park landscape. The first section—Environmental and Cultural Context and Setting—describes the battlefield within a regional and local context, including hydrological, geographical, and geological features, as well as the demographics and other traits that characterize the park’s contemporary setting and surrounding community. The second section—Site Description—describes the primary organizing elements and features that characterize the Vicksburg National Military Park landscape, including former park lands quitclaimed to the City of Vicksburg and Warren County in the 1960s. The third section—Landscape Description by Characteristic—depicts the individual extant landscape features and resources that together compose the Vicksburg National Military Park battlefield landscape. (See Fig. 7 and Fig. 8 for site location and context and study area boundary maps.)

The physical condition of the primary features described herein has been

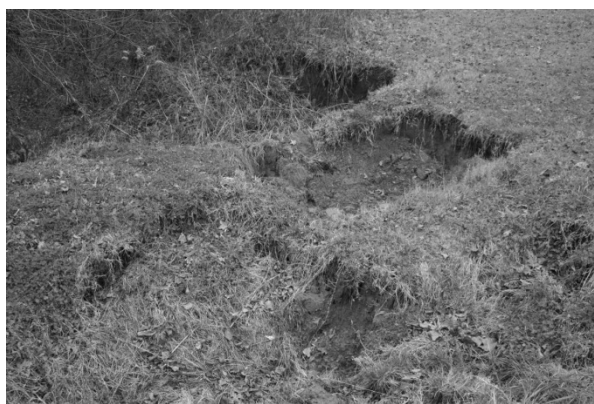
FIGURE 62. Example of erosion of the local loess soils, south of the walkway leading to the Stockade Redan Attack tour stop.

Over millennia, runoff water carved out deep ravines in all directions. The slopes dropping into the ravines are quite steep in many places.¹⁵⁰ The current condition of the park bluffs ranges from fair to good.

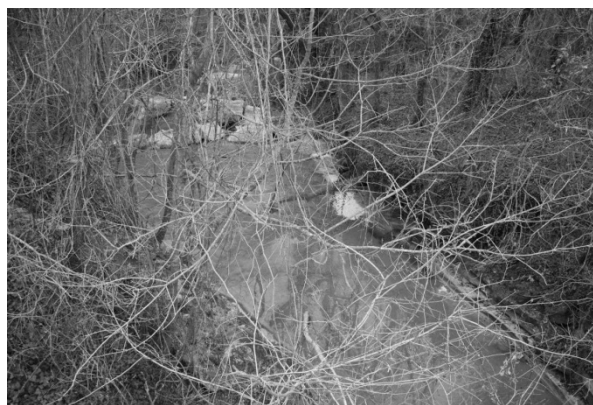
temperatures in Mint Spring Bayou (Fig. 63).¹⁵⁵ Currently, “restoration of Mint Spring Bayou [is] recommended to aid in re-introduction of native fish species, currently deficient due to invasion of a fathead minnow population, and depletion of streamside vegetation.”¹⁵⁶

FIGURE 63. Looking west and down at Mint Spring Bayou from the Connecting Avenue bridge between Vicksburg National Cemetery and Fort Hill; recent studies have been tracking sedimentation in the streams of the park.

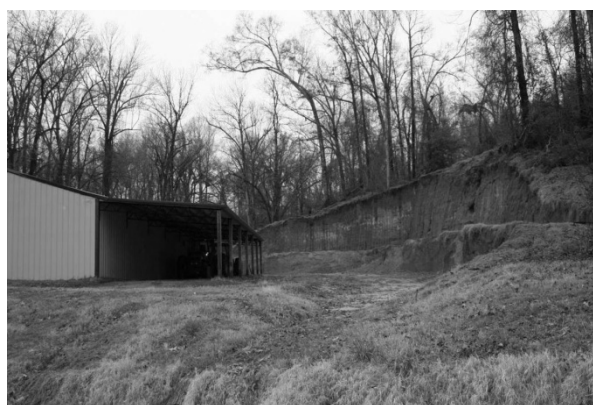
Today, the park continues to experience problems with sinkholes, cave-ins, and erosion (Fig. 73). A borrow pit behind the maintenance area is sometimes utilized to obtain material for repair of erosion problems (Fig. 74).

FIGURE 74. A borrow pit behind the maintenance complex, north of the visitor center, from which fill is used to repair erosion, an ongoing maintenance concern at the park.

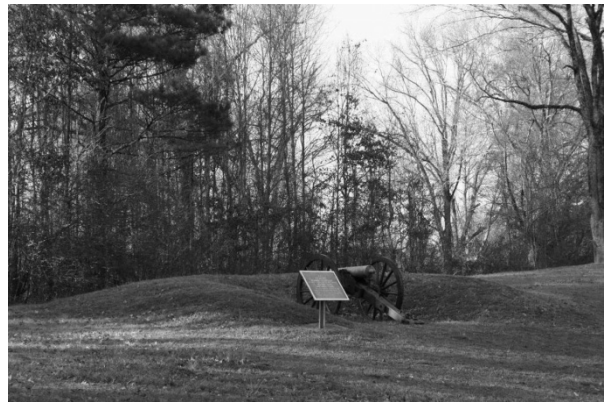
FIGURE 76. A cannon sitting into woodland, an example of how current vegetation is not consistent with historic conditions. There are many such examples within the park; this particular cannon is on Union Avenue, just south of Pemberton Avenue. This view is looking northwest.

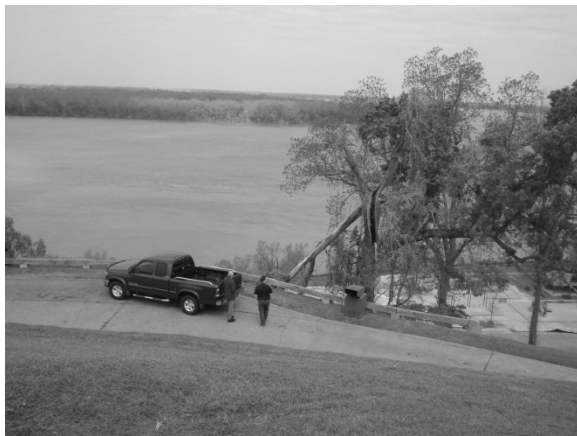
FIGURE 145. Vehicular parking at Louisiana Circle occurs where the road flares to accommodate up to three parallel-parked cars along its outer margin. The large deciduous tree was damaged in a storm and needs to be removed.

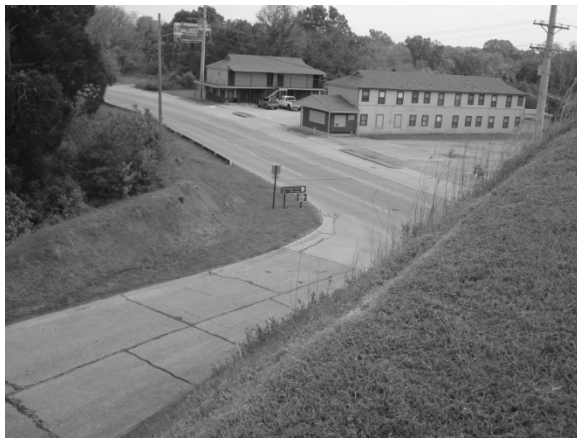
FIGURE 151. The concrete paving at Louisiana Circle that is cracked has been patched with a black asphaltic material that contrasts with the color of the paving.

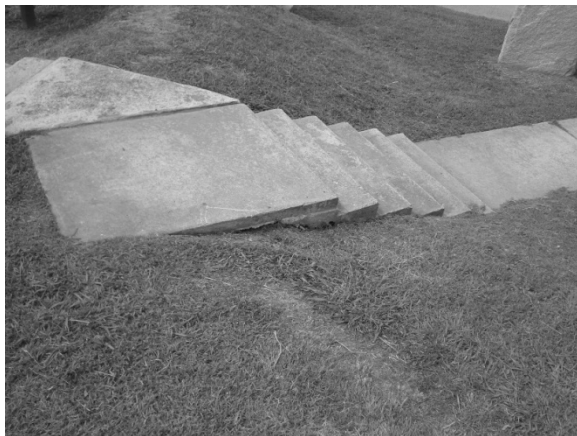
FIGURE 152. The upper walkway at Louisiana Circle includes a trip hazard near the approach to the cannon. Social trails are worn in the turf grass where visitors walk beyond the available path to reach the top of the knoll.

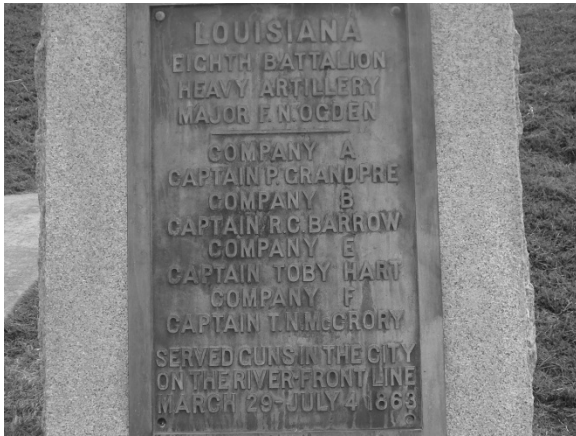
FIGURE 154. The bronze plaques at Louisiana Circle set within the granite markers are stained and need cleaning.

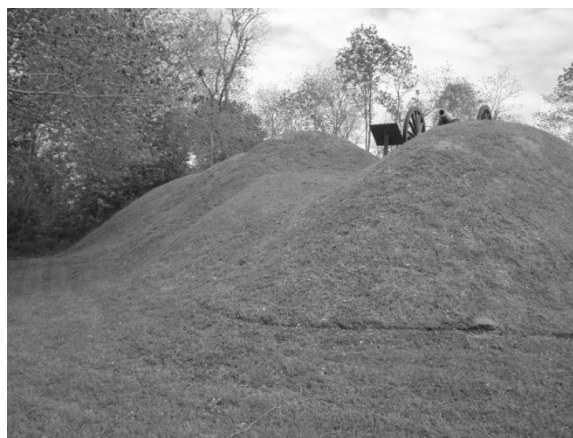
FIGURE 162. The parapet walls of the fortification at South Fort remain in good condition and retain a strong profile.

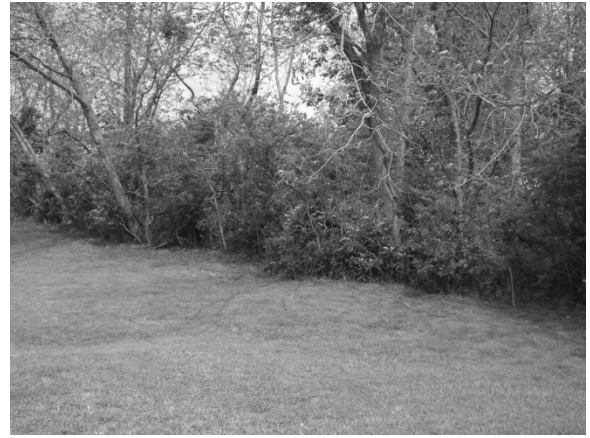
FIGURE 167. Woody vegetation occupying the margins of the parcel below the fortification's parapet walls obscures views of the river from South Fort.

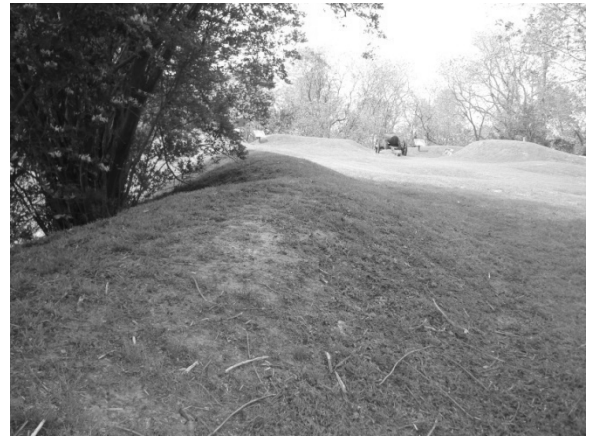
FIGURE 168. There are bald spots in the turf grass on the earthen fortification at South Fort that may lead to erosion.

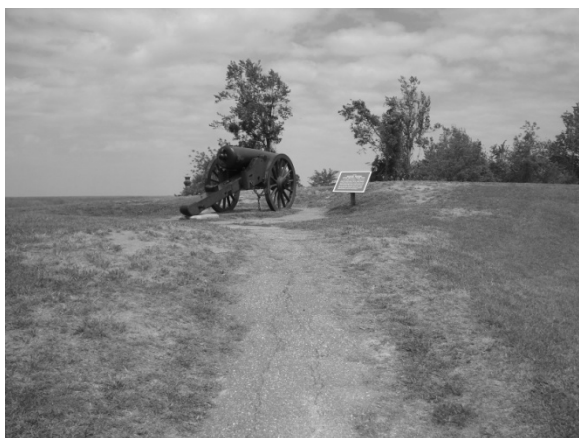
FIGURE 177. An asphalt walk leads from the stairs at Navy Circle to a paved area encircling an artillery piece. There are bald spots in the turf grass in the vicinity of the walk; this condition may lead to erosion.

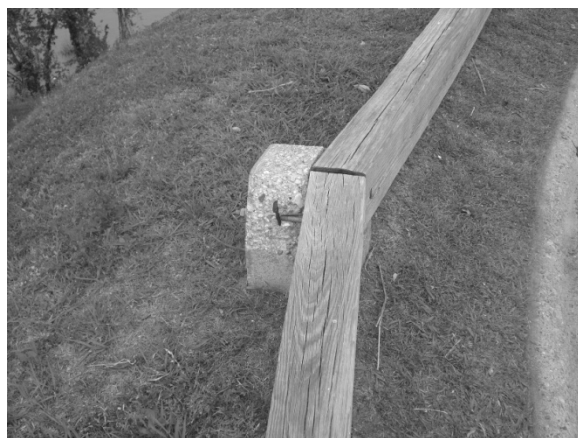
FIGURE 180. Portions of the timber guard rail along the Navy Circle access road have been damaged by cars.

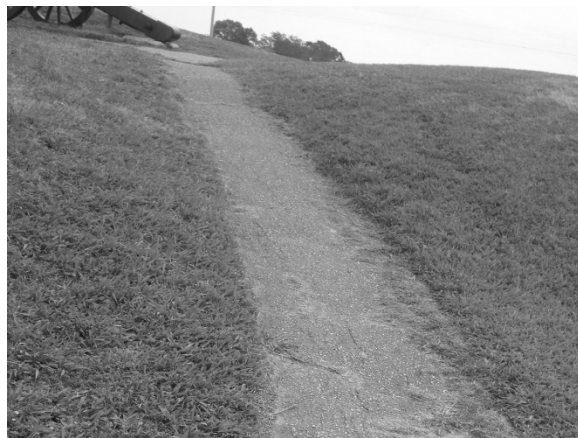
FIGURE 181. The asphalt on the walk leading to the top of the fortification at Navy Circle is cracking.
