## Replace Damaged Bench Slats with Composite Material Chancellorsville Visitor Center

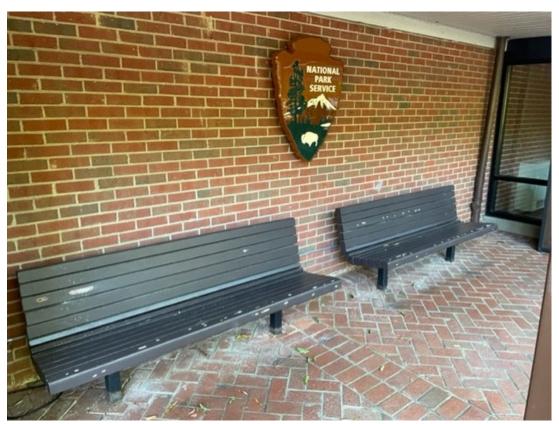
The two benches outside the main entrance and under the porch overhang show extensive carpenter bee/woodpecker damage on multiple wooden slats.

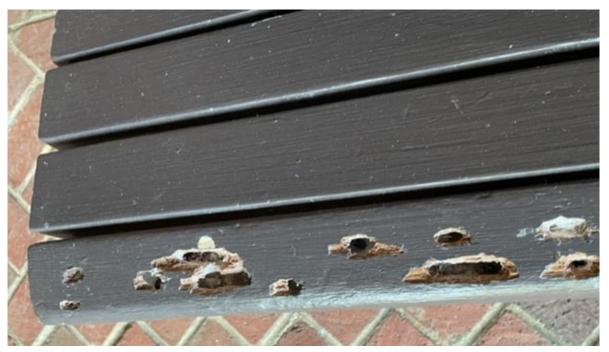
A close-up of the damage.

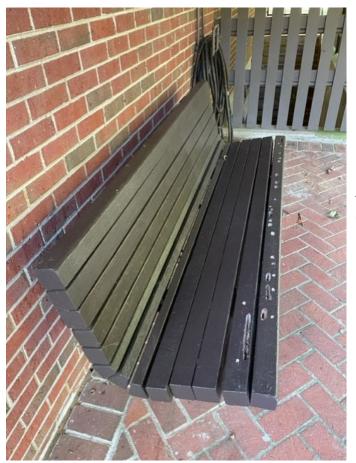
A stand-alone bench near the basement stairs also showing extensive damage.
