Clara Barton National Historic Site Conditions Assessment

Final Submittal

November 27, 2018

Contract No. P14PC00202
Order No: 140P3018F0013
AECOM Project No.60562621

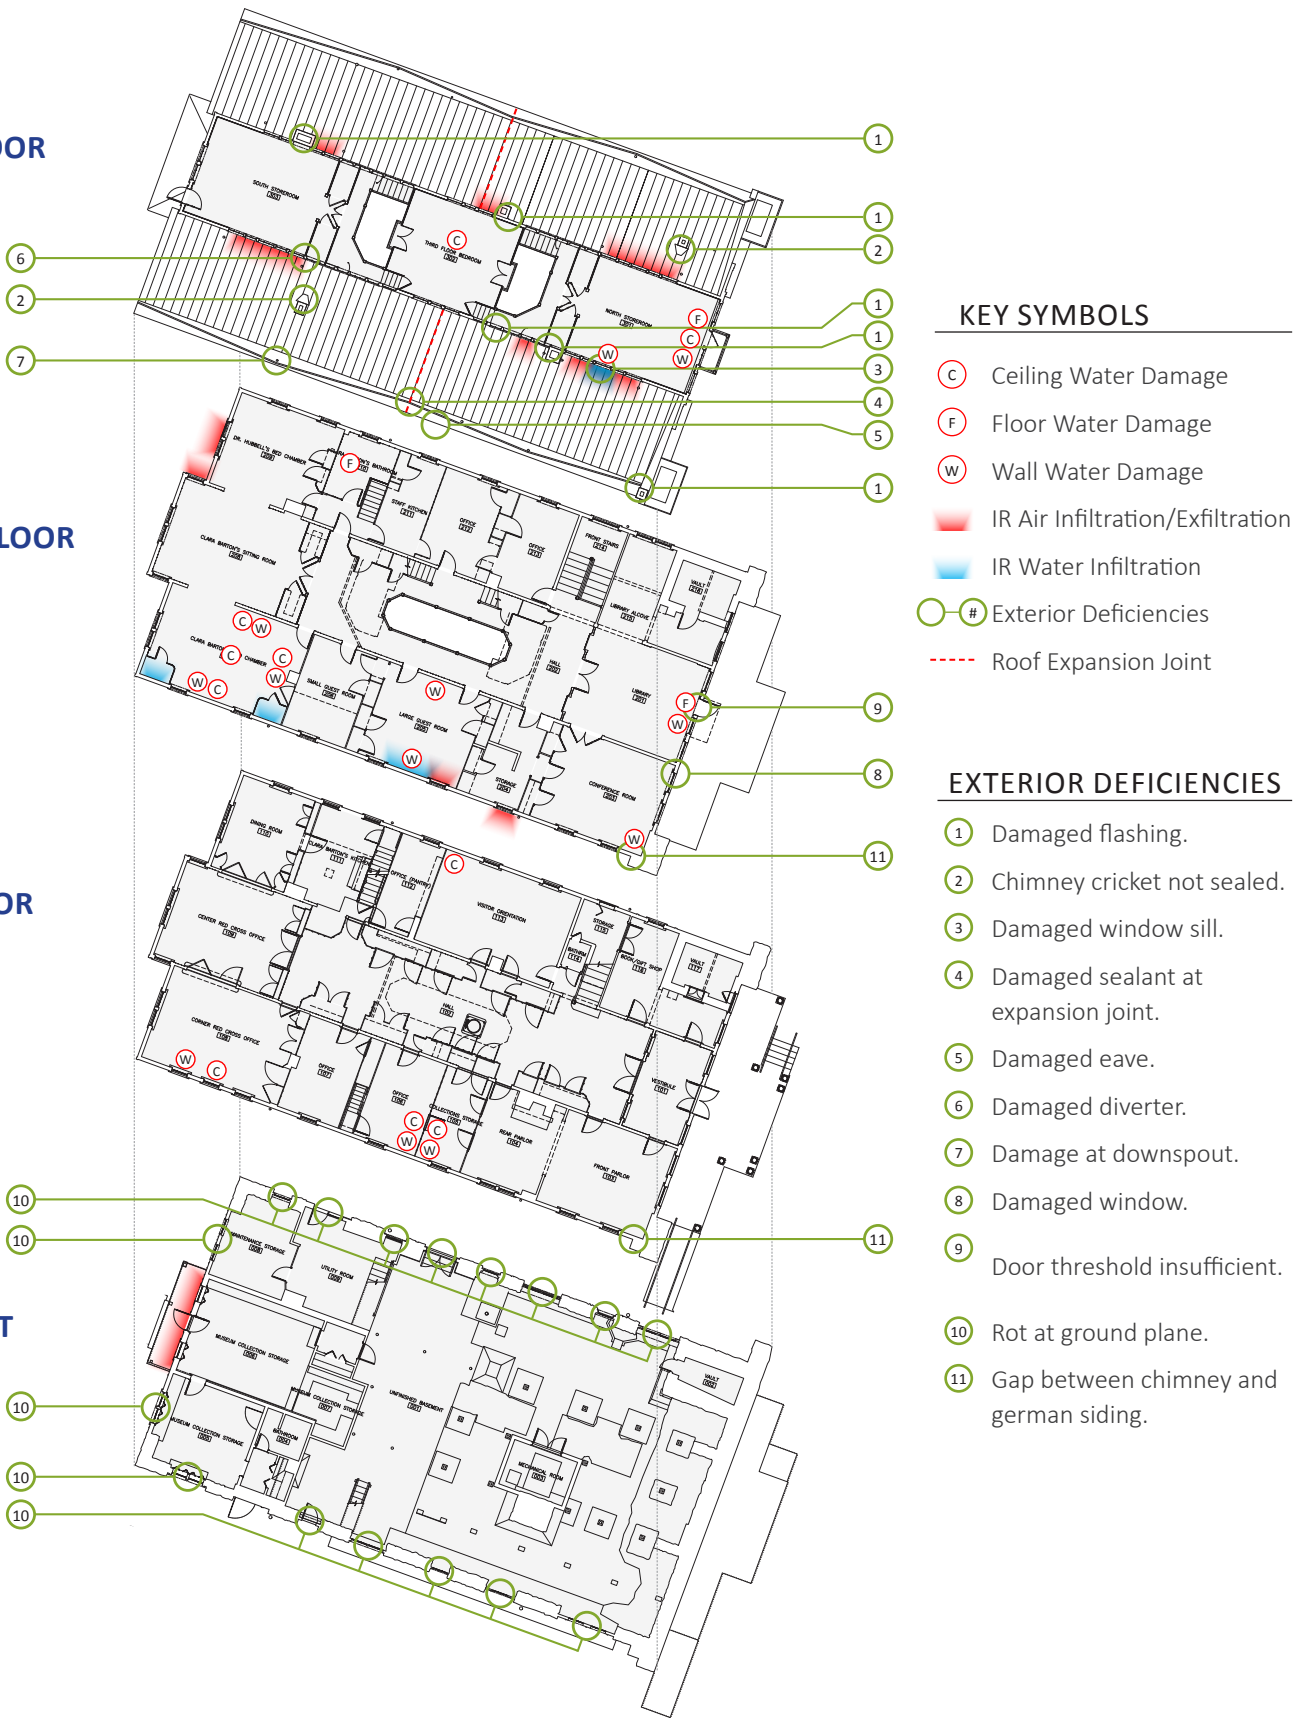
Figure 3.2 Water Damage Diagram (for enlarged diagrams, refer to Appendix)

There is water damage in the center of the ceiling, where the structural support for the flag pole is located. After the installation of the new flagpole, the roof membrane became damaged due to the constant movement of the new structure. There is visible staining in the bracing members and the cloth wall application is pulling away from the wall structure (Refer to Section 3.2 for structural analysis.

There is visible staining on the north wall, running along the bottom of the ceiling and on the south wall. It appears as though water is entering from above the north wall and running towards the lowest point. It is moving along the bottom of the ceiling joists and pooling at the south wall. The path of this water appears to continue down to the Corner Red Cross Office [108] below as staining is present at the ceiling and wall at the same location.

The water infiltration could be due to the damaged diverter above this location on the upper roof or due to the poor condition of the windows located on the southern wall of the South Storeroom [303]. A lack of moisture was noted indicating that this issue may have been resolved by the installation of the new lower roof.

On the south wall, visible staining and moisture is present. Additionally, the thermal imaging scan discovered active water infiltration at this location. Water moves from the ceiling, down the wall and pools at the horizontal framing in the center of the wall. It then proceeds to move towards the floor passing through to the Office [107] and Collections Storage [105] below. There is slight staining at the north wall but moisture is not present. Due to the recent restoration of the walls, any historic water movement is not present and movement from the north wall to the south wall could not be determined.

The water infiltration is likely caused by the roof expansion joint above. This joint occurs at a low point on the roof, allowing for water to pond at this location. The sealant is cracked and peeling. This allows water to penetrate the roof membrane and enter the wall cavity below. Additionally, there is damage to the eave outside of this room. This could allow water to penetrate the building envelope and allow water to move down the walls.

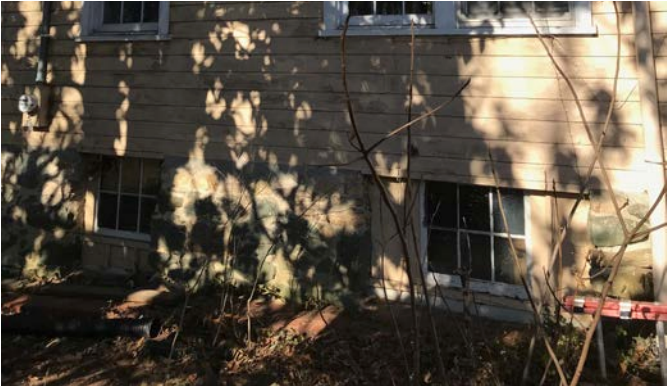
W0.3 AND W0.4 Water Infiltration and Rot at Ground Plane

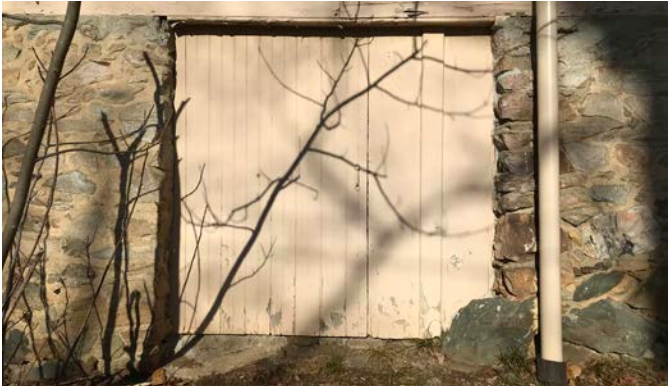
D0.2 Water Infiltration and Rot at Ground Plane. Peeling Paint.

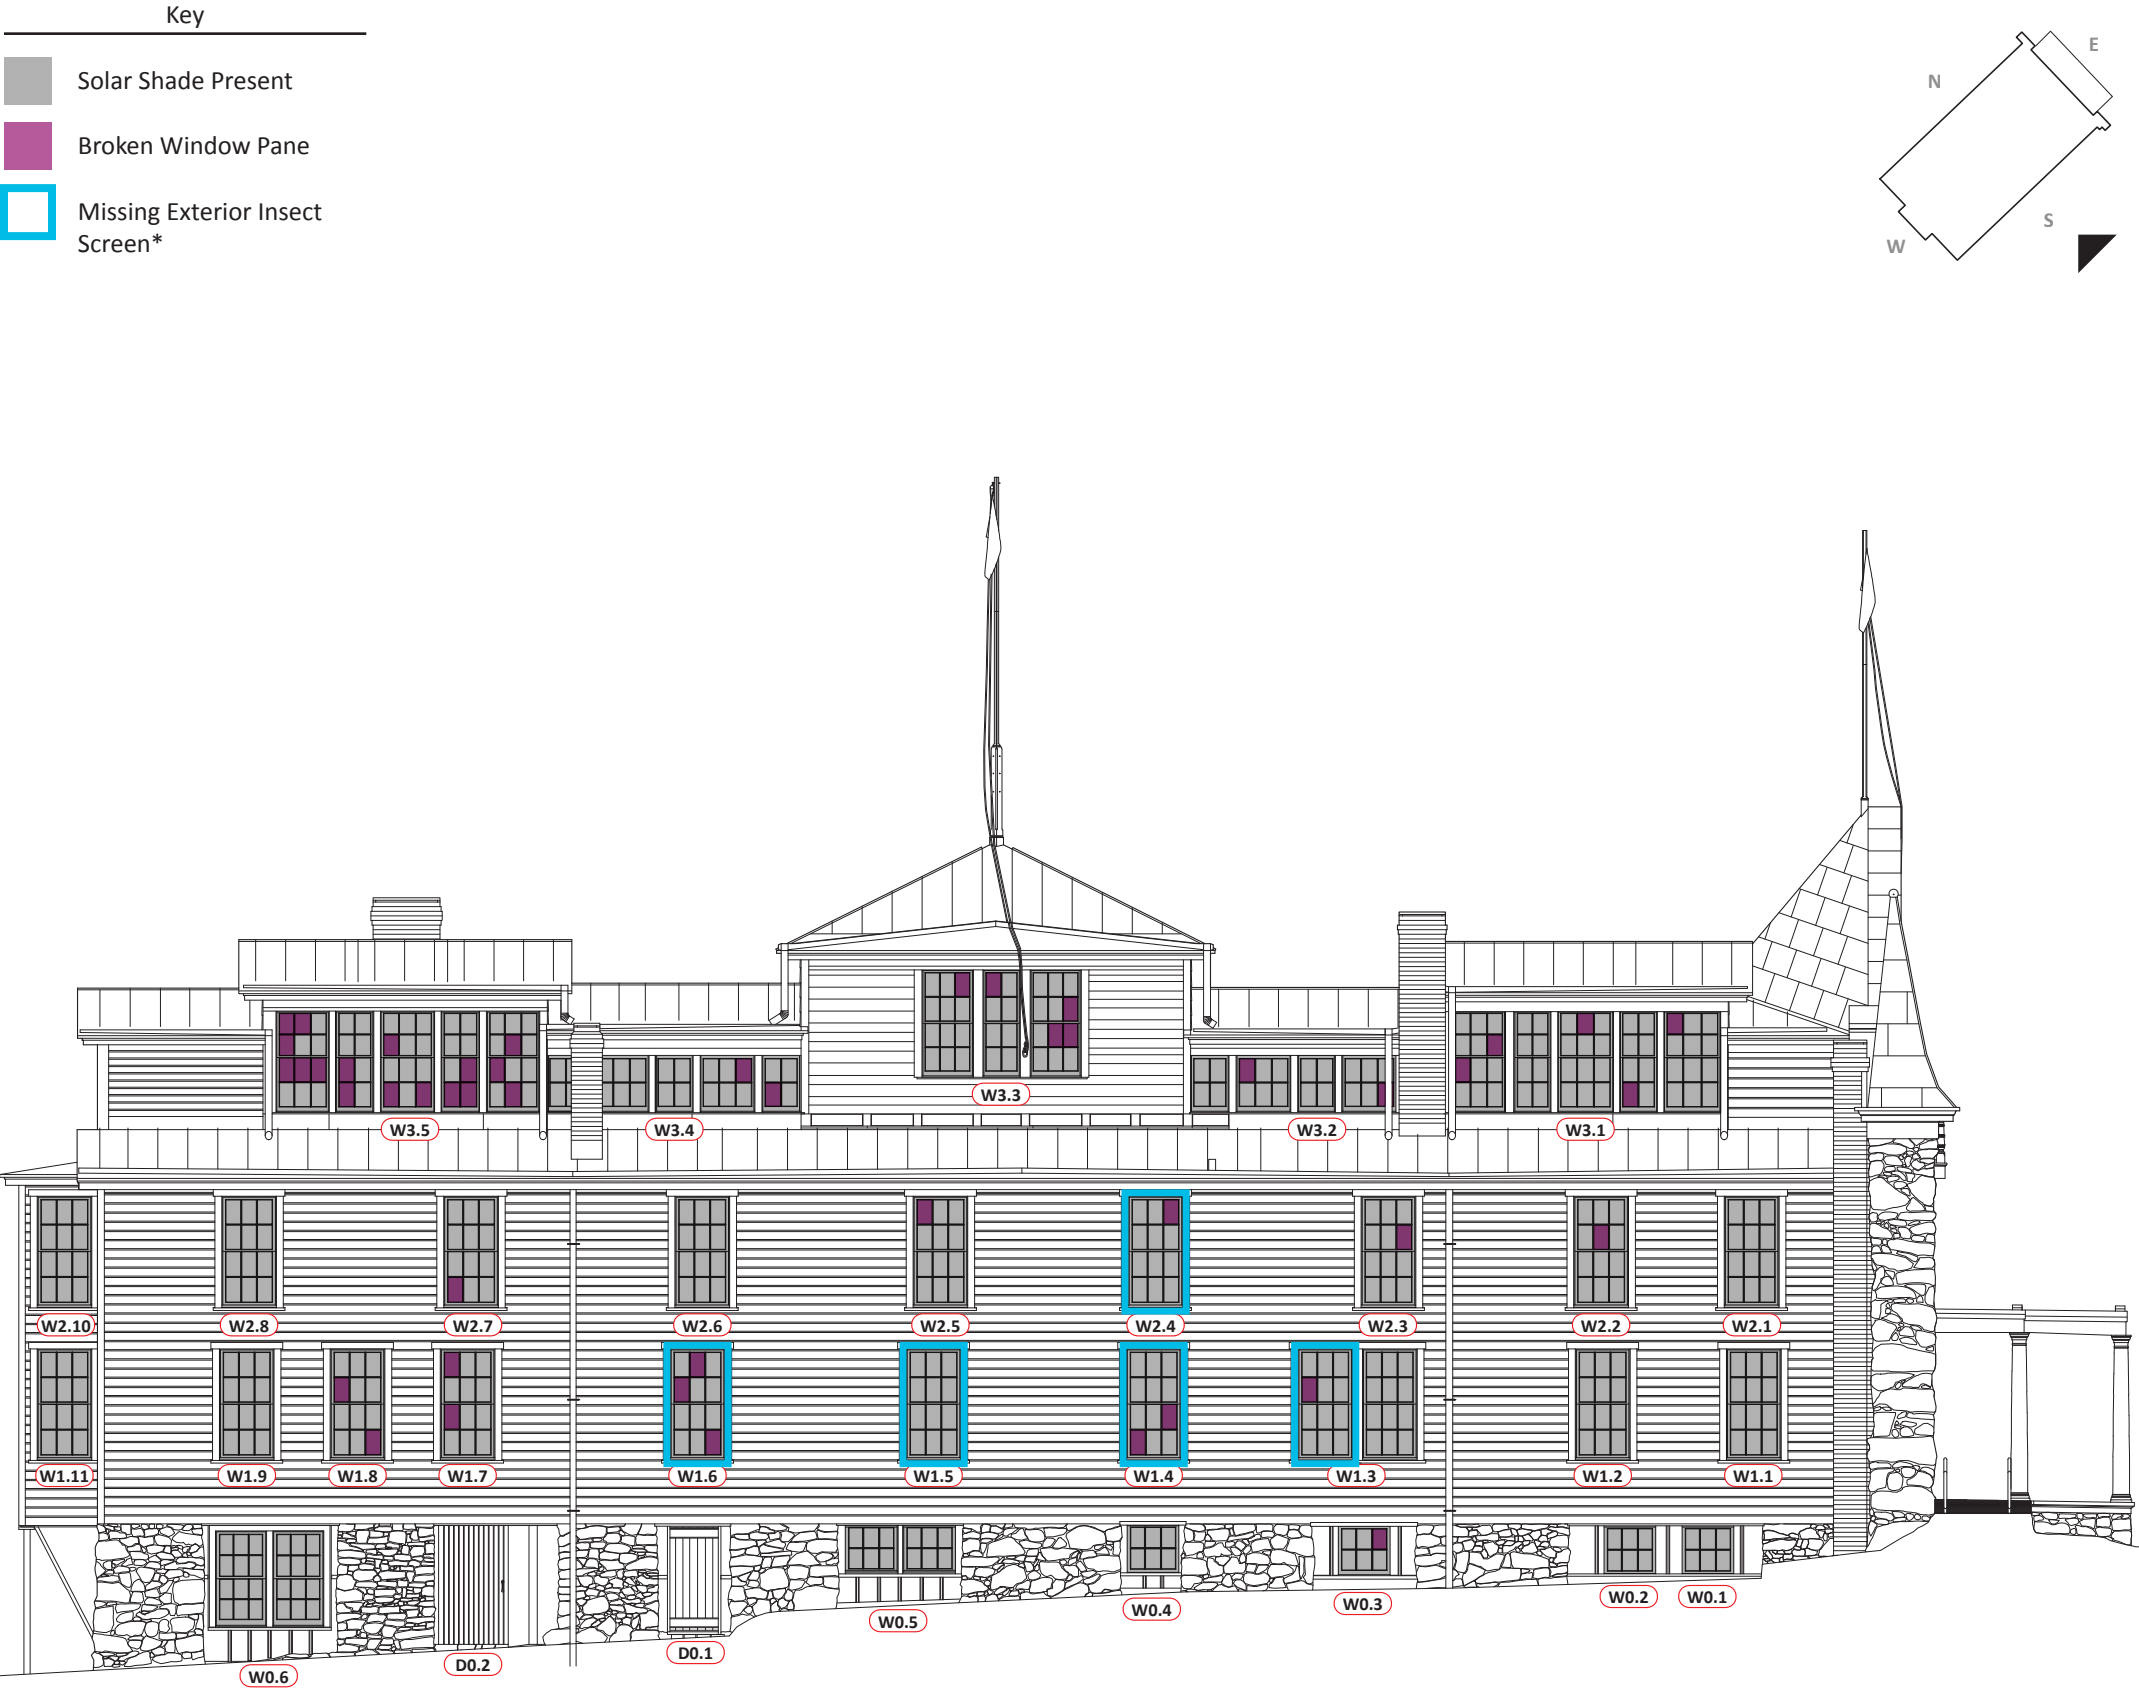
Figure 3.4 South Elevation Window and Door Assessment

SOUTH FAÇADE												
	Flaking Paint	Deteriorated Sill / Threshold	Deteriorated Frame	Missing Sealant	Deteriorated Mullion	Broken Glass Panes (ref. elevations)	Glazing Compound missing	Double Hung Sash Cord broken	Weather stripping Interfers with operation	Air infiltration	Water ingress	Inoperable
W0.1	X	X		X							X	X
W0.2	X			X			X			X	X	X
W0.3	X			X		X	X				X	X
W0.4	X		X	X			X				X	X
W0.5	X						X				X	X
W0.6	X						X				X	X
W1.1	X											
W1.2	X											
W1.3	X					X				X		
W1.4	X			X		X				X		
W1.5	X			X						X		
W1.6	X			X		X				X		
W1.7	X					X						
W1.8	X					X						
W1.9	X	X	X	X			X					
W1.11	X			X		X						
W2.1	X											
W2.2	X					X						
W2.3	X					X		X				
W2.4	X					X		X				
W2.5	X											
W2.6	X											
W2.7	X					X						
W2.8	X							X				
W2.10	X		X									
W3.1	X					X	X					
W3.2	X					X	X					
W3.3	X		X			X	X					
W3.4	X					X	X					
W3.5	X					X	X					
D0.1	X	X	X	X							X	
D0.2	X	X	X	X							X

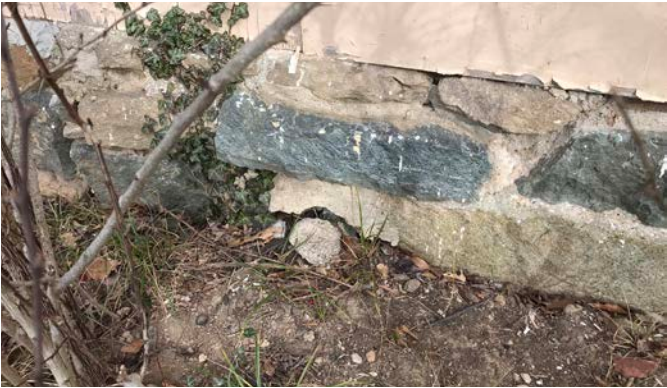
Damaged Masonry

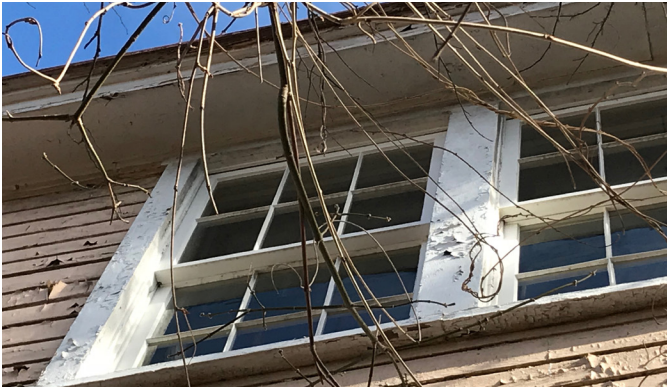
W2.13 Peeling Paint

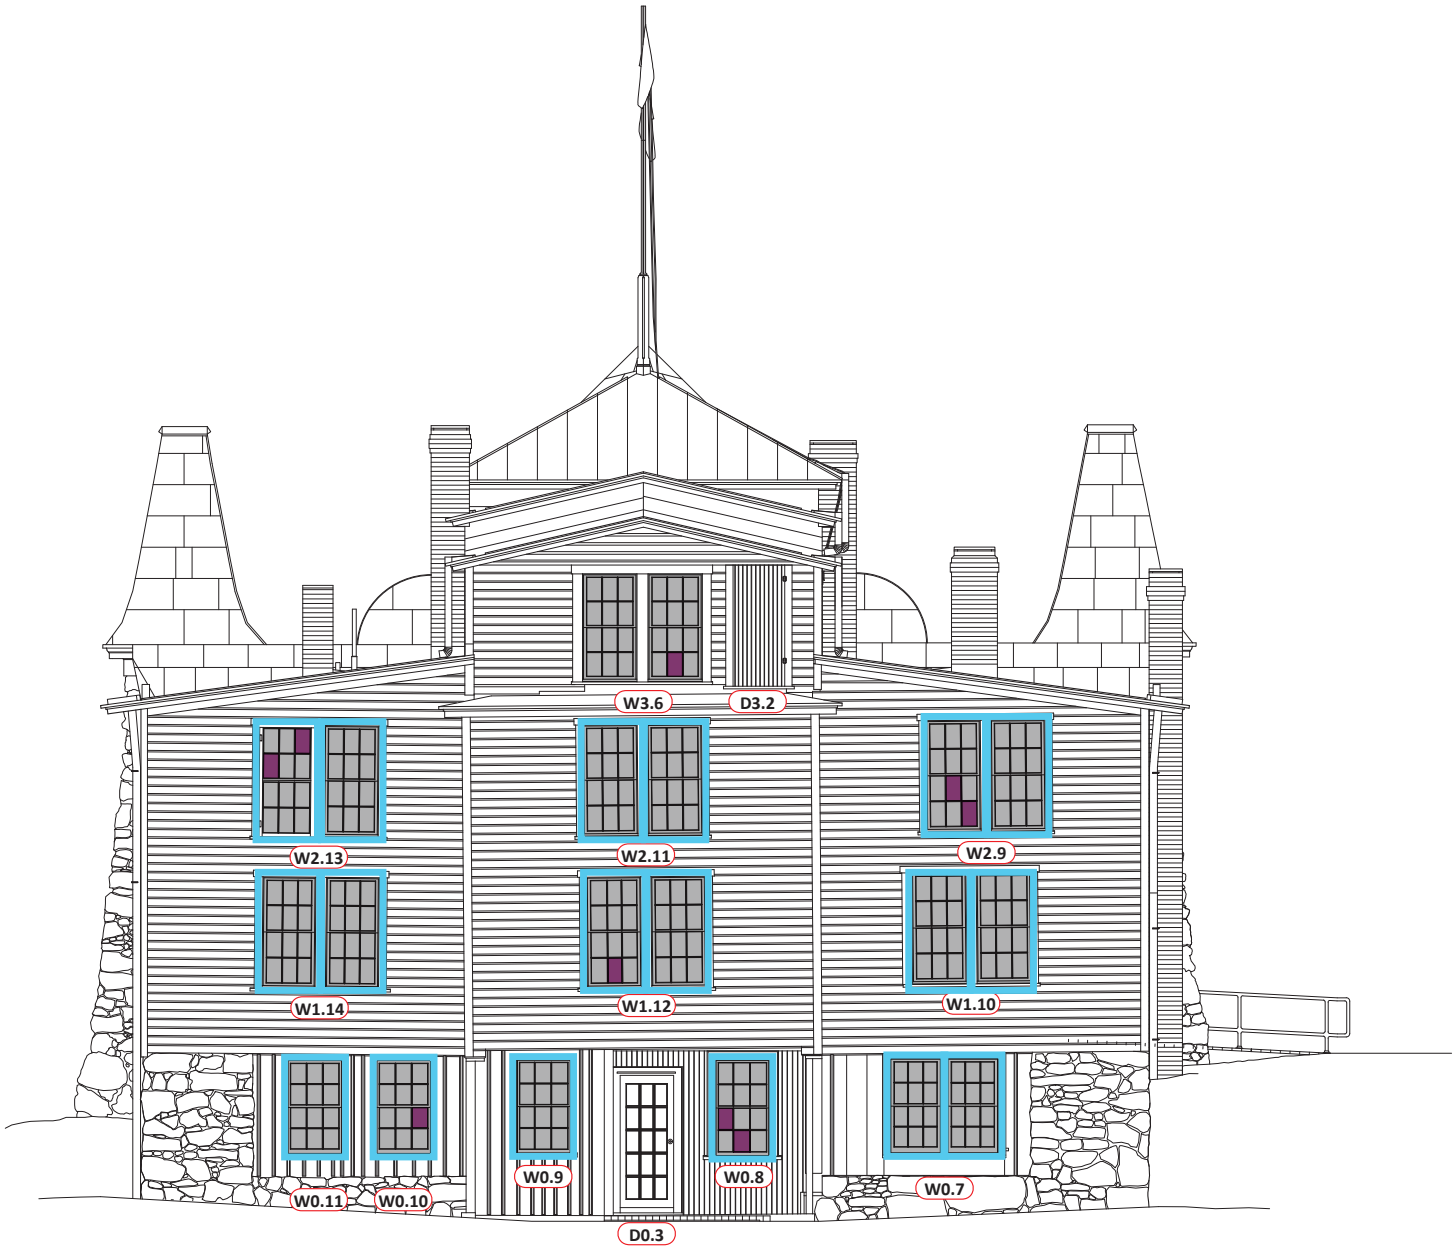
Figure 3.6 West Elevation Window and Door Assessment

WEST FAÇADE											
	Flaking Paint	Deteriorated Sill / Threshold	Deteriorated Frame	Missing Sealant	Deteriorated Mullion	Broken Glass Panes (ref. elevations)	Glazing Compound missing	Double Hung Sash Cord broken	Weather stripping Interfers with operation	Air infiltration	Water ingress
W0.7	X						X				
W0.8	X					X	X			X	
W0.9	X						X				
W0.10	X					X	X				X
W0.11	X										X
W1.10	X										
W1.12	X					X	X				
W1.14	X			X			X				
W2.9	X						X	X			
W2.11	X										
W2.13	X			X			X				X
W3.6	X					X	X				
D0.3	X										
D3.2	X										X

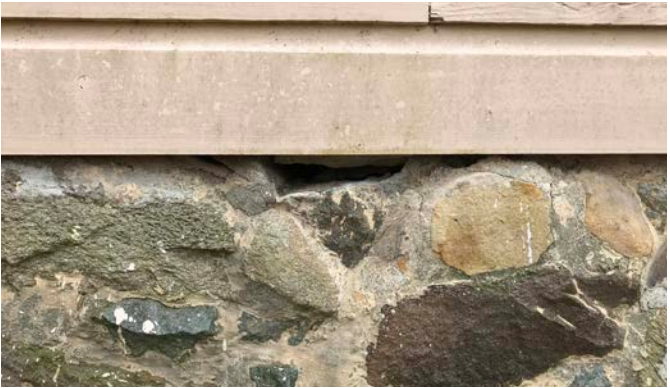
Damaged Masonry

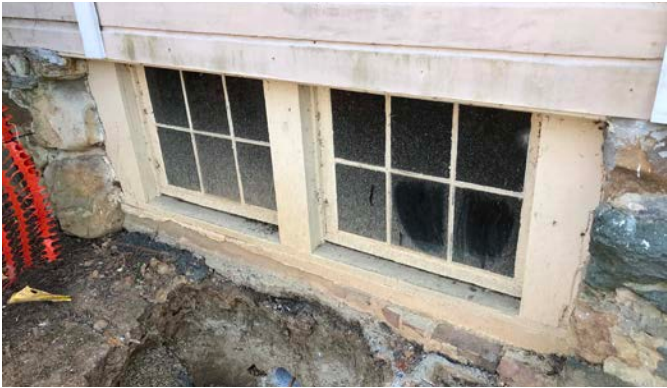
W0.17 Rotting at Ground Plane

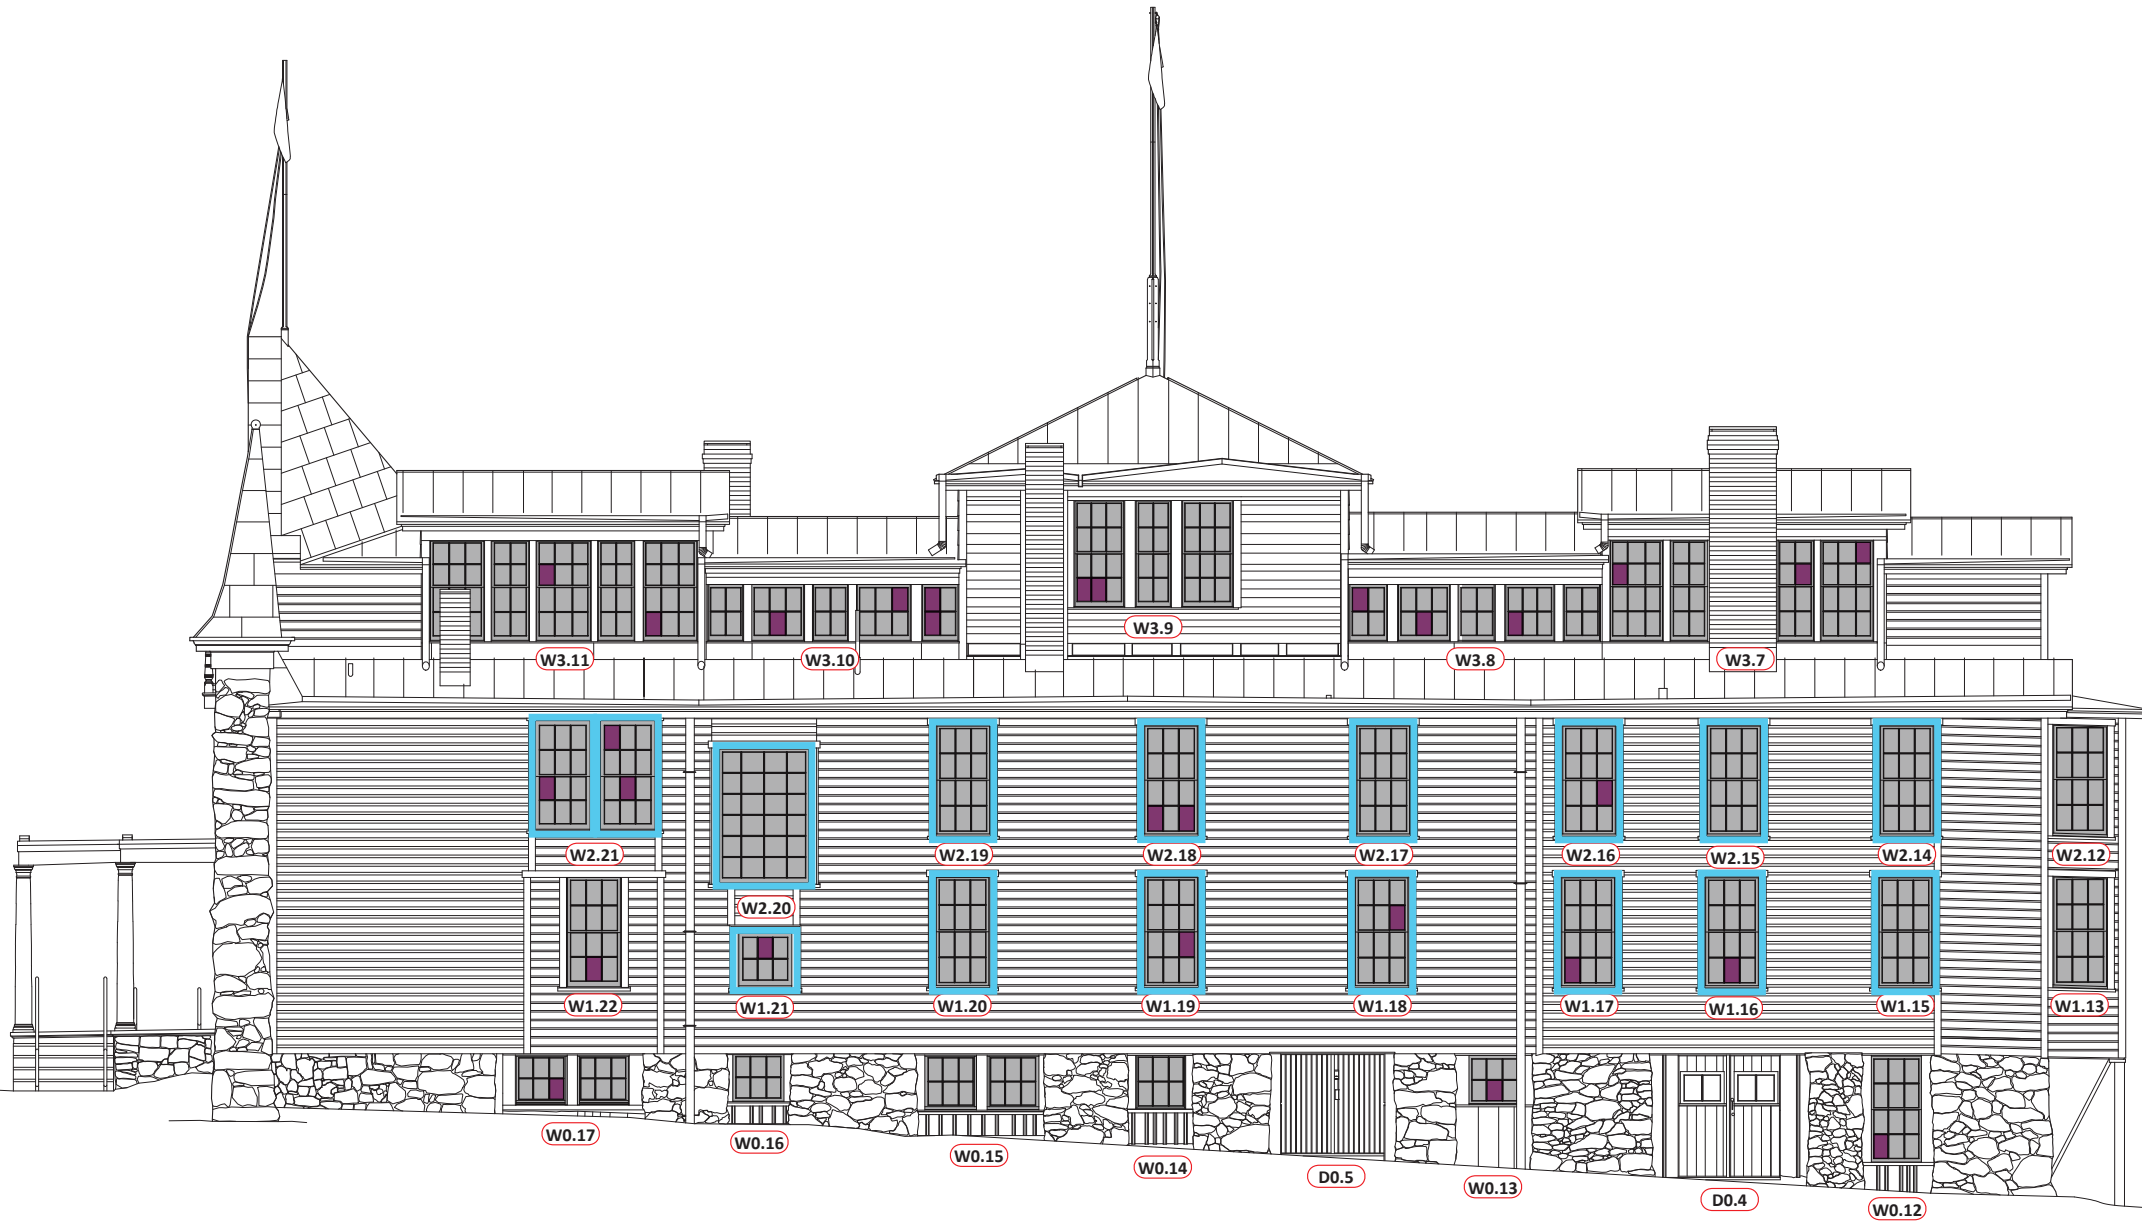
Figure 3.8 North Elevation Window and Door Assessment

NORTH FAÇADE										
	Flaking Paint	Deteriorated Sill / Threshold	Deteriorated Frame	Missing Sealant	Deteriorated Mullion	Broken Glass Panes (ref. elevations)	Glazing Compound missing	Double Hung Sash Cord broken	Weather stripping Interfers with operation	Air infiltration	Water ingress
W0.12	X			X		X	X				X
W0.13	X					X					X
W0.14	X			X							X
W0.15				X							X
W0.16				X							X
W0.17						X					X
W1.13	X	X									
W1.15	X										
W1.16	X						X				
W1.17	X			X			X				X
W1.18	X						X				
W1.19	X								X		
W1.20	X						X				
W1.21	X			X			X				X
W1.22	X										
W2.12	X		X								
W2.14	X										
W2.15	X										
W2.16	X					X	X				
W2.17	X						X				
W2.18	X					X	X				
W2.19	X						X				
W2.20	X						X				
W2.21	X					X	X				
W3.7	X					X	X				
W3.8	X					X	X				
W3.9	X		X			X	X				
W3.10	X					X	X				
W3.11	X					X	X				
D0.4	X	X	X	X							X
D0.5	X	X	X	X							X

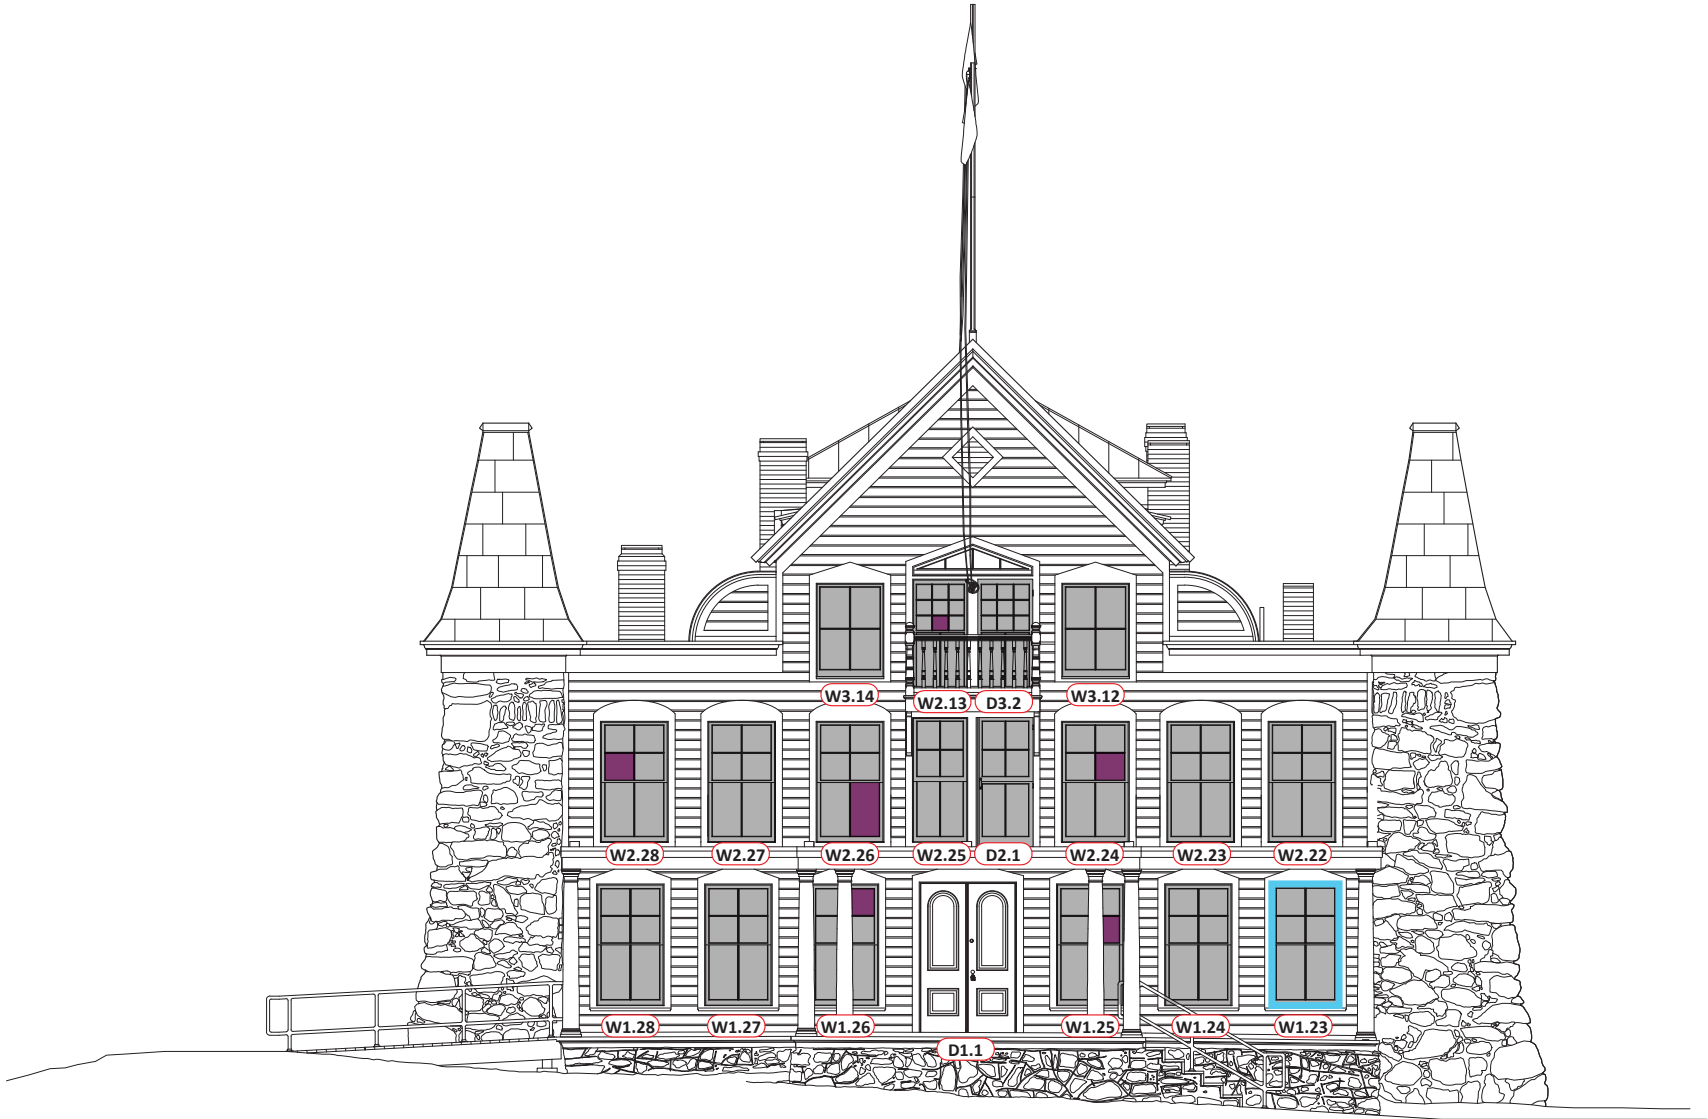
Figure 3.10 East Elevation Window and Door Assessment

EAST FAÇADE											
	Flaking Paint	Deteriorated Sill / Threshold	Deteriorated Frame	Missing Sealant	Deteriorated Mullion	Broken Glass Panes (ref. elevations)	Glazing Compound missing	Double Hung Sash Cord broken	Weather stripping Interfers with operation	Air Infiltration	Water ingress	Inoperable
W1.23	X			X			X				X	
W1.24	X			X			X				X	
W1.25	X					X						
W1.26	X			X		X	X				X	
W1.27	X			X			X					
W1.28	X			X			X					
W2.22	X						X					
W2.23	X						X					
W2.24	X					X	X					
W2.25	X						X					
W2.26	X						X					
W2.27	X					X	X					
W2.28	X						X					
W3.12	X			X								
W2.13	X					X				X		
W3.14	X			X			X					
D1.1	X	X										
D2.1	X	X								X	X	
D3.2	X	X								X	X

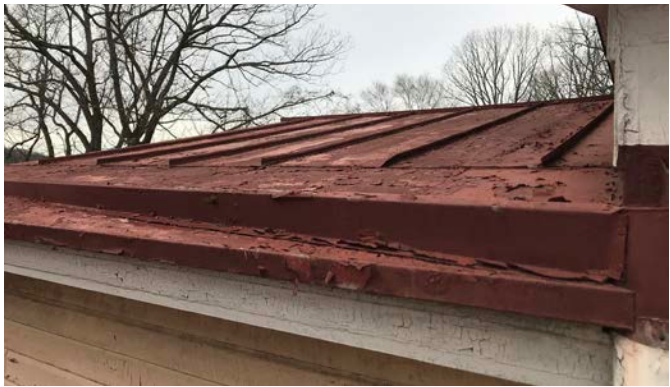
Peeling Paint at Upper Roof A15

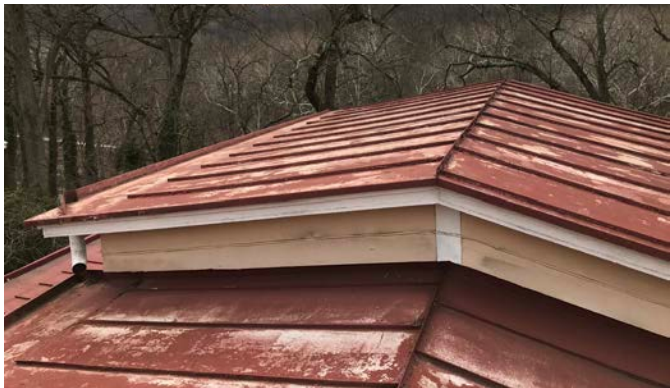
Peeling Paint at Upper Roof A17

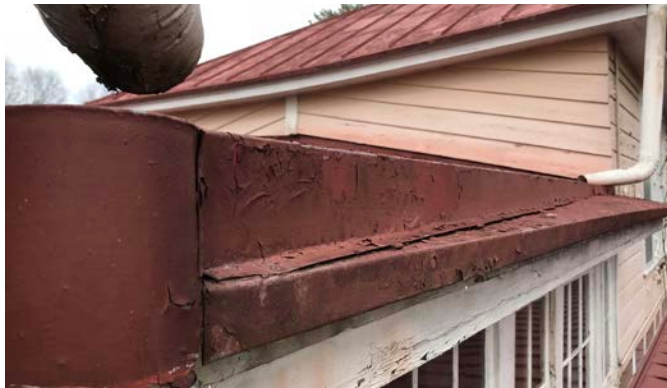
Diverter Separating A13

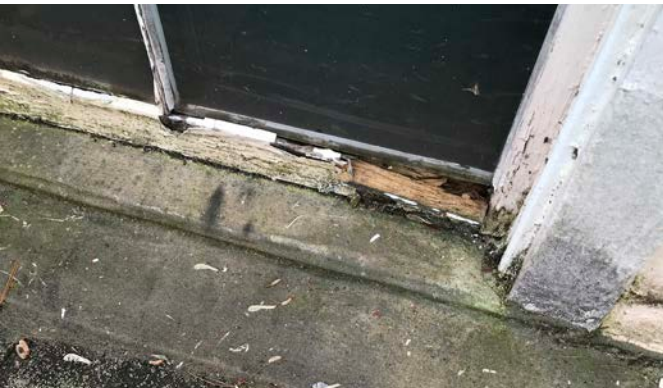
Water Damage to Sill and Window at Porch Roof A4

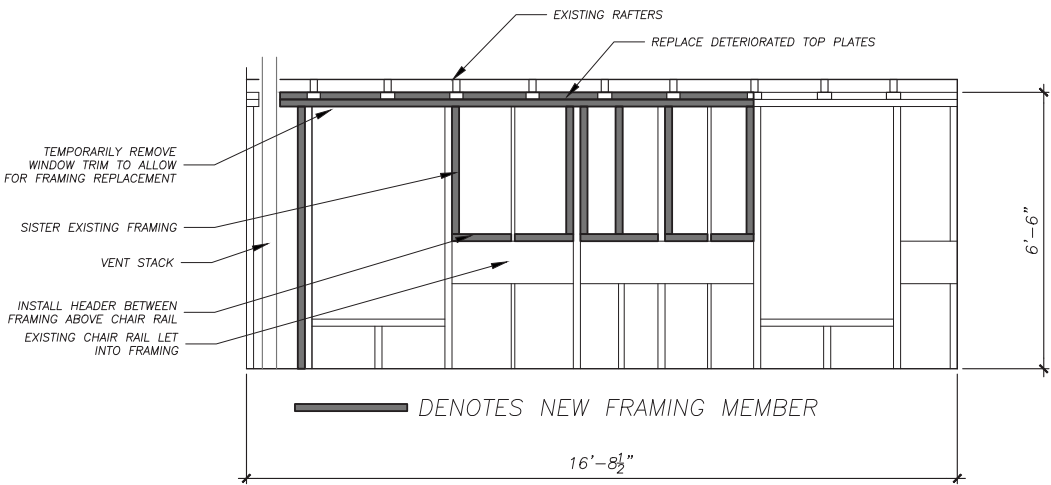
Figure 3.12 Repair of Wood Framing on south wall; see PMIS #196219 Drawings

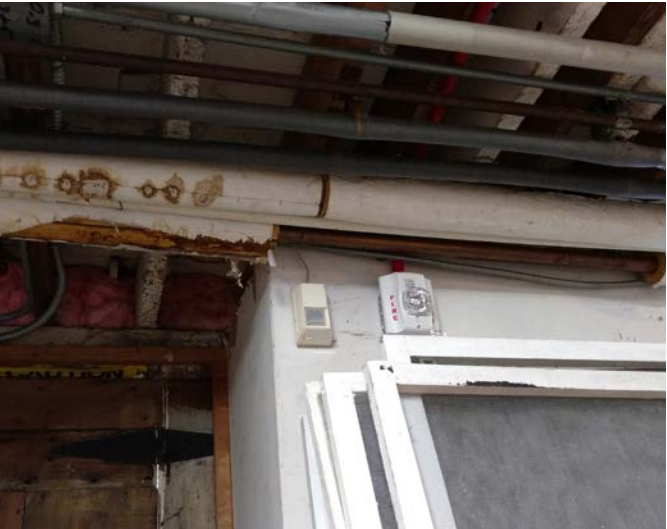
Figure 3.37 Rust on Heating Hot Water Piping & Damaged Insulation M37

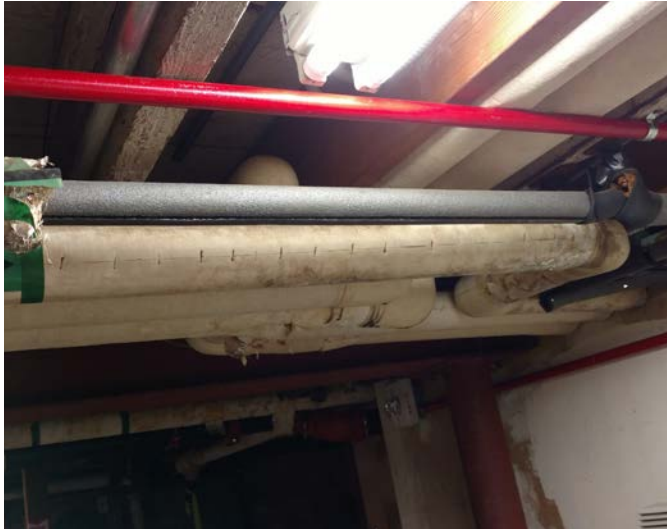
Figure 3.39 Chilled Water Piping with Mismatched Insulation Materials M38

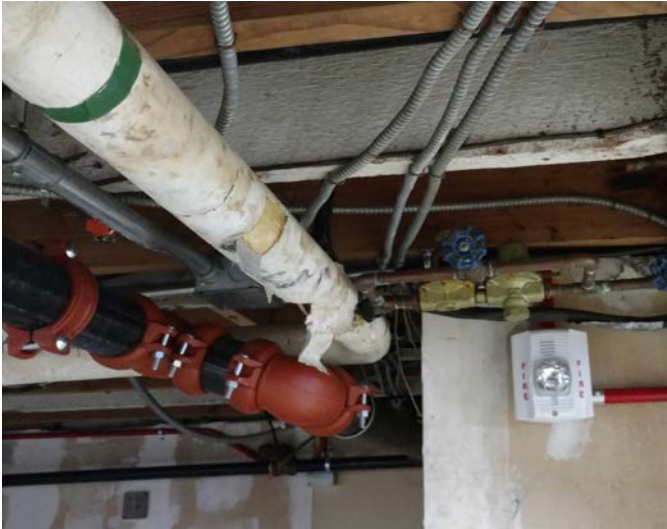
Figure 3.41 Chilled Water Piping with Torn & Water Damaged Insulation M39

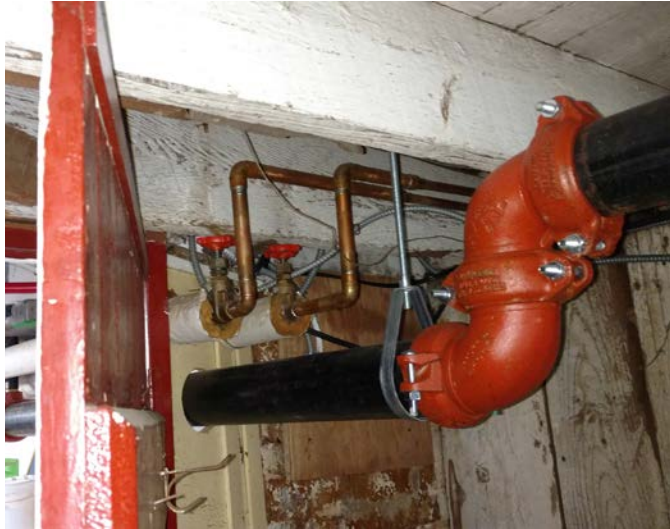
Figure 3.43 Missing Insulation on Heating Hot Water Piping M39

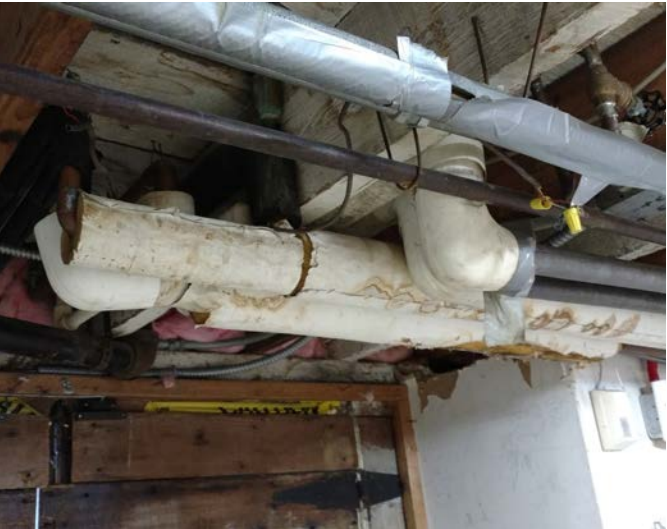
Figure 3.38 Rust on Heating Hot Water Piping & Damaged Insulation M37

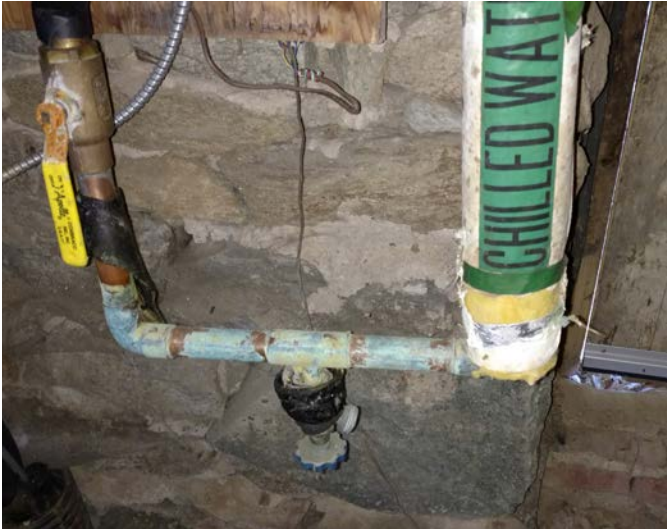
Figure 3.40 Chilled Water Piping with Calcium Build-up & Missing Insulation M38

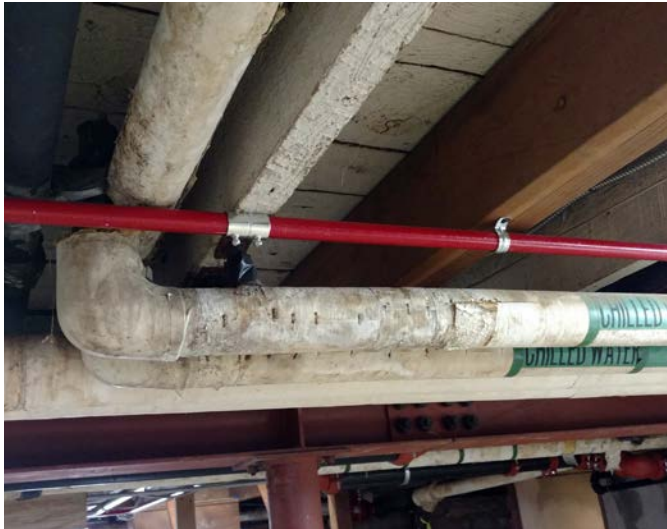
Figure 3.42 Chilled Water Piping with Water Damaged Insulation M39

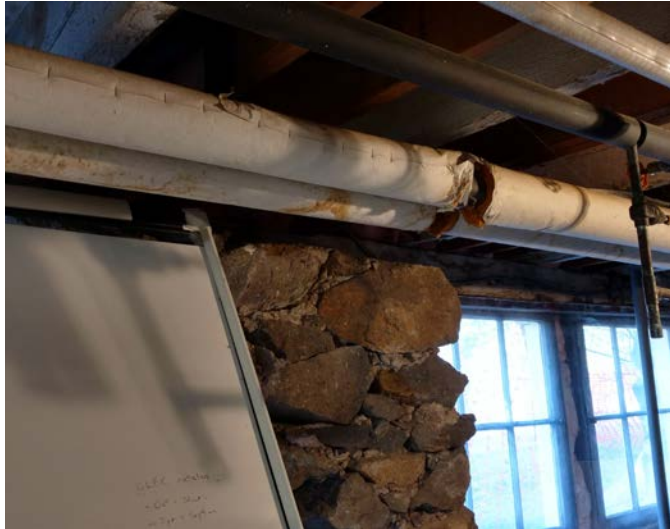
Figure 3.44 Damaged Insulation on Heating Hot Water Piping M39

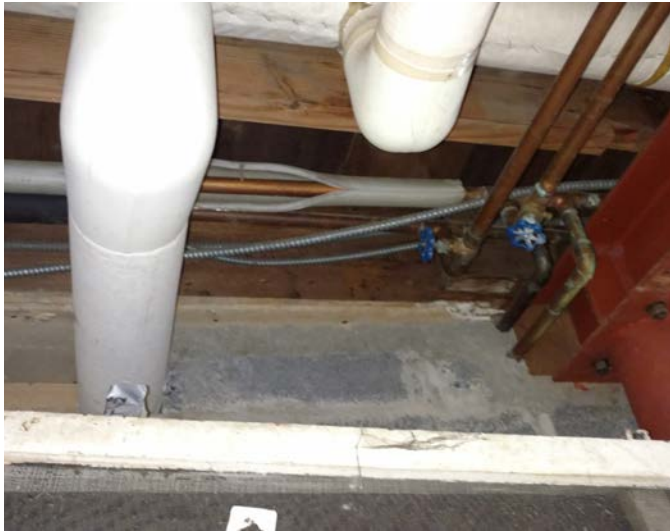
Figure 3.58 Uninsulated Domestic Water Piping & Valving Exhibiting Rust P2

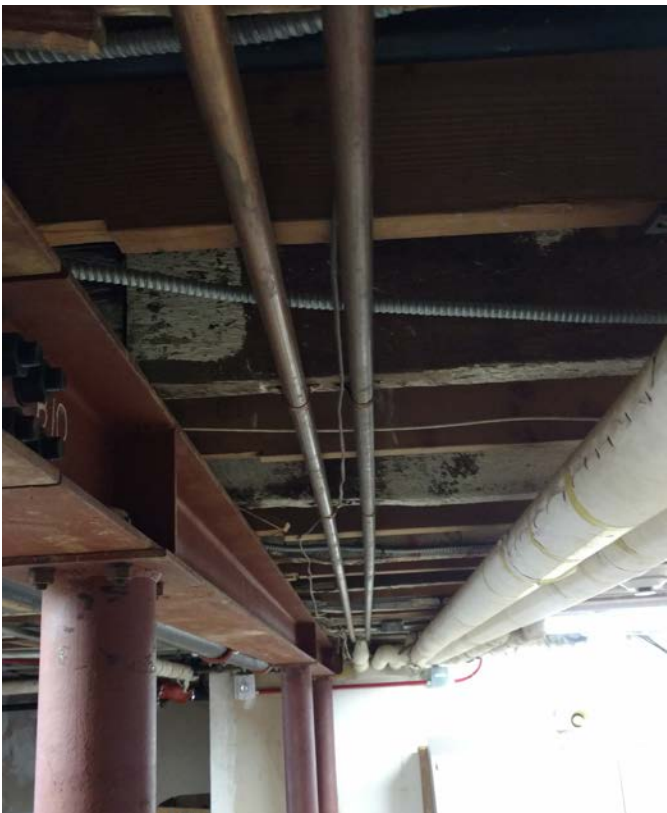
Figure 3.60 Uninsulated Domestic Water Piping P2

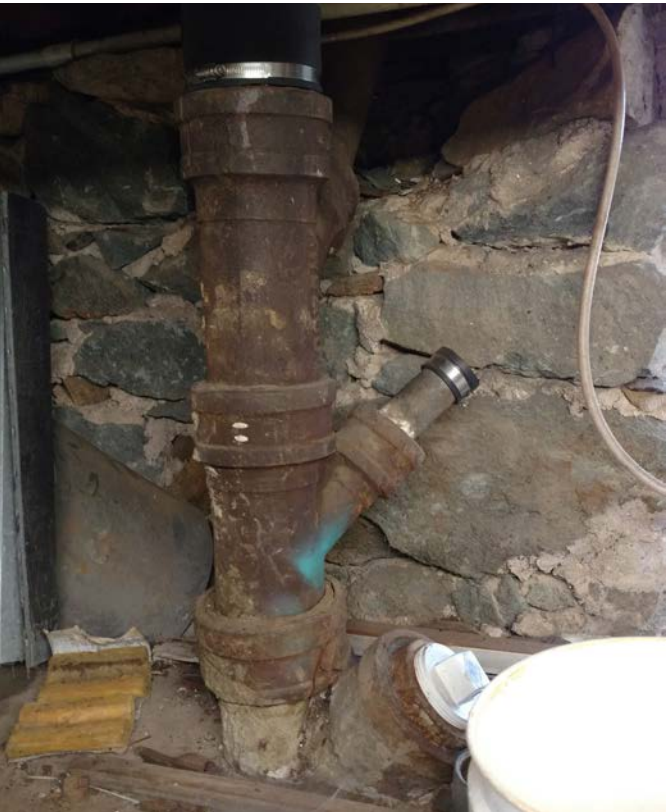
Figure 3.61 Large Amounts of Rust on Sanitary Piping in Unfinished Basement P3

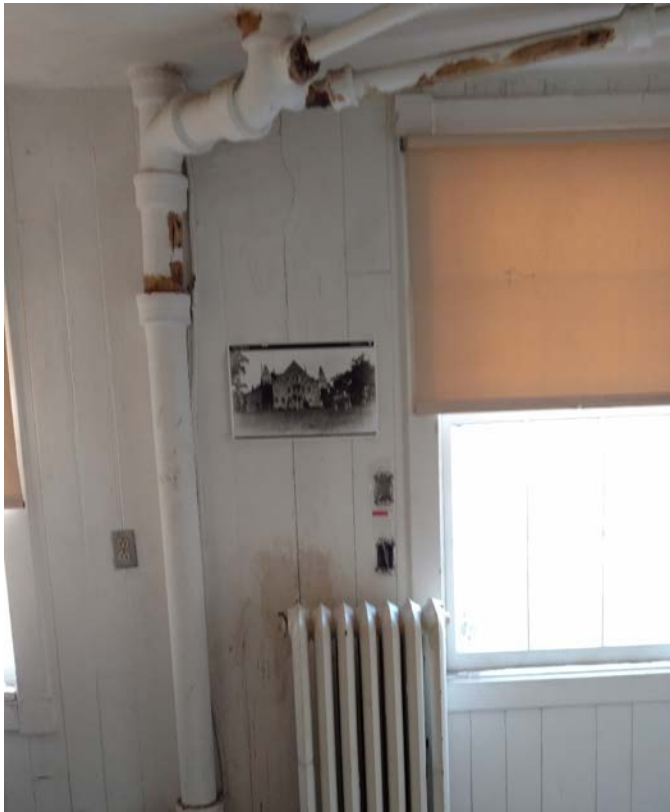
Figure 3.82 Damage on Sanitary Piping Insulation within Clara Barton’s Kitchen 111 P5

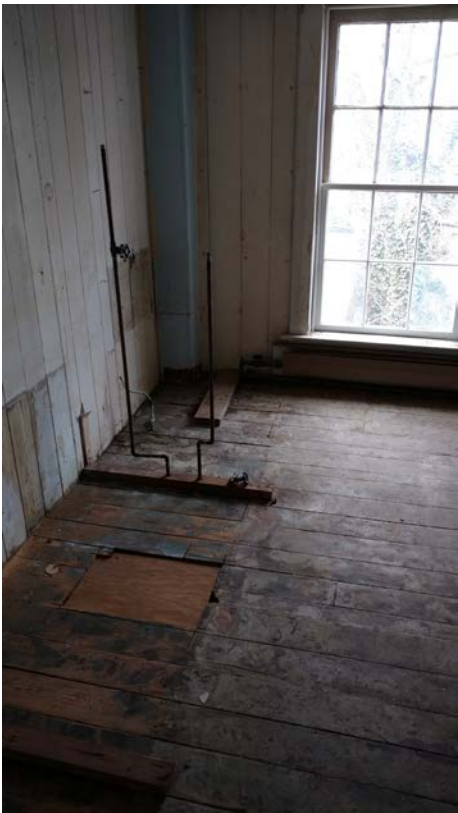
Figure 3.98 Domestic Water Lead Piping Exhibiting Rust within Clara Barton's Bathroom 210

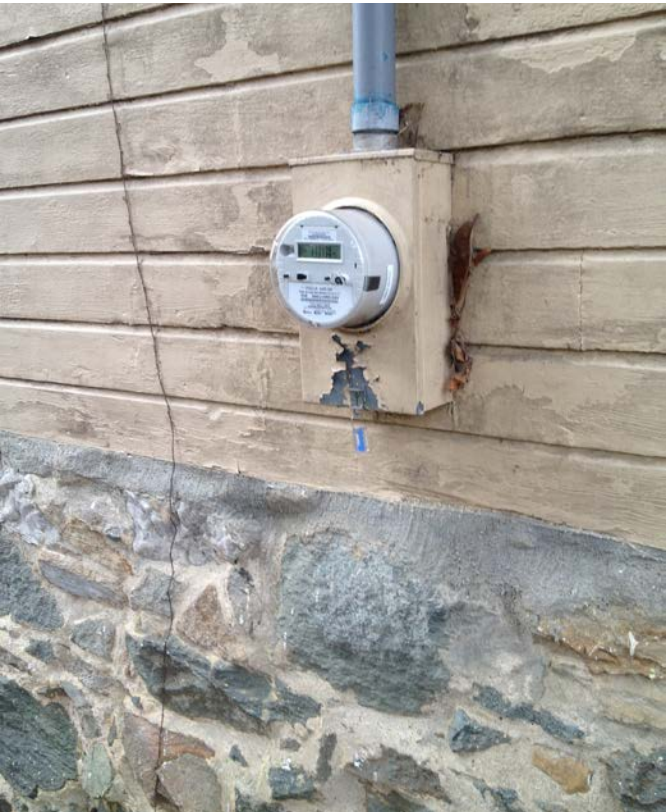
Figure 3.104 Electrical service capacity insufficient for future additional mechanical load and the change in usage of the building E1
