Clara Barton National Historic Site Conditions Assessment

Final Submittal

November 27, 2018

Contract No. P14PC00202
Order No: 140P3018F0013
AECOM Project No.60562621

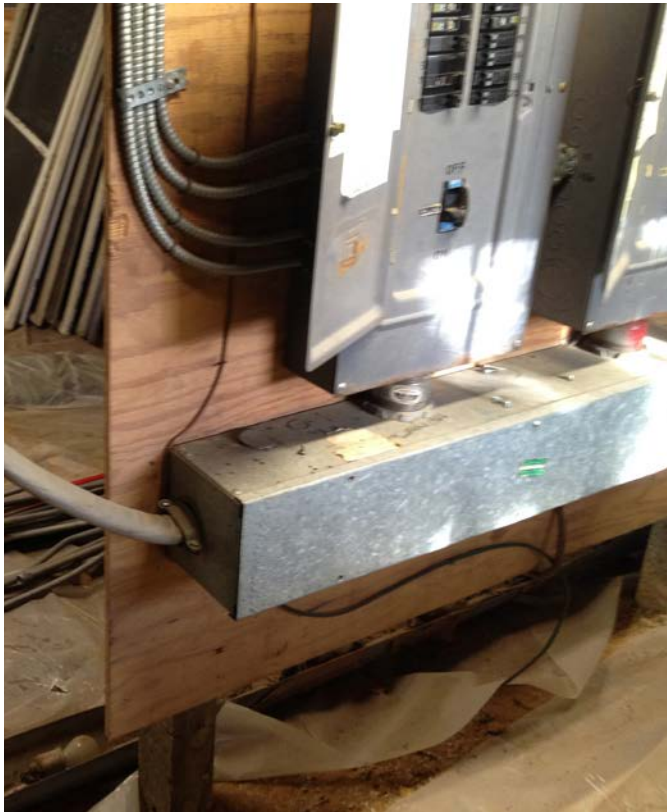
Figure 3.106 Service entrance cable is exposed and subject to physical damage E3

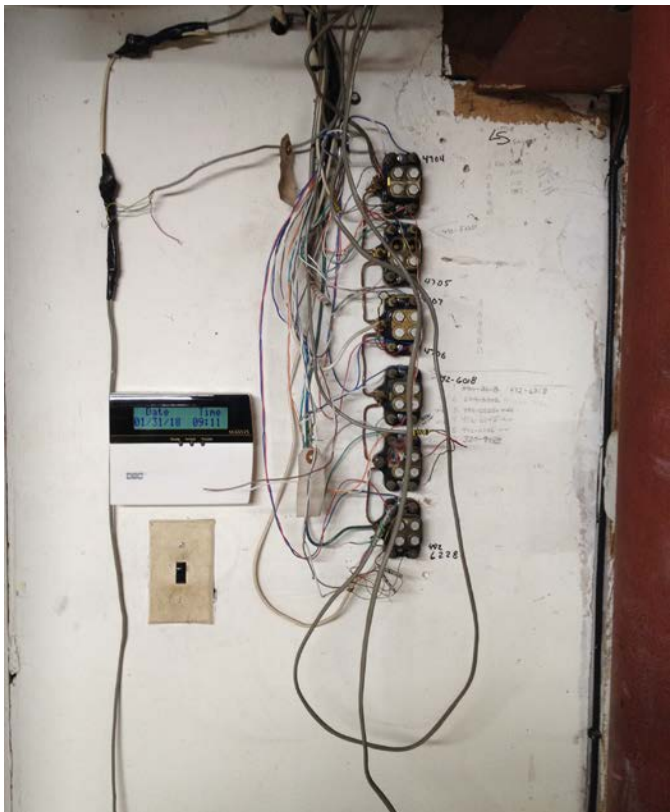
Figure 3.108 Telephone service entrance cable is exposed and unprotected; primary protection is obsolete and inadequate E5

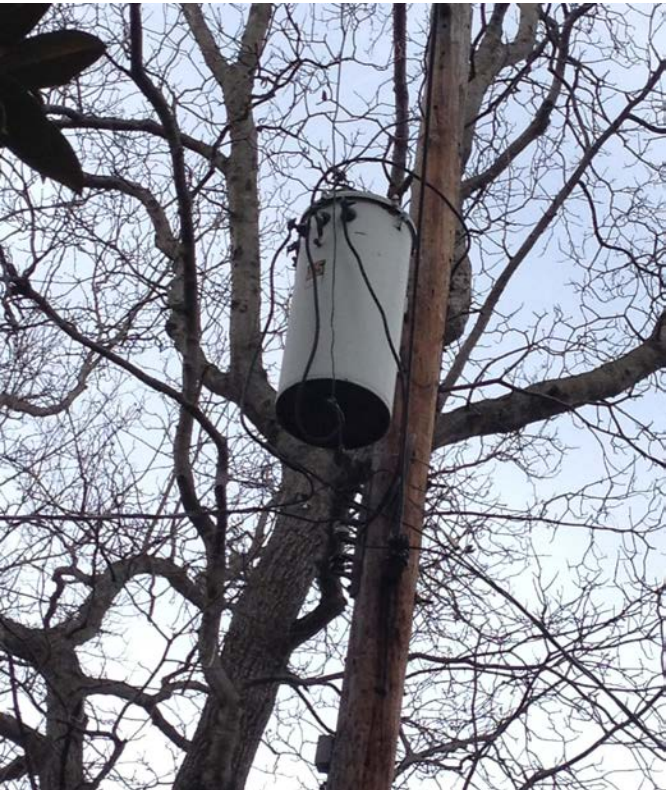
Figure 3.105 Electrical service capacity insufficient E2

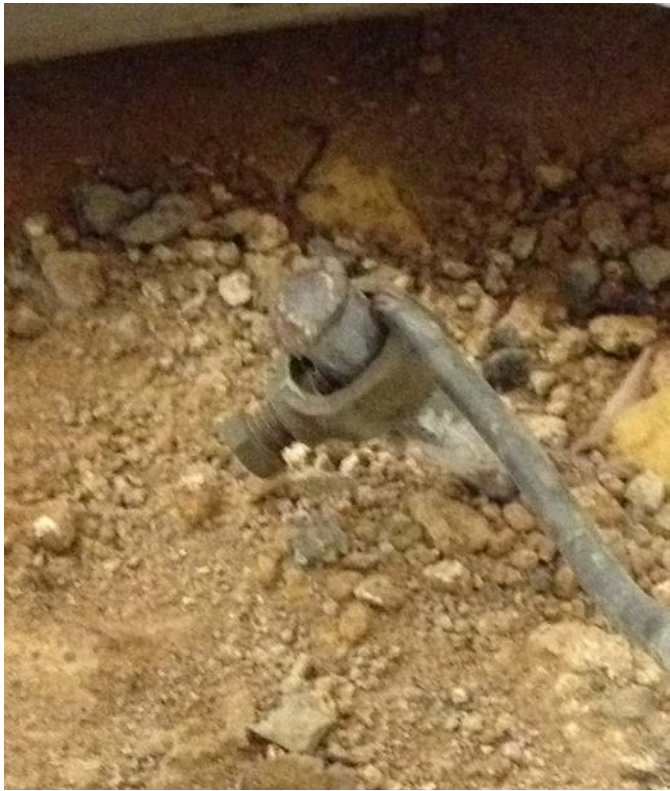
Figure 3.109 Insufficient grounding E6

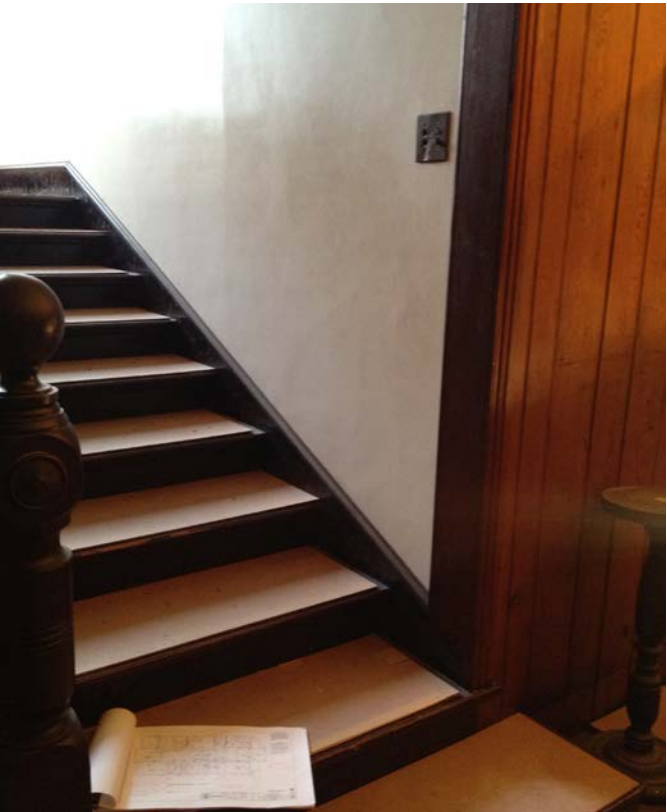
Figure 3.111 ADA compliance violation - device mounted too high E7

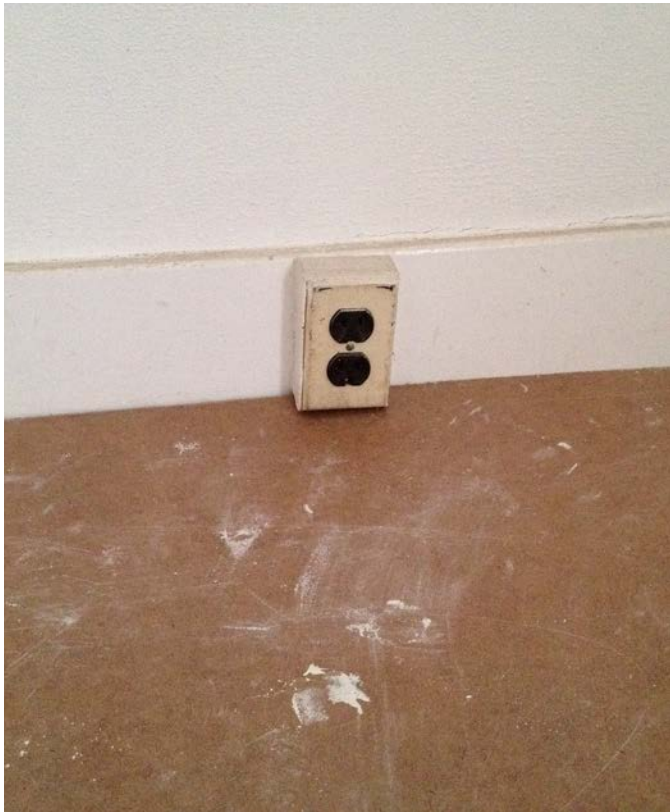
Figure 3.113 ADA compliance violation - device mounted too low

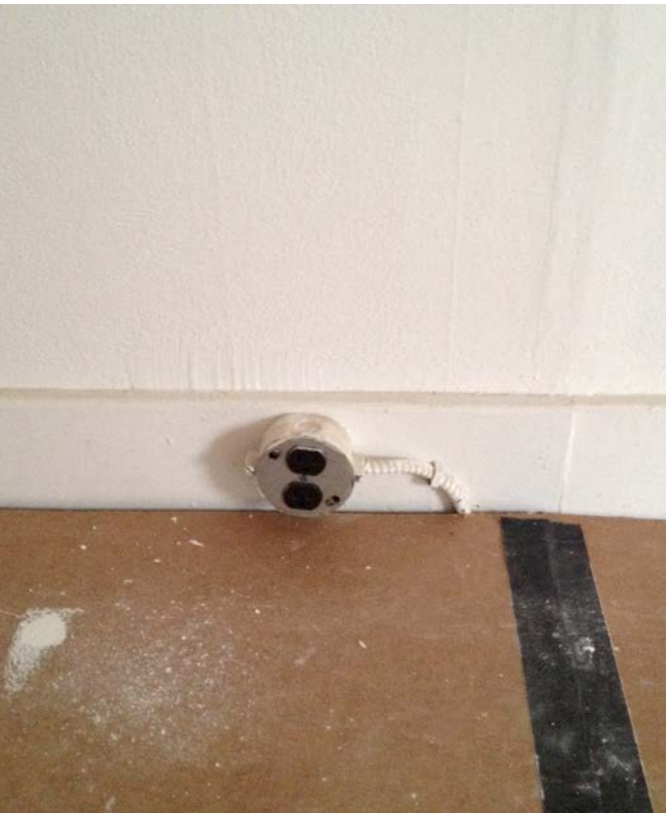
Figure 3.112 ADA compliance violation - device mounted too low

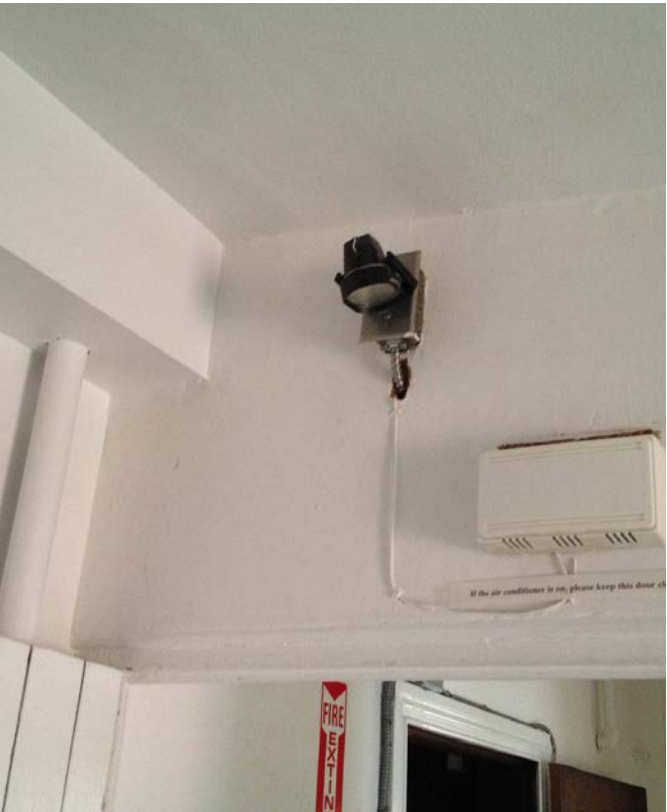
Figure 3.115 Emergency lighting and exit signage deficiencies E8

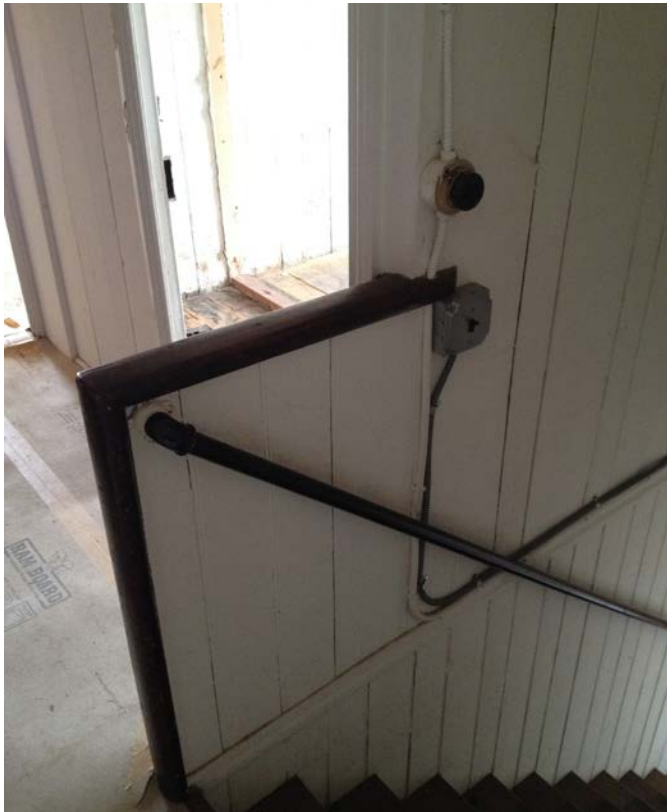
Figure 3.117 ADA compliance violation - device mounted too high or too low E10

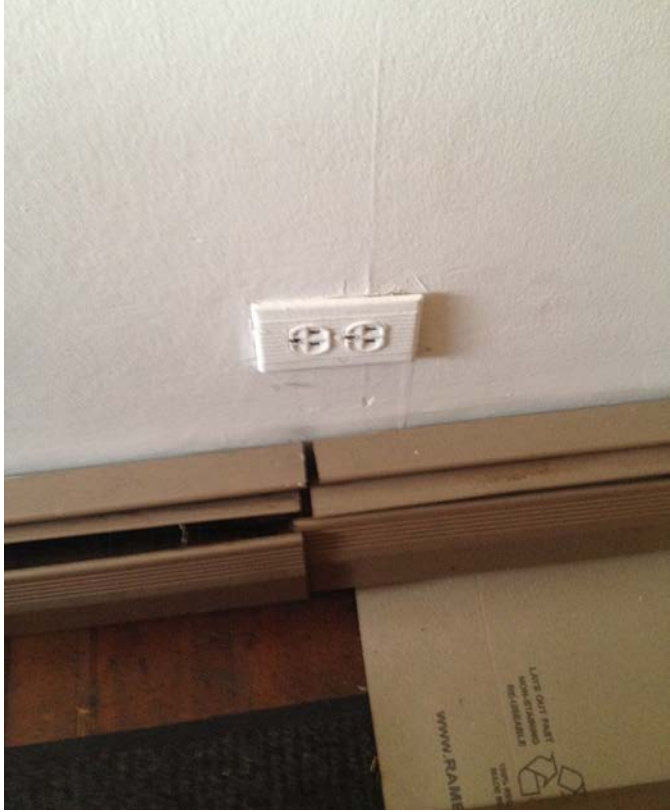
Figure 3.119 Receptacle located above baseboard heater E12

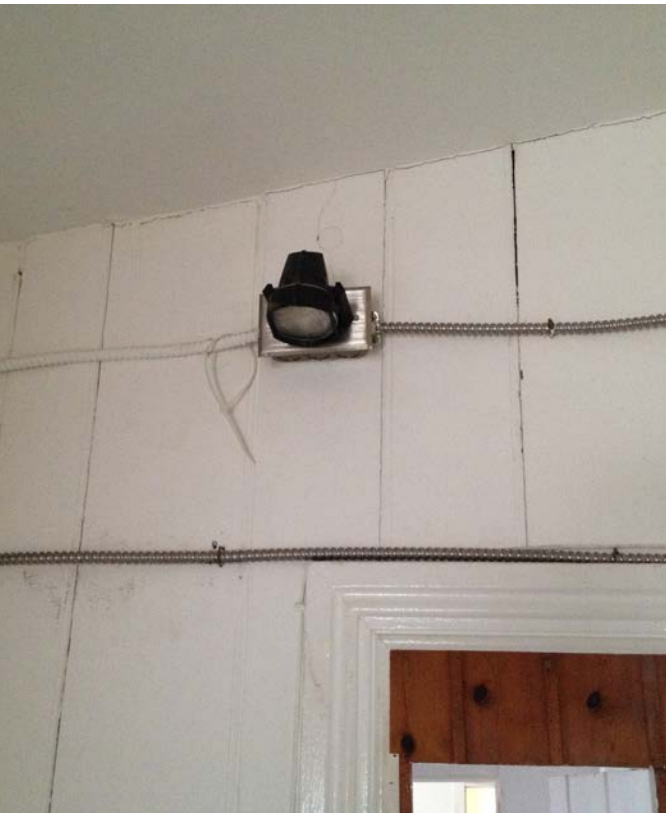
Figure 3.116 Emergency lighting and exit signage deficiencies E9

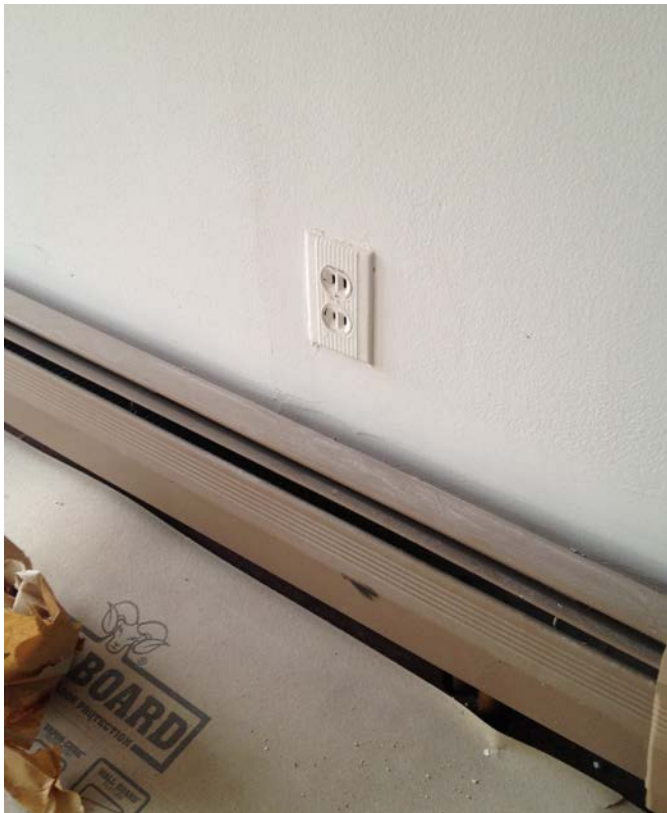
Figure 3.118 Receptacle located above baseboard heater E11

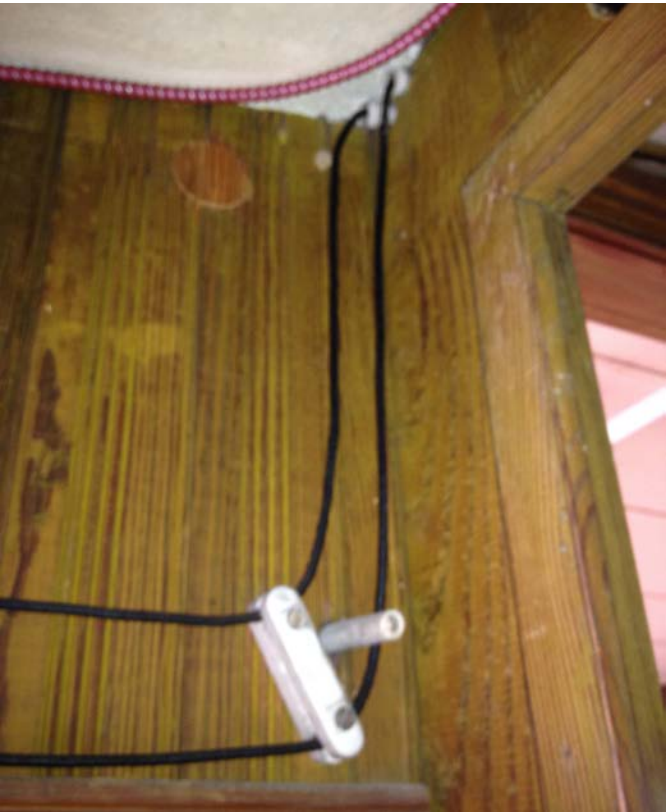
Figure 3.121 Obsolete knob-and-tube wiring E13
