**REMOVAL ACTION SUMMARY
BEAUTY BAY MINE
KENAI FJORDS NATIONAL PARK, ALASKA**

September 2006

By:
Shannon & Wilson, Inc.
2355 Hill Road
Fairbanks, Alaska 99709-5326

31-1-11325-001

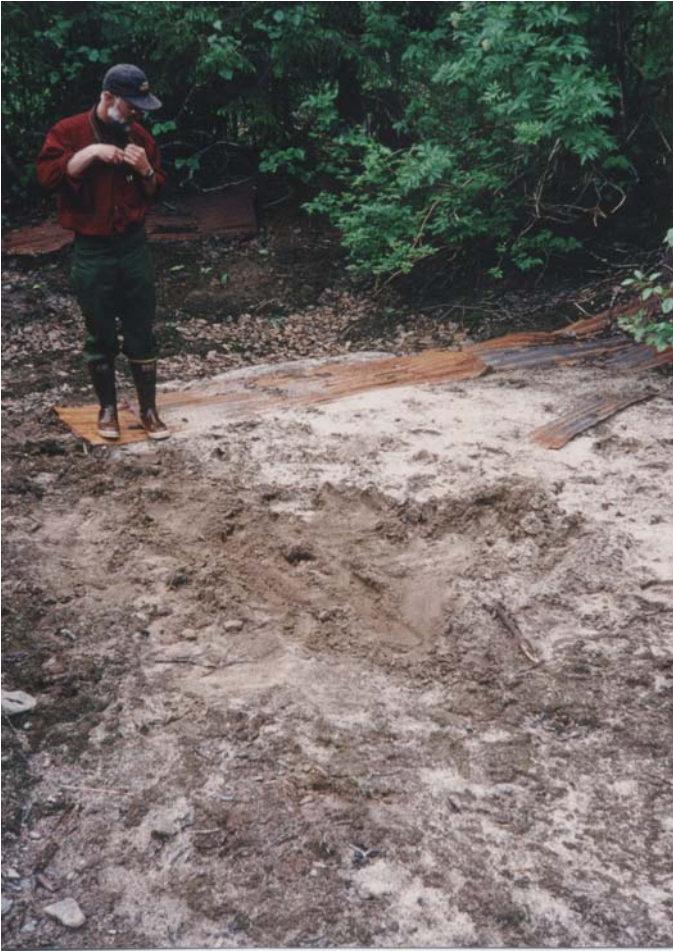
On June 28, 1994, an NPS explosives removal team visited the site; a white precipitate coating the surface of tailings pond D was noted (Figure 2; Photo 1). According to NPS personnel, the existence of the white precipitate was transient, having been observed on several of the ponds, and not during previous and subsequent site visits. No samples of the white precipitate were collected. During this visit a deceased moose calf, believed to be 1 month old, was found on the site. Apparently there was no indication of trauma, birth defects, or other blemishes or injuries noted. The presence of hoof and nose prints and kneel marks in the tailings ponds indicated that moose may have been disturbing the tailings, and potentially ingesting the material.

Photo 1. Beauty Bay Mine tailings on June 28, 1994; note white precipitate on surface.

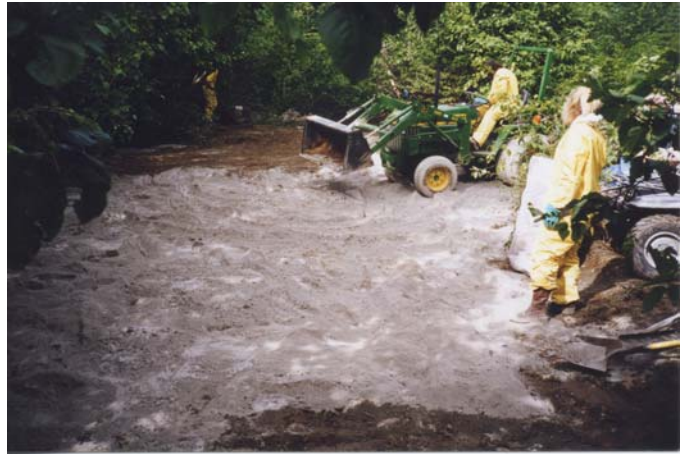
Photo 3. Application of Portland cement to surface of Pond D- July 1998.

decontamination area was set up and surface water was diverted from the area of Pond D. The surface of Pond D was scarified with a tractor-mounted roto-tiller and dry Portland cement was placed on the ground surface (Photo 3). The roto-tiller was used to blend the cement with the upper portion of the tailings and a plate compactor was used to densify the mixture (Photos 4 and 5). As the natural moisture content was sufficient to hydrate the cement no additional water was added to the mixture. Material from the Ponds C, F, and G (Figure 2) was then excavated and placed on Pond D in two 7- to 8-inch lifts; each lift was combined with cement and compacted. (Photo 6). Figure 3 shows a schematic of the solidification process. About 210 bags of cement were used during the solidification process. The upper lift was contoured to avoid ponding of surface water (Photo 7).

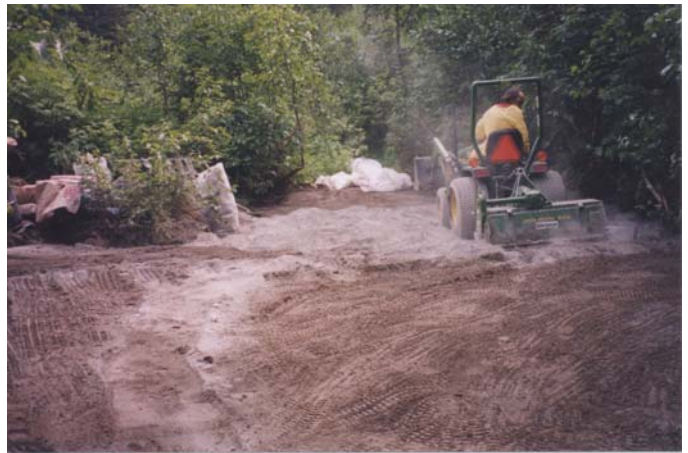
Photo 4. Rototiller mixing cement with tailings.

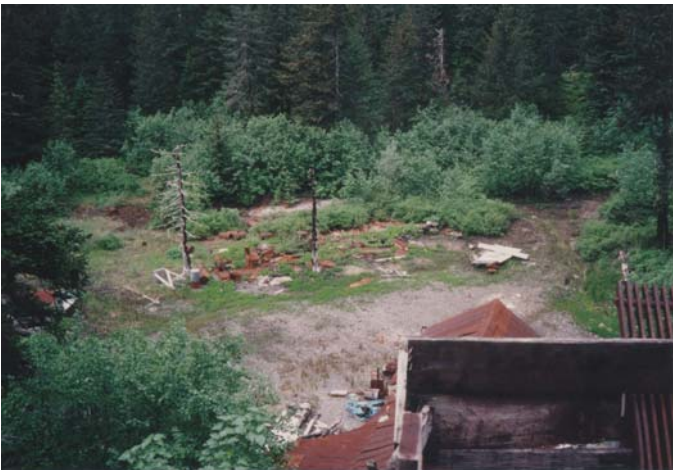
Field observations indicated the tailings in ponds C, D, F, and G covered an estimated area of about 1,225 square feet (Figure 2, Photo 2). Data from a limited number of test pits excavated on August 29, 1995 suggest the thickness of the tailings in these areas ranged from a minimum of 2 inches to a maximum of about 36 inches. From the field observations and test pit data, the volume of tailings was estimated at about 61 cubic yards; based on information collected during the removal action the estimated volume of tailings at the site was increased to 73 cubic yards.

Photo 2. Beauty Bay Mine site looking northwest; Pond D is near center of picture - August 1995.

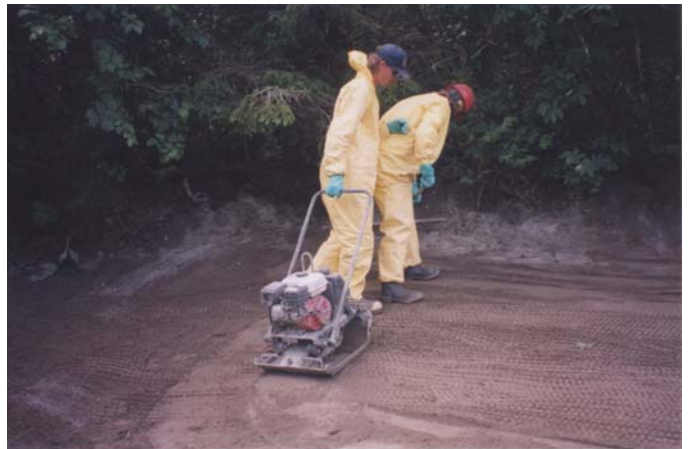
Photo 5. Compacting tailings/cement mixture.

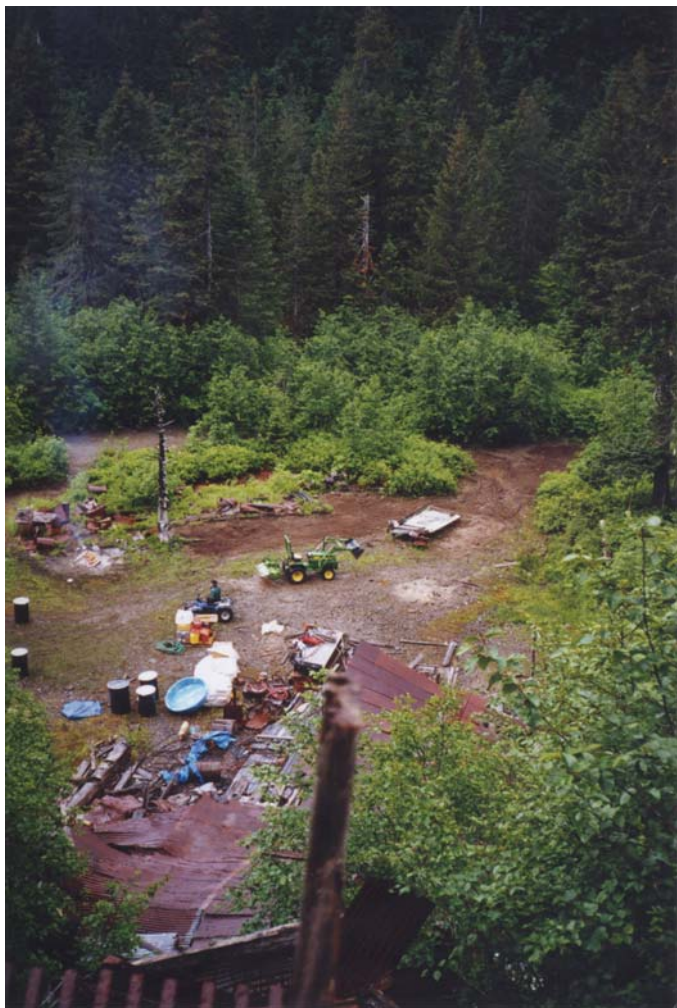
Photo 6. Beauty Bay Mine site looking northeast following the removal of tailings from Ponds C and G.

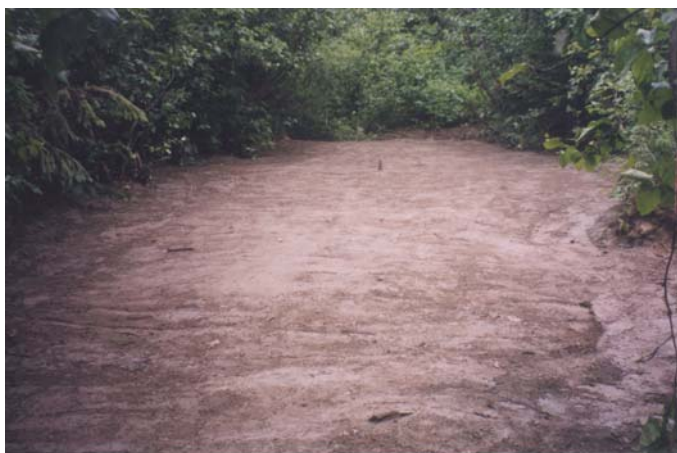
Photo 7. Pond D following the completion of the solidification process.

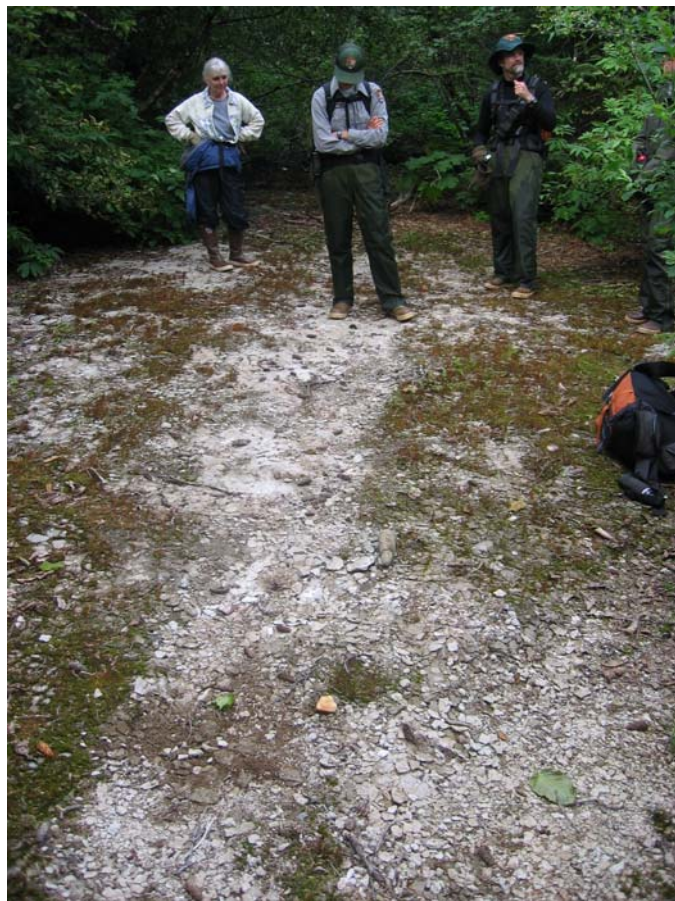
In August 2006 Park Service personnel visited to the site and noted that the surface had spalled; the cap did not appear to have been disturbed by weather, wildlife, or humans. The tailings cap appears to be supporting plant growth (Photos 8 and 9). No surface water was noted in the area of the tailings.

Photo 8. Pond D – August 2006; note plant growth on surface.

To alleviate concerns about the bioavailability of arsenic in the spalling solidified mass, analytical testing could be performed. However, the release mechanism thought to be responsible for the generating arsenic-bearing precipitates has been eliminated. Analytical testing would reconfirm the presence of arsenopyrite at the site but without the release mechanism the arsenic within the arsenopyrite is believed to be relatively stable. Future site visits should concentrate on observing the physical integrity of the solidified mass, the amount and type of vegetation that is taking root, and any surface water drainage that may be compromising the edges of the solidified mass.

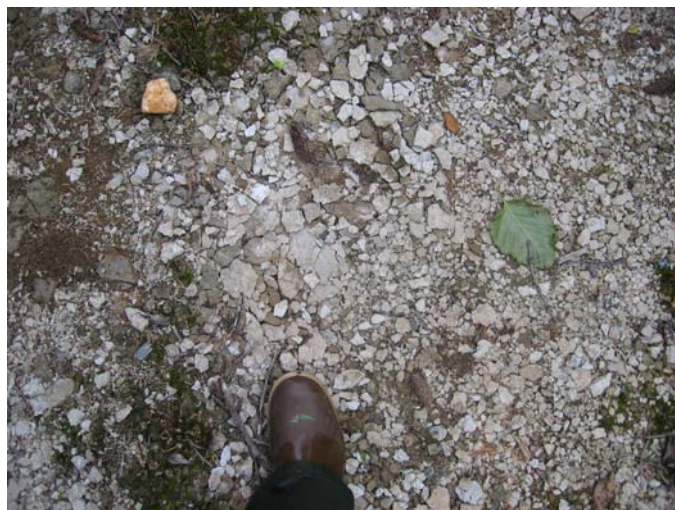
Photo 9. Close-up Pond D – August 2006
