THOMAS BLACKSTONE HOUSE

HISTORIC STRUCTURES REPORT

SEIP EARTHWORKS UNIT – HOPEWELL
CULTURE NATIONAL HISTORICAL PARK
BAINBRIDGE, OHIO

APRIL 17, 2017
NPS PMIS # 218963

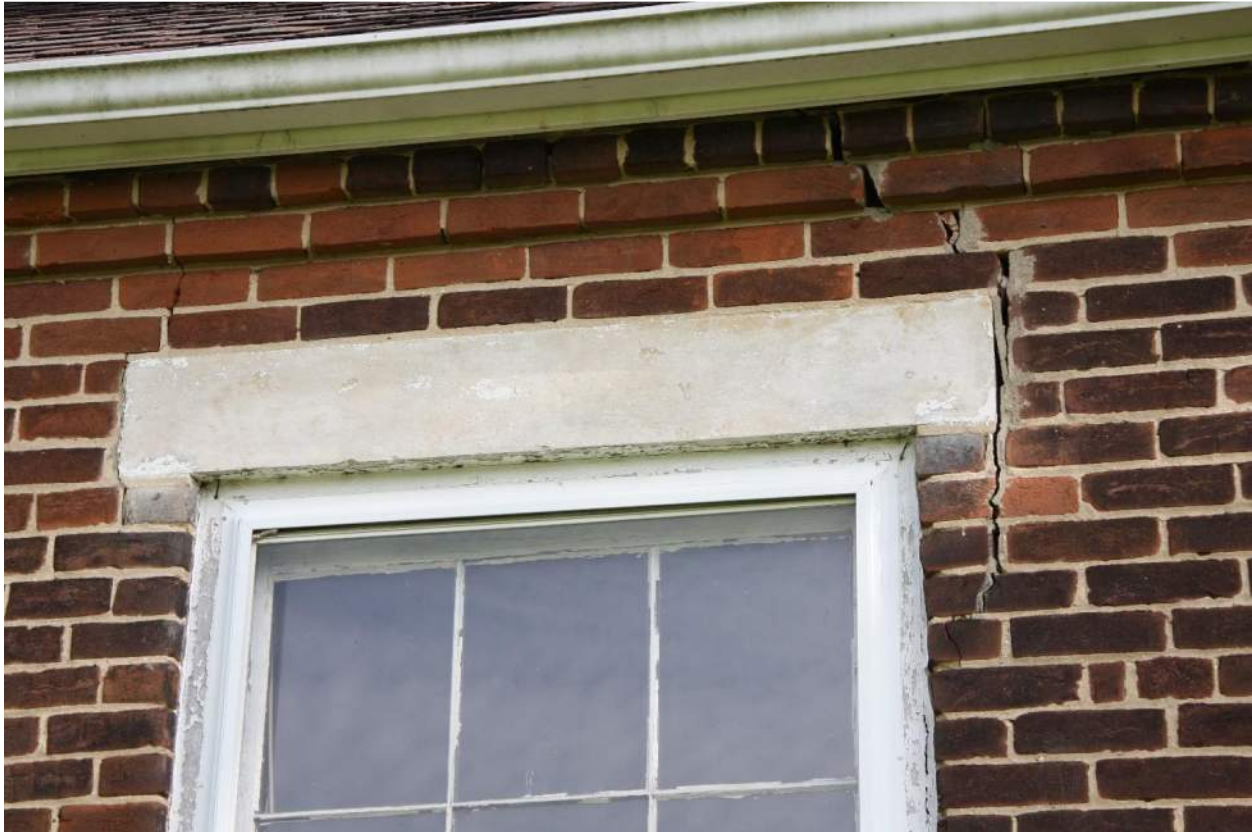
Figure EX-54. Cracks at top of Window 100, north elevation. (Strata 2016)

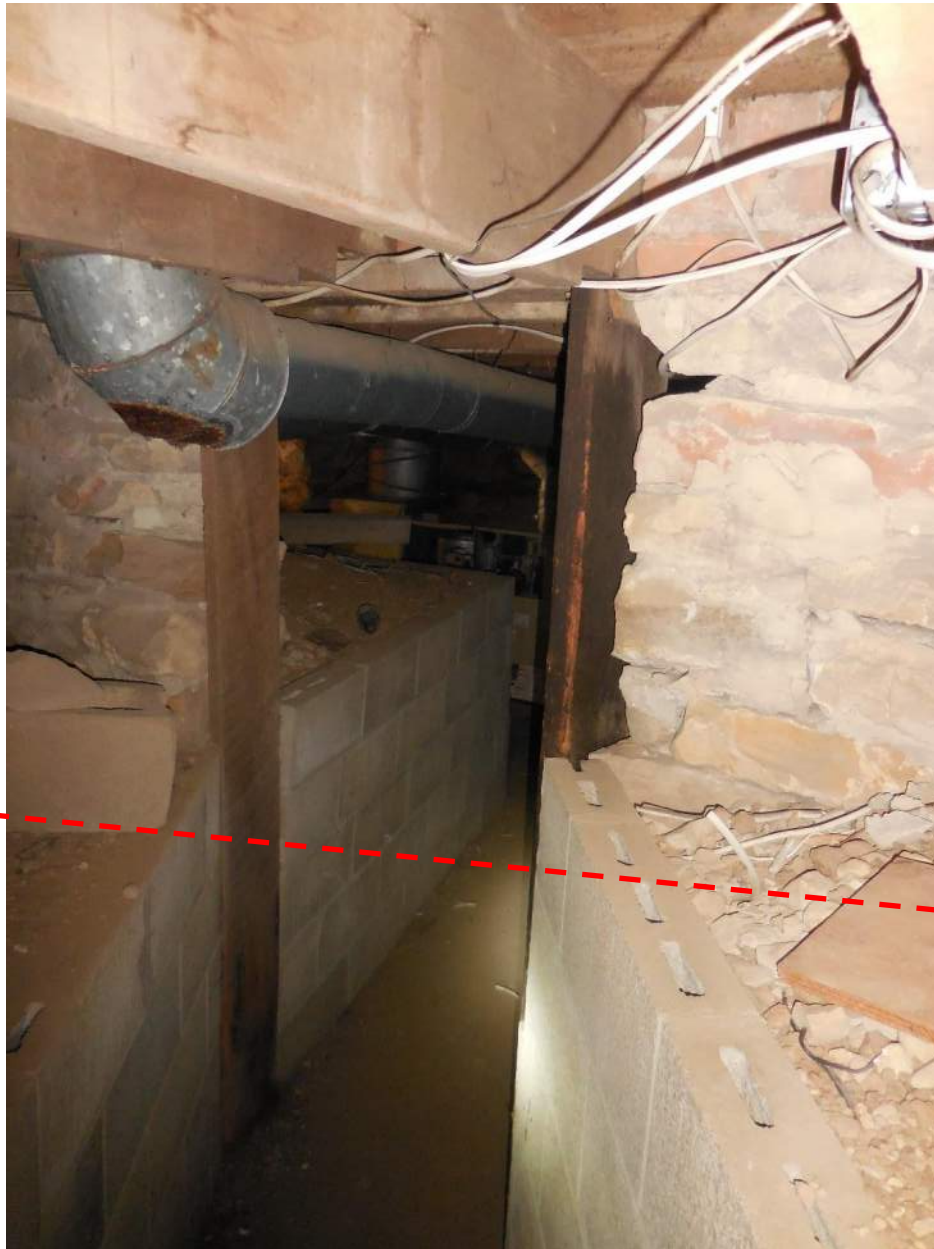
Figure B19. Door opening cut through stone foundation wall. Note there is no formal lintel above the opening to support the brick wall above. The dashed line indicates the approximate bottom of the interior stone foundation walls prior to excavation. Taken from Room 000, looking into Room 005. (Strata 2016)

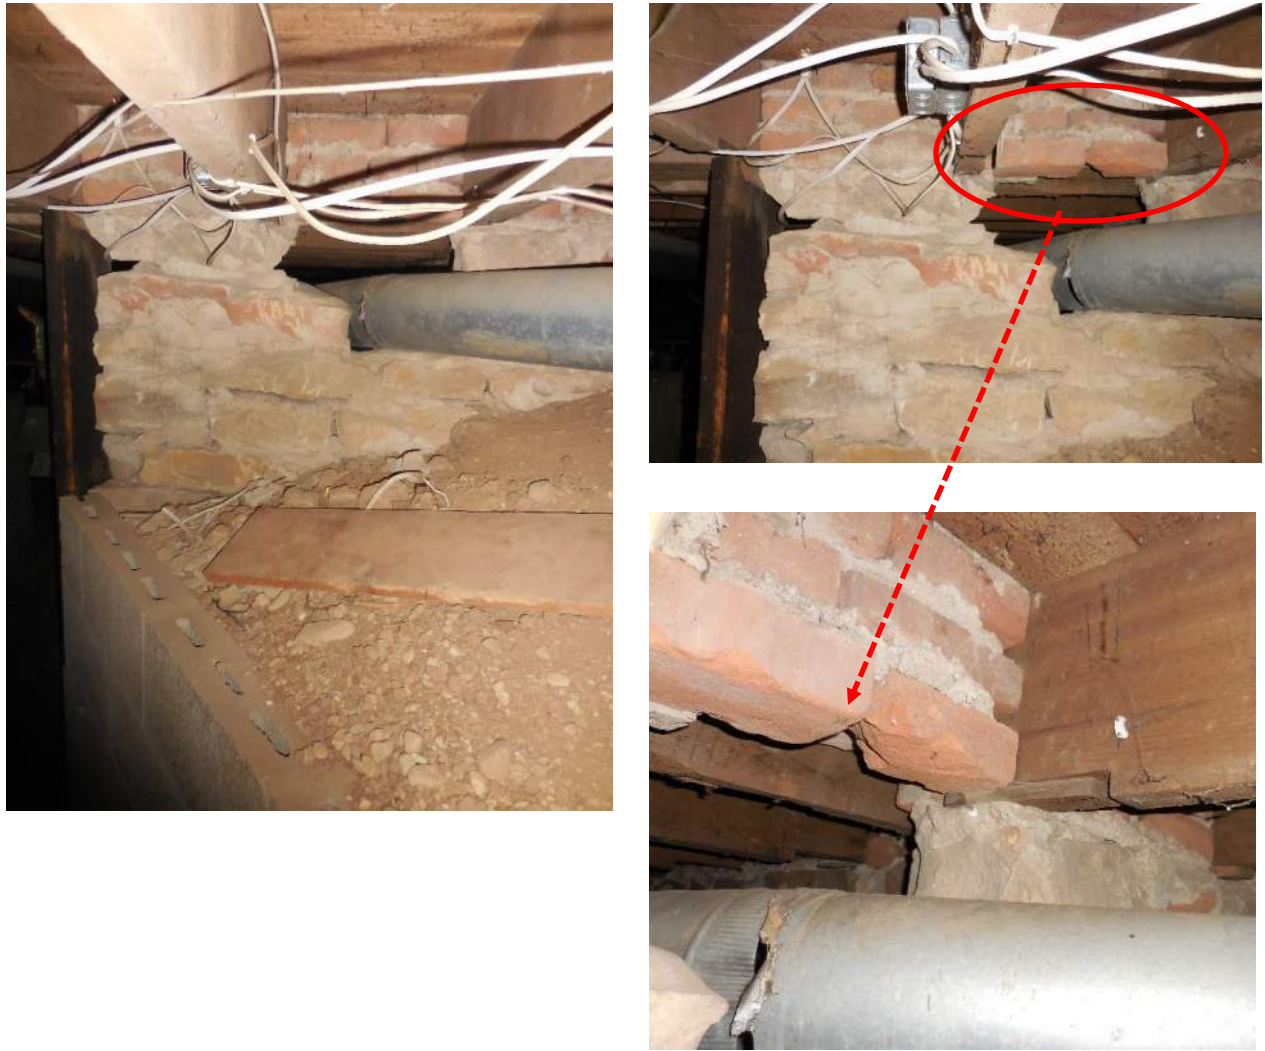
Figure B20. Detail of north/south stone foundation wall. Note the penetrations through the wall with no lintels supporting the brick structure above. Top left and top right: Note there is only a single stone supporting the wall in this location, which is missing mortar. Bottom right: bricks have fallen from this area, leaving the wall above unsupported. (Strata 2016)

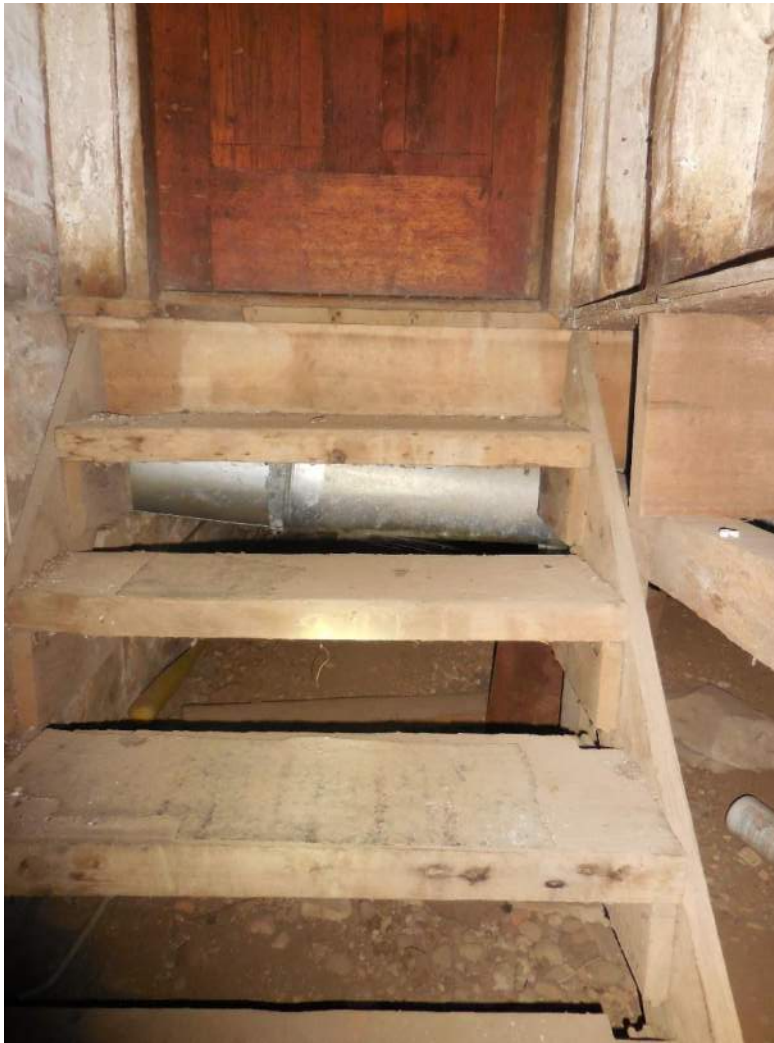
Figure B21. Detail of the stair, Room 000. Note the treads on the stair are repurposed floor joists that were cut from the floor structure to create this stair opening. Remnants of linoleum are installed on the stair treads. (Strata 2016)

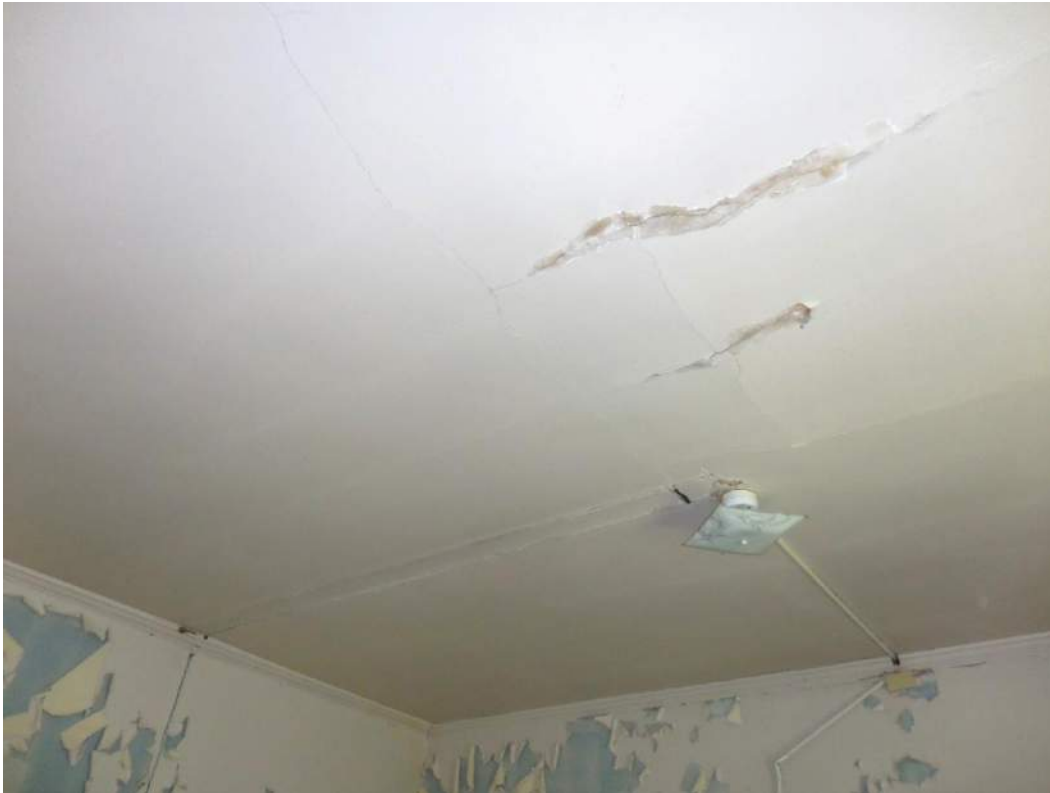
All four walls are brick load bearing walls with plaster installed directly to the brick. The brick walls are cracked in many locations, which have projected through the plaster. The cracks indicate signs of previous footing settlement, as these walls rest on shallow stone foundations. The plaster ceiling is in poor condition and is cracked throughout (Figure 1.23). The walls and ceiling are painted. The paint is peeling and is in poor condition.

Figure 1.23. Plaster ceiling deterioration, East Parlor 101. (Strata 2016)

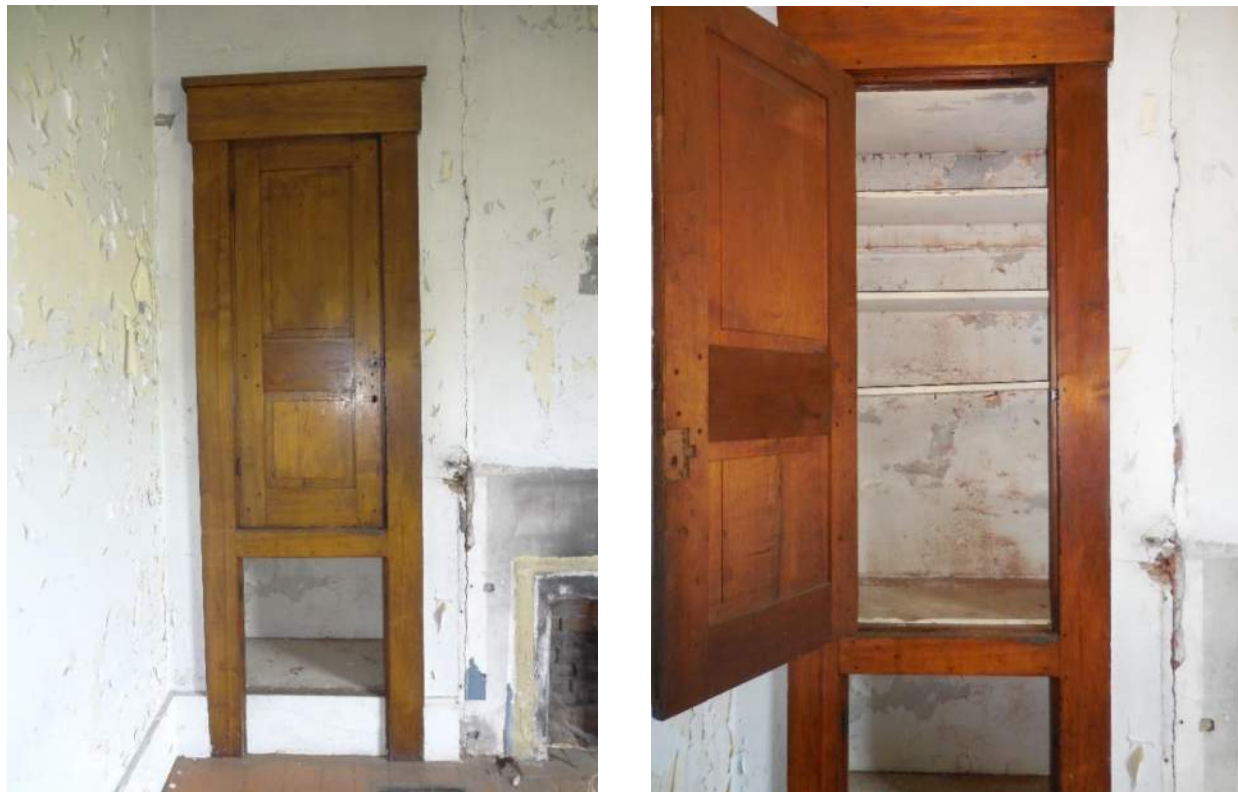
Figure 1.51. West Parlor 103, South cabinet. The door is no longer installed, but it is stored nearby.
(Sheals and Strata 2016)

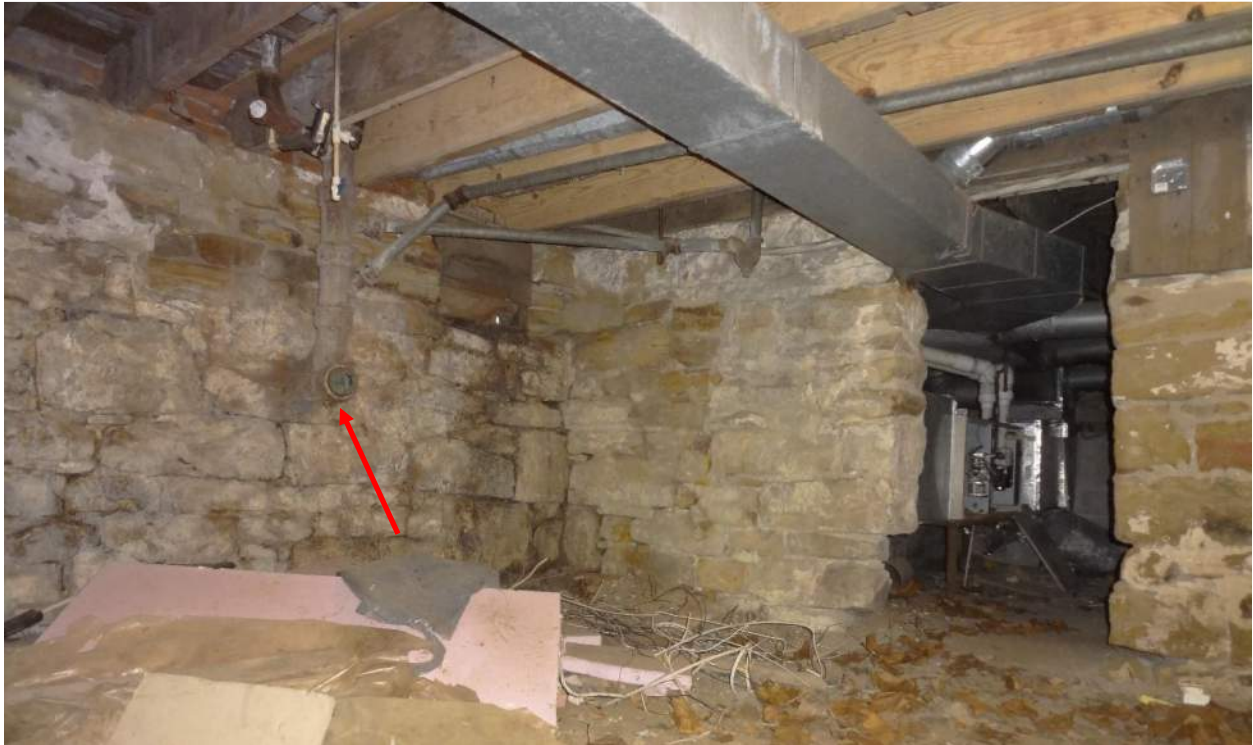
Figure P3. Sanitary waste pipe exiting through west foundation wall, Basement Room 005. (DS 2016)

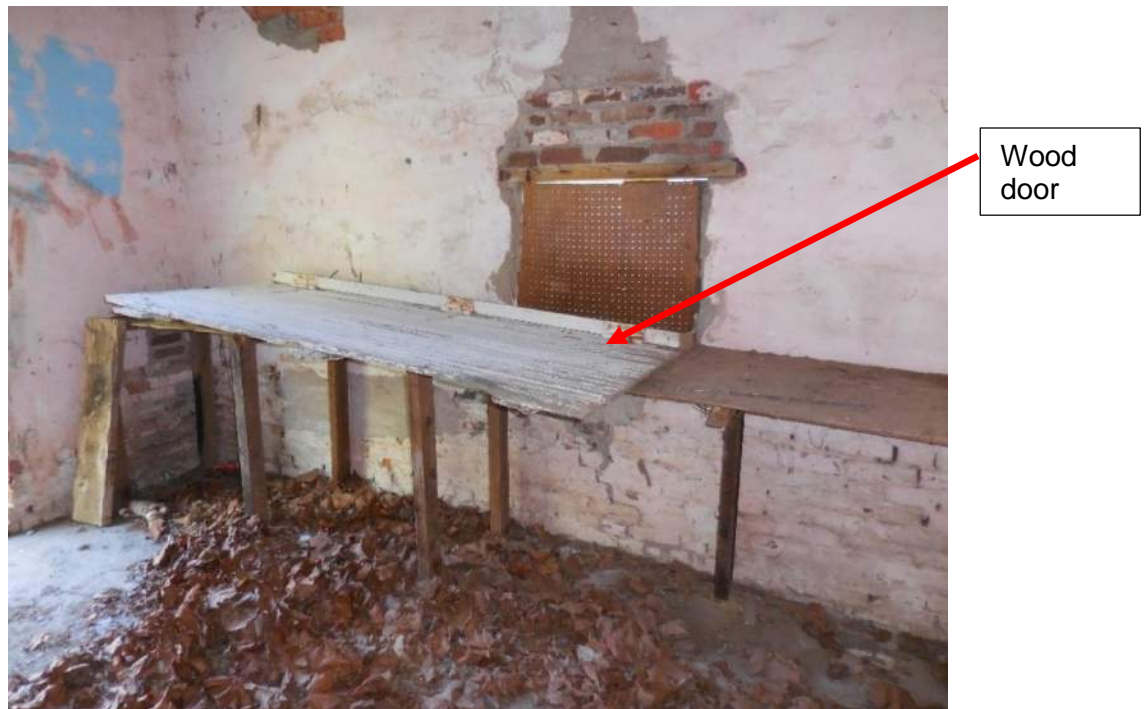
Figure MH.22. Interior, looking east. The door is now missing. (Strata 2016)

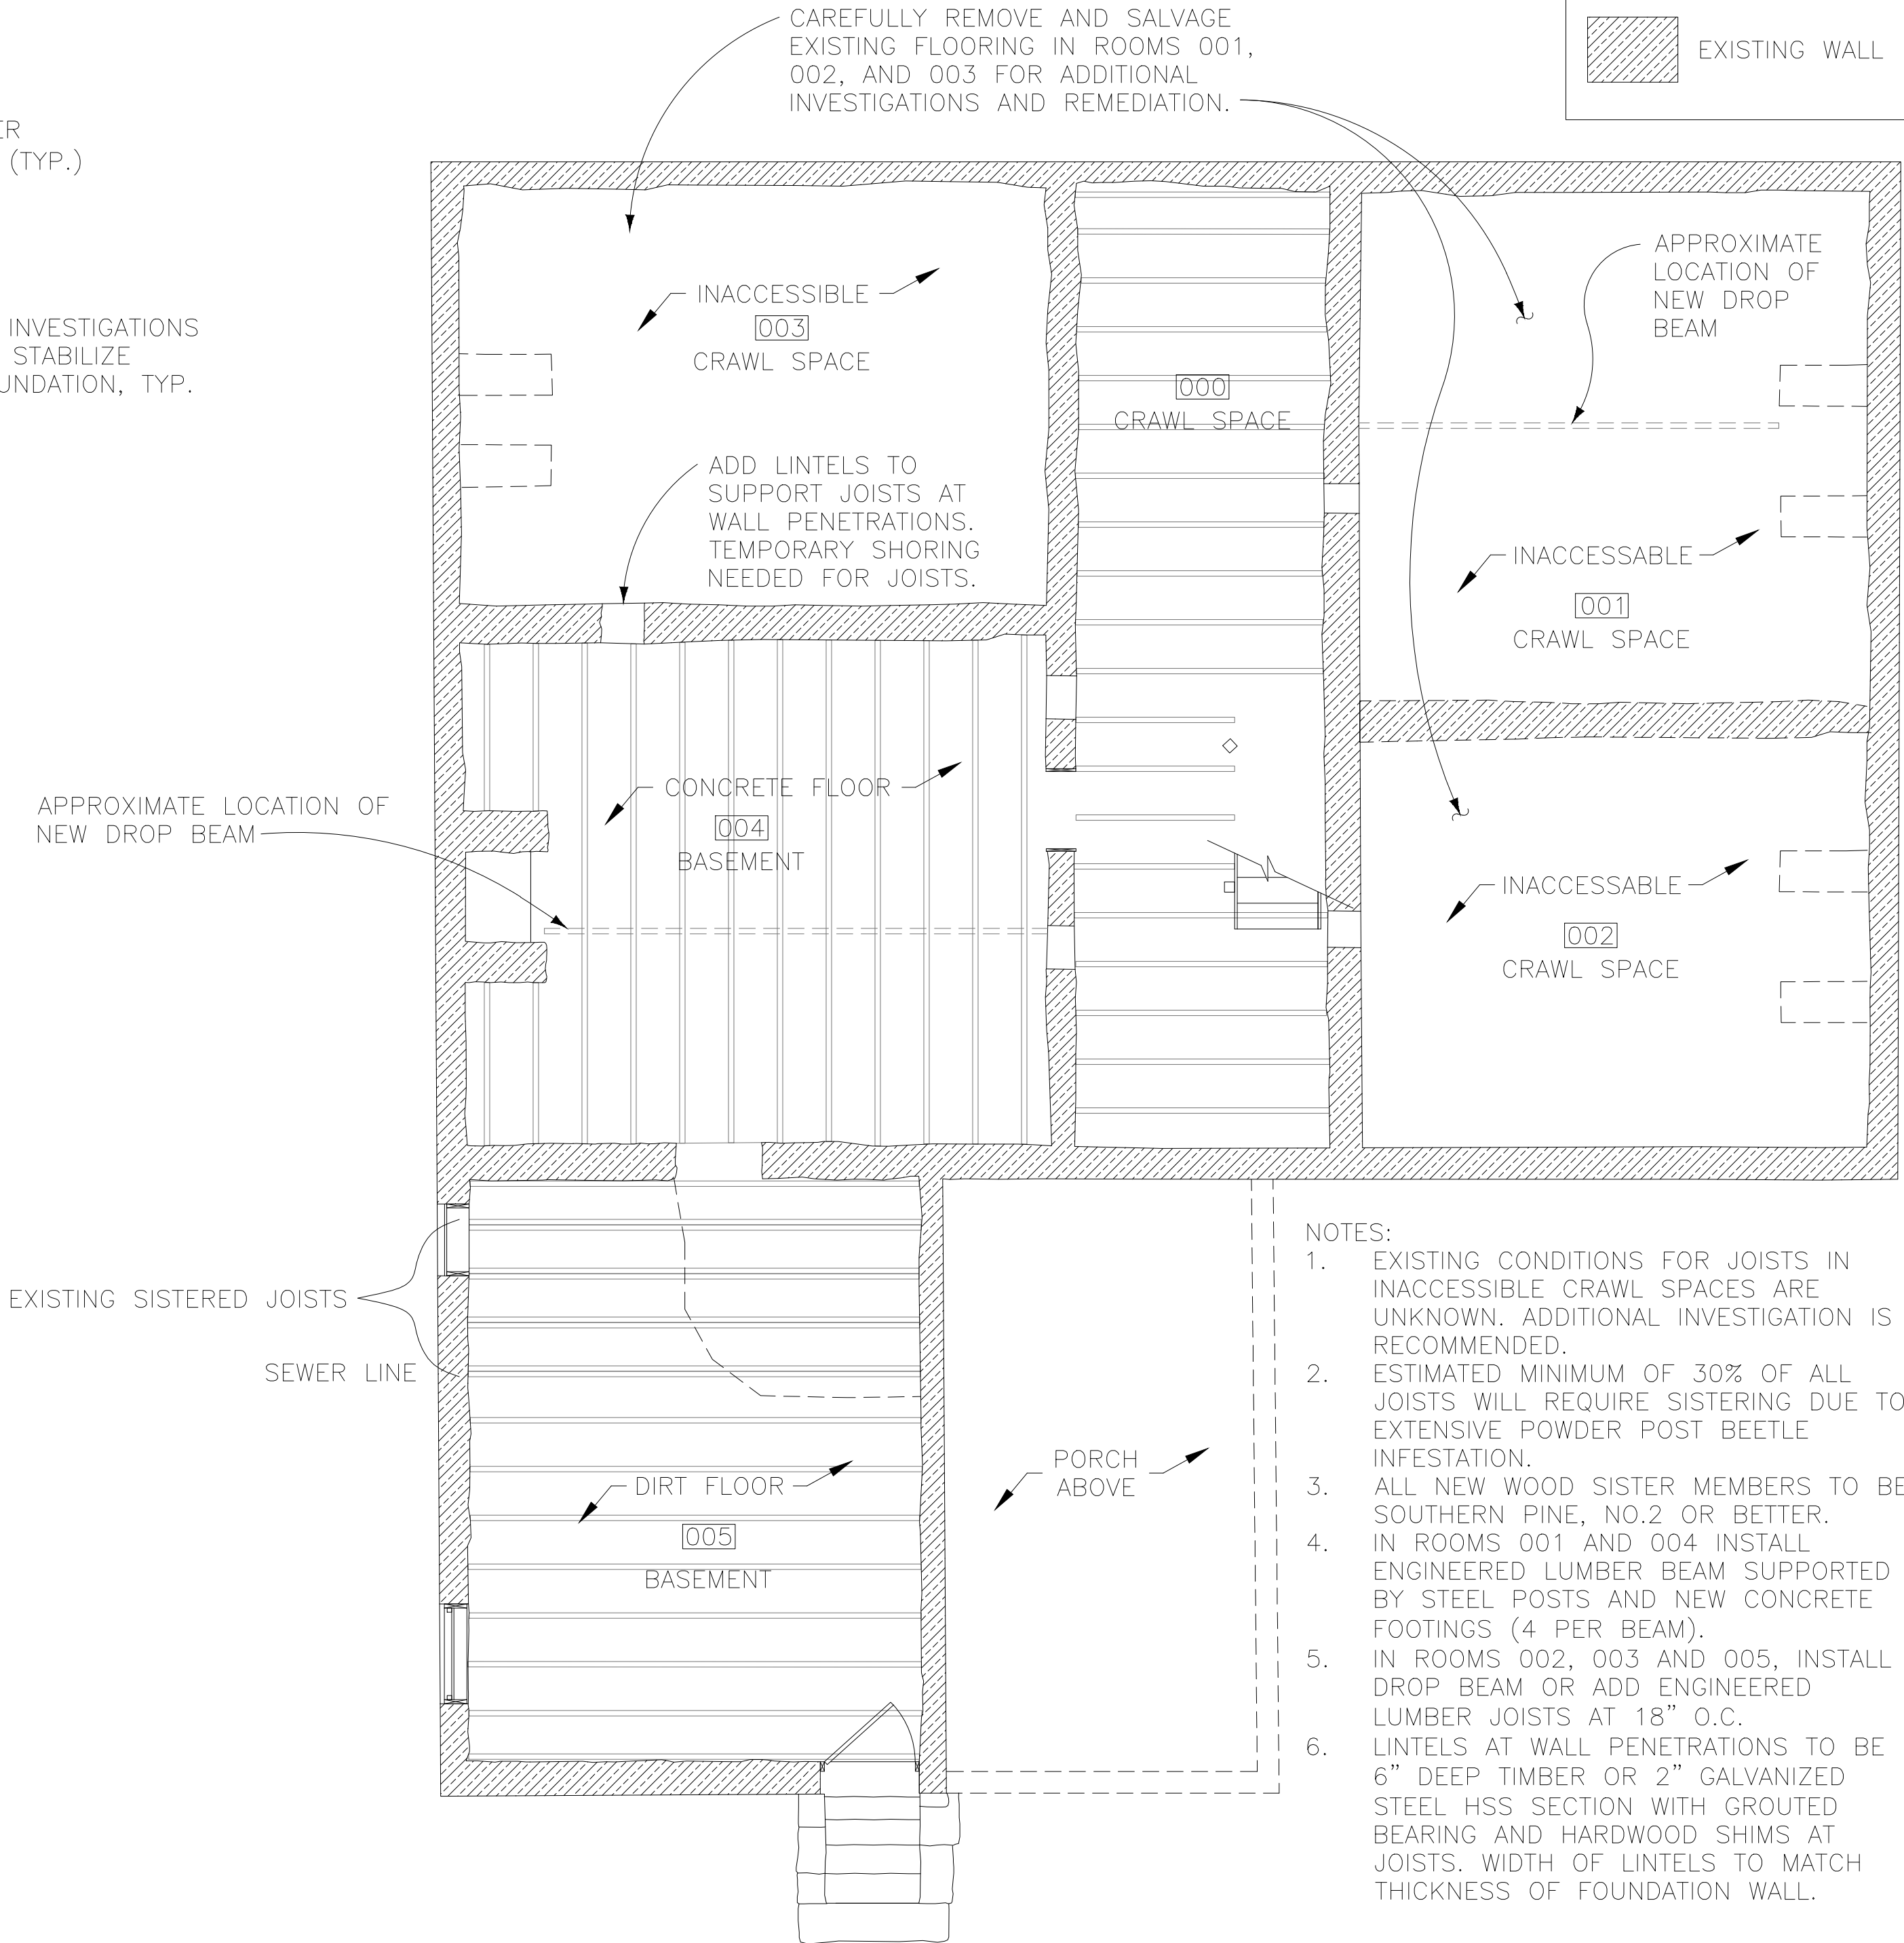
- NOTES:
1. EXISTING CONDITIONS FOR JOISTS IN INACCESSIBLE CRAWL SPACES ARE UNKNOWN. ADDITIONAL INVESTIGATION IS RECOMMENDED.
 2. ESTIMATED MINIMUM OF 30% OF ALL JOISTS WILL REQUIRE SISTERING DUE TO EXTENSIVE POWDER POST BEETLE INFESTATION.
 3. ALL NEW WOOD SISTER MEMBERS TO BE SOUTHERN PINE, NO.2 OR BETTER.
 4. IN ROOMS 001 AND 004 INSTALL ENGINEERED LUMBER BEAM SUPPORTED BY STEEL POSTS AND NEW CONCRETE FOOTINGS (4 PER BEAM).
 5. IN ROOMS 002, 003 AND 005, INSTALL DROP BEAM OR ADD ENGINEERED LUMBER JOISTS AT 18" O.C.
 6. LINTELS AT WALL PENETRATIONS TO BE 6" DEEP TIMBER OR 2" GALVANIZED STEEL HSS SECTION WITH GROUTED BEARING AND HARDWOOD SHIMS AT JOISTS. WIDTH OF LINTELS TO MATCH THICKNESS OF FOUNDATION WALL.
