Appendix A: Paint Analysis Report

MICROSCOPICAL PAINT AND COLOR ANALYSIS

Minuteman Missile National Historic Site

Historic Structures Report/Cultural Landscape Report/Environmental Assessment

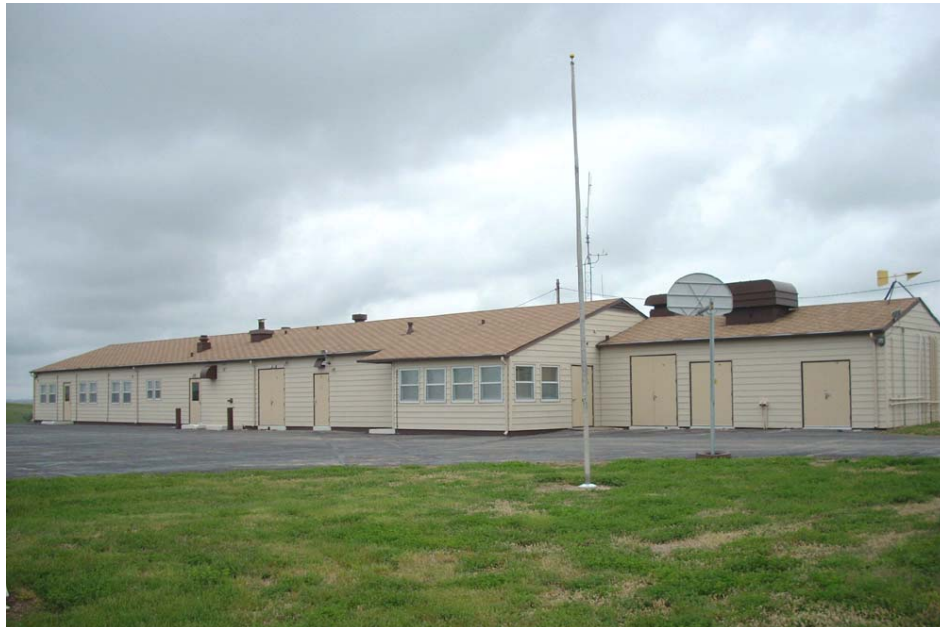
In the late 1990's, the metal door trim and ventilation hoods were painted dark brown. The metal doors were painted grayish yellow. The ca. 1980's pre-finished metal siding retained its original yellowish gray color and the windows were painted white. (See photo below taken in June 2009.)

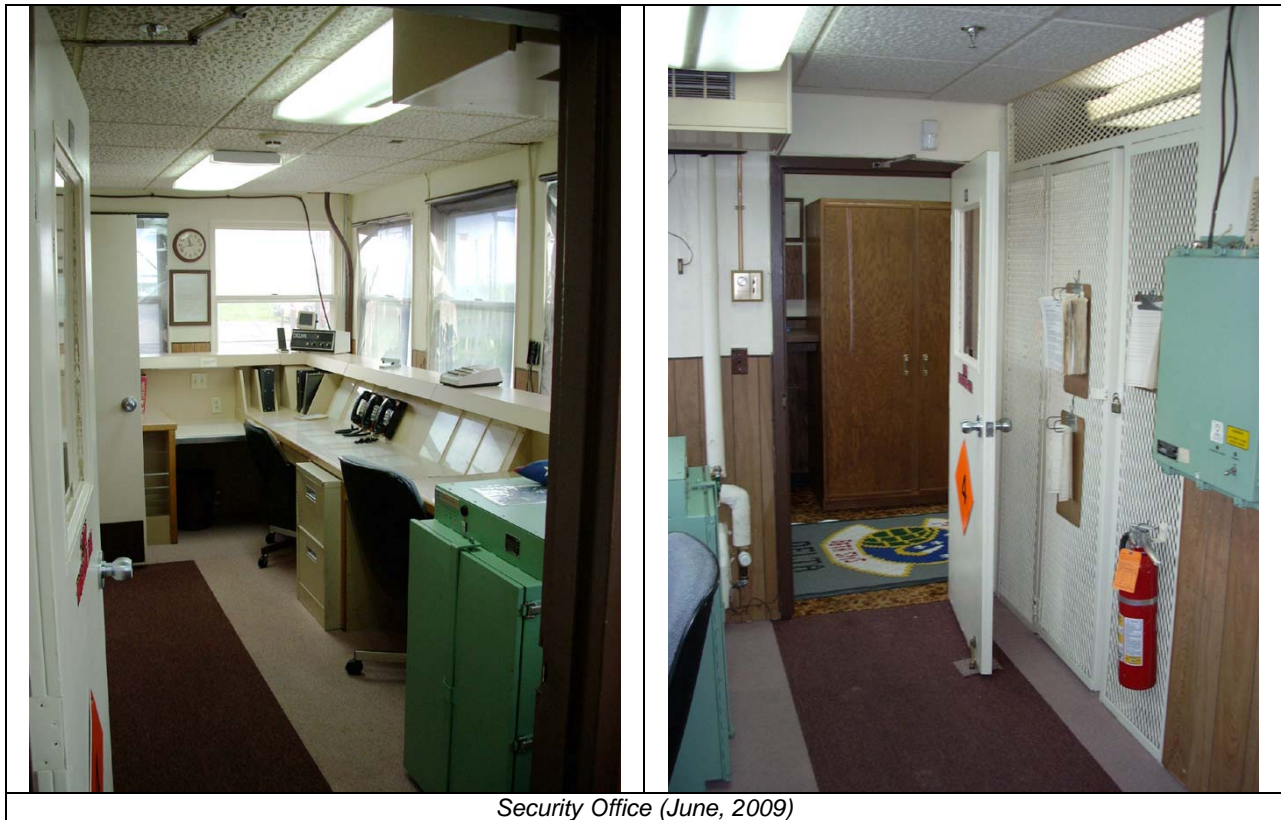
Security Office (June, 2009)

In this small but most visible interior space the original specifications called for light green walls and trim, a green wainscot and a white ceiling. Our analysis discloses that these colors were actually used. In 1973, the specified colors were spring green on the trim, doors and wainscot, green on the walls and white on the ceiling. Once again, these colors were in fact used. In the most recent painting of the room, everything was painted white with the exception of the dropped ceiling and the small alcove space separated by a metal screen partition. The walls in this alcove space were painted dark brown. We were not able to take samples from the wainscot, as it was not accessible because of the console and also the wainscot paneling.

Of all the rooms investigated, this room has been repainted the most – approximately a dozen times with the exception of the metal door to the Entrance Shaft Vestibule. This door has been painted almost twice as many times as the other features in the room. By-and-large the color schemes evolved from light greens to medium greens to a medium blue, then dark brown and orange yellow in the mid-to-late 1900's until arriving at the present simplified scheme of all white. The complete layer structure on the eight samples taken in this space is presented in the appended laboratory data.

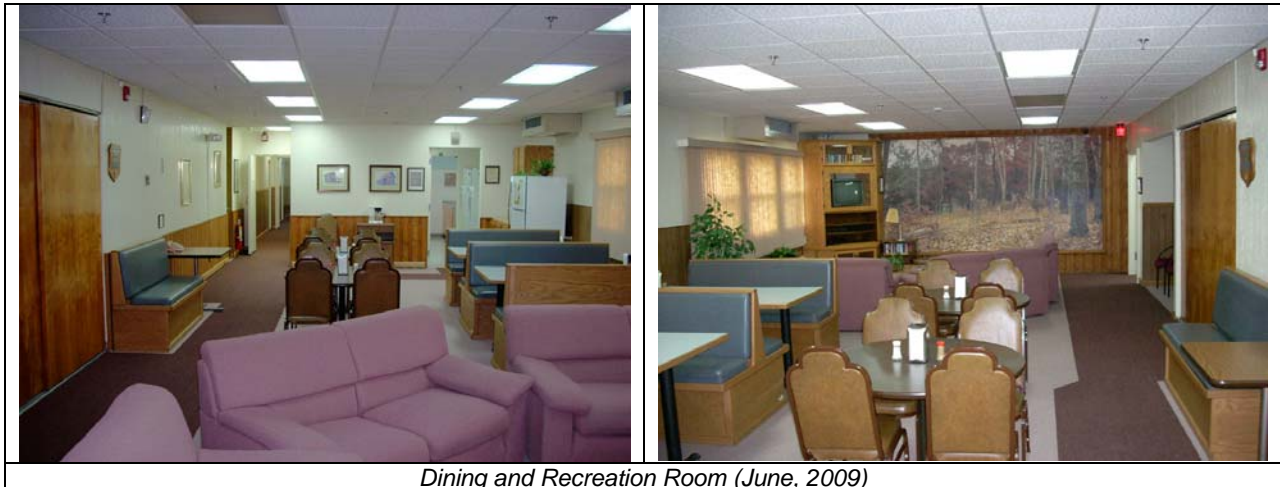
Dining and Recreation Room (June, 2009)

In this large gathering space the original specifications called for light tan trim, a different light tan for walls, and off white on the ceiling. None of the specified colors were used. A different light tan was used on the trim, doors and walls, and a different white was used on the ceiling. In 1973, the specified colors were sand on the trim and doors, buff on the walls, and white on the ceiling. None of these colors were used. Instead one shade of light green was used on both the doors, trim and walls and the ceiling was painted a different white. In the most recent painting of the room, everything was painted white with the exception of the ceiling which now has a dropped ceiling installed.

Over the years the color schemes evolved from light and medium greens to yellowish whites and whites. Wallpaper in imitation of grass cloth was installed on the walls in the mid-to-late 20th century. It was removed and the walls painted white in the late 1990's – at the same time that the dropped ceiling was installed. The wallpaper survives above the dropped ceiling and also around the water cooler on the south wall.

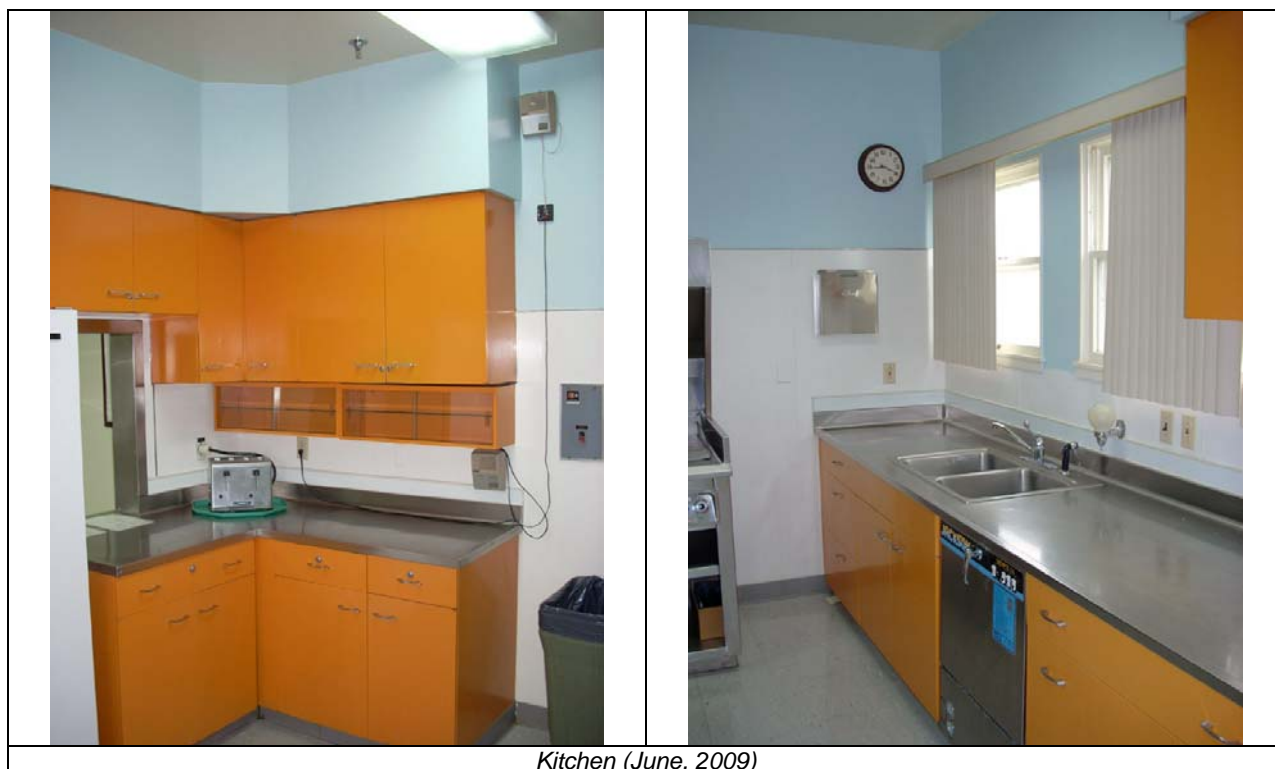
Kitchen (June, 2009)

Over the years the color schemes evolved from light to yellowish whites and whites. The light blue on the walls is a very recent change. The painted masonite on the walls may or may not be original; it is impossible to know without removal of a small section to ascertain whether or not the walls behind are painted. Painted masonite panels were available in the 1960's. They are painted white now.

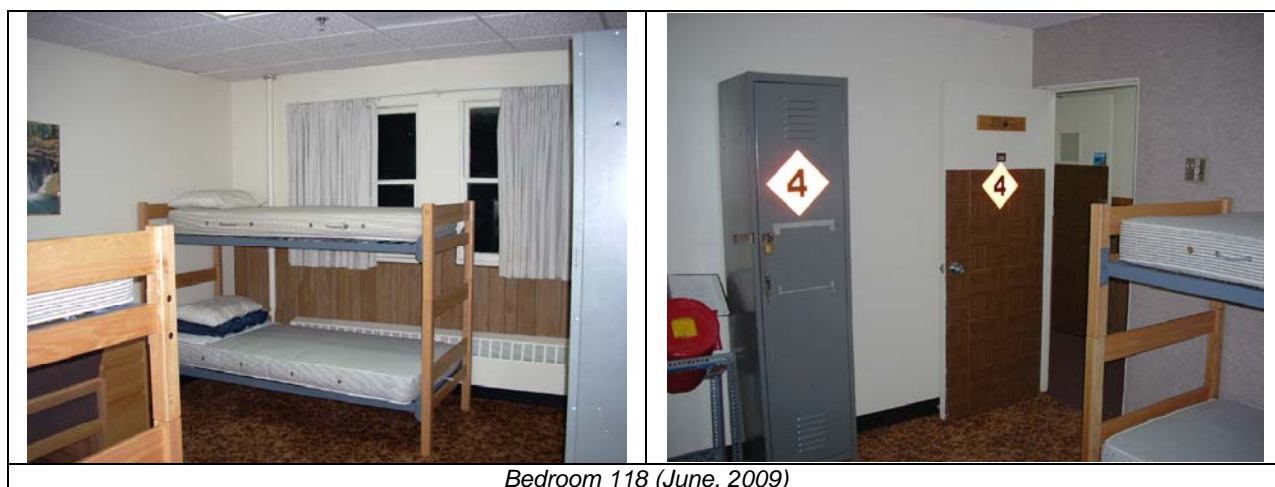
Bedroom 118 (June, 2009)

In this bedroom the original specifications called for light tan on the walls and trim and white on the ceiling. These colors were used. In 1973, they specified the same colors as in 1962. These colors; however, were not used. The walls and trim were painted light green; the ceiling white. In the most recent painting of the room, everything was painted white with the exception of the ceiling, which now has a dropped ceiling installed and the window glass, which is painted black.

Like other rooms, the color schemes in this bedroom have changed from the early light tans and greens to yellowish whites and now white.

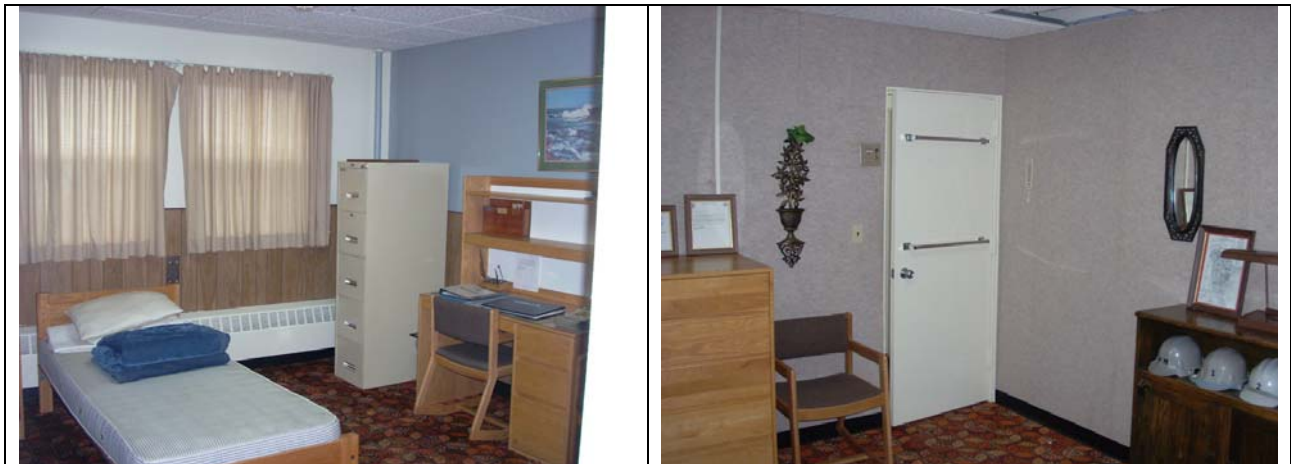
In this bedroom the original specifications called for light tan on the walls and trim and white on the ceiling. These colors were used. In 1973, they specified the same colors as in 1962. These colors; however, were not used. The walls and trim were painted light green, the ceiling white. In the most recent painting of the room, everything was painted white with the exception of the west wall that was painted a medium gray and the ceiling, which now has a dropped ceiling installed.

Like other rooms the color schemes in this bedroom have changed from the early light tans and greens to yellowish whites and now white.

Facility Manager's Bedroom (June, 2009) Note the fabric on the north and east walls and the drop ceiling.
