# **MOUNT RAINIER NATIONAL PARK**

## **SITE ASSESSMENT AND DESIGN OF ROCK BARBS, CHECK DAMS AND OTHER FLOOD DAMAGE REDUCTION MEASURES**

## **THE CARBON RIVER ROAD**

**30% DESIGN- CARBON RIVER ROAD  
FLOOD DAMAGE REDUCTION MEASURES**

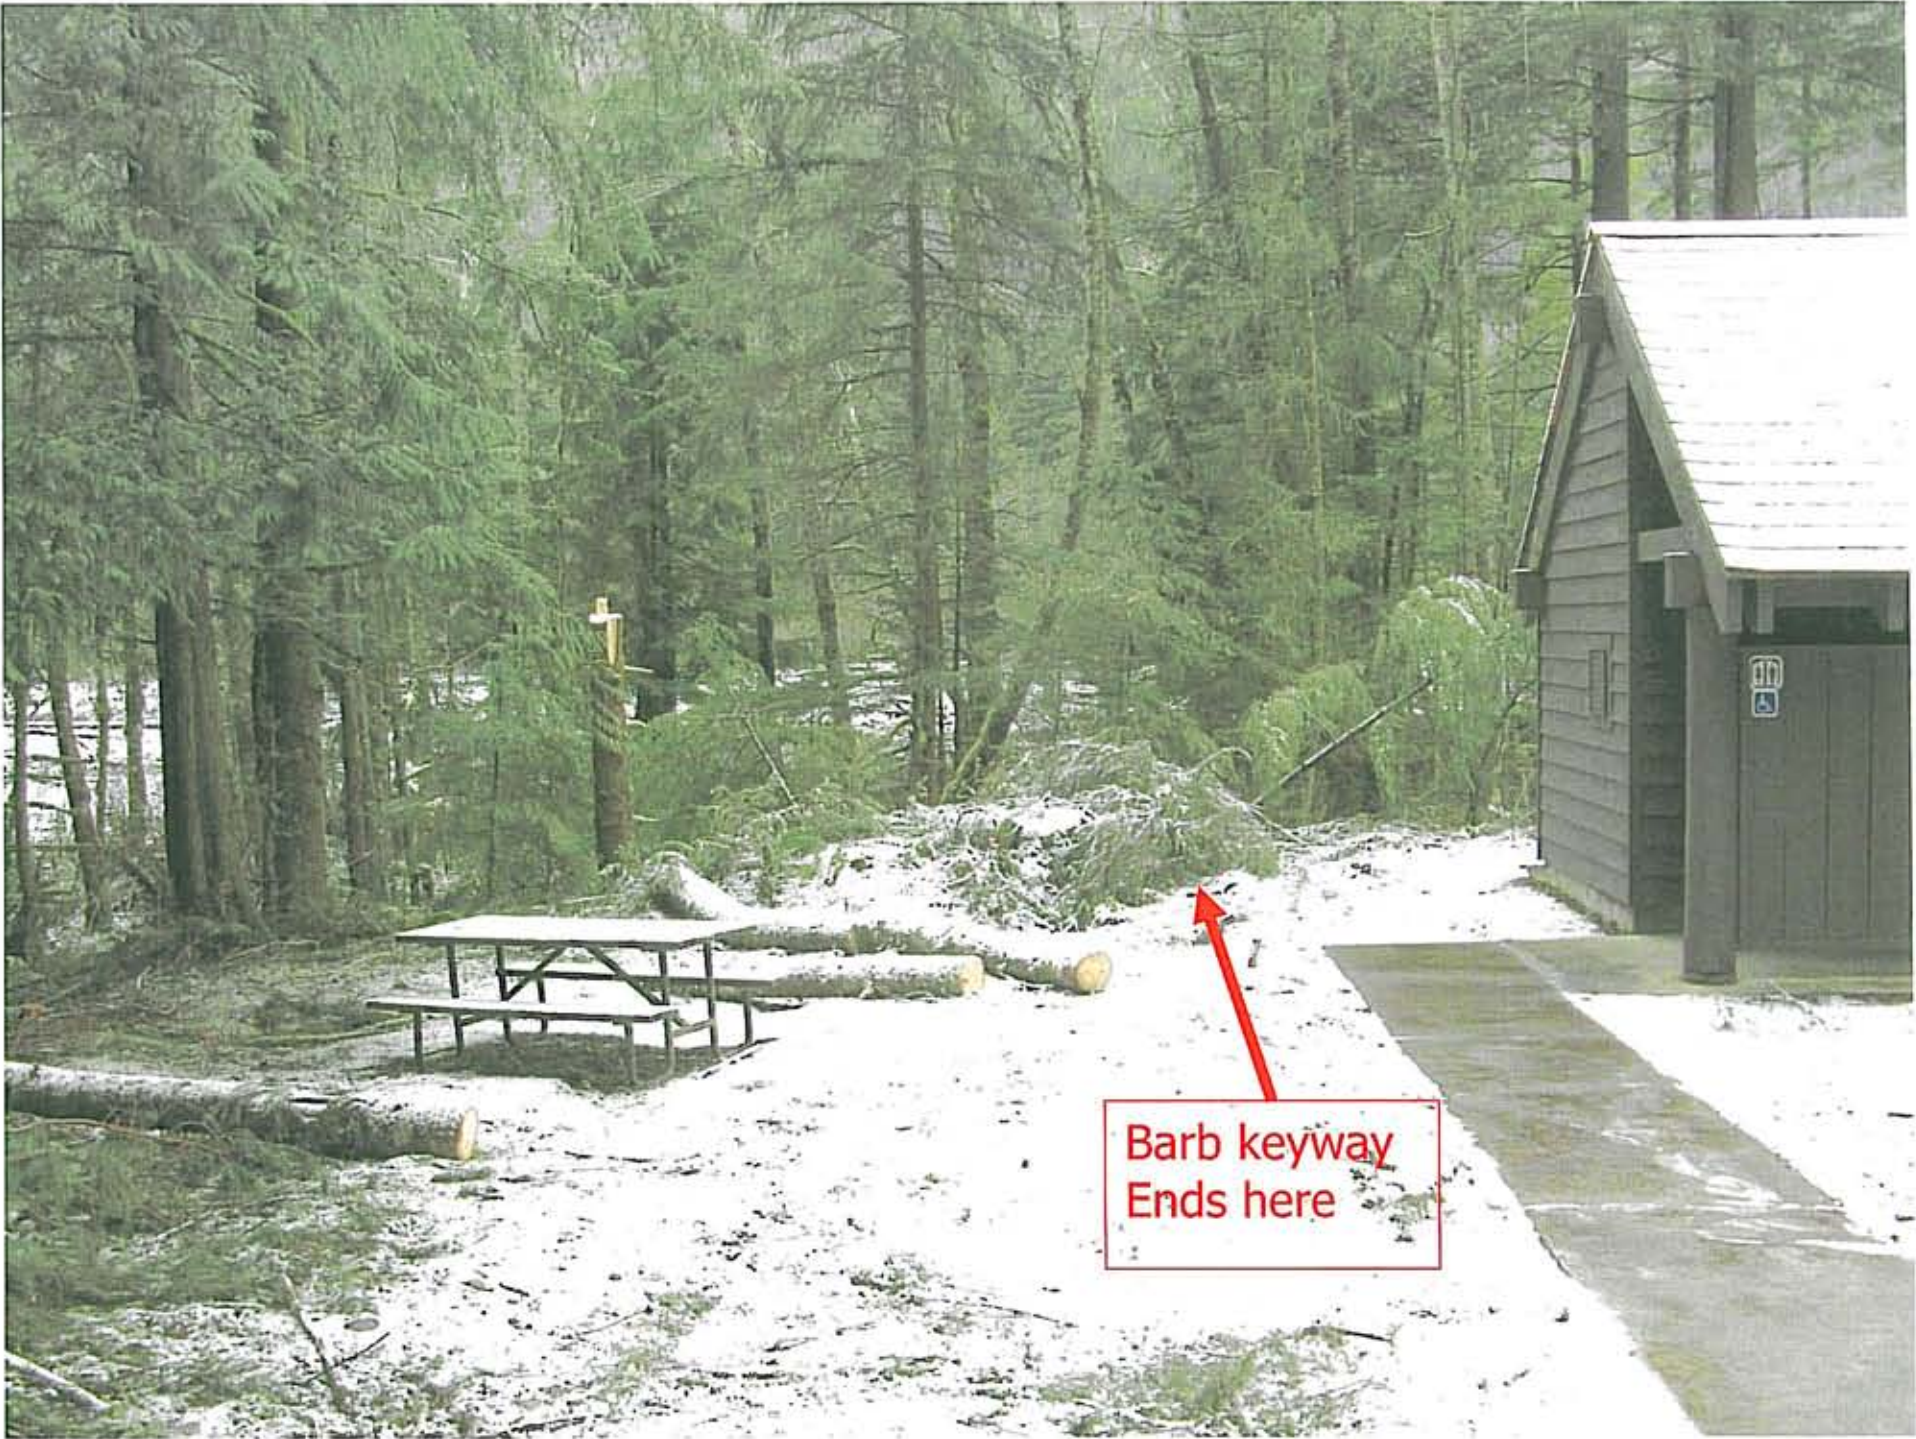
A Geomax survey indicates that the Carbon Ranger Station foundation is 5 feet above the average elevation of the adjacent gravel/cobble bar. It is however, threatened by channel migration and loss of protective trees. See Appendix A for 1997 cross-sections and discussion of this area.

Construct a bank barb north of this location, with an elevated keyway extending to the high ground adjacent to the restroom facilities. In addition, construct a 2-3 foot high dike section 100 feet long, curving around the buildings upstream. Tie into end of remaining dike. If the bank loss cannot be prevented, the buildings may eventually have to be relocated.

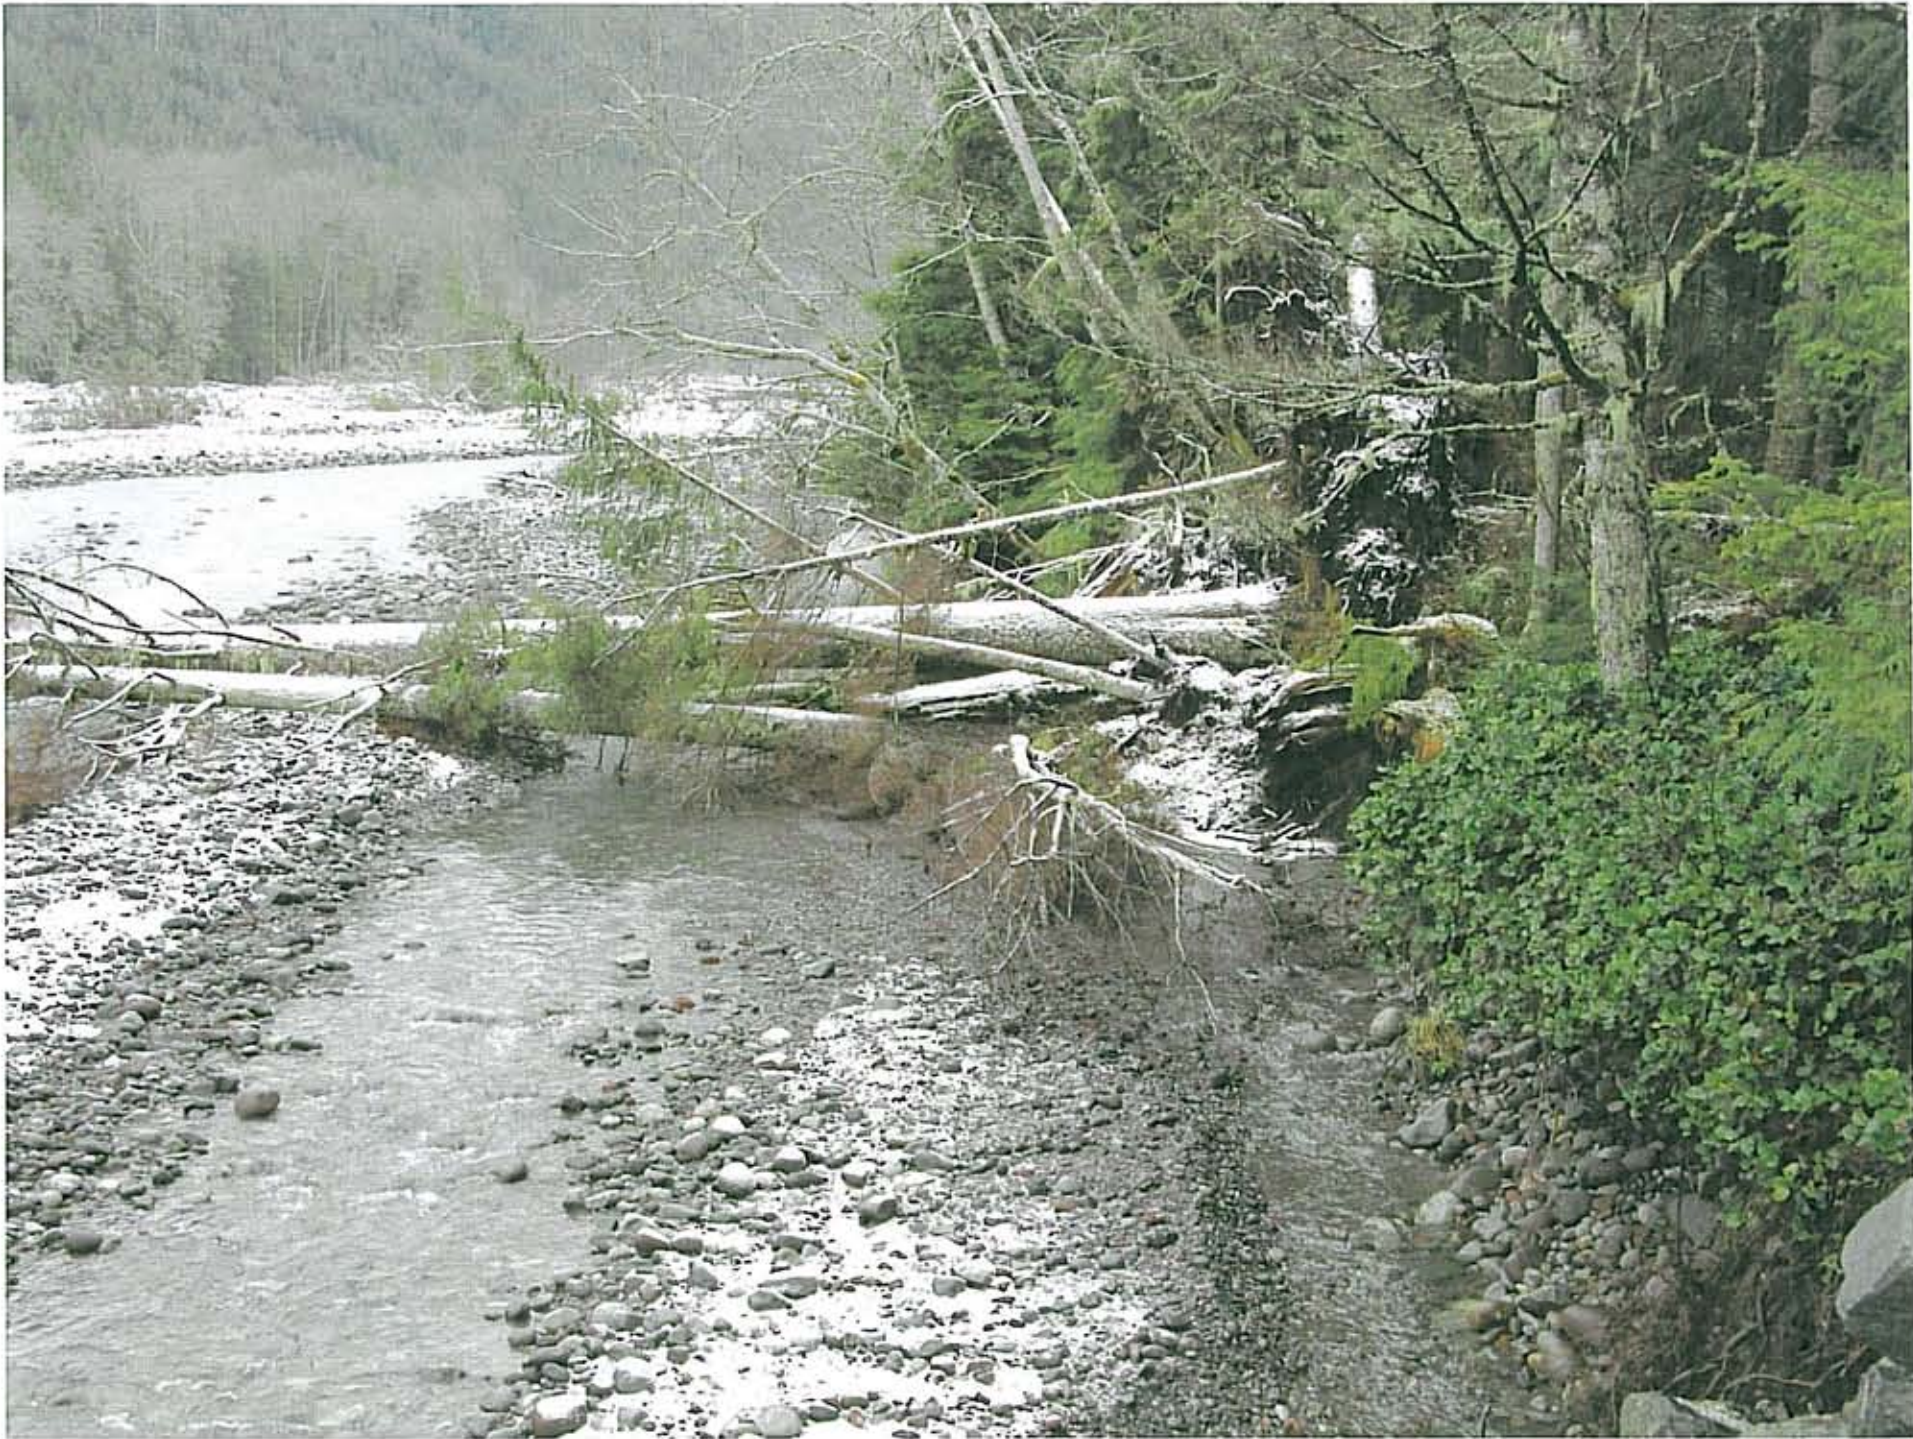
Low lying areas of the Carbon River are experiencing accelerated loss of old growth trees due to saturated ground conditions and repeated high winds. Rangers indicated that there were three high wind events in the fall/early winter of 2007 that toppled a significant number of trees in the Carbon Entrance area alone. When trees along the bank are lost, the bank stability is also lost.

As a management policy, Geomax recommends that toppled trees be used for bank protection by turning the stalks parallel to the bank and anchoring them with cable to either other trees or buried deadmen at 90 degrees. Root balls can be cut off if necessary to be able to position the trees.

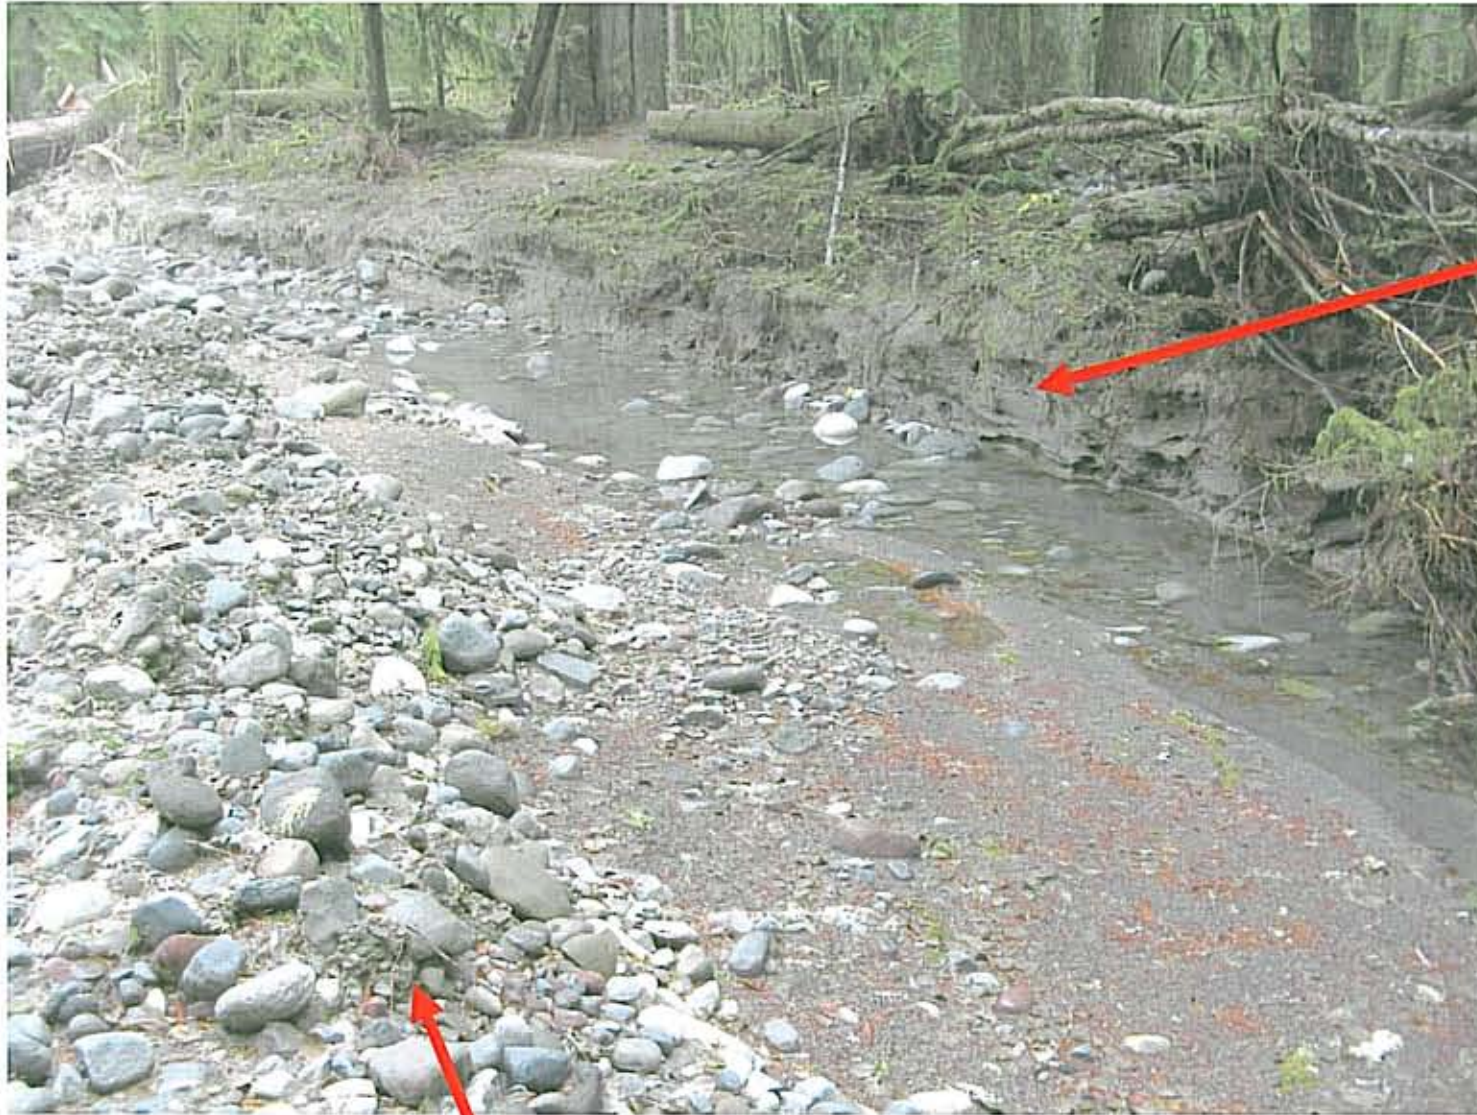
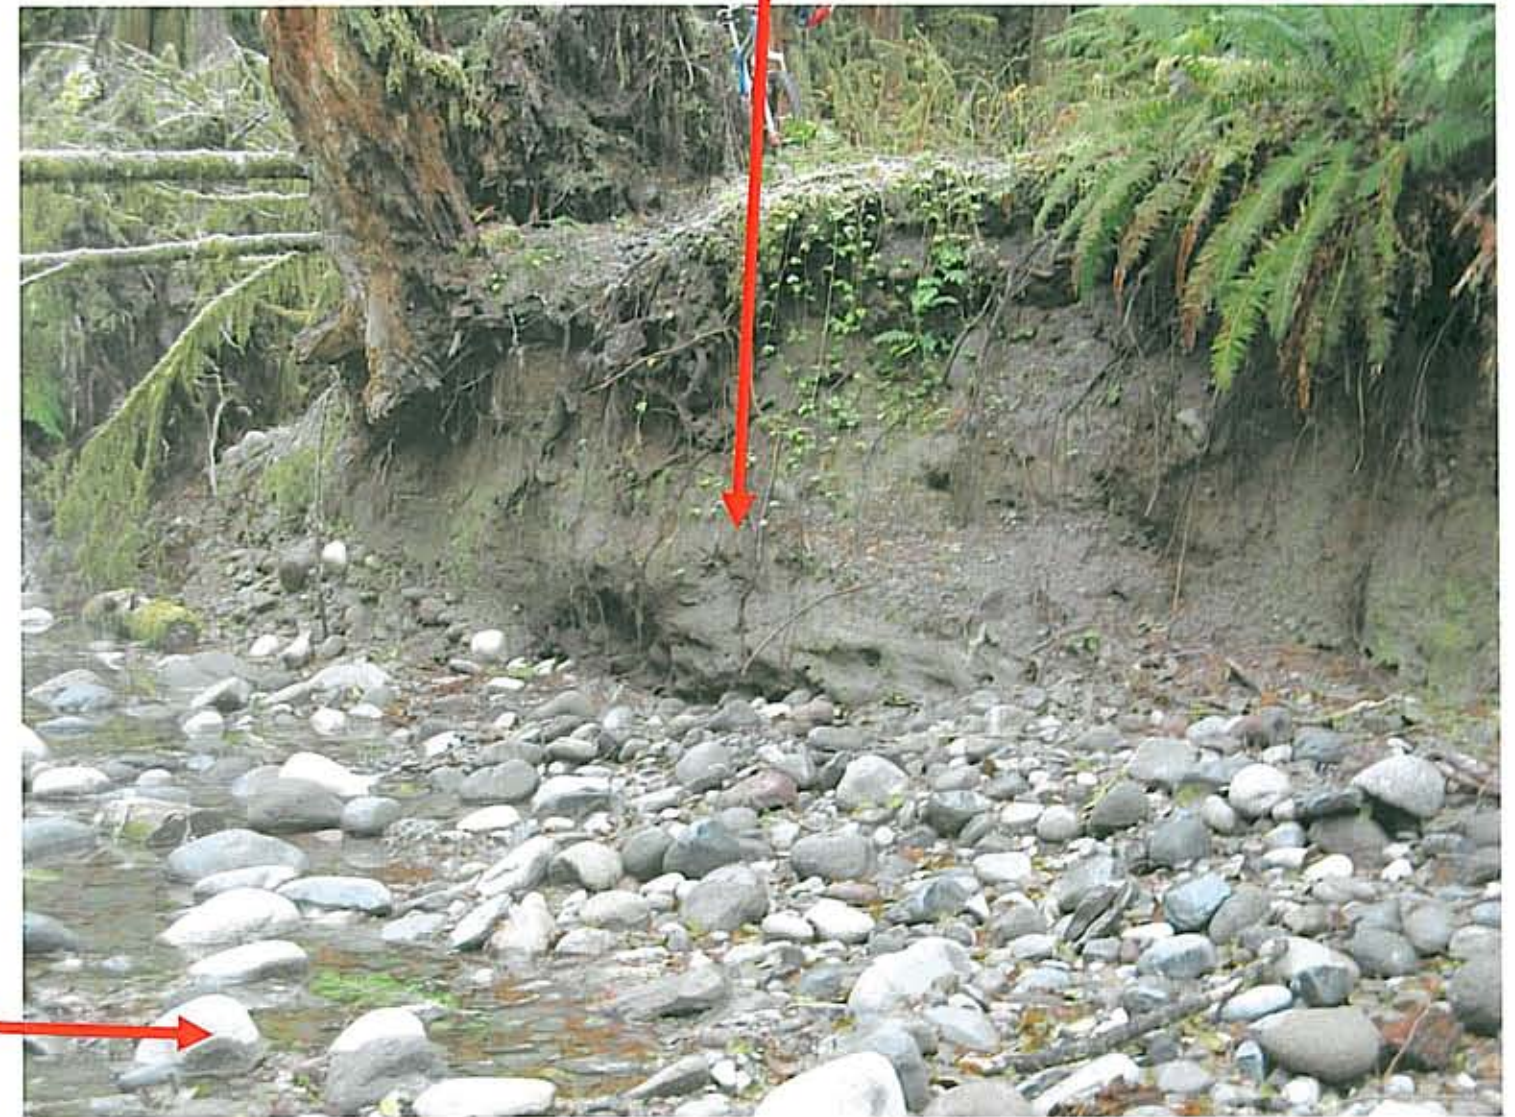
## Lateral Replacement in Falls Creek Washout

Note coarse gravel and cobble on left (north) side of photos and fine grained soils on the right (south) side

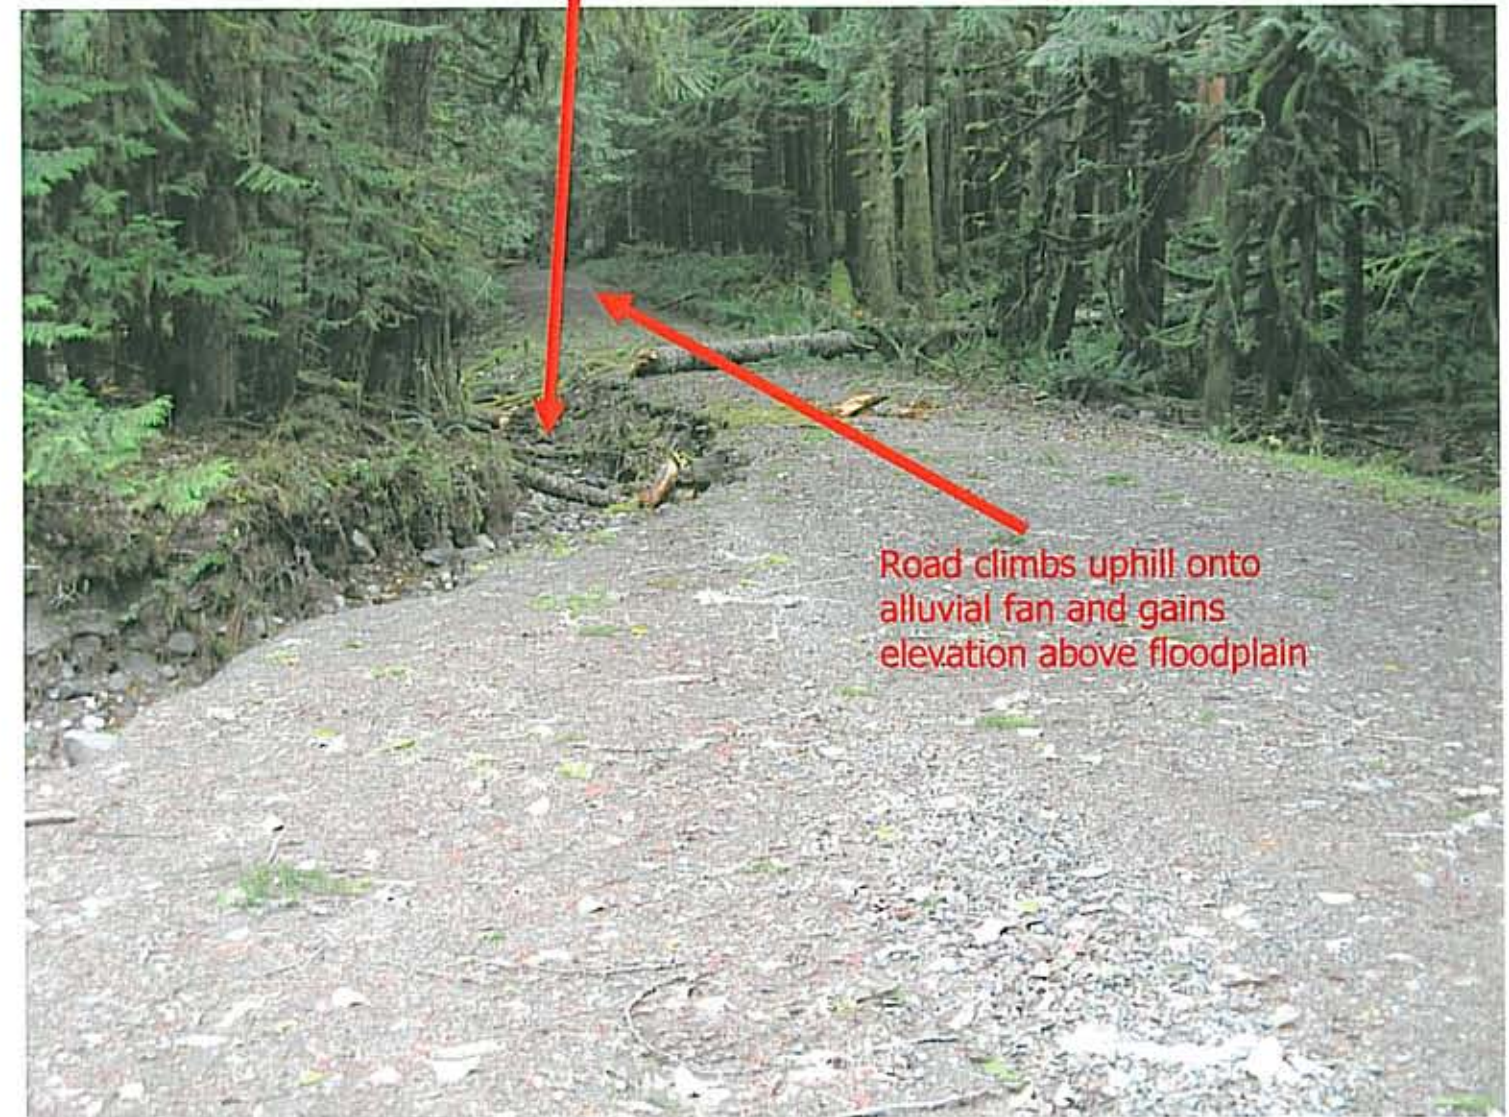
Road climbs uphill onto alluvial fan and gains elevation above floodplain

Place temporary log checks in gulley if a method can be found to allow bull trout to escape

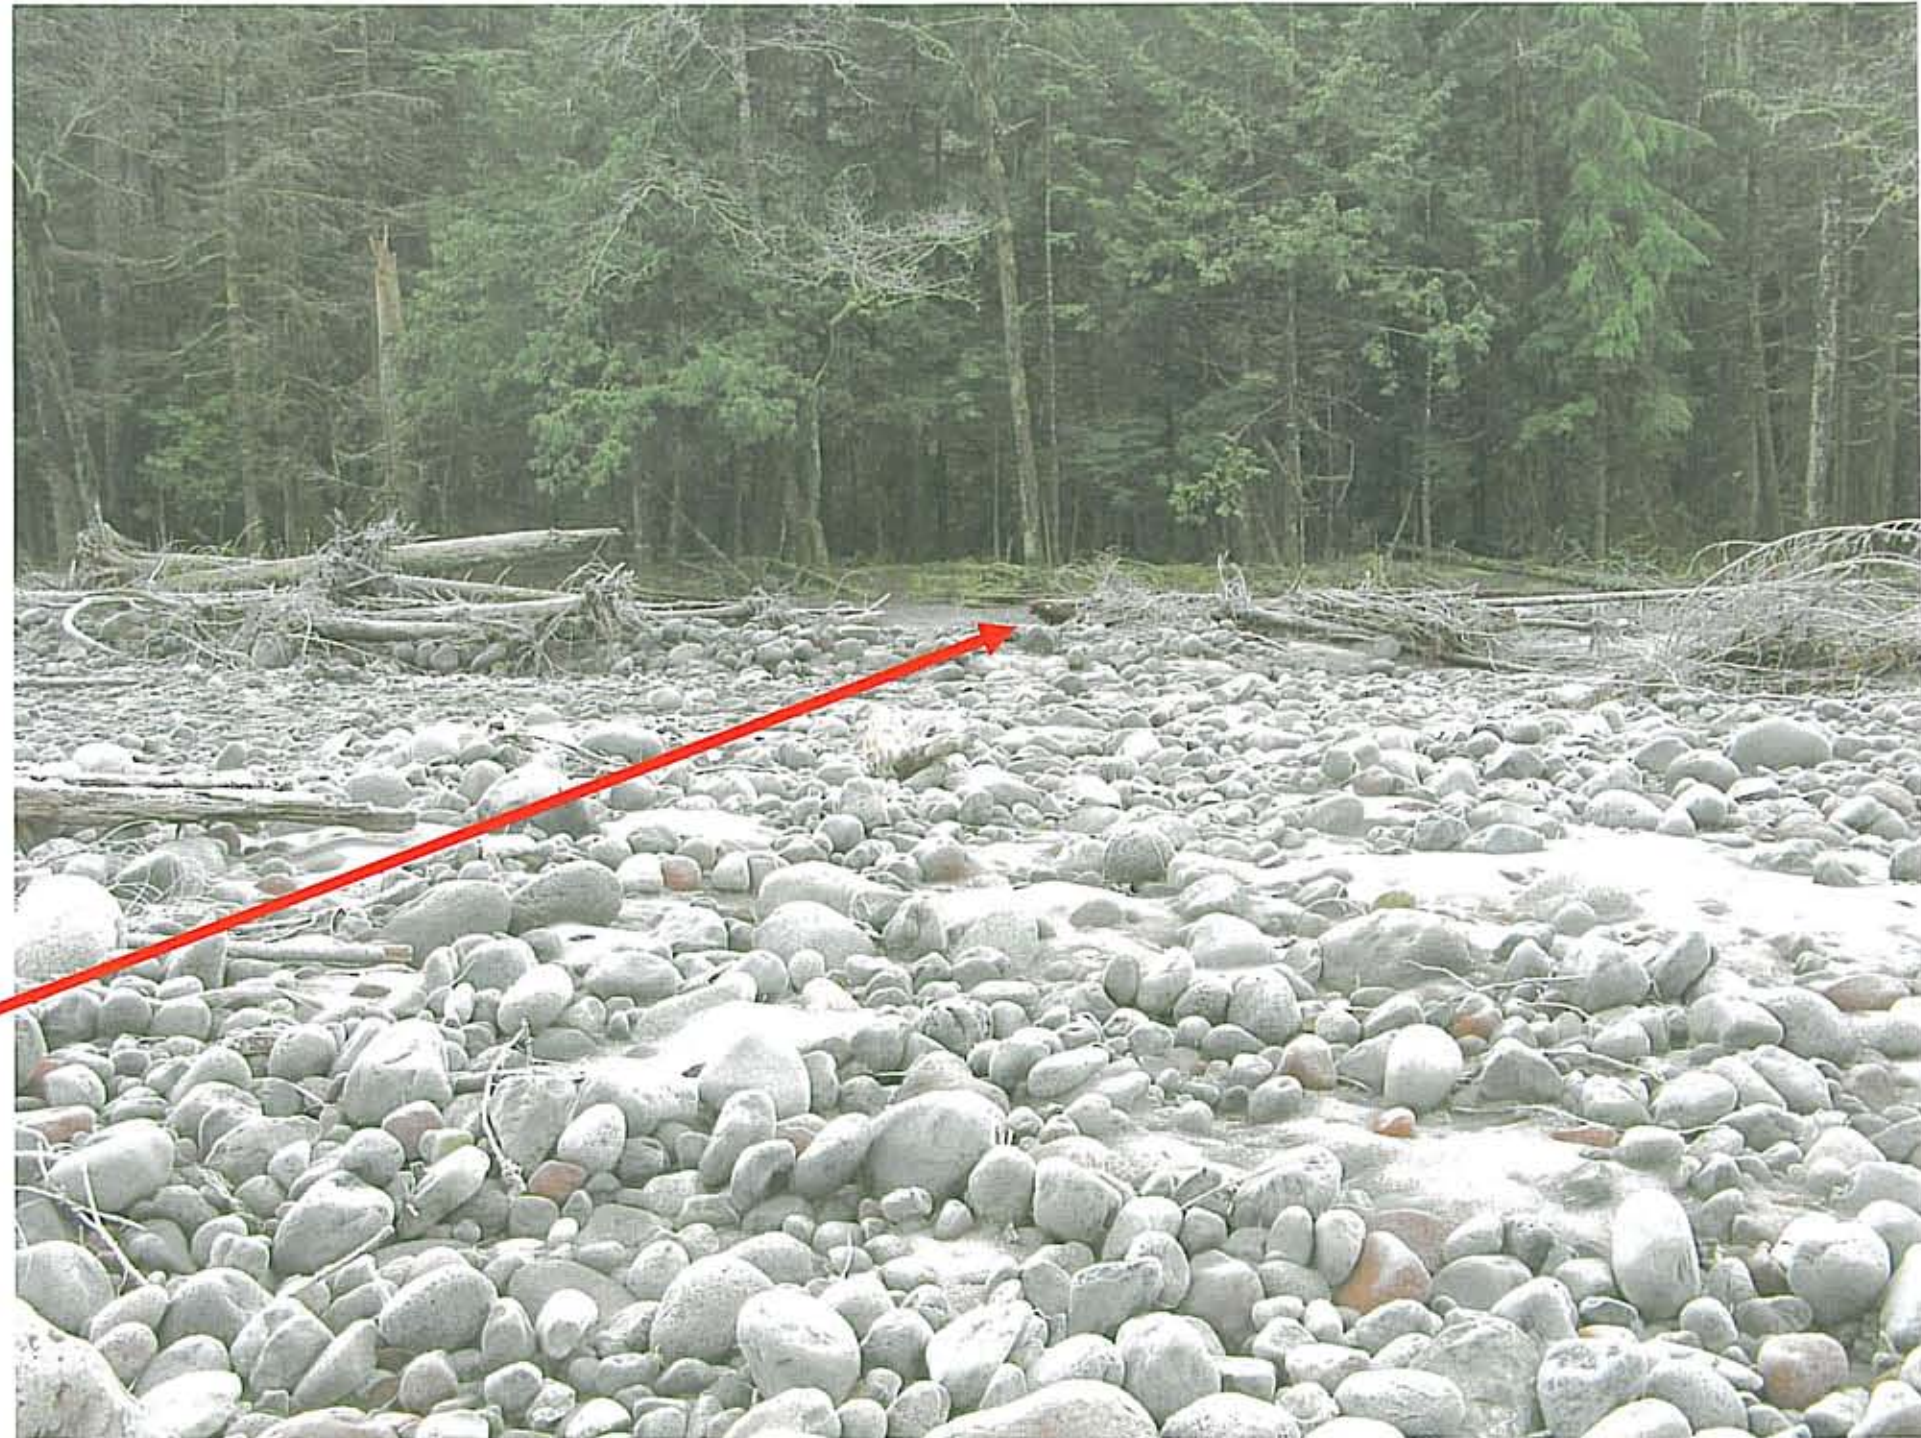
Note that river bed is almost level with the top of the bank on the south side.

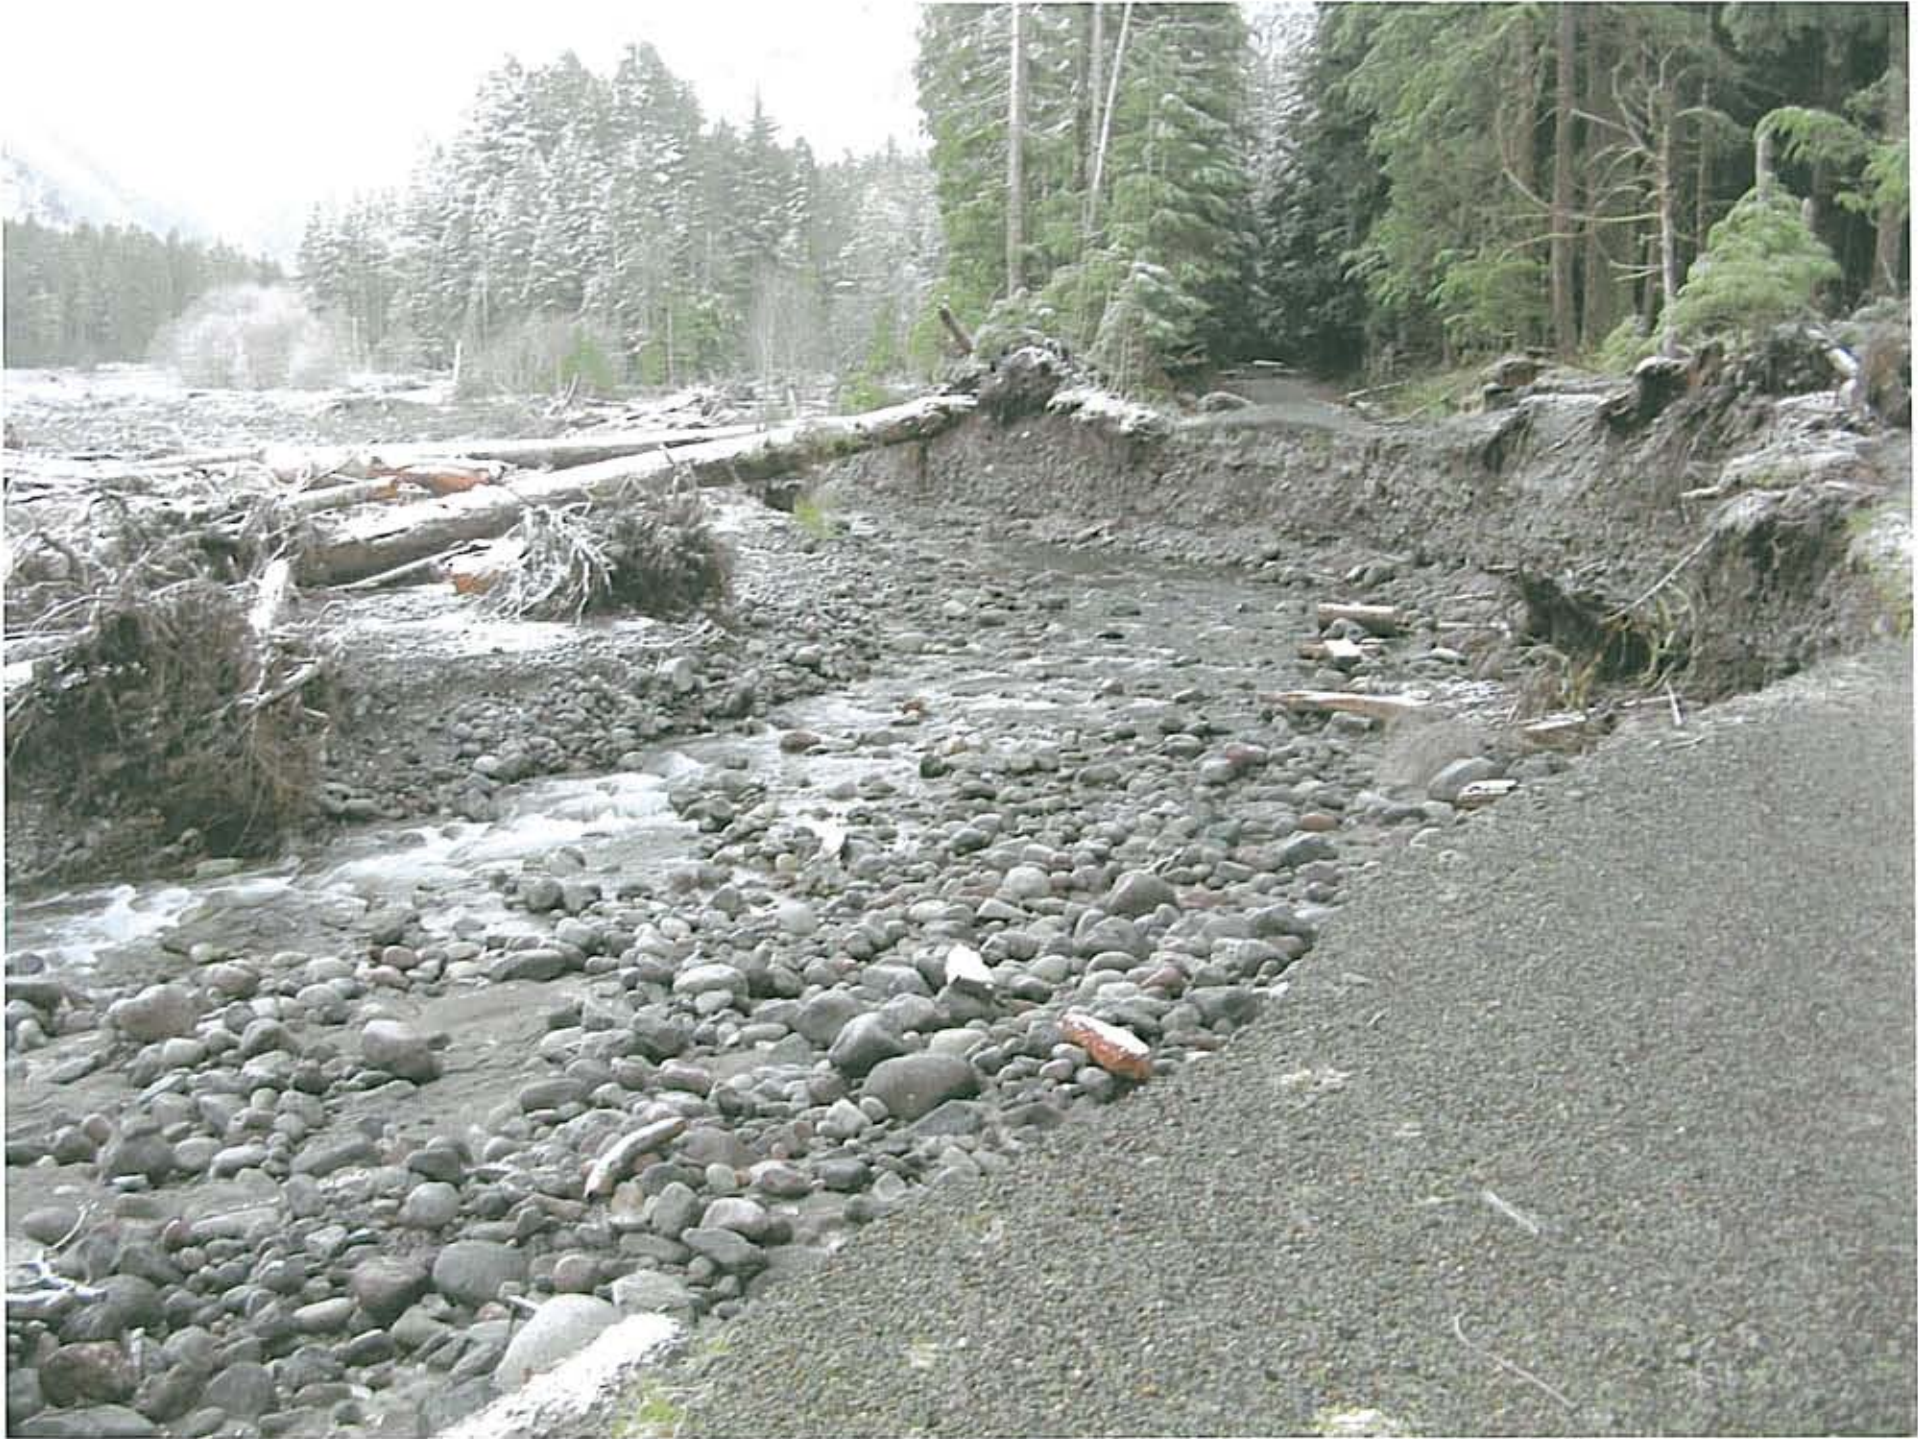
Another example of lateral replacement, where the river erodes fine roadbed soil, and leaves behind coarse river bedload.
