Calumet Unit

Keweenaw National Historical Park
Cultural Landscape Report & Environmental Assessment

Agassiz Park Existing Conditions

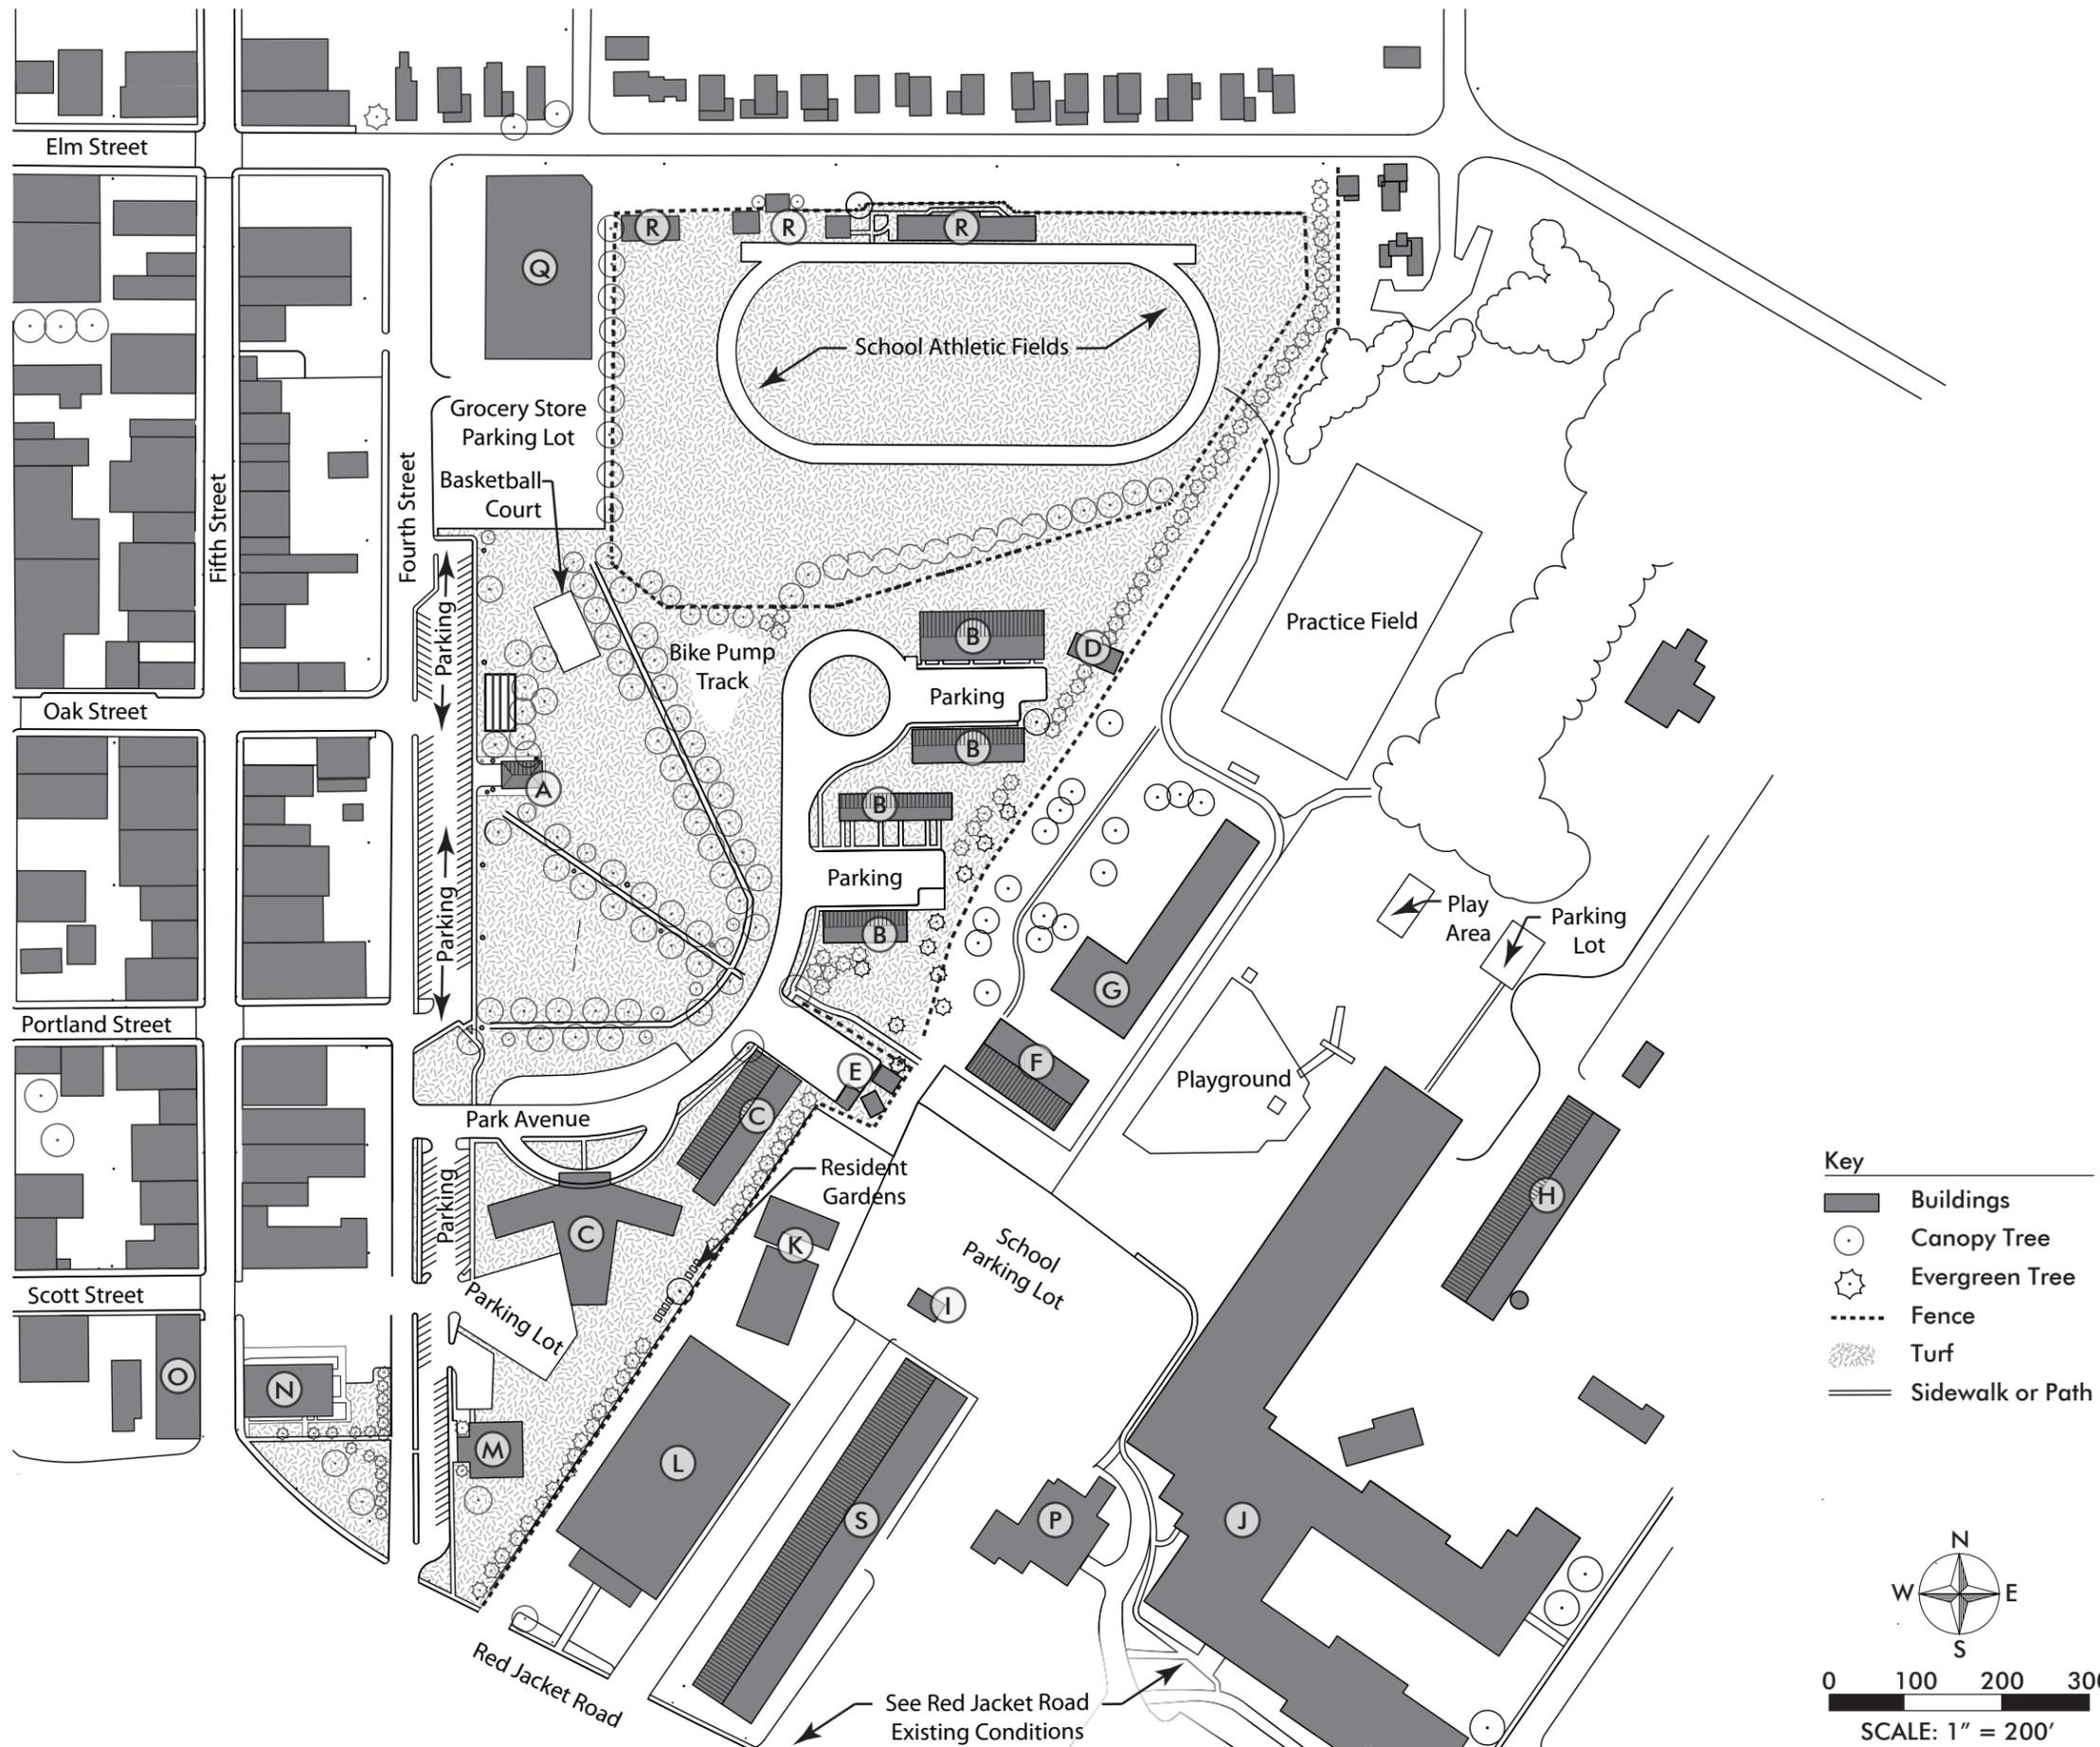
Figure III-76

Map Key	Building	Figure #	Contributing/ non-contributing	Rationale
A	Restrooms	III-78	Non-contributing	Built after 1960. Not part of Manning design for park.
B	Park Place Townhouses	III-79	Non-contributing	Four residential townhouses built in 1982. Encroaches on historic park.
C	Park Place Senior Housing Complex	III-80	Non-contributing	Two residential apartment buildings built in 1969 and 1982. Encroaches on historic park.
D	Large shed (Housing commission)		Non-contributing	Built after end of period of significance, does not reflect the historic design character. Used for maintenance purposes by Calumet Housing Commission.
E	Sheds (Housing Commission)		Non-contributing	Built after end of period of significance in location of ornamental plantings associated with the statue of Alexander Agassiz. Used for maintenance purposes by Calumet Housing Commission.
