**Scotts Bluff National Monument  
Oregon Trail Ruts Landscape Study  
and Environmental Assessment ■ 100% Report**

281 **Character Area A**

286 **Existing Condition**

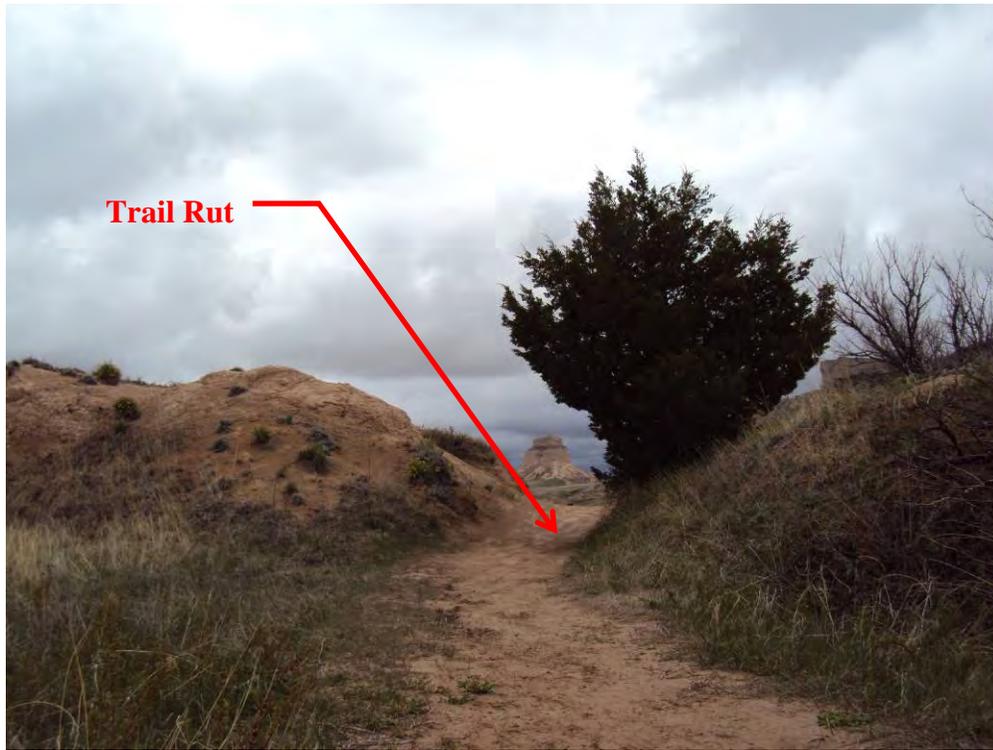
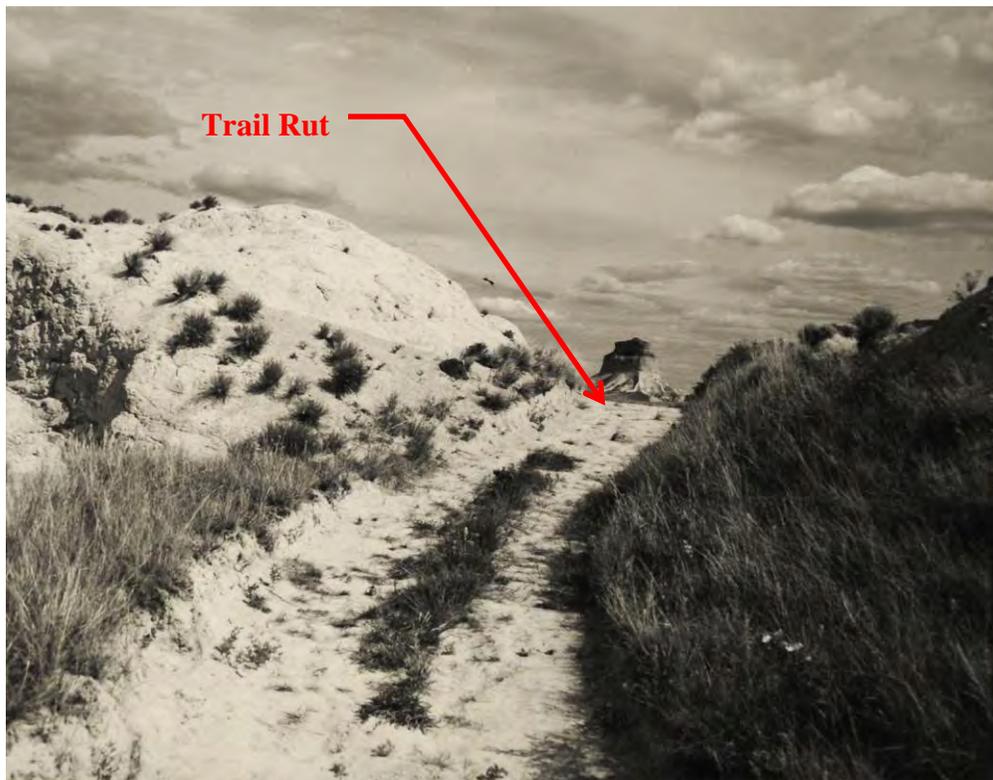
**Figure 3 - 2.** Character Area A *Above* - Trail ruts existing condition (2010) (MBD DSC\_00151.JPG); *Below* - Trail ruts looking eastward (c. 1969) (MBD DSC\_0241.jpg) (source: SCBL archives)

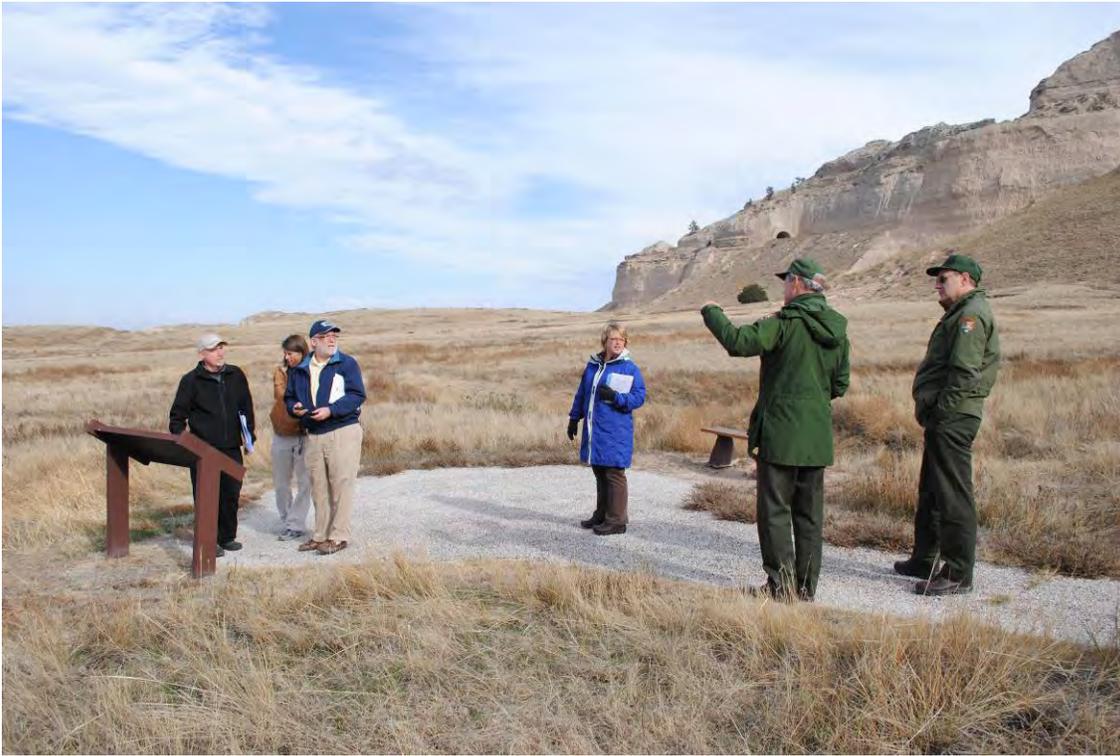
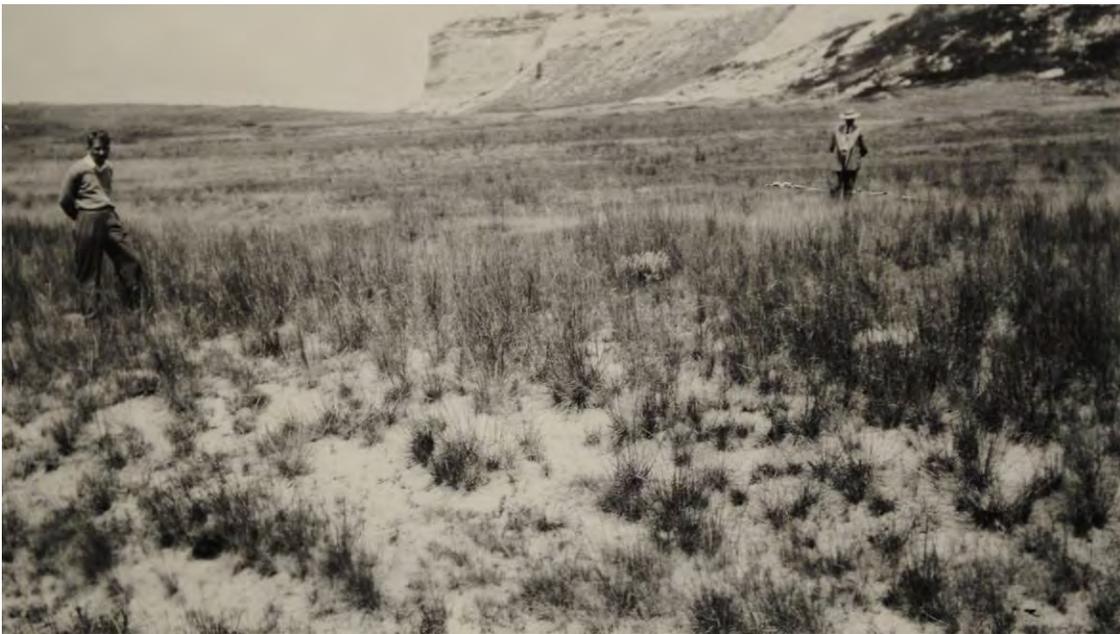
**Figure 3 - 3.** Character Area A *Above* - W. H. Jackson Campsite (2009) (MBD DSC\_0235.jpg); *Below* - W.H. Jackson Campsite (c. 1943) (MBD DSC\_0035.JPG) (source: SCBL archives)

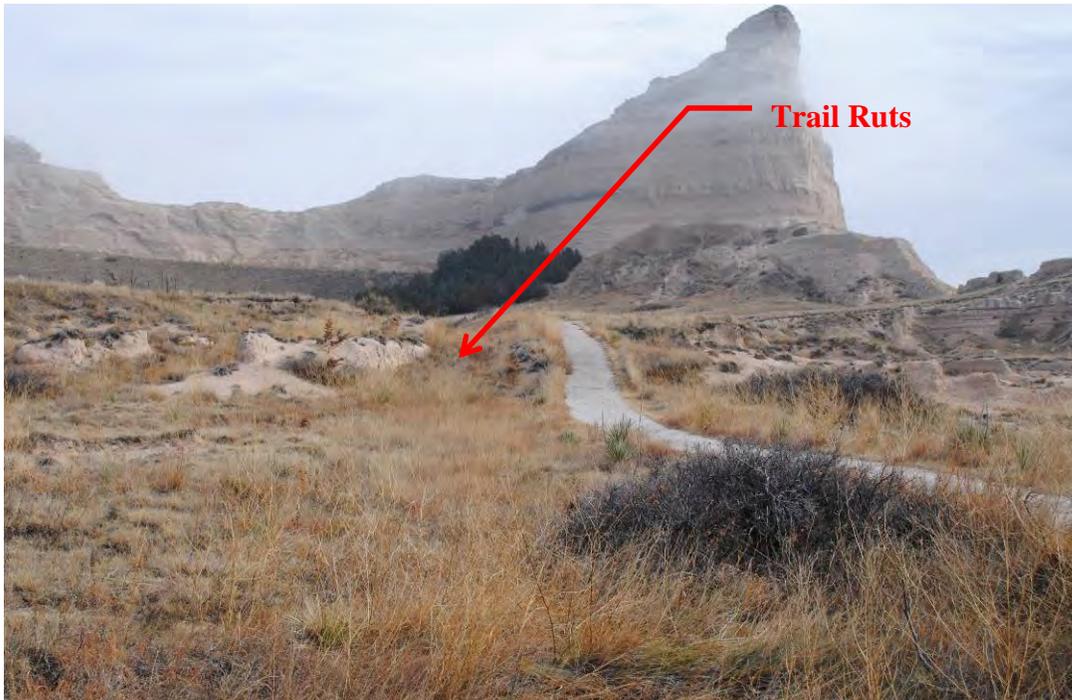
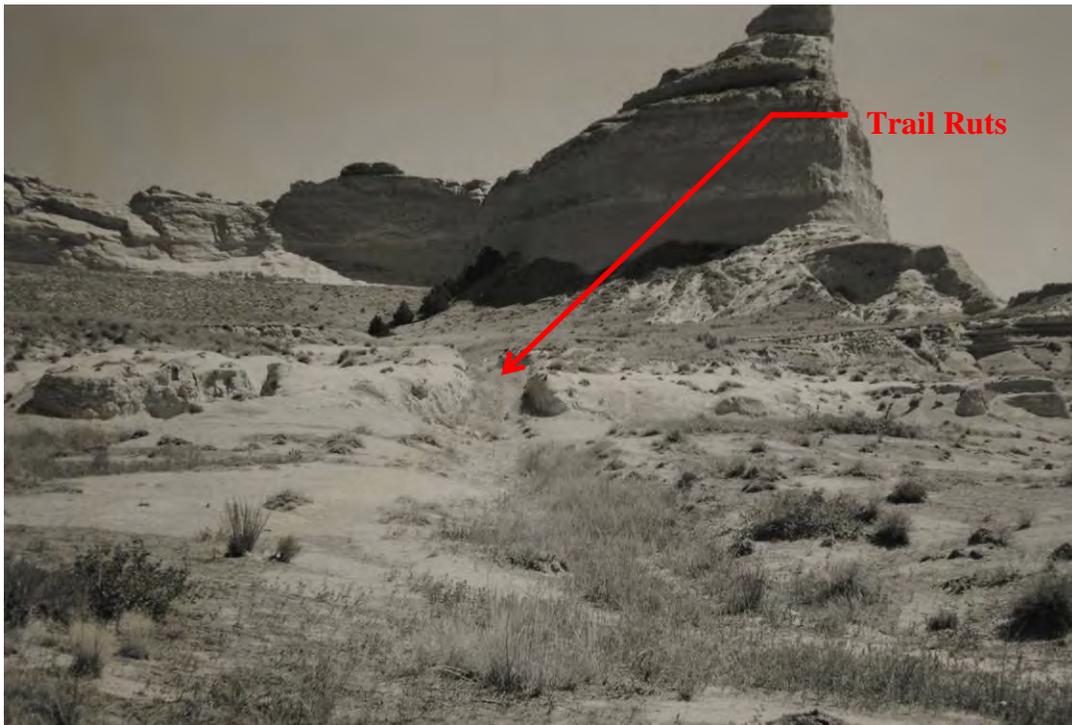
**Figure 3 - 4.** Character Area A *Above*- Oregon Trail resource on left with asphalt trail adjacent to trail resource (2009) (MBD DSC\_0012.JPG); *Below* - Oregon Trail (c. 1950) (MBD DSC\_0026.JPG) (source: SCBL archives)

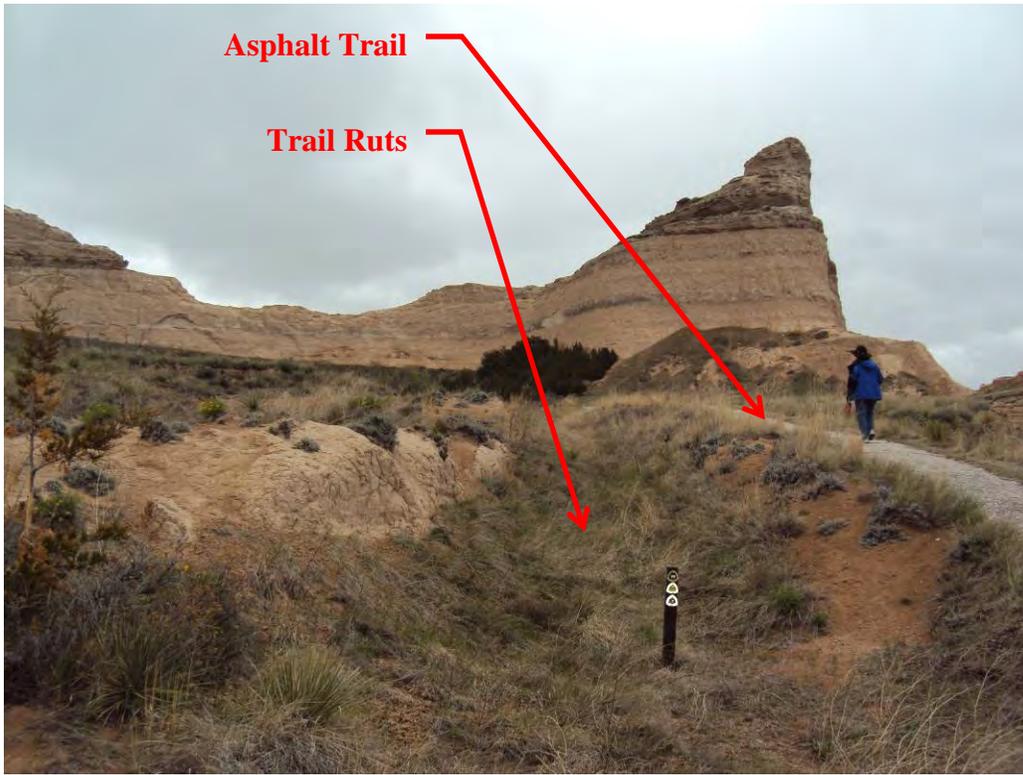
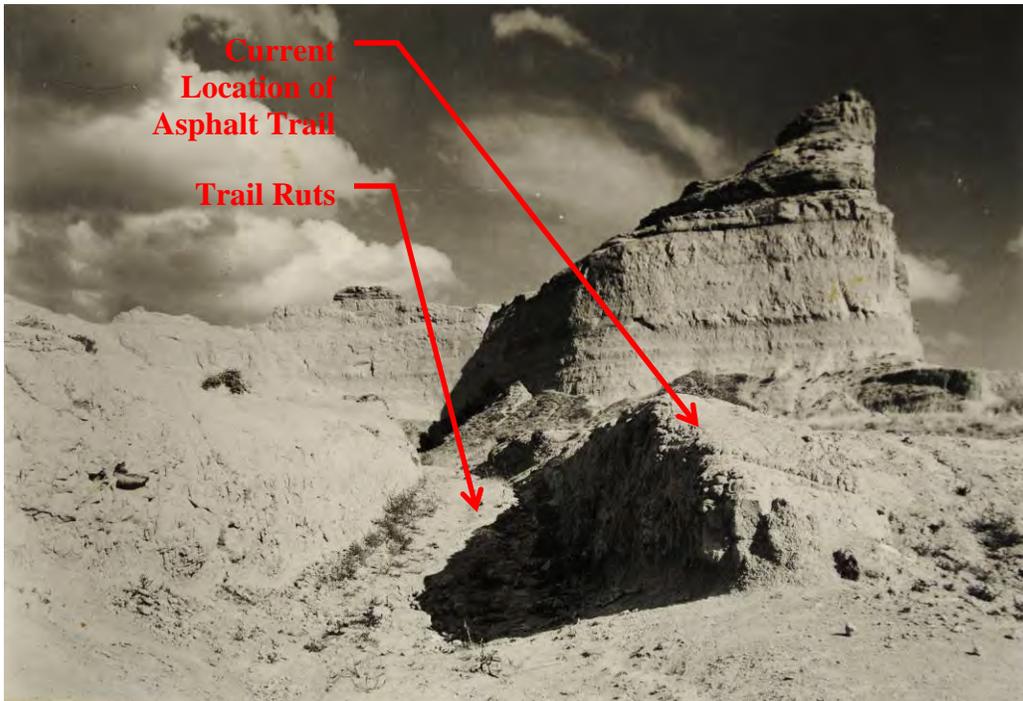
**Figure 3 - 5.** Character Area A *Above*- Oregon Trail resource on left with asphalt trail adjacent to trail rut resource (2010) (MBD DSC\_00137.jpg); *Below* - Oregon Trail looking northeast toward Scotts Bluff (c. 1939) (MBD DSC\_0216.jpg) (source: SCBL archives)

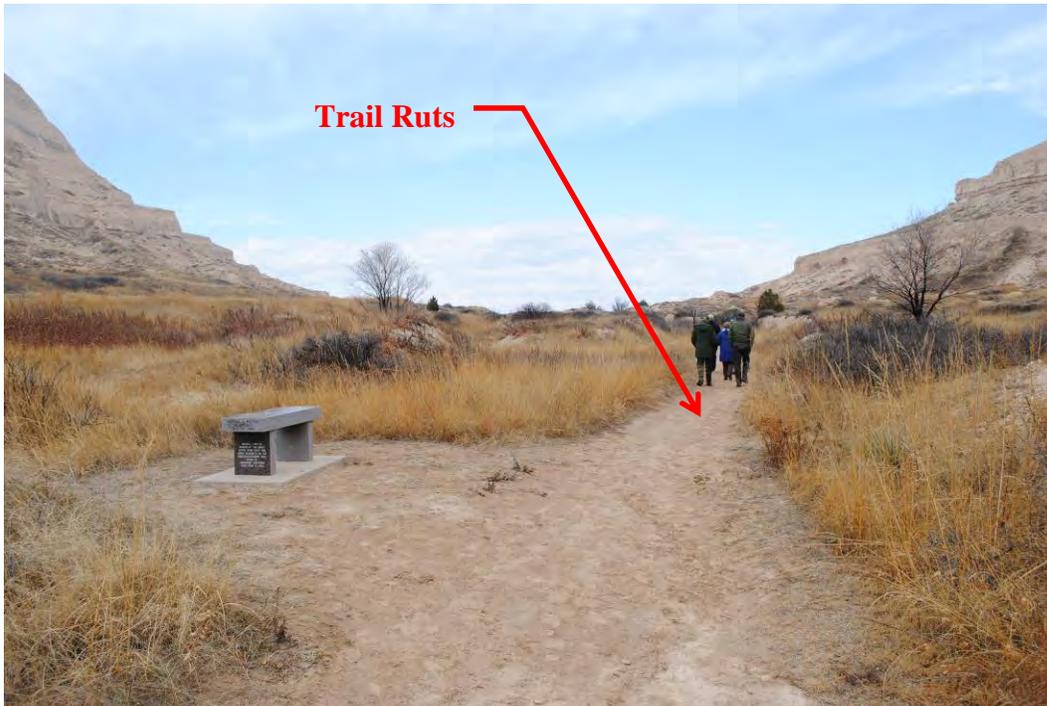
**Figure 3 - 6.** Wayside with granite bench and interpretive sign in Character Area A at the intersection of asphalt trail from Visitor Center and Oregon Trail resource- Class 4 (2009) (MBD DSC\_0012.JPG)

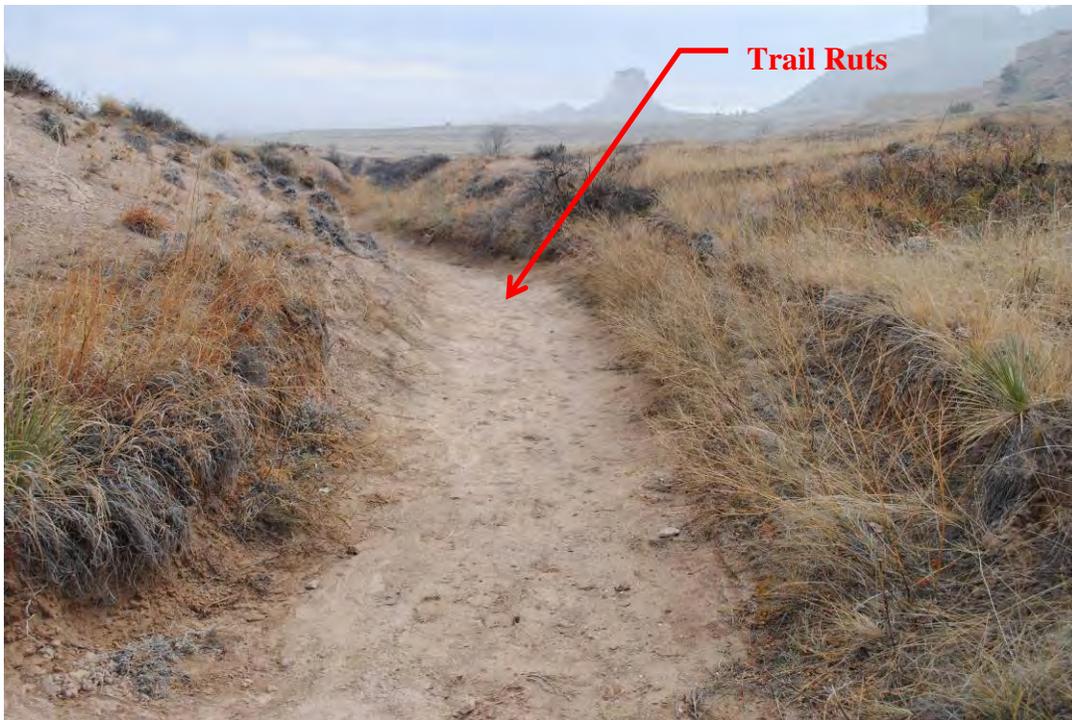
- 312     ■ Approximately 50% of the emigrant trail in Character Area A that is located between  
313     the two sections of the paved visitor trail is a Class 4 (altered and impacted) resource.  
314     The ruts have been altered by erosion, sediment deposition and visitor use. The  
315     Class 4 section of the trail is close to the original alignment and the trail is a  
316     contributing feature.

- 317         ○ The soils are highly erosive, leading to significant erosion along sections  
318         of the trail. Erosion occurs primarily in large storm events.

- 319         ○ This portion of the trail is said to have been excavated to allow crossing  
320         of Mitchell Pass. Sections of the emigrant trail in this area are straight and  
321         steep. The combination of trail alignment, natural topography, erosive  
322         soils and visitor use contributes to erosion and runoff issues.

**Figure 3 - 7.** Visitor trail on trail rut alignment looking east – Class 4 in Character Area A (2009) (MBD DSC\_0020.JPG)

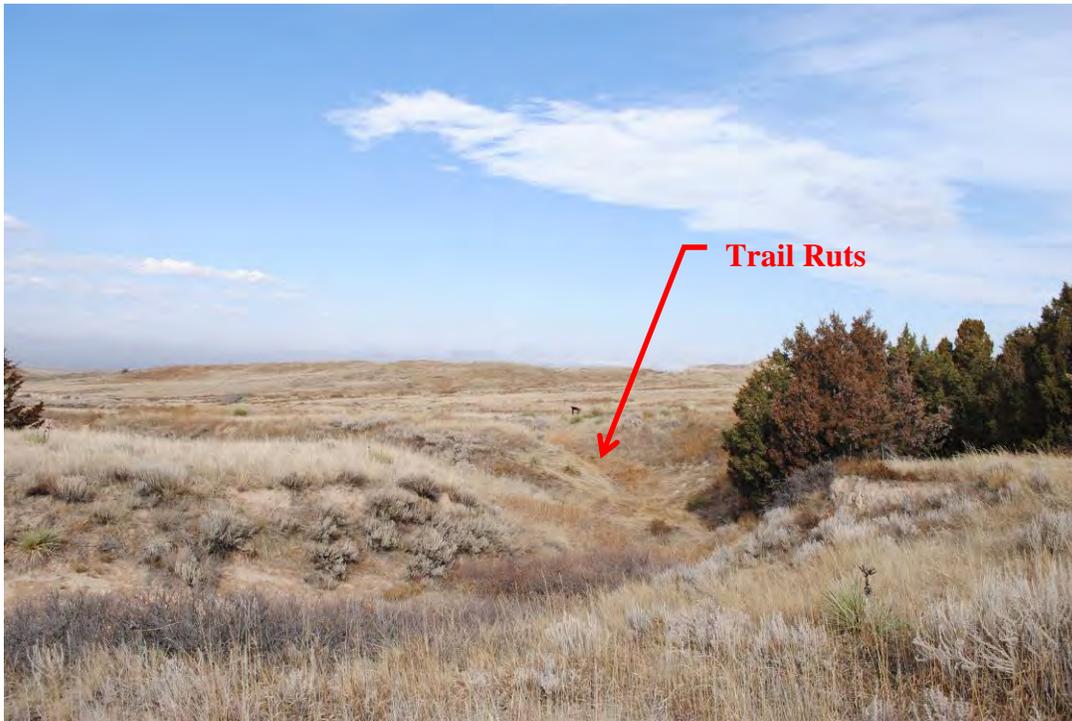
- 323         ○ Drainage ditches and culverts have been constructed to control runoff  
324         and damage to the resources with limited success.
- 325     ■ Approximately 25% of the emigrant trail resource remains intact and is classified a  
326     Class 1 (unaltered original trail). The Class 1 section of the trail is located adjacent to  
327     the paved trail extending past the W.H. Jackson site and toward Character Area B.  
328     This section of trail in this character area is contributing.

- 329         ○ In areas of Class 1 (unaltered original trail) trail resources historic photos  
330         indicate that vegetation has encroached into the trail areas protecting  
331         them from excessive erosion. The vegetation encroachment and  
332         establishment of grasses helps reduce the erosion within and adjacent to  
333         the trail ruts.

**Figure 3 - 8.** View of trail rut resource in Character Area A (Class 1) from asphalt trail with W.H. Jackson campsite and double cut in background (2009) (MBD DSC\_0031.JPG)

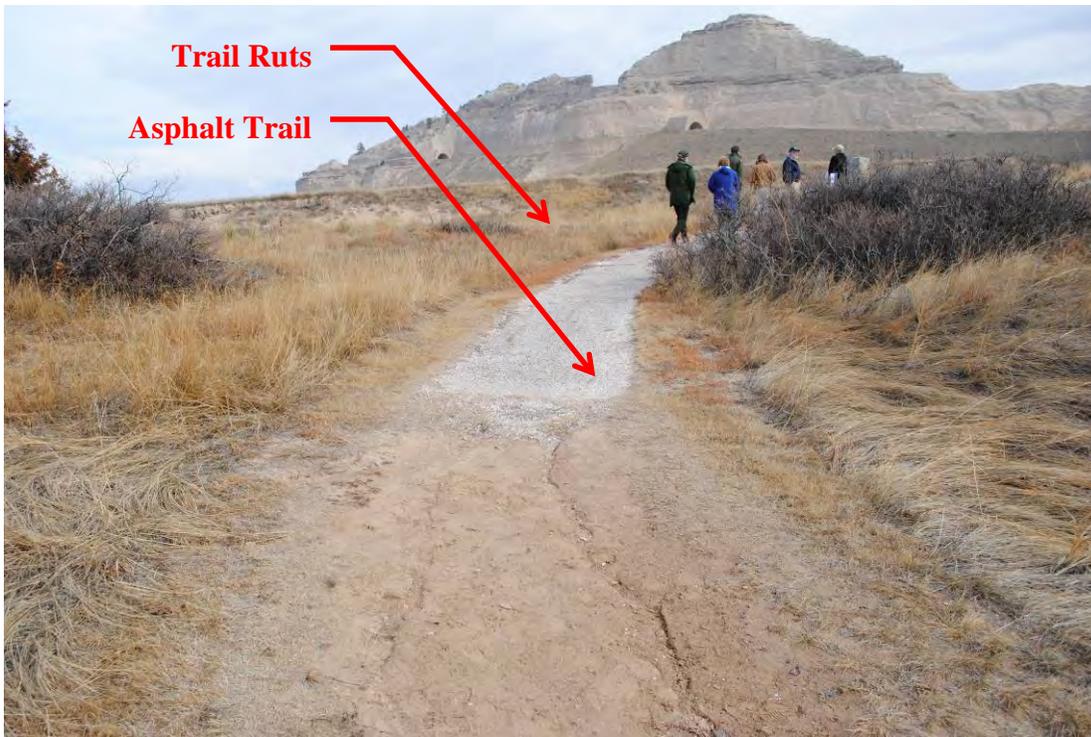
**Figure 3 - 9.** Transition from soft surface trail to asphalt trail in Character Area A – trail shifts from location on trail resource to adjacent to trail resource- Class 4 (c 2009) (MBD DSC\_0024.JPG)

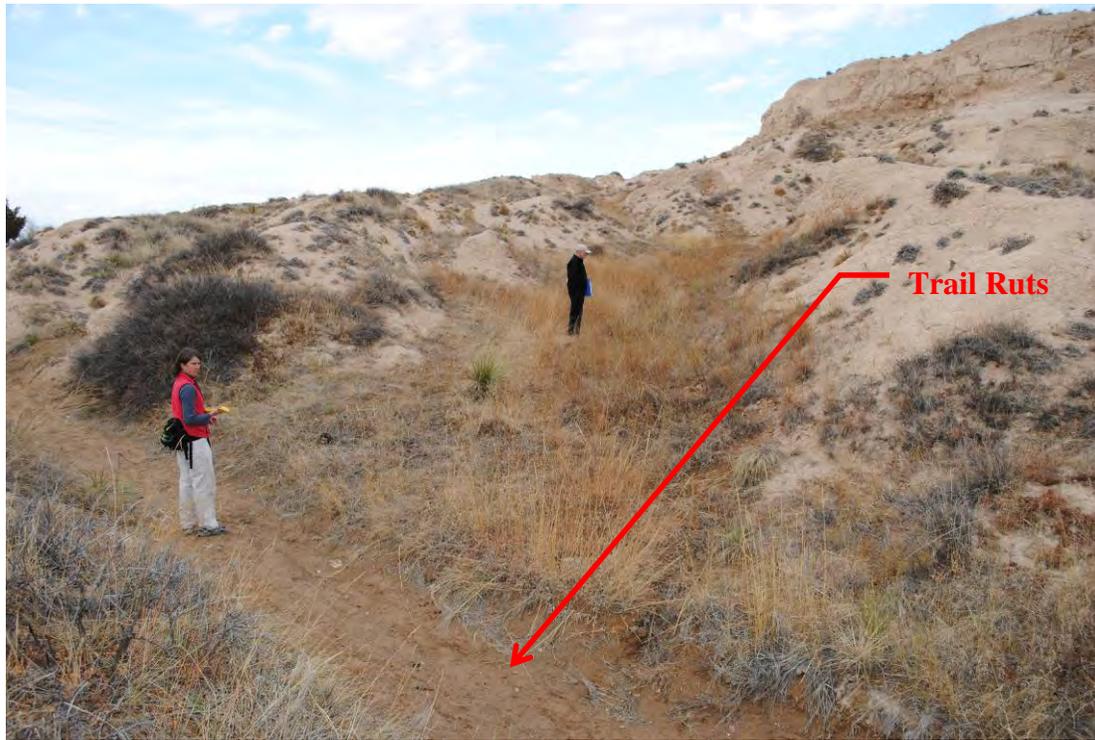
- 334     ■ Much of the landscape adjacent to this area consists of naturally occurring, highly  
335     erosive soils and minimal natural vegetation. This increases runoff volumes along  
336     the trail corridor, particularly along the north (bluff) side of the trail.

**Figure 3 - 12.** Watershed to north of trail in Character Area A (2009) (MBD DSC\_0071.jpg)

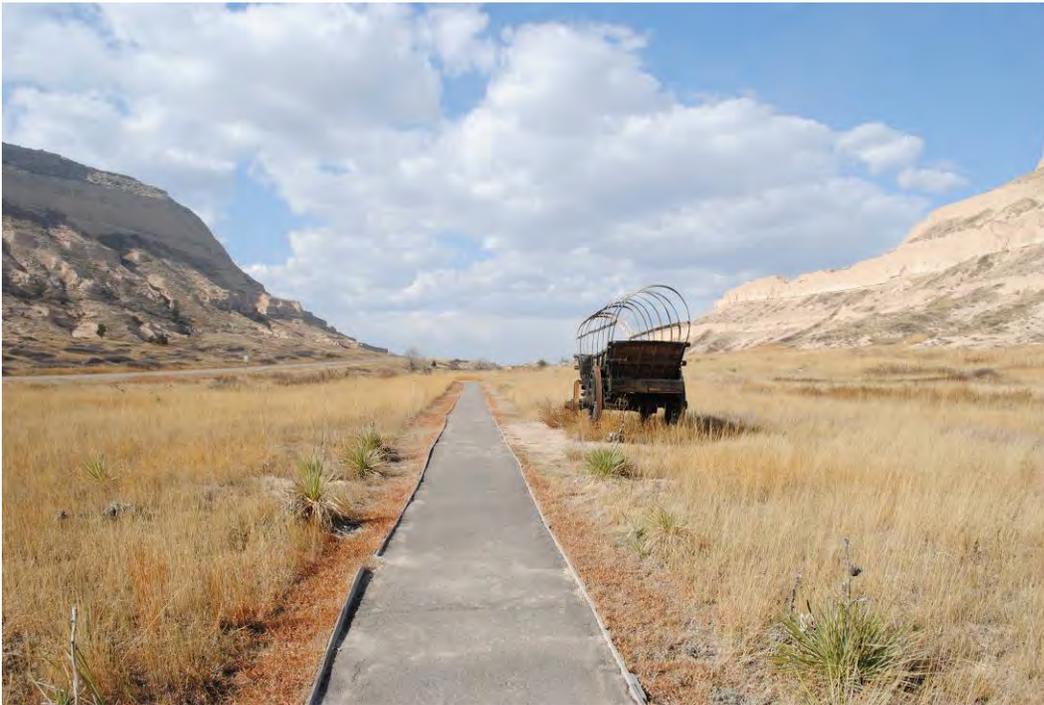
**Figure 3 - 14.** Looking west toward Mitchell Pass, asphalt trail with wood edge connecting visitor center/parking with Oregon Trail in Character Area A (2009)  
(MBD DSC\_0044.JPG)

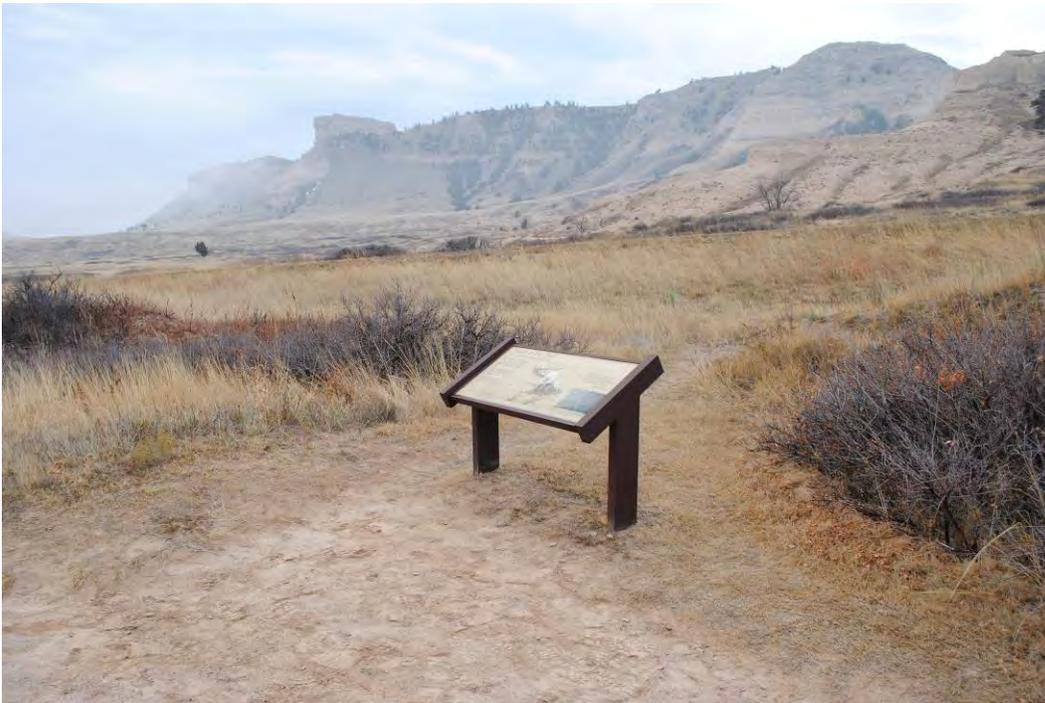
**Figure 3 - 16.** Interpretive sign at wayside with erosion sediment deposition in Character Area A (2009) (MBD DSC\_0011.JPG)

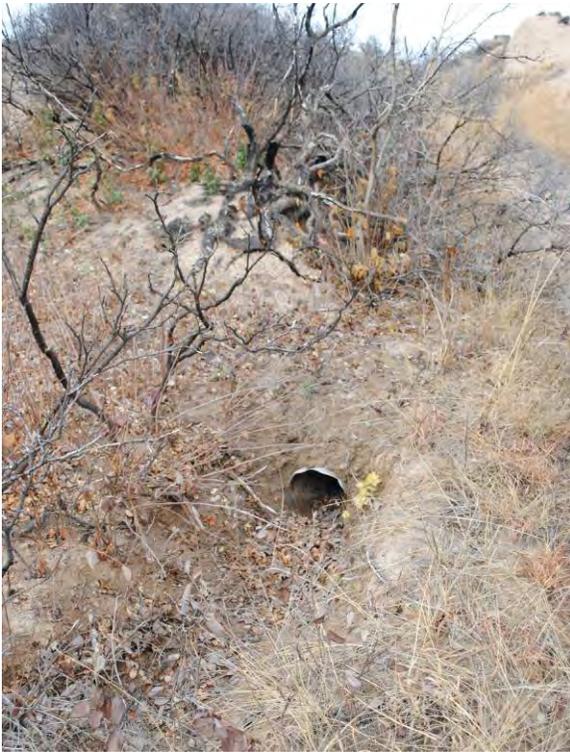
**Figure 3 - 18.** Corrugated metal culvert for drainage diversion in Character Area A (2009) (MBD DSC\_0016.JPG)

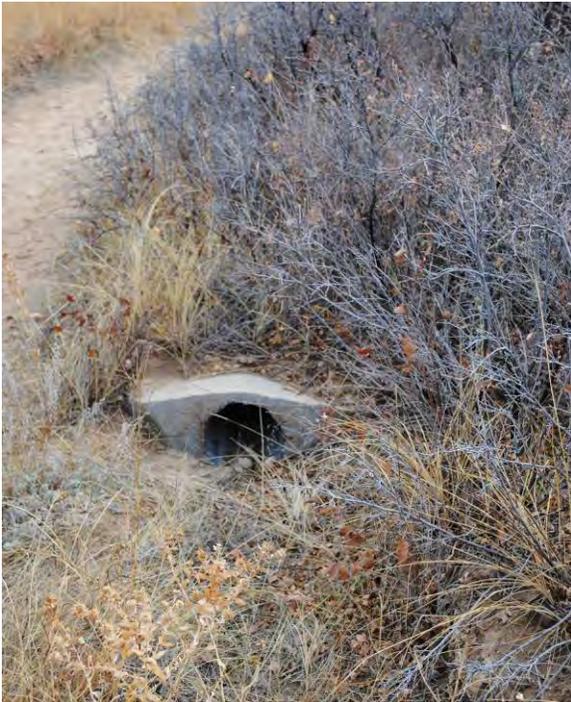
433  
434 **Figure 3 - 19.** Corrugated metal culvert encased in concrete in Character Area A (2009)  
435 (MBD DSC\_0017.JPG)  
436

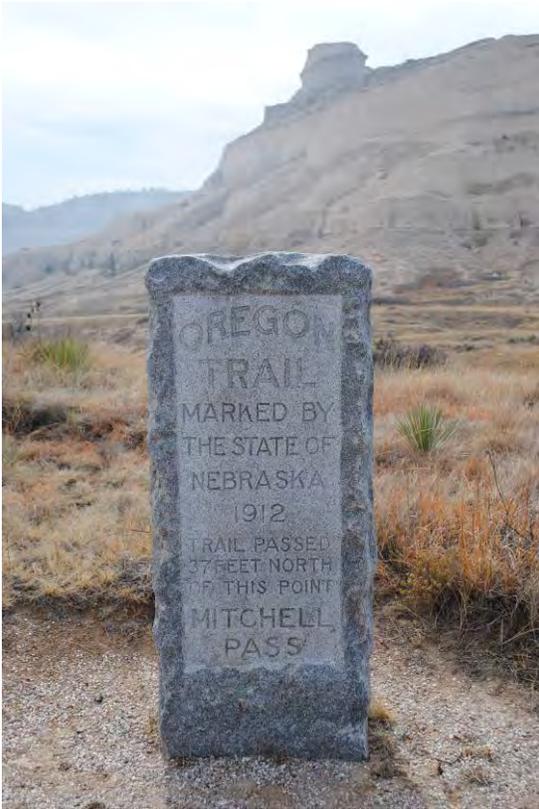
440  
441 **Figure 3 - 21.** Granite monument located along asphalt trail in non-historic location in  
442 Character Area A (2009) (MBD DSC\_0027.JPG)  
443
