Preliminary N spotted owl nesting habitat suitability assessment

SCOTT LUCHESSA | SENIOR ENVIRONMENTAL ANALYST
HYDRO LICENSING AND NATURAL RESOURCES DIVISION

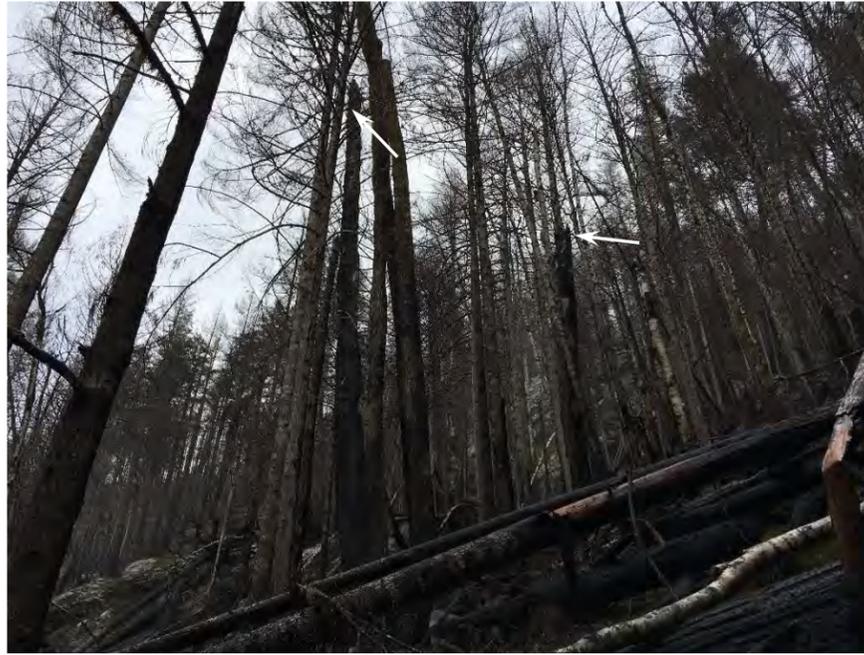
Photograph 1 – Severely burned forest with a couple of hard snags (arrows) from the east edge of the trail switchback, no apparent cavities; canopy cover <20% and relatively simple structure

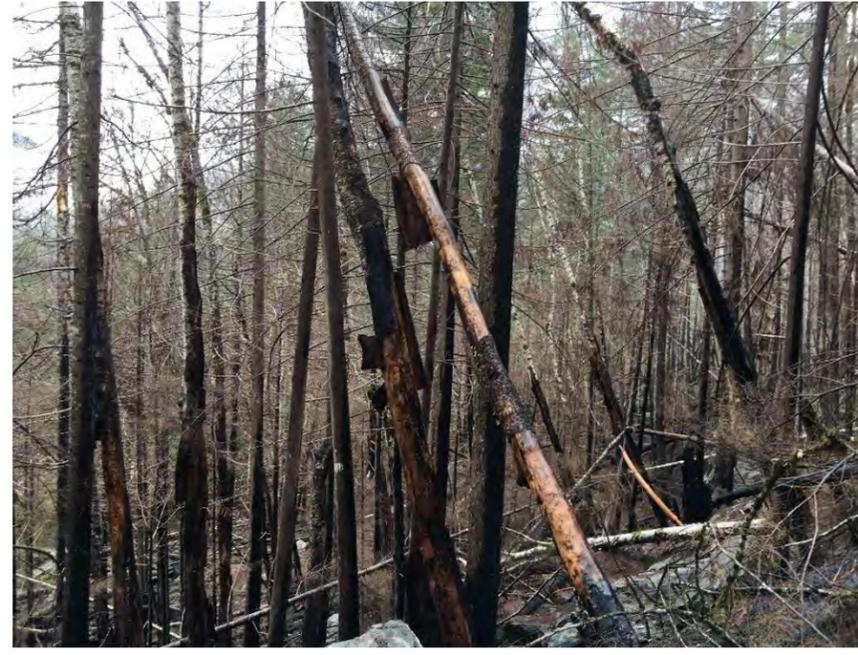
Photograph 2 – Looking north, downslope at severely burned forest from same location as Photograph 1 on 3/22/17

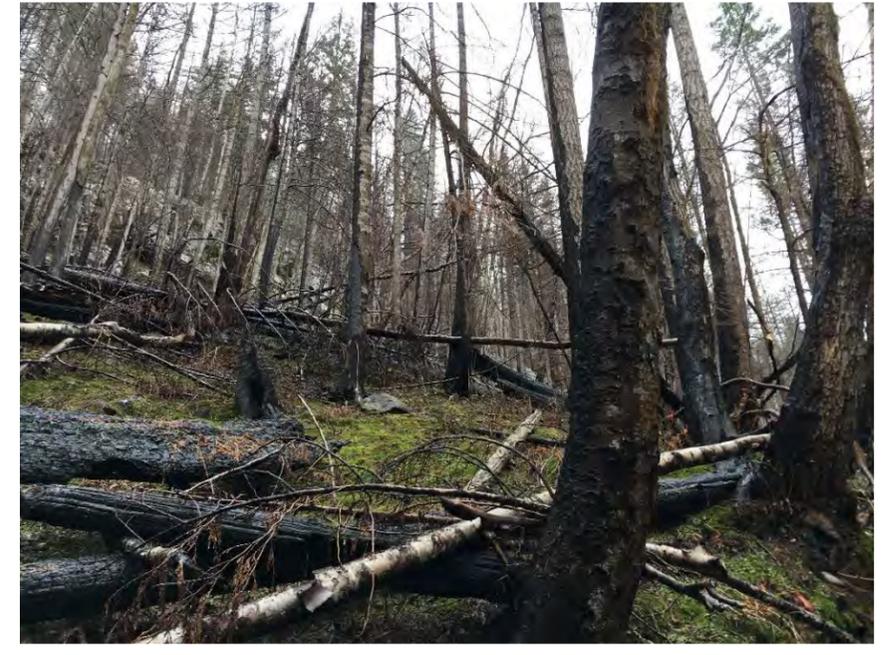
Photograph 3 – Looking south, upslope at severely burned forest from same location as Photograph 1 on 3/22/17

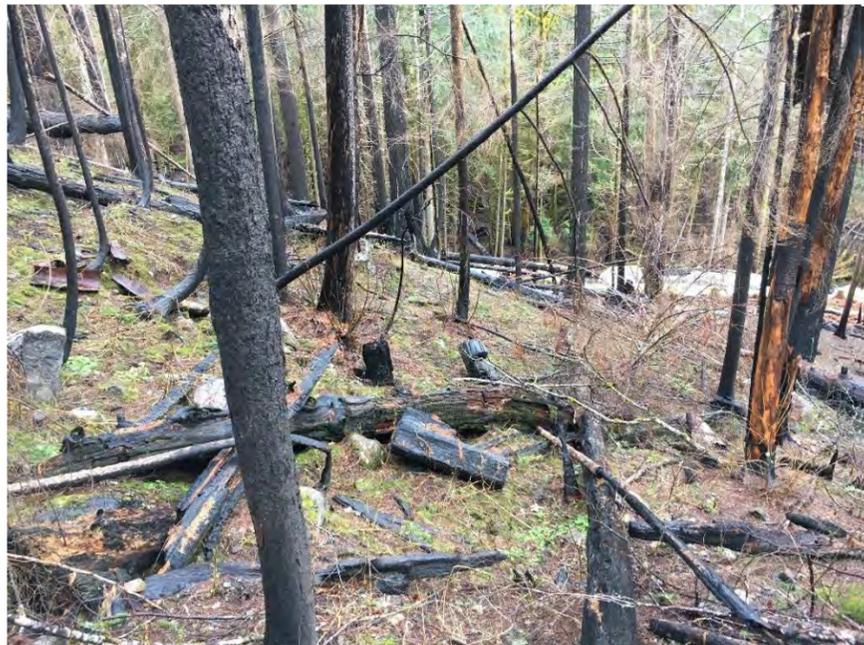
Photograph 4 – Looking north northwest downslope within severely burned stand towards the covered penstock on 3/22/17.

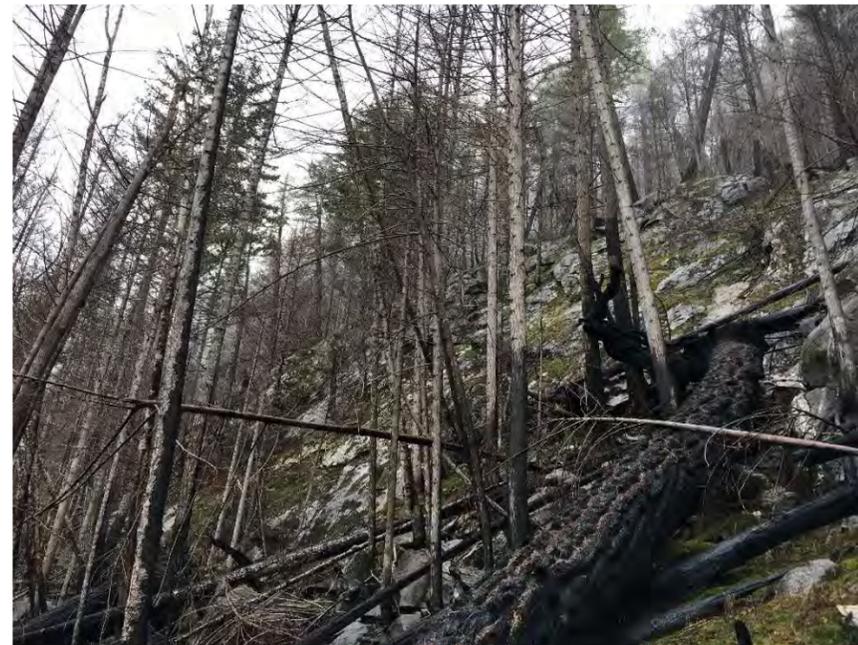
Photograph 5 – Looking east southeast (upslope) from the top of the penstock access trail at severely burned stand structure.

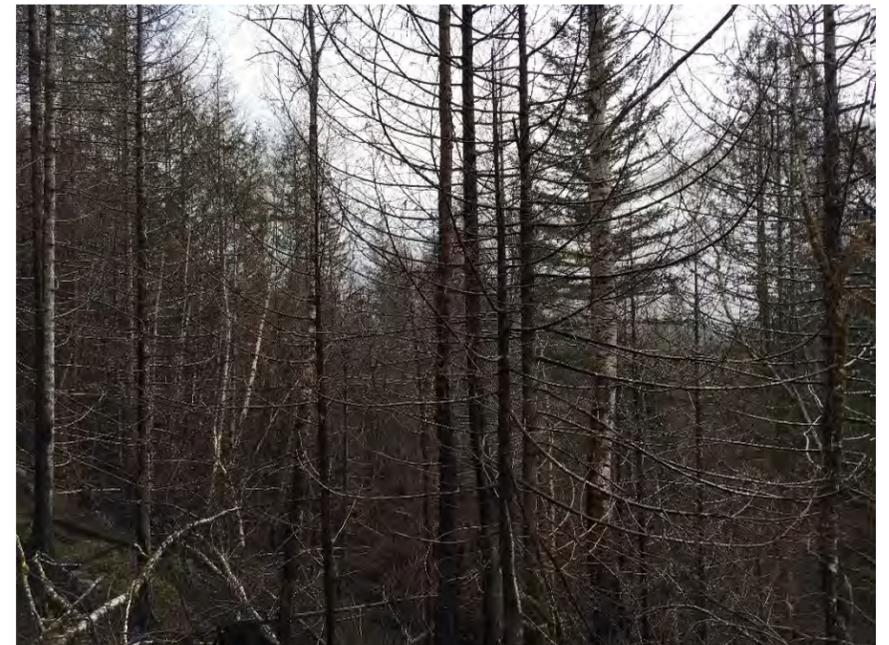
Photograph 6 – Looking west at moderate to severely burned forest on the west side of the penstock from the top thrust block.

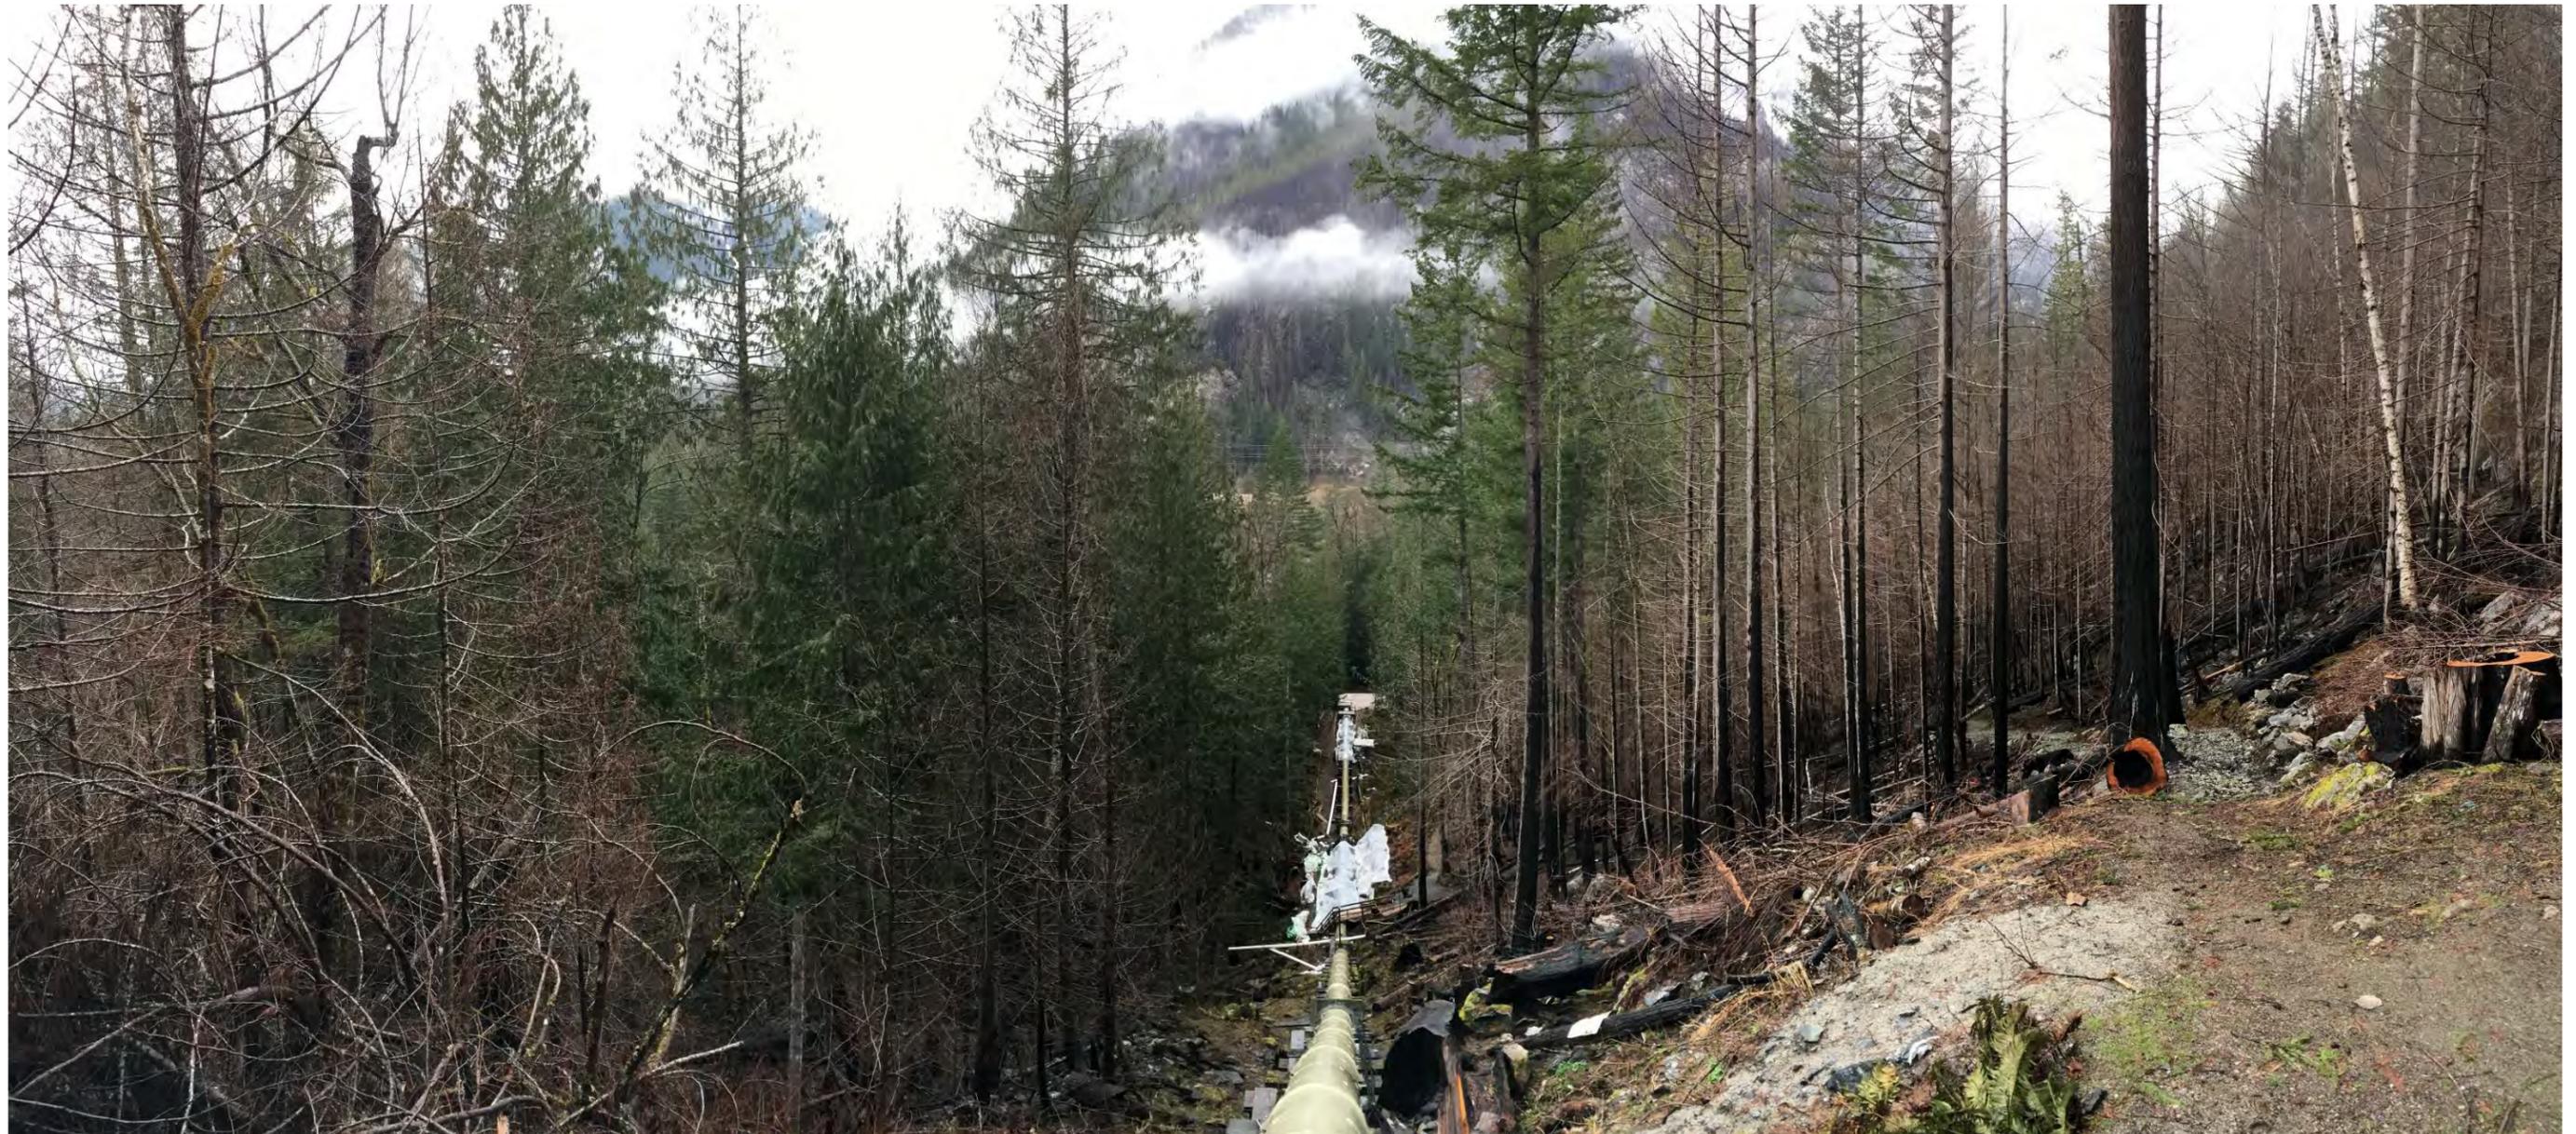
Photograph 7 – Looking North northwest to north northeast from the top thrust block near where the penstock enters the tunnel at typical burned forest stand structure on 3/17/17.

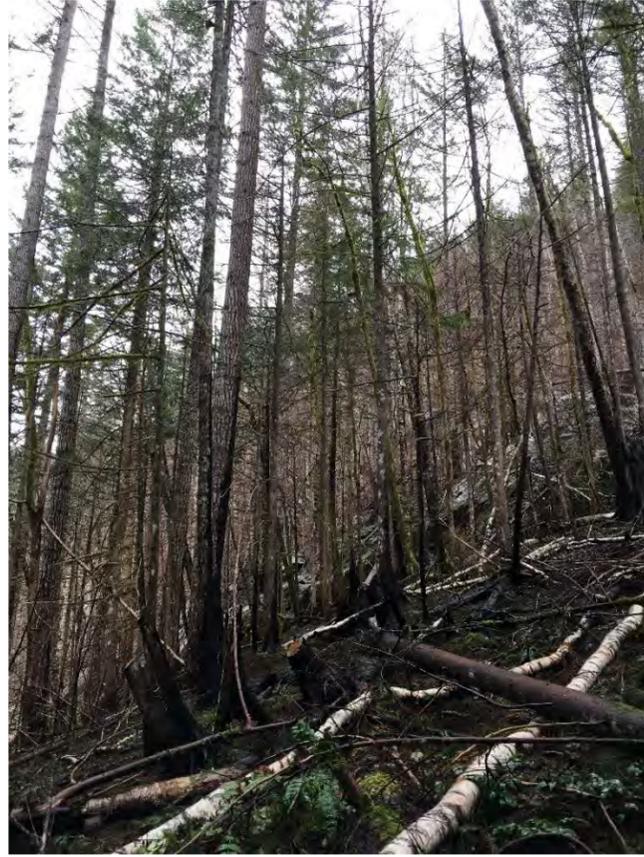
Photograph 8 – Looking east at moderate to severely burned forest east of the penstock.

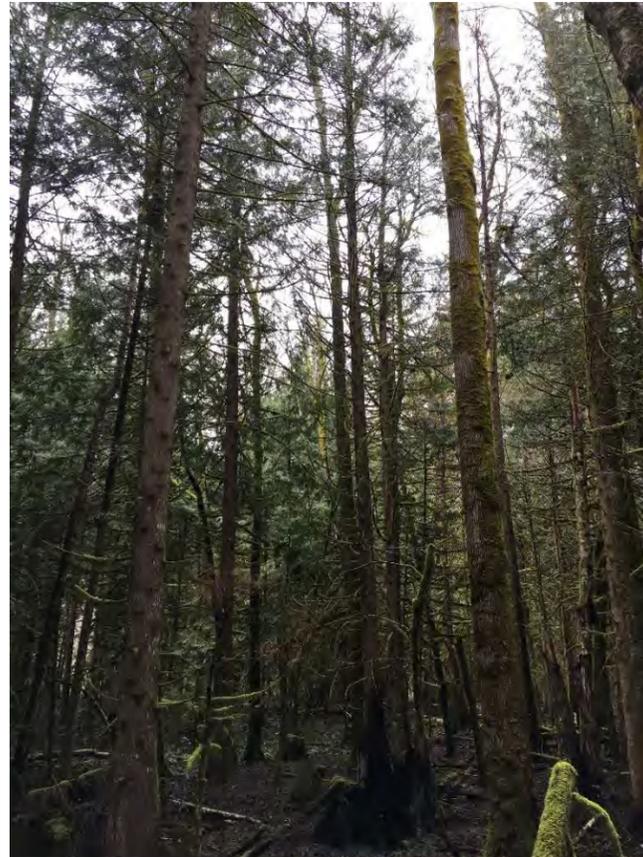
Photograph 9 – Looking north at typical lightly burned forest stand structure on the lower river terrace east of the penstock on 3/22/17.

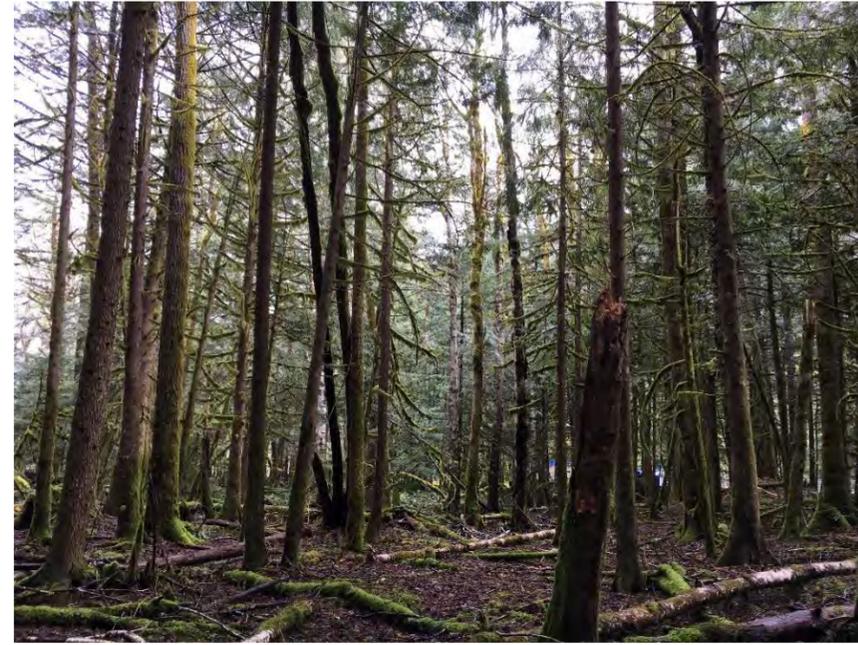
Photograph 12 – Looking west back towards the penstock from 300 ft west at stand structure on the lower river terrace on 3/22/17.
