# SAGAMORE HILL LIGHTING MASTER PLAN

**John G. Waite Associates**  
New York, New York

21 January 2011

**FMS** **FISHER MARANTZ STONE**  
Partners in Architectural Lighting Design

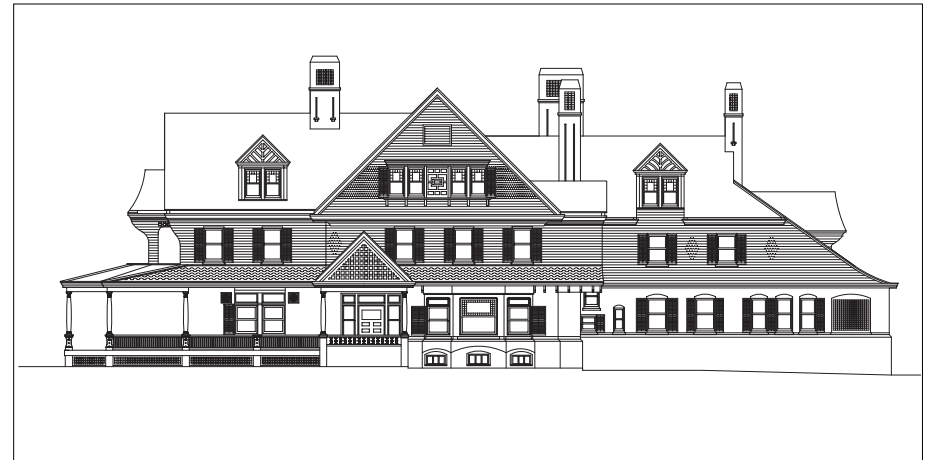
SOUTH ELEVATION

1. Current house floodlighting consists of four ground mounted high pressure sodium floodlights located far back from the house, and an additional fixture lighting the drive to the house.

2. Floodlighting effect is unflattering due to both the poor color rendering and orange color of the sodium lamps lighting the largely blue and grey color scheme of the house.

3. Floodlight locations also contribute to a less than flattering night time appearance of the House.
4. Ground mounted fixture located within the drive circle of the Porte Cochere produces large shadows on the house from the projection of the Porte Cochere.

7. Parking lot lighting to utilize the minimal number of low height poles necessary to satisfy the illumination criteria noted above.
8. House floodlighting to minimize hard shadows from projected portions of the building.

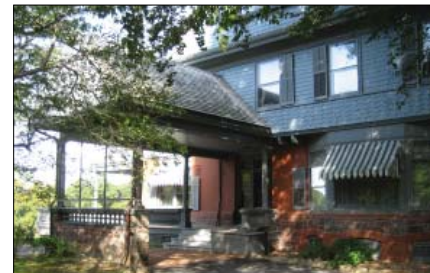
LOOKING NW AT PORTE-COCHERE

6. The porte cochere has one semi-recessed lensed light fixture outside the front door (only) which was not lighted during our visit.
7. Porches have vitually no external lighting, the exception being an unresolved location on the west porch.

9. While the lensed light fixture under the porte cochere was not lighted during our visit, it appeared that the effect would be glary and unflattering in the nighttime environment. We have not found any historical references to this fixture and if appropriate we recommend that it be replaced with a less obtrusive fixture to light the stairs. The front entry façade lighting may be best addressed as part of the overall building façade lighting scheme.

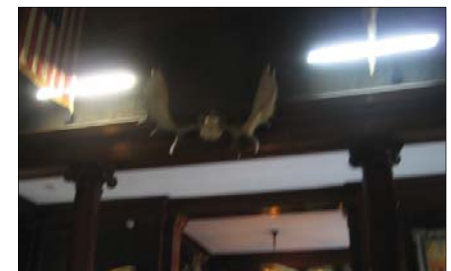
6. There are three table lamps in the room that are good visual accents but add little illumination.
7. Awnings were still in place on the west facing windows.

SUPPLEMENTAL FLUORESCENT FIXTURES

3. The four supplementary fluorescent light fixtures are to be replaced with neutral or warm white LED sources. Source color is to blend with the current available light in the room in order to be as unobtrusive as possible. The LED sources have far less UV and their projected beam would allow selected areas to be better served than the broad beam of the fluorescent. The new supplementary light fixtures might still be located on the vertical fascia above the viewing area.

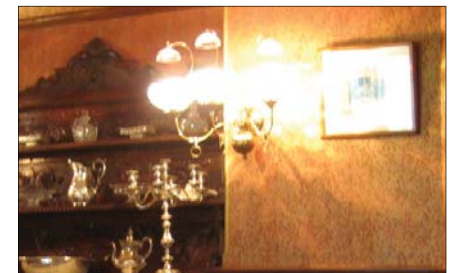
5. The 3 headed sconces were observed to be quite large given the scale of the room and the lamps somewhat bright.
6. The historic sconces were observed to be quite bright, perhaps partly due to these being powered by the 120V supply system in the house.

HISTORIC SCONCE

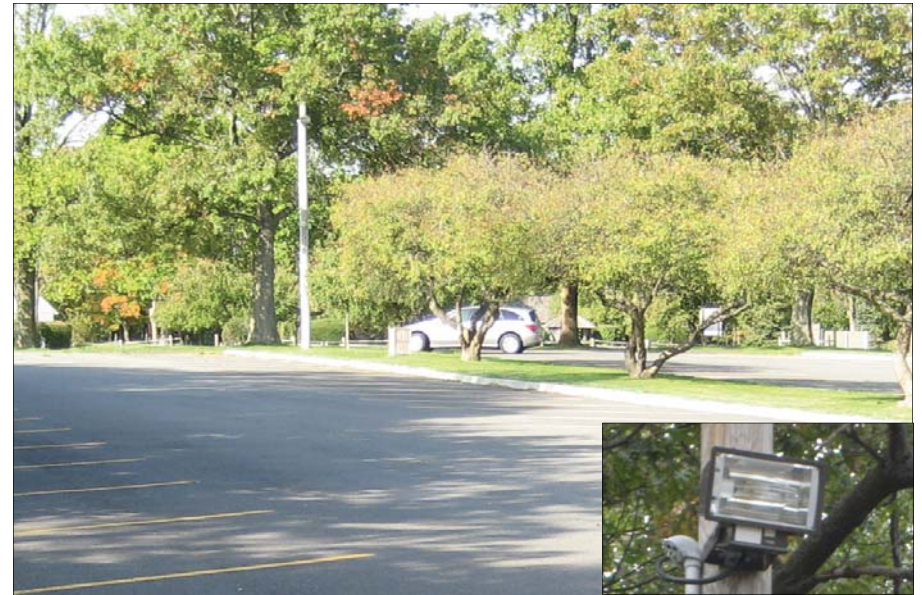
EXISTING PARKING LOT AND LONE LIGHT POLE

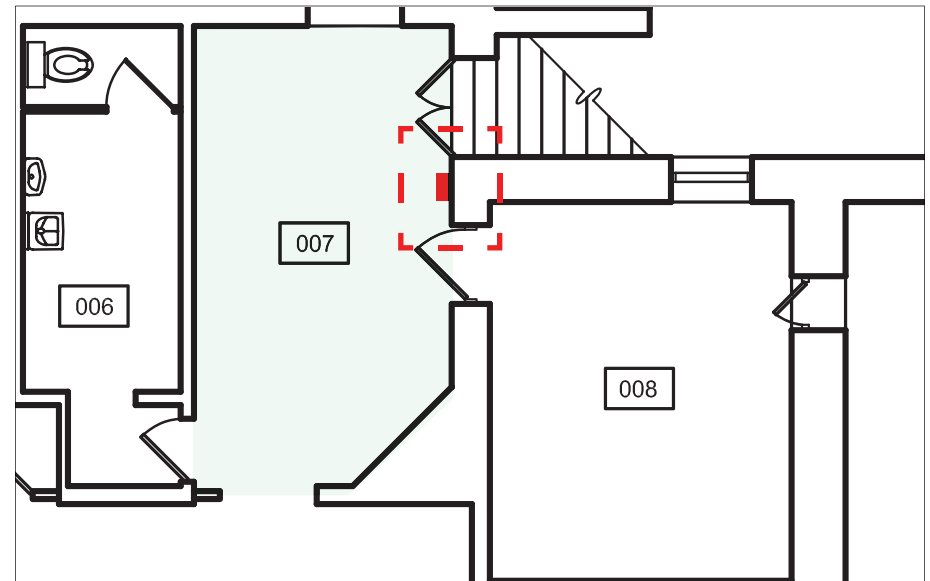
1. It was noted that the house lighting timer override switch is not near the Basement entry door requiring one to negotiate through the dark to find the switch. A local switch more convenient to the entry is recommended.

BASEMENT PANEL ROOM 007 WITH RECOMMENDED LOCATION FOR OVERRIDE SWITCH.

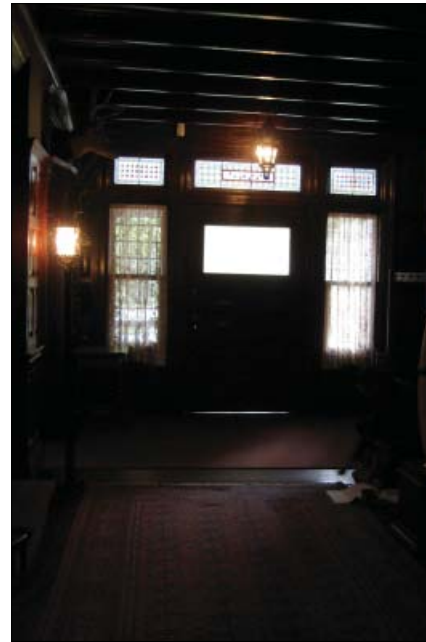
7. While most rooms in the house can only be viewed from the threshold making close inspection of artifacts difficult or impossible, the Entry Hall allows visitors to freely navigate and view objects from up close. However even this advantage is not enough to appreciate the room and its artifacts due to the lighting shortcomings.

LOW VISABILITY IN ENTRY HALL

6. Restore the skylight system to the second floor Stair Hall. The second floor laylight would have been a major light source in the center of the house (and Entry Hall) before it was covered. The original skylight might have delivered 10 to 50 times the current amount of light to the Stair Hall area depending on time of day, sky conditions and tree cover. In addition to more light, the diffuse light from the light shaft above would have added much needed vertical illumination on all surfaces that “see” the laylight.

7. Small, very low brightness, low wattage floodlights (painted to match the wood) might be surface mounted to the dark wood beams to provide some base illumination to the fireplace wall and mantle area.

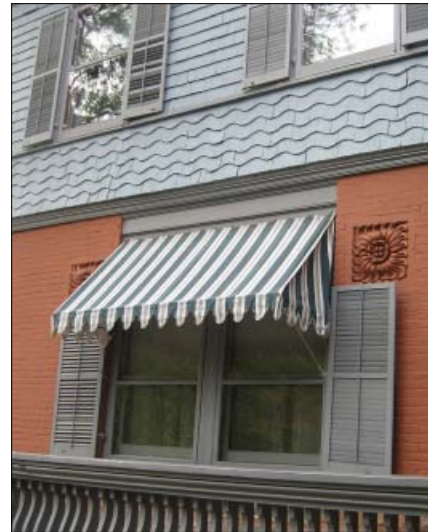
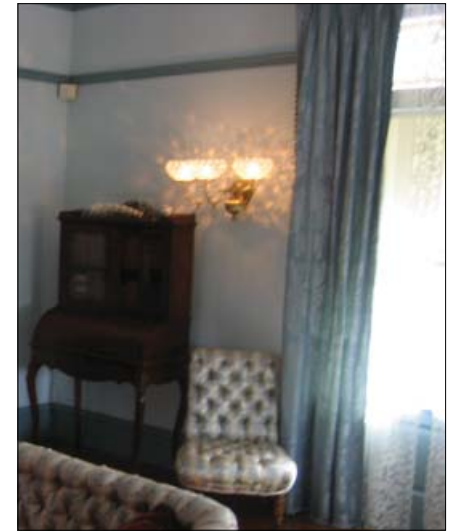
SOUTH WINDOW EXTERIOR

SOUTH WINDOW INTERIOR

1. The south facing window had an awning in place but the lower portion of the window was still quite bright, particularly as viewed from the Entry Hall. This window may benefit from some light reducing film as opposed to the west and north facing windows that are shielded by the porch.

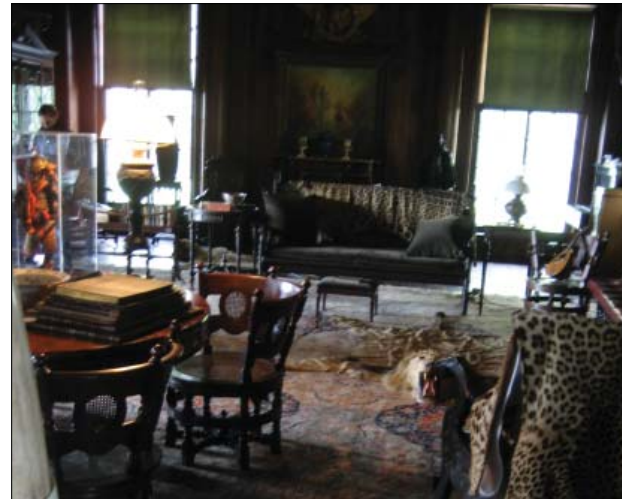
LOOKING N

5. The large size of this room results in Visitors being a long distance from many of the objects and magnifies the problems caused by the high contrast, glare and low light levels.

2. The view to the north wall is dominated by two extremely bright windows that cause the painting and objects on the center wall to be in near darkness. Clear light reducing film is recommended to reduce the transmission of this glass perhaps as much as 80% while maintaining the view beyond.

5. Clear light reducing film is recommended on the east and west windows of the viewing area where these bright sources hamper the Visitor's view of the surrounding space.
