Appendix V: Photographs

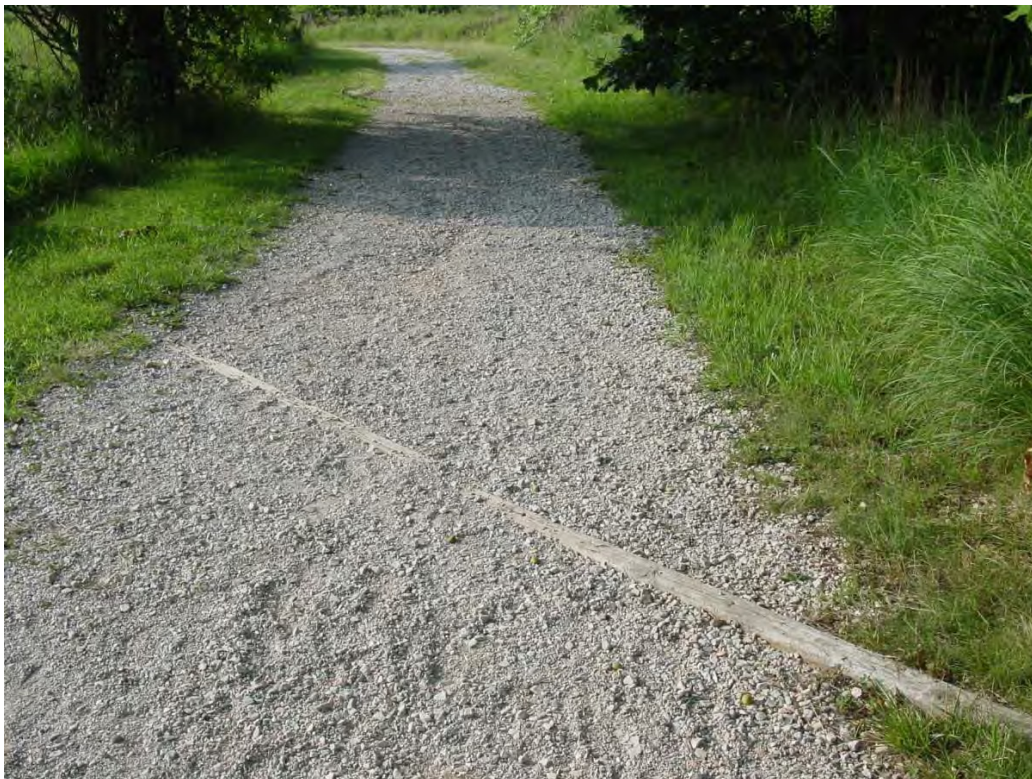
Existing timber used to control runoff limits access

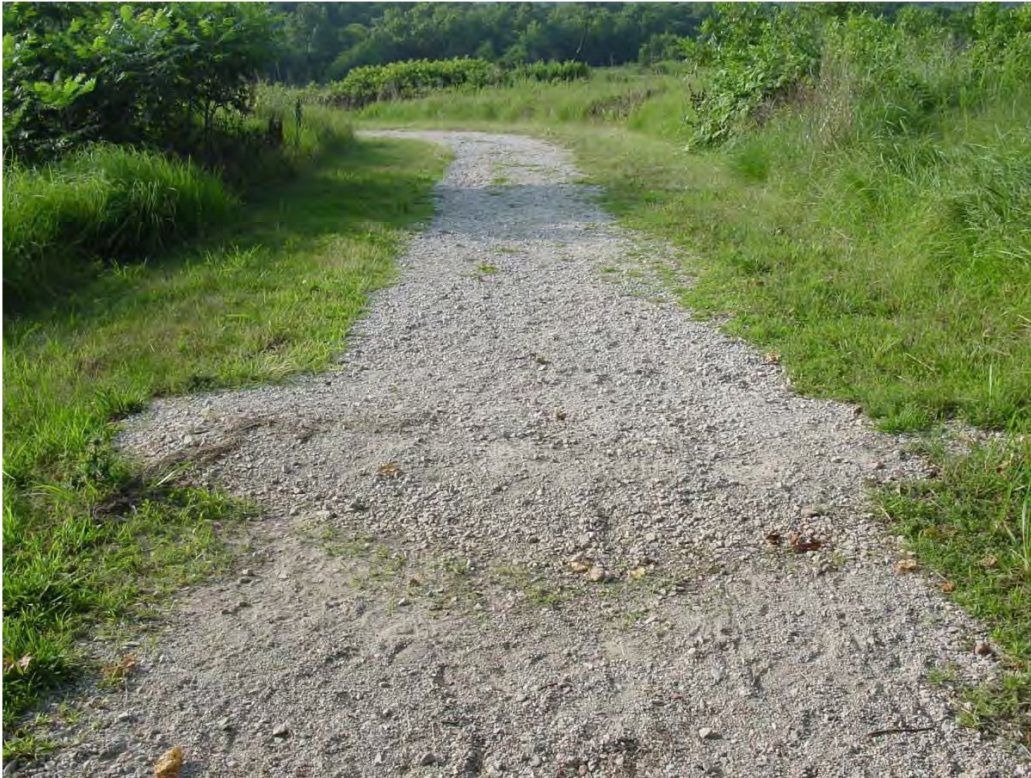
Existing drainage pipe running under trail limits access

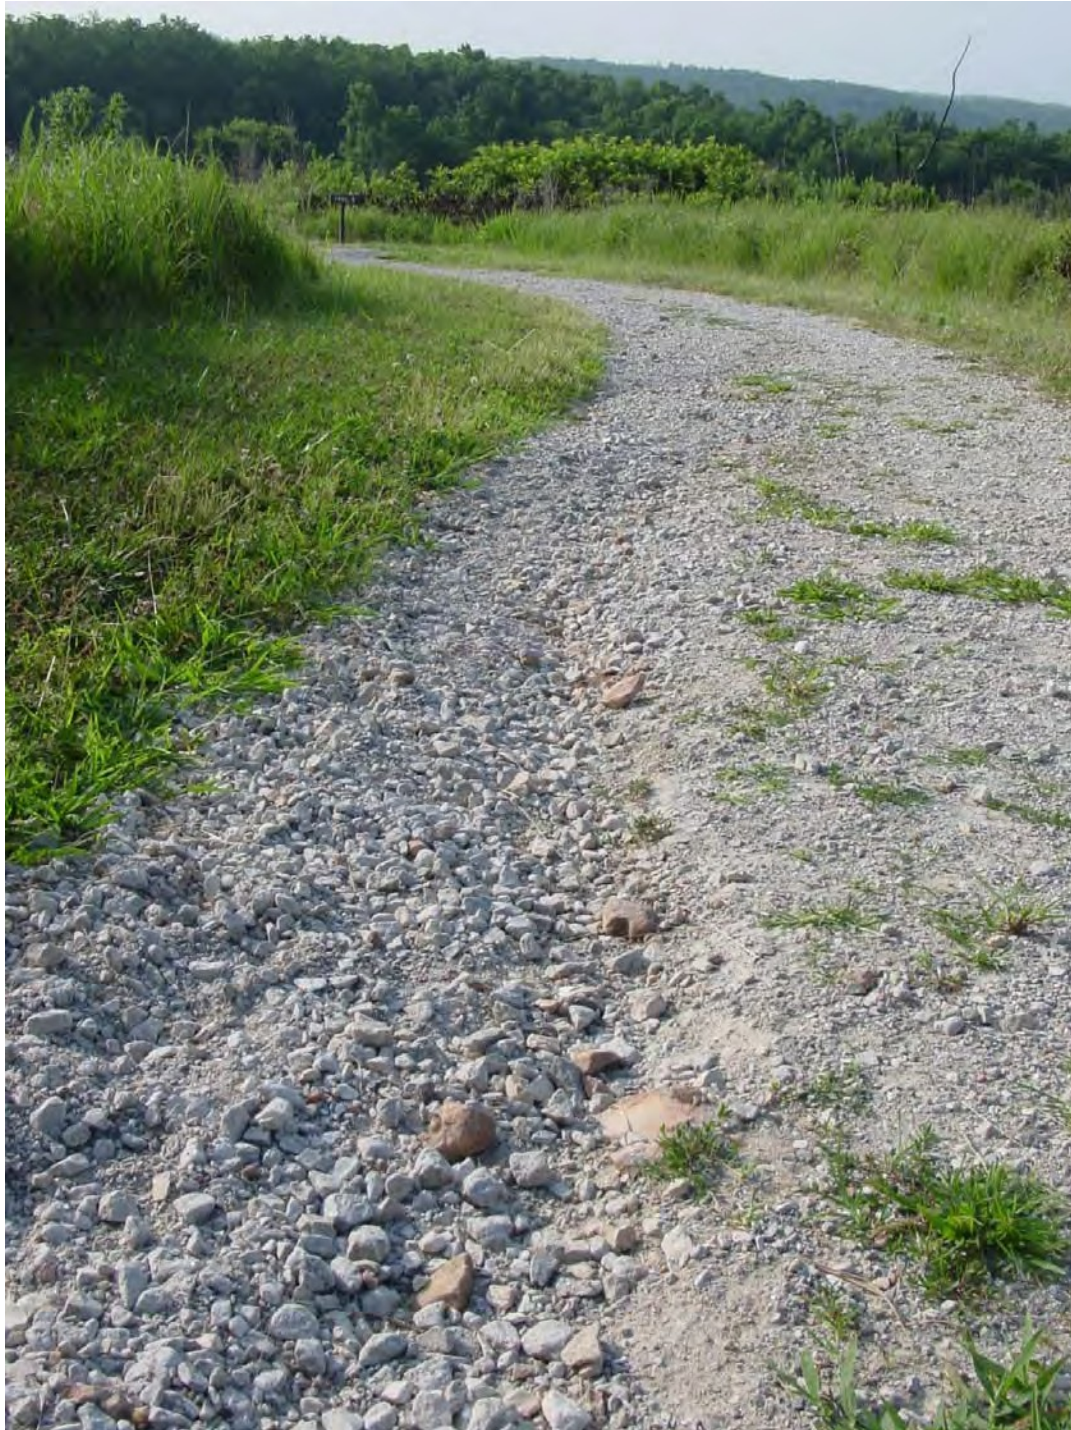
Wash out of materials on existing trail

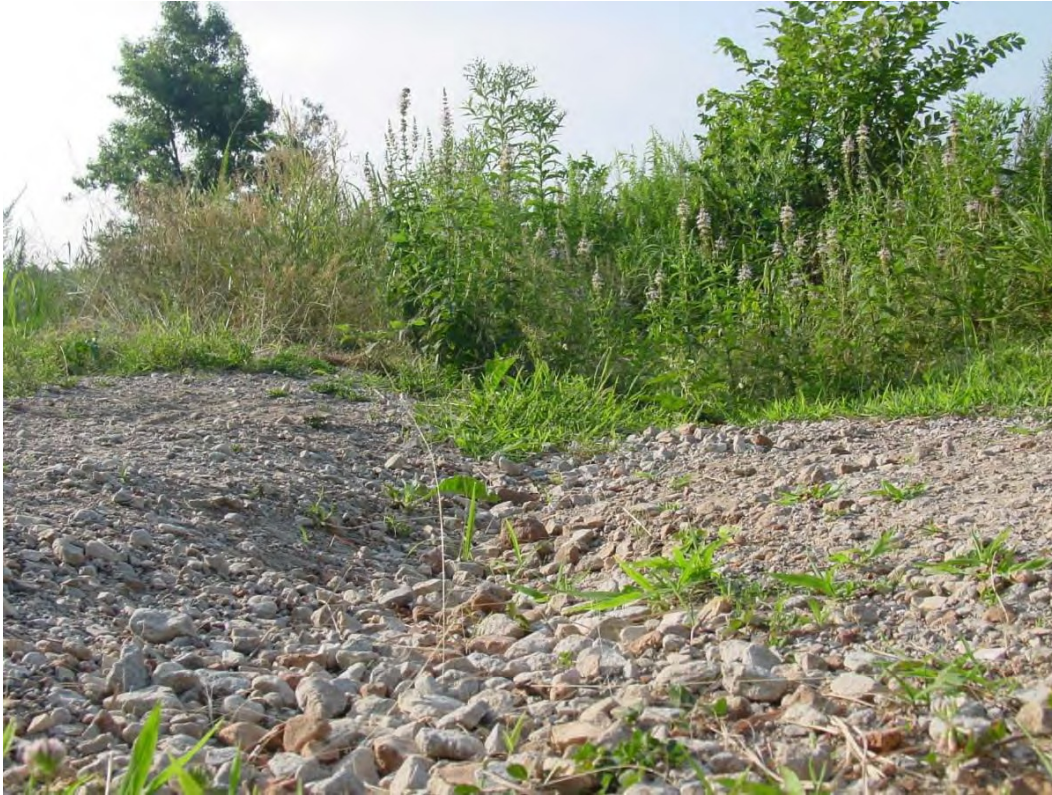
Existing water pipe under trail causes sudden grade change

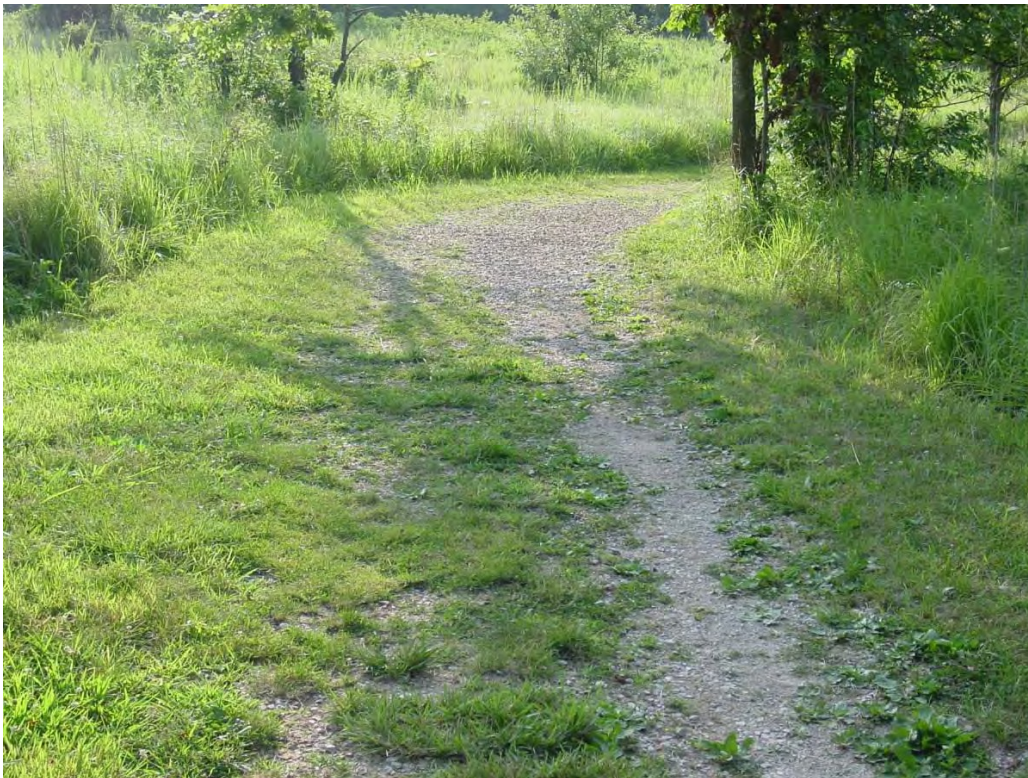
Existing uneven distribution of trail materials and vegetative growth on path

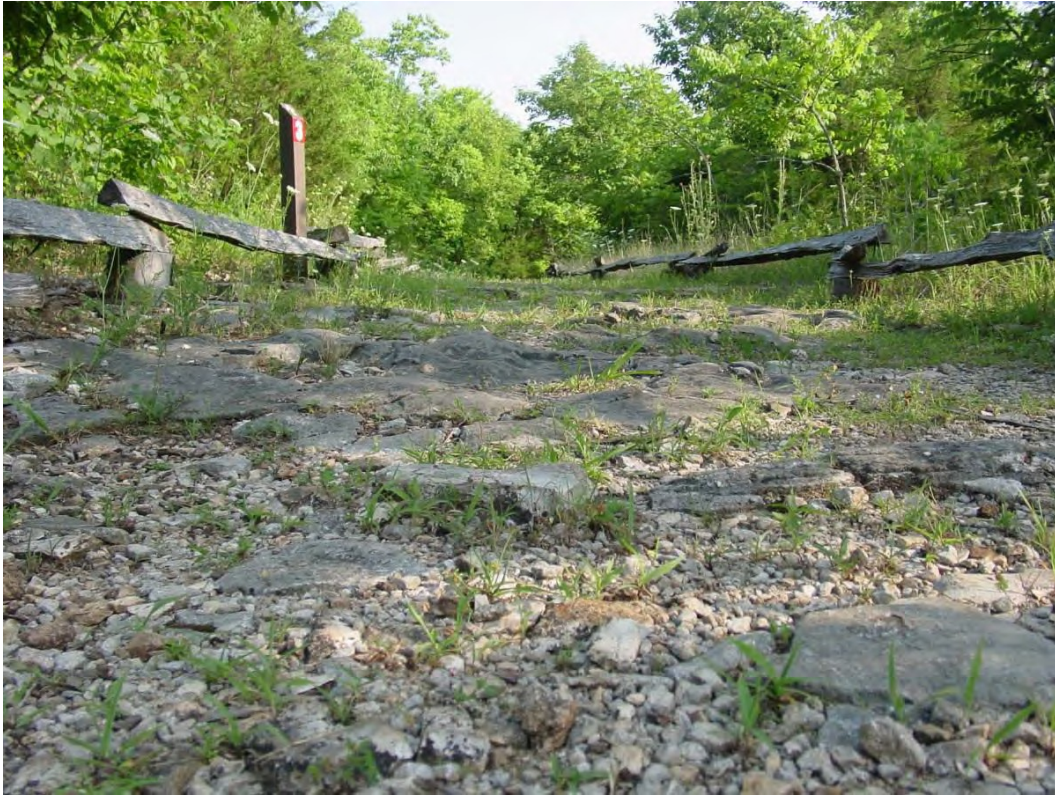
Existing uneven slope on glade near Lyon marker

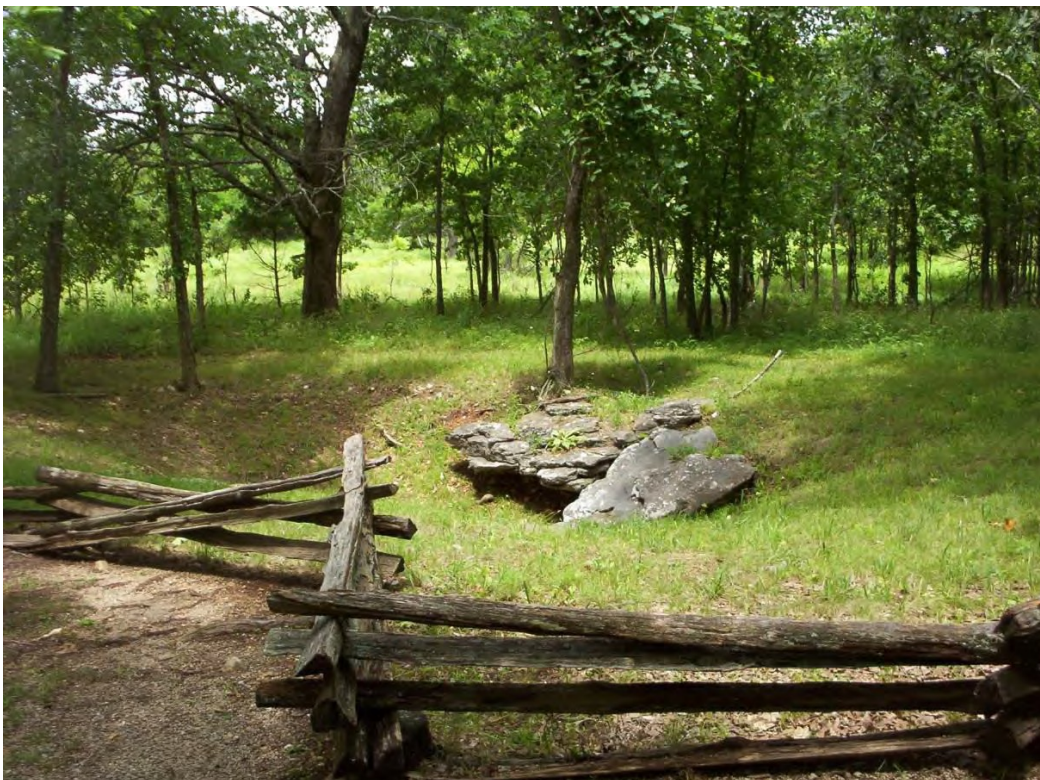
Existing view of sinkhole on Bloody Hill Trail
