Memorandum for the Record

Organ Pipe Cactus National Monument - Zone A
Class 2 UVR pre -restoration

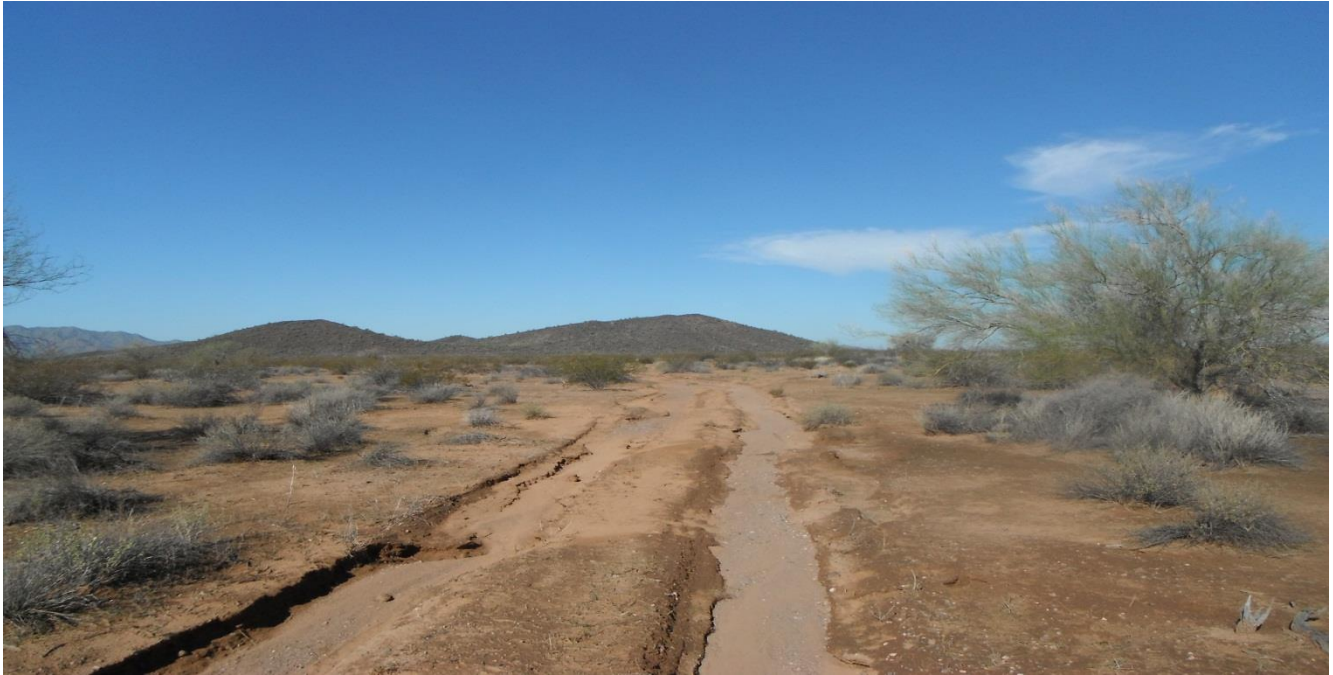
On October 11, 2014 technicians were evaluating the efficacy of restoring 0.99 miles of UVR in Zone A by hand. The Class 2 route was deeply rutted and a field decision was made to attempt an alternative restoration technique test, attaching a wood beam to a truck and allowing the drag to erase the UVR. On October 21, 2014 a drag was used on a second UVR that was both rutted (Class 2) and braided (Class 3). A 0.24 mile section of this UVR was graded and leveled using a drag behind a vehicle. Between October 10 and October 23, 2014, 18 UVRs totaling 7.46 miles were restored. Sixteen of the UVRs (6.23 miles) were restored using hand tools alone. The pre and post restoration photos of the first UVR graded and leveled using a drag are attached at the end of this document.

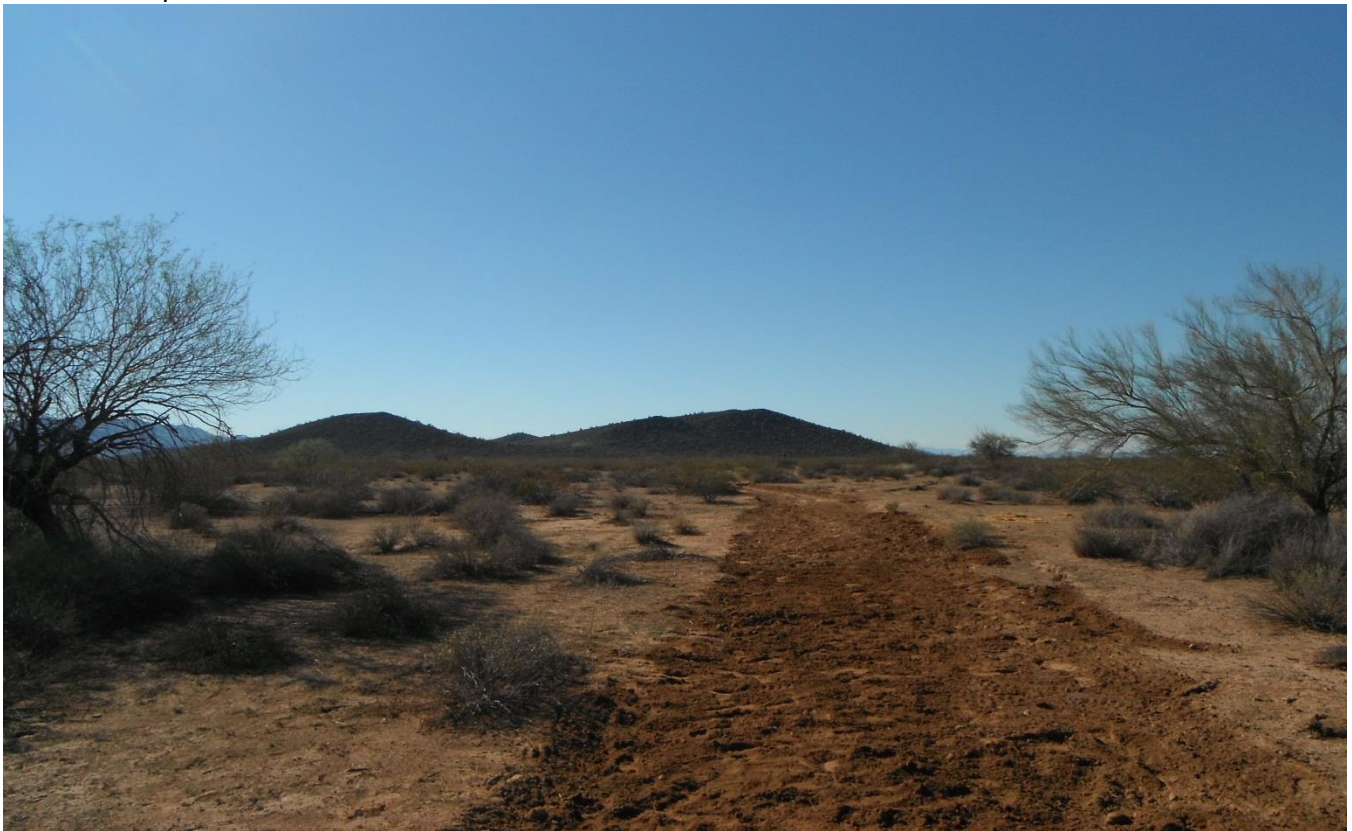
There were no observed adverse effects to natural or cultural resources as a result of allowing vehicles to access UVRs in wilderness for restoration. Use of the drag did not adversely affect natural and cultural resources but did improve the efficacy of restoration efforts and improved the overall condition of the two UVRs resulting in a net beneficial gain for the area and endangered Sonoran Pronghorn by eliminating 1.2 miles of road from use, thereby knitting together two areas and reducing effects of habitat fragmentation.

Class 2 UVR post-restoration
