# Northern Hydrology & Engineering

## **TECHNICAL MEMORANDUM**

Re: **50% Culvert #2 Design for Redwood Creek Trails Project**

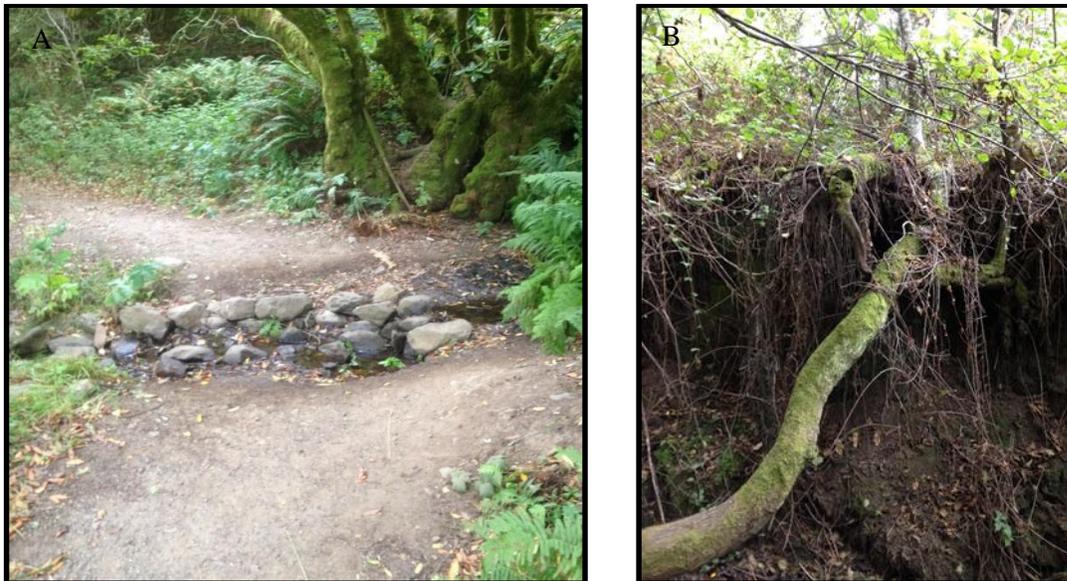
**Figure 2.** Tributary crossing showing the channel flowing over the top of the plugged culvert (A). Water falls over a vertical drop 8.25 feet and the left bank is actively eroding (B).

In addition to the accelerated erosion on the left bank, the material beneath the culvert is also actively eroding, undercutting the downstream end of the culvert. The material exposed below the culvert is predominantly fine grained with discrete chunks of concrete in the upper portion. Additional concrete (appears to be a stem wall) is exposed, roughly parallel to the longitudinal axis of the trail along river left, approximately 6 feet from the left bank. The concrete stem wall and concrete debris found in the vicinity of the crossing do not appear to be structurally related to the existing culvert and are assumed to be remnants of structures that were built prior to Park ownership. Water pipes were found in the subsurface, upstream of the crossing, and may cross the work area.

The upstream side of the culvert is buried with sediment and is not exposed at the crossing. The length of the culvert is estimated to be 14 feet by California State Parks staff (personal communication, Caroline Christman) and the culvert outlet invert is perched approximately 6.25 feet above the channel bed. There is no information available regarding the channel condition at the time the culvert was placed. One possibility is that the culvert was placed at grade (~1960's)

The components of the former crossing that will be removed include: the 2'x 14' culvert, the associated fill below the culvert, the sediment plug that has formed upstream of the culvert, the concrete stem wall (~4-6' x 17.5'), and miscellaneous concrete rubble from the scour hole at the culvert outlet (Figure 3, Plans - Sheet C1). The restoration components include: reducing excessive bank erosion occurring downstream of the culvert outlet and returning the channel to a natural grade, channel geometry, grain size and channel morphology. These modifications are intended to restore hydrologic and geomorphic processes, and ecological function.

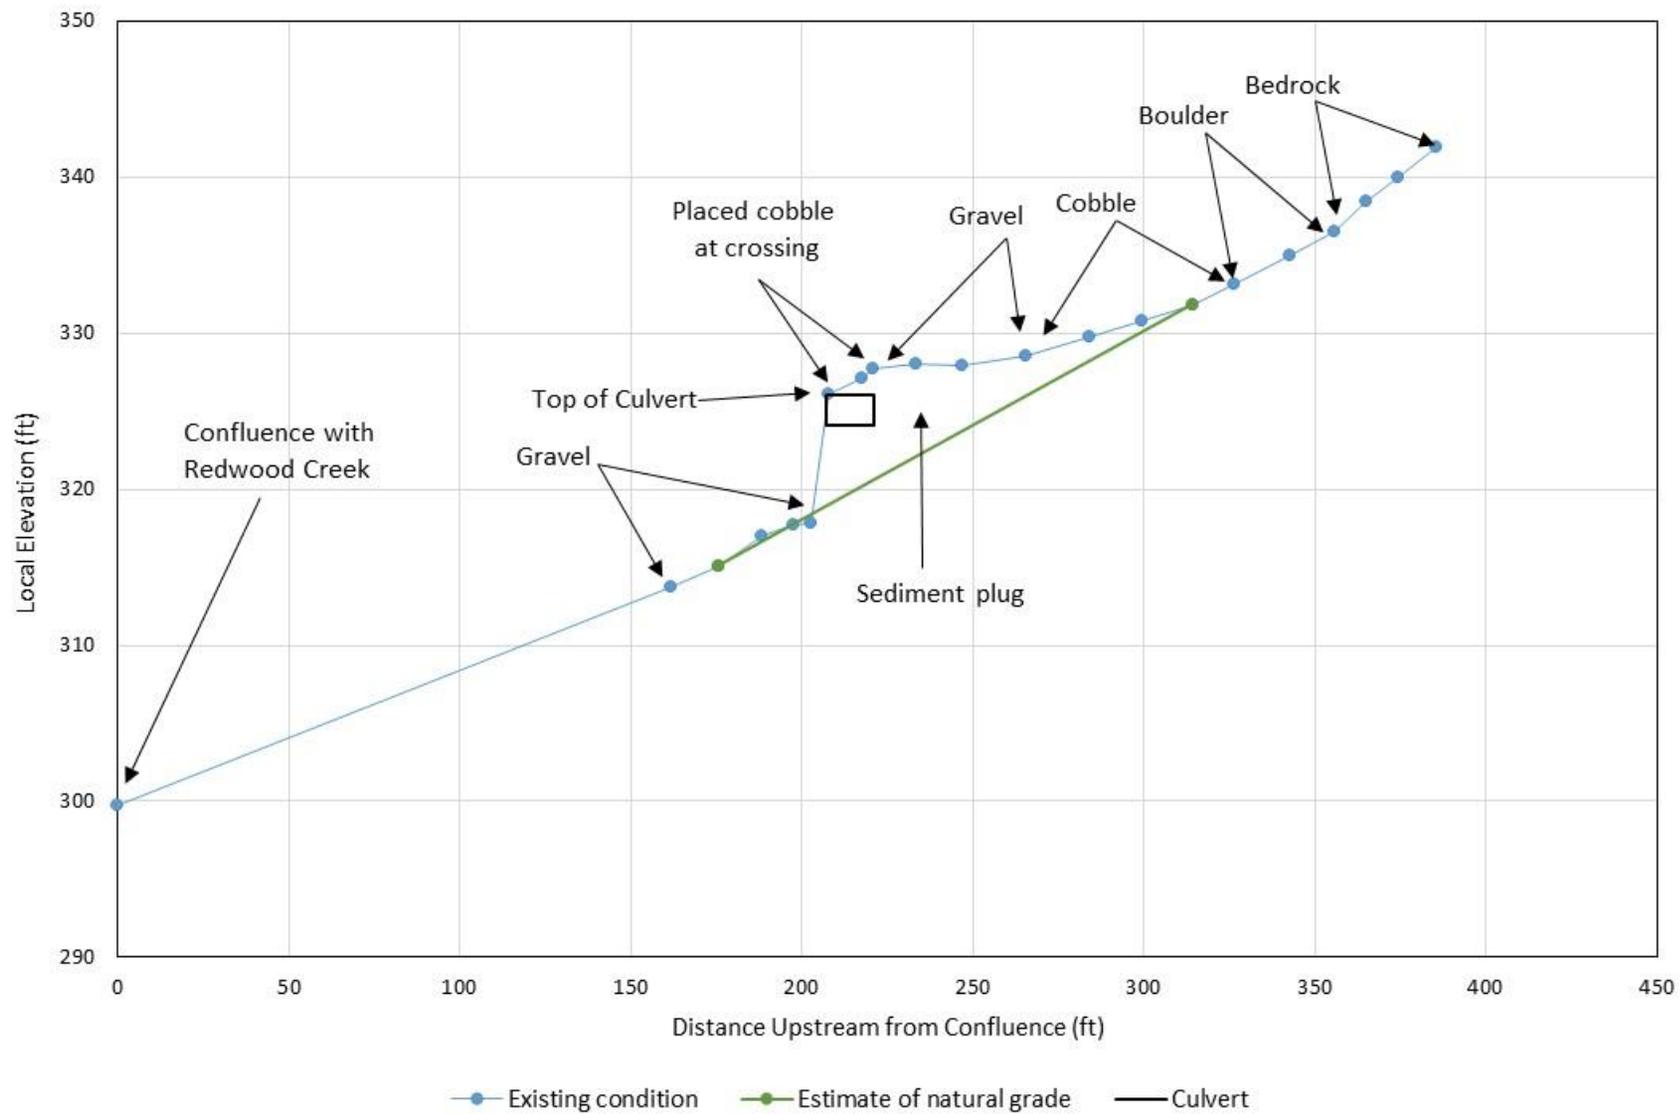
A longitudinal profile of the tributary was surveyed from the confluence with Redwood Creek (0 feet), through the crossing (~200 feet) to the bedrock controlled reach (~385 feet) (Figure 3). A detailed topographic survey was conducted over 165 feet. The channel gradient from the culvert downstream to the confluence with Redwood Creek is 9%. The channel is dominated by coarse gravel substrate and wood drops with roughness dominated by irregular bed and banks, and woody and herbaceous vegetation. The stream banks are typically 1H:1V or steeper and are partially covered by herbaceous vegetation and roots from adjacent trees. A large buckeye is located on river right, immediately upstream of the crossing (Figure 1).

Upstream of the culvert, the slope flattens to 2% over 45 feet and is predominately gravel bedded. These changes in slope and channel dimensions are a direct result of the existing crossing. The depth of the channel is approximately 2 feet, bottom width is 3 feet and top width is 10 feet. The channel begins to steepen dramatically upstream of this sediment plug and the channel bed coarsens to cobble, boulder, and finally a boulder/bedrock channel. The slope increases to 8% in the cobble reach, 11% in the boulder reach and 17% in the boulder/bedrock reach. The channel size varies from a bottom width of 10 feet and top width of 20 feet at the widest location, to a bottom width in the boulder reach of approximately 4.5 feet, top width 10 feet and channel depth 5 feet.

Figure 3. Longitudinal profile, substrate, and estimate of natural grade in the vicinity of the crossing.

Design channel grading will extend the full length of the sediment plug, (105 feet upstream of the existing culvert outlet, Figure 3). Downstream, channel bed grading will occur in the vicinity of scour hole created by the culvert (12 feet) and along the left channel bank where excessive bank erosion has occurred (60 feet downstream of the culvert). The right bank downstream of the outlet is more stable, is partially vegetated and will not be graded. Channel bank slopes are designed at 1H:1V up to the 100-yr peak flow water surface elevation and sloped to 1.5H:1V above the 100-yr peak flow water surface elevation. The bed is 4.5 feet wide. Design cross-sections are shown in Sheet C2 of the Plans. The design channel alignment follows the existing alignment. The top of the right bank is generally preserved with the majority of the grading occurring in the channel and along the left bank (Plans - Sheet C1). This configuration was selected to preserve riparian vegetation on the right bank, including a large buckeye tree located on the right bank immediately upstream of the crossing, and treat the most actively eroding bank (left bank) downstream of the culvert. Due to close proximity of the left valley wall to the design channel, further reducing the bank slopes would require shifting the channel alignment toward river right and removing the large buckeye tree as well additional trees along the right bank.
