BENTHIC SURVEY OF SEAGRASS ABUNDANCE FOR THE CAPE SABLE PLUG RESTORATION PROJECT

Prepared By: Christopher Kavanagh

Florida Bay Interagency Science Center

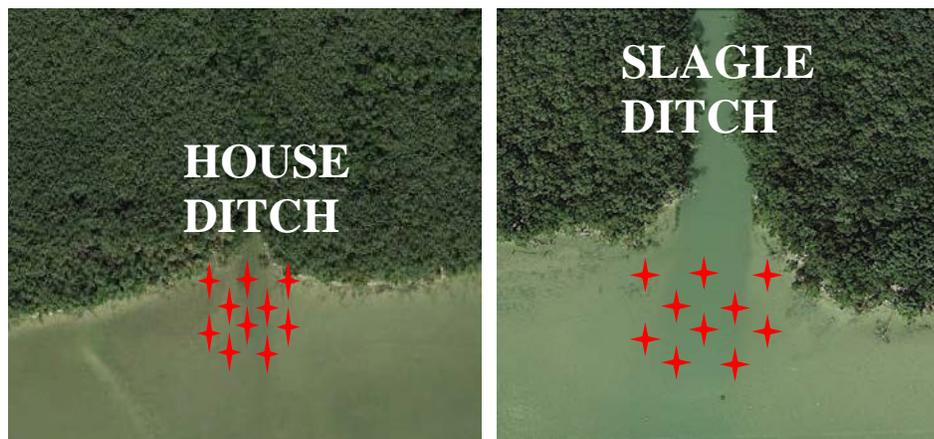
The area consisted of a canal mouth into open bay with mangrove shoreline and a central 2.5 m deep channel. Canal and bay waters at this site were milky brown and opaque and visibility less than 0.15 m from surface to bottom. Benthos was composed of a mud and sand mixture in shallows with sandy shell in the deeper channel area of high flow. No living seagrass was found at either site. Some dead *Halodule wrightii* seagrass leaf blades were part of the detritus and debris on the bottom. *Gracilaria sp.* (red macro-alga) was drifting loose on the substrate in the shallower areas.

Figure 1. Sample sites at House Ditch and Slagle Ditch.

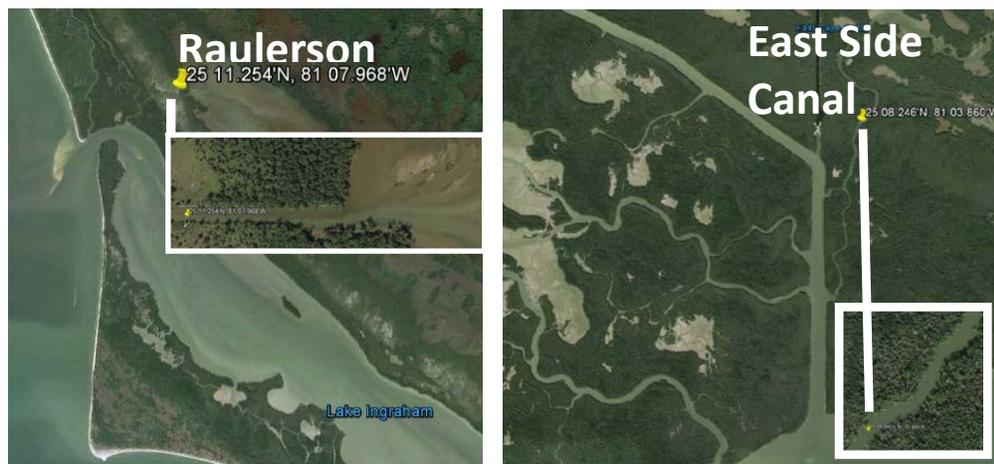
Canal waters at this site were milky brown and opaque with visibility less than 0.15 m at the surface (measured by Secchi disk). Water flow rate was high. Crocodiles are commonly present in the canals. Water quality parameters were measured with a handheld YSI probe, and can be seen in Table 1. Penetration of light to 2 m depth was reduced by 92% to 98% of irradiance

measured just below the surface of the water (0.2 m). The attenuation coefficients ranged from 2.7 to 3.3, which can be compared to attenuation of open Florida Bay water of 0.5.

Figure 1. Sample sites at Raulerson Canal and East Side Canal. Inset shows site characteristics.
