SAND POINT/MUNISING USCG LIFE SAVING STATION
PICTURED ROCKS NATIONAL LAKESHORE
Cultural Landscape Report and Environmental Assessment

February 20, 2017
Public Review Draft

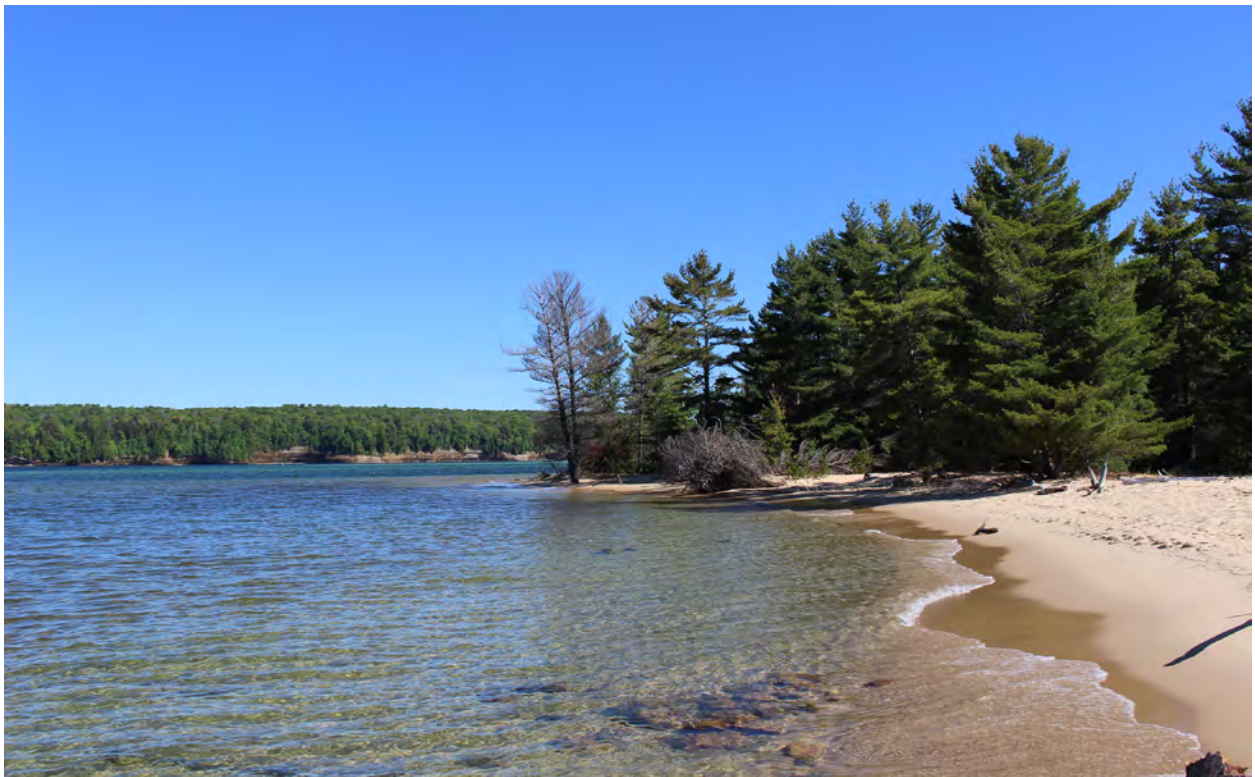
Figure 3-4. On the south side of the point the lakeshore cuts inland resulting in some vegetation being flooded. (source: Mundus Bishop 2016)

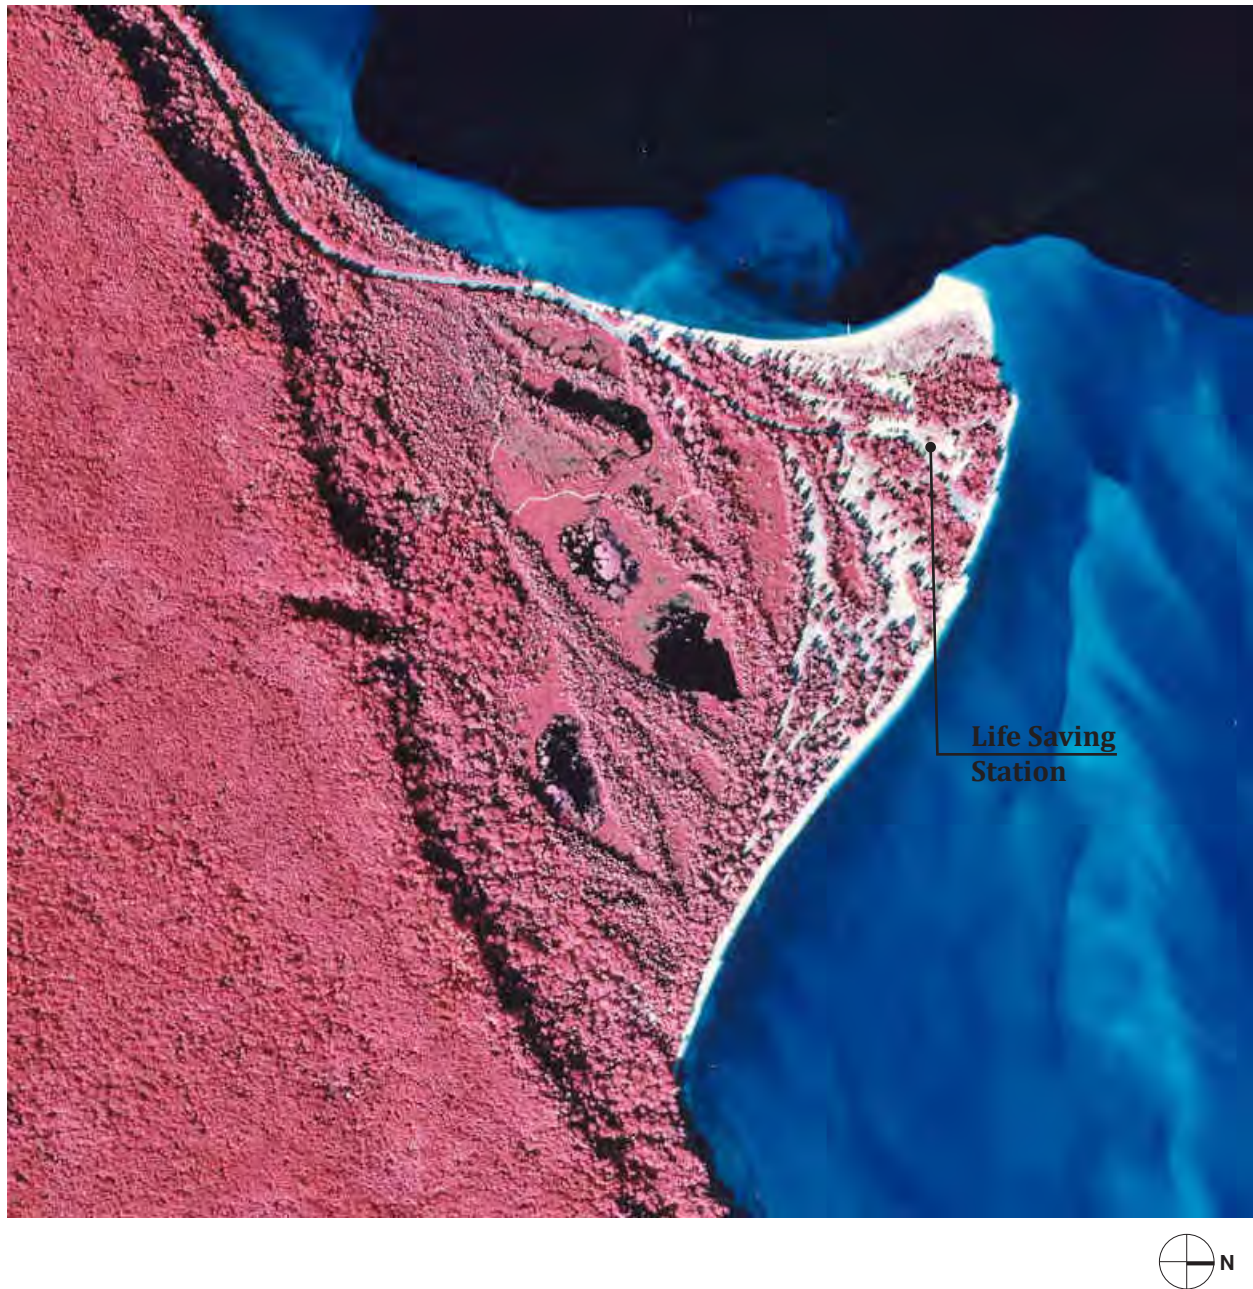
Figure 3-6. Erosion has removed much of the sand at Sand Point since the 1970s, altering the appearance of the point. "Aerial of Sand Point, 1994." (source: PIRO Archives)

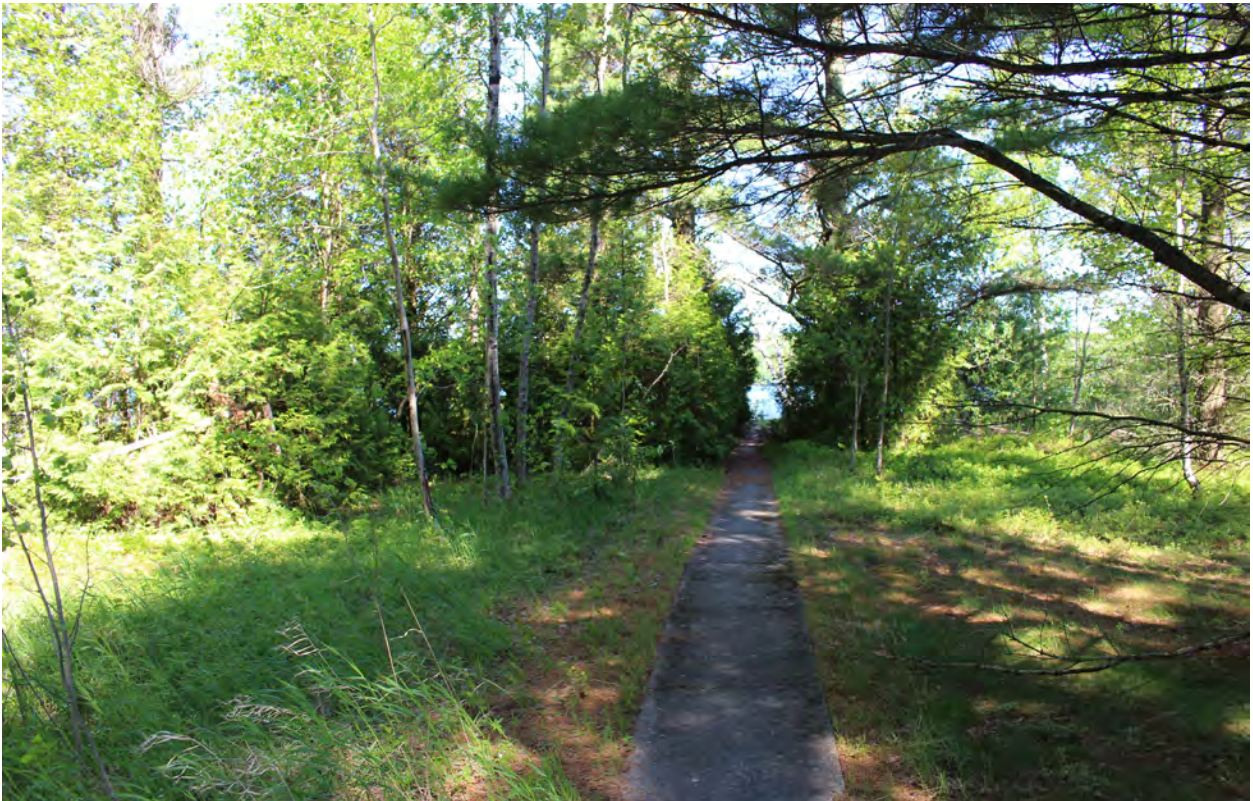
Figure 3-21. The walk between the Communications Tower and the Lookout Tower is in fair condition, portions are covered by encroaching vegetation. (source: Mundus Bishop 2016)

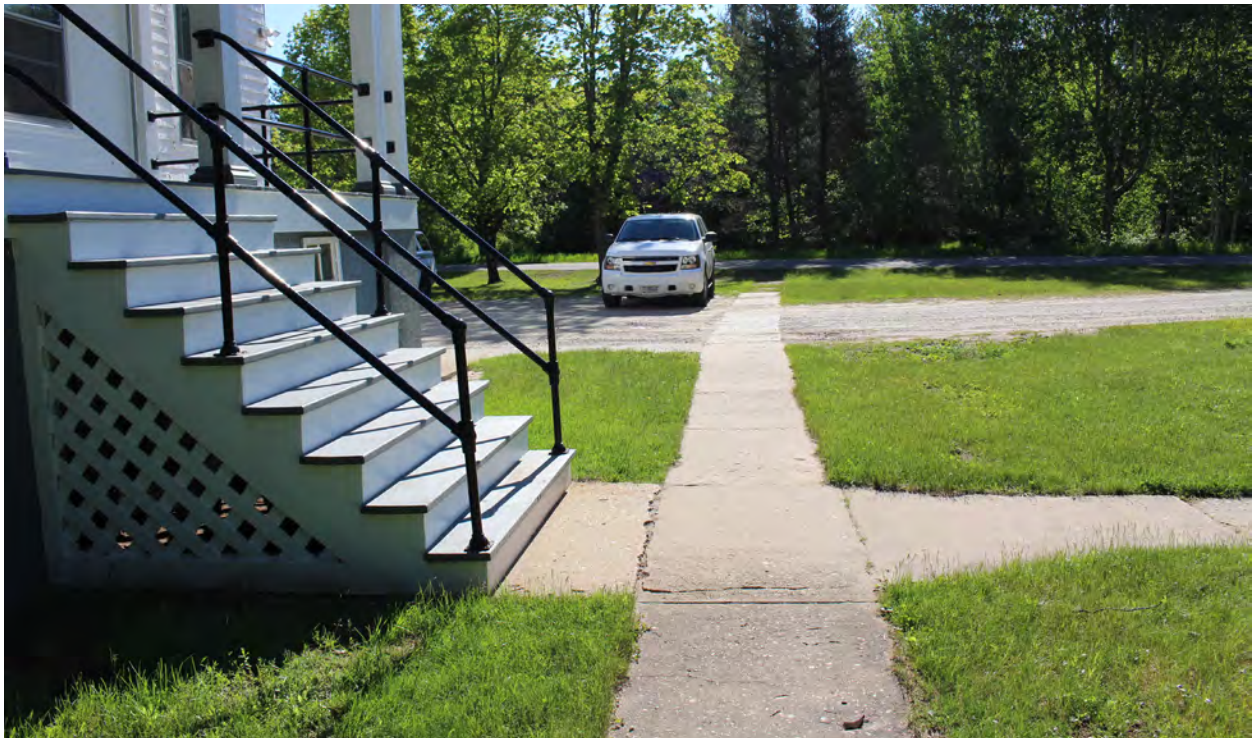
Figure 3-29. The Station Walk at the south facade of the Life Saving Station is in fair condition; damaged where the entrance drive crosses the sidewalk, at rear of photograph. (source: Mundus Bishop 2016)

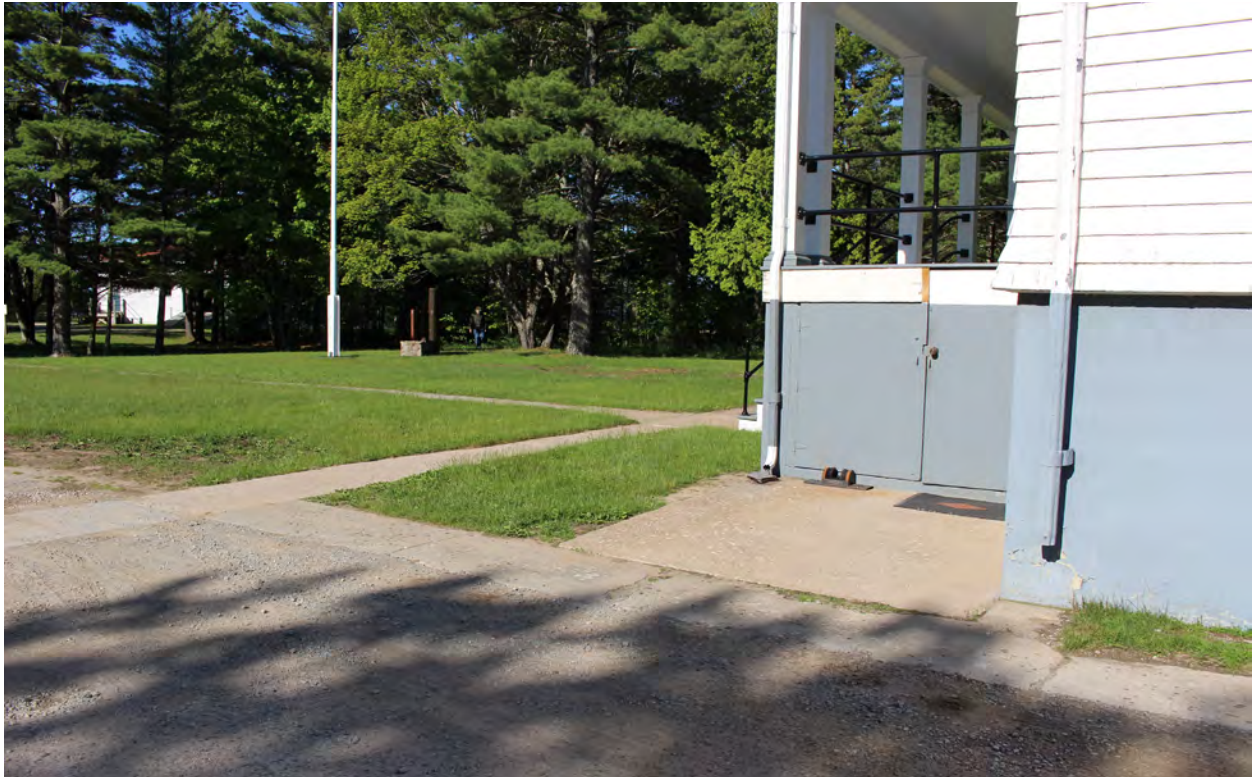
Figure 3-30. The Station Walk on the southeast corner of the Life Saving Station is in fair condition. (source: Mundus Bishop 2016)

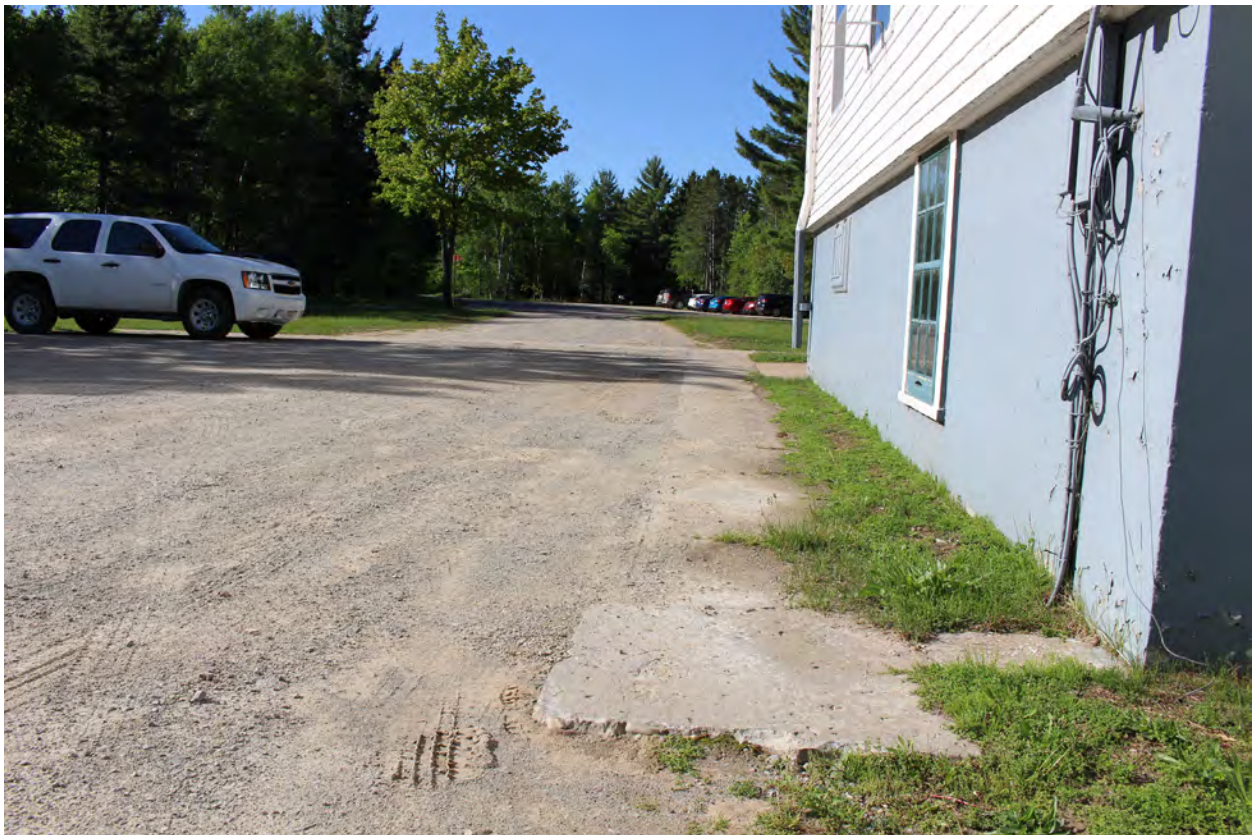
Figure 3-31. The Station Walk on the east side is damaged adjacent to the staff parking area. (source: Mundus Bishop 2016)

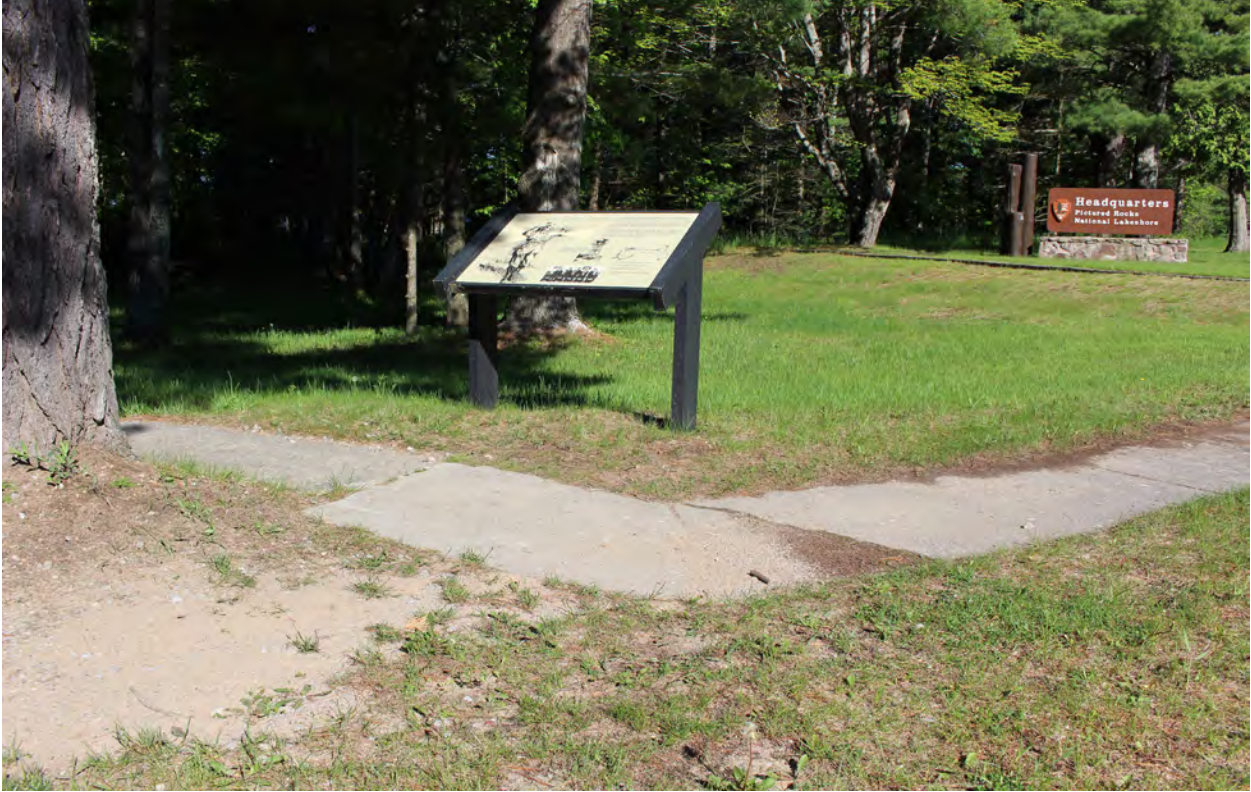
Figure 3-32. The North South Main Walk has been damaged at the south end by erosion and uplift due to tree roots, especially where it turns towards the Boathouse, above. (source: Mundus Bishop 2016)

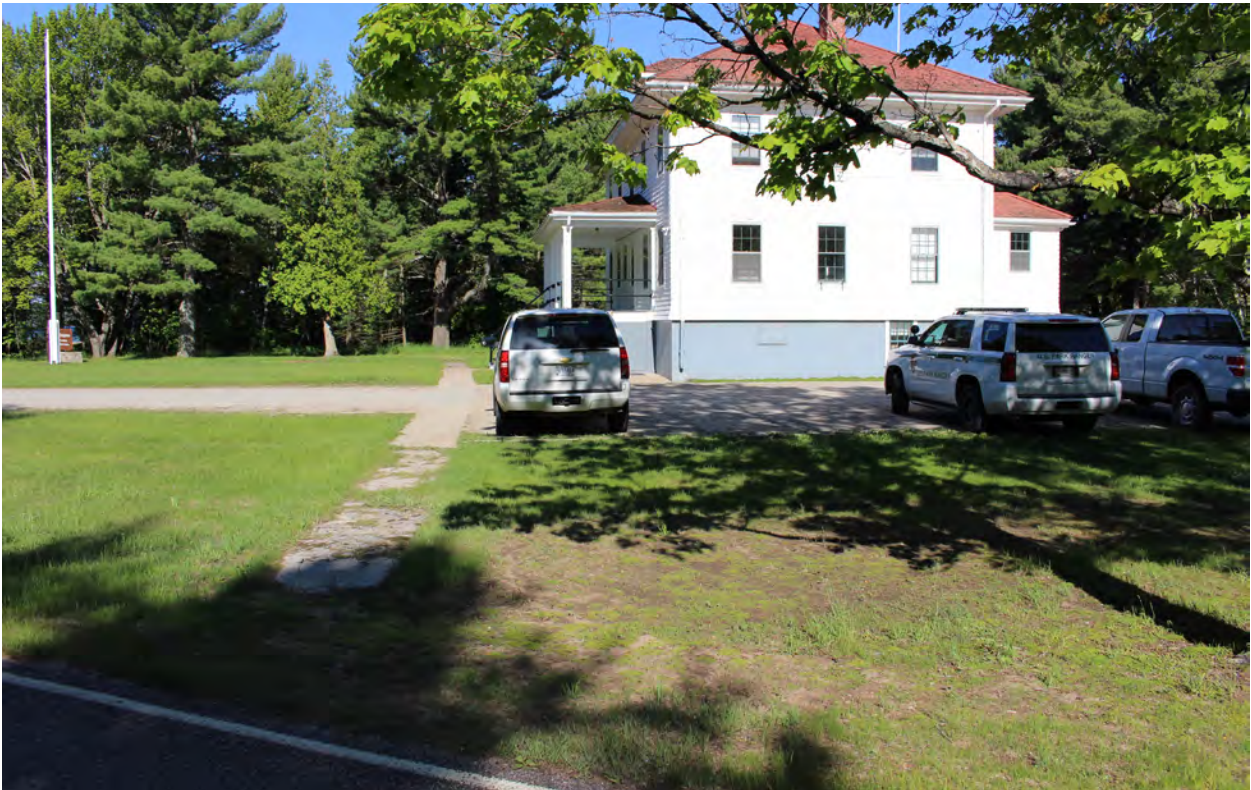
Figure 3-33. The Station Walk extended to the east, to connect to the residences on the opposite side of Sand Point Road. This portion of the walk is in poor condition. (source: Mundus Bishop 2016)

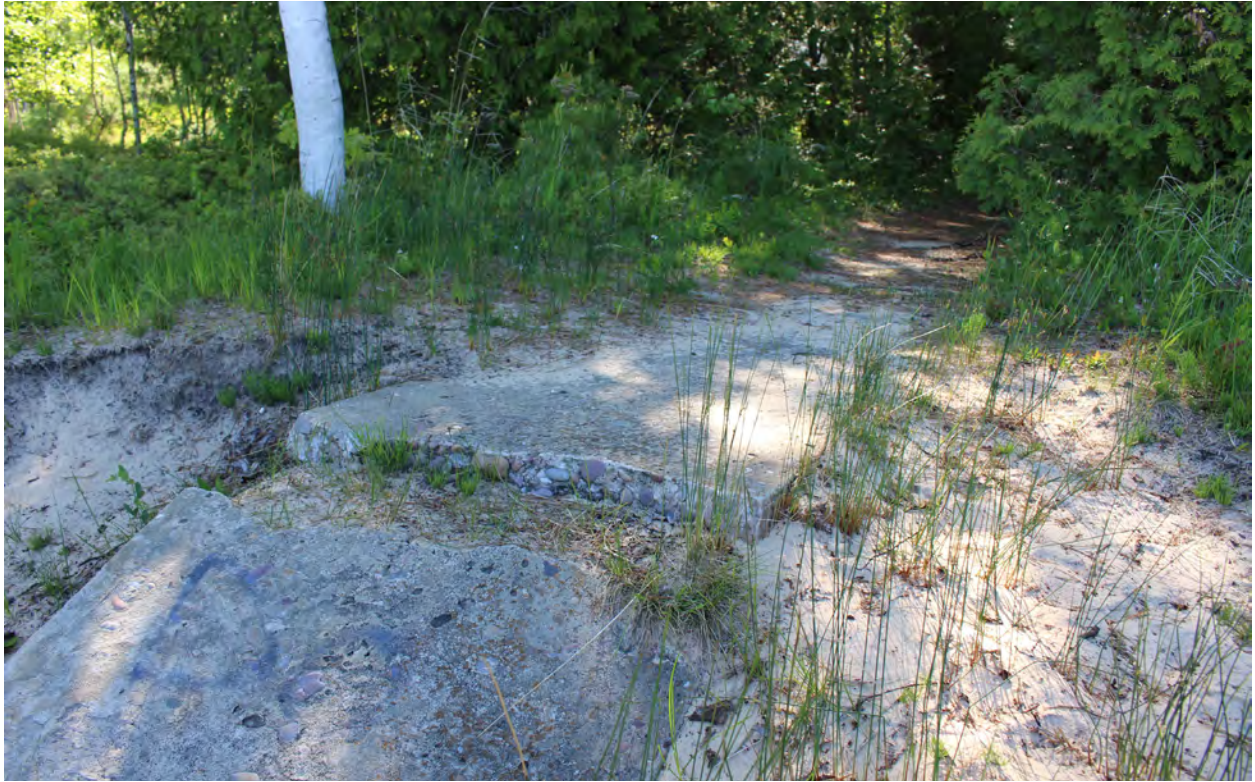
Figure 3-34. The walk to the Lookout Tower is damaged by erosion of the beach, and the end of the walk has washed out. (source: Mundus Bishop 2016)

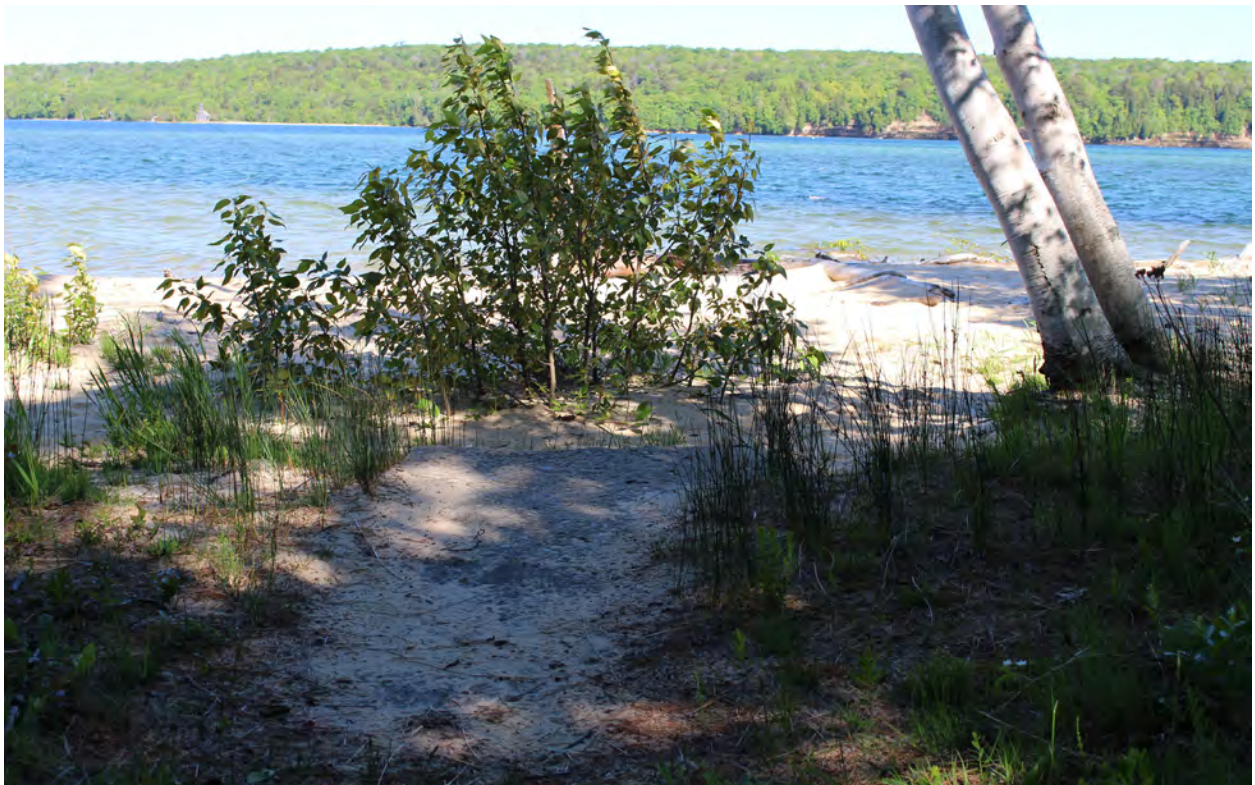
Figure 3-35. The walk to the Lookout Tower disappears into the sand. The loss of the walk diminishes the integrity of the circulation pattern. (source: Mundus Bishop 2016)

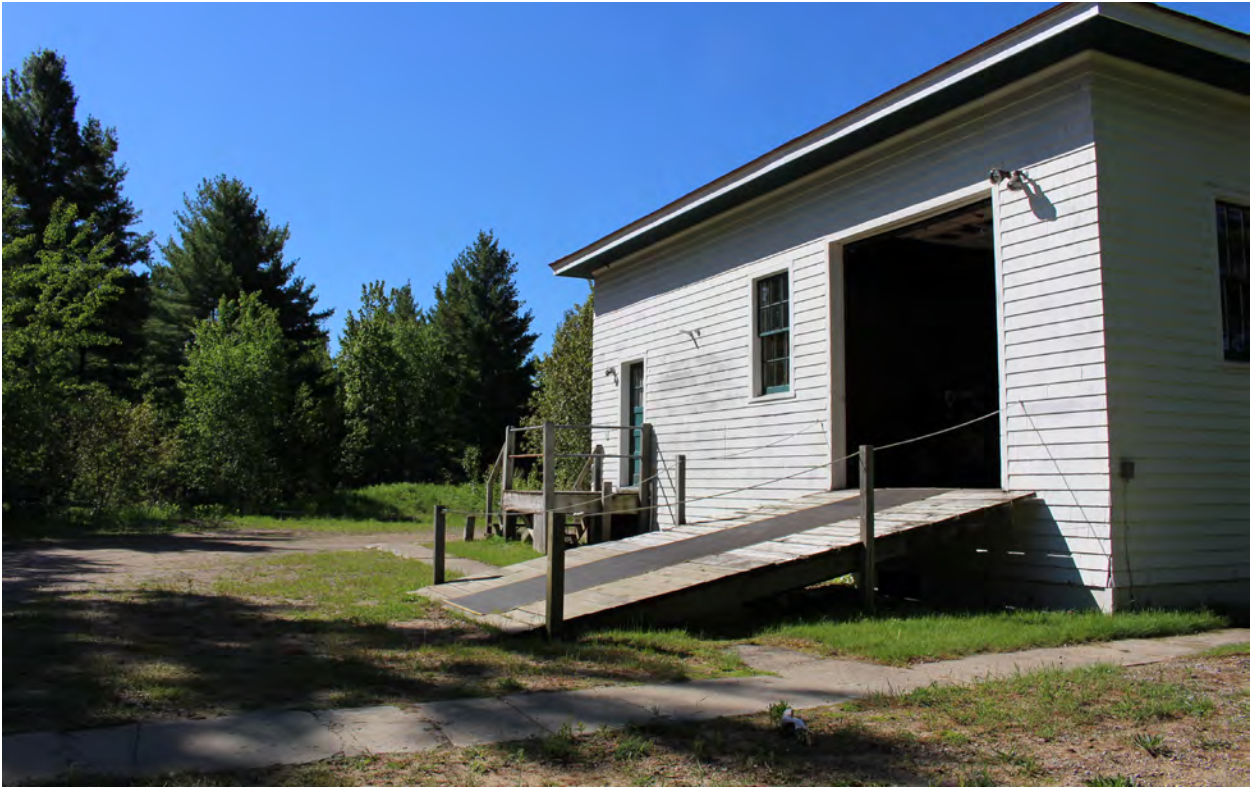
Figure 3-36. Concrete walks surround the Boathouse on three sides. The east walk has been covered over by the ramp, and is in poor condition. (source: Mundus Bishop 2016)

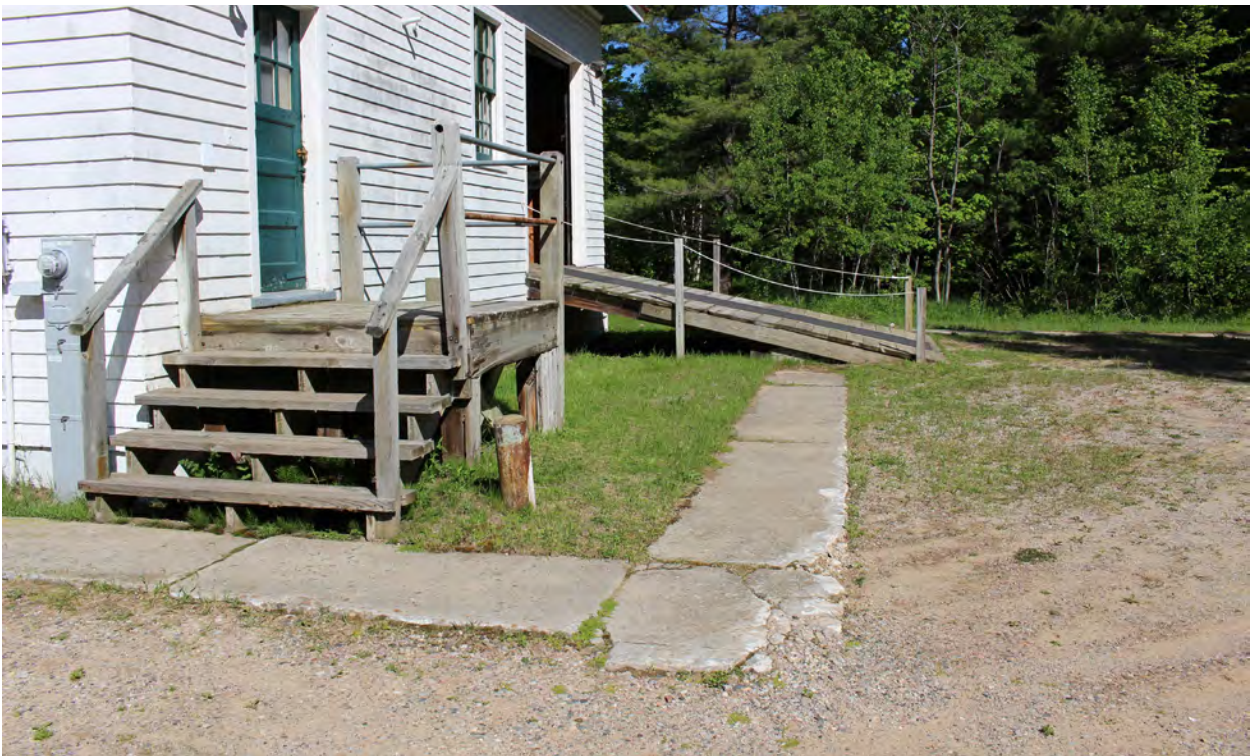
Figure 3-37. The porch and steps, and ramp into the Boathouse are recent additions in historic locations, although the ramp was shorter historically. Note poor condition of concrete walk in foreground. (source: Mundus Bishop 2016)

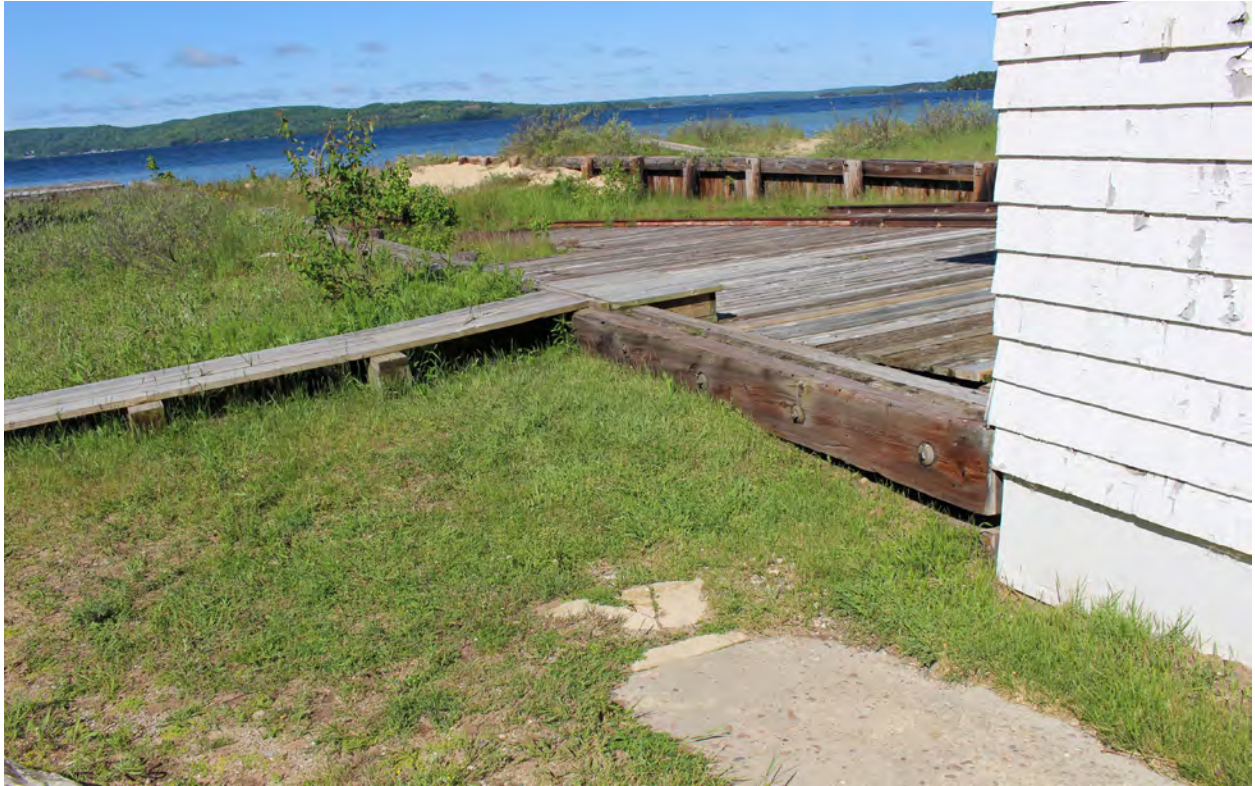
Figure 3-38. The concrete walk at the south facade of the Boathouse, in foreground, is in poor condition. The boardwalk, at left, connects to the Launchway with a wooden step. (source: Mundus Bishop 2016)

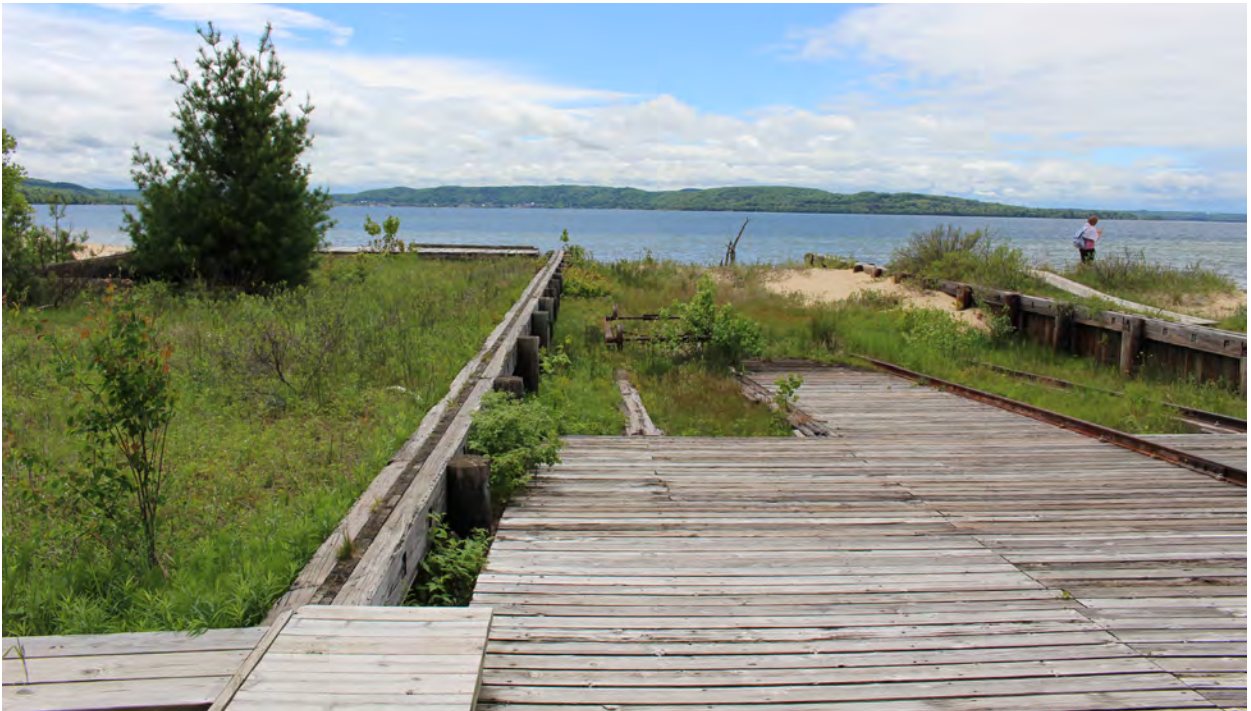
Figure 3-41. The Launchway is in fair to poor condition. Today, water routes do not reflect the historic pattern because the Launchway and Boathouse are no longer actively used. (source: Mundus Bishop 2016)

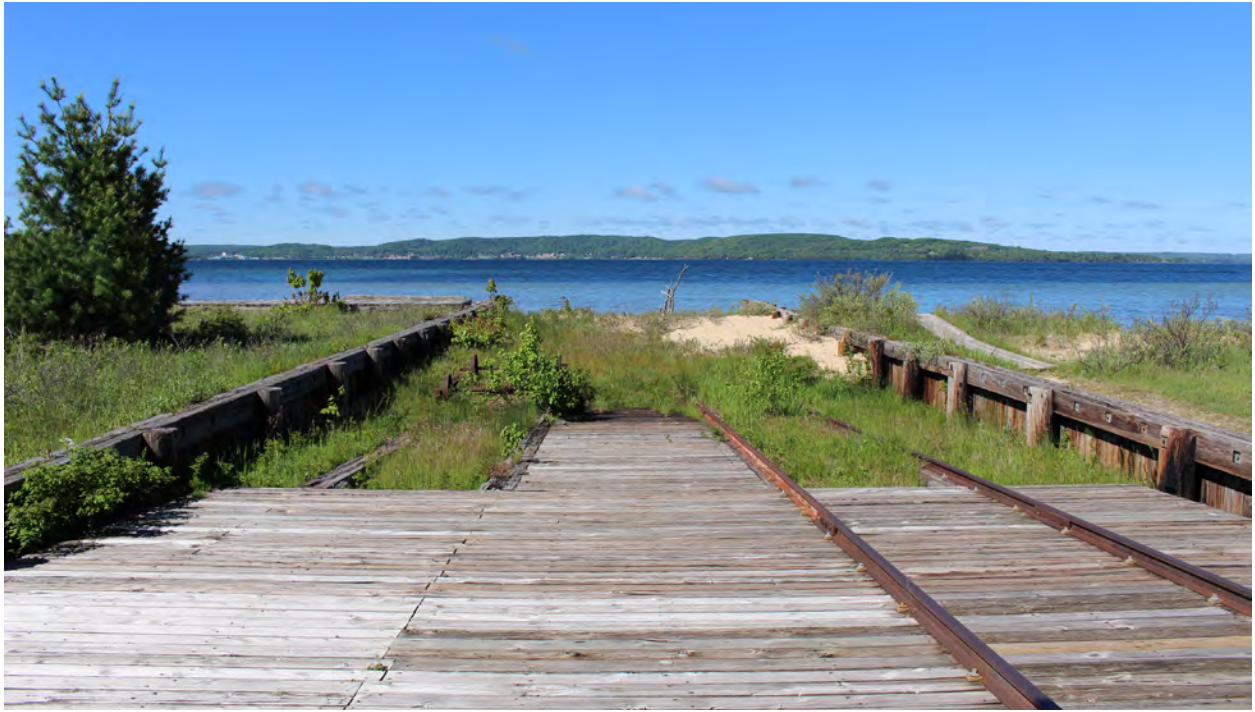
The Launchway is partially covered in sand, and guidance is needed on its preservation or repair.

Figure 3-46. The Launchway is in fair to poor condition. Sand and vegetation have covered the west end of the Launchway, diminishing the spatial relationship that once existed between the structure and the lake. Northwest winds across Lake Superior shift the sands at Sand Point, creating a general trend of younger beach ridges from southeast to northwest along Sand Point. (source: Mundus Bishop 2016)

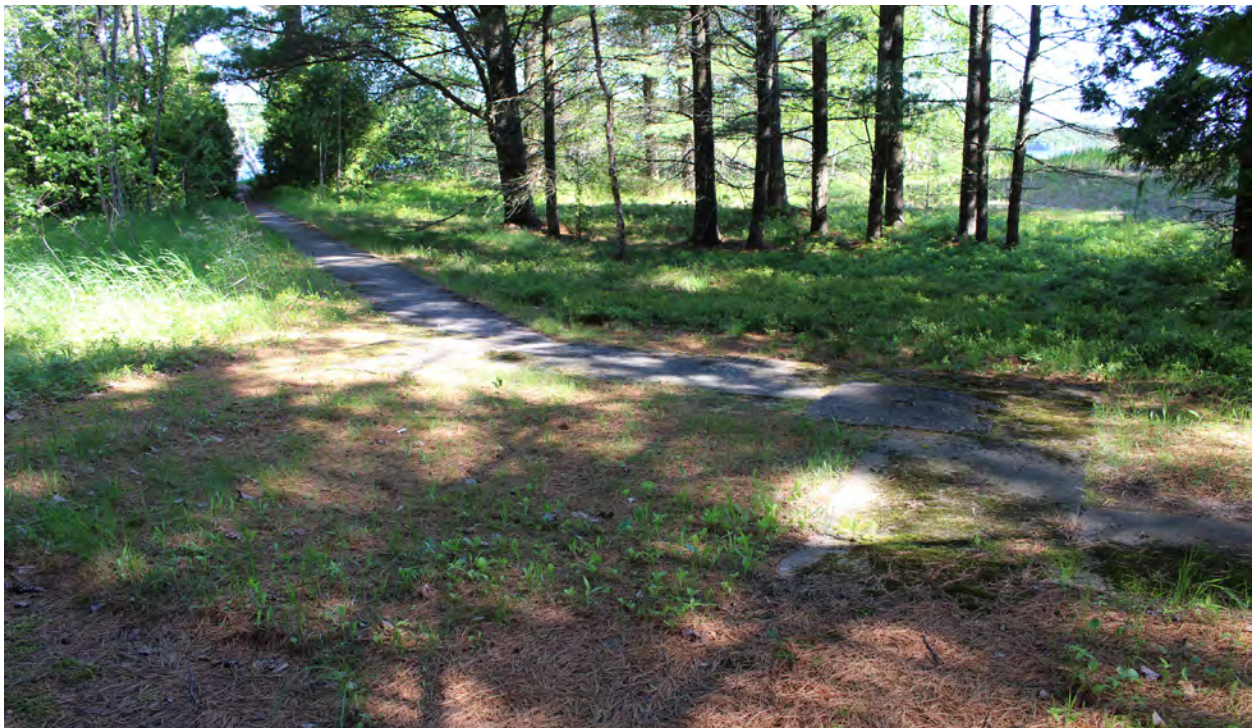
Figure 3-47. The foundation of the Communications Tower is covered by dirt and debris, and enclosed by dense forest, making it difficult to discern the scale of the structure that once stood here. (source: Mundus Bishop 2016)

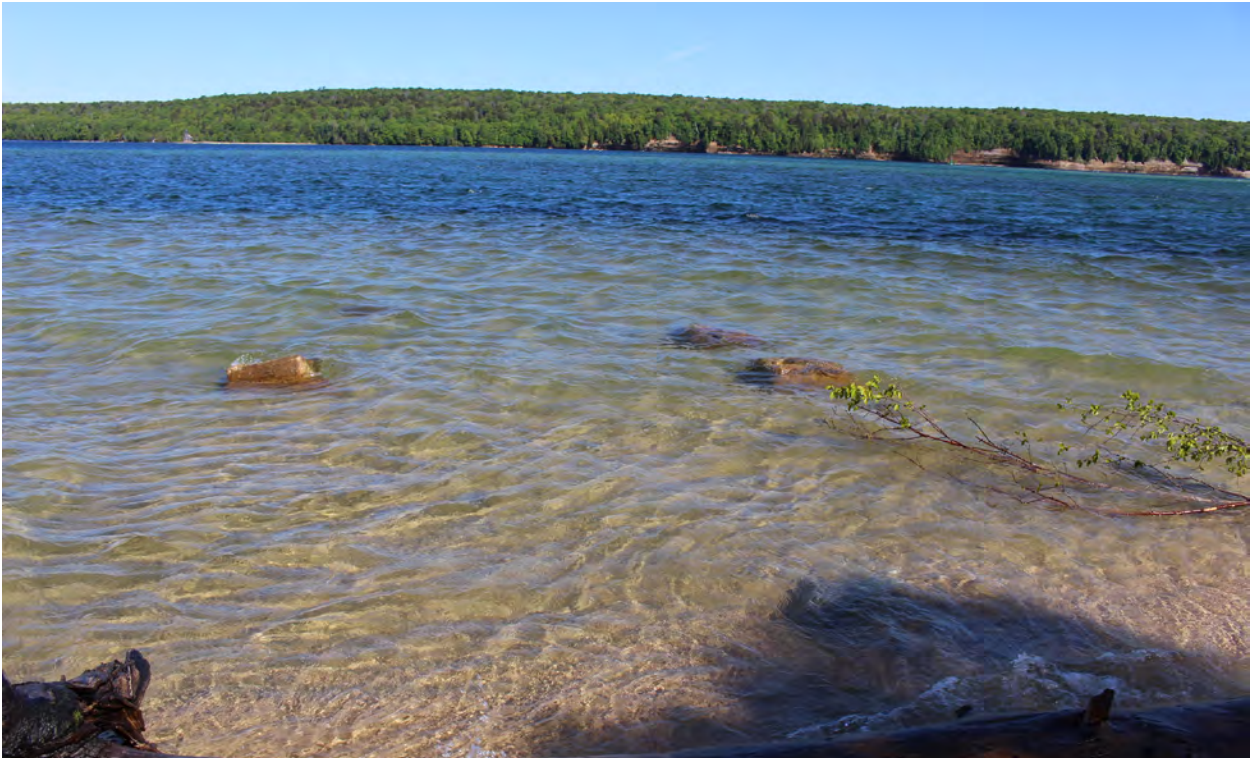
Figure 3-48. The extant foundation of the Lookout Tower is visible as four concrete block submerged in the lake. Loss of the structure has negatively impacted the pattern of buildings and structures across the cultural landscape. The loss of sand at Sand Point is part of the natural cycle of beach erosion and accretion. (source: Mundus Bishop 2016)

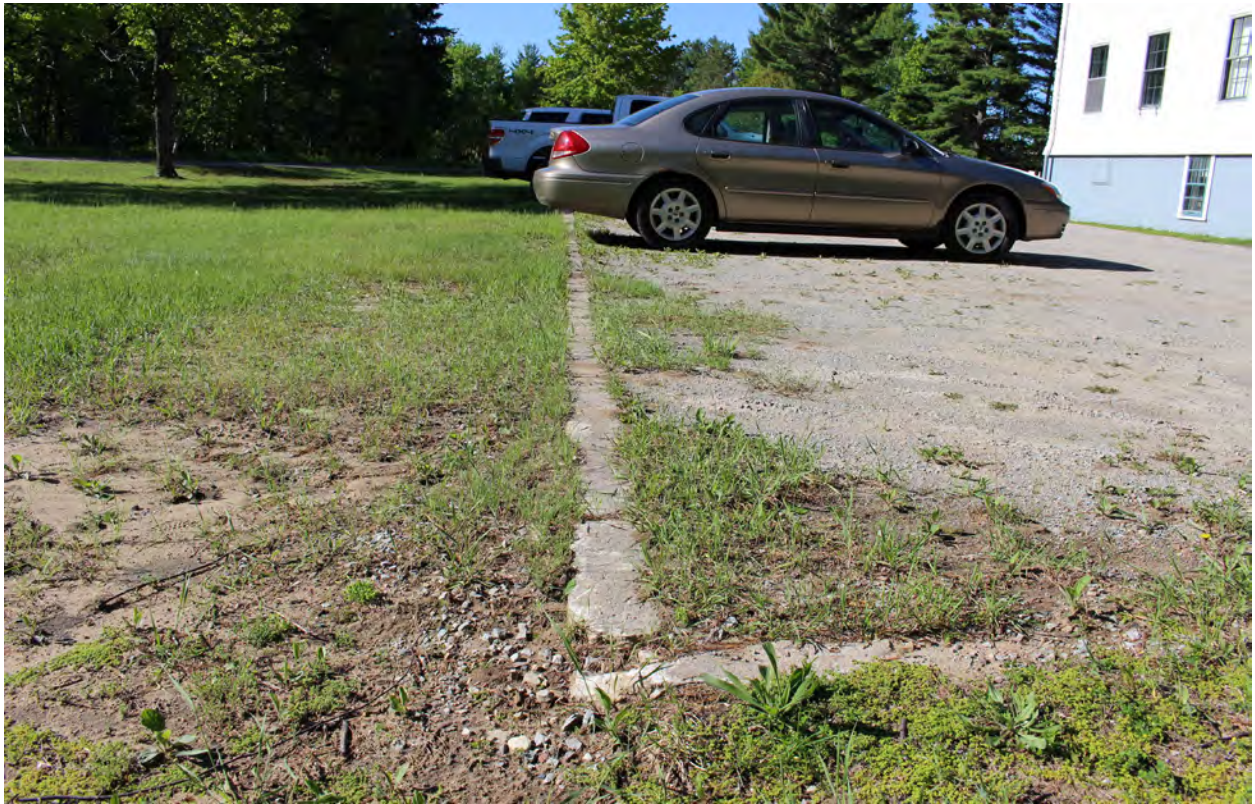
Figure 3-51. The concrete curb at the east edge is in poor condition and does not enclose the formal lawn space, as was the original design intent. (source: Mundus Bishop 2016)
