Morning Star Community Landscape Character Area

TITLE OF PROJECT
**CULTURAL LANDSCAPE REPORT
 AND ENVIRONMENTAL ASSESSMENT**
 TITLE OF DRAWING
 EXISTING CONDITION - MORNING STAR HOTEL, MILL, AND MINE COMMUNITY, AND HOUSE ROW
 NAME OF PARK
RUSH HISTORIC DISTRICT
 REGION COUNTY STATE
 MIDWEST MARION ARKANSAS
 Illustration 3-2.
 3-83

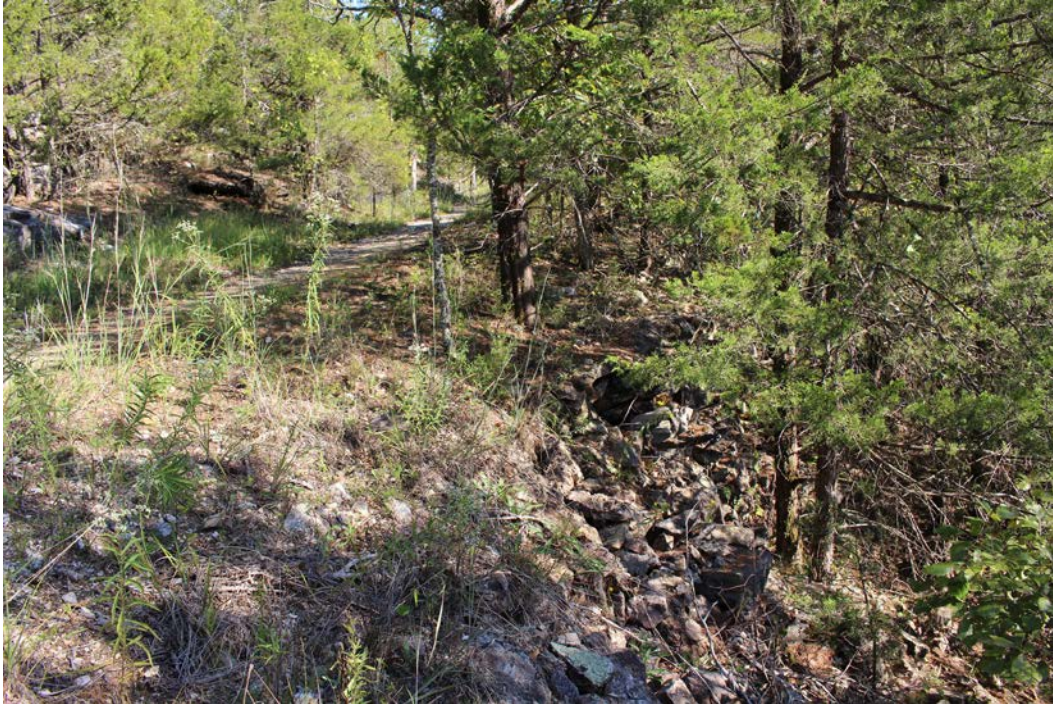
Figure 3-87. Ashe's juniper glade near Morning Star Mine (M1). (Mundus Bishop 2017)

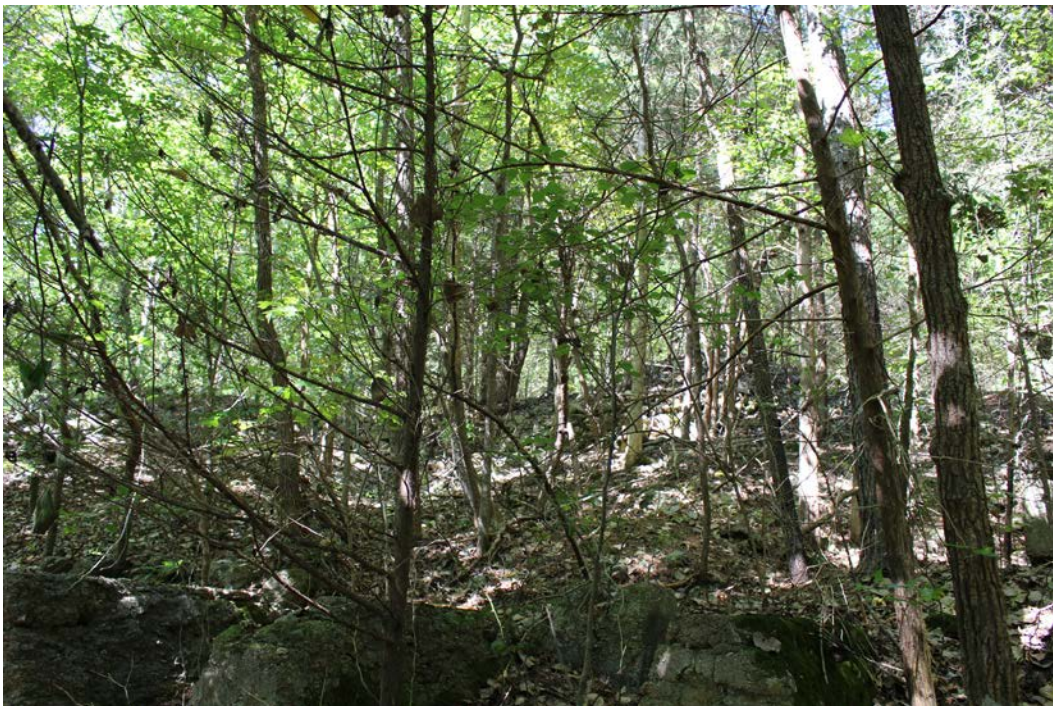
Figure 3-88. Successional forest near Yellow Rose Mine Complex (M7) and Edith Mine Complex (M12). (Mundus Bishop 2017)

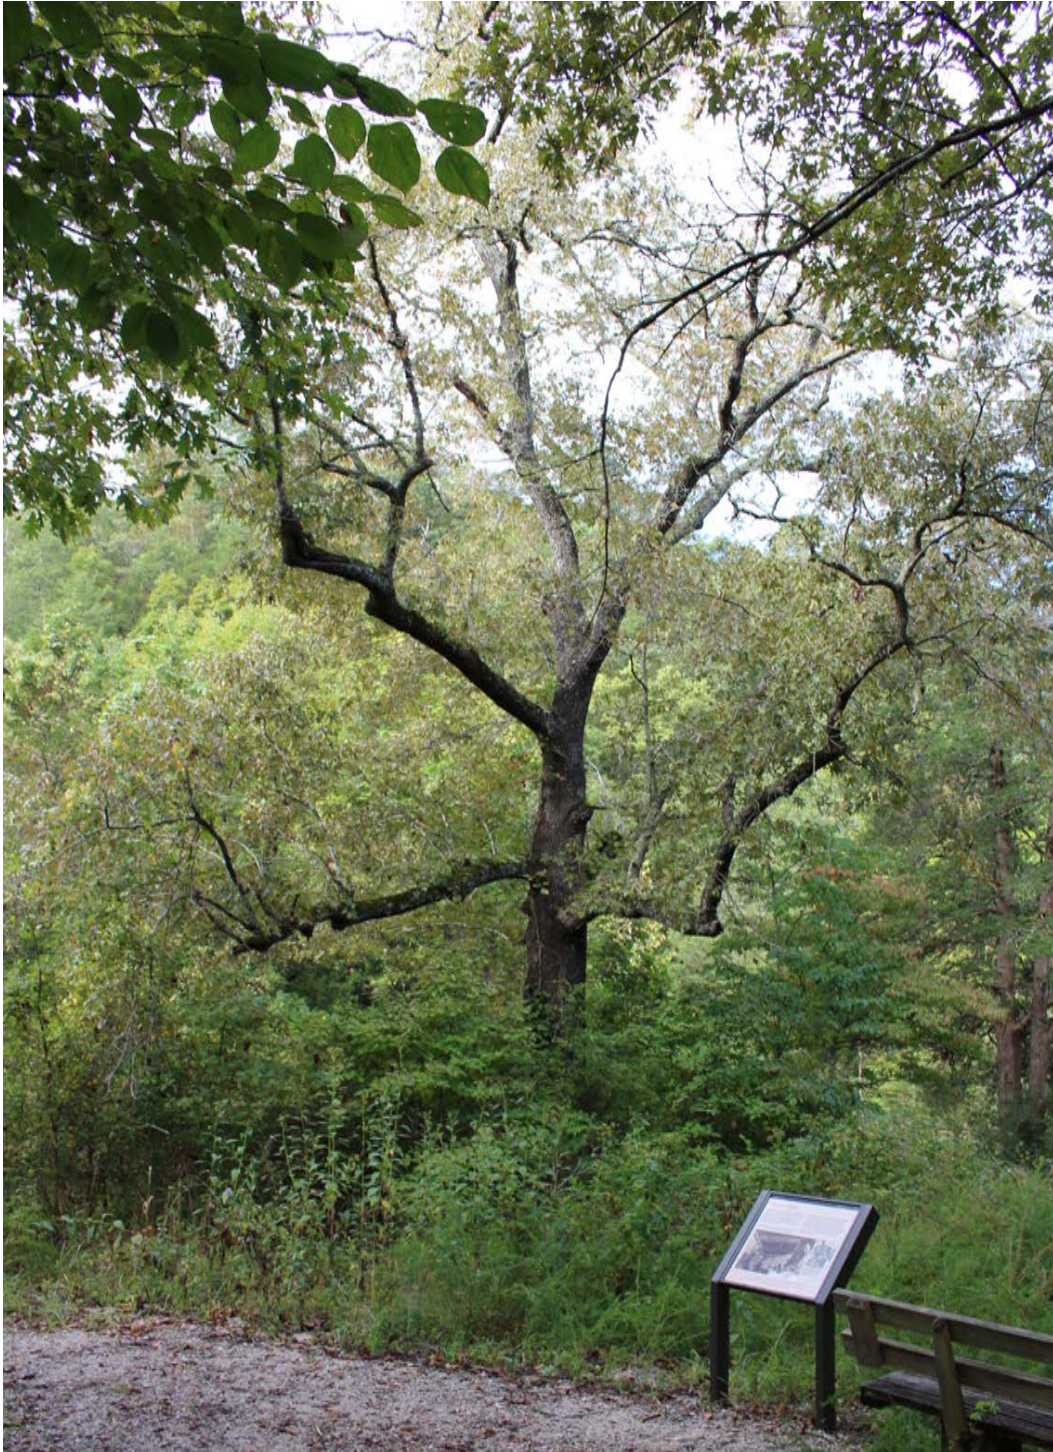
Figure 3-89. Several large oak and hickory trees are extant from the period of significance, located near extant buildings and ruins. (Mundus Bishop 2017)

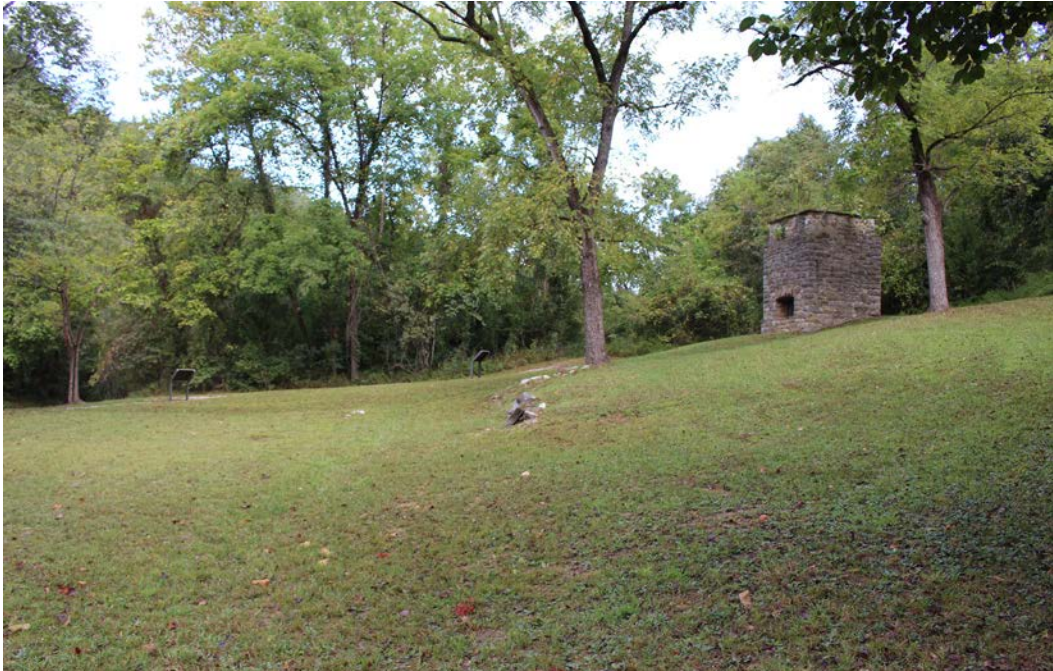
Figure 3-93. The opening in the woodland vegetation marks the foundation of Morning Star Livery Barn and provides a view from Rush Road into the formerly developed area. (Mundus Bishop 2017)

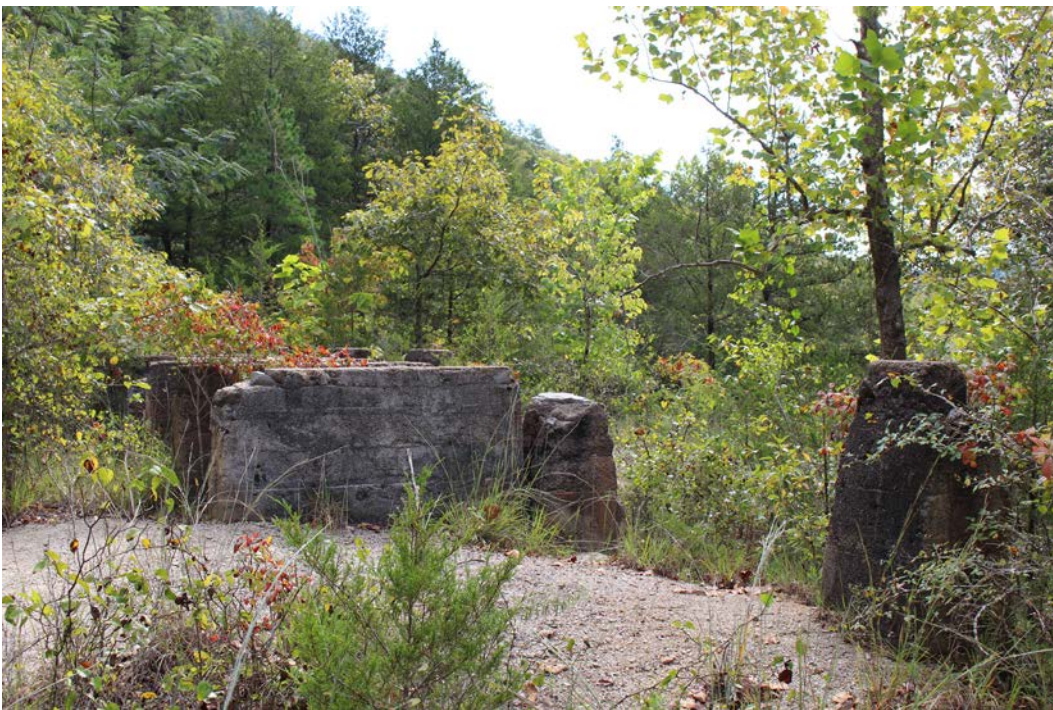
Figure 3-94. Morning Star Mill ruins include a series of concrete and stone piers, a stone retaining wall at the northern slope, a concrete platform for the engine, and a stone and brick boiler room. The mill is set on a level terrace above the remainder of Morning Star Hotel, Mill, and Mine Community. (Mundus Bishop 2017)

6 Morning Star Mill was built in 1898 and was
7 connected to Morning Star Mine (M1), Ben
8 Carney Mine, and Capps Mine (M11) by an
9 elevated tramway. Today mill ruins include a
10 series of parallel concrete and stone piers, a
11 stone retaining wall at the northern slope, a
12 concrete platform for the engine and a stone
13 and brick boiler room. A stone retaining
14 wall extends east to west along the hillside
15 providing level space for mill building and
16 operations. A large retention basin is extant to
17 the south, excavated into the earth and fed by
18 a small natural drainage from Rush Mountain.
19 Tailings piles are to the south and downhill of
20 the mill. The mass and scale of this building
21 and its relationship to other mine features
22 is not discernible today due to overgrown
23 vegetation.

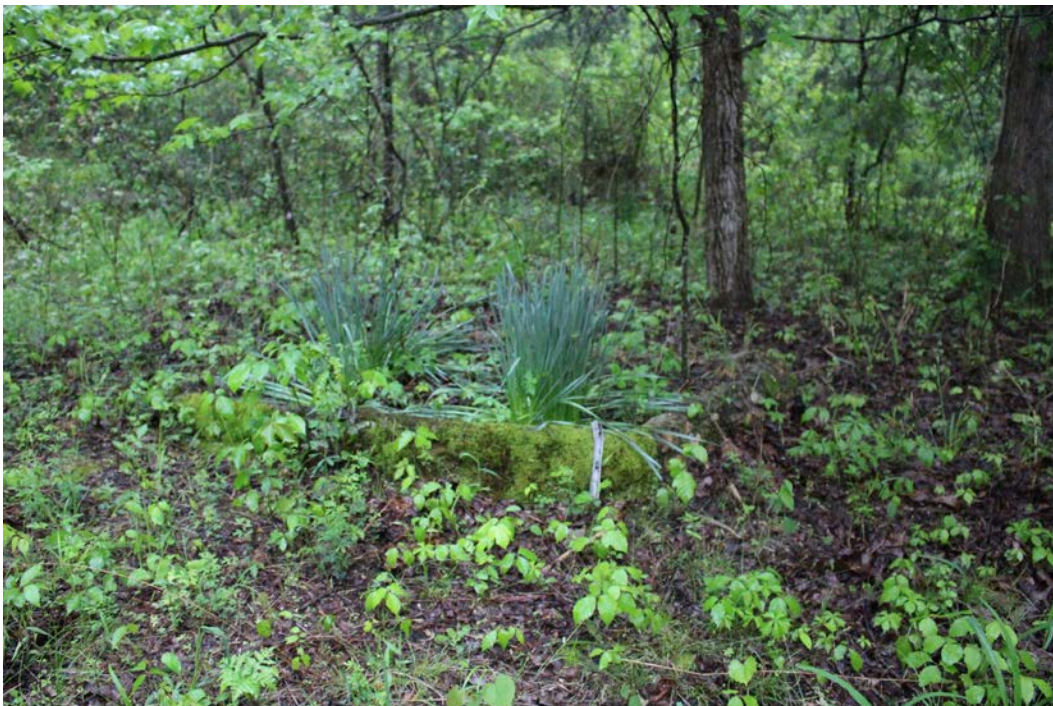
Figure 3-96. Extant trees and ornamental vegetation at Hicks Hotel assist in maintaining the historic character of the landscape character area. (Mundus Bishop 2017)

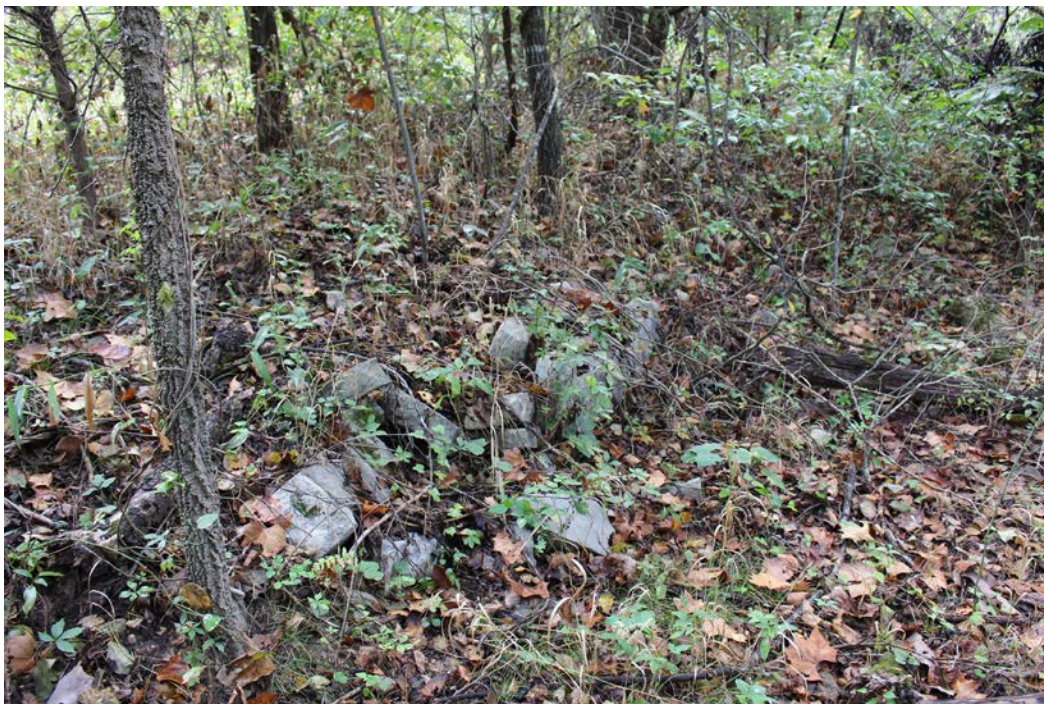
Figure 3-98. Stone retaining wall rubble near Morning Star Hotel ruins, Lyons House ruins, Post Office ruins, and Barn ruins area. (Mundus Bishop 2017)

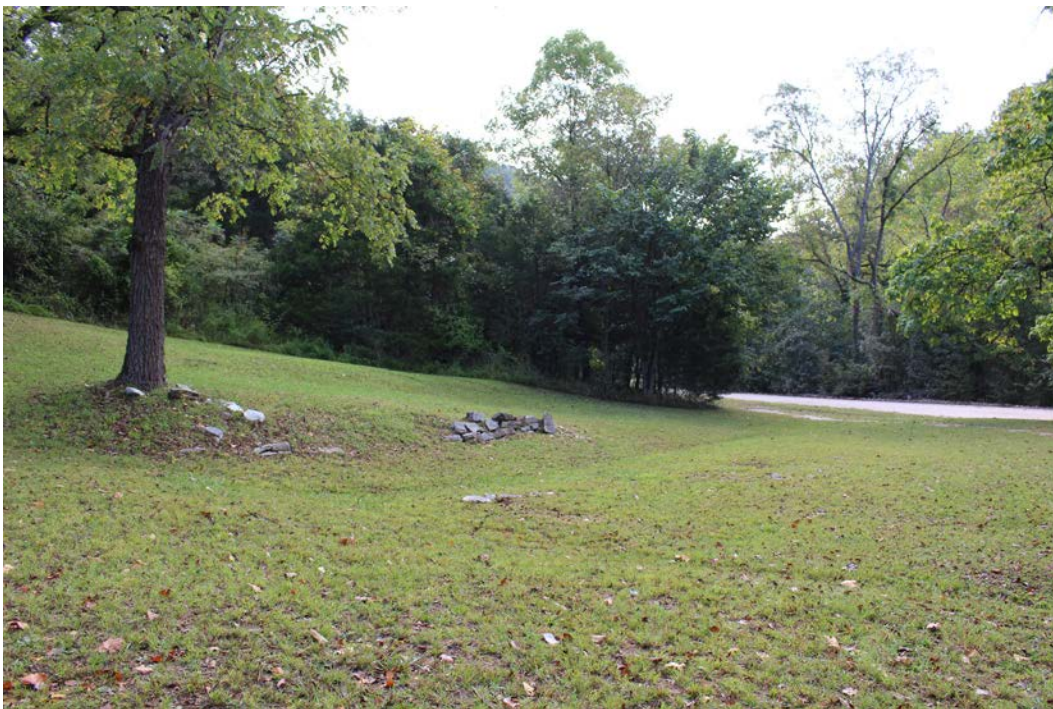
Figure 3-100. Morning Star Livery Barn ruins. (Mundus Bishop 2017)

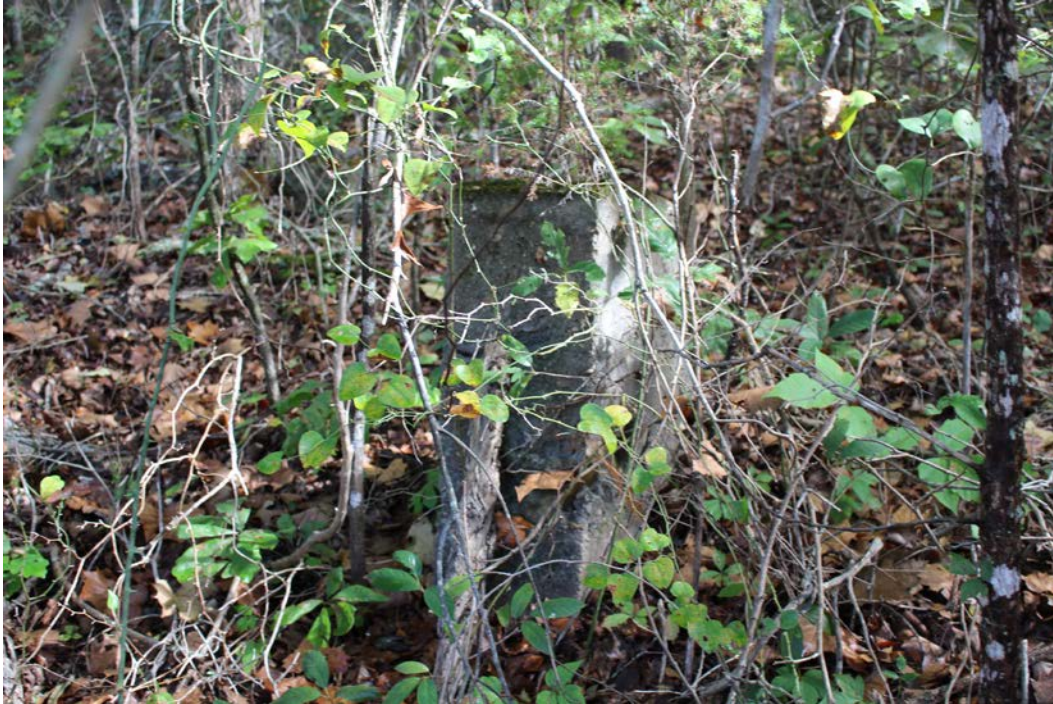
Figure 3-101. Oil Storage House ruins. (Mundus Bishop 2017)

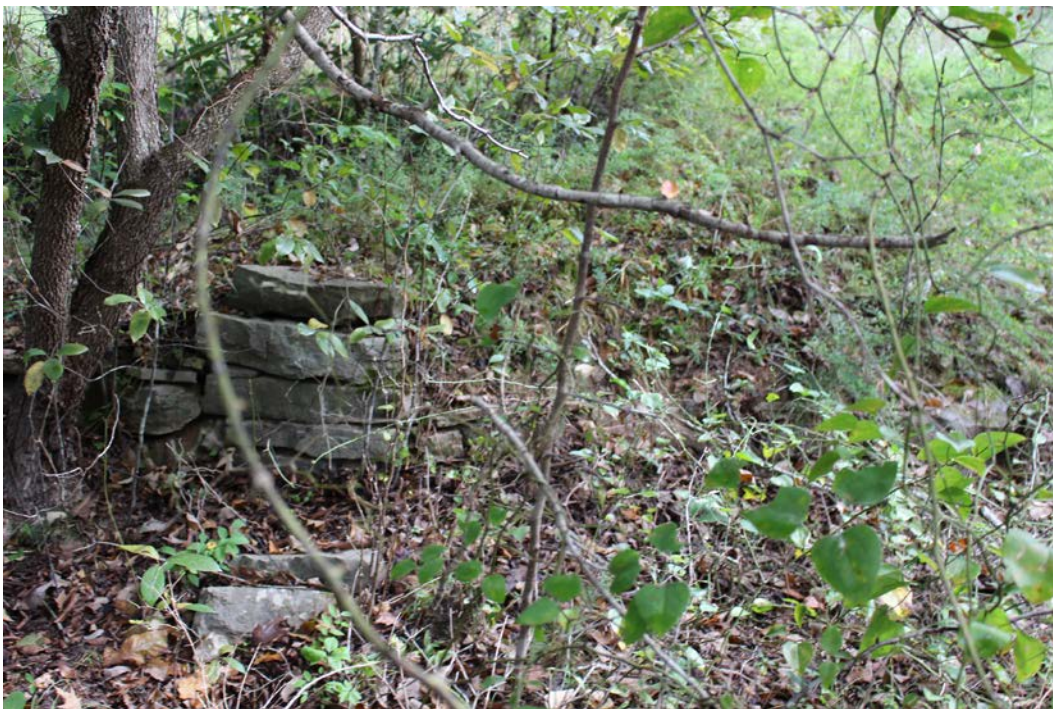
Figure 3-102. Stone retaining wall at Chase and Mulholland Store. (Mundus Bishop 2017)
