Establish a Trail Connection with the 114th Pennsylvania Monument at Chancellorsville Photos

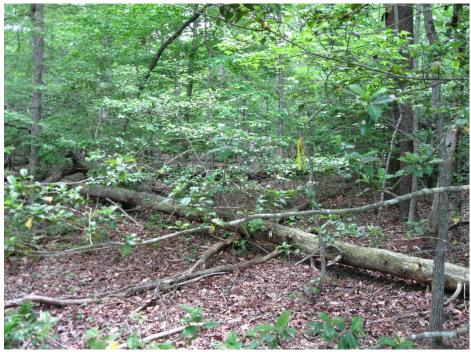
Proposed beginning of trail, at point where it departs from Hazel Grove-Fairview Trail. Yellow flagging indicates the route.

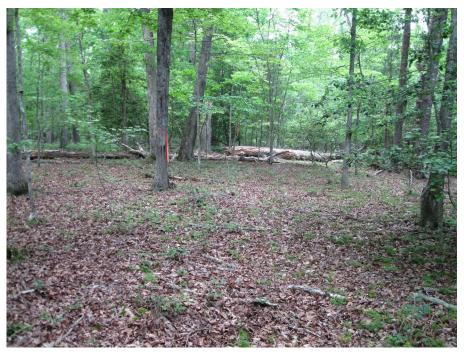
Much of the proposed trail route goes through open woods, requiring minimal work to establish.

Route follows orange flagging.

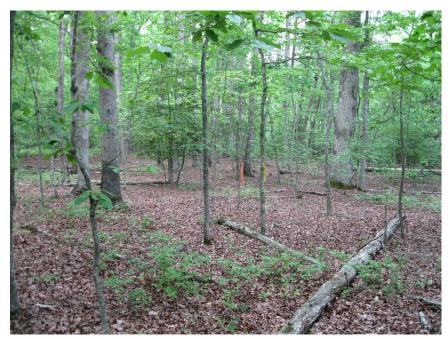
A representative view of most of the trail route, marked with flagging through open woods.

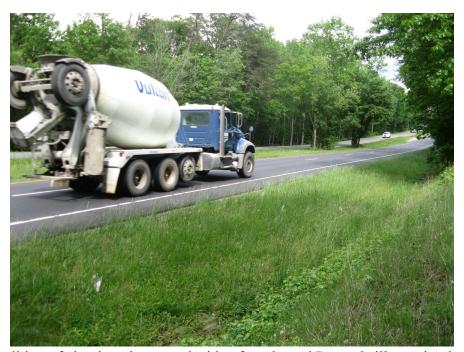
Current condition of clearing along south side of eastbound Route 3, illustrating lack of a safe pull off for park staff and visitors. Traffic is extremely heavy and moves at high speed.

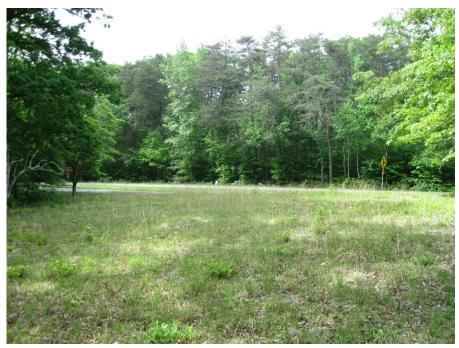
View of the clearing, looking north to Route 3. Both east and westbound lanes are visible in the middle ground. The 114th PA Monument is to the left of the view.

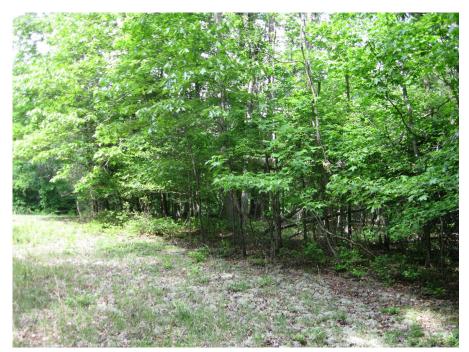
This view shows how the clearing has not been able to be maintained, resulting in high grass and encroachment by the surrounding woods.

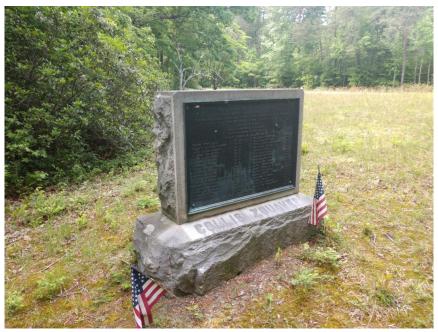
The 114th PA Monument, with Route 3 in the background. Note the stains on both the stones and metal tablet, a result of lack of safe access for maintenance crews to clean the monument and the encroaching forest cover.
