## **APPENDIX A**

### **CATOCTIN AQUEDUCT RESTORATION METHODS FOR ALTERNATIVE C**

## CATOCTIN AQUEDUCT PROJECT METHODOLOGY

**UNDERWATER INSPECTION  
AND EVALUATION  
OF  
CATOCTIN AQUEDUCT  
OVER  
CATOCTIN CREEK  
LANDER, MARYLAND**

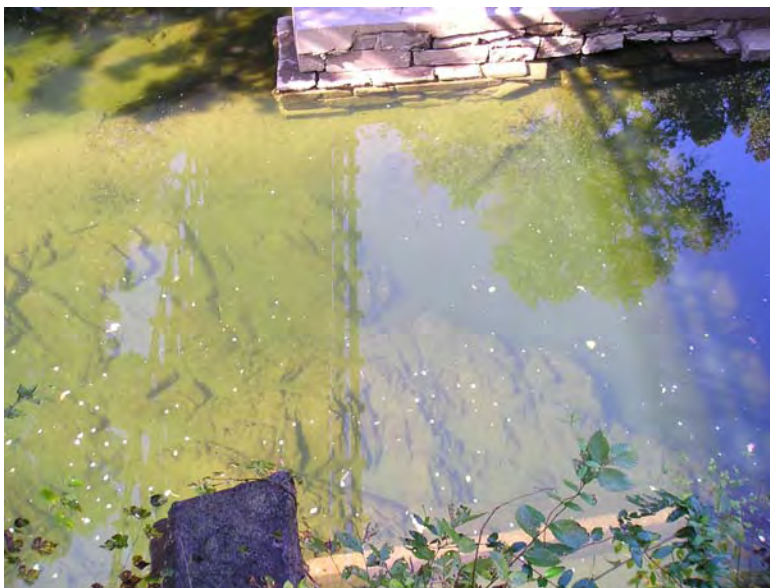
Photo 3. Contact between mylonite and diabase dike.

The mylonites occur within smaller, localized shear zones and is softer material that is more susceptible to differential weathering and scour forces.

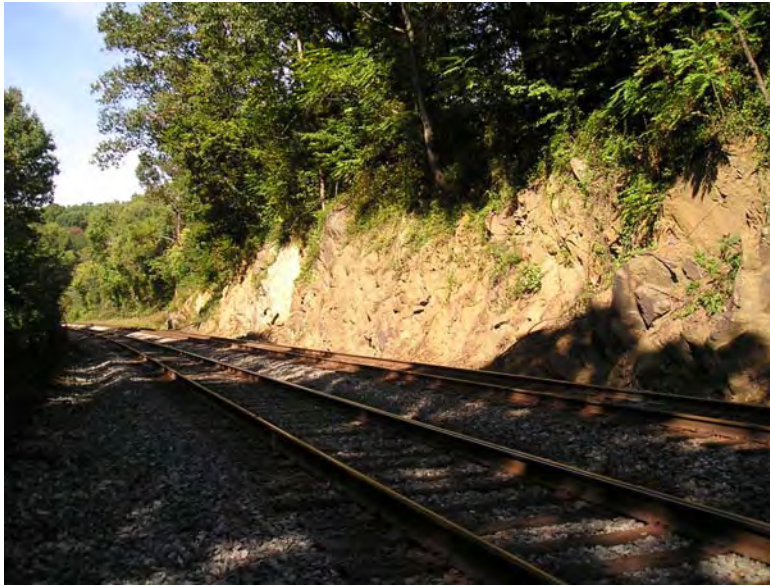
North of the project site is a set of railroad tracks that expose rock outcrops along their north side. On examination, the rock outcrops east and west along the railroad tracks display a series of faults and resultant shear zones. The shear zones are concurrent with the strike and dip of the rock formations and conform to the geology at the aqueduct. Secondary shear zones and dike intrusions are also found at this location. Rocks identified in the area of the railroad tracks include mylonites, cataclasites, and phyllonites. The cataclasites are made up of augen gneiss (blue gneiss) as described in the local geology. Rocks along the tracks are typically brown, and highly weathered to crumbly.

Photo 4. Outcrops north of tracks with shear zones.

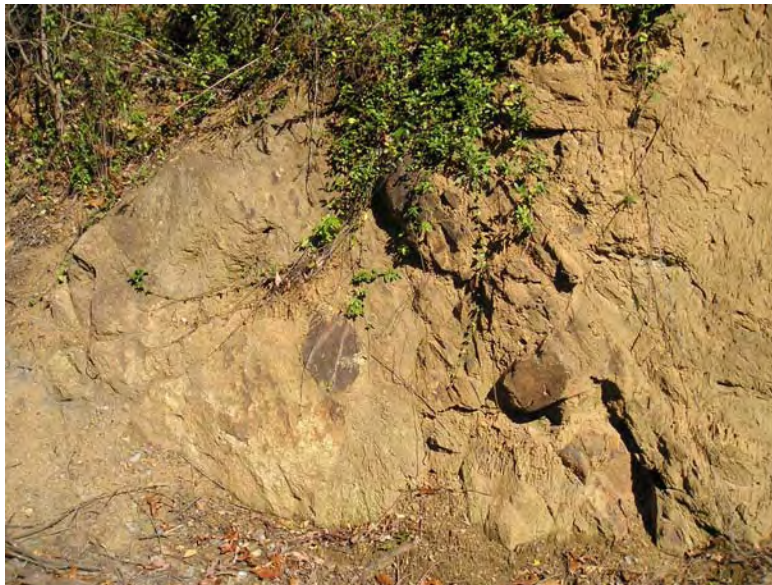
Photo 5. Weathering of rock (note spherical weathering in lower right).

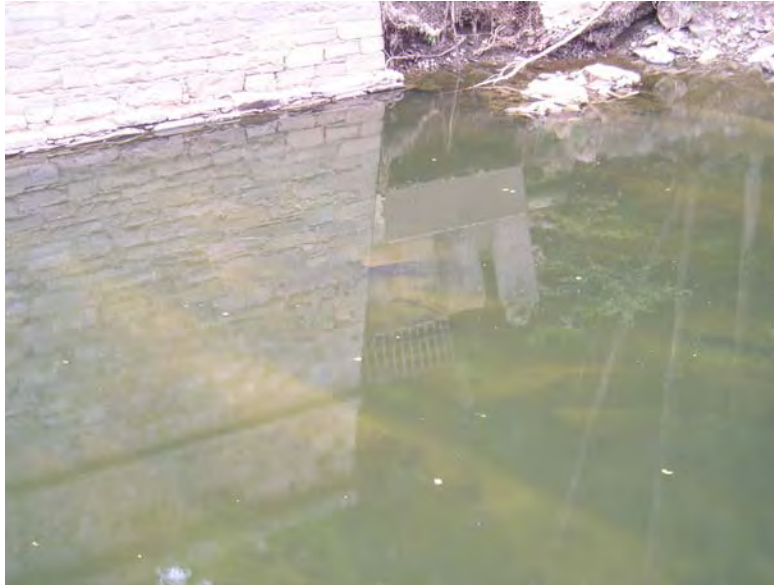
Photo 6. East abutment and wingwall.

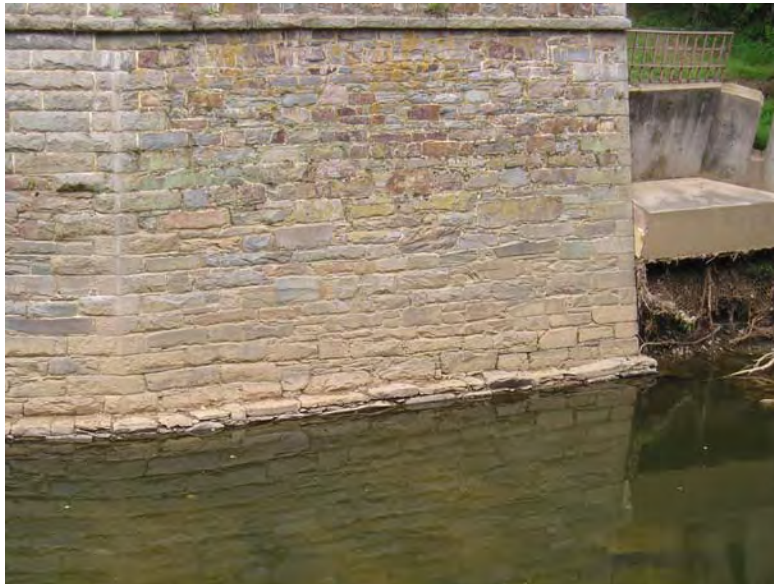
Photo 7. West abutment and wingwall.

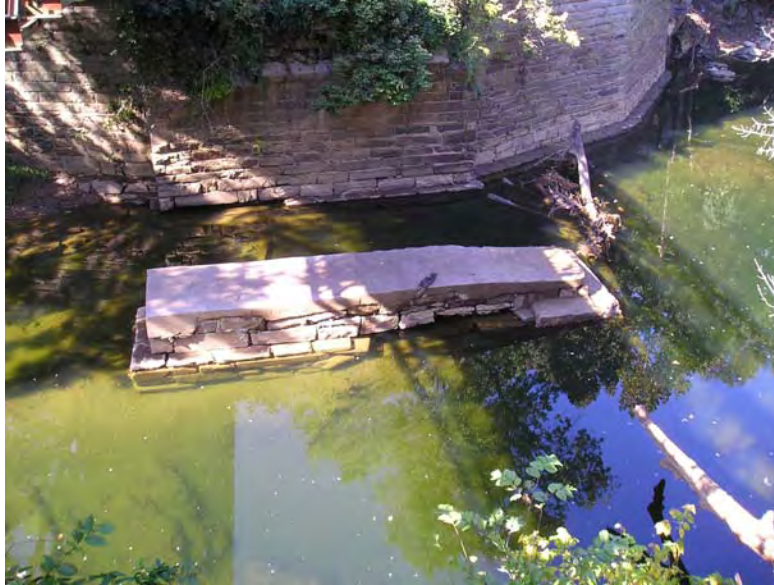
The west pier has experienced the most structural deterioration of all the aqueduct components; an extensive void is visible above the waterline. The underwater investigation revealed a void on the east side of the structure that measures approximately 8'x 3'x 5'. The material in the channel at this location is described as being gravel-sized, loose and unstable. The characteristics of the geological formation that the pier is built on correlates to the softer mylonite rock that alternates with greenstone within the shear zones.

Photo 8. West pier along its east side.

To retain the existing pier, the rock material that is susceptible to scour should be covered to secure the area from scour forces and abrasion. Cement grouting by tremie pipe behind temporarily placed grout bags is an effective and economical method for stabilizing the foundation.

Removal and replacement of the west pier and its foundation is an alternative that will provide greater structural stability of the pier. This method of rehabilitation can be achieved by cataloging the individual stone before deconstruction of the pier, placing a spread footing, then replacing the stones as a façade to resemble the original structure. Water flow in the channel will need to be stopped either by diverting the stream or by the construction of a temporary cofferdam.

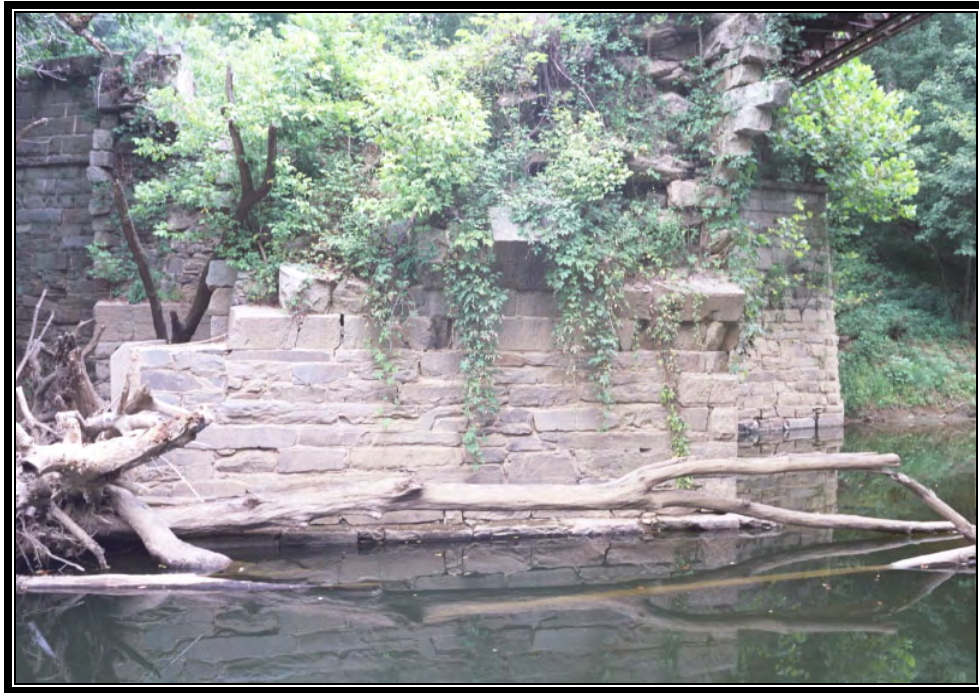
The East Pier was found to be in overall satisfactory condition. Stone construction is similar to the East Abutment with rocky channel bottom. No mortar was found in any of the joints around the pier. The north end of the pier could not be thoroughly inspected due to extensive timber debris, broken concrete, and reinforcing steel. A concrete end panel was found to be constructed at the north end in front of the pier and is in satisfactory condition. A concrete T-beam was found on the bottom along the west side of the pier with steel reinforcing exposed. Similar channel bottom material along the west side as found and described for the East Abutment. This has resulted in voids along the bottom, primarily near the north end. Stones found to bear on a level section of channel bottom along the east side with minimal voids.

Random cracking was observed in the bottom of the arch running east to west in approximately five stones. This arch is still intact and extends from the East Abutment to the East Pier.

A small void was found at the southwest corner just below water due to a missing stone. Vertical cracking was found at the southeast corner that extended from the water up through a minimum of four stone courses.

Photo No. 1: West face of East Pier.

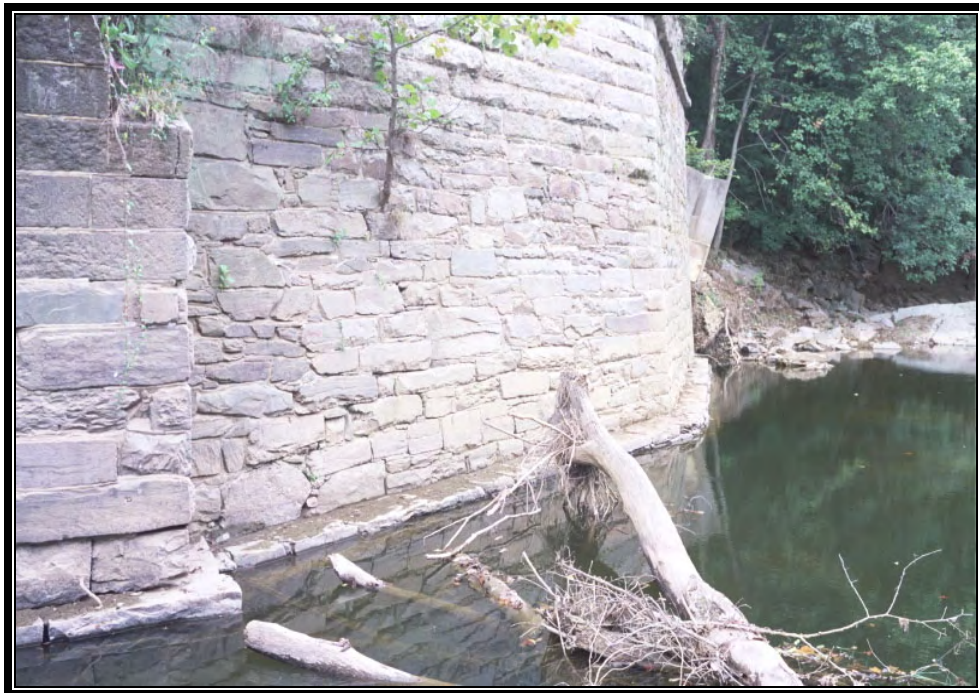
The overall condition of the abutment and wingwall was found to be satisfactory. Same construction with no mortar below water as described for the previous substructure units. Stones all found to bear on fairly uniform or level channel bottom along the abutment and wingwall. Only random minimal voids found along the channel bottom. Two areas of missing stones found near the south corner of the abutment. The first area starts 2'-0" north of the corner and is approximately 13'-0" long by 2'-0" high by 3'-0" deep. The second area starts approximately 8'-0" north of the first area and is 6'-0" long by 4'-0" high and 5'-0" deep. Stones from these areas could be found along the channel bottom. Channel bottom was found to be rocky with silt along the abutment and wingwall. Water depth varied from 2'-0" at the south end of the abutment to over 6'-0" along the wingwall. The area at the end of the wingwall beside the gabion foundation was found to be intact with no undermining or movement.

Photo No. 2: West Abutment, north wingwall.

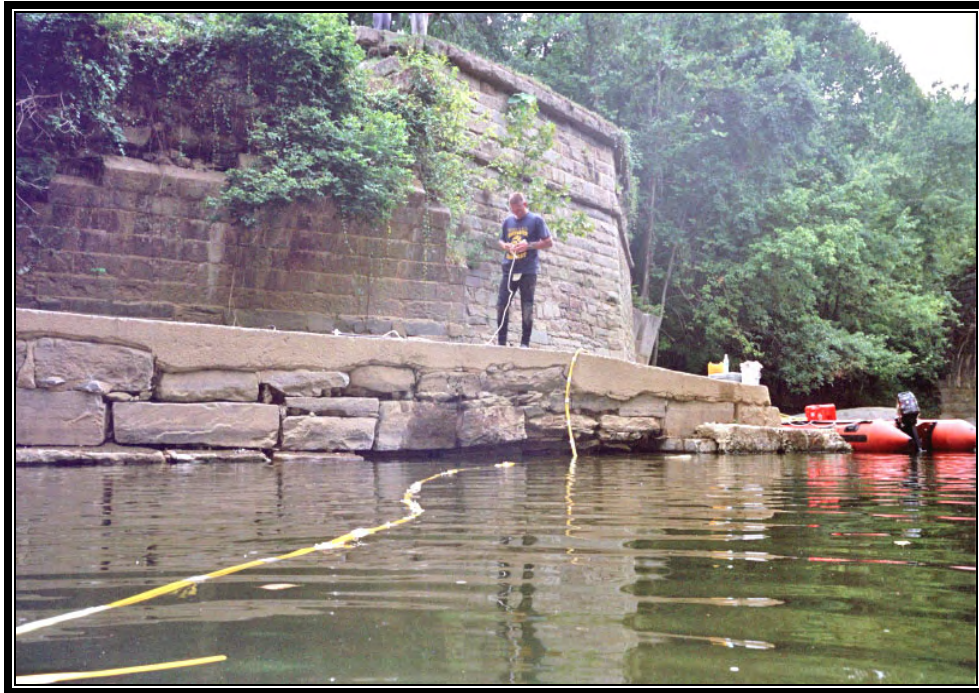
No evidence of settlement along the north, west or south sides. A large void was located near the center of the pier along the east side. This void or opening is approximately 8'-0" wide by 2'-0" – 3'-0" high and extends back towards the west approximately 5'-0" deep. No loose stones were found inside the void or directly below the void. Probing up to 3'-6" could not find a firm or solid foundation in this area. The material in this area consisted of gravel type material varying in size up to ½" maximum. The stones directly above this opening were loose and unstable. Diver could not penetrate or go into this area due to this unstable stones which could collapse. The channel bottom between the West and East Pier was checked but no large stone could be found (possibly from this void or opening). The gravel material sloped downwards towards the east on an approximate 5:1 pitch.

No rock or firm bottom could be found at the opening along the east side of the West Pier. Based upon the direction and flow of the Catoctin Creek, the east side of the pier would appear to be somewhat protected from scouring action. Additional investigation and probing is needed to determine the depth of solid foundation material. We recommend that the West Pier be repaired as soon as possible to prevent further deterioration, which will result in collapsing of the center section of the West Pier.

Photo No. 3: West Pier, east face looking at the void.

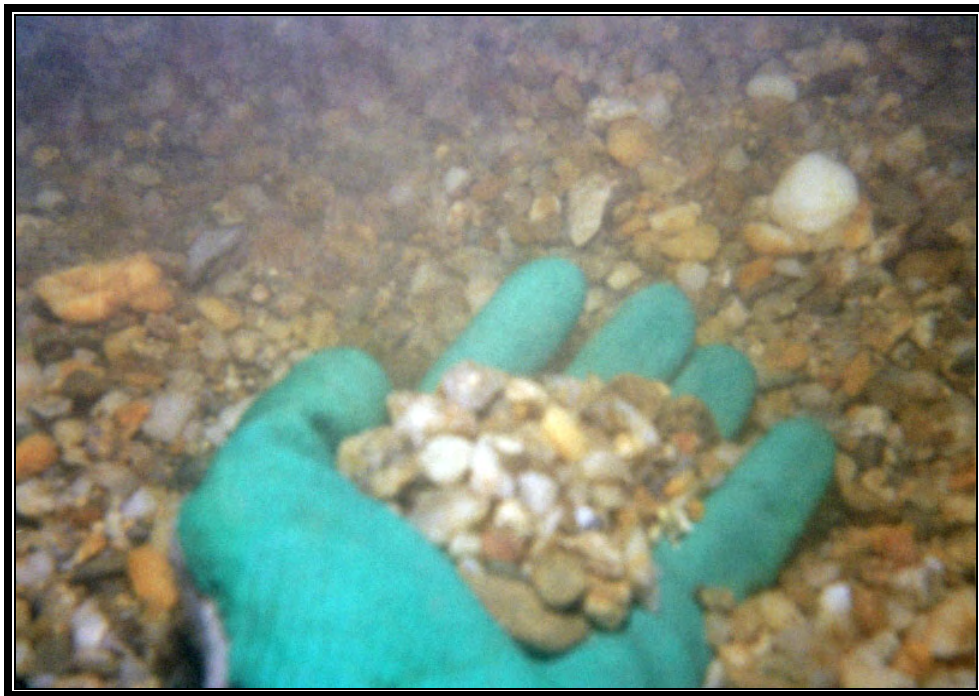
Photo No. 4: West Pier, typical channel bottom material in void on east side.

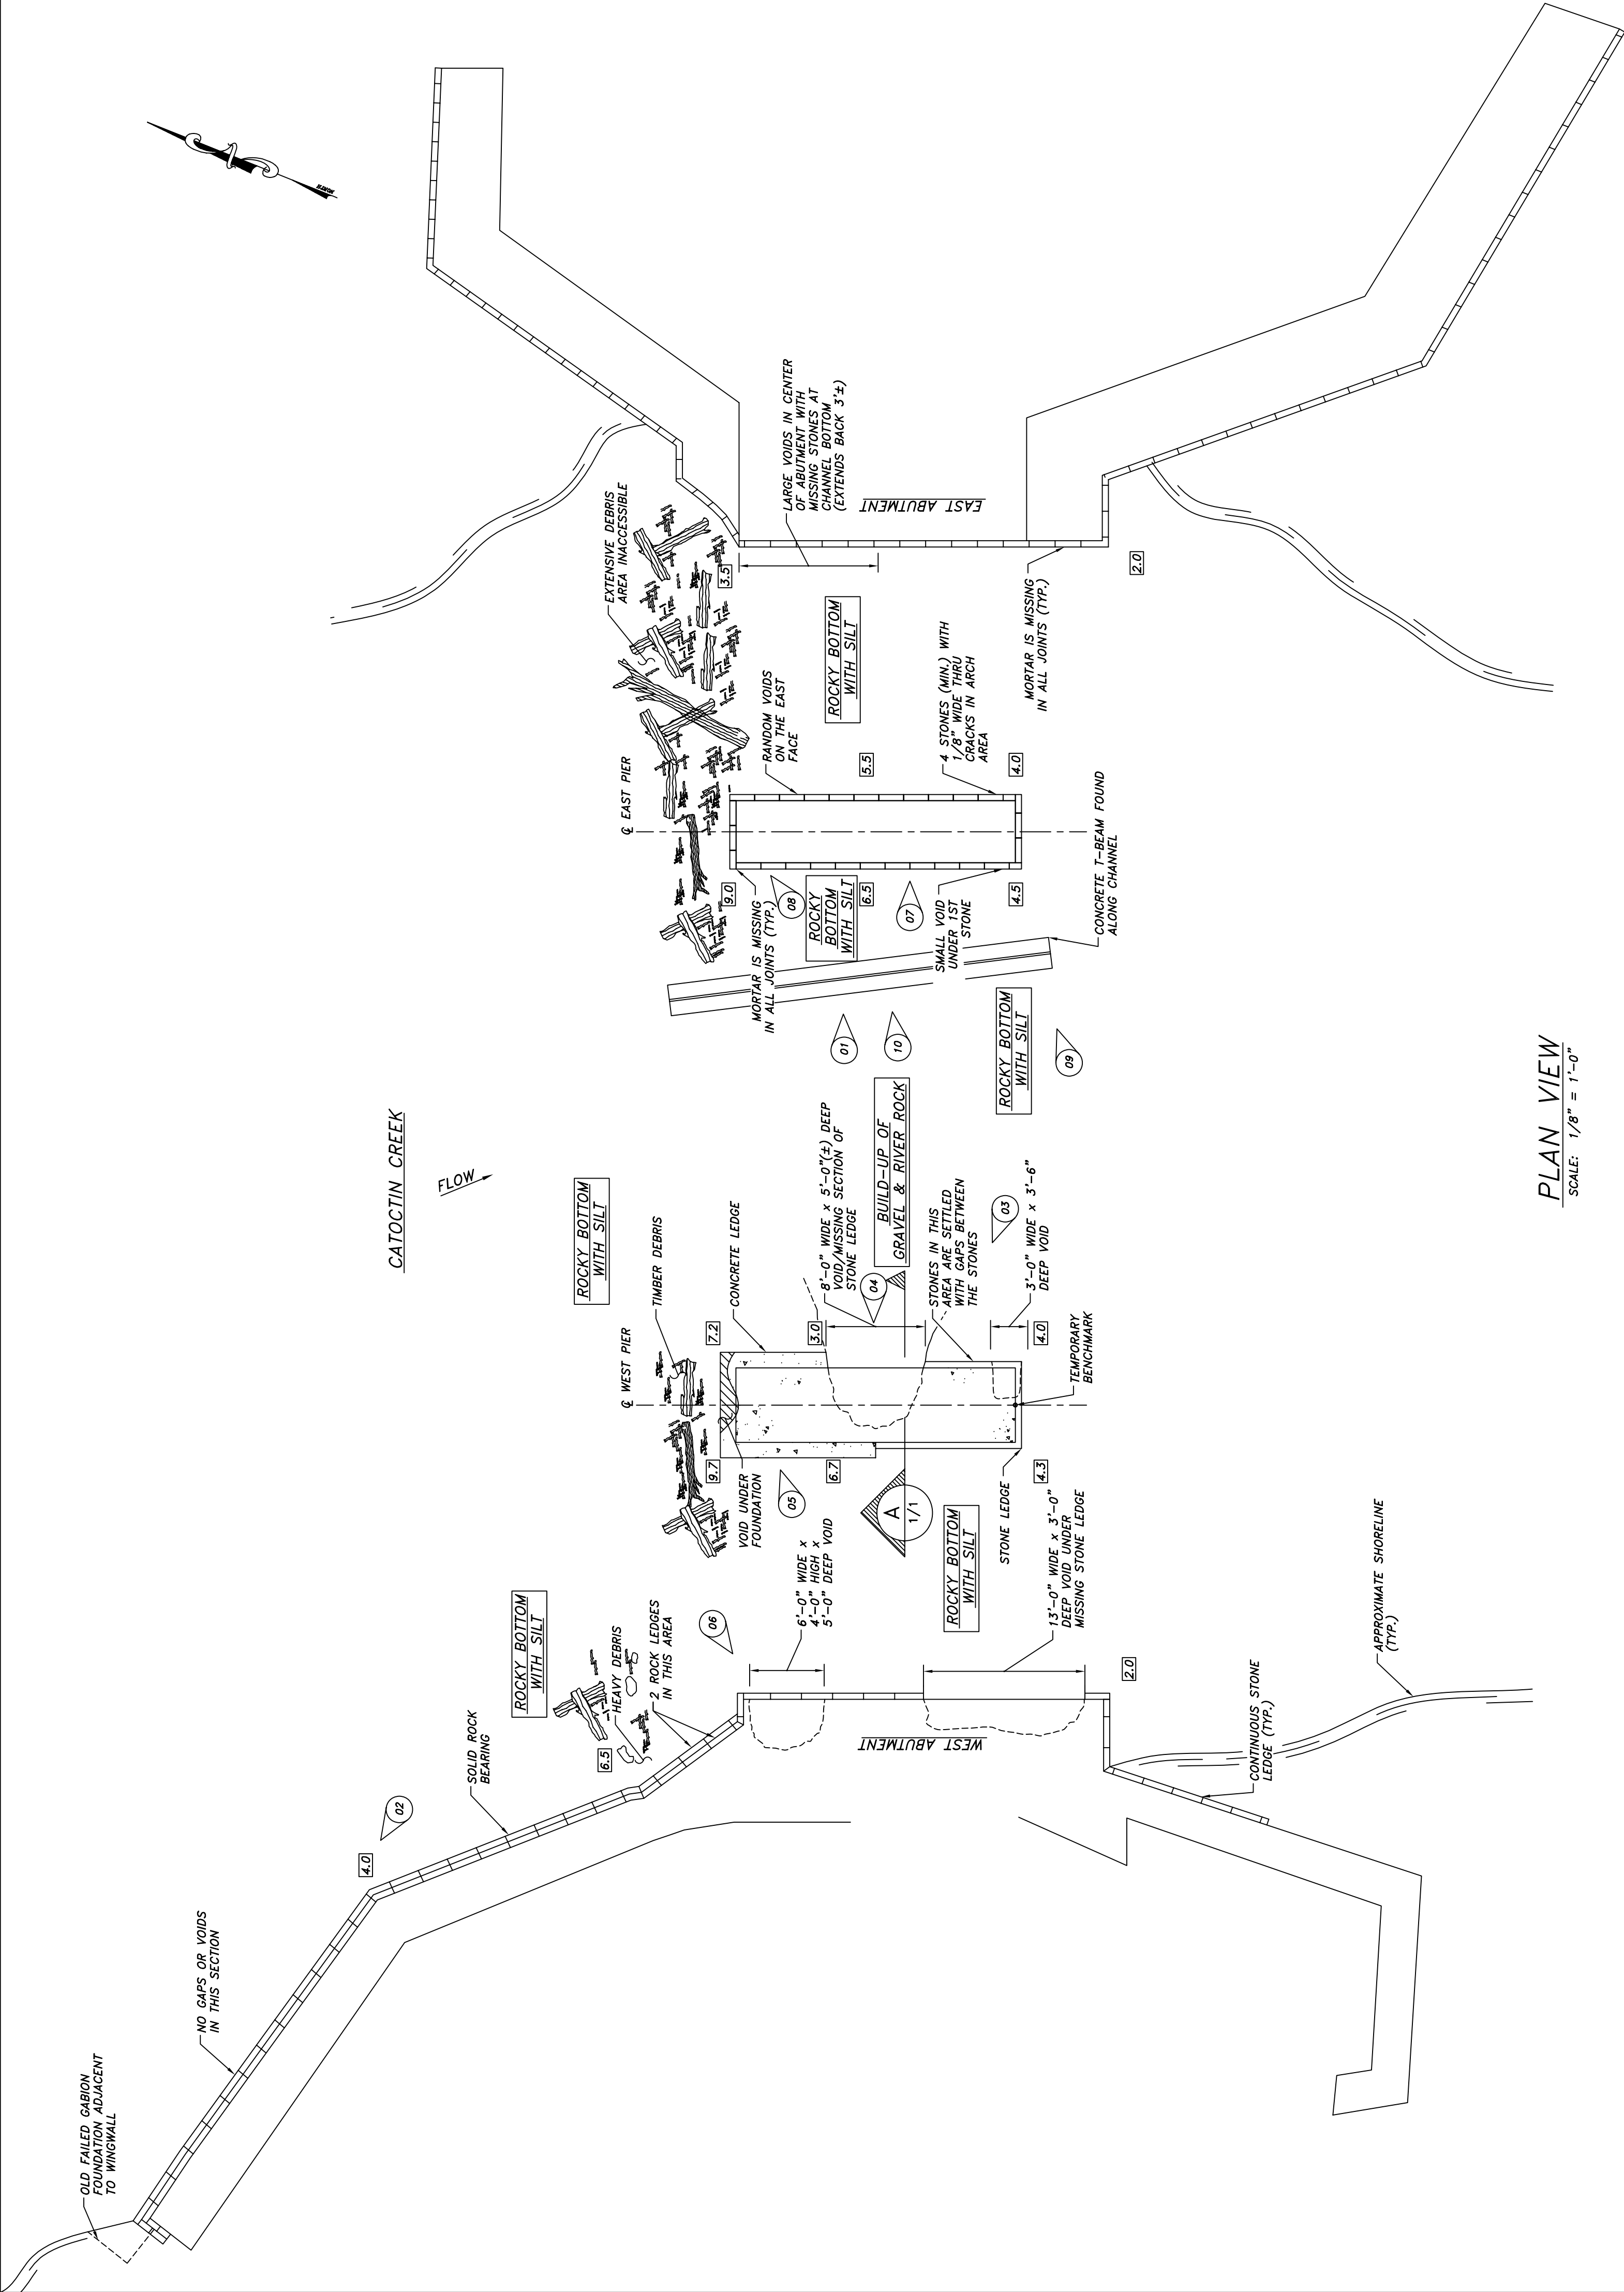
PLAN VIEW  
SCALE: 1/8" = 1'-0"

- THE UNDERWATER INSPECTION OF THE CATOCTIN AQUEDUCT WAS PERFORMED ON AUGUST 30, 2006 BY W.J. CASTLE, P.E. & ASSOCIATES, P.C.
- DRAWINGS DEVELOPED FROM FIELD NOTES AND DRAWINGS SUPPLIED BY CLIENT.
- EXTENSIVE DEBRIS FOUND AT THE NORTH END OF BOTH THE EAST AND WEST PIERS HINDERED THE INSPECTION.
