United States Department of the Interior

NATIONAL PARK SERVICE

Water Resources Division

Subject: Report for Travel to Channel Islands National Park during December 6-10, 2004

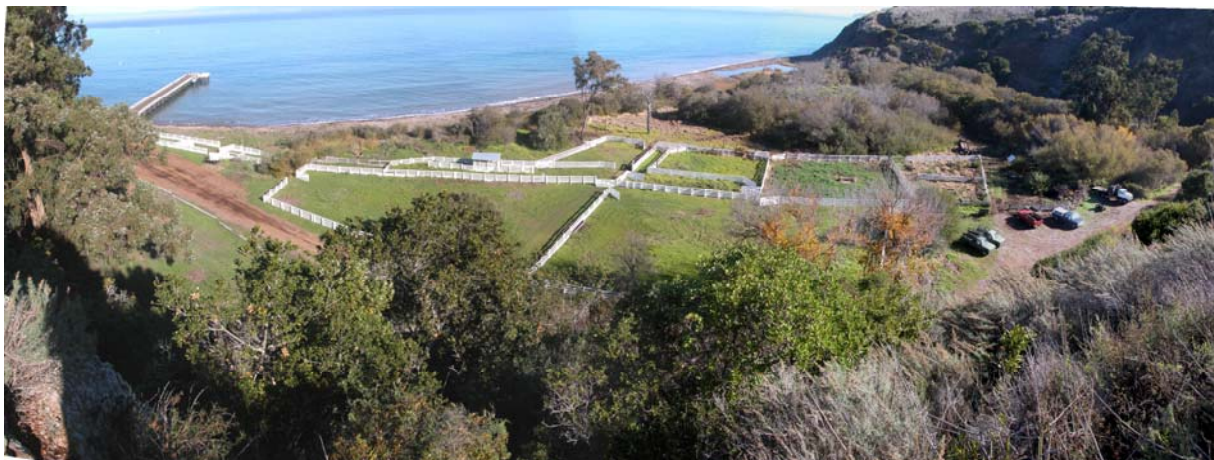
Canada Del Puerto Creek at Prisoners Harbor (12/10/04)

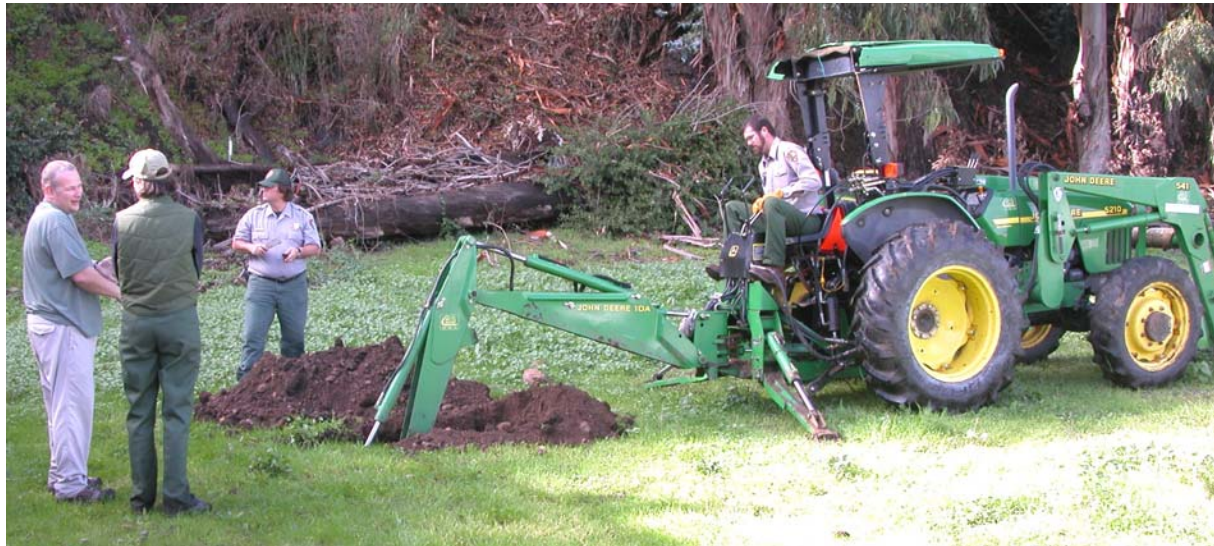
Installation of Well #18

Well #18 - located 55' from the warehouse building

PH18	Interval	Material
	0-60"	Brick and charred brick foundry material, obvious excavated hill-slope fill to 60"
	60-72"	Clay loam, organic, black layer starts at 60" , bagged sample available at WRD, Denver

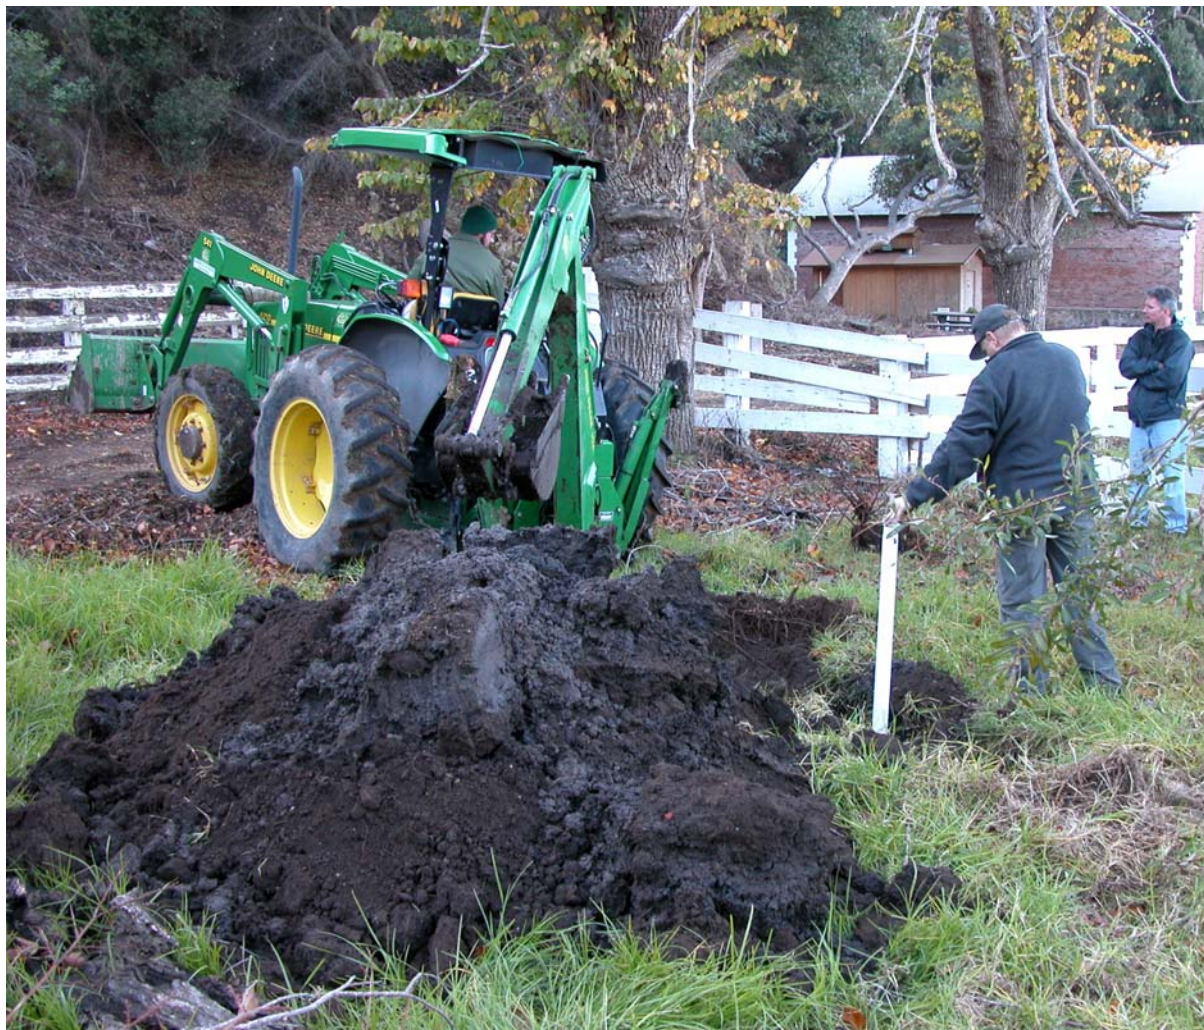
Installation of Well #3

Well #3 - Located about 175 ft due SE of warehouse SE corner
Elevation relative to warehouse SE corner: about -0.2 ft

PH3	Interval	Material	Other Data
	0-30"	mixed fill material: brick fragments, angular rock.	water table - 6.4 (bls)
	30"	shell material	specific conductance - 900
	30 – 36"	angular rock (likely fill from hillslope). Probably excavated hill-slope fill to 36"	
	36-60"	Interpretation: about 36" of anthropogenic fill on overbank deposits.	Salinity - 0.5
	60-75"	silt and clay, mottled	
		silt and clay, gleyed

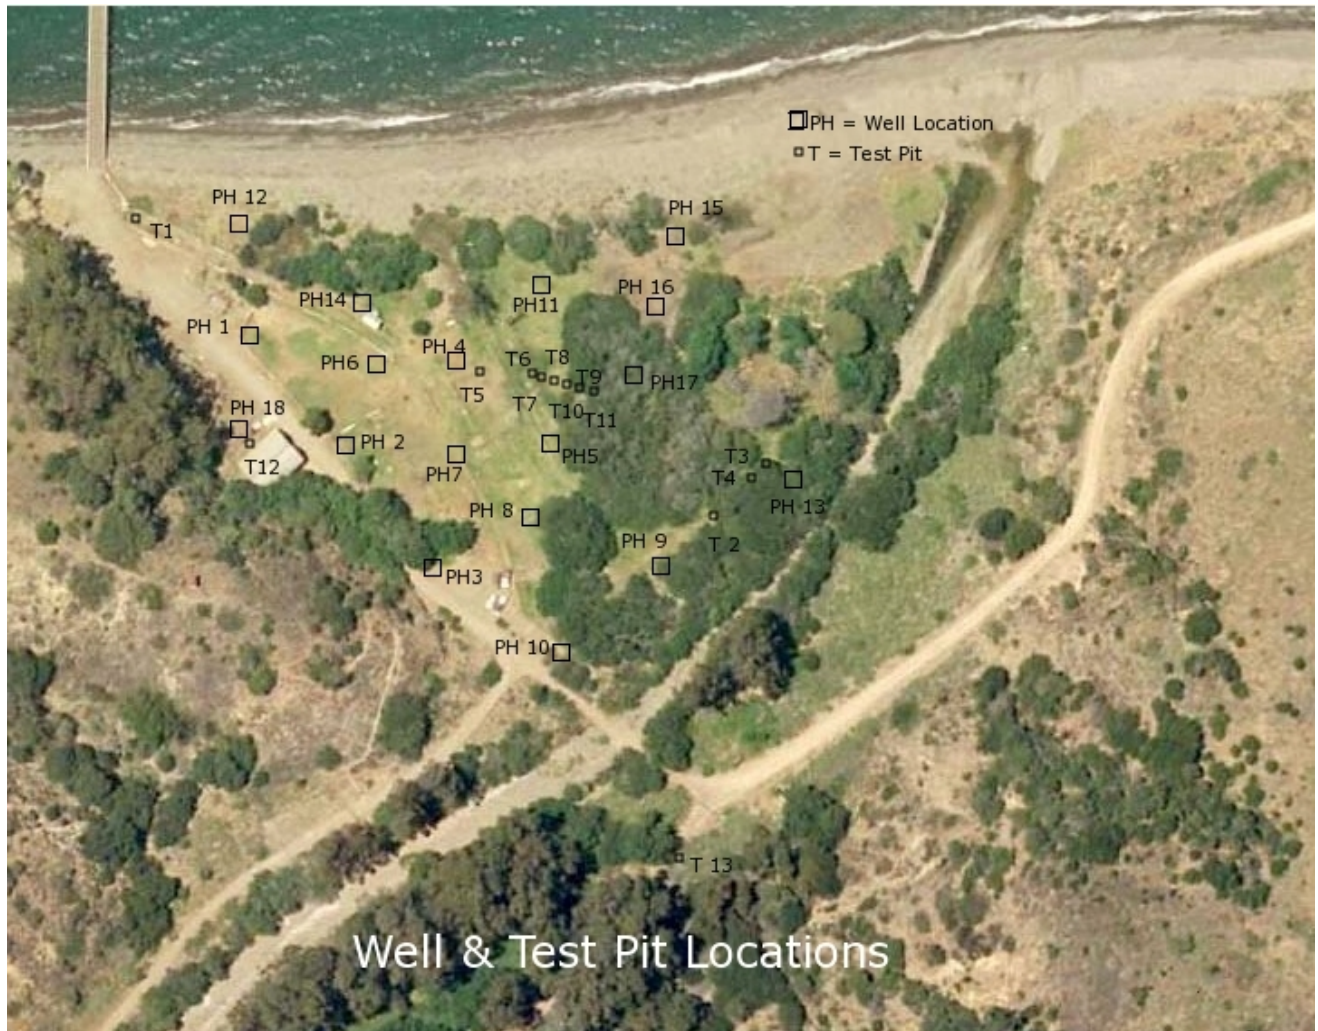
Well and Test Pit Locations

Overall it appears that the proposed restoration area contains a mixture of anthropogenic fill and natural channel overbank and eolian deposits. We believe that there were two sources that supplied fill to the floodplain. One is dredged material from the creek channel which would resemble natural channel deposits. We noted numerous zones of rounded cobble, gravel, and

In 15 of the 31 well and test pits, we found a distinct layer of clay loam with a fairly high organic matter content colored 10yr 2/1 when saturated. We found this horizon at depths ranging from about three to five feet. Most of us agreed that this is a pre-disturbance surface which is likely a former estuarine surface. This layer is referred to as the “black layer” in the notes below.
