Repair Chimneys on Buildings P12 and P13 (Employee Residences) in the Headquarters Historic District

Cultural Resource Report No. 2022- DENA-008

> > April 2022

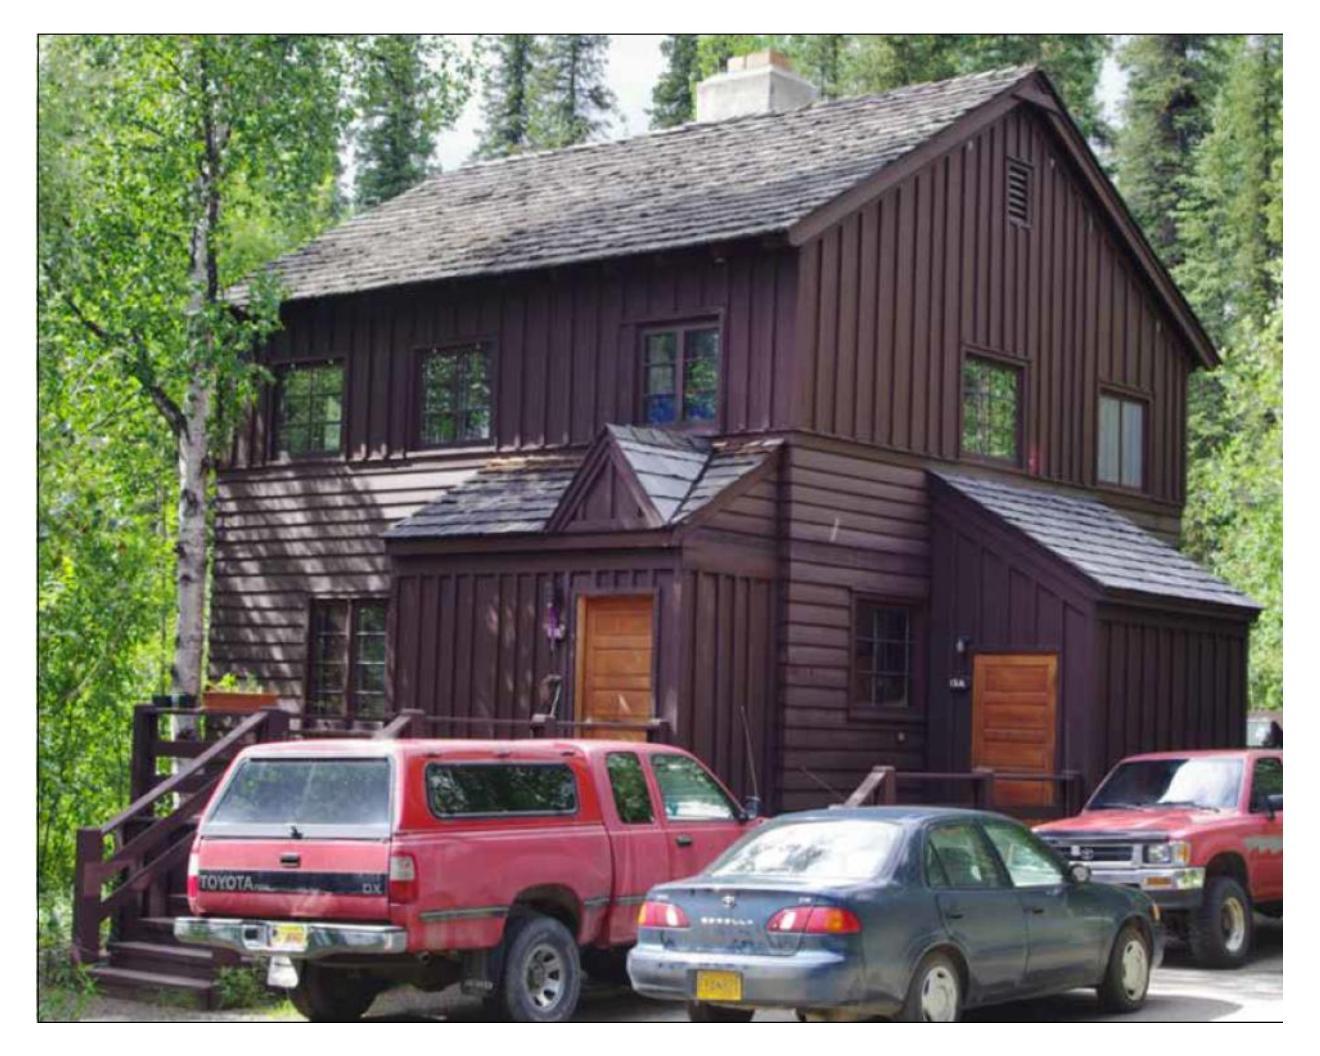
Figure 6- P-13 in 2014 prior to install of new boiler. Chimney is in fair condition (NPS Photo).

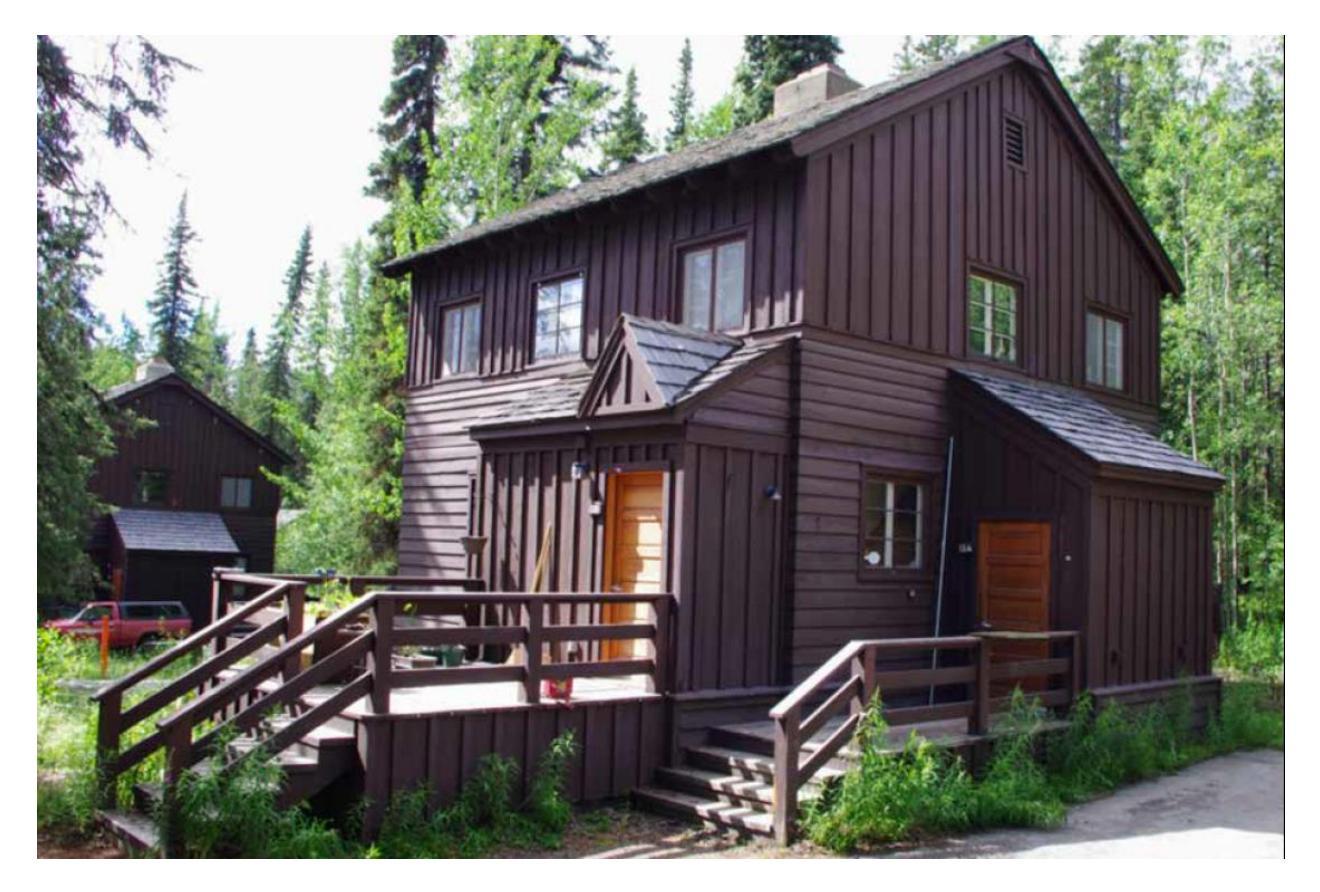
Figure 7- P-12 in 2014 prior to new boiler install. Chimney is in fair condition (NPS photo).

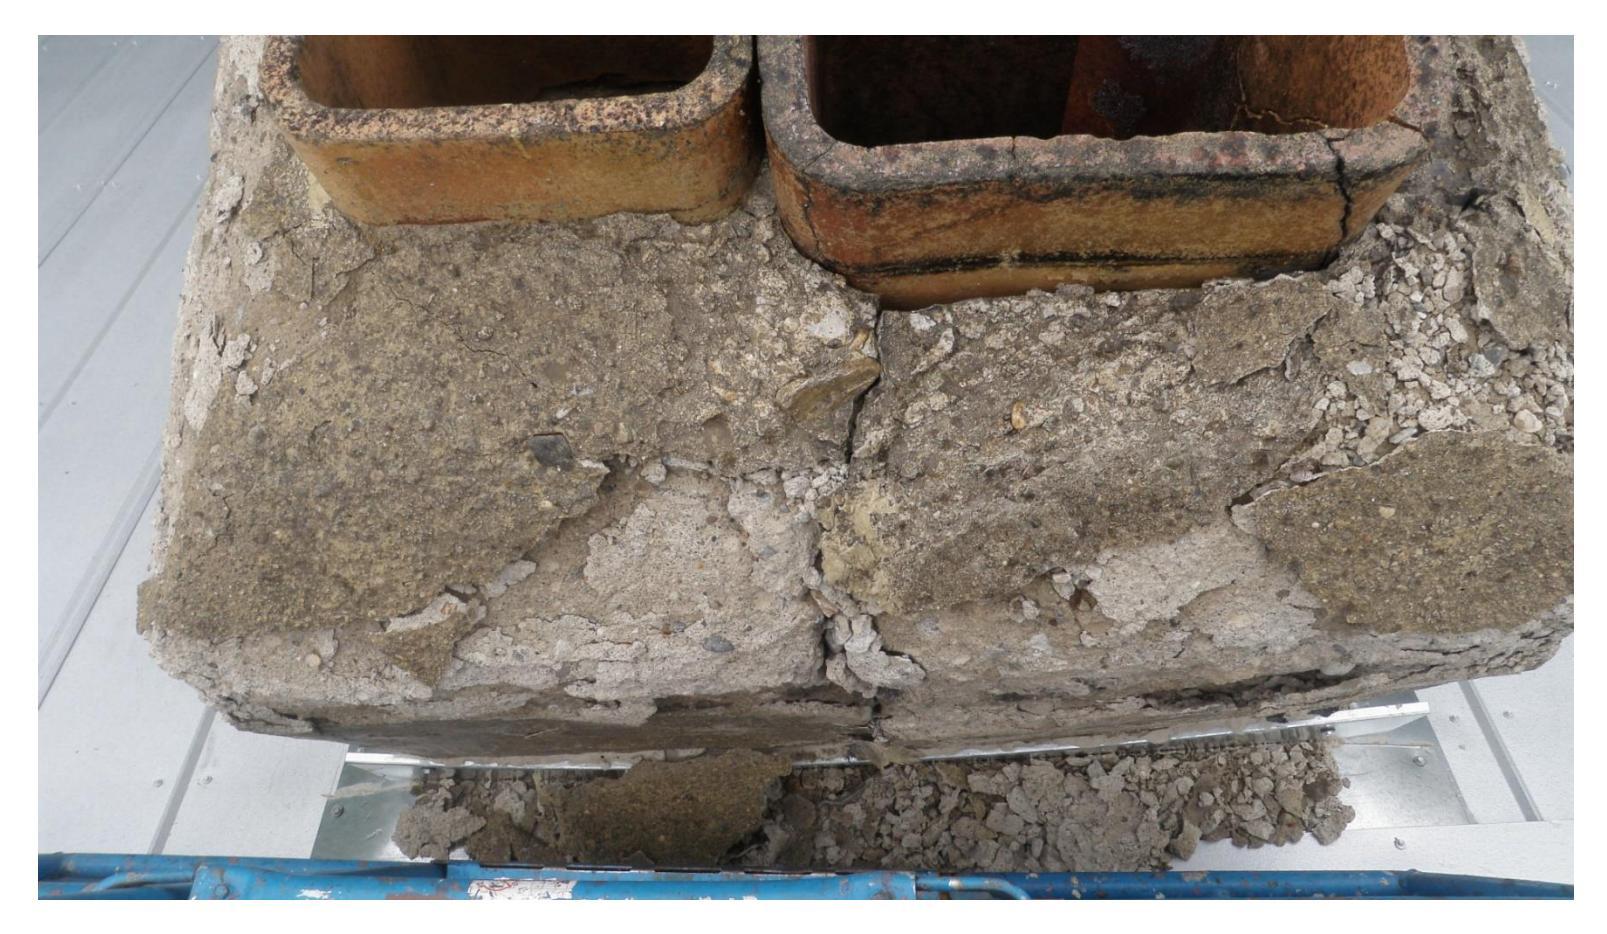
Denali National Park and Preserve (DENA) is considering an undertaking to repair the chimneys on Buildings P12 and P13. The chimneys have deteriorated due to age and the caustic effects of flue gasses. The chimneys are experiencing extensive spalling, deteriorating parge coats, and have fractures throughout the concrete and clay liners. Due to the extensive failure of the portions of the chimneys exposed to the weather much of the exposed structure would be replaced. Replacement would be in kind and would reflect the original design accurately, including replacement of damaged clay flue liner sections. When possible, historic fabric and materials would be retained.

Figure 8-Cracked, spalling concrete, and crack clay flue liner on P-12 Chimney (NPS Photo 2021)

Minimization efforts thus far have included reaching out to mason historic preservation experts in to see if it would be possible to repair, rather than replace, the concrete and clay flue liners. While the methods suggested by these experts would be used in the project, the majority of the historic fabric would still need to be replaced. The new concrete would be painted to match the original as closely as possible, and the size and shape of the chimney would be retained.

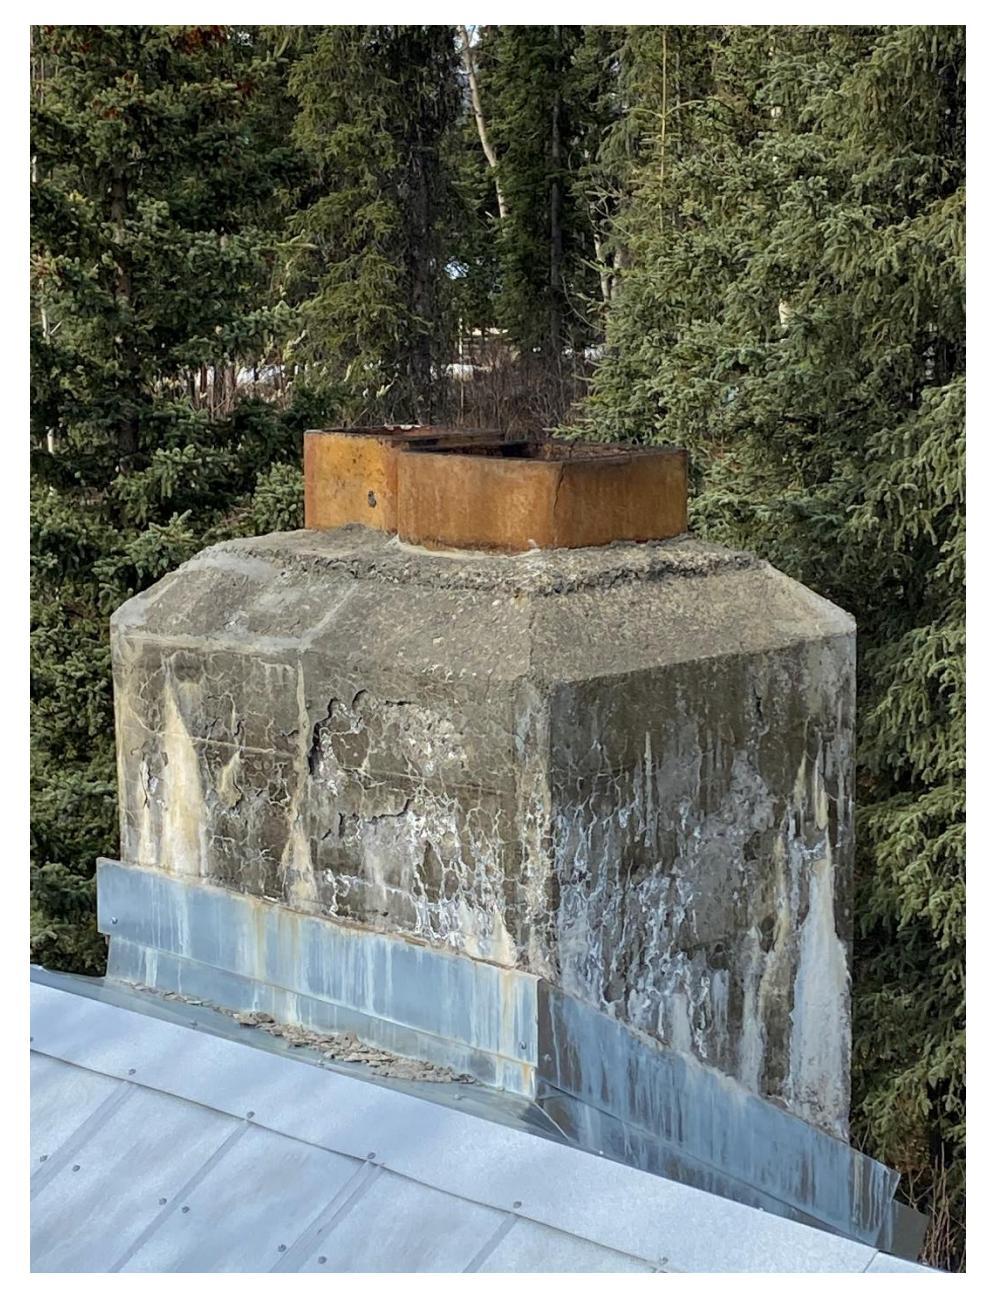
Figure 9- B-13 chimney showing spalling and deteriorated parge (NPA Photo, 2021)

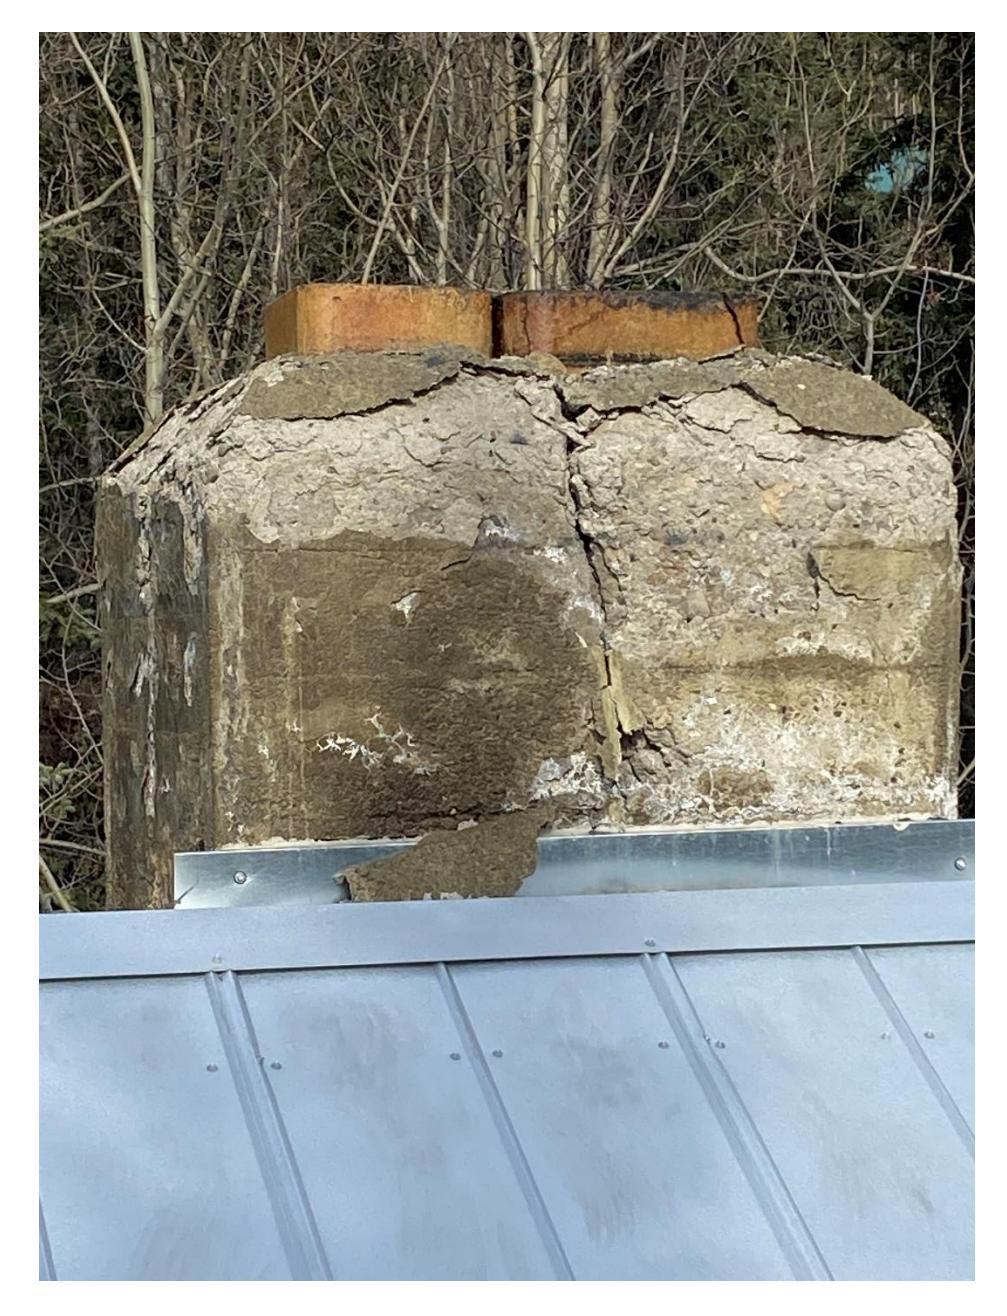
Figure 10- B-12 chimney showing fractures in concrete and clay liner (NPA Photo, 2021)

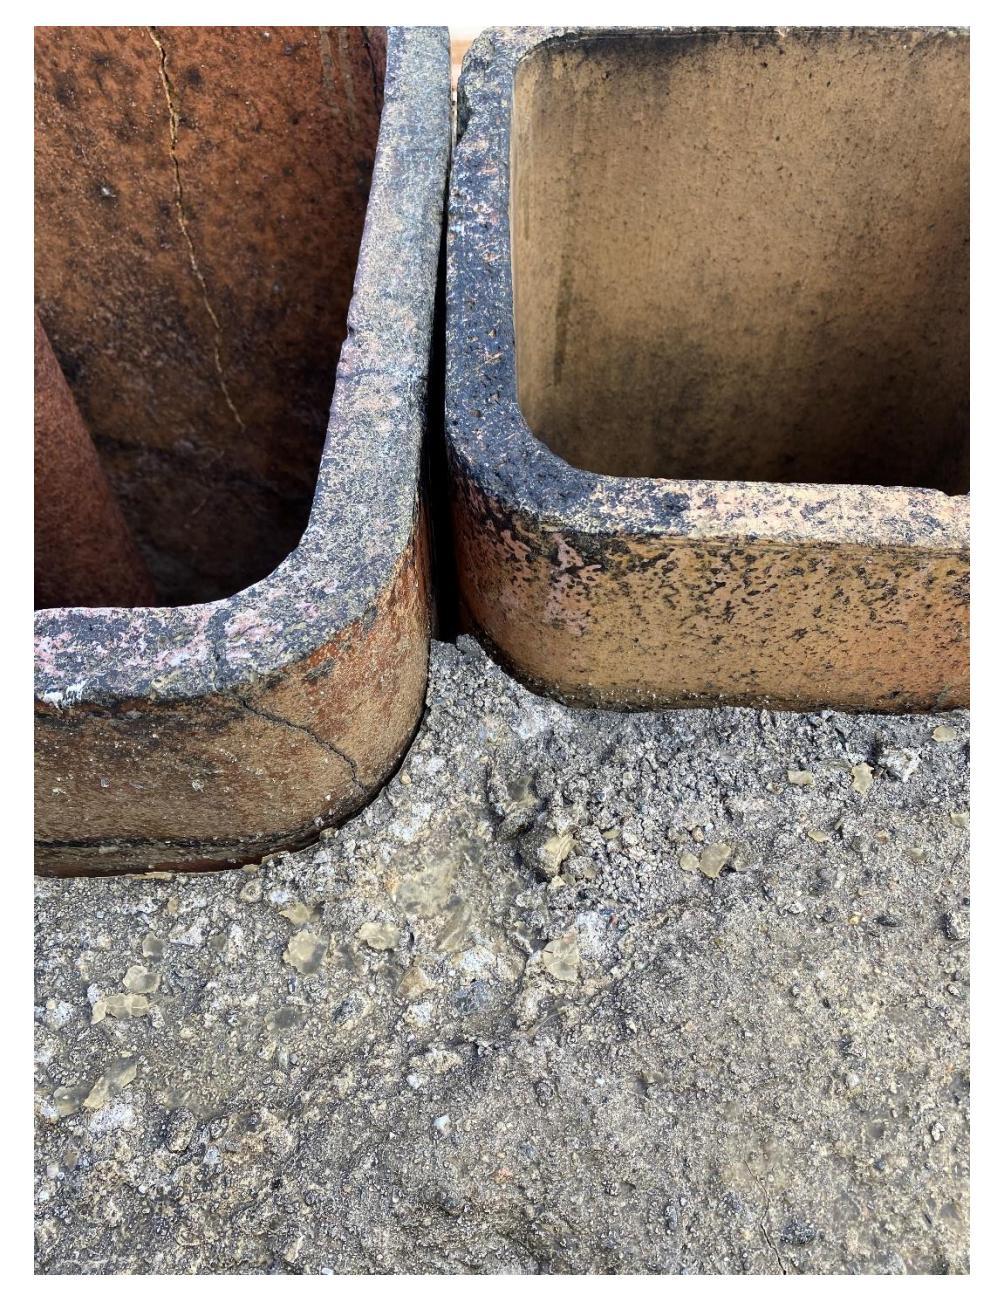
Figure 11- B-12 flue liners showing gaps where water infiltrates (NPS Photo, 2021).
