## REHABILITATE CLARA BARTON NATIONAL HISTORIC SITE CLBA 312325 ASSESSMENT OF EFFECTS REPORT

December 19, 2023

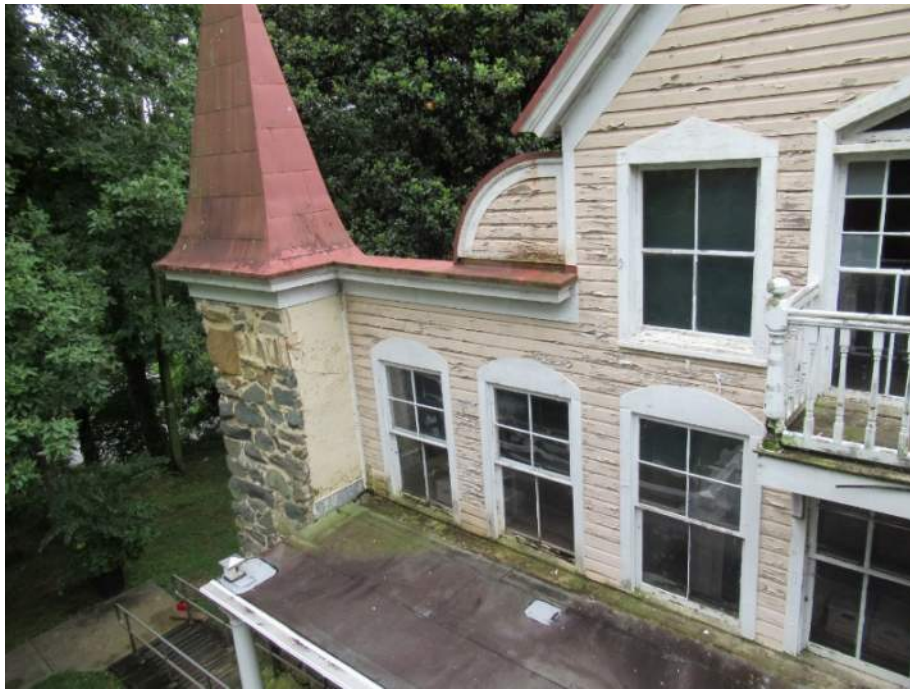
- The clapboard wood siding will be replaced in kind where rotted or where clapboard is cupped and deteriorated. This condition occurs primarily on the north elevation above the porch roof. All other clapboard will be repaired or replaced in kind only as needed.
- The new wood clapboard will match the profiles of the existing where removed.

*Photograph 6. North elevation clapboard above the existing porch is severely deteriorated and requires replacement. The porch has caused water infiltration at the wall and rotted window sills.*

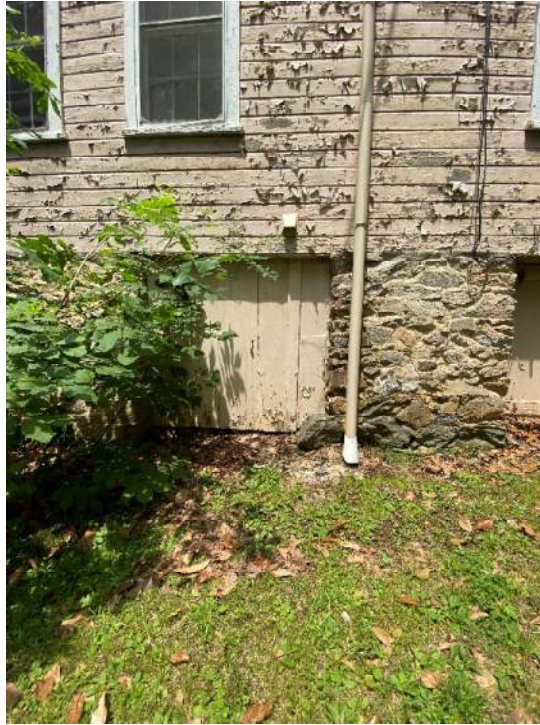
*Photograph 9. The door at the east elevation of the basement will be modified to accommodate a code compliant egress. The grade will be lowered slightly to allow for the required height.*

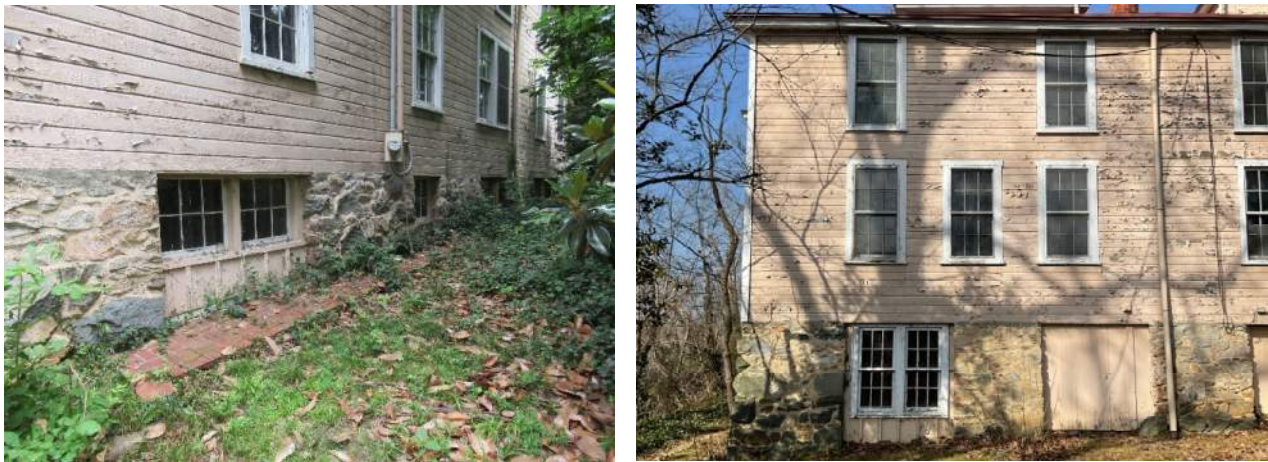
**Analysis** – Two basement windows will require replacement with louvers for the mechanical system air intake and exhaust.

*Photograph 10 and Photograph 11. Exhaust air and outdoor air intake louvers are proposed for two basement windows located on the east elevation. The proposed locations are pictured above.*

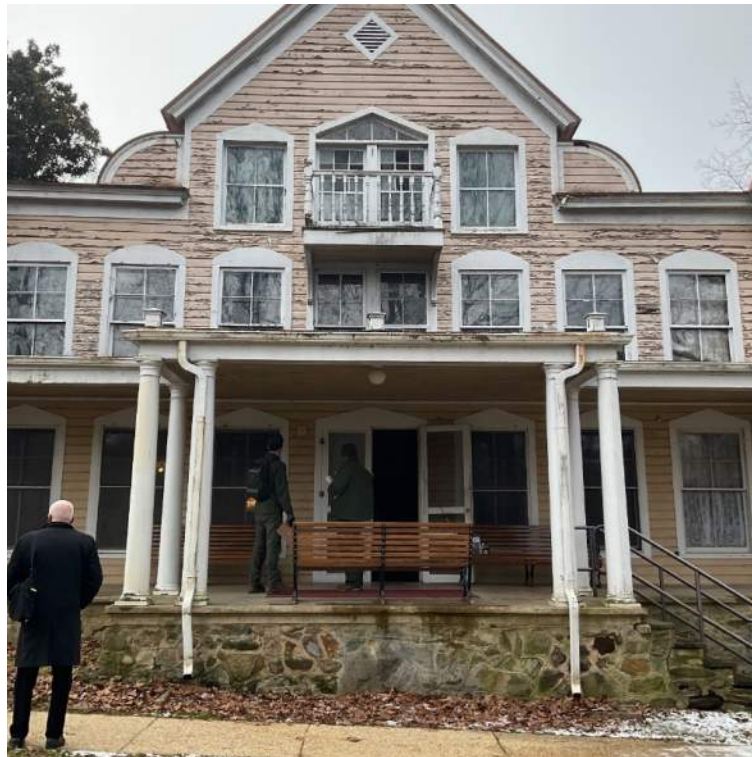
The existing front porch does not date to the period of significance and is causing deterioration of the north façade clapboard and windows. The design of the new porch will be more in keeping with how the house appeared during Clara Barton's occupancy and present visitors with a more historically appropriate design. The existing porch and third floor balcony contain little to no original materials and lack the workmanship of the original. The balcony will be restored.

Photograph 13. Existing Colonial Revival porch which dates to 1919.

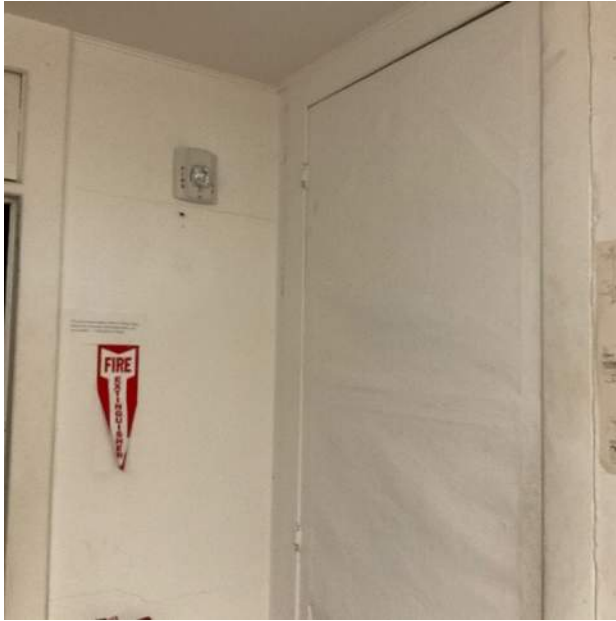
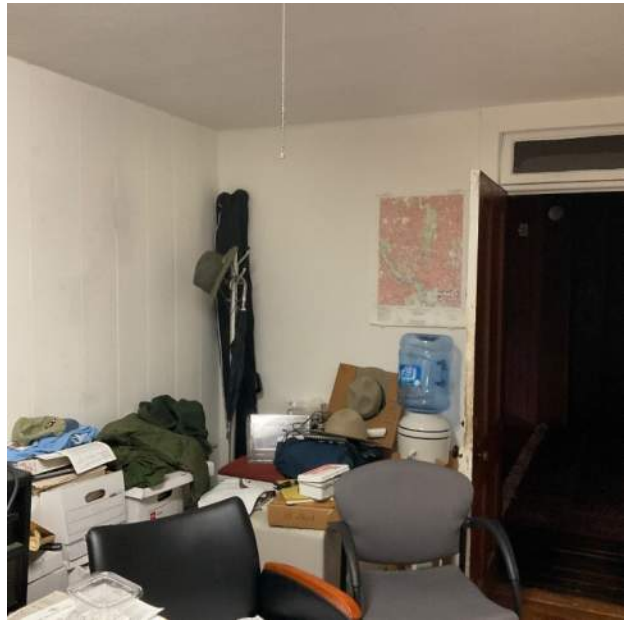
Photograph 16 and Photograph 17. Room 115. (Left) Wood frame closet door with painted muslin covering will be removed and salvaged. (Right) The southwest / northwest corner will be enclosed within new partitions for the egress stair.

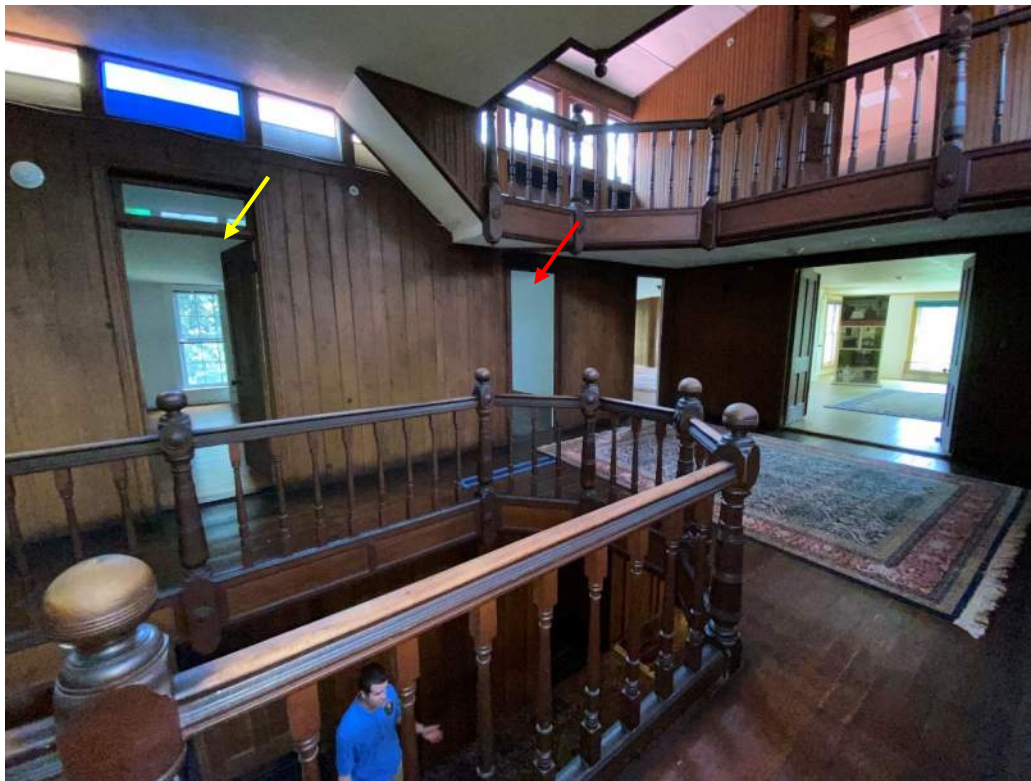
18  
19    *Photograph 20. Two openings in the atrium of Main Hall 202: the opening shown with the red arrow will be widened by +/- 6"*  
20    *for the egress stair. The opening with the yellow arrow will have the door and stops removed for a wider clear opening.*

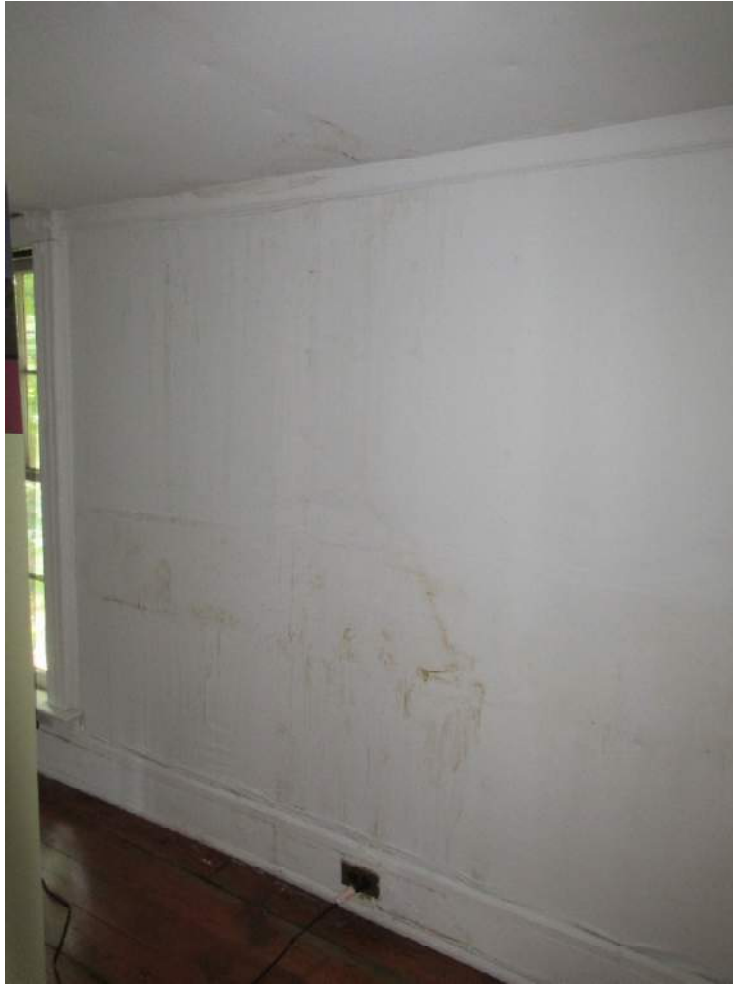
*Photograph 21. The southeast wall of Room 215 has damage due to water infiltration. This wall's finishes will be restored.*
