Destructive, Prior Ground-Disturbance, George Washington's  
Boyhood Home National Historic Landmark

George Washington Foundation

July 27, 2015

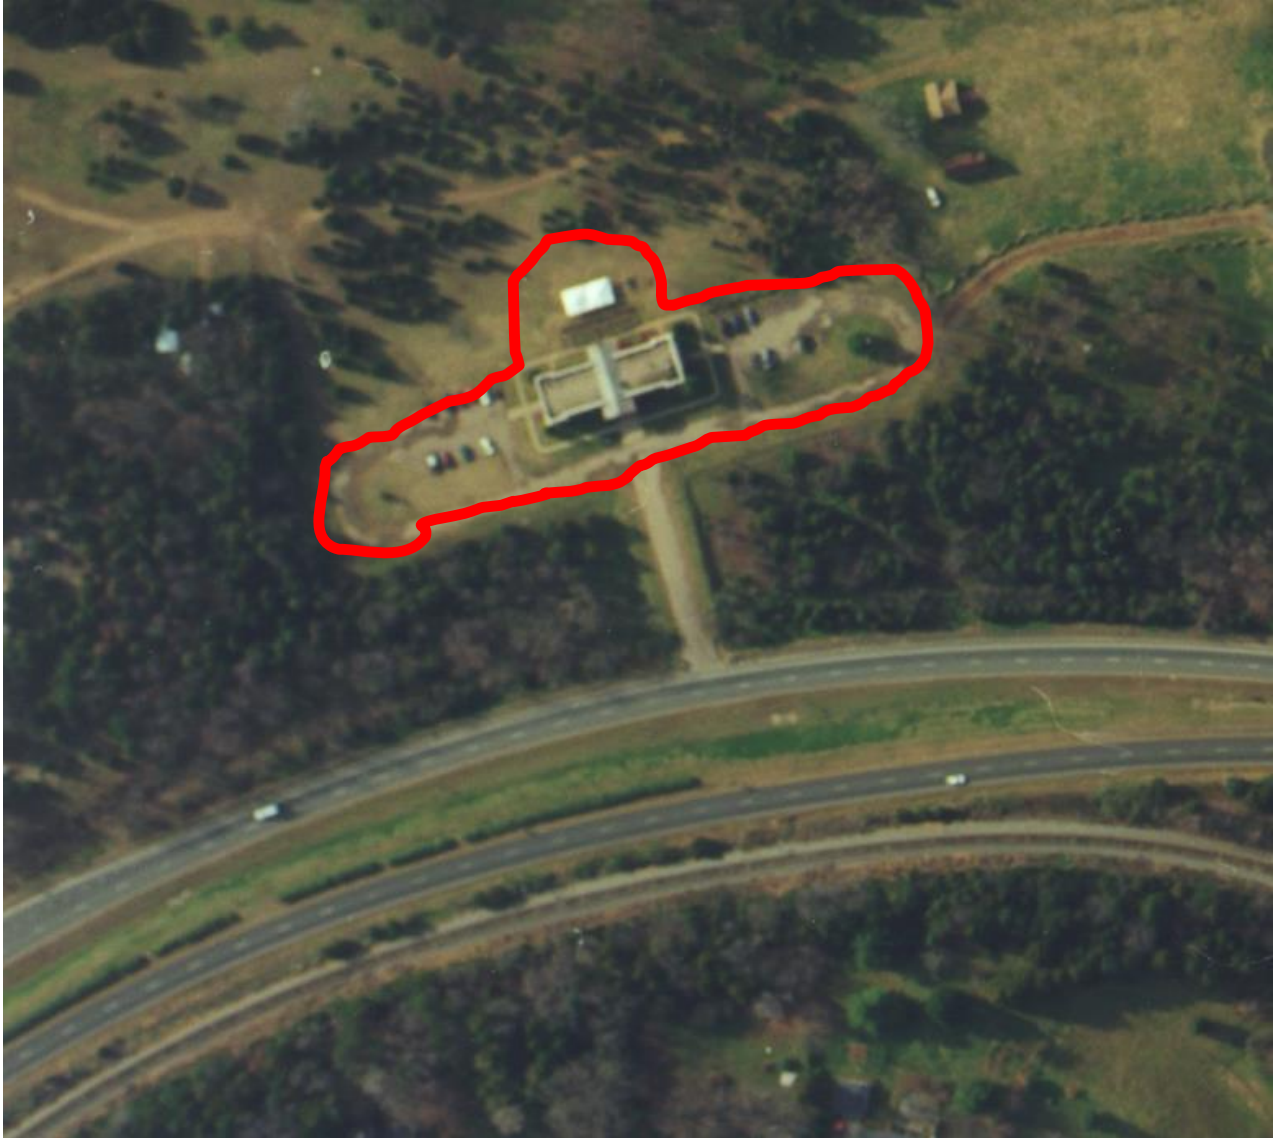
In 1963, Youth for Christ International took ownership of the property with plans to establish a home for wayward boys. This purchase led to the eventual construction of the Boys' Home and its associated parking lots, entrance road, and septic field. This construction project created a large disturbed area in the center portion of the property. This disturbance ranges in depth from top to subsoil to 2 ft. into subsoil. This disturbance has been confirmed by shovel testing (see Stantec Report -Stewart and Brady 2015 p. 5-60; Dovetail Survey - Schamel- González and González, 2007 p.33)

Figure 2. Visitor Center, Parking Lots, and Septic Field. (Looking West)

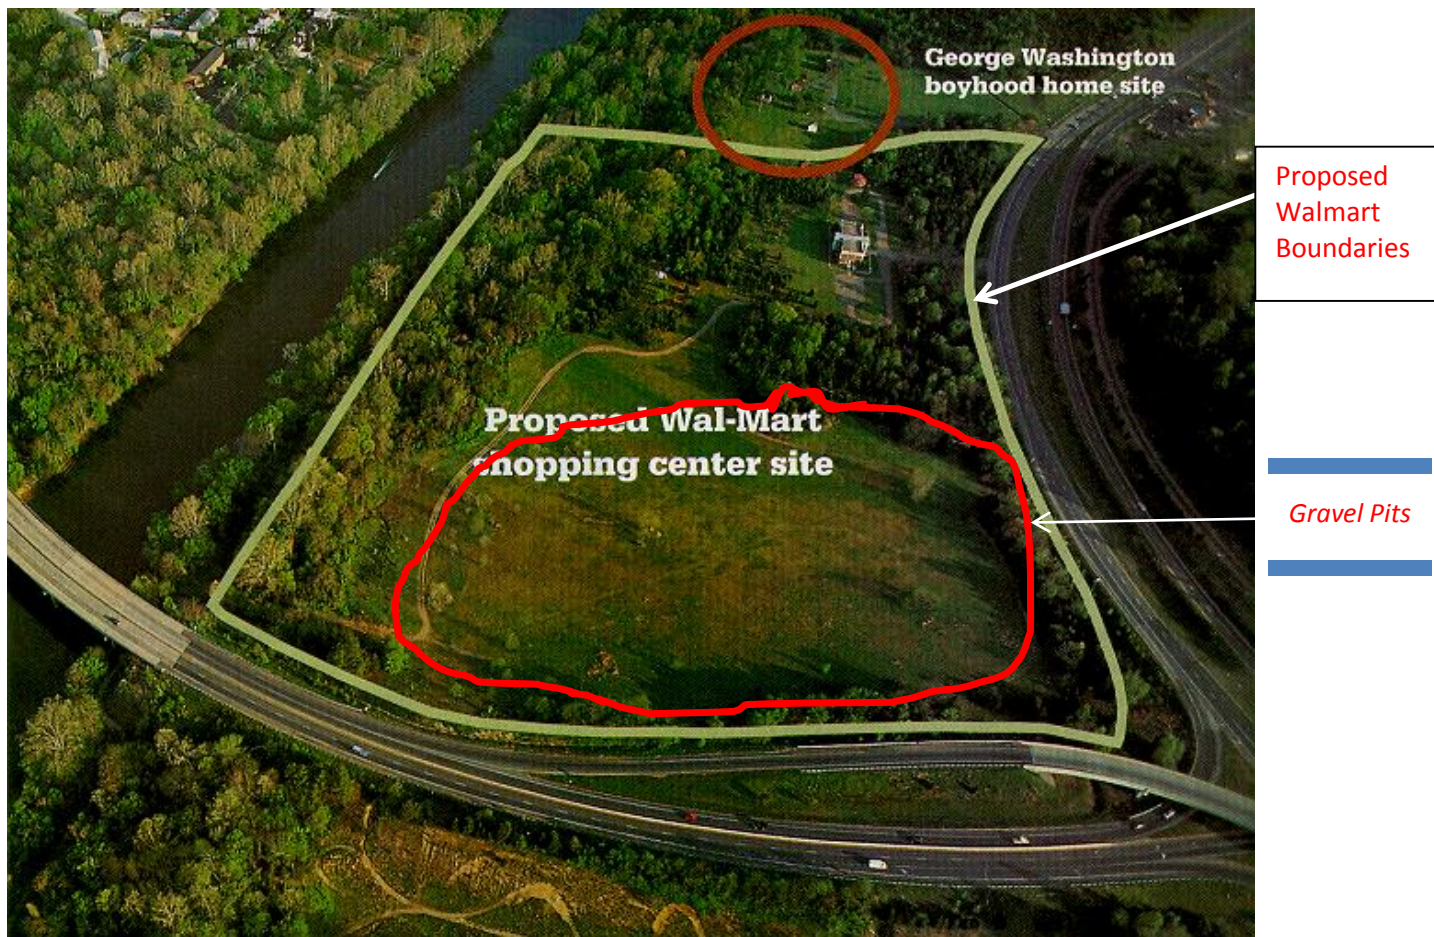
This photograph from around the time the property was acquired by Walmart shows the extent of the Gravel Pits. This photograph and Figure 5 are particularly helpful in determining the extent of the mining activity.

Figure 3. Area Containing Gravel Pits C. 1994 (Looking North).

In the late 1960s a new road project in Stafford County was in need of crushed stone for road bedding material. The owners of the Boys' Home sold soil and stones from a 15 acre area situated on the southern end of the property. The machinery removed soil up to 15 ft. in depth in this pit. (Levy 2013). This disturbance has been confirmed by shovel testing (See Ferry Farm Dovetail Survey 2007 - Schamel-González and González, p.33).

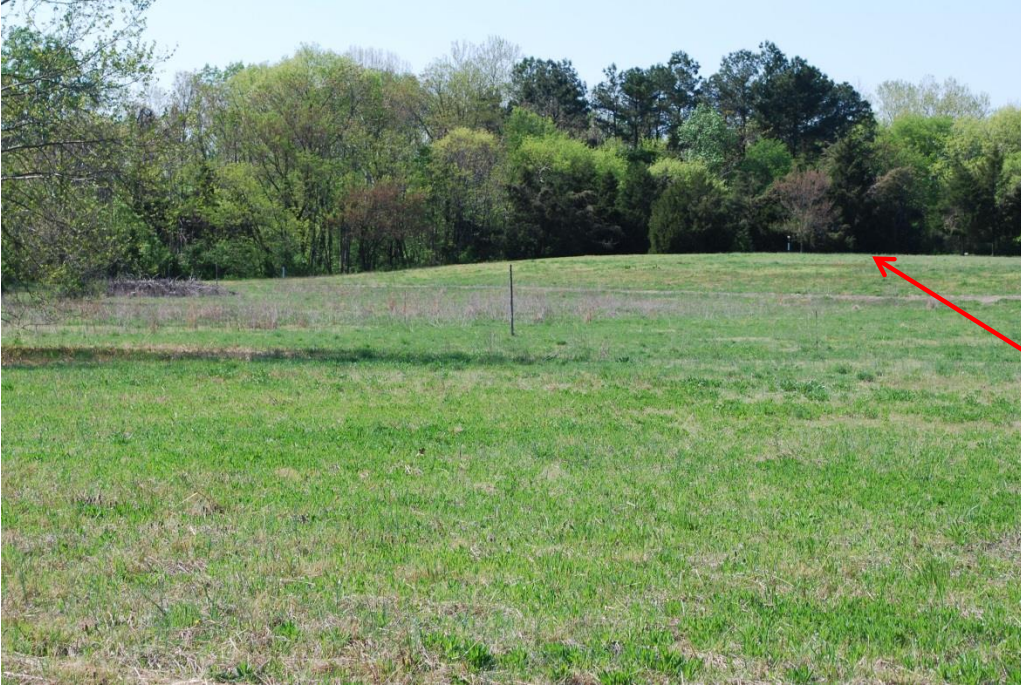
Figure 6. 2009 Photograph Showing Visible Grade Change in Gravel Pit area (Looking North). The Edge of the Pit is Marked by Arrow.

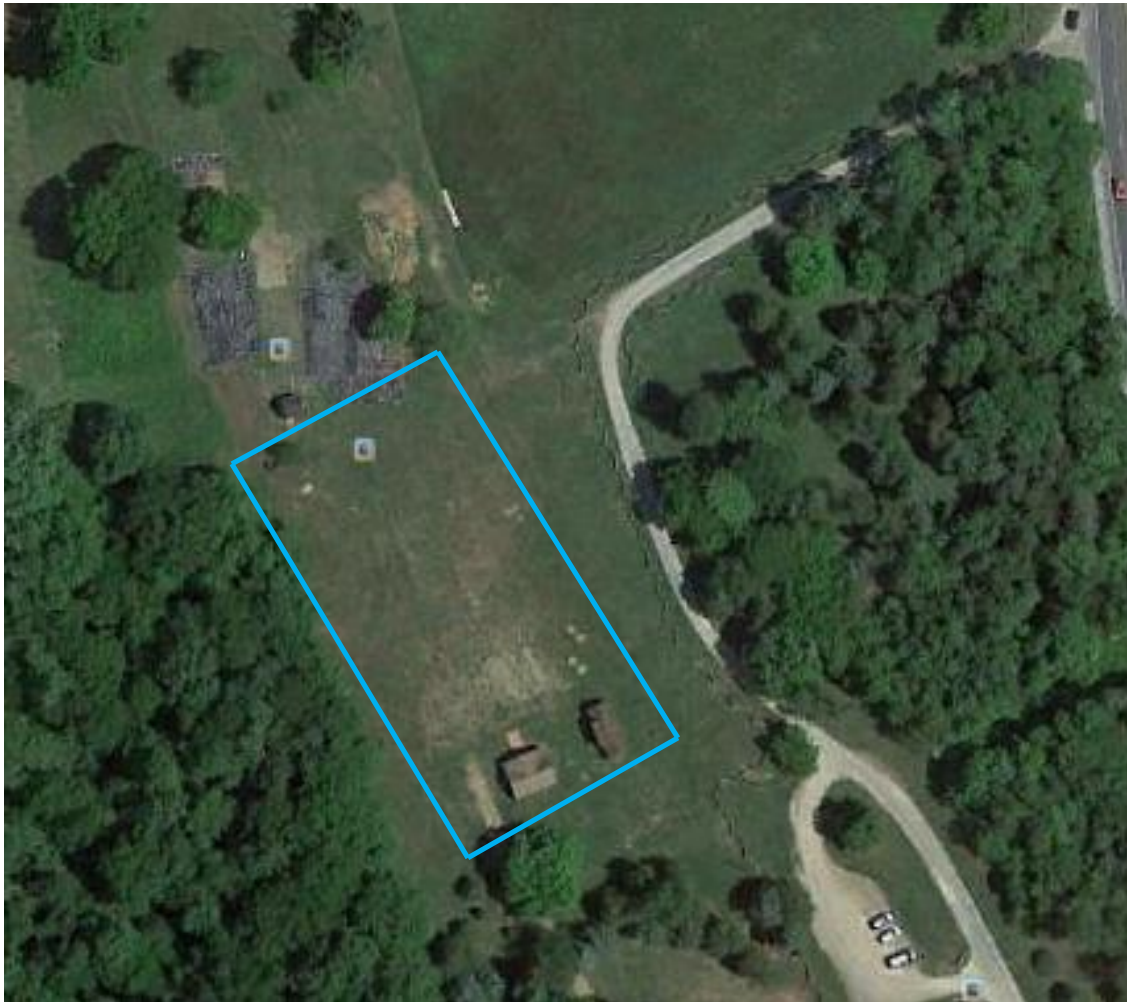
In the 1920s and 30s Ferry Farm was an operating farm. Its owner J.B. Colbert was a big man in Fredericksburg, and operated a number of business enterprises. As part of his farm operations he built a complex of outbuildings, barns, and other agricultural buildings in the area just south of the Washington House archaeological site (44ST174). This photo from 1930 demonstrates the extent of these structures on the landscape. Shovel testing has confirmed the existence of disturbance but not the extent (See Ferry Farm Dovetail Survey 2007 - Schamel- González and González Pp. 44 -45). The disturbance seems to be related to the removal of these structures and the disturbance is variable depth but extends to the top of subsoil for most of this area. The archaeological potential of this area is yet to be determined, but these structures have certainly damaged this area.

Figure 9. Aerial View of Area 3- Marked in Blue.

The nature of the disturbance in this area makes shovel testing impractical. In the place of shovel testing, Foundation archaeologists will supervise the machine grading of disturbed soils to subsoil followed by archaeological monitoring in all area scheduled to be disturbed by Phase I construction activities. Both NPS and VDHR will be notified if significant archaeological remains are encountered.

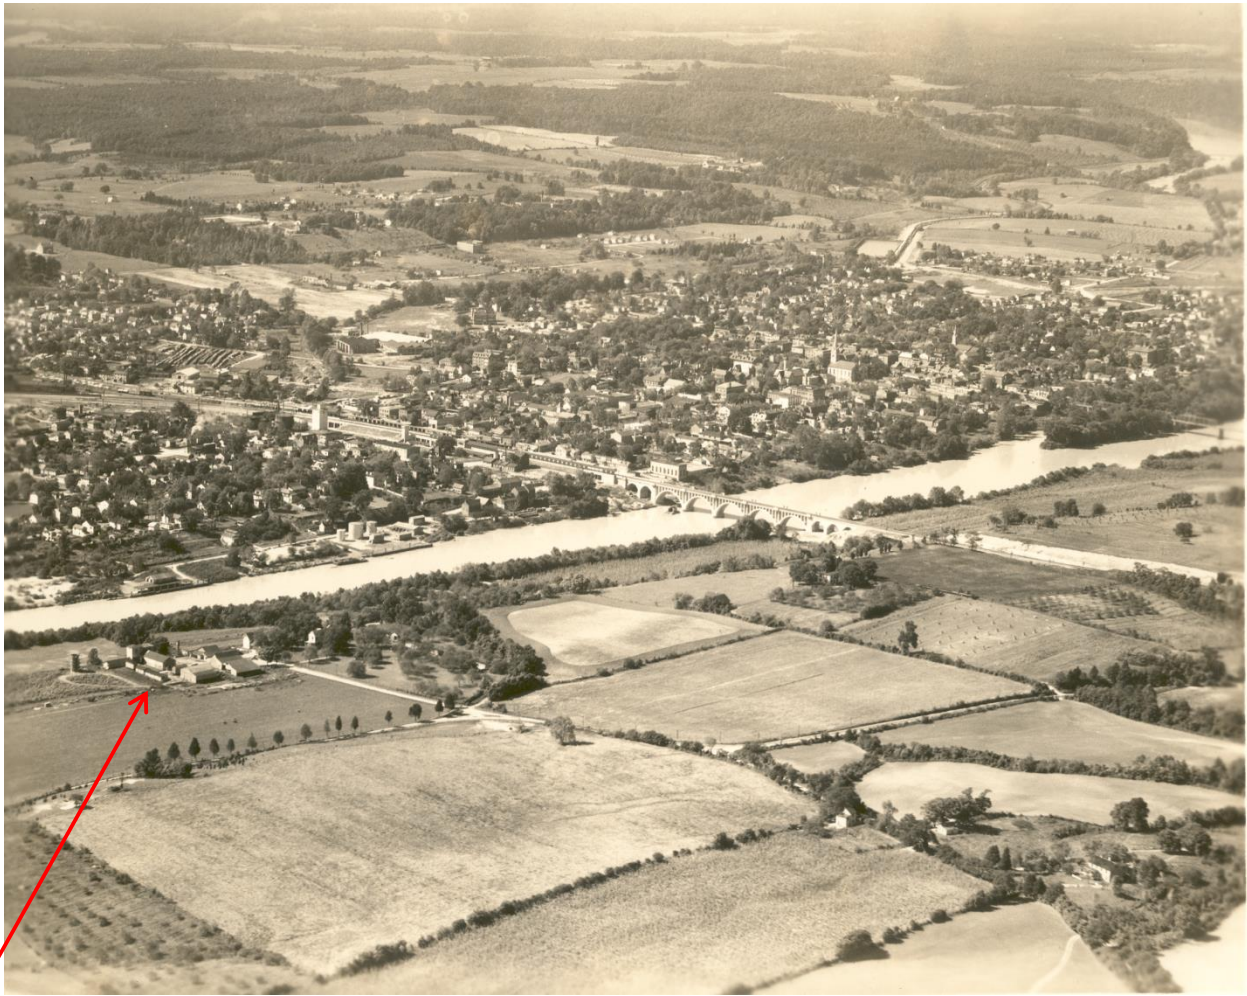
Figure 8. Area 3. Just South of the Archaeological Site 44ST174 Washington House Site. (Looking West)

Note that most of the farm building are situated south of the entrance road that marks the southern boundary of the George Washington Boyhood Home Site (44ST174).

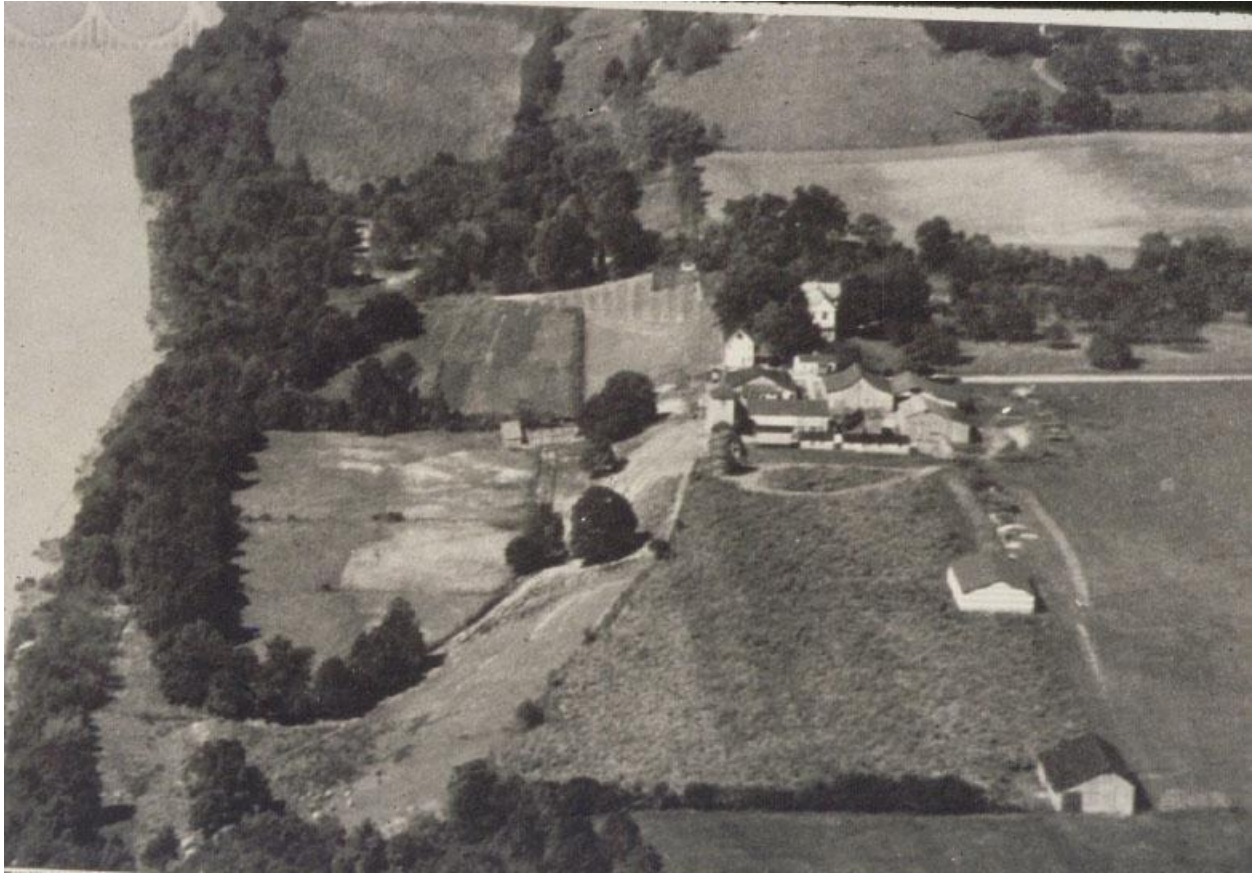
Figure 9. Another view of Colbert farm complex taken around 1930. (Looking North)
