**Various Tracts
Caneel Bay Resort**

**Level I
Pre-Acquisition
Environmental Site Assessment
Survey**

September 4, 2012

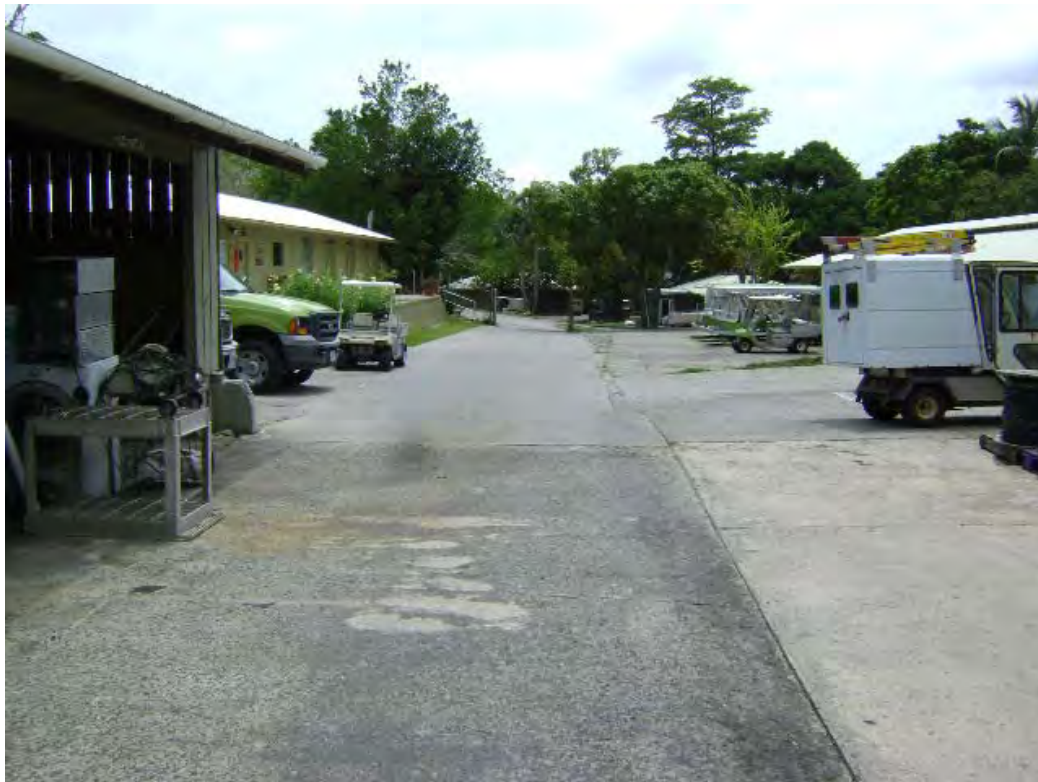
Engineering & Maintenance Area in Southeast Part of Subject Property

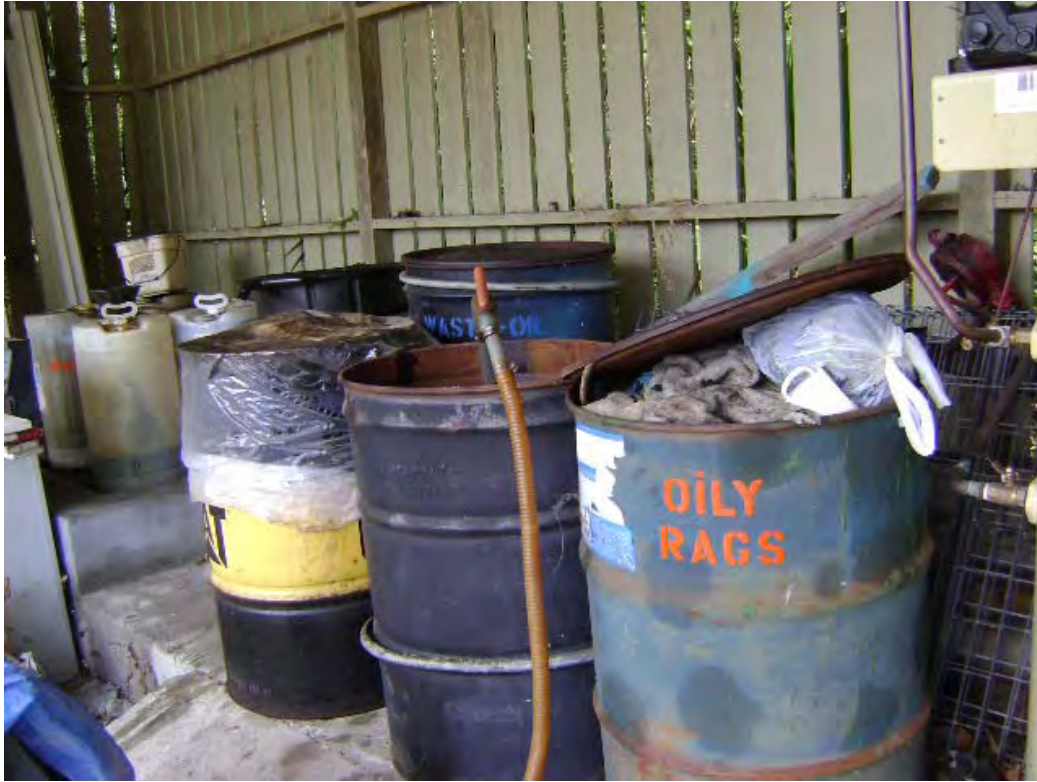
- Approximately 20 buildings are located in the engineering and maintenance area, which is in the southeast part of the property. The area appears to be used for the repair and maintenance of buildings, vehicles, golf carts, and landscape maintenance equipment, and for charging vehicular batteries. Numerous open and closed containers of waste motor oil, and oil filters were present in this area. Automotive batteries were observed on the concrete floors; the floors were stained from battery leakage. Several areas of oil stains on the work tables, concrete floors and on the soil outside the buildings were observed in this area. Numerous storm water drains are present near buildings with oil stained floors. The storm water drains and the surface drainage in the area appear to flow east and north to a small drainage ditch north of the engineering area. The stained tables, floors and soil are considered to be a recognized environmental condition (REC).

Waste Oil Storage Area in Engineering & Maintenance Area

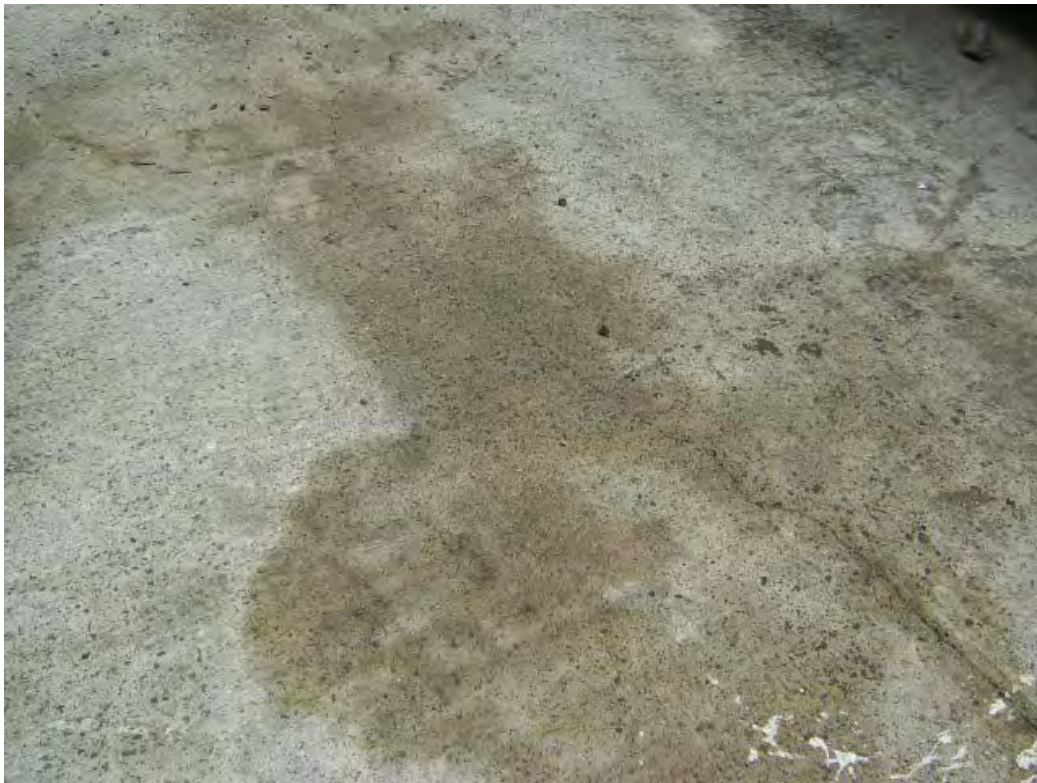
Oil Stained Concrete Floor in Engineering & Maintenance Area

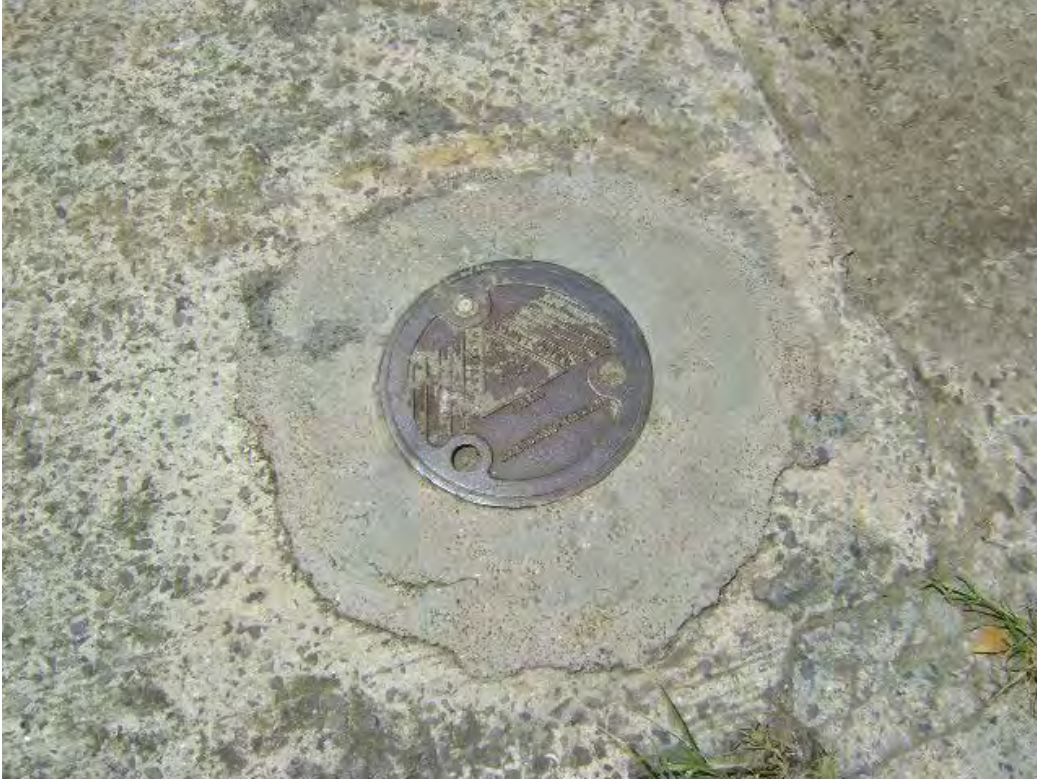
- A flush-mounted monitoring well manhole was observed in the concrete pavement just south of the diving storage building. Alvin Nazario with the Caneel Bay Resort indicated that the well was put in to monitor underground fuel storage tanks (USTs) that were removed from that area in the 1990s; Mr. Nazario stated that no contamination was detected in the well. The former USTs and monitoring well are considered to be a REC.

Monitoring Well in Pavement Near Diving Storage Building in Engineering & Maintenance Area

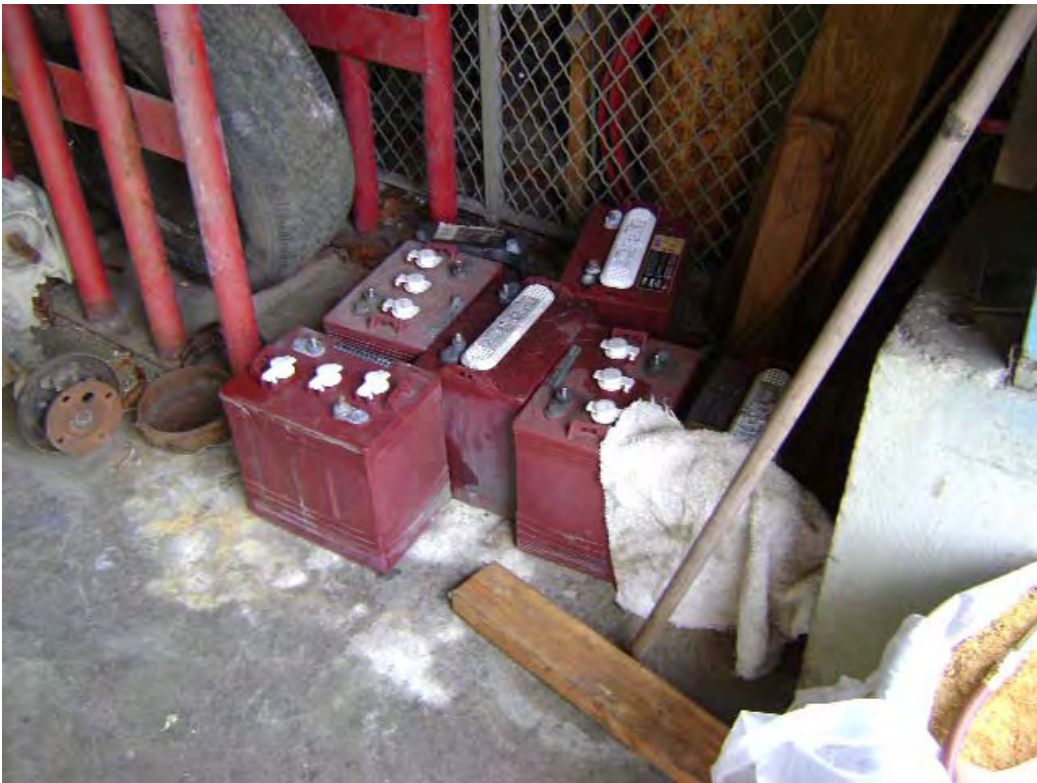
Automotive Batteries & Stained Concrete Floor in Engineering & Maintenance Area

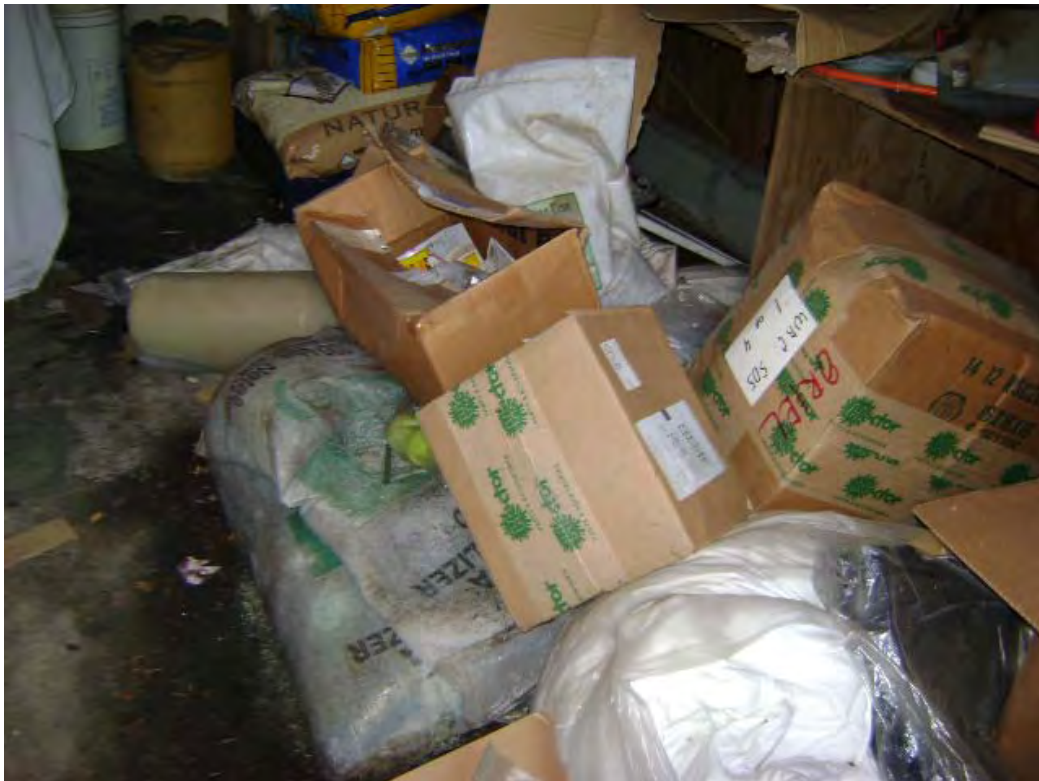
- Approximately six buildings are located in this area, which is just west of engineering. The area appears to be used for growing plants, landscape equipment repairs, and storage of lawn and garden chemicals and supplies. Several storage buildings were observed with bags and containers of various pesticides, herbicides and fertilizers; these materials were observed to have leaked or spilled onto the unpaved floors of the sheds. These leaked or spilled materials are considered to be a REC.
- An open-sided equipment maintenance building was observed to have numerous pieces of oily equipment, oil stained tables, oil-stained concrete floors, an open container of used motor oil, and numerous cans of gasoline and oil. An oily odor was present in this area. The oil-stained tables and floors are considered to be a REC.

Fertilizer Spilled on Ground in Storage Shed in Grounds & Landscaping Area

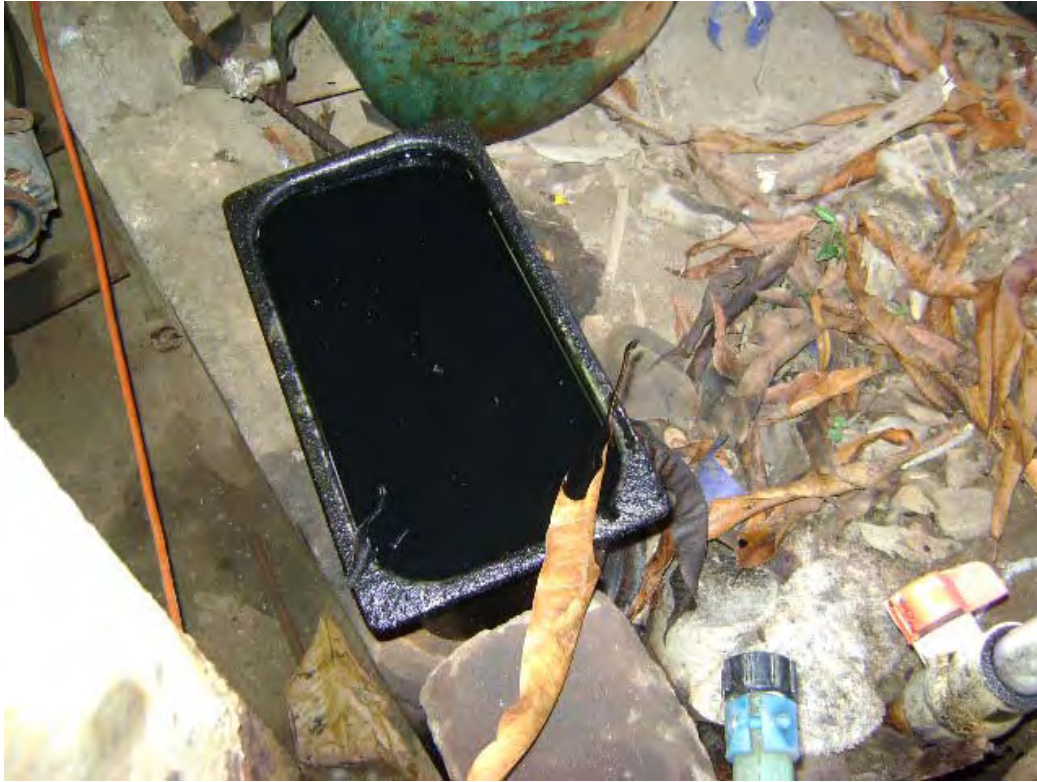
Open Container of Waste Oil in Building in Grounds & Landscaping Area

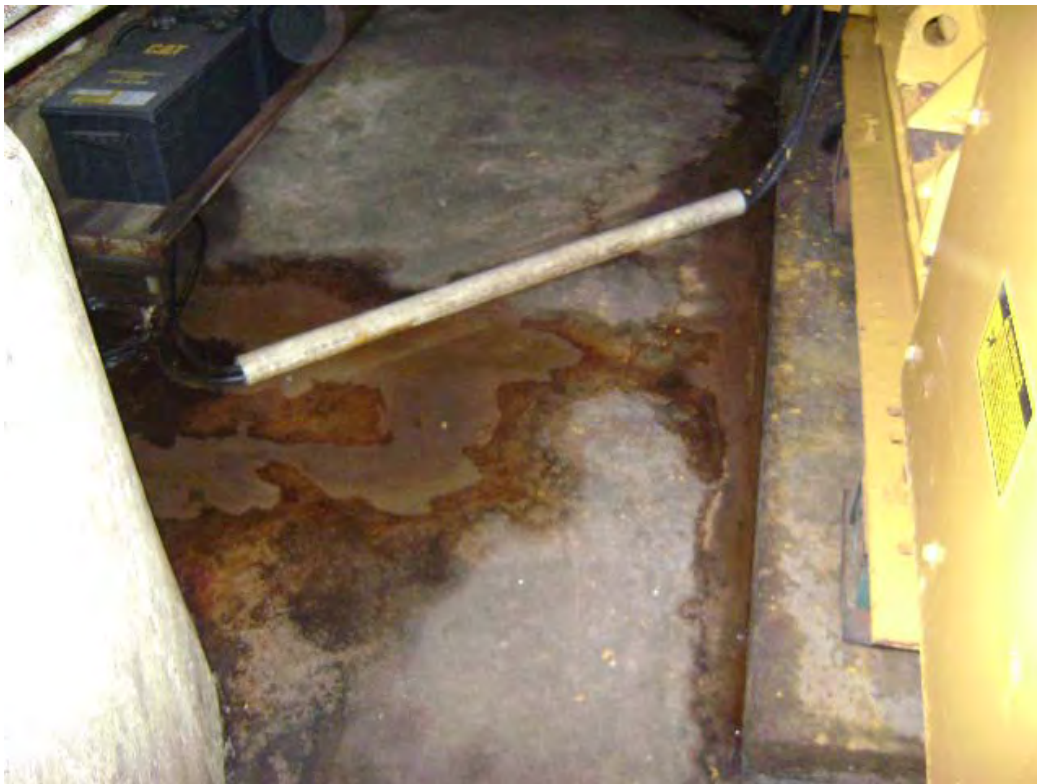
- This building is west of engineering and houses two large diesel-powered emergency electric generators. A strong oily odor was present in the building. The concrete floor beneath the generators was oil stained. Several large lead-acid batteries were present on the floor of the building. Two shallow floor gutters in the building appear to discharge oil or other liquid leaks from the generators to the soil outside on the east side of the building; two areas of oil-stained soil were present on the ground beneath these two

discharge points. The oil-stained floors and soil are considered to be a REC.

Oil & Batteries on Concrete Floor of Emergency Generator Building

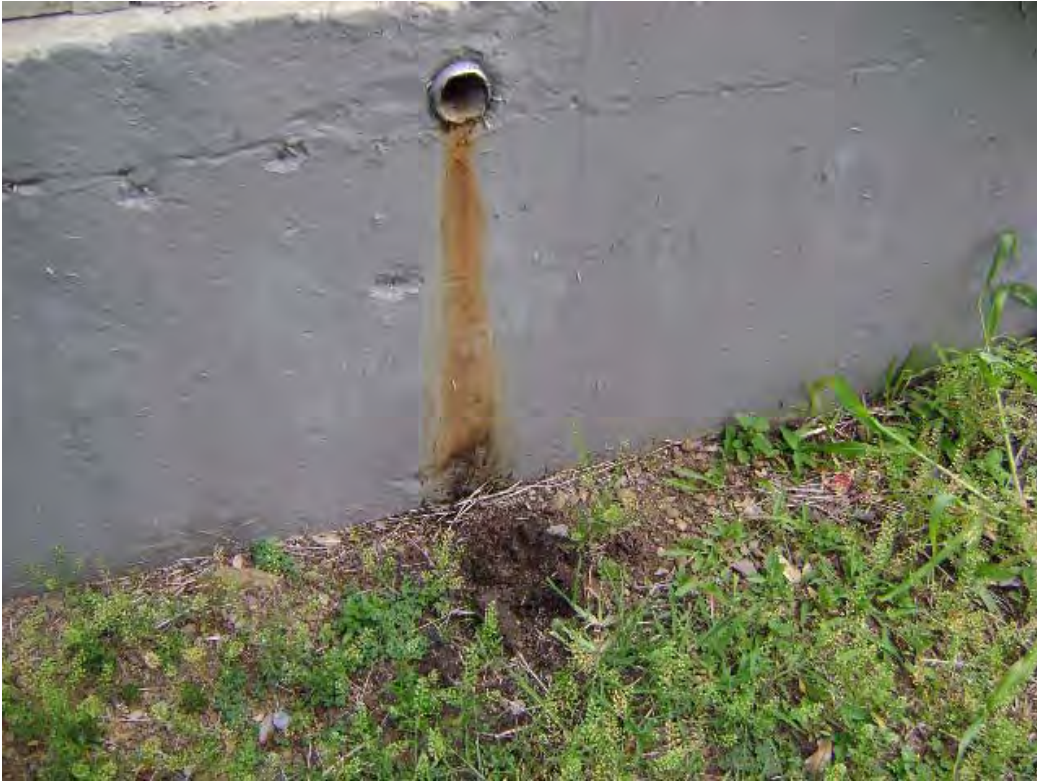
Oil Discharge From Floor of Emergency Generator Building to Soil Outside Building

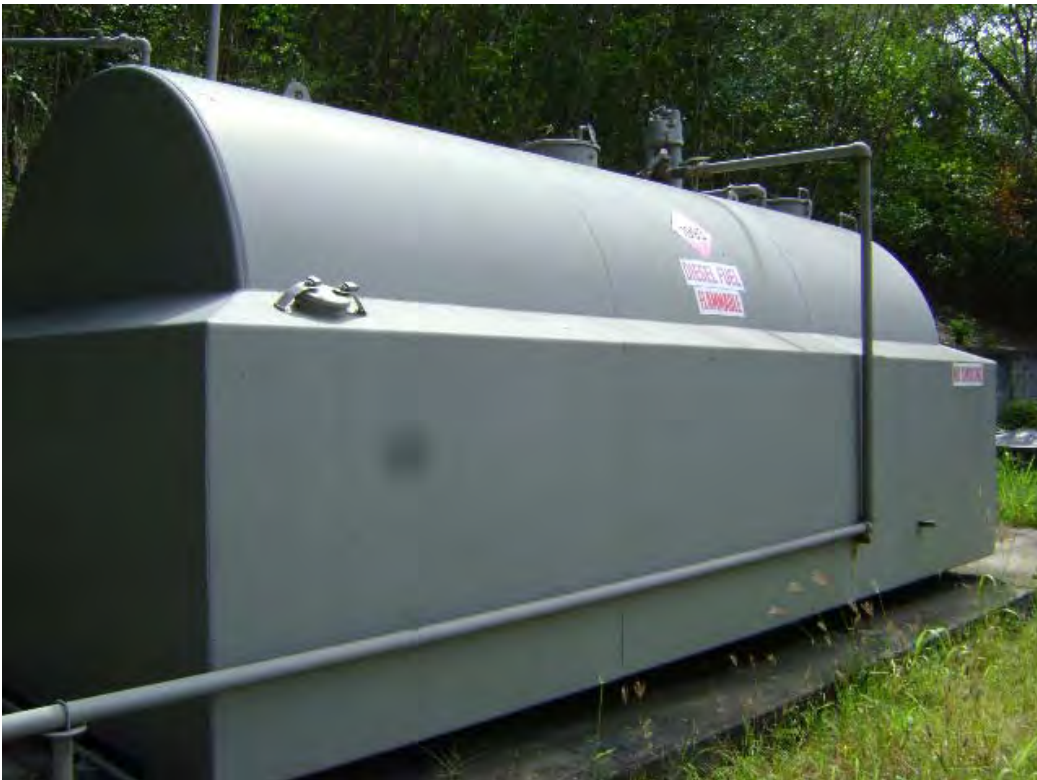
- Three above ground storage tanks (ASTs) are present just north of the generator building. One AST is approximately 20,000 gallons in capacity and appears to hold diesel fuel for the emergency generators. One AST is approximately 10,000 gallons and appears to hold gasoline. One AST is approximately 500 gallons and appears to hold gasoline. A diesel and gasoline fuel dispenser was present in the area. A diesel fuel leak is reported to have occurred two years ago; the fuel-impacted soil is reported to have been excavated, covered with a tarp and placed on a concrete pad near the ASTs. A covered area of stockpiled soil (approximately 15' by 40') was observed in this area; however, the exact area from which the soil was excavated was not determined.

Above Ground Diesel Fuel Storage Tank for Emergency Generator

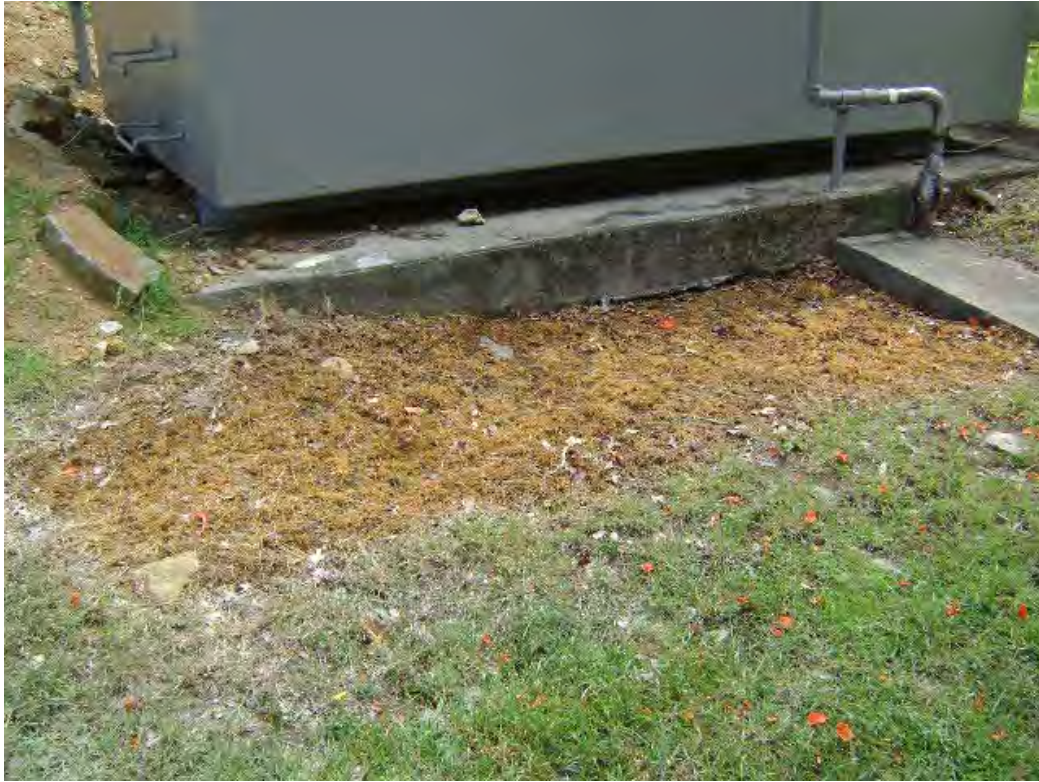
- An approximately 5' by 12' area of distressed vegetation and fuel-stained soil was observed just east of the 10,000-gallon gasoline AST; the leaked fuel appeared to be gasoline. The depth of the fuel-impacted soil was more than 6 inches.

- The past and current fuel leaks and fuel-impacted soils in this area are considered to be RECs.

Distressed Vegetation & Fuel Impacted Soil Near Gasoline Fuel Tank North of Generator Building

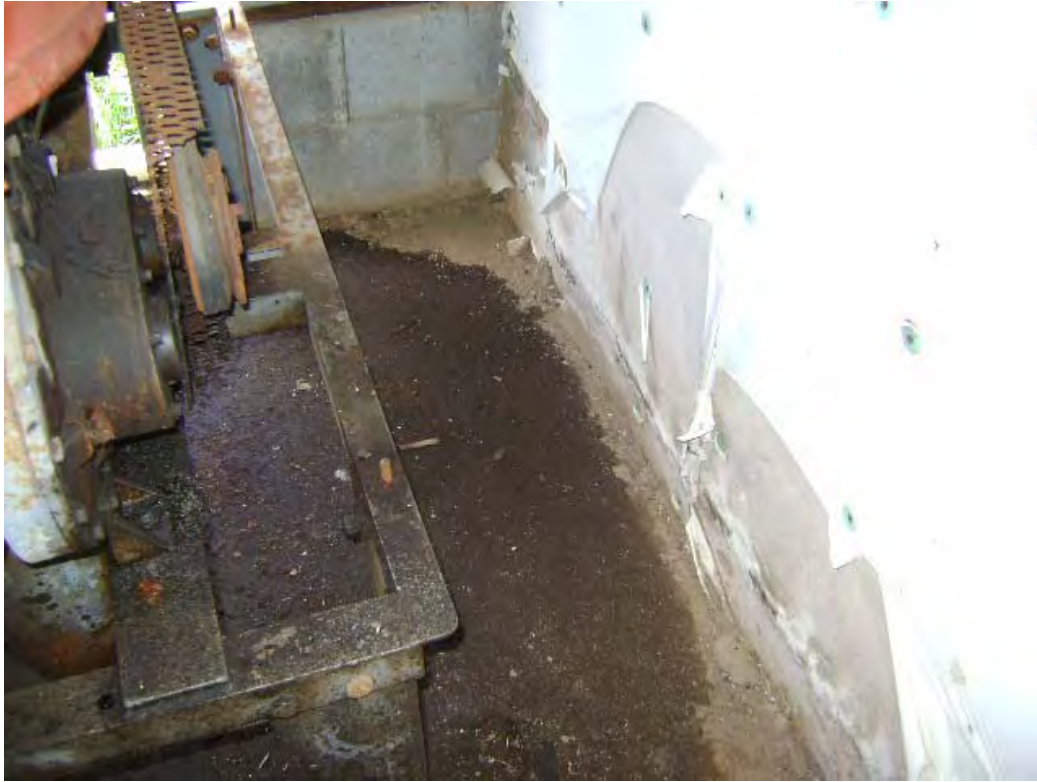
- An approximately 5' diameter oil stain was observed on the concrete floor of a small pump building for the plant.
- An approximately 2' diameter oil stain was observed on the ground near the treatment plant buildings. The stain appeared to be oil that leaked from a vehicle or other equipment previously parked at that location.
- The oil-stained floor and soil are considered to be RECs.

Oil Stained Floor Near Pump in Building at Wastewater Treatment Plant

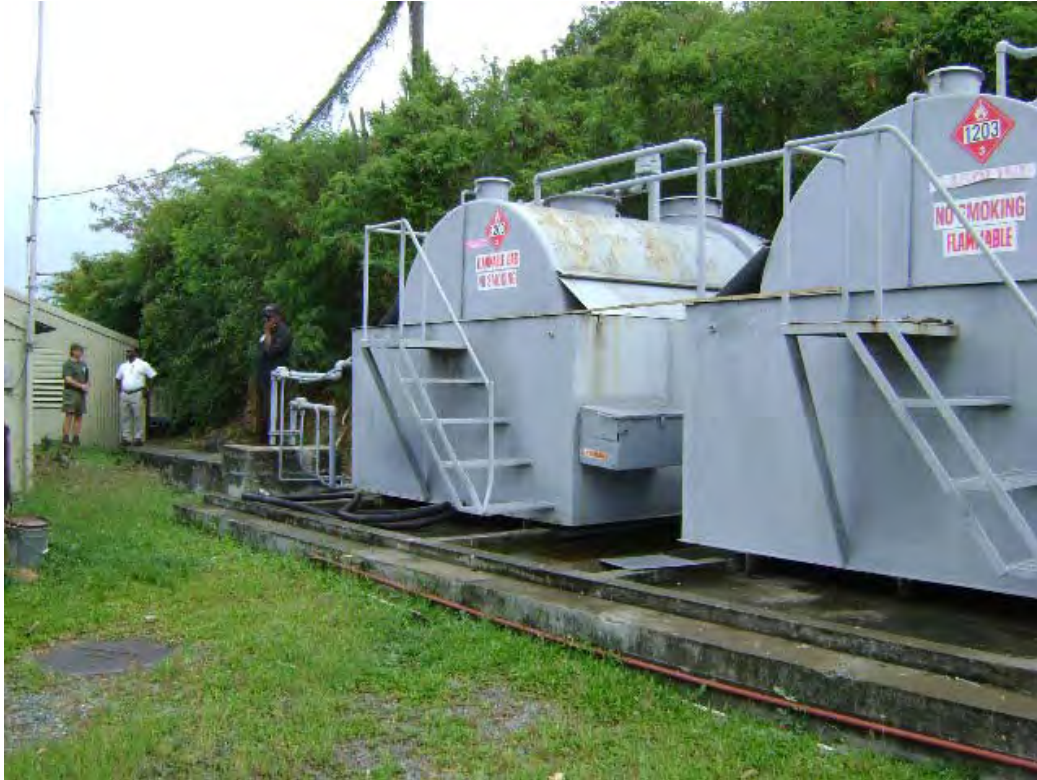
- The past and current operation of the marina, the fueling station, the fuel and waste oil ASTs, the fuel pipeline and boat repair facility (since the 1960s) are considered to be a REC for this tract.

Above Ground Fuel Storage Tanks at Marina Facility

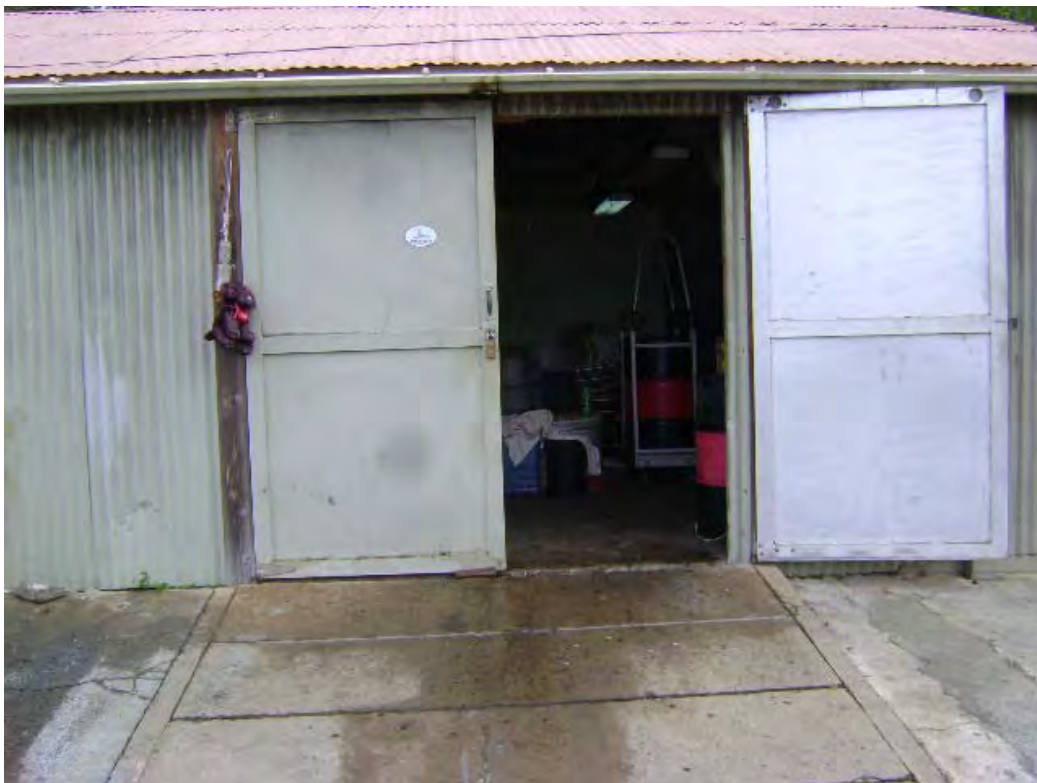
- Oil-stained concrete floors and an oily odor were present in the west building near open and closed containers of waste oil. Approximately ten lead-acid batteries were observed to be stored on the concrete floor; the floor near the batteries was stained. Numerous containers of paints, oils and cleaners were present in the west building. Outboard motors, fuel cans, air compressors and electric generators were also present in the building.

Oil Stained Pavement Near West Building of Marina Facility

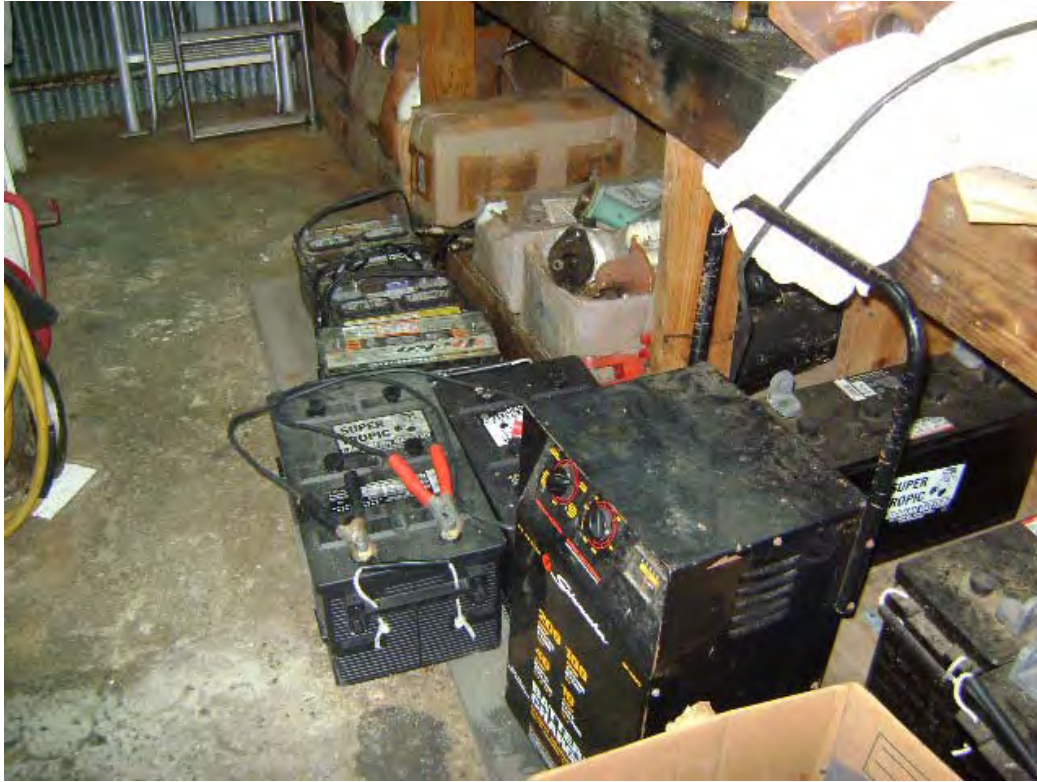
Batteries & Stains on Floor of West Building of Marina Facility

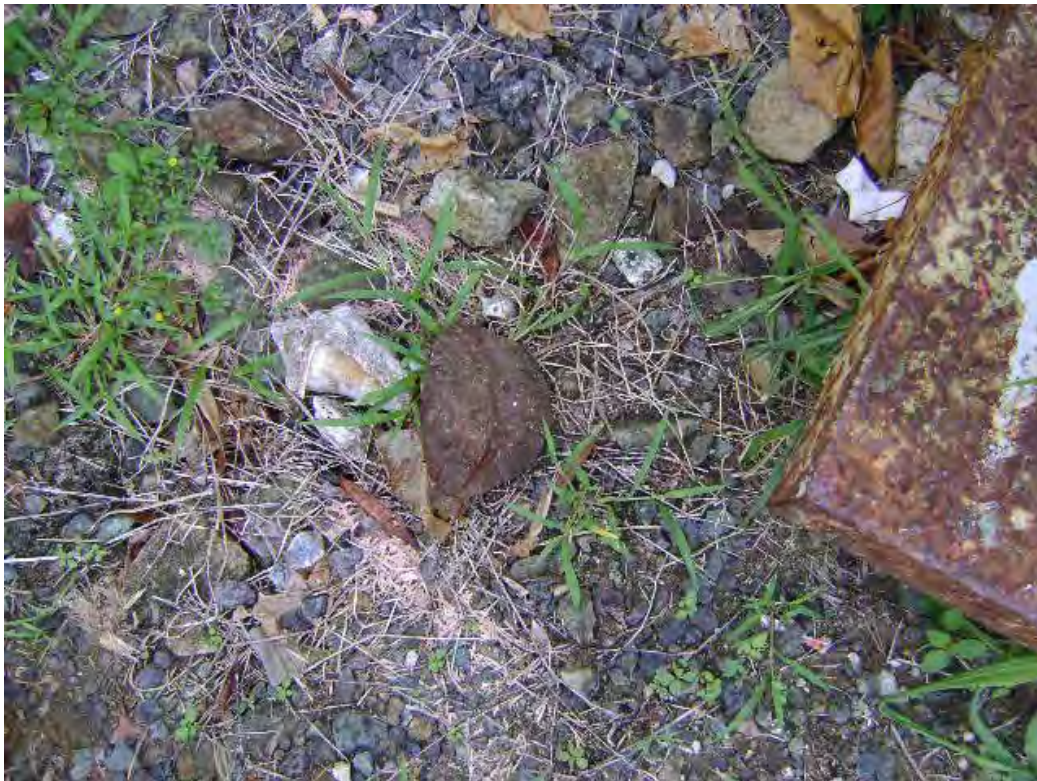
- The grounds of the marina near the water were reported to have been formerly used for repairs and maintenance of dry-docked boats, including boat-bottom re-painting. Boat bottom paints are known to have contained heavy metals. Sanding of old bottom paints may have contaminated surface soils and bay sediment with metals. Pieces of fiberglass and polyurethane or epoxy resin were observed on the ground in this area. An oil-stained wooden pallet was also observed on the ground in this area.

Polyurethane Resin on Ground at Marina Facility

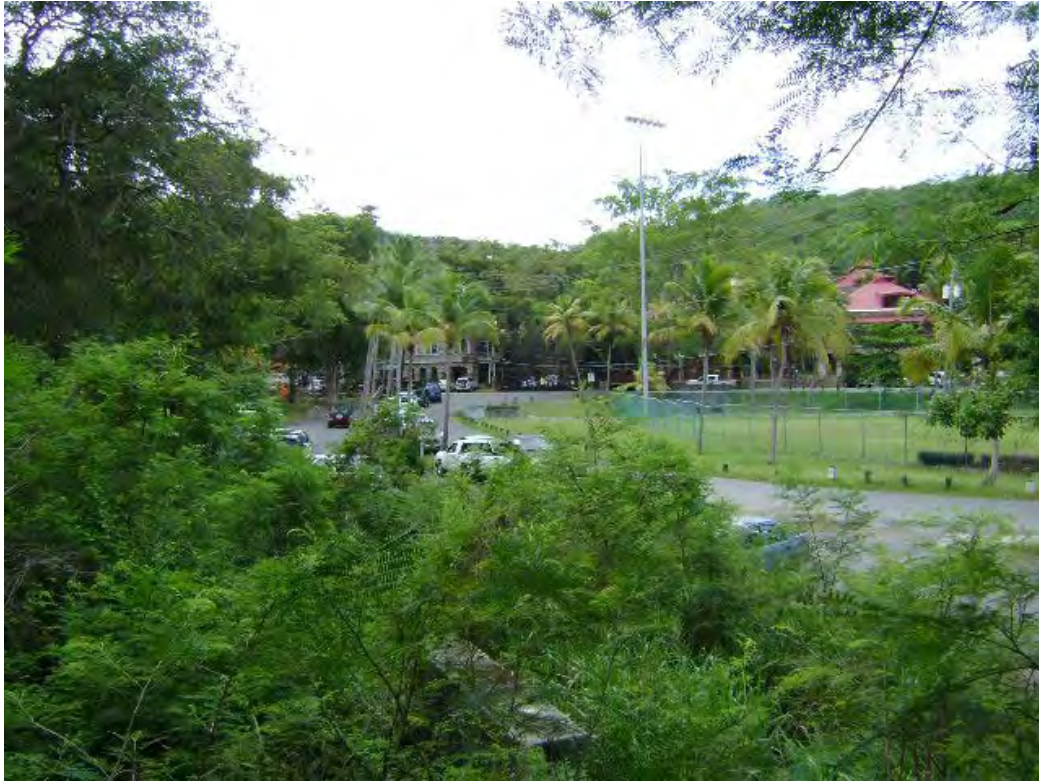
- The former location of the fuel ASTs is an overgrown area with two concrete tank support structures. No direct evidence of fuel spills or releases was observed in this area. However, the past operation of the fuel ASTs and underground pipeline is considered to be a REC for this tract.

Area of Former Above Ground Fuel Storage Tanks on Tract 04-104 (in foreground)

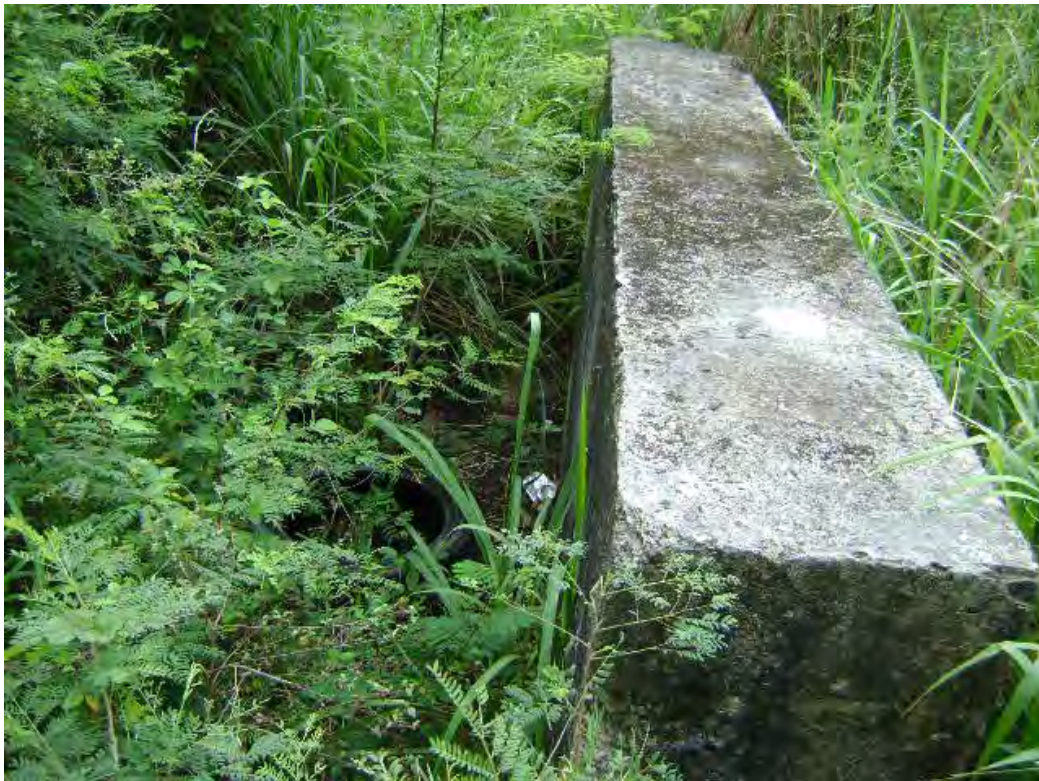
Concrete Structure in Area of Former Above Ground Fuel Storage Tanks on Tract 04-104

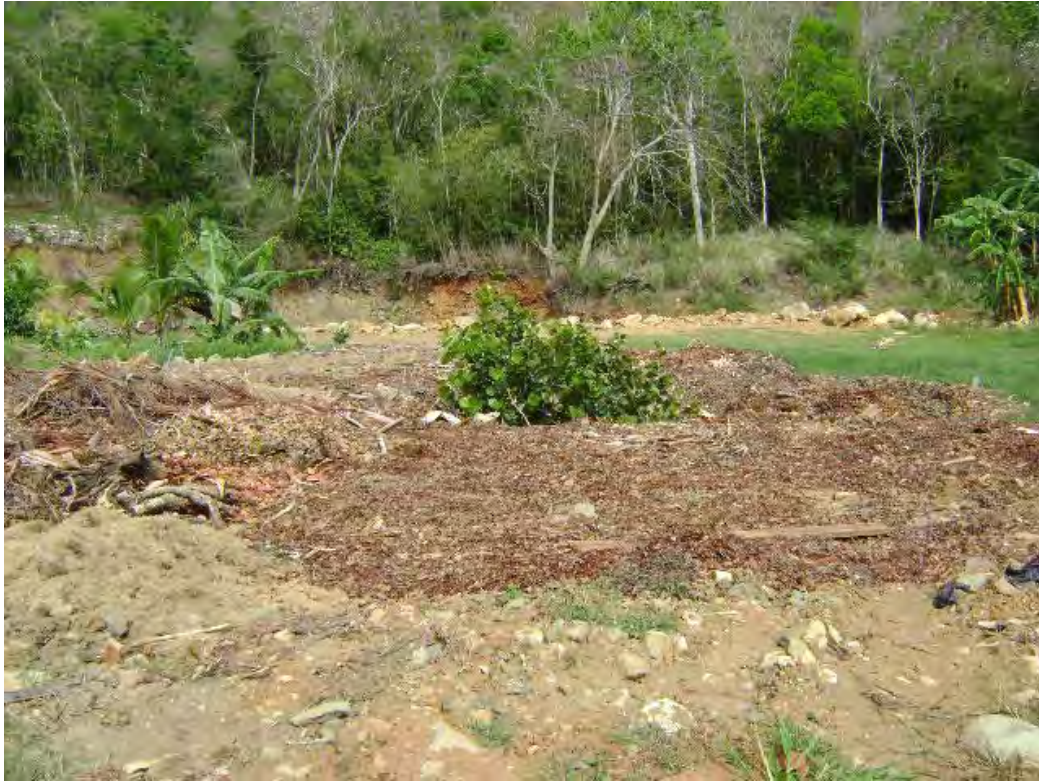
Debris Landfill Near Honeymoon Beach
