# **MINUTE MAN NATIONAL HISTORICAL PARK**

# **STRATEGIC FACILITIES PLAN**

## **Project Development**

*Prepared by the Historic Architecture, Conservation and Engineering Center  
April, 2021*

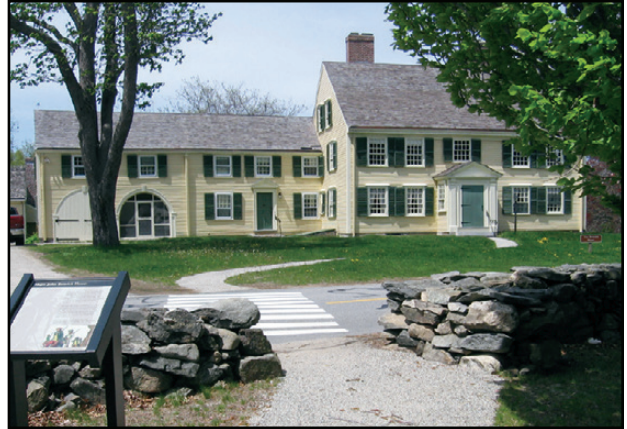
Major John Buttrick, one of the fourth generation of Buttricks in Concord, was charged with the raising of militia from within the township. His father, Jonathan Buttrick, built the house on family property between 1710 and 1717. It was a two-story, rectangular with an ell on the northwest side. Like most Colonial era homes, it has seen many alterations over the years.

- Replace Bulkheads
- Rehabilitate Shutters

- Replace Electrical Service Panel (2)
- Replace Main Service Disconnect (2)
- Install Arc Fault Circuit Interrupters - 2 Panels
- Remove and Replace interior main water service line, including meter
- Remove and Replace Domestic Water Supply Manifold
- Remove and Replace Piping and Fittings as Required

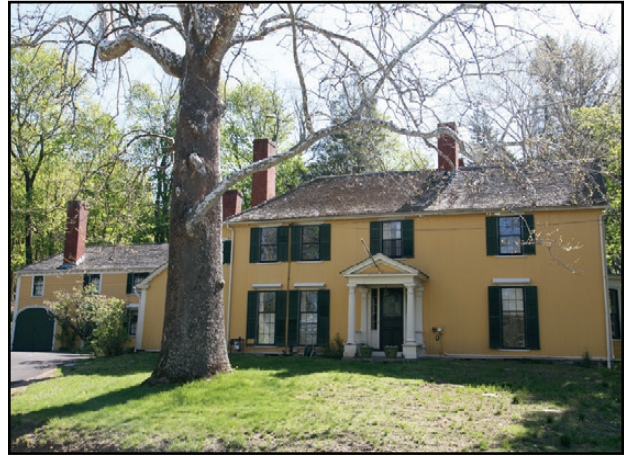
The Elisha Jones House (a.k.a. The “Bullet Hole House”), built approx. 1740, played an important role in the history of Concord as a Witness House to the Battle of 1775. Only yards from the bloody fighting at Concord’s North Bridge, the house is thought to bear the scar of a British musket ball aimed at Elisha Jones on April 19, 1775.

- Sill and Post Repairs - North Wall Garage
- Sill Replacement - Ell Shed
- Wall Stabilization - Upper Floor Ell

- Repair or Replace Deteriorated Wall Cladding
- Rehabilitate Wood Window Sash and Frames
- Repair or Replace Deteriorated Trim
- Selective Repointing of stone foundation
- Prep and Paint siding, trim and openings
- Repair or Replace Wood Elements at Porches
- Repair Deteriorated Wood Shutters
- Rehabilitate Exterior Doors
- Remove and Replace Steel Bulkhead
- Provide pest management service/application

- Install Arc fault circuit interrupters
- Remove and Replace Service Panels
- Remove and Replace Main Disconnect
- Replace aged/deteriorated boxes/fixtures
- Replace aged/deteriorated conductors as required

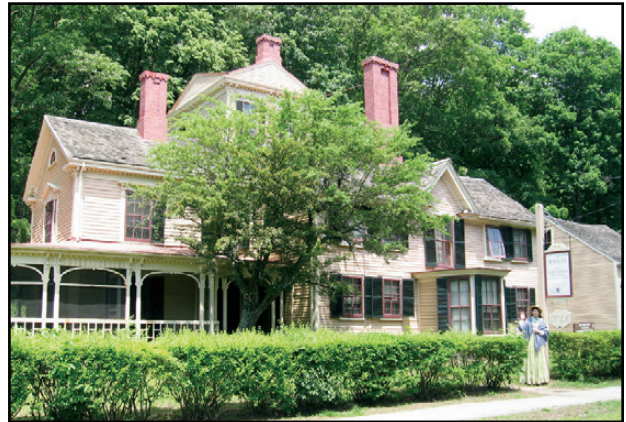
The Wayside was initially home to Samuel Whitney, who was muster master for Concord's minute man companies and a delegate to the Provincial Congress. He stored ammunition at his home for the Revolutionary cause. In the 19th century, the house acquired even greater significance as the home of the noted author Louisa May Alcott, and, later, American novelist Nathaniel Hawthorne.

- Prep and Paint siding, trim, openings
- Rehabilitate Sash and Frames
- Rehabilitate Exterior Doors
- Repair Wall Cladding and Trim
- Remove and Replace Bulkhead
- Repair Coal Bin
- Rehabilitate Exterior Shutters
- Rehabilitate Storm Sash

- Replace Deteriorated/Defective Valve, Joint and Piping - Steam Heat System
- Replace Damaged Plumbing Vent Stack Pipe Section
- Repair and/or replace aged and non-code compliant electrical infrastructure

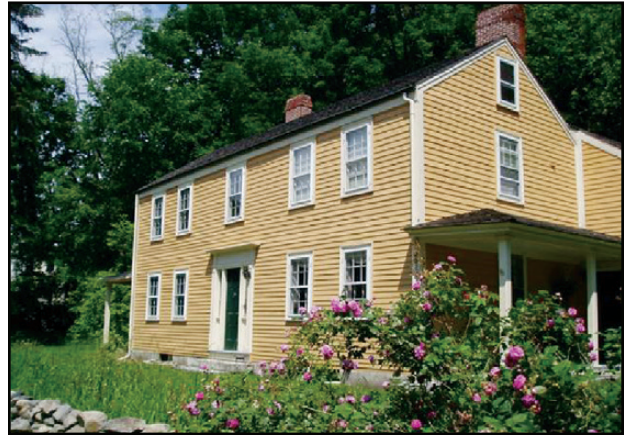
## GOWING-CLARK HOUSE

Situated across Old Bedford Road from Miriam's Corner, the location where the running battle began as British troops retreated to Lexington, the land on which the Gowing-Clark House sits is important in the interpretation of the historic battle that occurred between British and American troops. Constructed c. 1836, the building itself reflects its use as the center of operations for a typical New England nineteenth-century farm along the Battle Road.

- Provide selective repointing to foundations

- Remove, Repair and/or Replace deteriorated clapboard siding
- Remove, Repair, and/or Replace deteriorated trim as required
- Remove and Replace wood shingle siding
- Remove and replace cellar bulkhead
- Rehabilitate entry doors
- Rehabilitate wood window sash
- Remove and replace storm windows
- Provide treatment and monitoring for insect and pest management
- Prep and Paint siding and trim
- Refinish porch flooring
- Remove and Replace Gutters and Downspouts

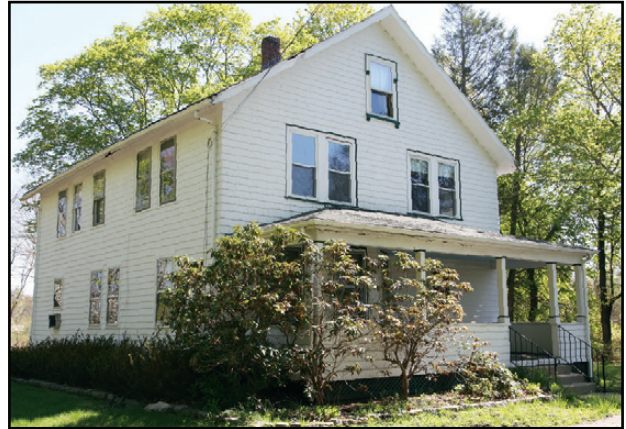
The Town of Concord erected the Second East Quarter Schoolhouse (c. 1854) on land that was historically part of the Meriam farm. Its architectural style is similar to other local schoolhouses built during this era. Following the school's closure in 1887; it was converted to residential use in 1903-04.

- Replace failed steel pipe columns

- Repair and/or Remove and Replace deteriorated or damaged wood shingle siding
- Repair and/or Remove and Replace deteriorated trim
- Prep and repaint exterior siding, casings, and trim
- Rehabilitate entry doors
- Remove and replace combination storm doors
- Rehabilitate wood window sash
- Remove and replace storm windows

- Remove existing slate shingle roof
- Remove and Replace deteriorated sheathing
- Install asphalt shingle roof, including underlayments, flashings and trim, complete
- Remove and Replace porch asphalt shingle roofing
- Remove and Replace gutters and downspouts

- Rehabilitate and/or replace interior finishes
- Renovate existing kitchen and bathrooms
- Upgrade and/or repair electrical and plumbing distribution systems
- Upgrade heating system and distribution as required

- Replace electric panel with new main breaker load center having arc fault circuit interrupters

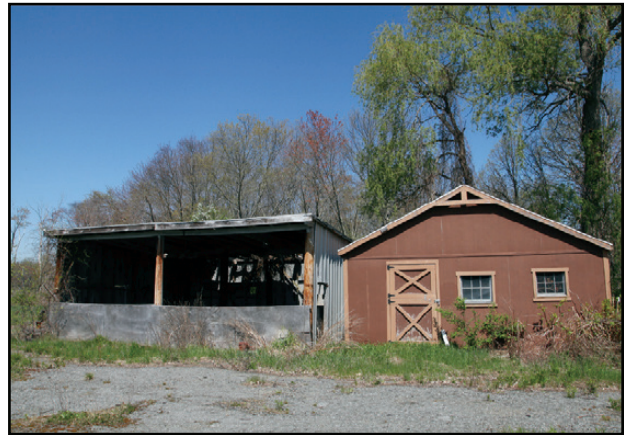
Located in the Meriam's Corner portion of the Battle Road Unit, Palumbo farm encompasses approximately 17 acres of land purchased by the Palumbo family in 1926. On the south side of North Great Road are the Palumbo Farm Enclosed Garage and the Open Metal Shed, both constructed in the 1950s, and the more recent Farm Shed. All extant structures on Palumbo Farm are significant for their association with the modern agrarian period in Concord. The buildings reflect typical utilitarian mid-20th century design.

- Asbestos Survey to be performed at 4 farm buildings and a report prepared in accordance with 310 Mass. Reg. 7.15.
- If asbestos-containing material is found, it is to be removed and disposed of in accordance with all local, state, and federal regulations. MassDEP is to be notified.

- Protect existing adjacent actively cultivated agricultural fields to the north of structures and wetland area to the south.
- Carefully remove and store all items to be salvaged, if any, upon direction of NPS.
- Demolish structures. Remove all floors, foundations, footings, basement and retaining walls to a minimum of eighteen inches below grade, or as otherwise required.
- Remove all asphalt and other hard paving surfaces on the site.
- Remove utility pole.
- Dispose of all materials in a safe and efficient manner in accordance with all local, state and federal regulations. Include all hauling, disposal fees, and dump fees.

- Backfill the footprint of each demolished structure as needed and fill any other depressions with clean, compacted earth.
- Clear overgrown brush and grub stumps from site.
- Roughly grade site, match existing neighboring grades, and provide slope so that surface is smooth with adequate drainage to prevent water ponding.
- Provide layer of topsoil.
- Landscape is to be left in good condition for future projects, such as restoring agricultural fields, orchards, or installing trails.

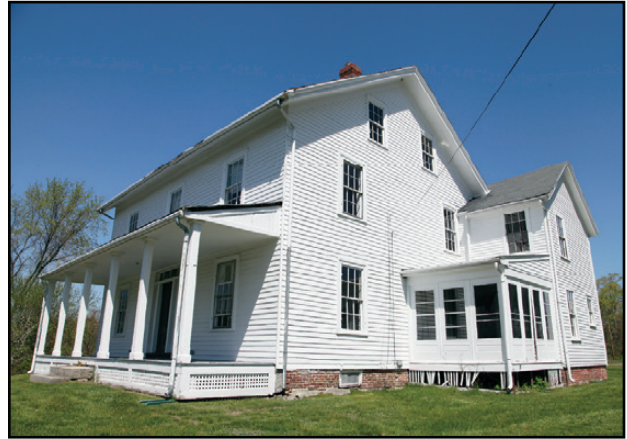
The wood-framed farmhouse now known as the George Hall House faces the historic “Battle Road”. Although a structure may have occupied this site as early as 1639, the extant house was erected ca. 1865 on the site of a home occupied by Deacon George Minot between 1765 and 1808.

- Selectively repoint brick foundation wall
- Reconstruct failed sections of brick and stone foundation walls
- Provide structural shoring as required
- Pour new concrete footings

- Floor Construction
- Infill/patch missing first floor system at NW corner
- Remove rotted porch posts and associated framing
- Provide replacement front porch posts; reinforce framing to remain, as required
- Provide 1x4 front- and side-porch flooring
- Roof Construction
- Selectively repoint brick chimney
- Provide replacement roof sheathing

- Repair and/or Remove and Replace wood clapboard siding as required
- Repair and/or Remove and Replace deteriorated trim
- Remove and replace wood lattice panels at side porch
- Prep and repaint exterior siding, soffits and trim
- Rehabilitate wood window sash
- Remove and Replace storm windows
- Replace basement windowsill
- Rehabilitate entry doors
- Remove and Replace door assembly on side porch
- Prep, repair and refinish wood gutters and metal downspouts

- Remove and Replace all asphalt shingle roofing including underlayments, trim and flashings
- Replace lead and galvanized steel chimney flashing
- Replace and replace wood gutters and galvanized steel downspouts

- Rehabilitate and/or replace interior finishes
- Renovate existing kitchen and bathrooms
- Upgrade and/or repair electrical and plumbing distribution systems
- Upgrade heating system and distribution as required

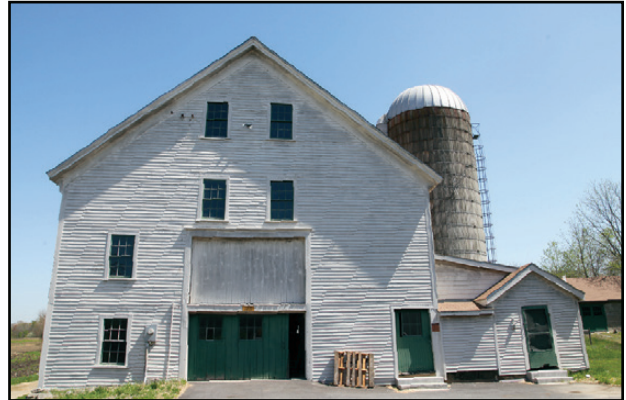
The Carty Barn, also referenced as The Barn at the Farwell Jones Site, was constructed c.1903. Its historical significance is its association with the agricultural use of the property in the early 18th century. The 2 ½-story post and beam barn is the largest structure in the park, measuring 40 feet by 80 feet in plan, and includes an attached silo and Milk House.

- Rehabilitate Stone Foundation

- Remove and Replace Deteriorated and/or Missing Structural Framing
- Replace wood decking/planking on Ramp at N. Elevation

- Replace exterior wood siding as required.
- Provide in-kind replacements for missing and damaged exterior door and window casings.
- Prep and repaint exterior siding, soffits and trim, complete.
- Repair Louver Gable Vent – North Elevation
- North Elevation Track Door
- Replace Upper Track Cover
- Reinstall lower track to provide full operation of door.
- Exterior Windows
- Repair/renew/re-glaze operable wood windows
- Exterior Doors - Prep, repair and refinish

- Sheet Metal Flashings
- Remove and Replace Flashing at Cupola, Milk House and Silo Connector
- Restore weathervane

- Remove and Replace service panels
- Remove and Replace exterior lighting fixtures

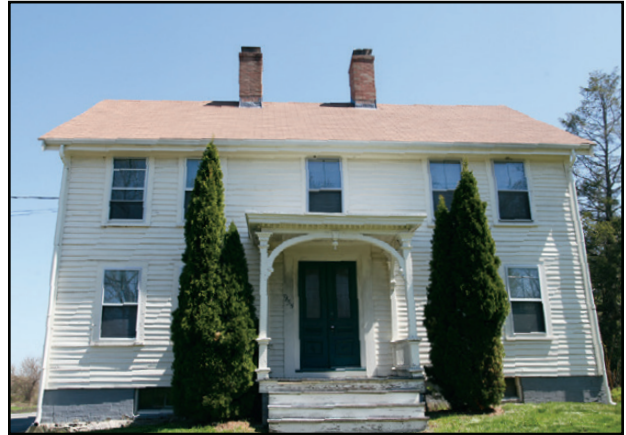
Farwell Jones House was part of a farmstead established as early as 1686, although the Farwell Jones House itself dates to the early 18th century and was extant by 1716. The House is significant to the agricultural history of the district and as part of a collection of thirteen Colonial-period dwellings representative of local building trends from the early 18th century through the mid-20th century.

- Selective repair and repointing of stone foundation wall
- Selective replacement of concrete apron at foundation perimeter

- Perform pest inspection, treatment and/or mitigation at wood structural framing
- Repoint/repair brick chimney base
- Repoint/repair brick structural columns

- Selective replacement/repair/augmentation of first floor framing members
- Replace deteriorated/undersized support columns
- Selective replacement of deteriorated wood sill at perimeter basement wall

- Preserve, repair and/or replace in-kind deteriorated wood shingle and clapboard siding
- Selective replacement of wood wall sheathing
- Repair and/or Remove and Replace deteriorated wood trim
- Preserve and perform selective repairs at wood porch elements
- Selective repointing at exterior brick chimney masonry and cap
- Prep and Paint wood siding, trim and foundation masonry walls
- Rehabilitate wood window sash
- Rehabilitate entry doors
- Remove and Replace cellar bulkhead

- Remove and Replace asphalt roofing including underlayments, trim and flashings
- Selective replacement of deteriorated roof sheathing

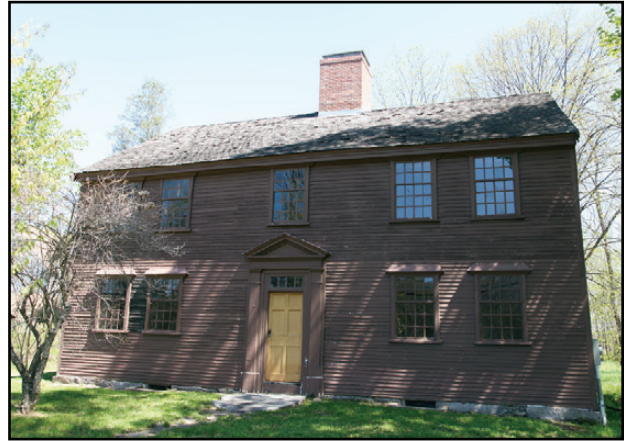
The Stow-Hardy house likely replaced a 17th-century structure thought to be occupied by Olive Stow and her children during April of 1775. Constructed c. 1786 by Ebenezer Hardy, husband of Olive Stow's daughter Sarah ca. 1781-82, the home remained occupied by Olive until her death in 1811.

- Repair/repoint stone foundation wall
- Point cracks in poured concrete basement window wells

- Remove and replace various girts and connecting joinery
- Remove/replace and/or repair/reinstall joists at Kitchen, NW and NE quads
- Remove and replace portion of west-elevation sill – remove/replace/splice
- Repair various girt connections to north and south sills
- Repair floor assembly at Entry Hall

- Repair post bottoms (splice)
- Secure post to girt connections
- Girt repair (splice, post connection)
- Wall frame repairs

- Repair stud bottoms and brace bottoms
- Install new bracing as required
- Replace base sills as required
- Re-establish post connections to base sill

- Repair and/or Remove and Replace deteriorated wood clapboards
- Repair and/or Remove and Replace deteriorated wood trim
- Re-fasten loosened hand-wrought siding nails. Prime all nail heads with zinc-rich primer and topcoat
- Prep and Paint clapboard siding and trim
- Treat north elevation with penetrating stain

- Rehabilitate all entry doors
- Replace and Replace deteriorated thresholds
- Rehabilitate surrounds including architrave, pediment and joiners work
- Remove and Replace cellar bulkhead
- Replace/upgrade locksets at 2 exterior doors – Best hardware with interchangeable cylinders
- Provide galvanized steel hasp and stainless-steel padlock (interchangeable cylinder compatible with Best Co. locks) at bulkhead
