The Effect of Cell Towers on Birds and Bats at Rock Creek Park, Washington, D.C.

Evaluation of Coverage and Alternative Sites for the Two Verizon Wireless Towers Located in Rock Creek Park, Washington, DC

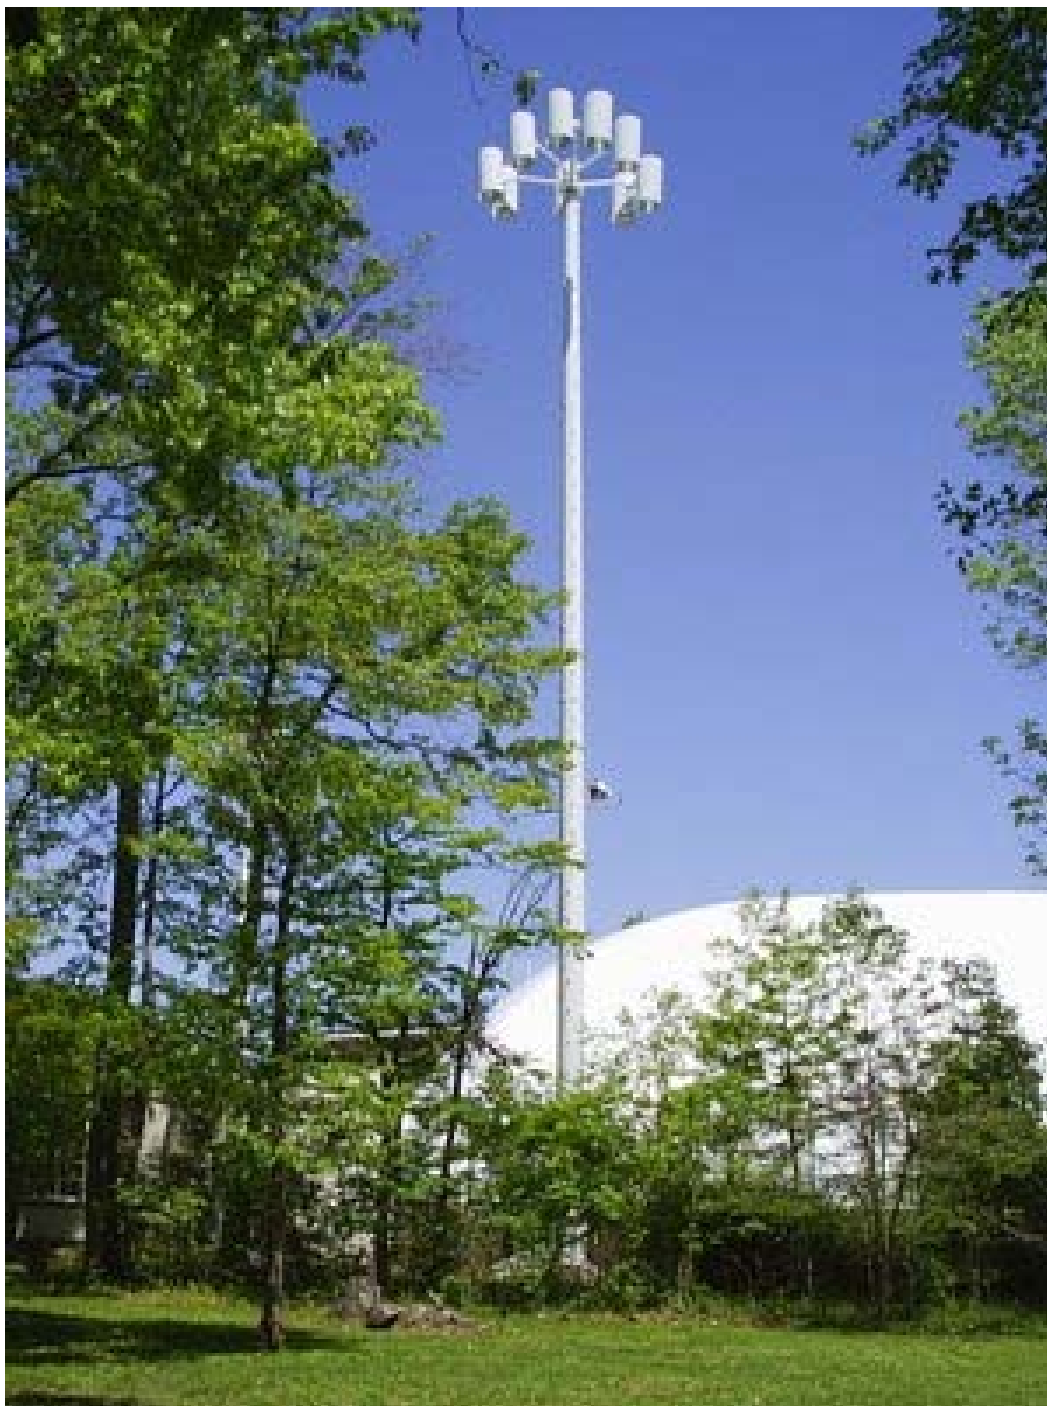
Figure 1. Tennis court (TC) tower located in Rock Creek Park, Washington, D.C., on 29 April 2006. Note the lights low on the tower and the white bubble dome over the tennis courts in the background.

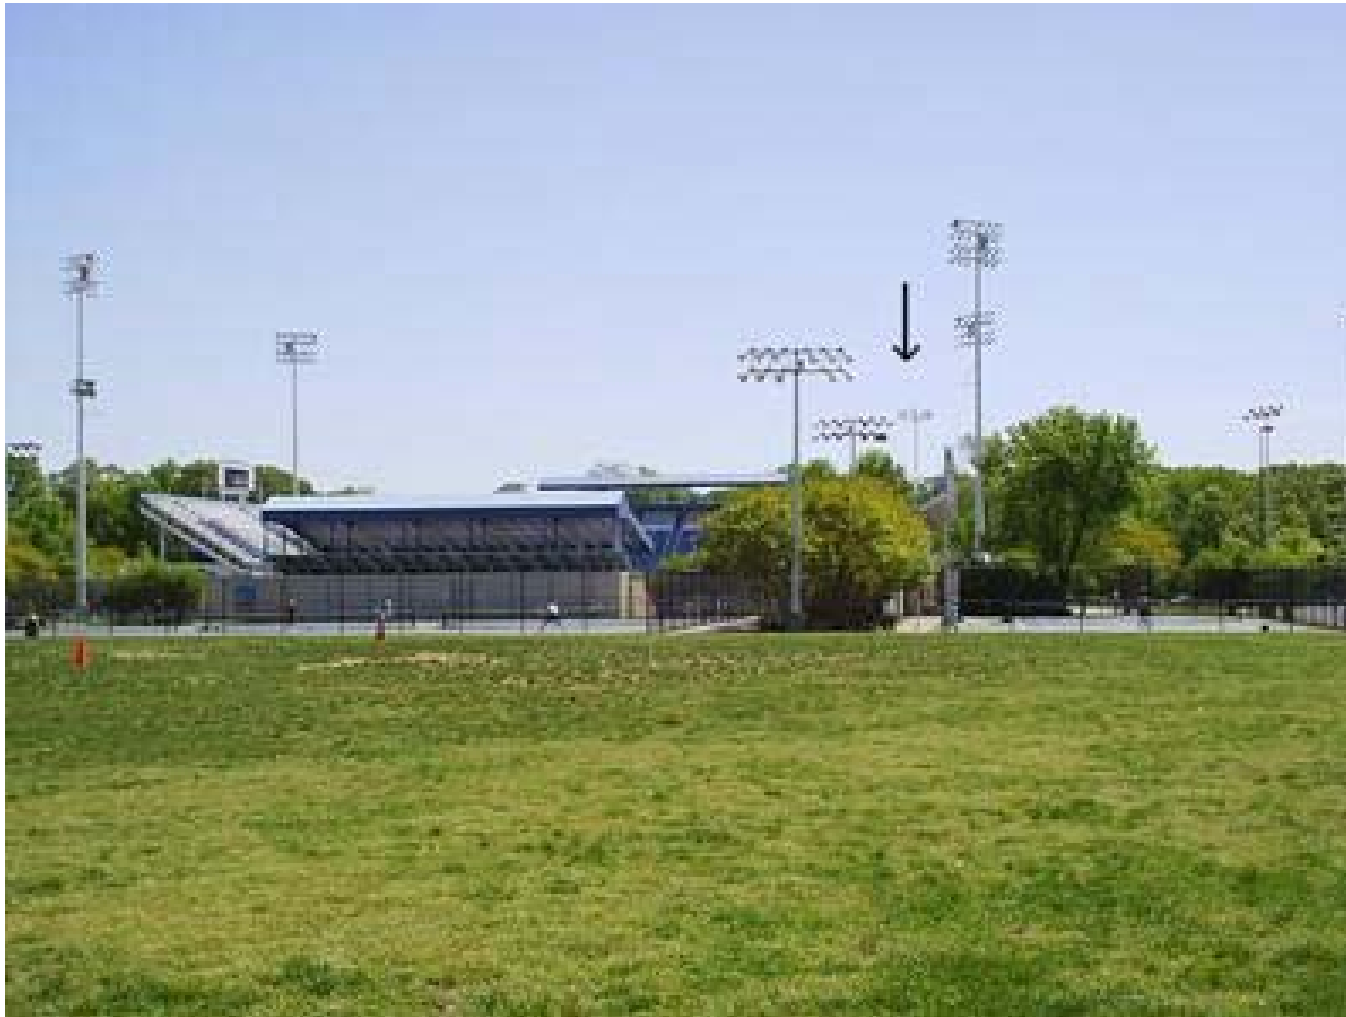
Figure 2. TC tower located north of the tennis facility in Rock Creek Park, Washington, D.C., on 29 April 2006. The black arrow indicates the position of the tower. Note that several lights surrounding the tennis arena are taller in comparison to the TC tower.

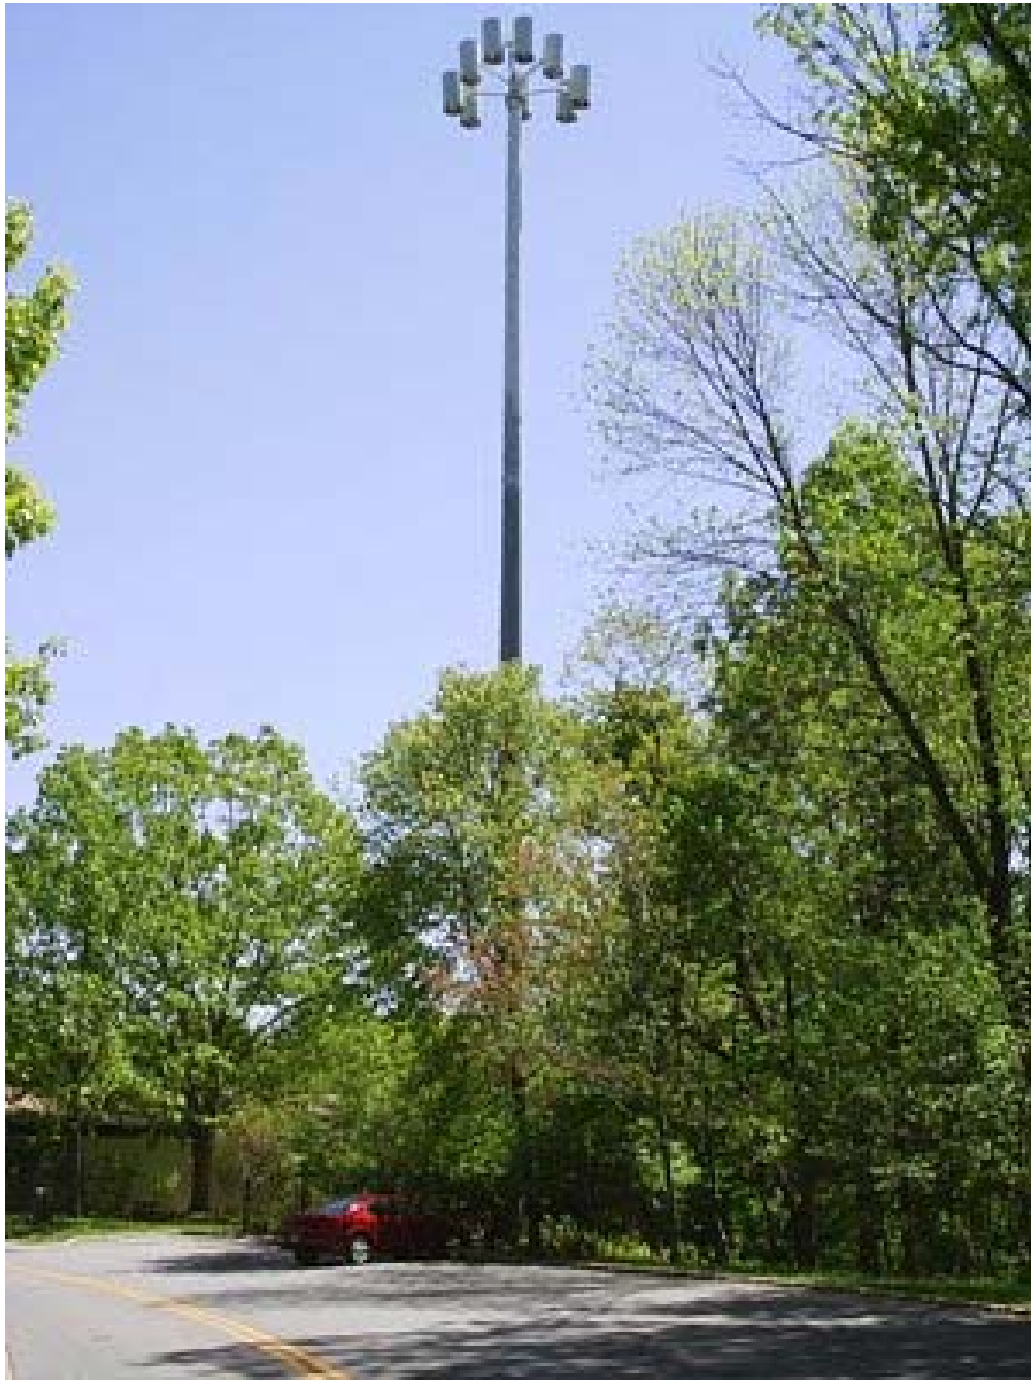
Figure 3. Maintenance yard (MY) tower located in Rock Creek Park, Washington, D.C., on 29 April 2006.

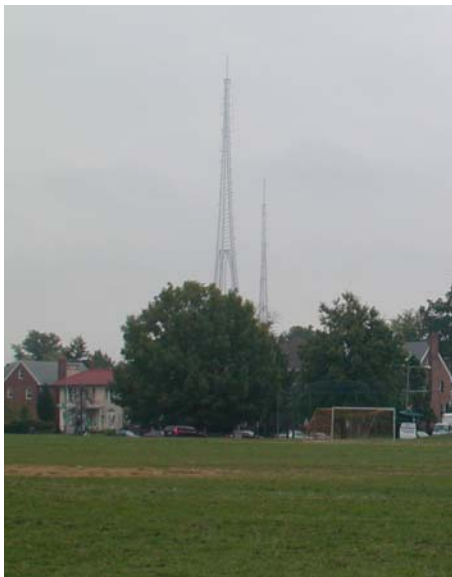
APPENDIX E FIGURE 3. HUGHES TOWER AS SEEN FROM THE ROCK CREEK PARK TENNIS CENTER

The “Hughes Tower,” located on Peabody Street between 9th Street and Georgia Avenue, has adequate height and ground elevation; however, again, an antenna siting in this location would not reach Rock Creek Park due to tree cover and terrain (see Appendix E Figure 3). The coverage simulation plot modeled the coverage from the site with antennas mounted at 150 feet on the Hughes Tower. The signal from this site would not reach the park and would also create interference for other Verizon Wireless sites; therefore, the site would not meet the Verizon Wireless coverage and capacity objectives.

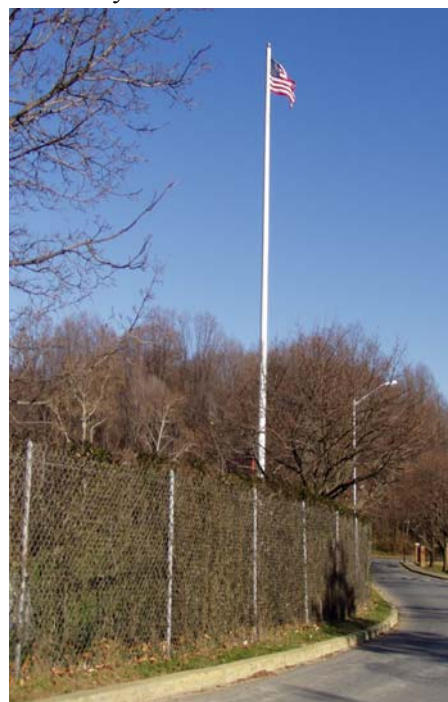
APPENDIX E FIGURE 4. FLAG POLE TOWER AT ST. JOHNS COLLEGE HIGH SCHOOL

area on and to the north of Military Road but provides no coverage to those areas of the park located south of Military Road (see Appendix E Figure 4).

The St. Johns College High School site existing cell tower designed as a flag pole does not have the necessary ground elevation to qualify as a good cell site for the coverage gap. The coverage analysis showed that this site does not have enough height to overcome the hilly terrain and trees to the south. The site does expand the coverage

Coverage simulation of a cell site located at St. Johns College High School on the existing flag pole, co-locating on an existing cellular telecommunications tower.
